PEER REVIEW FACT SHEET
Highway 1 Albion River, Br. No. 10-0136
August 15, 2007

01-MEN -1-PM- 43.74

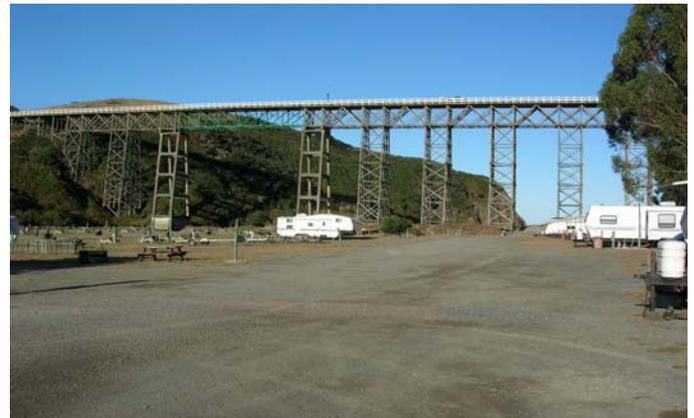
This 63-year-old structure is designated Functionally Obsolete due to a Deck Geometry Appraisal Rating of 3. The structure has an Inventory Rating of 30.8 metric tons, an Operating Rating of 71.3 metric tons and a Sufficiency Rating of 69.3.

The 63-year-old bridge is functionally obsolete.

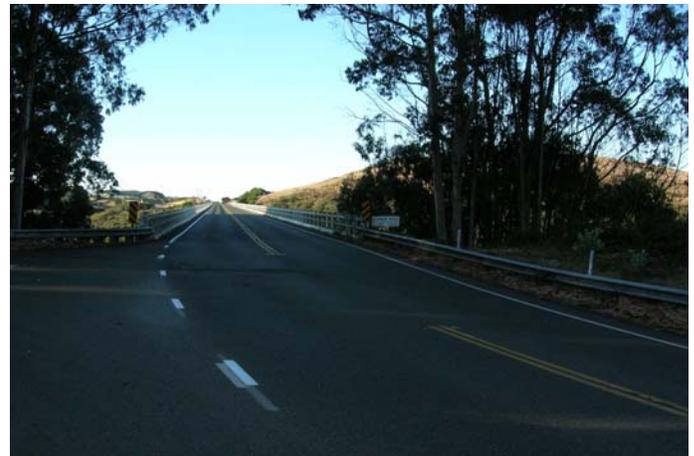
The bridge has a deficient rail that is recommended for replacement at an estimated cost of \$1,009,000. Upgrading the rail to current standards is not feasible without replacing the deck and modifying the superstructure.

Rehabilitation would require a bridge rail upgrade.

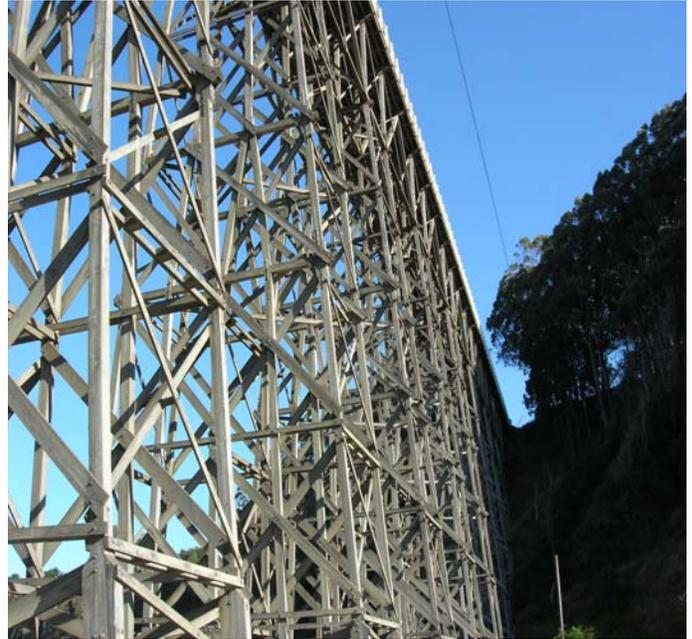
The Paint Health Index is 35.5. A recommendation has been made for full preparation and full paint work at an estimated cost of \$332,500 (9,430 square-feet). The stated cost has been updated from the estimated cost included in the last bridge inspection report (BIR). The bridge would need to be repainted about every 5 years because of the effects of the corrosive environment to which the structure is exposed.

Bridge will require repainting every five years.
