Bridge Investigation Team Report for the August 24, 2014 South Napa Earthquake

Introduction: On Sunday, August 24, 2014 at 3:20 AM PDT, a M6.0 earthquake struck south of the city of Napa (38.22° N, 122.31° W), in Napa County, at a depth (hypocenter) of 11 km. This is the third significant earthquake to impact the area over the last 25 years. On October 17, 1989 the M6.9 Loma Prieta earthquake occurred 100 km to the southwest, and damaged several bridges in the region due to amplification of long period motions in the unconsolidated soft sediments. The September 3, 2000 M5.2 Napa Earthquake caused a great deal of damage to waterlines, powerlines, and houses, but little significant damage to bridges. Experience with previous seismic events has shown bridge damage seldom occurs for earthquakes with magnitudes less than 6.0. However, it was unexpected to see such large recorded ground motion during this earthquake, especially by the Carquinez Bridge, 15 miles from the fault rupture. Additional study will be required to understand how such large recordings occurred.

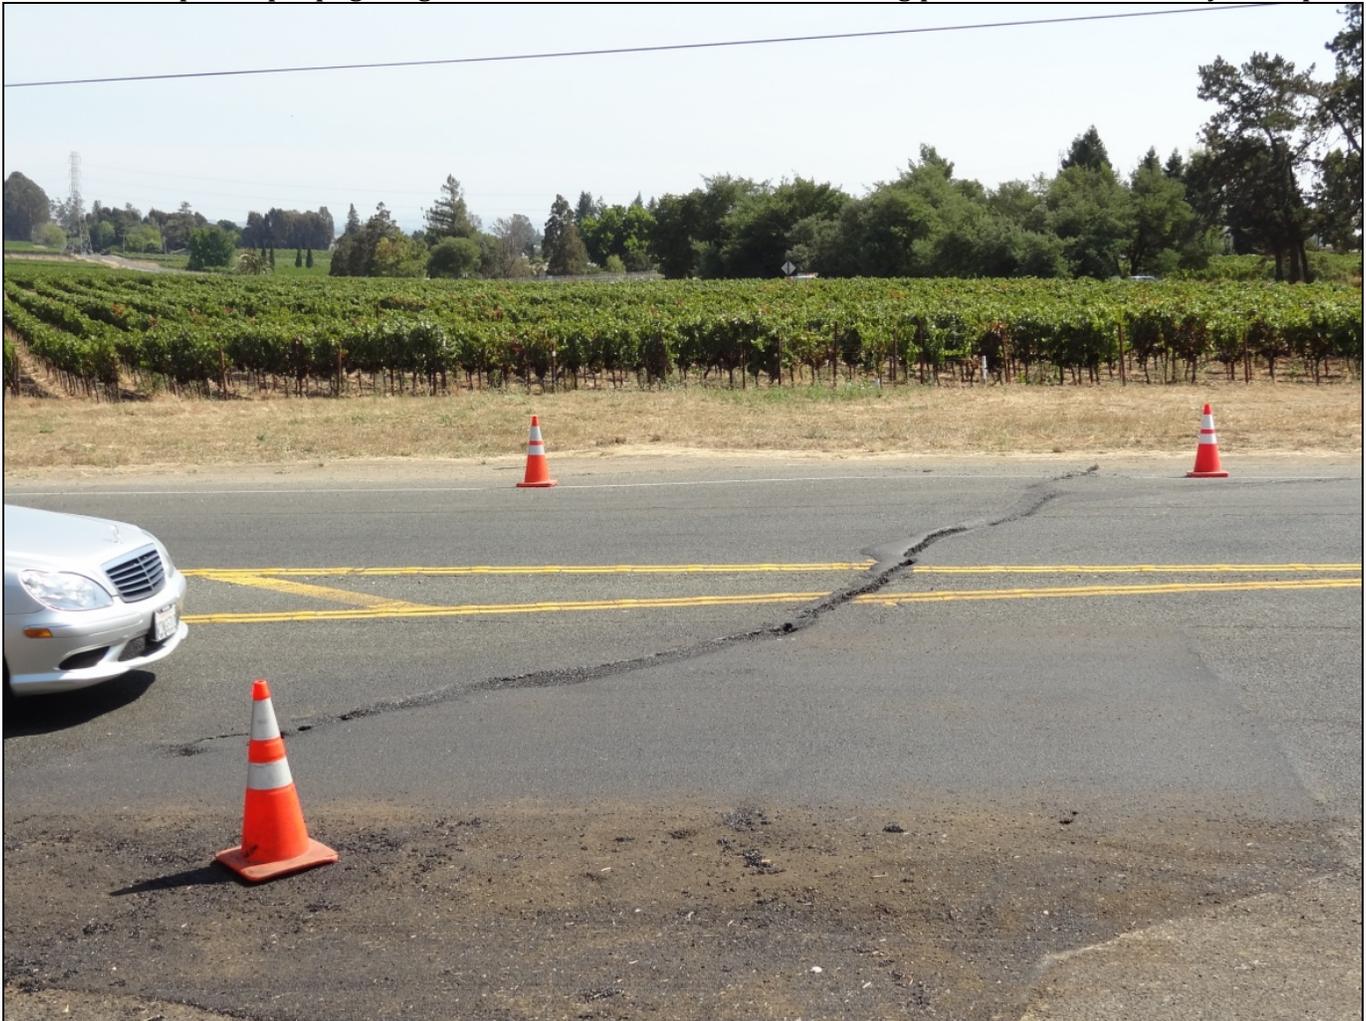
Figure 2. Fault offset across State Route 121 during the South Napa earthquake.

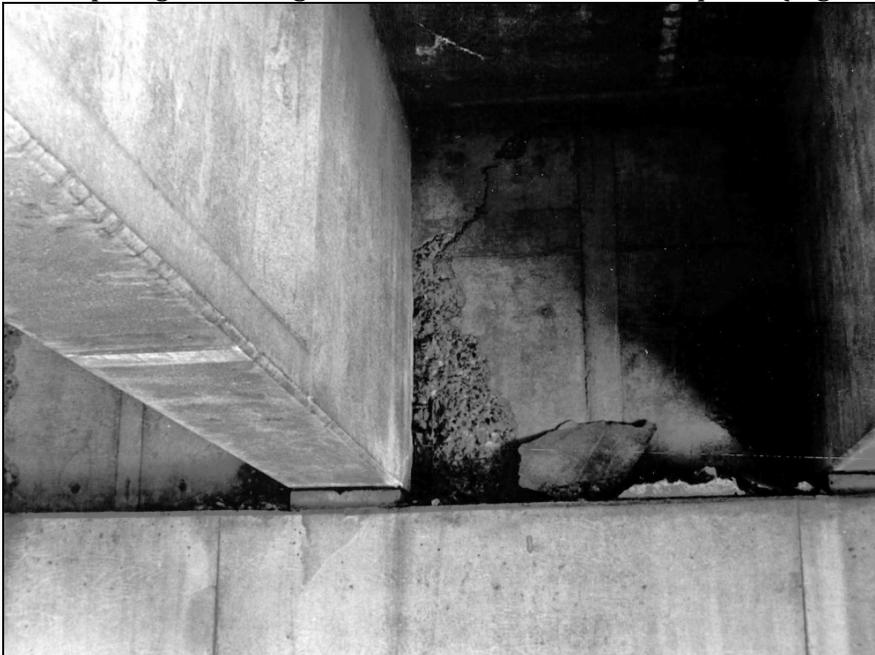
A problem with many older precast girder bridges is that the connections were not well designed for earthquakes. The girders need to be continuous to protect the superstructure and force plastic hinging into ductile columns. The girders on the Napa River Bridge were inadequately developed and many of them pulled on the end diaphragms during the 1989 Loma Prieta earthquake (Figure 6).

Figure 6. Damage to the Napa River Bridge during the 1989 Loma Prieta EQ.

The bridge was repaired after the earthquake and was extensively retrofitted in 1996. The retrofit included bolsters and transverse prestressing to the end diaphragms to increase girder continuity. Additional seat width and pipe seat restrainers were installed at locations with expansion joints. The

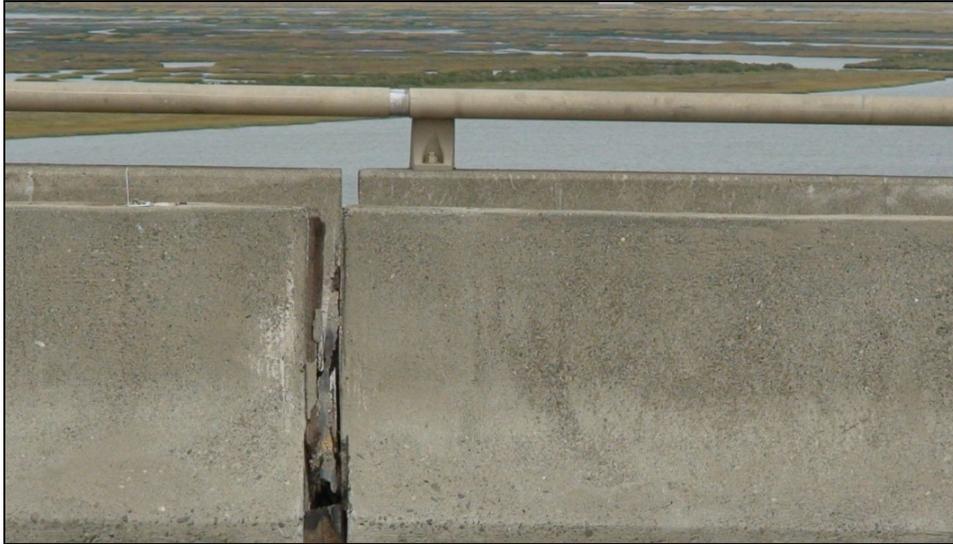
The only damage to the Napa River Bridge was that the expansion joints opened and closed enough to damage a few of the type B joint seals which are to be replaced. The hand railing at the expansion joints opened up enough (Figure 11) to cause the first responders to close the bridge as a precautionary measure. When Caltrans bridge engineers arrived at the bridge, a quick inspection showed them that there was no serious damage and they re-opened it to traffic.

Figure 11. Damage to the Napa River Bridge was permanent longitudinal displacement at the expansion joints.

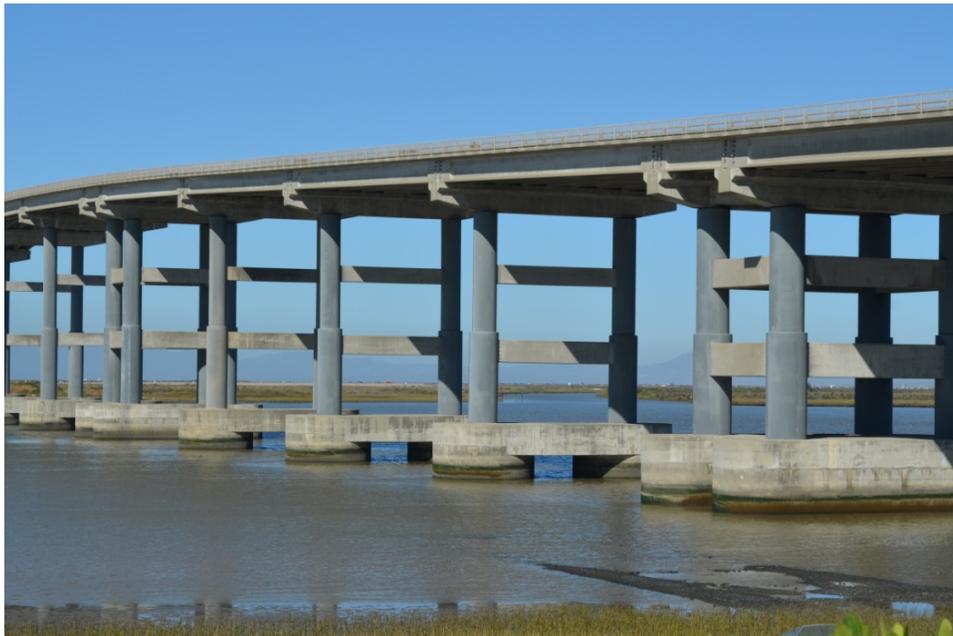
Researchers from the Pacific Earthquake Engineering Research (PEER) Center performed their own reconnaissance on the bridge and observed that Pier 19 seemed to be tilted to the north (right) relative to the other piers (see Figure 12). However, there are no cracks or deformations to indicate that this was related to the earthquake.

Figure 12. Photo of Pier 19 (2nd pier from right) taken by the PEER Team.

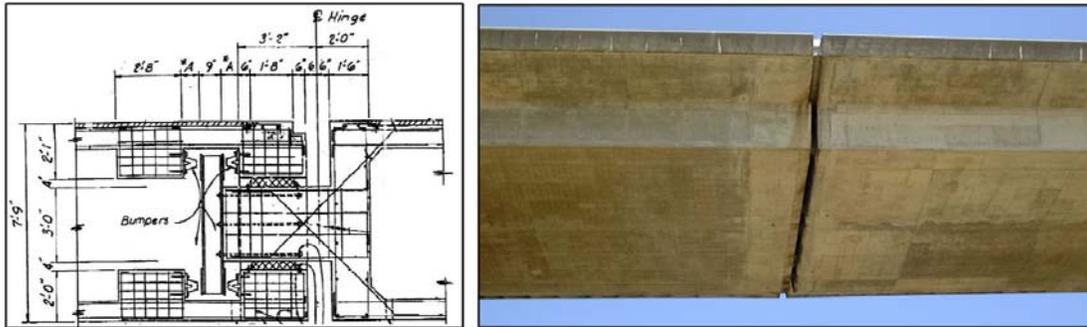
Figure 14. Unusual in-span hinges on the Napa River BOH.

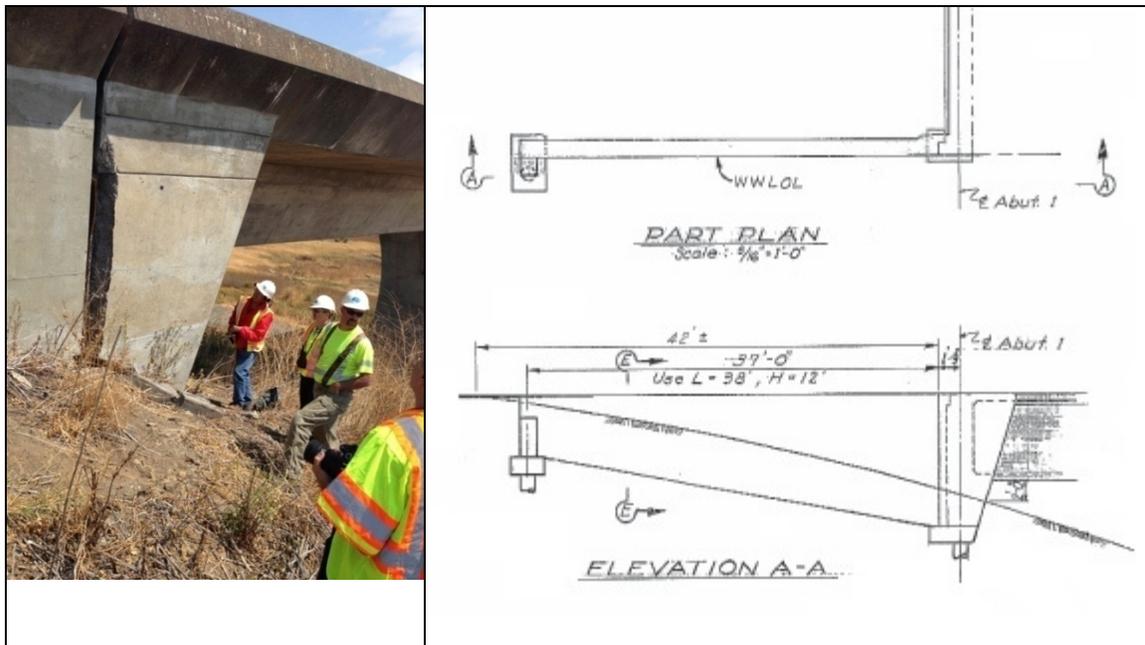
The only damage to the bridge structure during the earthquake was at Abutment 14 on the west side of the river. Where the abutment was in contact with the wingwall it had a concrete spall of six inches by six feet with exposed reinforcement (see Figure 16).

Figure 16. Abutment 14 concrete spall on the Napa River Bridge and Overhead.

21 0049	NAPA RIVER BOH	04-NAP-029-R6.99	0.31	Abutment 14, left side wingwall settled one inch and rotated outward 2 inches; abutment is spalled 6 inches x 6 feet with exposed rebar at abutment/wingwall joint	Replace wingwall and patch spall by saw cutting and recasting	8/24/2014
21 0071L	SUSCOL CREEK	04-NAP-029-R6.08	0.16			9/27/0214
21 0071R	SUSCOL CREEK	04-NAP-029-R6.08	0.16			9/27/0214
21 0077	TULUCAY CREEK (CAYETANO CREEK)	04-NAP-121-R5.71	0.18			8/24/2014
21 0086L	IMOLA AVENUE SEPARATION (29-121)	04-NAP-029-R10.38-NA P	0.15	Abutment 1, crack and delaminated concrete at corner	Remove unsound concrete and recast damaged area	8/24/2014
21 0086R	IMOLA AVENUE SEPARATION (29-121)	04-NAP-029-R10.38-NA P	0.15			8/24/2014
21 0087	OLD SONOMA ROAD OC	04-NAP-029-10.7-NAP	0.16	Existing rail and curb spalls on a rail in fair condition made worse by the EQ	Repair the bridge rail approach rail and curb spalls	8/24/2014

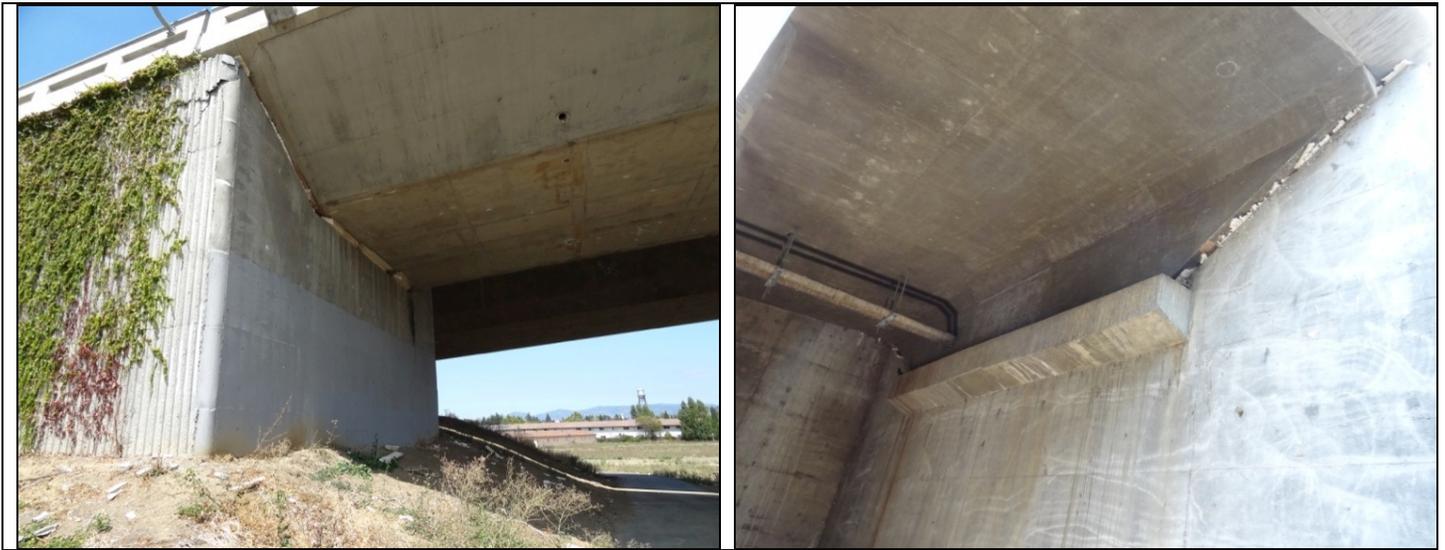
When the investigation team first saw the abutments on the West Imola Avenue Bridges they assumed there was soil behind them that was held in place with mechanically stabilized earth (MSE) retaining walls. However, when they looked behind the abutment they saw the approaches were actually slab bridges on standard concrete pile extensions. What they had thought were MSE Walls turned out to be precast curtain walls. Caltrans prefers to have soil behind the abutment to provide stiffness and damping during an earthquake. However, on such a long bridge a stiff abutment plays a much smaller role.

Figure 18 Outside and inside of an abutment on the Napa River (West Imola Avenue) Bridges.

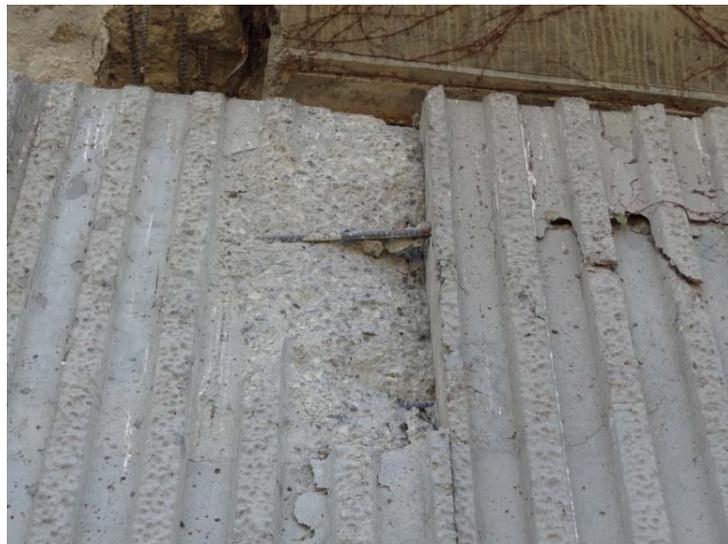
This bridge is also very close to the Napa College station that recorded peak acceleration of 0.375g during the earthquake. The damage that occurred during the earthquake, cracks and spalls of the curtain walls at all the abutments, was the result of the ends of the superstructure banging against the slender curtain walls (Figures 18 and 19). More substantial abutments could have held the superstructure more securely in place. However, it is unlikely that the superstructure could unseat since the approach slab is securely attached to the end of the superstructure. Also, when Caltrans Office of Structures Maintenance and Investigations (OSMI) went inside the superstructure, they found the hinge restrainers had been poorly installed and were damaged at the swage connections or at the tension indicators (Figure 20). Restrainers must be carefully installed, which requires tightening them until the spiral washers close and then backing off to account for the variation in temperature. However, restrainers are a secondary system for earthquake protection and the hinges all had 36 inch seats.

Figure 19. Close-up of damaged curtain walls on the Napa River (West Imola Ave) Bridge.

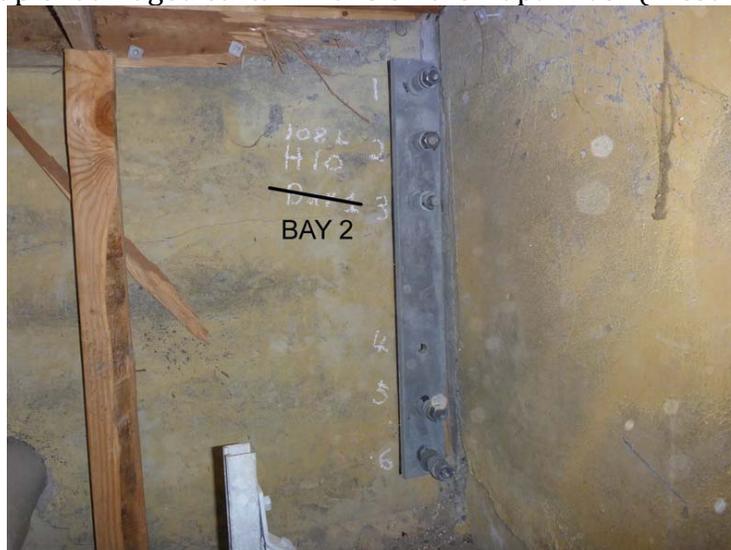
Figure 20. Restrainer damage at Hinge 10, Bay 2 of Napa River (W. Imola Ave) Bridge.

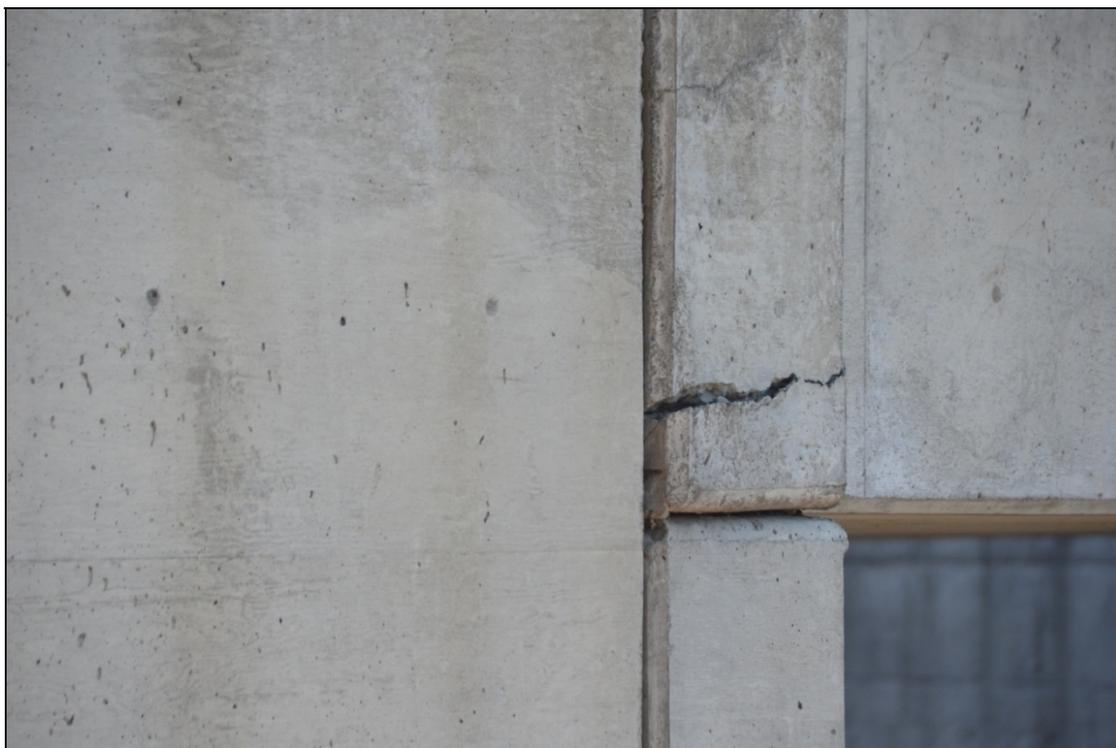
Figure 22. Damage to left bridge from banging against wingwall.

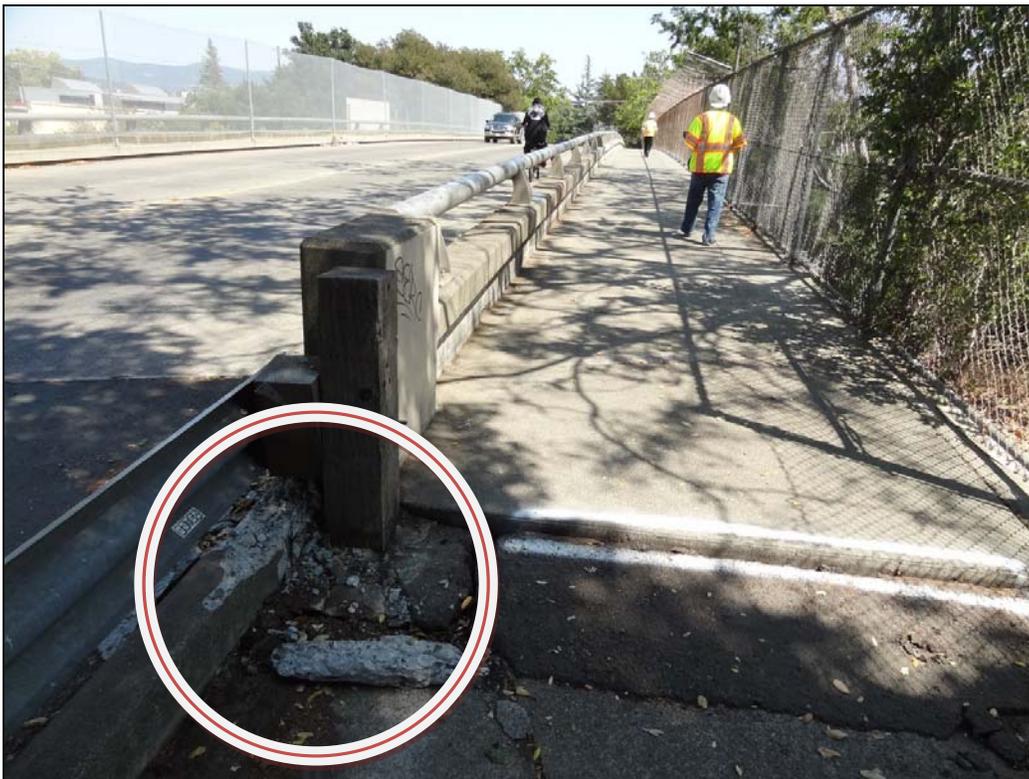
Existing damage such as banging between the railing and the curb and settlement of the bridge approaches was made worse by the South Napa Earthquake (Figure 25).

Figure 25. Earthquake damage (banging between the curb and the barrier) at the Old Sonoma Road Bridge.

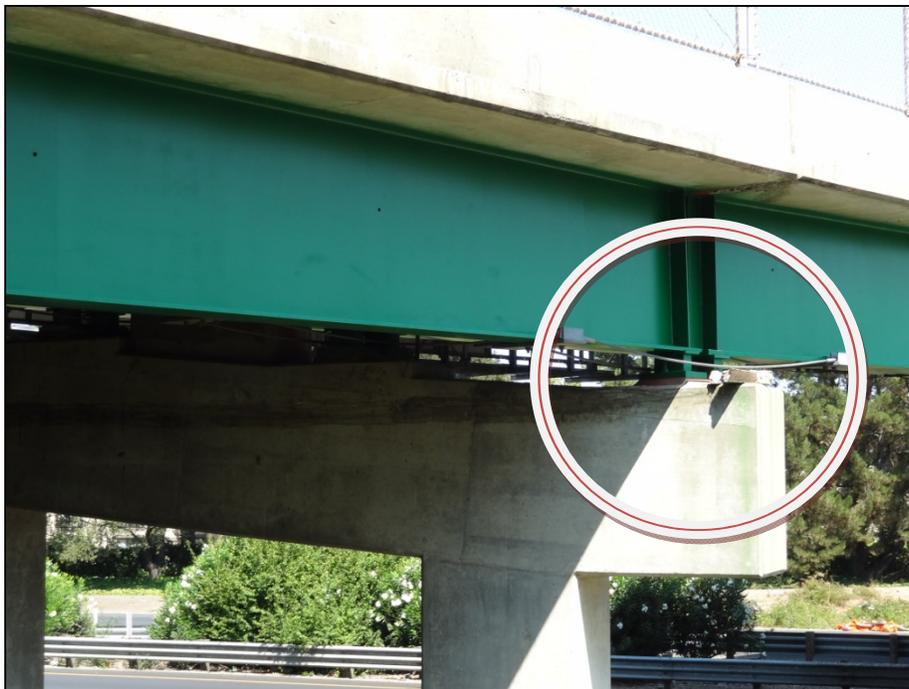
Figure 27. Spalling of the deck overhang at expansion joint (rubble on bent cap).

21 0088	FIRST STREET OC	04-NAP-029-11.55-NAP	0.16	4 inch wide x 24 inch long x 4 inch deep deck soffit spall in the deck overhang on the right side of the Bent 2 expansion joint	Patch the spall in the deck overhang	8/24/2014
21 0089	LINCOLN AVENUE OC	04-NAP-029-12.04-NAP	0.14	Damage was determined to be an existing condition	no action required	9/27/0214
21 0094L	FIFTH AVENUE UC	04-NAP-029-R6.63	0.20			8/24/2014
21 0094R	FIFTH AVENUE UC	04-NAP-029-R6.64	0.20			8/24/2014
21 0098	STANLEY CREEK	04-NAP-029-R8.33	0.25			8/24/2014
21 0101	TRANCAS STREET OC	04-NAP-029-13-NAP	0.12			9/27/0214
21 0102	NORTH NAPA UP	04-NAP-029-12.91-NAP	0.12			8/25/2014
21 0107	NORTH NAPA POC	04-NAP-029-12.9-NAP	0.12			9/27/0214
21 0108L/R	NAPA RIVER (W IMOLA AVE)	04-NAP-121-R5.3-NAP	0.19	Evidence of large movements at all four abutments (bin abutments) of these parallel bridges due to foam forming material on the ground in front of the abutments; 4 ft x 6 ft concrete spall at top corner of Abutment shear keys, typical at 6 of 8 locations. Abutment 1 external shear keys broken. Type A seals at both abutments and strip seals at bin abutments are torn from transverse movement. Ends of bridge rail damaged at joints. Restrainers damaged.	Repair shear keys on each side of each of 5 abutments. Replace 4 joint seals per bridge. Rebuild bridge rail. Replace broken restrainers.	8/24/2014

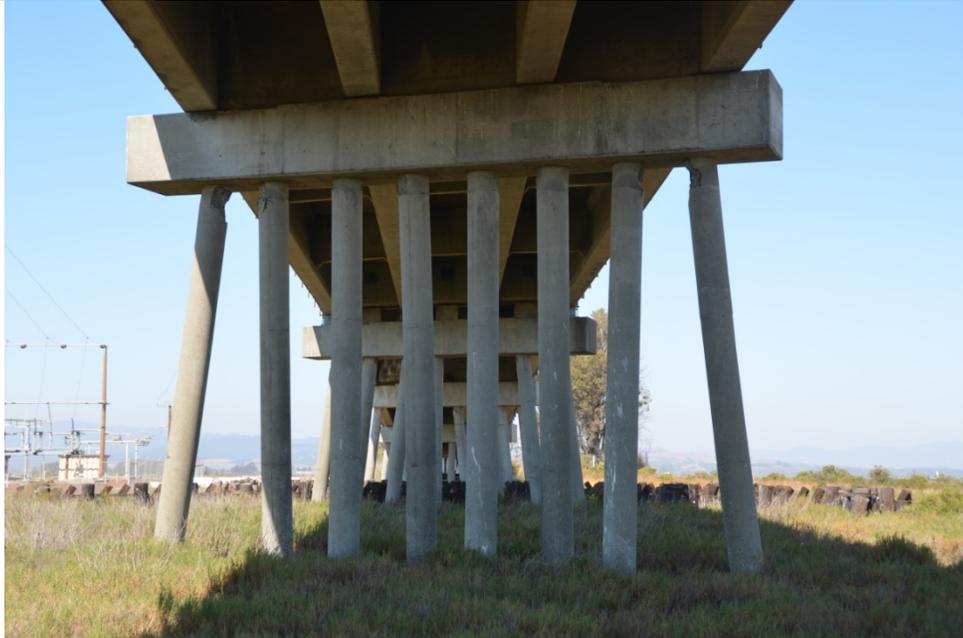
Although state-owned bridges performed well during the earthquake a few of the locally-owned bridges had serious damage. The Napa Slough Bridge is a 13 span precast girder bridge supported on battered pile extensions that was built in 1966. This bridge is now a privately-owned bridge and closed to public traffic. During the earthquake the piles were damaged as a consequence of the batter (which attracted more load) and because of the large motion that can occur in a slough (see Figures 28 through 30). Although some piles were damaged the earthquake was not of long enough duration to cause serious damage. The #4 hoops at 12 inches prevented excessive buckling of the main reinforcement and the piles continued to support the superstructure.

Figure 28. Tops and bottoms of the pile extensions spalled during the earthquake.

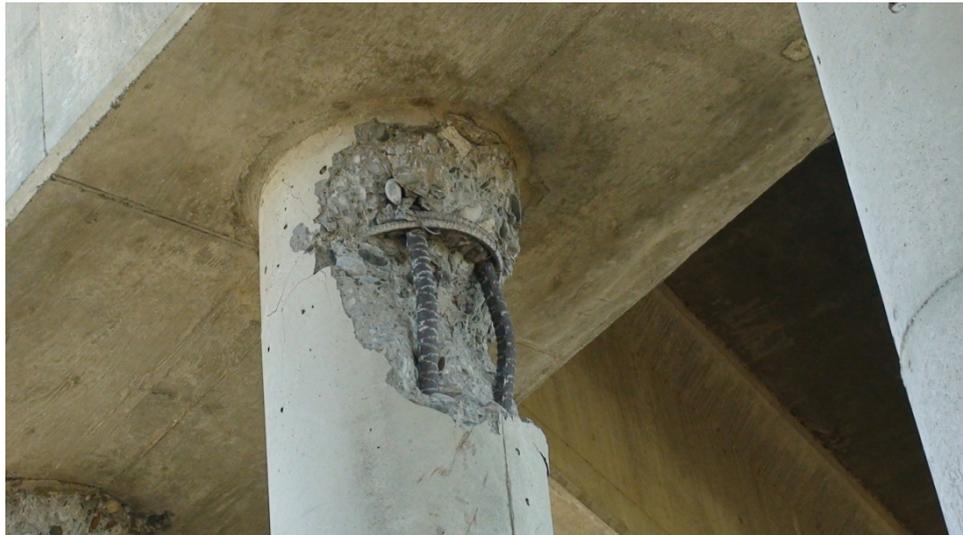
Figure 29. Closer view of damage at top of pile extensions.

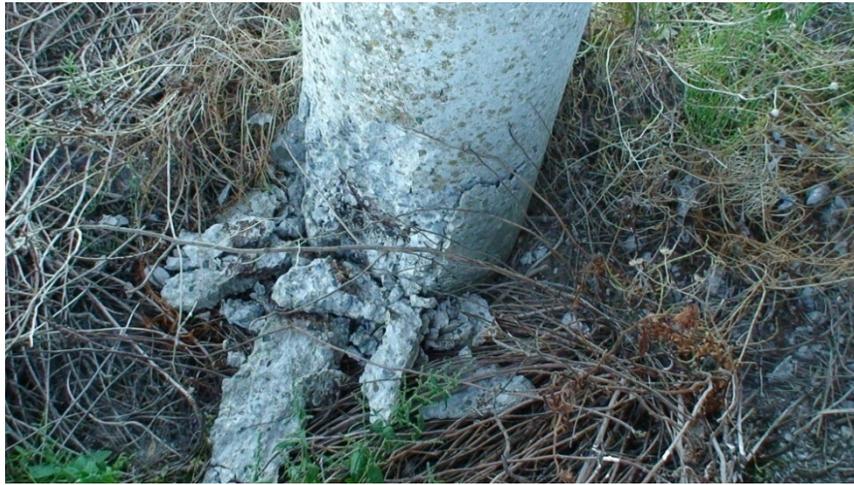
Figure 30. Damage at the bottom of pile extensions on Napa Slough Bridge.

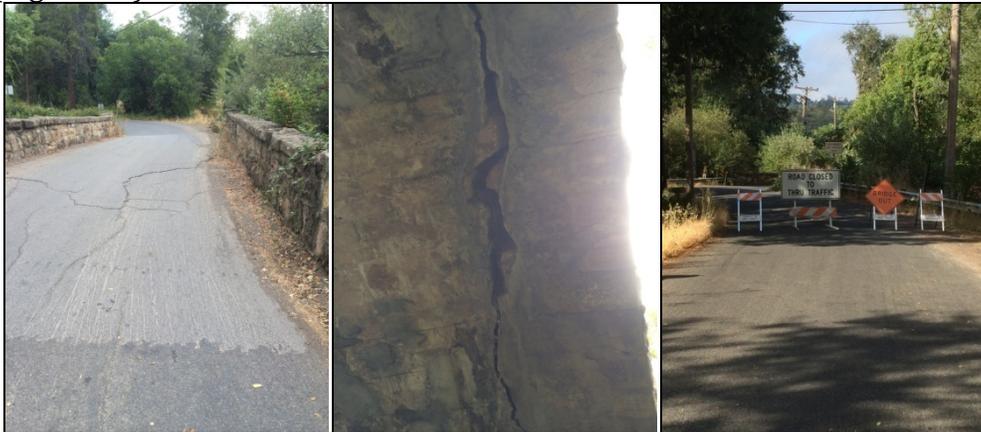
The Greenwood Avenue Bridge is a single span masonry arch that was built in 1904. It appears that existing damage was exacerbated by the earthquake resulting in the bridge being closed to traffic after the earthquake (Figure 34).

Figure 34. Photos of Greenwood Ave. Br. taken after the earthquake.

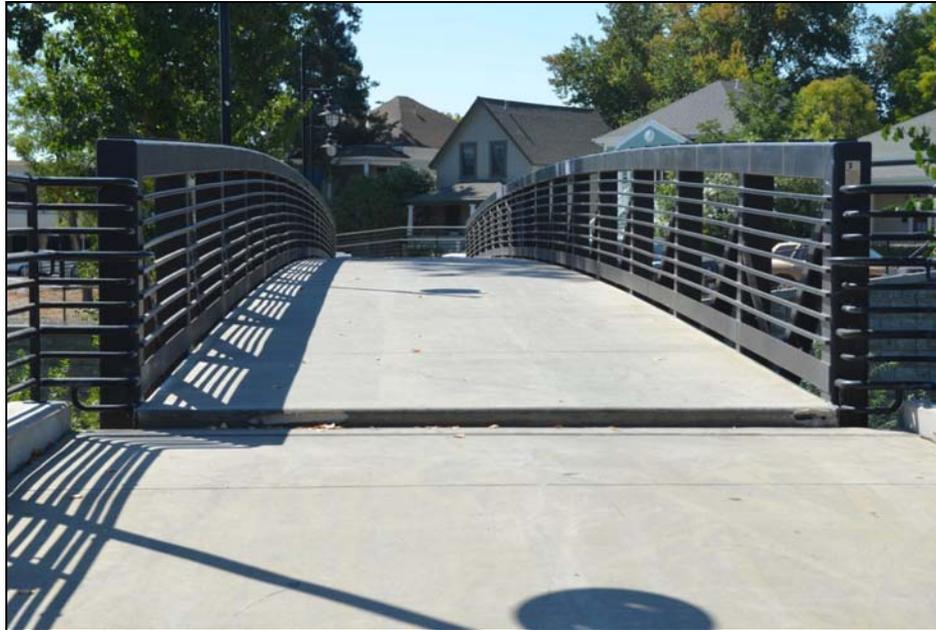
The Clinton Street Pedestrian Overcrossing is a recently built steel truss bridge. During the earthquake the anchor bolts at the bottom of the truss were broken and the approaches settled so much that the bridge was closed (Figure 35). NCSN Station N016 near the bridge recorded PGA=0.61g

Figure 35. Approach settlement on Clinton Street POC.

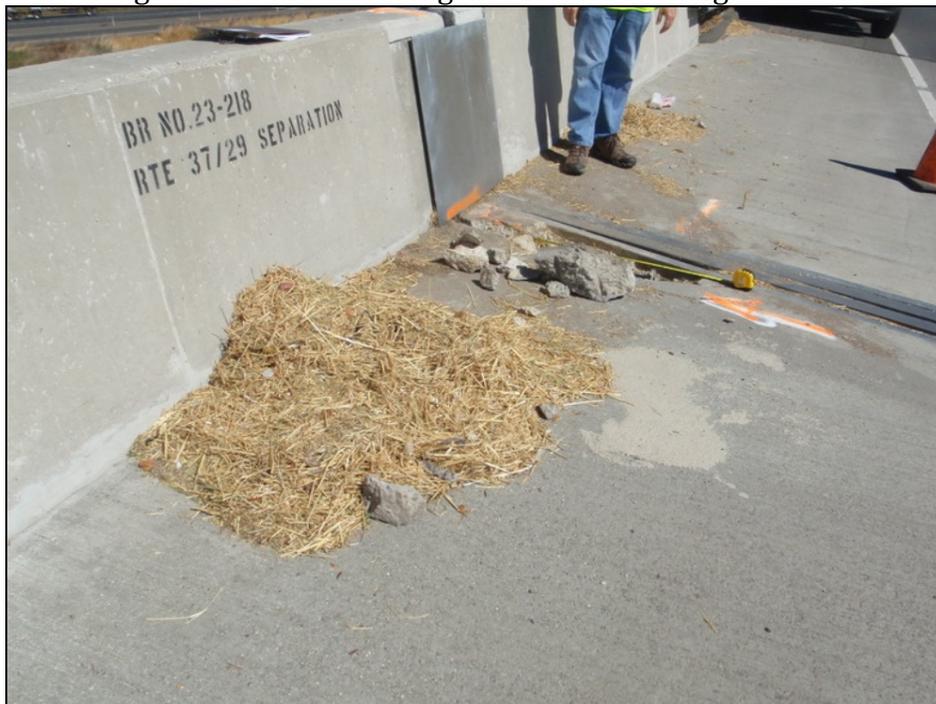
The Route 37/29 Separation is 6-span prestressed concrete continuous box girder bridge that was built in 2005. Damage to interior shear key at abutment and damage to expansion joints (Figure 36). CGS Station 68294 near the bridge recorded PGA=0.47g and 1 sec SA= 0.11g.

Figure 36. Damaged expansion joint at Abutment 7 on Route 37/29 Separation.

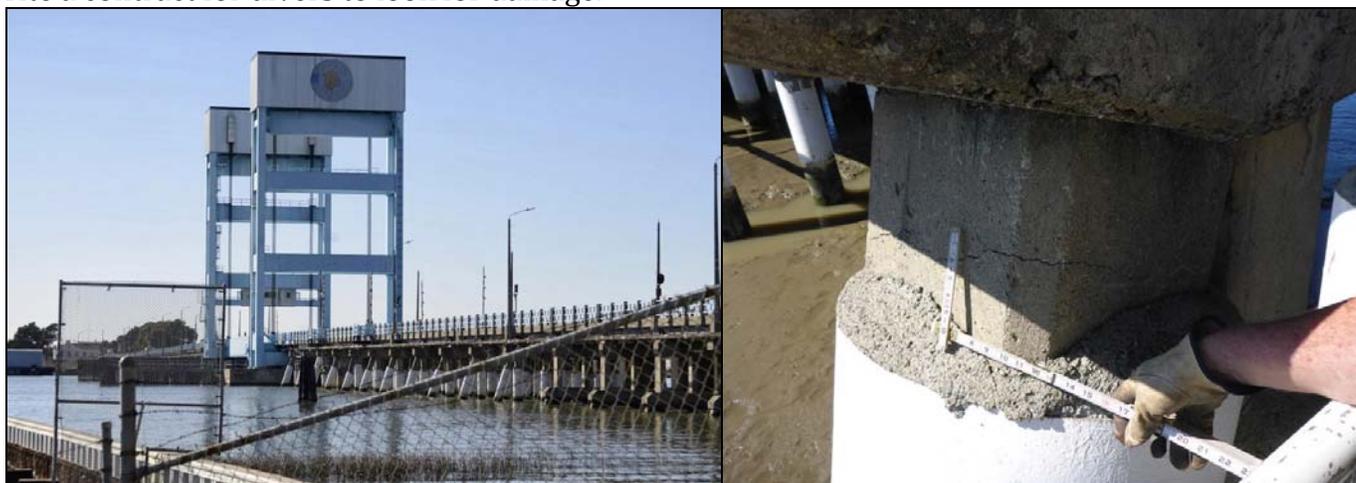
Steel lift bridge with steel girder and concrete trestle approaches. A bascule bridge was built in 1934 and replaced by the lift bridge in 1980. Bridge is near the Vallejo Fire Station (PGA = 0.329g, PGV = 21.11 cm/s, 1 sec SA = 0.18g) and the Napa River Bridge (PGA = 0.198g, PGV = 19.00 cm/s, 1 sec SA = 0.14g) Existing damage to the steel rocker bearings and concrete trestles was exacerbated by the earthquake (Figure 37). There was also concern about the piles and the local agency (City of Vallejo) was going to write a contract for divers to look for damage.

Figure 37. Mare Island Causeway and damage to battered piles of the concrete trestle.

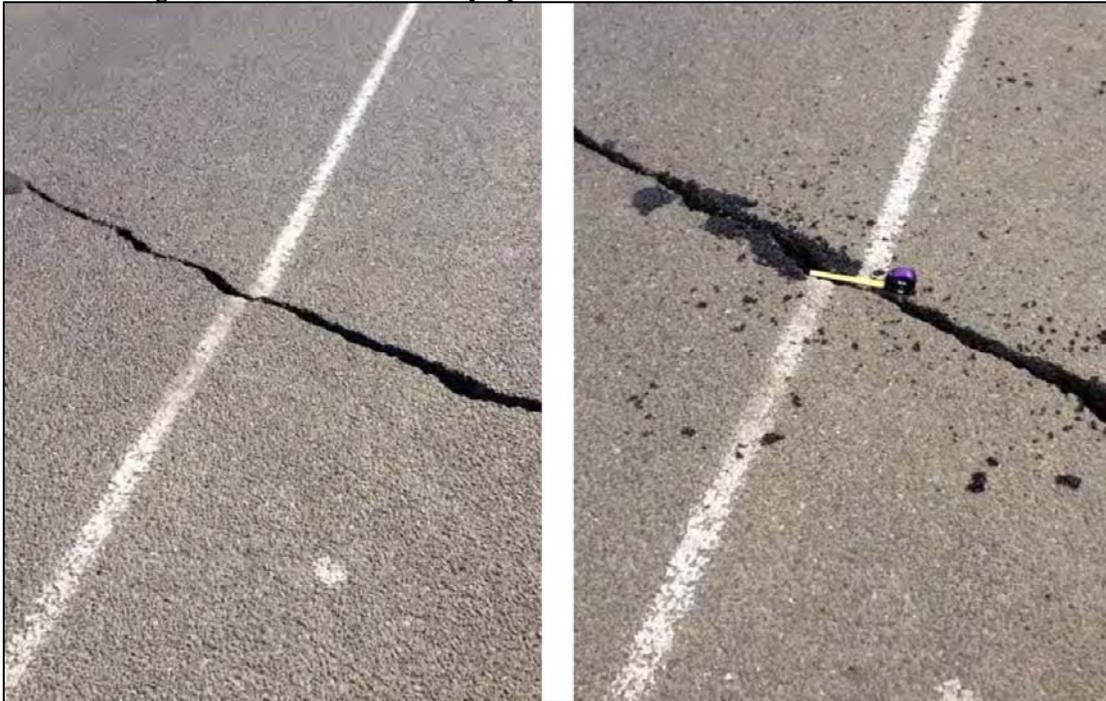
Over ten miles of surface faulting was observed during the earthquake. Geologists returning to the same sites over the next few days found the fault offset continued to grow over time. In Figure 39 we can see the fault offset continued to creep for 48 hours after the earthquake. This suggests that bridges over faults need to be carefully monitored and possibly shored up to prevent a possible collapse as the fault continues to slip. This also suggest it may not be necessary to design for the largest ground shaking displacement plus the largest fault offset displacement if the shaking ends before the full offset occurs. Finally, the fault was observed to rupture on several traces and to step between faults. This suggests it may be prudent to design for the offset at every span since we can't be certain where it will occur.

Figure 39. Fault offset across State Route 12 continued to slip for 48 hours after the earthquake.
