COMPETING AGAINST TIME

Report to Governor George Deukmejian
from
The Governor's Board of Inquiry
on the 1989 Loma Prieta Earthquake

George W. Housner, Chairman
May 1990

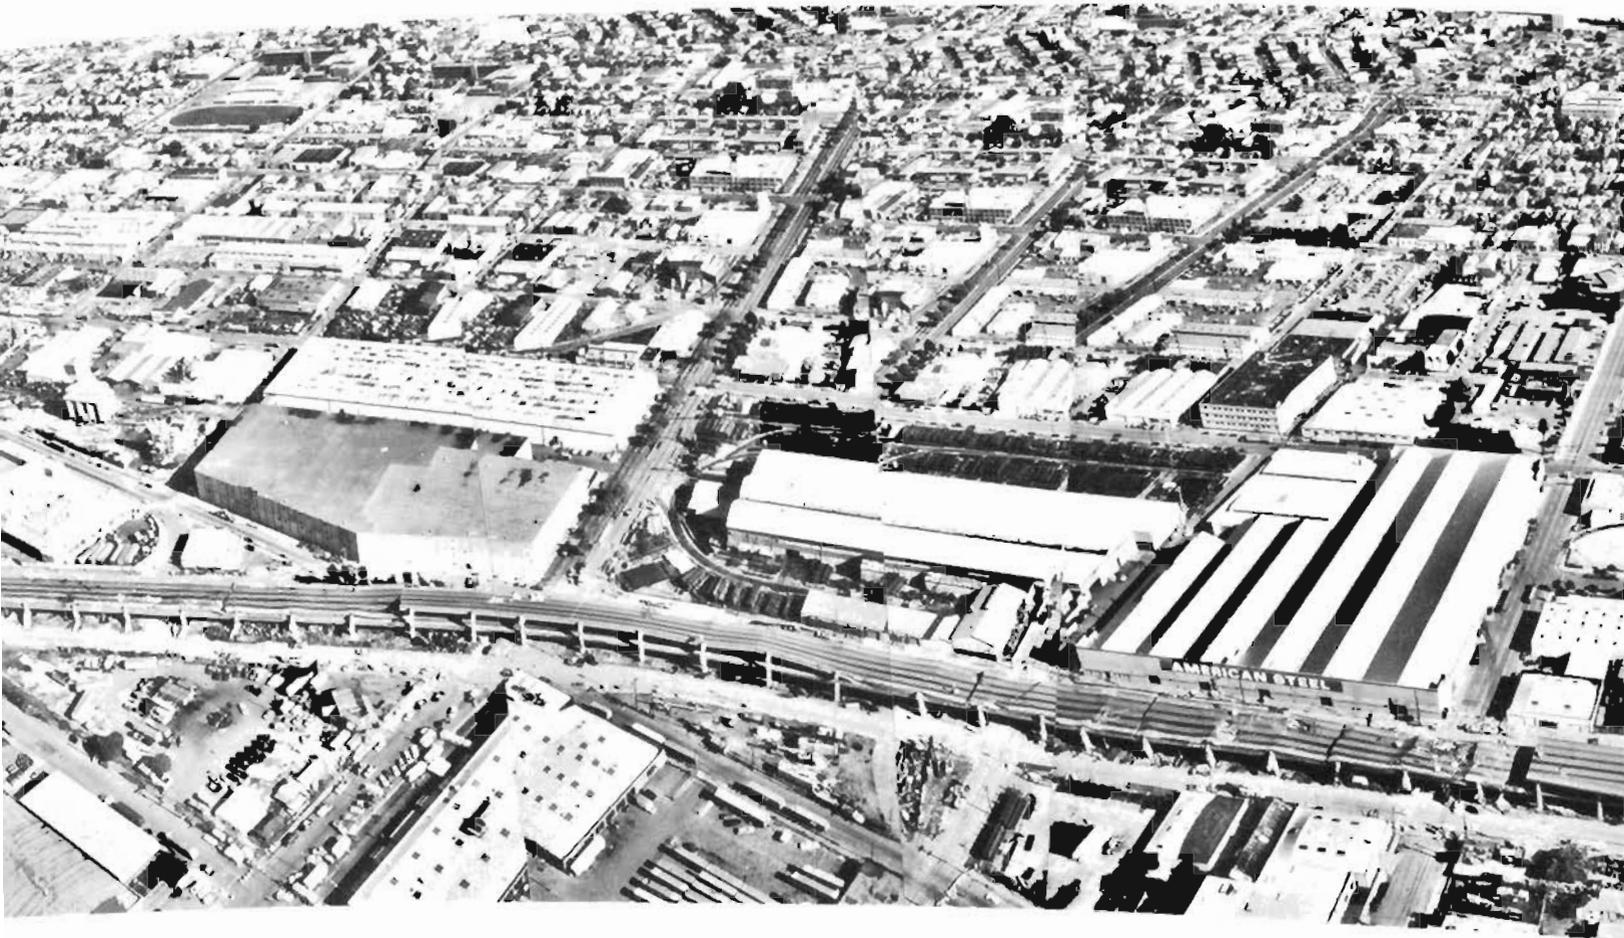
Figure 3-7. Composite aerial photograph of the Cypress Viaduct showing the extent of the collapse

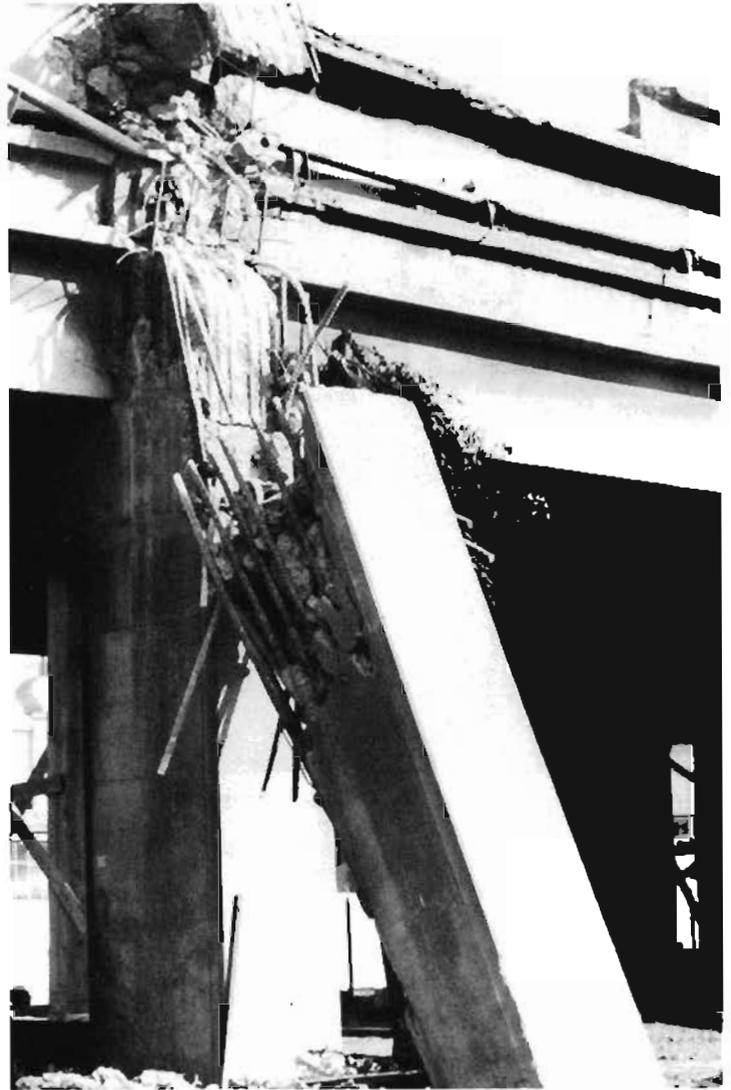
Figure 3-8. View of the failure of the west side of Bent 90 of the Cypress Viaduct

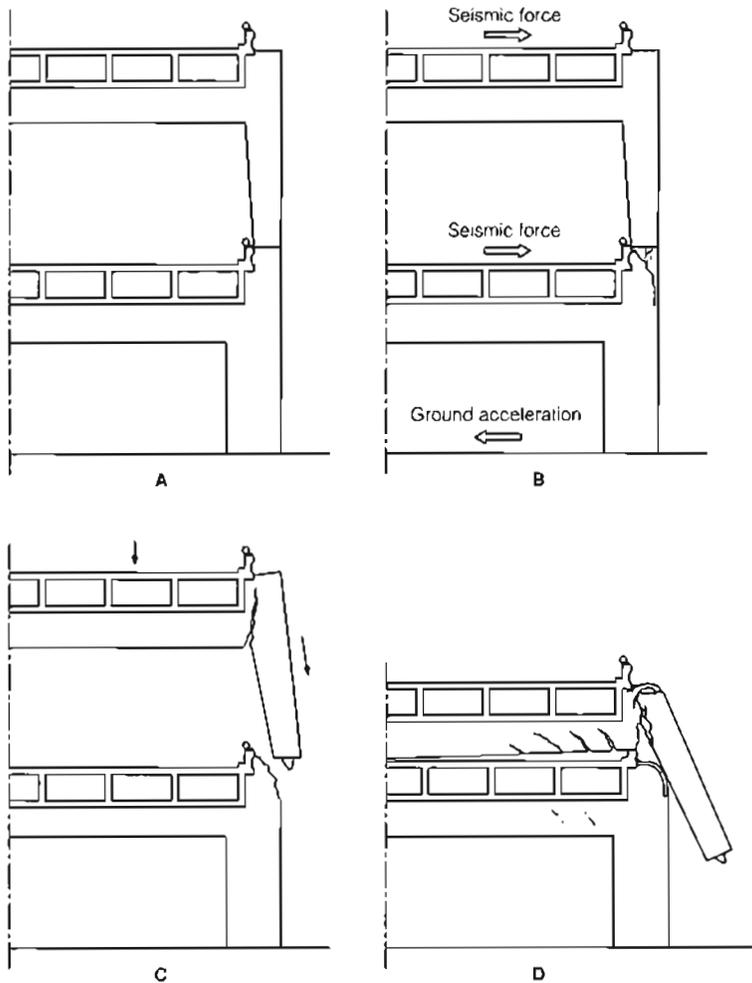
Figure 3-9. Typical failure sequence of a B1 bent. All but seven of the 48 collapsed bents failed in this way. For further discussion see Chapter 10 and Nims et al. 1989.

The common failure mode is illustrated by the sequence shown in Figure 3-9. A diagonal crack formed in the pedestals and lower girder-to-column joint regions. This crack followed a plane of weakness in the joint region defined by the plane of the bent-down negative moment girder reinforcement. Then the gravity and seismic forces pushed the upper column down and away from the joint, resulting in the collapse of the upper deck. Much of the damage to the upper columns, roadway, and girders was subsequently caused by the impact of the upper deck on the lower deck. Experiments performed on standing portions of the Cypress Viaduct, as well as static and dynamic analyses, indicate that the calculated seismic demands during the Loma Prieta earthquake required to initiate failure in this nonductile structure were greater than the available structural capacities.

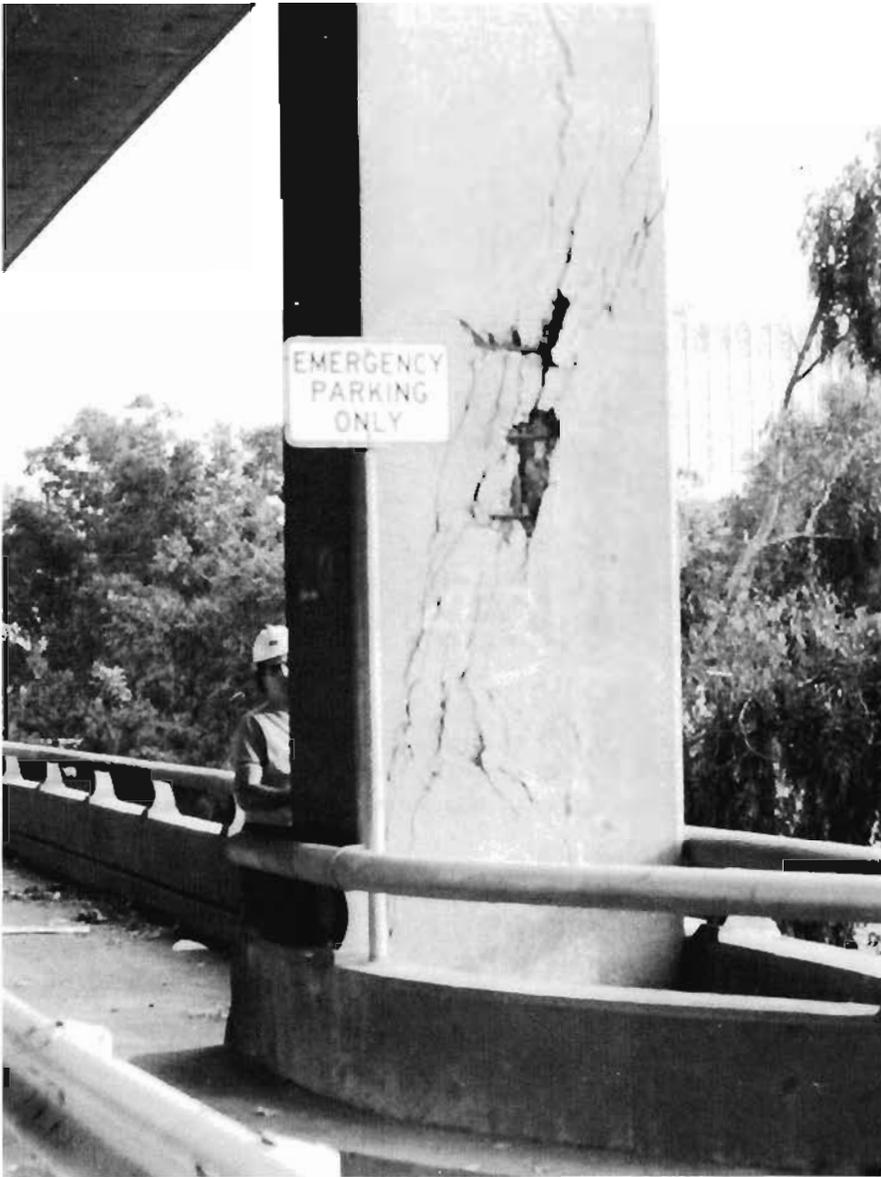
Figure 3-11.
Damage to the Central Freeway; typical of damage to the San Francisco Freeway Viaducts. See Chapter 11 for discussion.

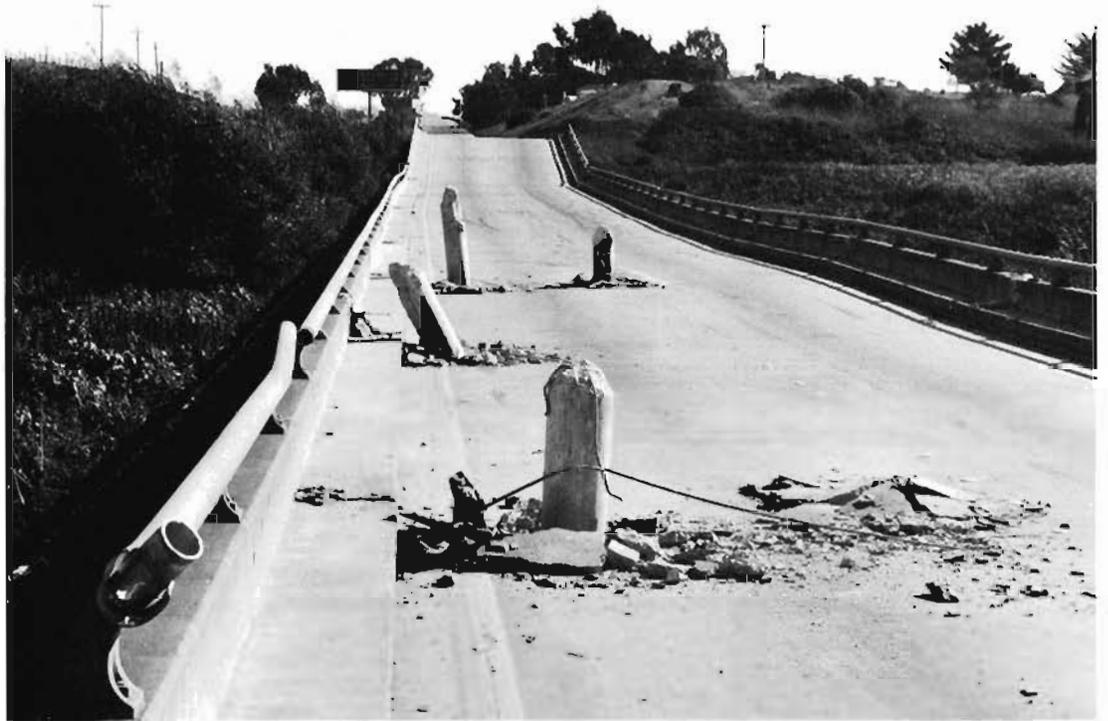
Figure 3-12. *Punching of severed pile extension columns through the deck of the Struve Slough Bridge.*

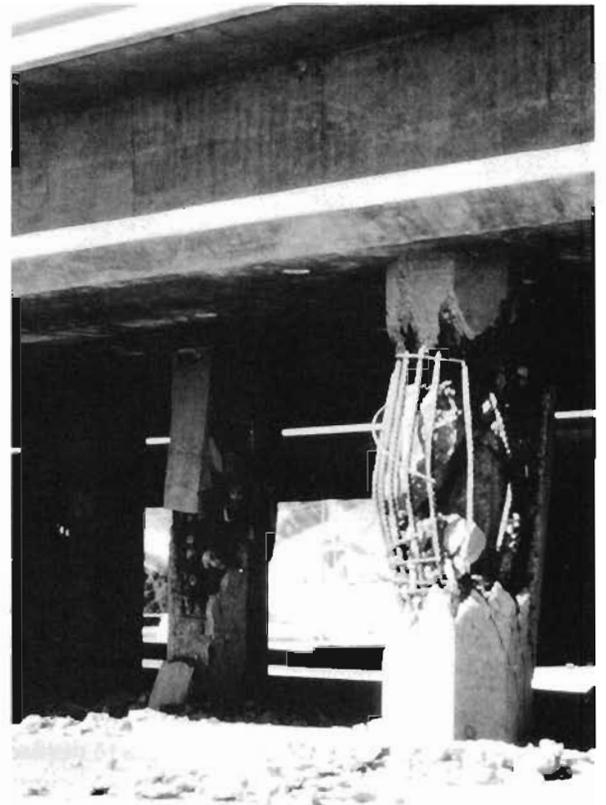
Figure 8-1. Many bridge columns constructed of reinforced concrete failed during the 1971 San Fernando earthquake because of a lack of ductility.

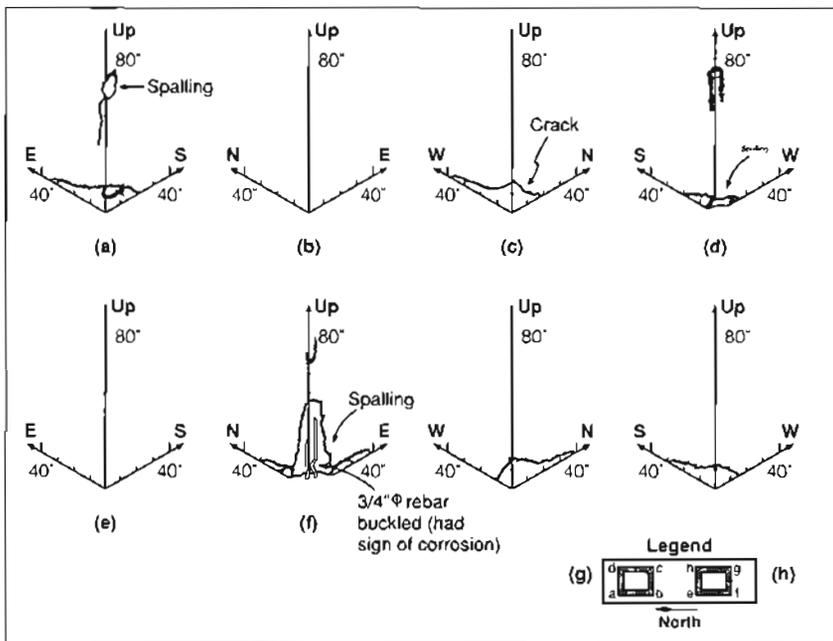
Figure 9-22. Cracking patterns at the corners of the bases of pedestals at Pier E17.

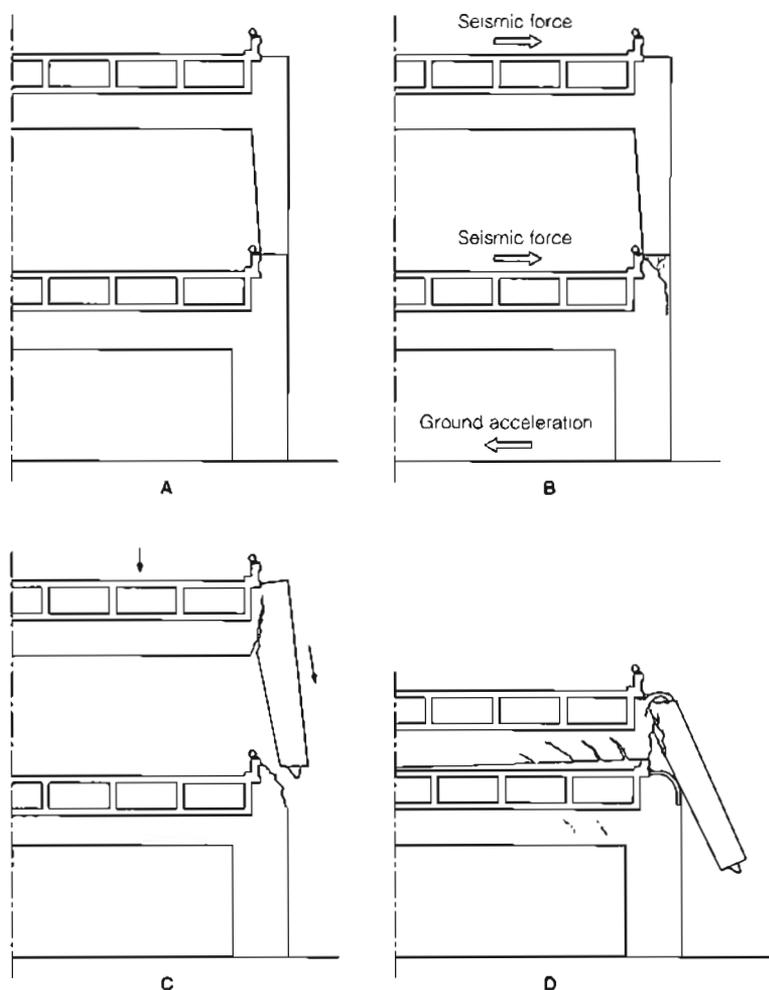
Figure 10-50. Typical failure sequence of a B1 bent.

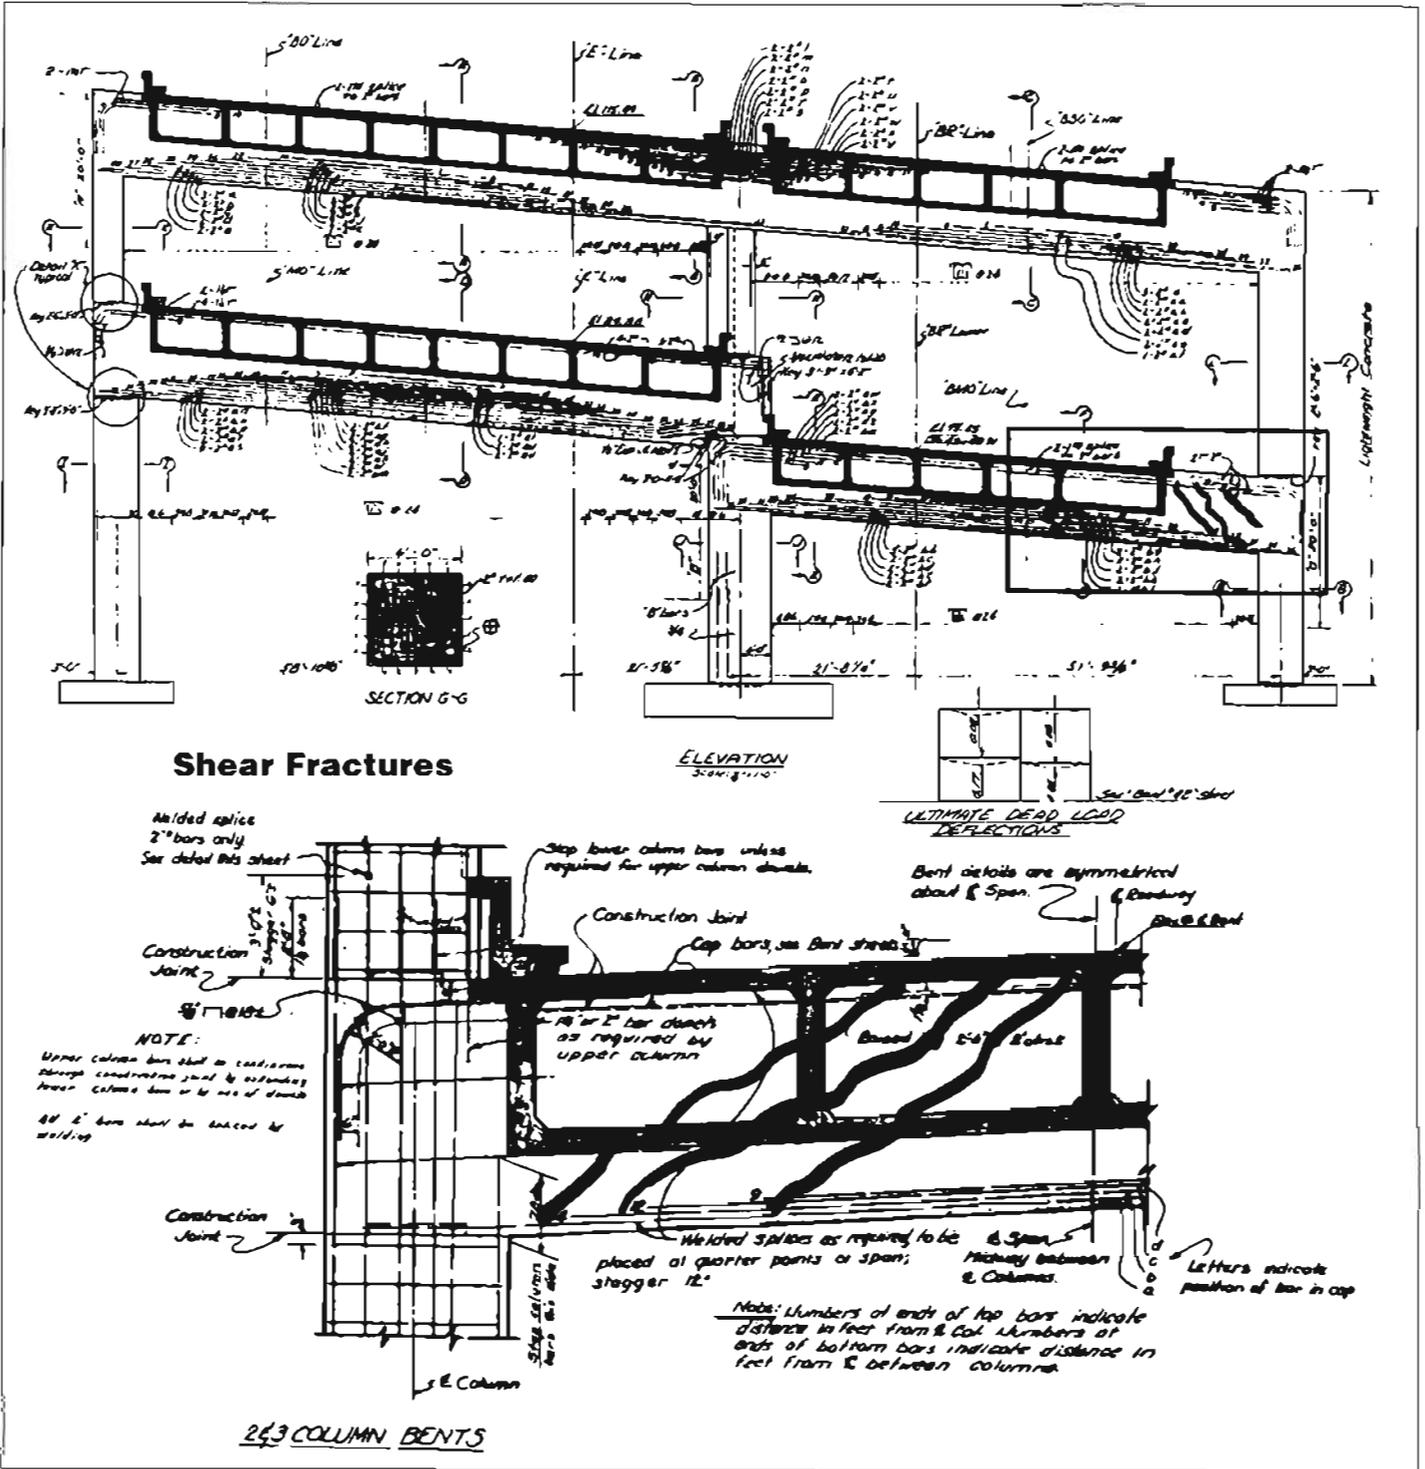
Figure 11-19. Earthquake damage to Terminal Separation Viaduct Bent 44; detail is from opposite side.

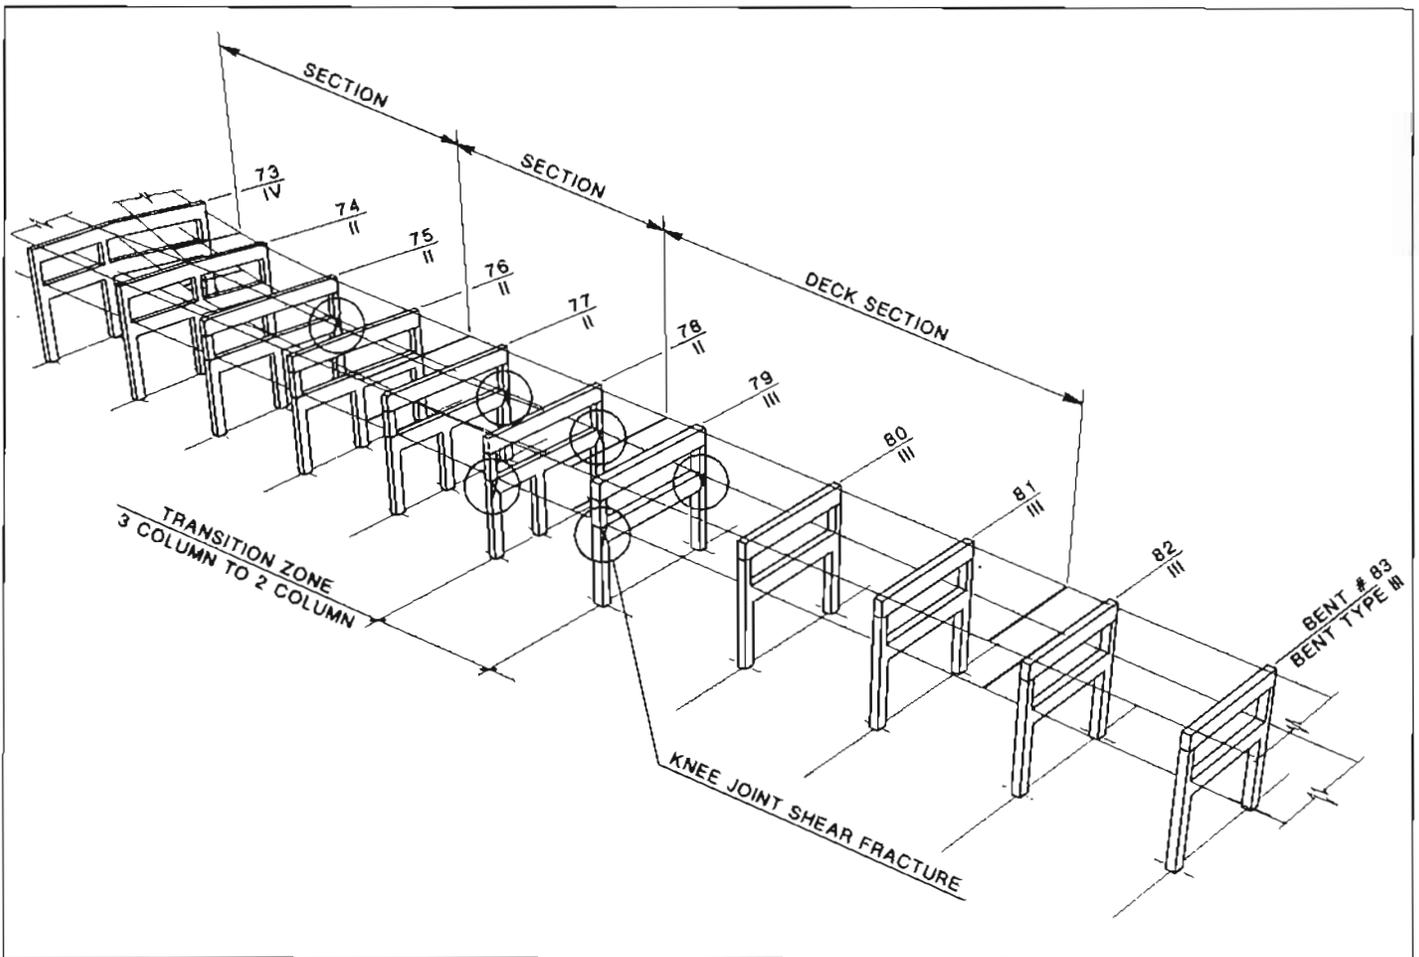
Figure 11-20. Earthquake damage to Embarcadero Viaduct, partial isometric view.

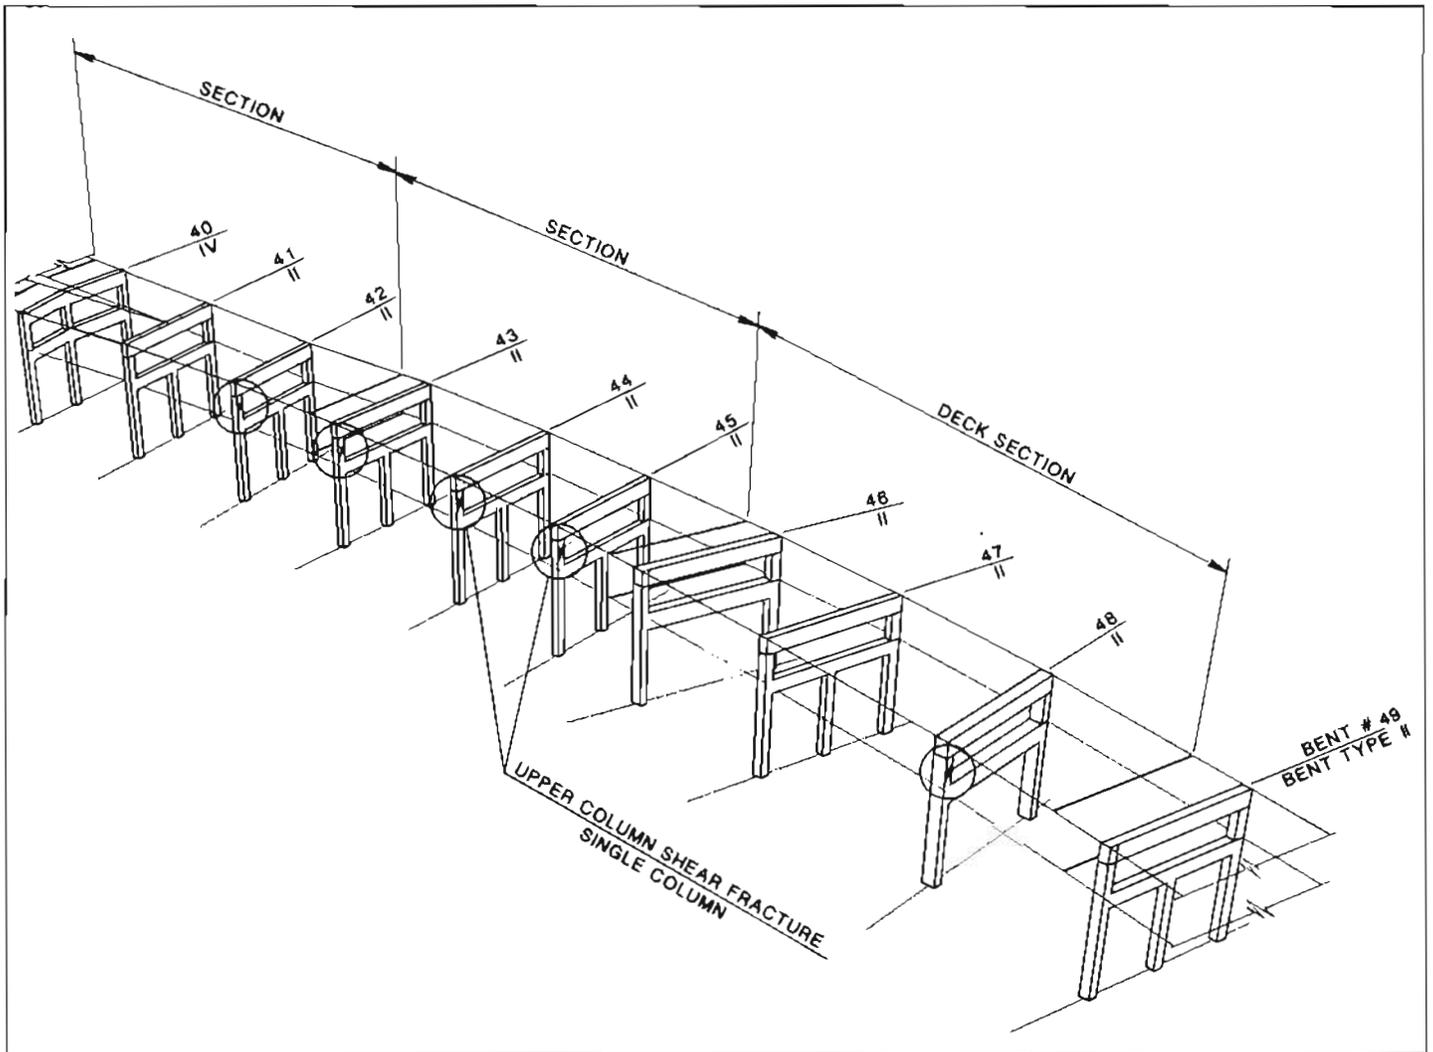
Figure 11-22. Earthquake damage to Central Viaduct, partial isometric view.

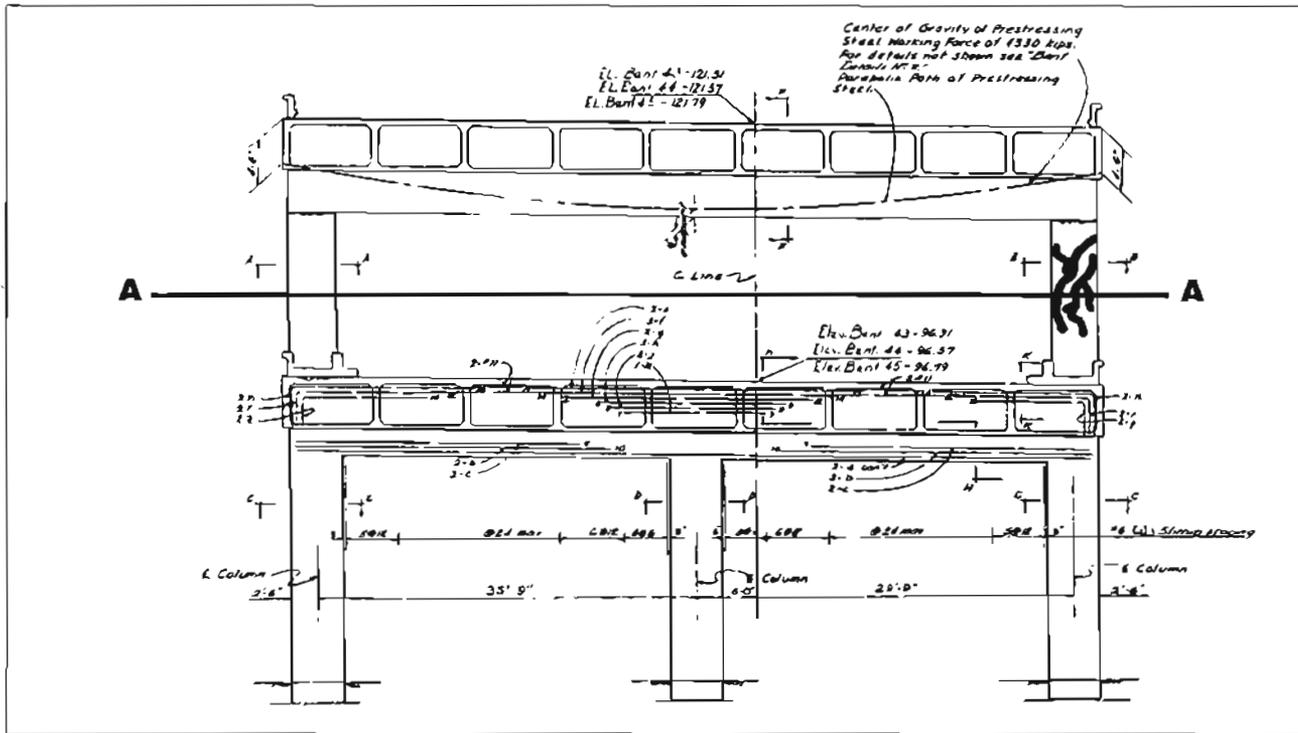
Figure 11-23. Earthquake damage to Central Viaduct Bent 43

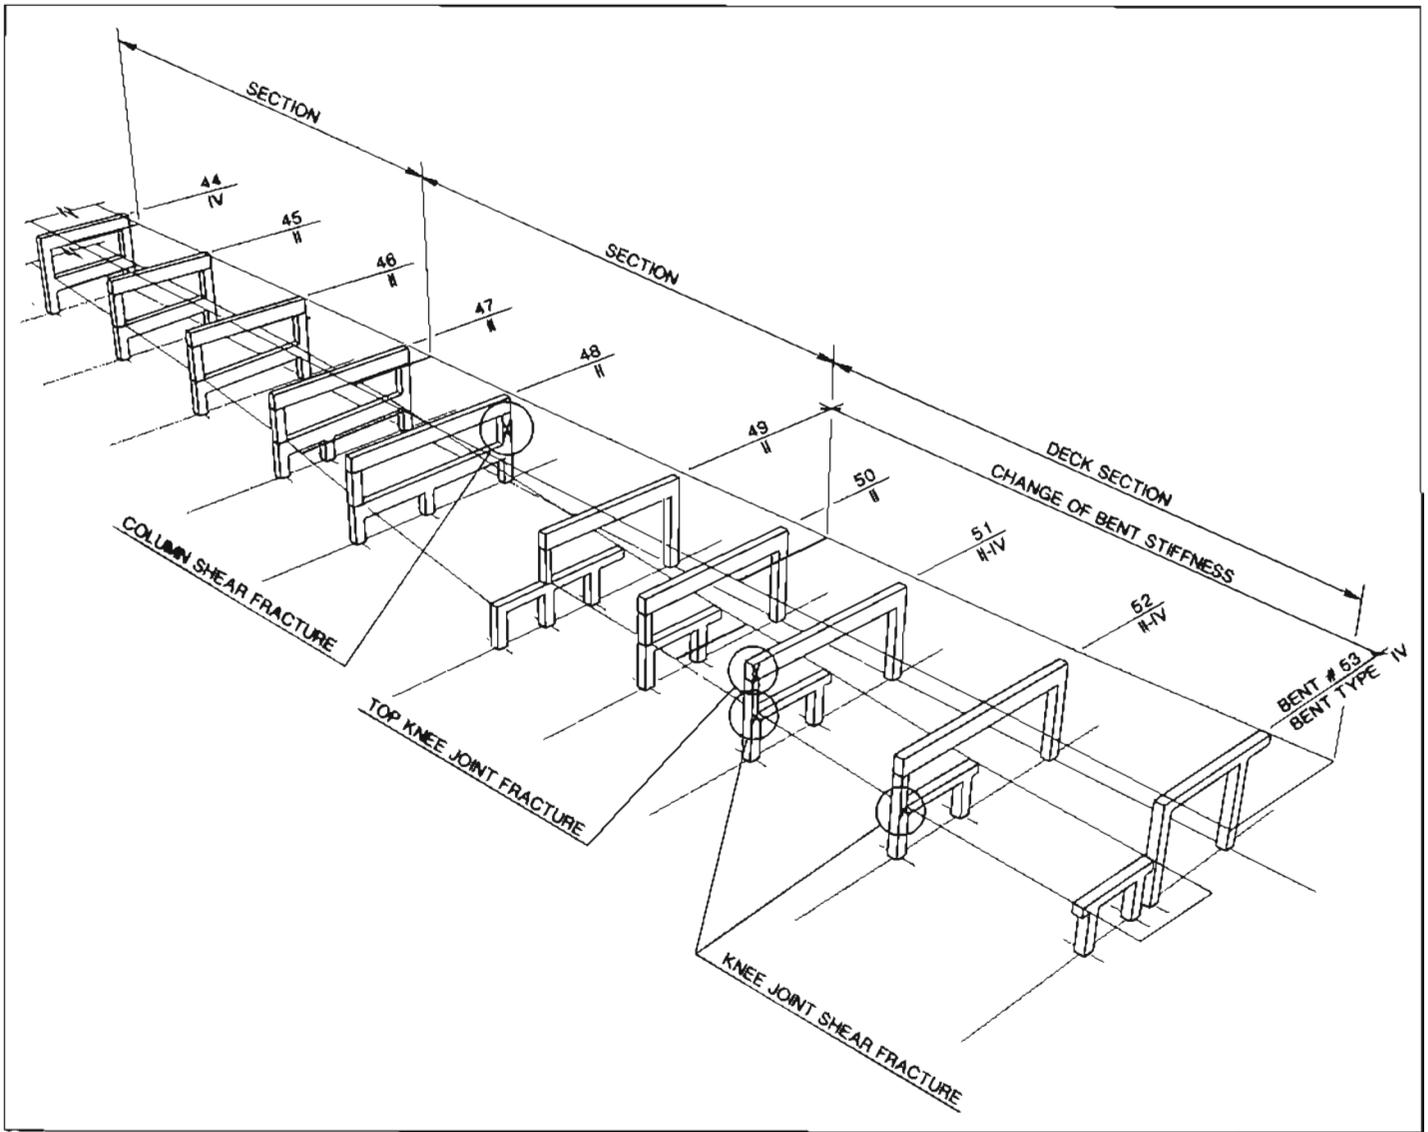
Figure 11-24.
 Earthquake damage to
 Southern Freeway
 Viaduct, partial isometric
 view

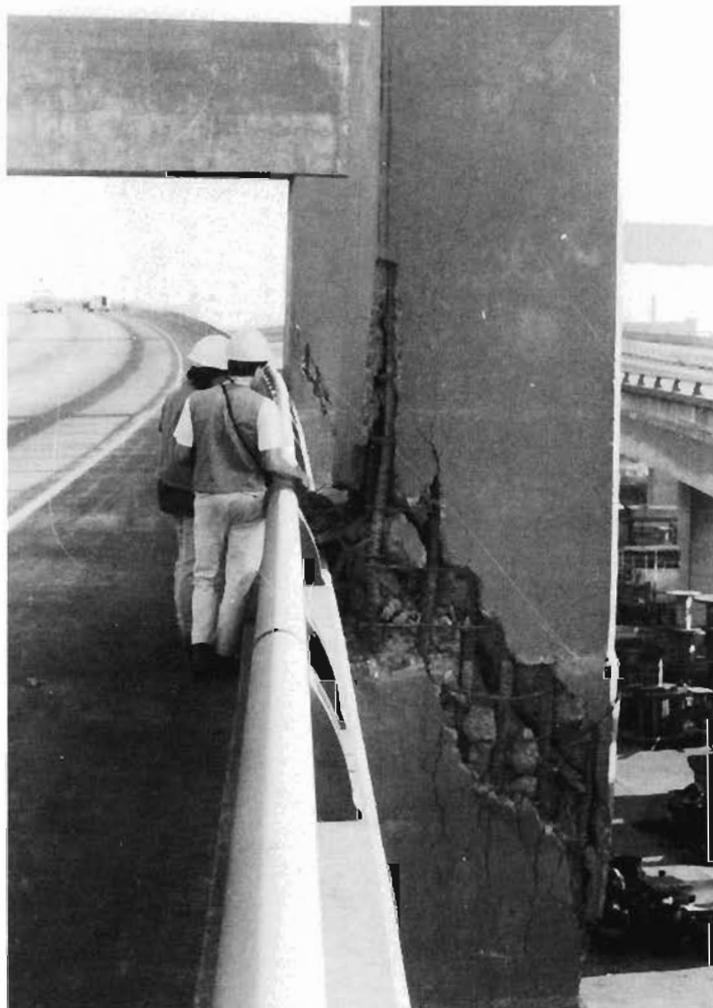
Figure 11-25. Earthquake damage to Southern Freeway Viaduct, Bent 51

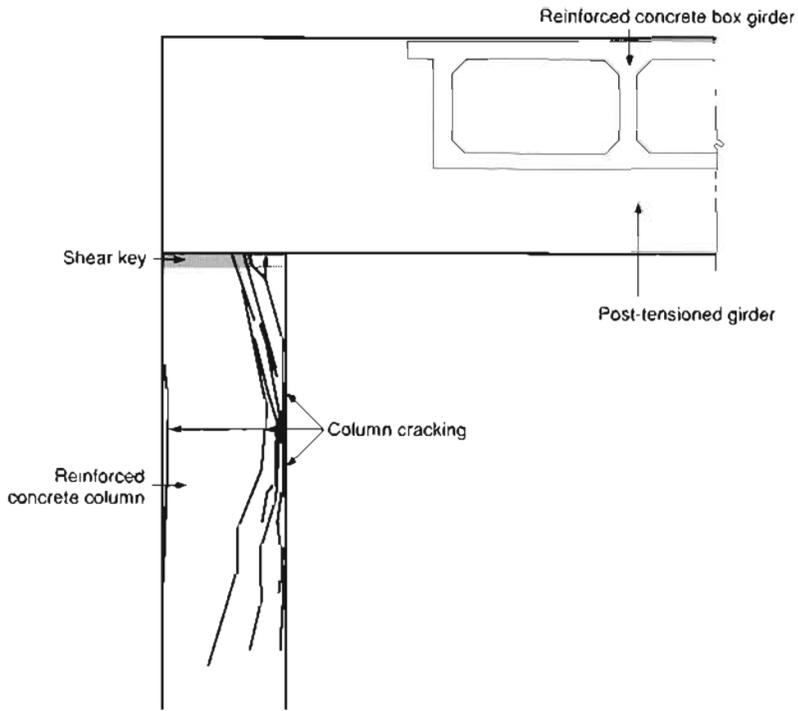
Figure 11-26. Earthquake damage to Southern Freeway Viaduct, Bent 48, lower photo shows reverse view of upper figure.

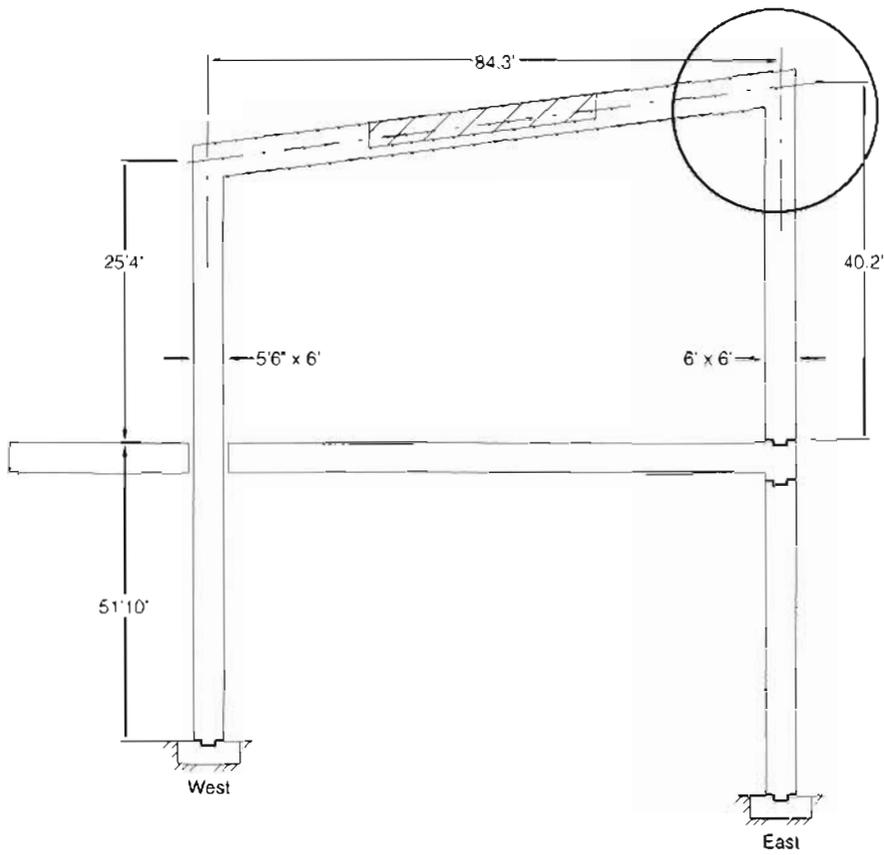
primarily limited to Bent 32 and to Bent N1-35, which is shown in Figure 11-27. Both bents show shear fractures of the upper outrigger knee joint.

Figure 11-27. Earthquake damage to China Basin Viaduct Bent N1-35. lower photo shows reverse view of upper figure
