THE NORTHRIDGE EARTHQUAKE OF JANUARY 17, 1994

Report to the Director,
California Department of Transportation

by the
Seismic Advisory Board

George W. Housner, Chairman
October 1994

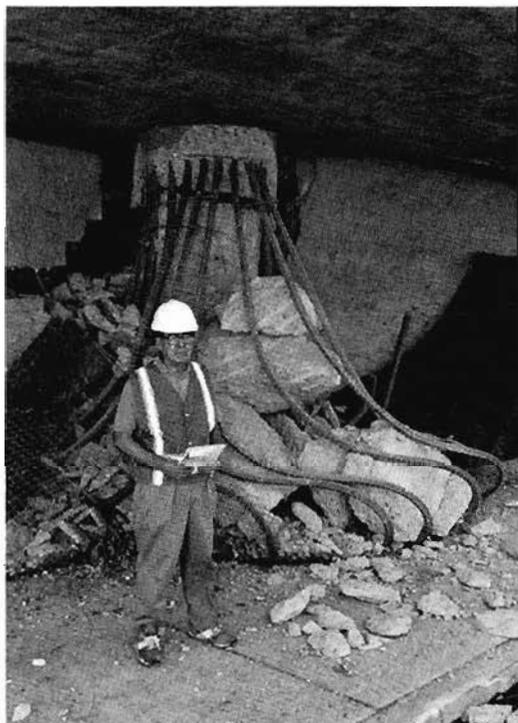
Figure 3-3. Bridge piers with completely disintegrated core, ruptured hoop reinforcement, and buckled longitudinal reinforcement. (photo: F. Seible)

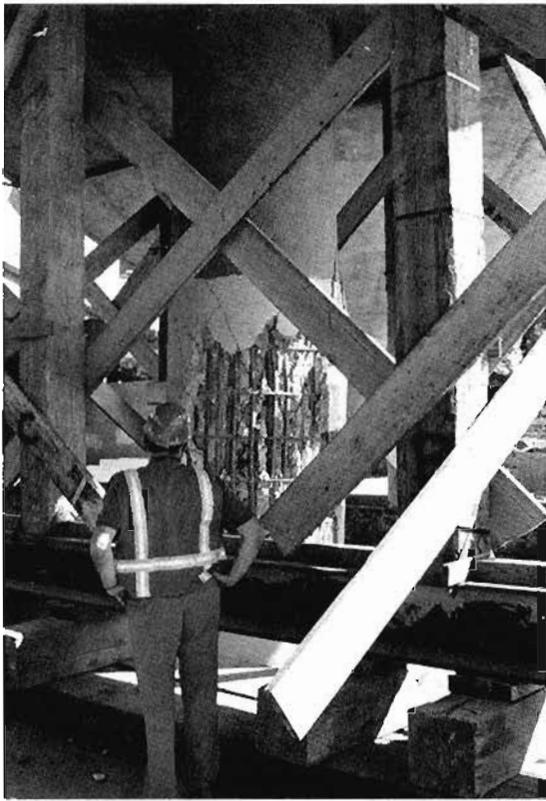
Figure 3-4. Steeply inclined shear cracks and cover spalling in one bent at Fairfax & Washington on I-10 (photo: F. Seible)

At Fairfax & Washington on I-10, steeply inclined shear cracks and cover concrete spalling (Figure 3-4), and flexural cracks at the column ends in the adjacent bent (Figure 3-5), clearly show the influence of column height and boundary conditions, with the shorter columns fixed at both ends showing the critical shear failure patterns. Columns retrofitted with circular steel jackets (Figure 3-6), at the Cadillac Avenue off ramp directly adjacent to Washington and Fairfax showed only minor cracking and

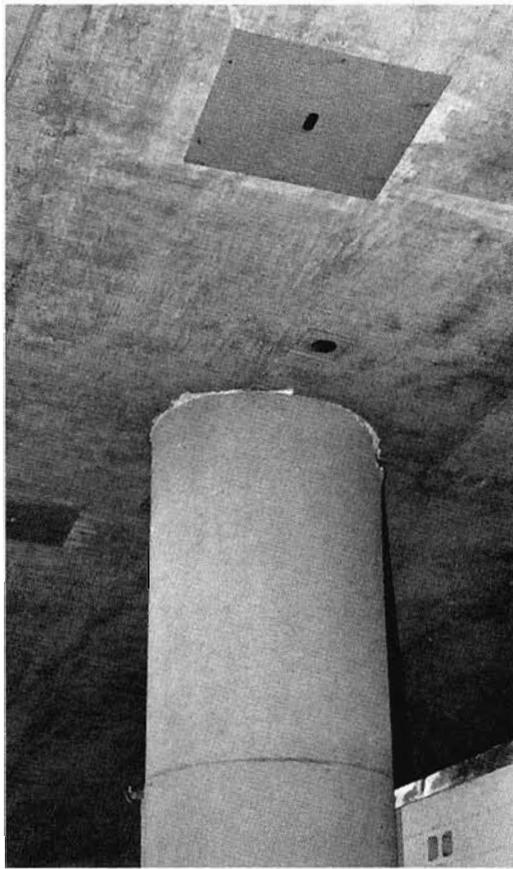
Figure 3-5. Flexural cracks at the column ends in the adjacent bent at Fairfax & Washington on I-10. (photo: F. Seible)

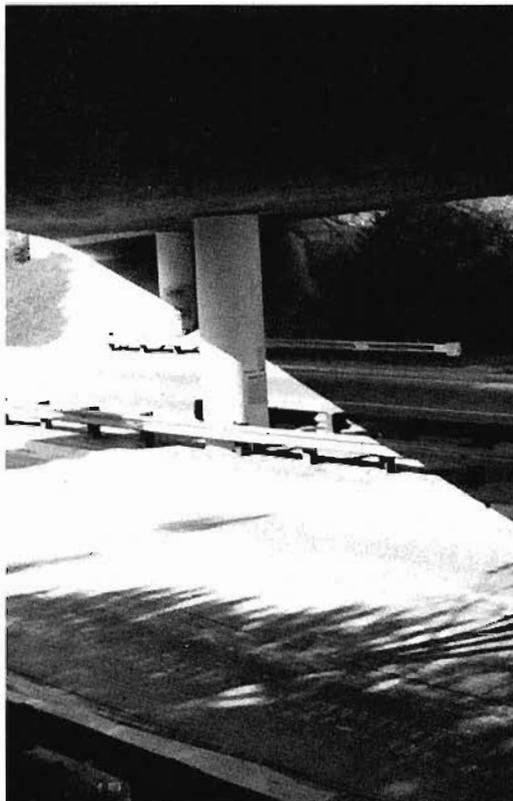
Figure 3-6. Columns retrofitted with circular steel jackets at the Cadillac Avenue offramp directly adjacent to Washington and Fairfax. These columns survived without problems the same ground accelerations that caused the Washington and Fairfax collapse (Figures 3-4 and 3-5). (photo: F. Seible)

spalling in the joint between the steel jacket and the bottom soffit. These retrofitted columns survived, without signs of damage, the same ground accelerations that caused the Washington and Fairfax columns to collapse.

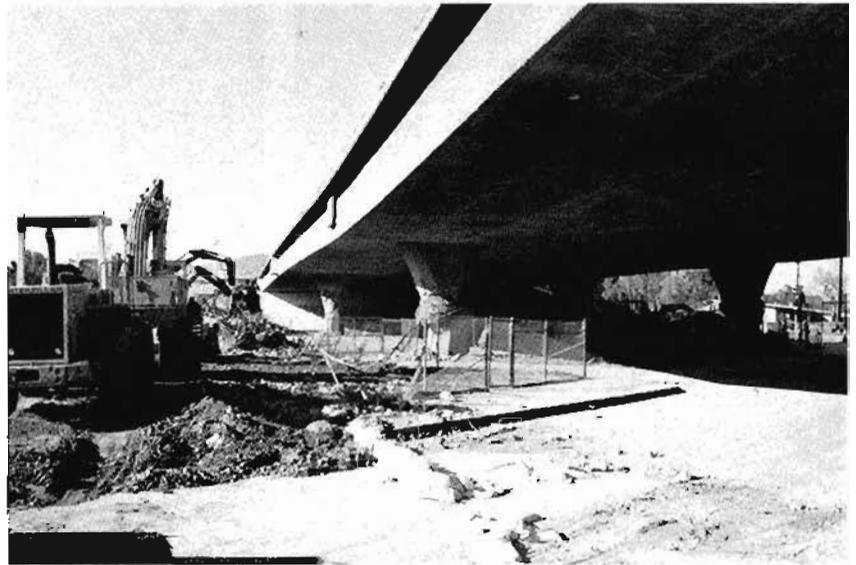
Figure 3-7. Flexure/shear failure in the bottom of the flared columns still visible in the westbound bridge, even though demolition was in full progress at the SR-118 Mission & Gothic Undercrossing. (photo: F. Seible)

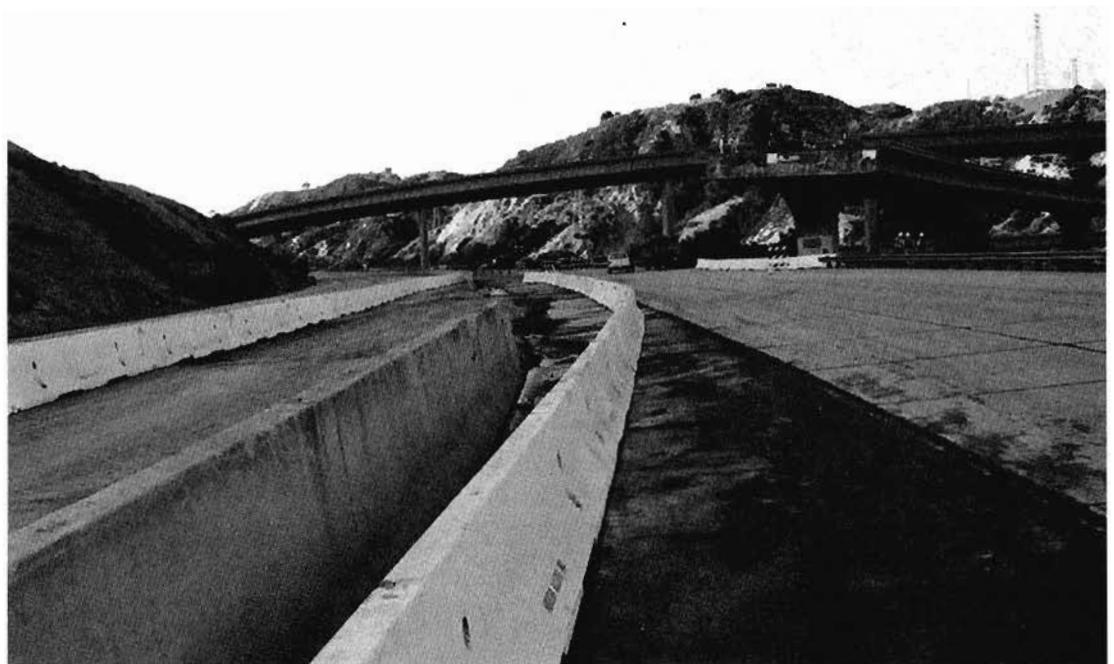
Figure 3-8. Completed demolition of the southbound connector at the Antelope Valley I-5/SR-14 Interchange five days after the earthquake (photo: F. Seible)

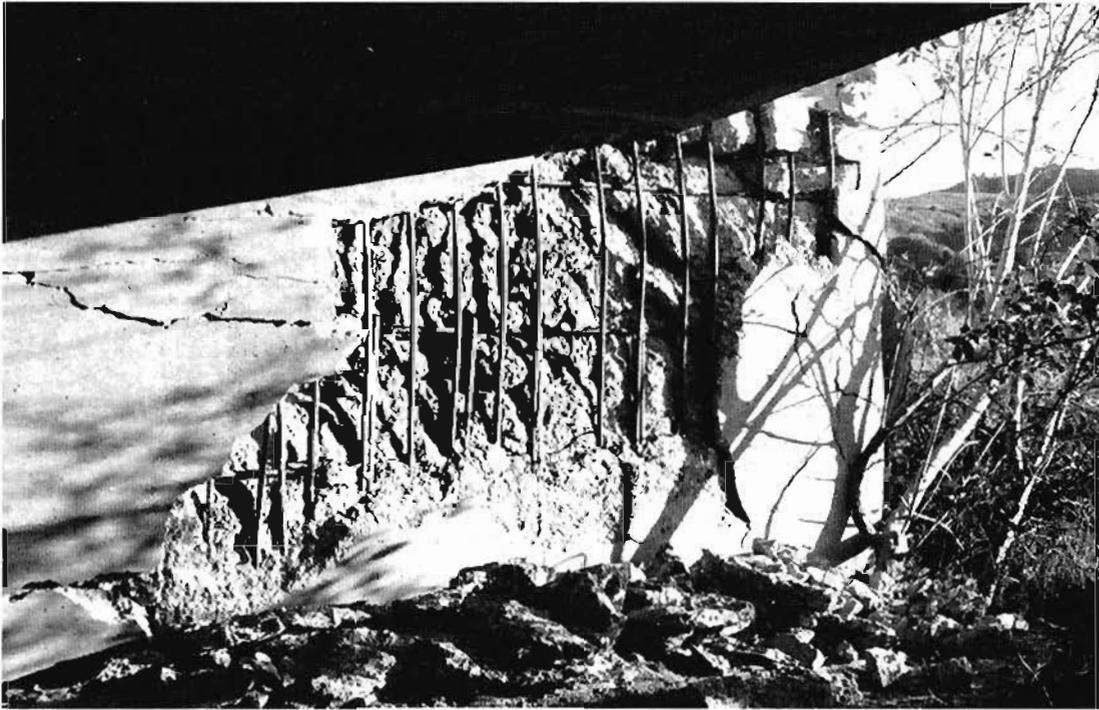
Figure 3-9. Abutment joint damage in the separation structures at the Antelope Valley I-5/SR-14 Interchange (photo: F. Seible)

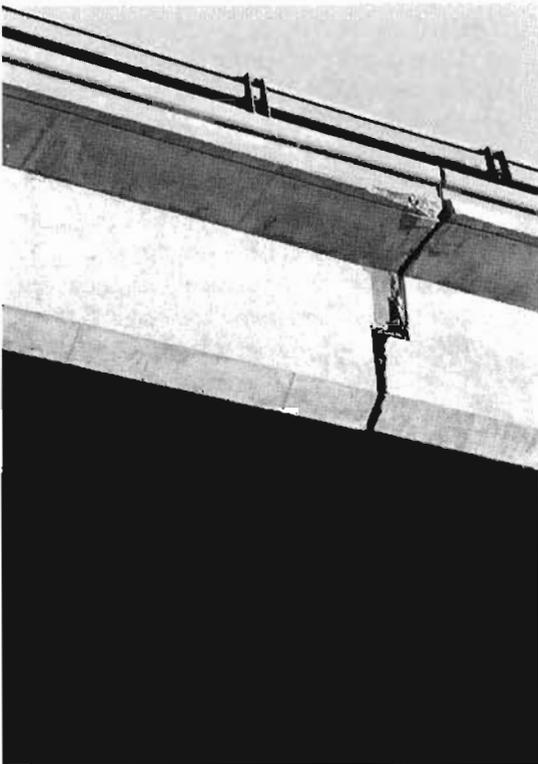
Figure 3-10. Expansion joint damage in the separation structures at the Antelope Valley I-5/SR-14 Interchange (photo: F. Seible)

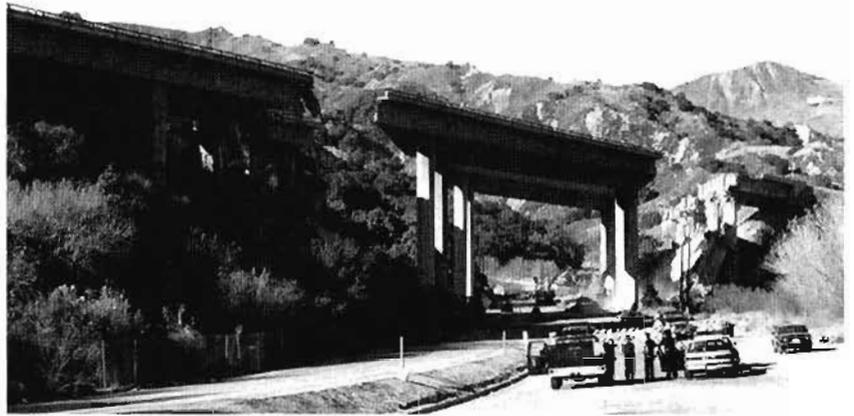
Finally, at I-5 Gavin Canyon, the collapsed section of the bridge structure had been removed, but the highly skewed geometry and narrow joint seat width was evident from the still-standing center frame (Figure 3-11).

Figure 3-11. The highly skewed geometry and short expansion joint seat width of the still-standing center frame of the I-5 Gavin Canyon bridge. (photo: F. Seible)

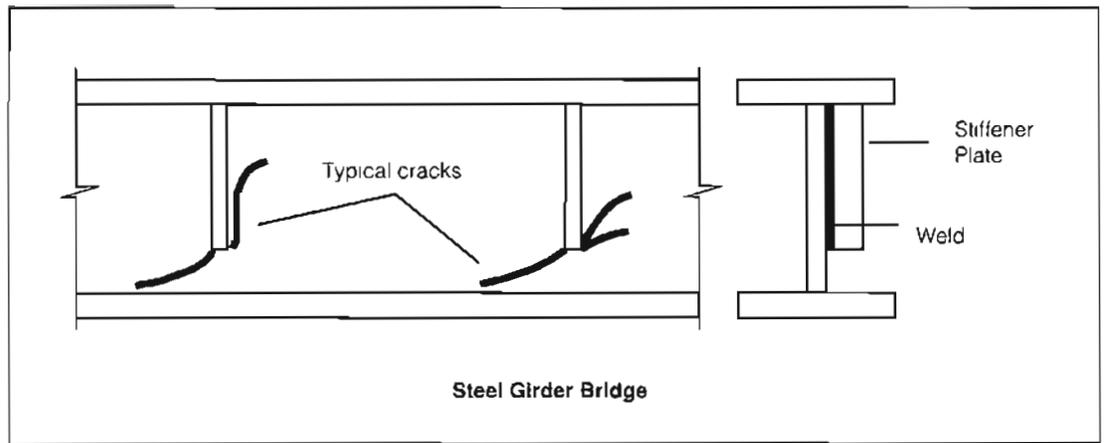
Figure 3-12. Typical cracking associated with x-bracing observed in some steel girder bridges, Northridge earthquake.

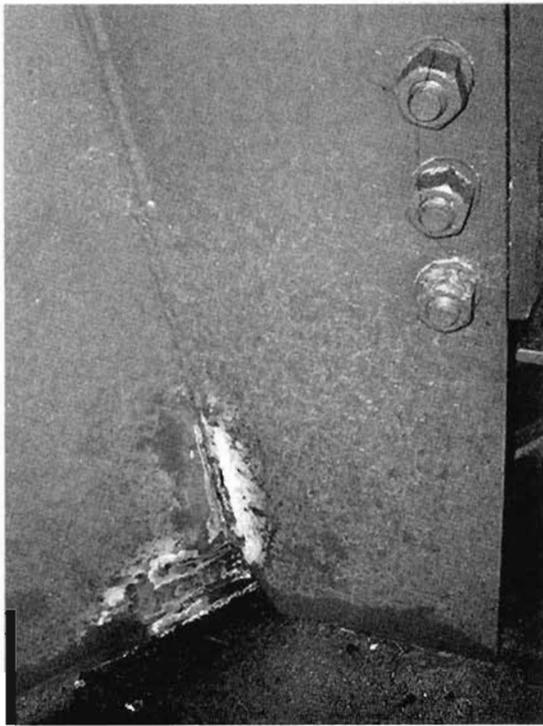
Figure 3-13. Cracks in bottom region of plate girder web, northern bridge of Pico-Lyons Overcrossing (photo A. Astaneh-Asl)

In addition to the damage to the bearings and the supports, several steel girder bridges sustained a different kind of damage to the web-plate of a girder near stiffeners (Figure 3-12). Two skew bridges in the region of very strong shaking have been identified as having such cracks. It appears that some cracks were initiated during the earthquake, and others were there before the

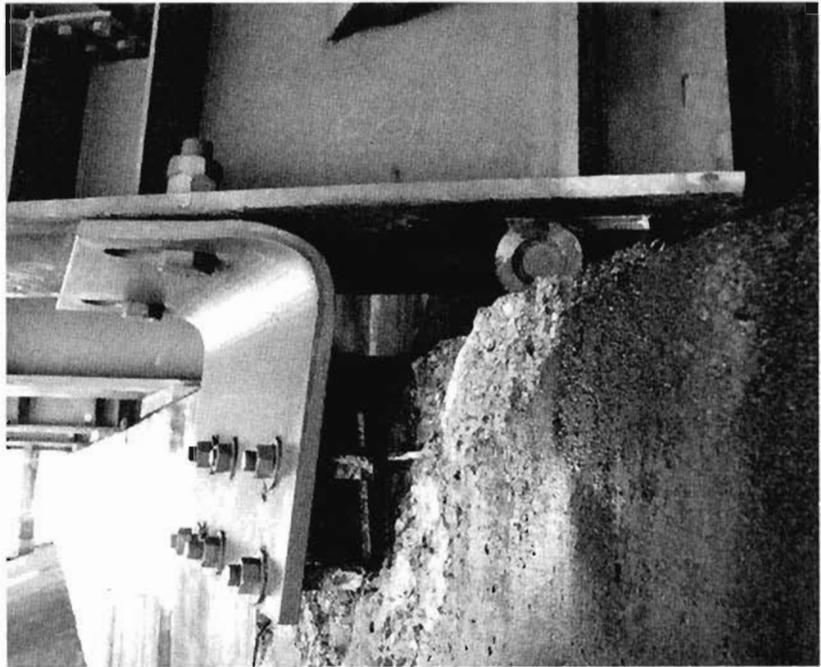
Figure 3-14. Roller and seismic restrainer damage, southern bridge of Pico-Lyons Overcrossing (photo A. Astaneh-Asl)

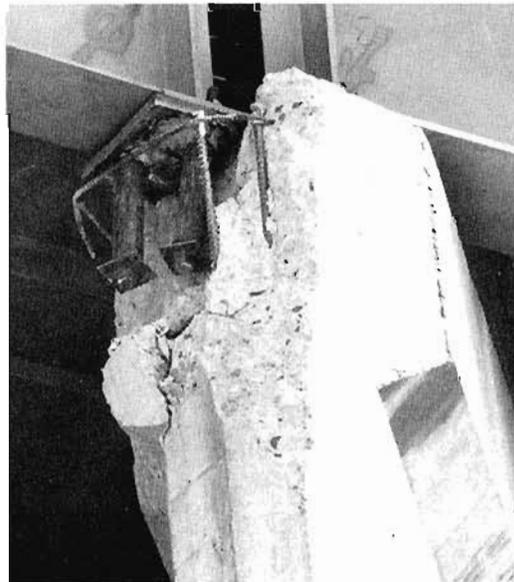
Figure 3-15. Support damage at top of Pier No. 6, Santa Clara River Bridge. (photo A. Astaneh-Asl)

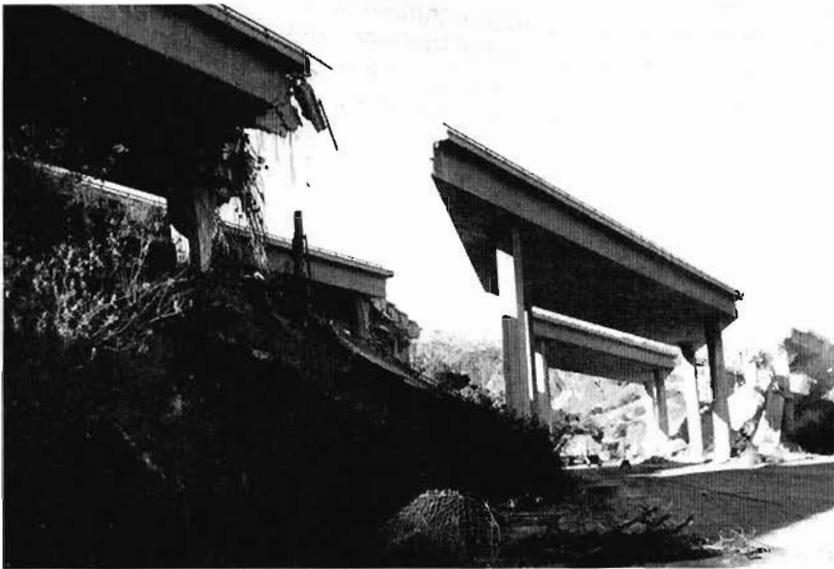
The collapse at the I-5 Gavin Canyon Undercrossing (Figure 4-1) can be attributed to geometric complexities arising from the 66 degree skew orientation of abutments and in-span expansion joints, as well as the 8-inch seat width. Even though retrofitted with first generation restrainers in 1974 (as a direct result of the 1971 San Fernando earthquake), restrainer design and detailing were not sufficient to prevent unseating and subsequent superstructure failure in the acute corners of the bridge at the in-span expansion joints.

Figure 4-1. I-5, Gavin Canyon Undercrossing, Northridge earthquake. (photo: F. Seible)

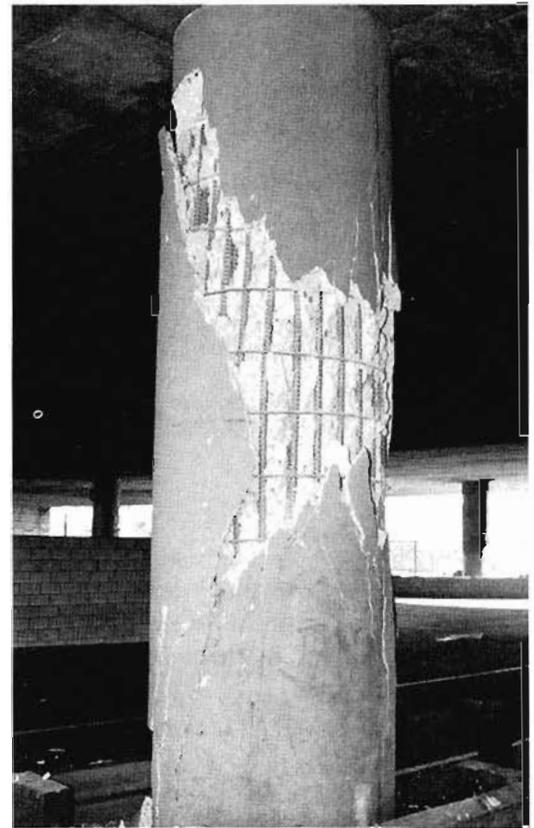
Pre-1971 transverse reinforcement detailing in columns was also a problem due to the low transverse reinforcement (nominal #4 @ 12") for the two bridge collapses at the I-10 Santa Monica Freeway. As stated above, the state-of-the-art in bridge design at the time provided transverse column reinforcement only nominally, and not as a result of engineered capacity requirements that would today result in transverse reinforcement ratios exceeding the nominally-provided ones by a factor of 8 to 10 or more. As a consequence of the low transverse reinforcement and underestimated flexural over-strength, the I-10 structures at Fairfax & Washington (Figure 4-2), and at La Cienega and Venice (Figure 4-3), collapsed with column shear failures either before or shortly after their initial flexural yielding. Quantitative failure

Figure 4-2. Shear distress pattern at I-10, Fairfax & Washington, Northridge earthquake. (photo: F. Seible)

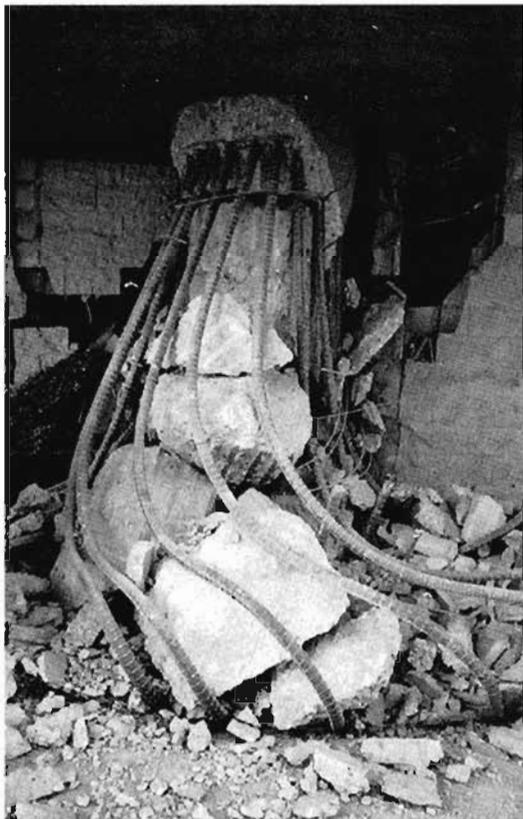
Retrofit designs for both of the collapsed I-10 structures were complete at the time of the Northridge earthquake. However, retrofit implementation reportedly was compounded by legal problems concerning the leased airspace under the La Cienega and Venice structures, reemphasizing the fact that time is of essence in the seismic retrofit program.

Figure 4-3. Brittle column failure at I-10, La Cienega and Venice. Northridge earthquake. (photo: F. Seible)

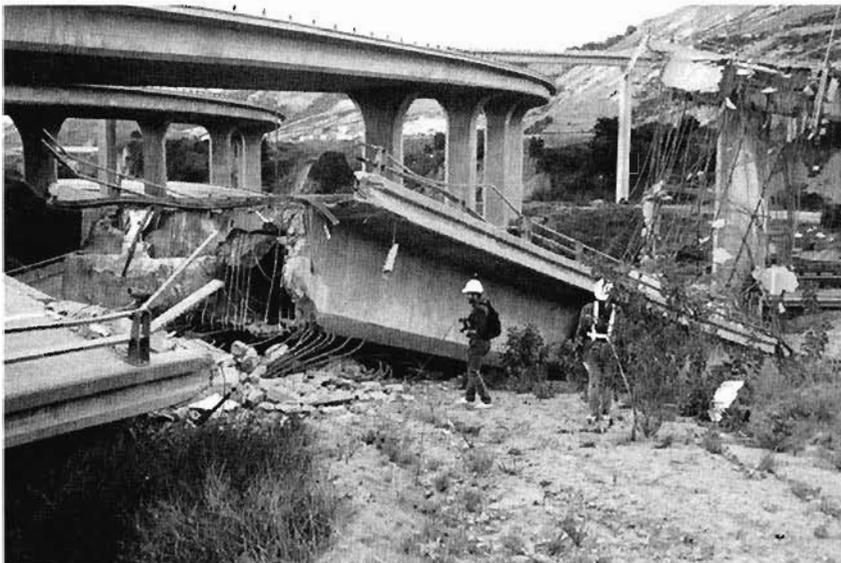
Figure 4-4. SR-14/I-5 North Connector Overcrossing, Northridge earthquake. (photo: F. Seible)

During the Northridge earthquake, the two bridge failures at the I-5/SR-14 Interchange (Figures 4-4 through 4-6) can be attributed to brittle shear failure of short or stiff columns. These columns, proportionally to their stiffnesses, attracted more seismic force than their more flexible adjacent bents and did not have the necessary deformation capacity due to the pre-1971 transverse reinforcement detailing [Priestley, Seible and Uang, 1994]. In addition, the shear failure of the north connector of bent #2 was aided by

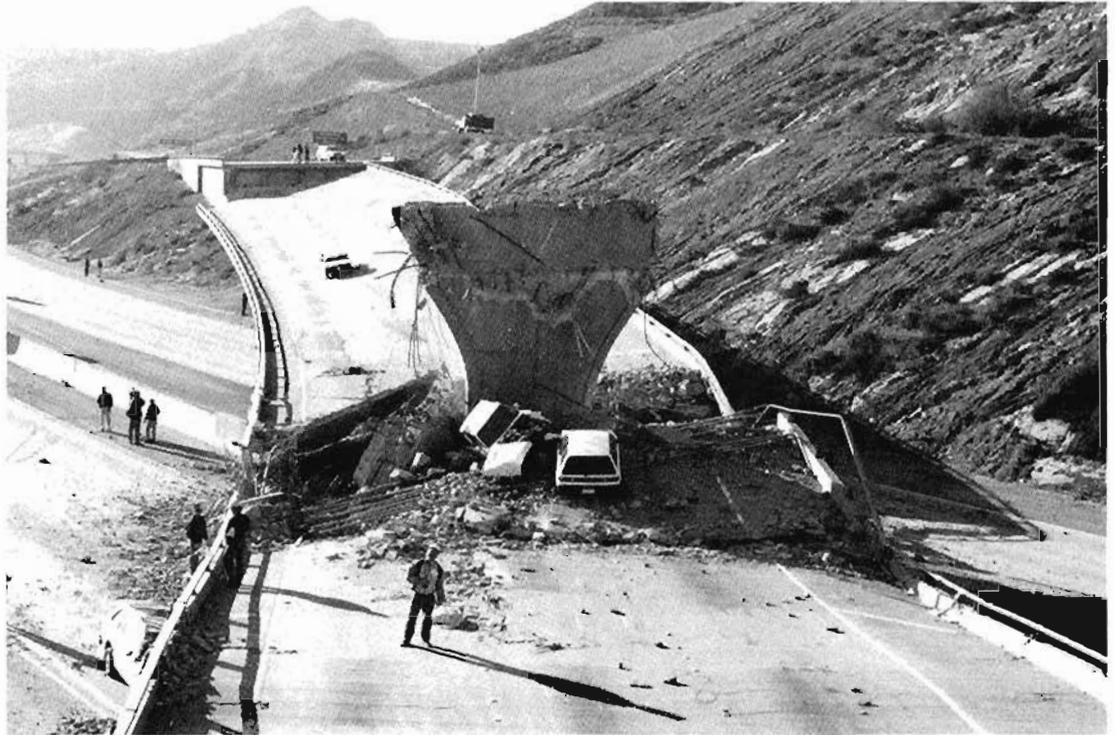
Figure 4-5. SR-14/I-5 South Connector Overhead, Northridge earthquake. (photo: F. Seible)

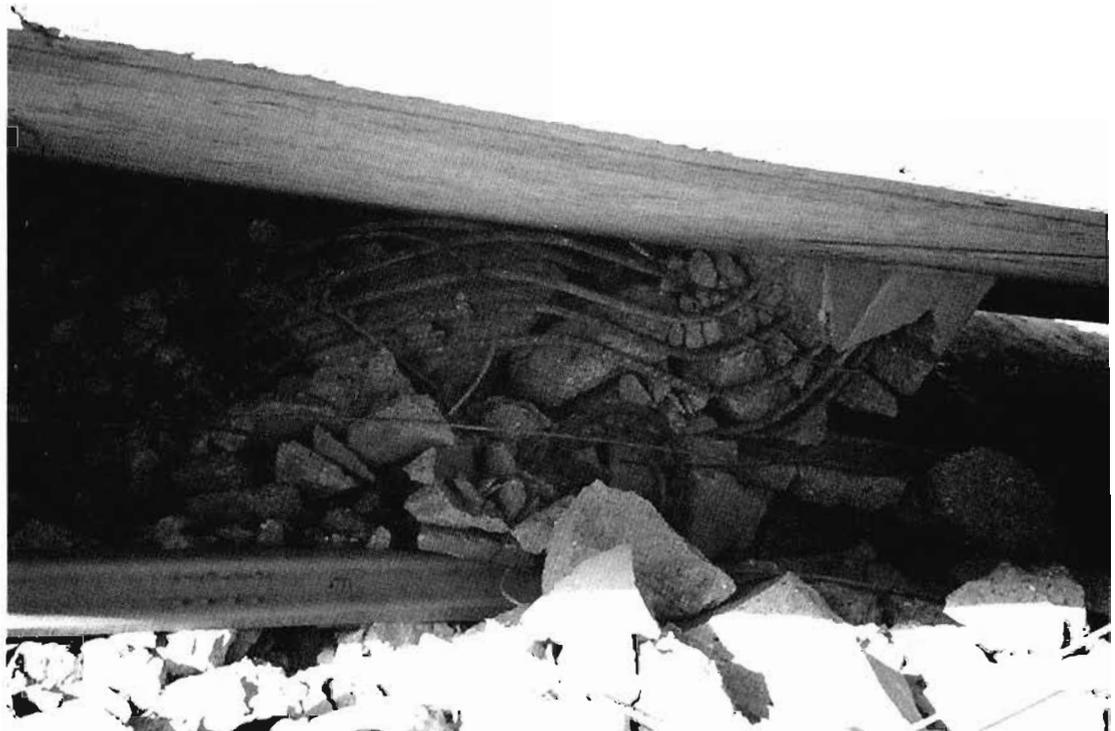
Figure 4-6. Short column failure SR-14/I-5 South Connector Overhead, Northridge earthquake. (photo F. Seible)

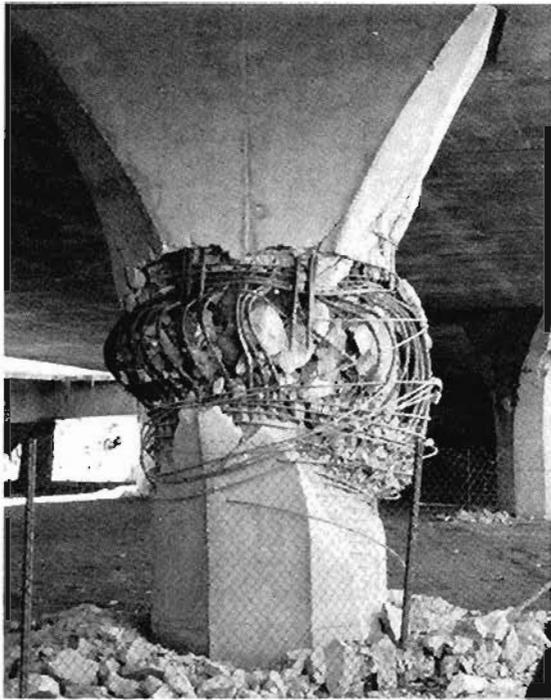
Figure 4-7. SR-118 Mission & Gothic Undercrossing, Northridge earthquake. (photo: F Seible)

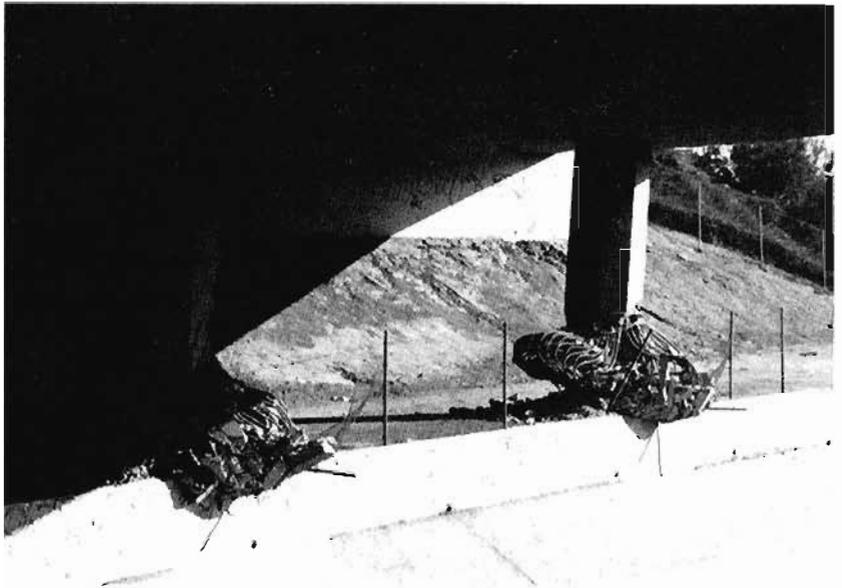
Figure 4-8. Bull Creek Canyon Channel Undercrossing, SR-118, Northridge earthquake. (photo: T Saido)

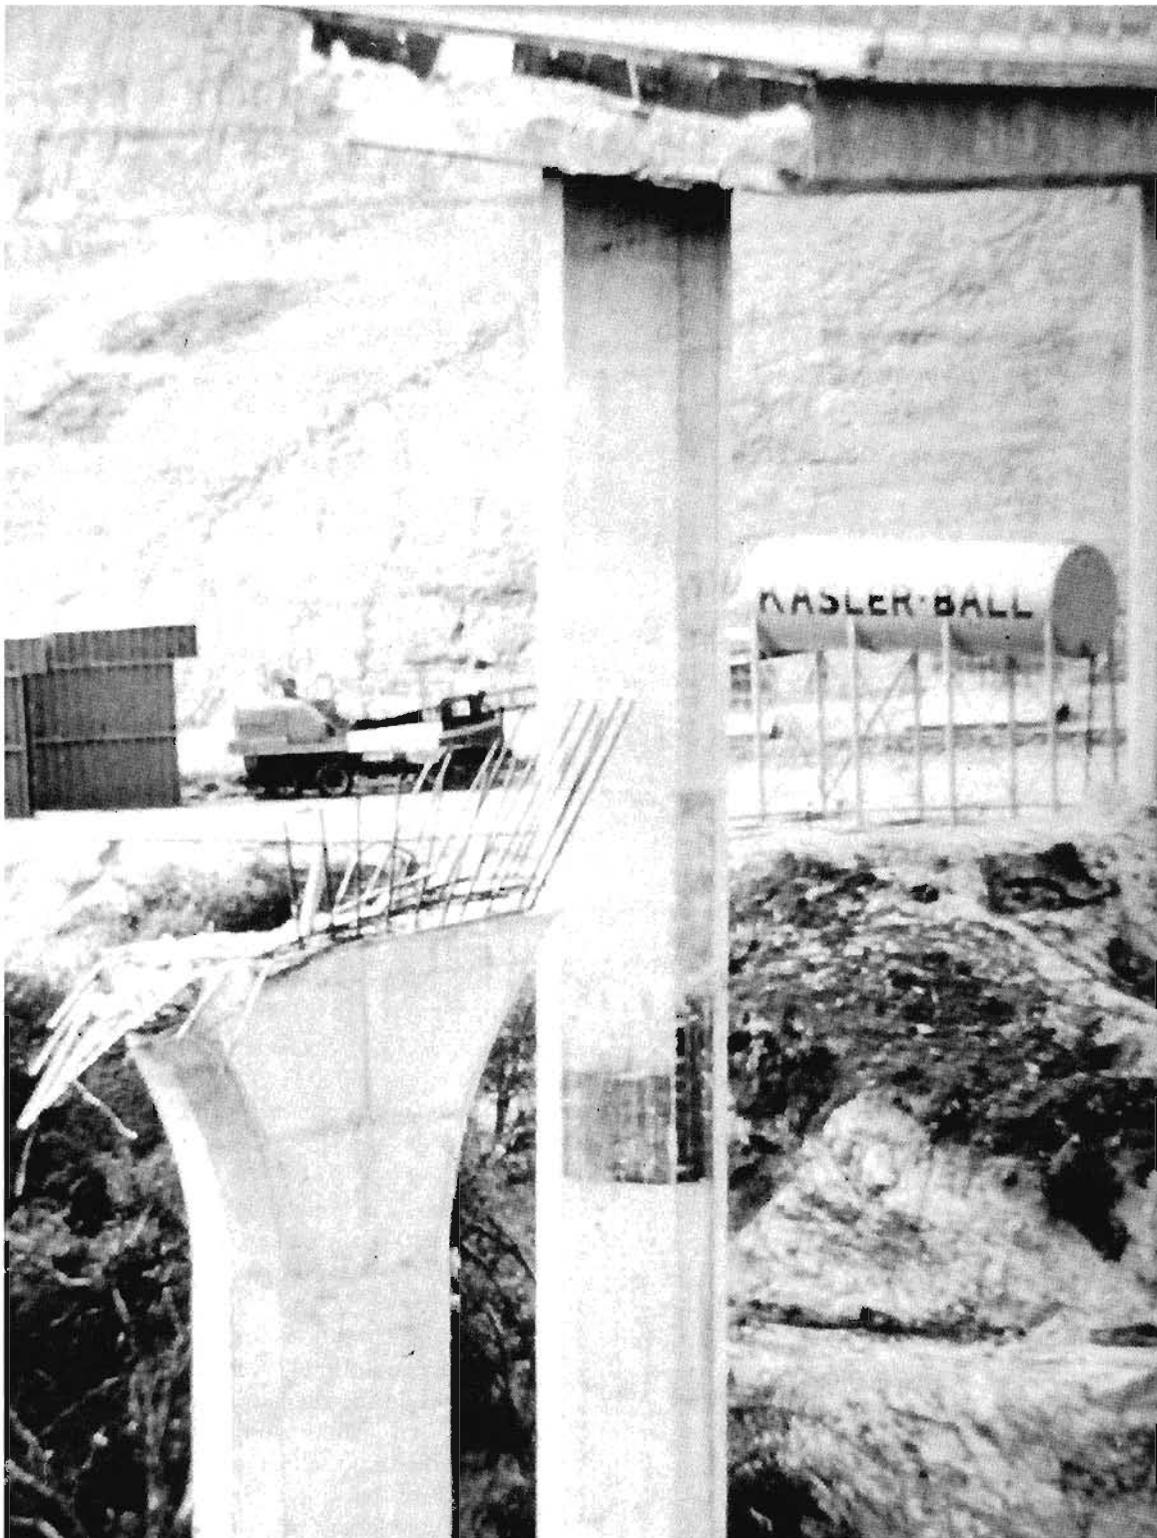
Considering the locations and orientations of the abutments and expansion joints, and considering the general form of the deck curvature in plan view, it is quite apparent that the deck was highly constrained against large displacements in all directions except in the westerly direction. As the vibratory motions of the deck built up with considerable bias in the that direction, the deck separated at the centrally located expansion joint, allowing one end of a span to fall off its support and initiate collapse of the entire structure.

Figure C-2. The most dramatic of all bridge damage caused by the San Fernando earthquake occurred at the Golden State Freeway (I-5) and Foothill Freeway (I-210) Interchange. The highest overcrossing at this site, which carried southbound traffic from Foothill Freeway onto the Golden State Freeway, collapsed during the earthquake. Note the similarity to the performance of the I-14/I-5 connection overcrossing in the Northridge earthquake, Figure 4-2. (photo: National Earthquake Engineering Information Service archive)

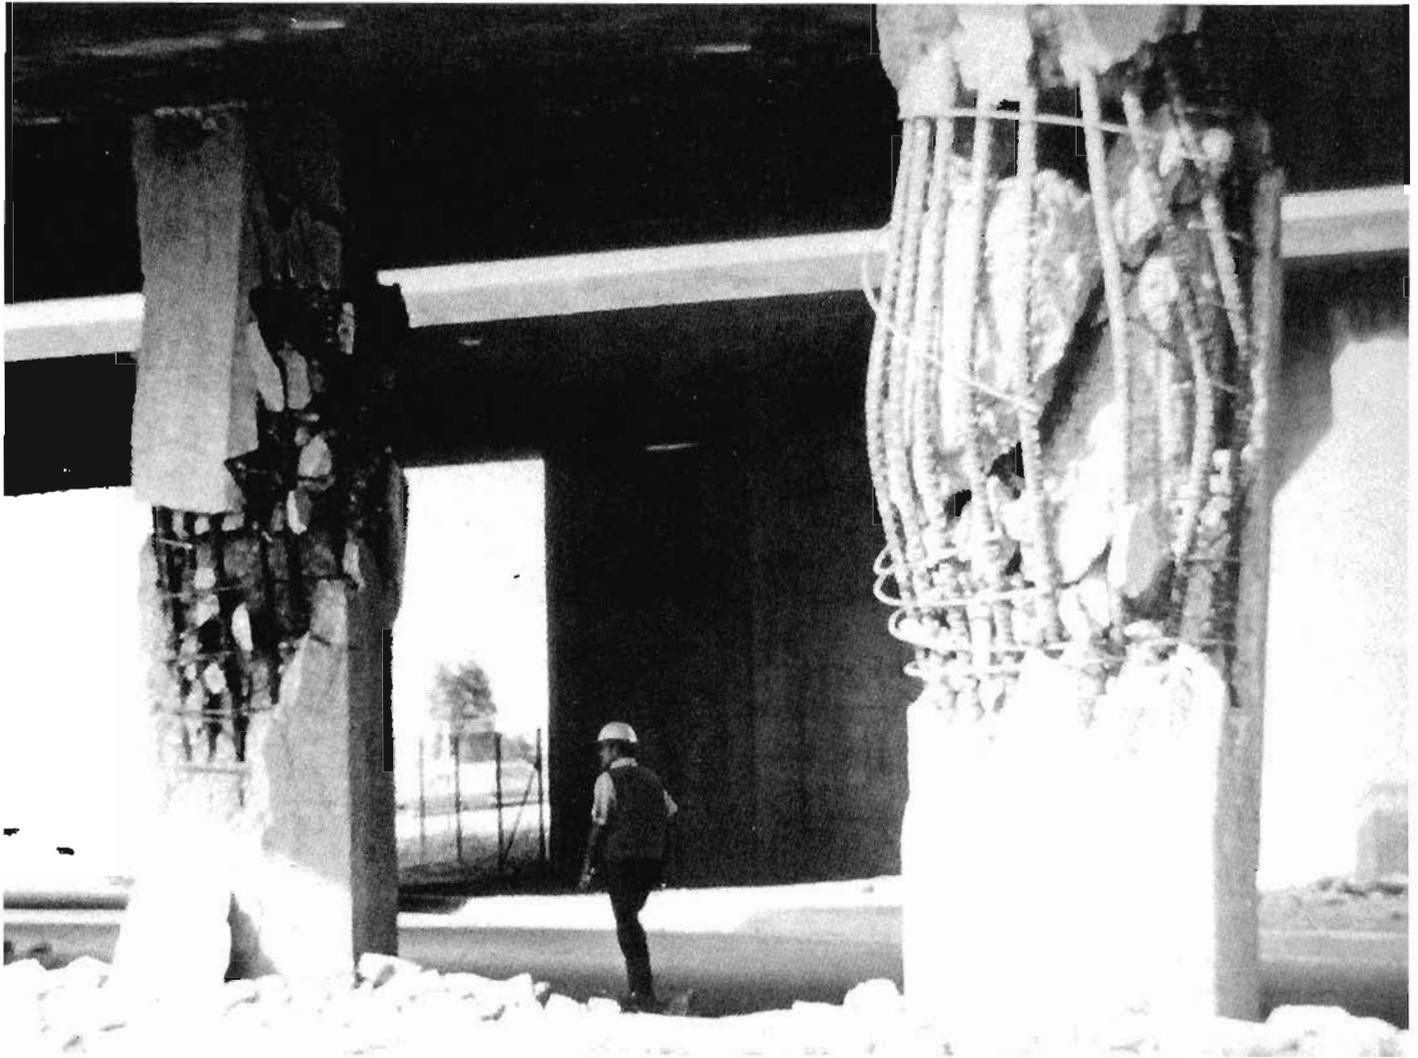
Figure C-3. Columns of the San Fernando Road Overhead suffered heavy damage during the San Fernando earthquake. Note the similarity to the performance of the I-118 Mission and Gothic undercrossing in the Northridge earthquake, Figure 4-6. (photo: National Earthquake Engineering Information Service archive)

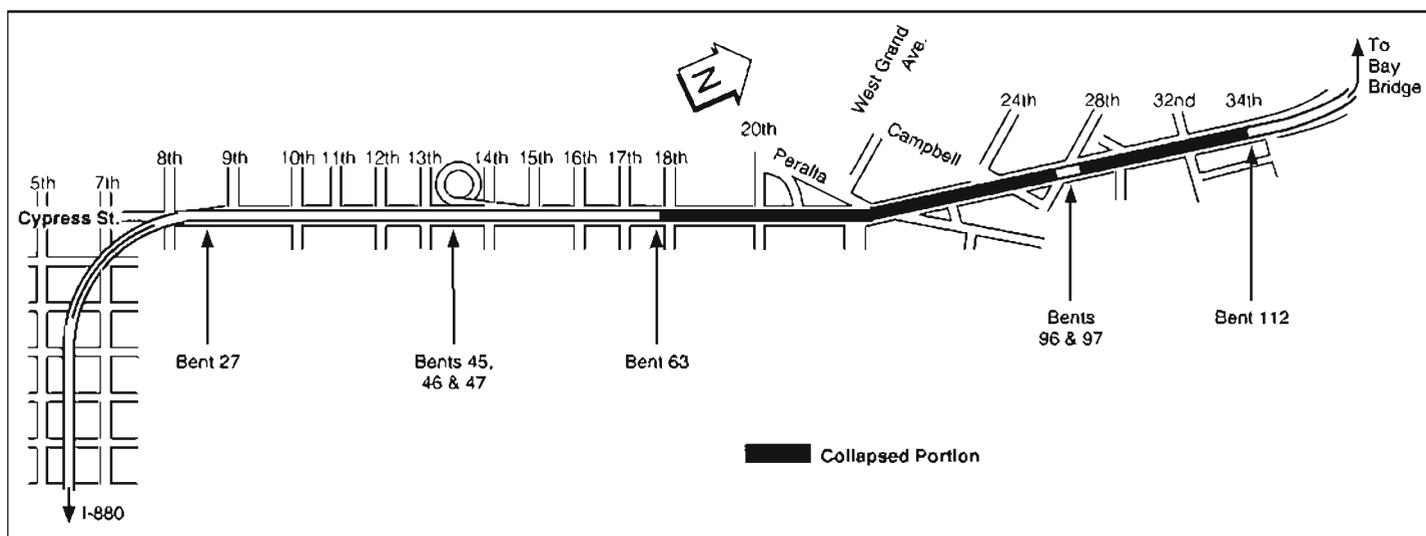
Figure D-2. The Cypress Viaduct showing the extent of the collapse during the 1989 Loma Prieta earthquake. (Housner 1990)

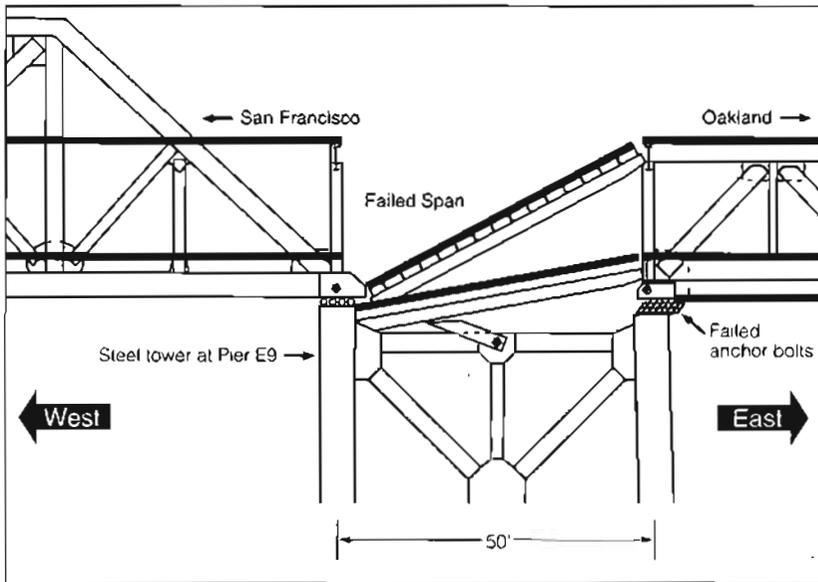
Figure D-3. The west sections of the San Francisco-Oakland Bay Bridge fell during the Loma Prieta earthquake. The upper and lower closure spans fell when the bolts attaching the east (right) truss-span were severed and it moved to the east, pulling the link spans off their western supports. (Housner 1990)
