An Investigation of Causes of Corrosion of Reinforcing Steel in San Mateo-Hayward Bridge IV-SM, ALA-105-B,A

October 1954

Bailey Tremper

State of California
Department of Public Works
Division of Highways
Materials and Research Department

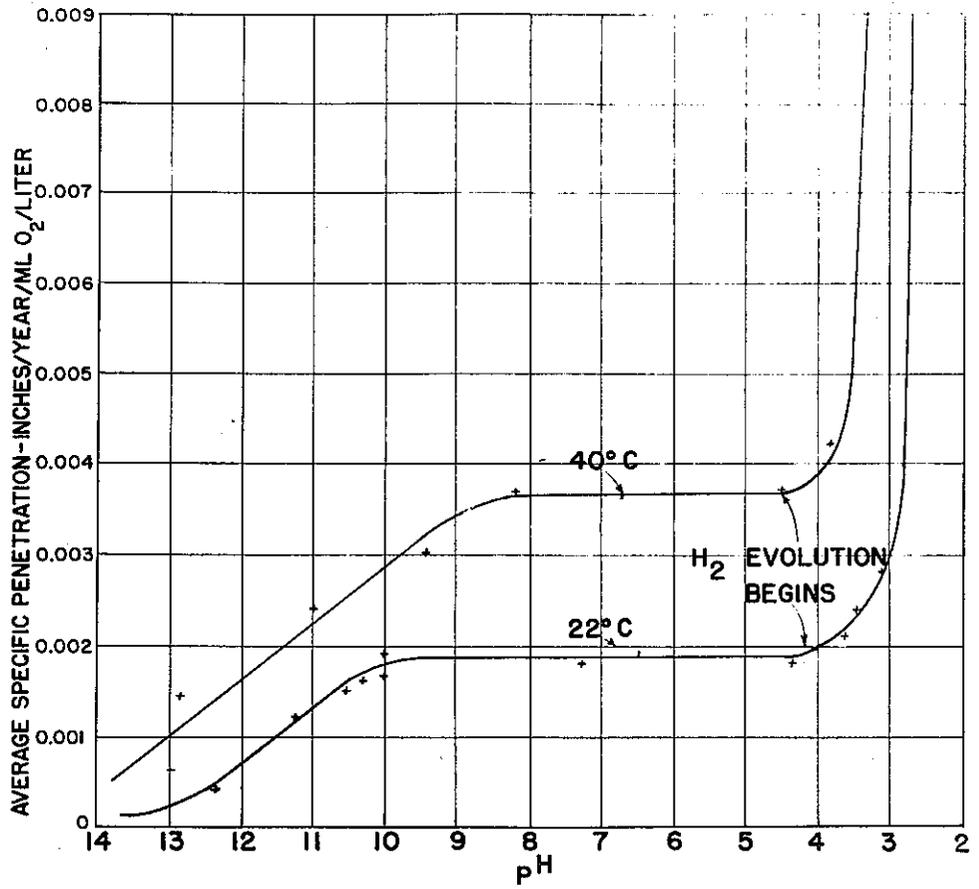
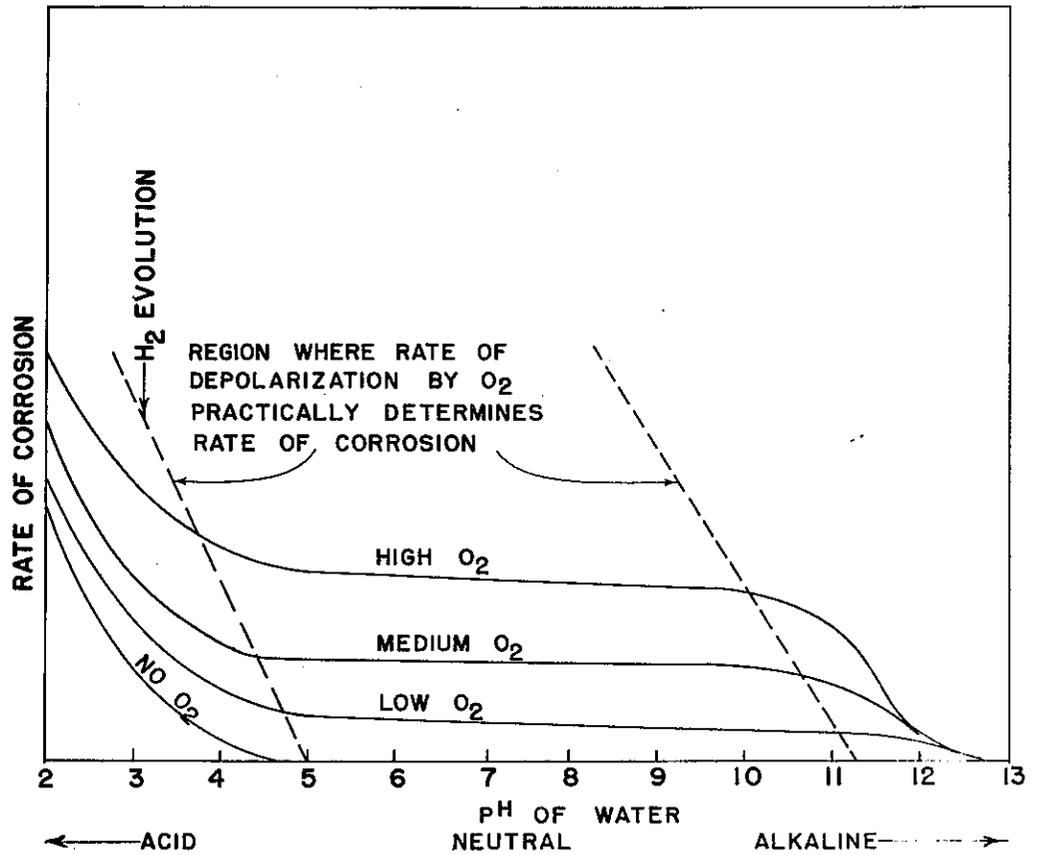
FIGURE I
EFFECT OF PH OF AQUEOUS SOLUTIONS
ON
RATE OF CORROSION ON STEEL

The rate at which corrosion proceeds is influenced greatly by the pH of the medium surrounding the metal. Figure 1 shows curves illustrating this effect. The upper chart is reproduced from Reference (1) and shows that rate of pitting of steel in water containing a controlled amount of oxygen. The lower chart is from Reference (2) and expresses the rate of corrosion in general terms. Both charts illustrate the same principle. In waters more acid than pH 4 or 5 hydrogen is evolved freely and corrosion will proceed whether oxygen is present or not. In the region between pH 4 or 5 and about 10 the rate is substantially constant for a given rate of supply of oxygen at the surface of metal where it can act as a depolarizer. Above a pH of about 10 the rate of corrosion diminishes with increasing pH

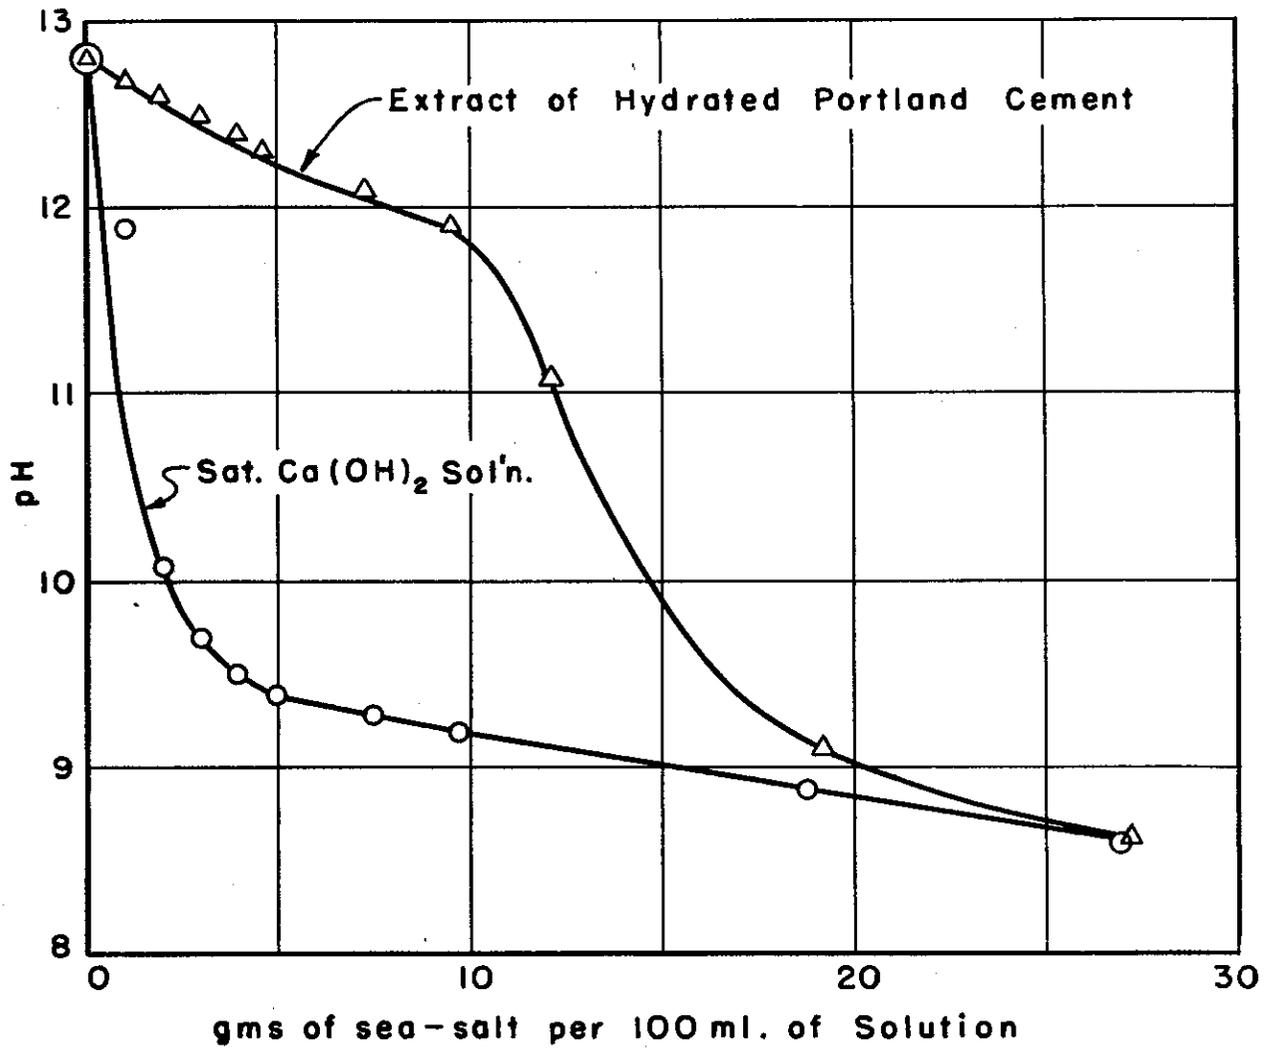
FIGURE 3.

portland cement, it is seen that theoretically a pH of 10 would result when the concentration of sea-salt in the water present in concrete amounts 2 grams per 100 ml. The data presented in the preceding section show that sea-salt in excess of 0.45 percent (0.25 percent chlorides) was found frequently in the samples that were analysed. The absorption of concrete from the beams, caps and piles were shown in Table II to be about 7 percent which is equivalent to about 12 percent of the mortar. With 0.45 percent sea-salt its concentration in the water of saturated concrete would be about 3.7 grams per 100 ml. From the calcium hydroxide curve of Figure 3 the resulting pH would be about 9.5.

Figure 3 also contains a curve for which the solution is a water extract of freshly hydrated portland cement paste. The paste was made with Golden Gate cement (the brand used in the bridge) which contained about 1.10 percent alkalis (Na_2O and K_2O). The paste was mixed at normal consistency and was cured in the moist room for 7 days. It was then oven-dried and granulated. Water was added to bring the total quantity to 7-1/2 gallons per sack of original cement and the mixture was agitated continuously for 3 days and then filtered. Varying amounts of sea-salt and a small amount of hydrated cement were added to portions of the extract. pH values were determined at intervals up to 7 days at which time they were constant. Each sample was then analysed for chlorides and calcium hydroxide in solution. The data were used to construct the curve as shown in Figure 3. The data of the tests are given in Table XI at the end of the report. Only one series of tests was made and the shape of the resulting curve has not been verified.

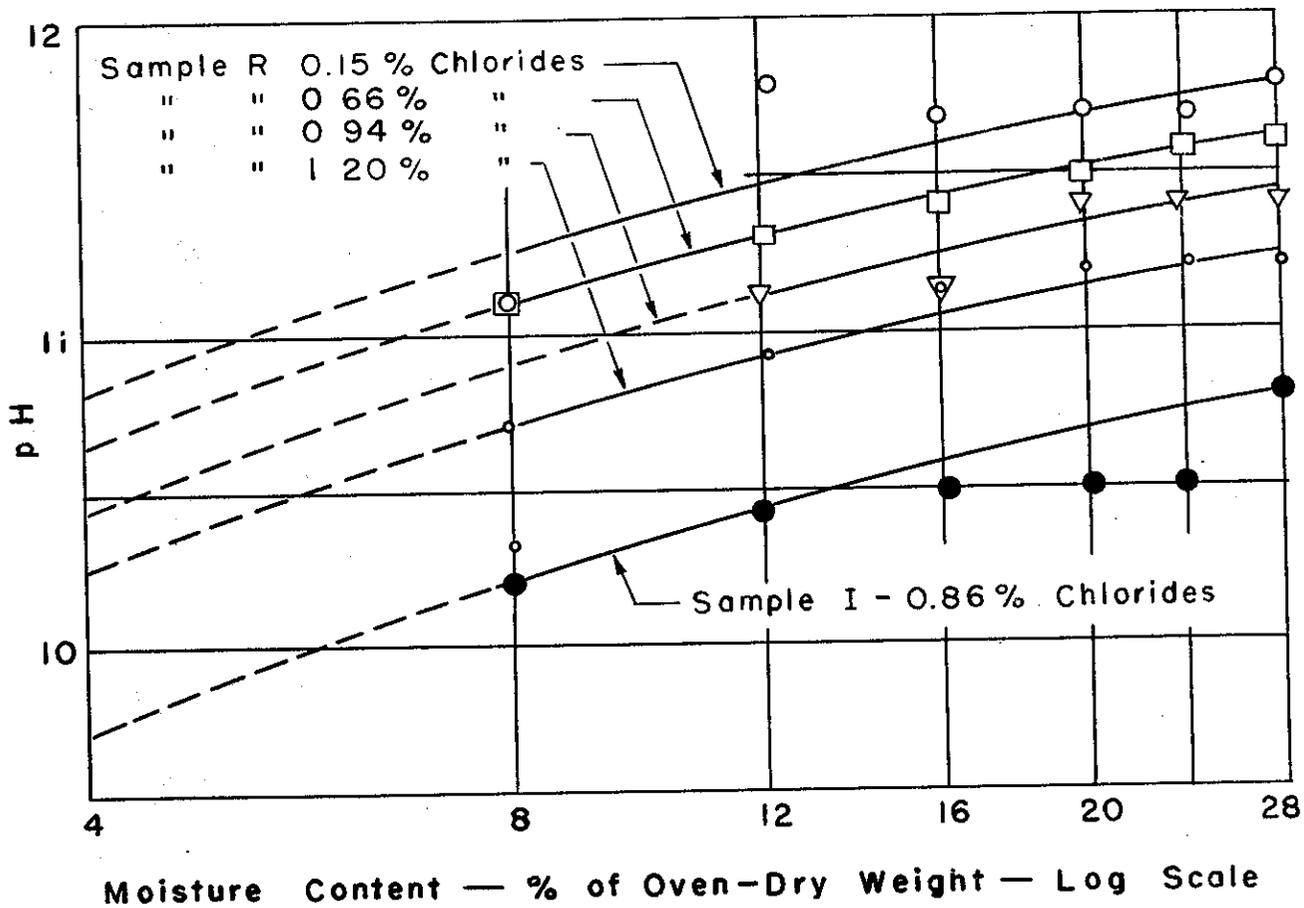
FIGURE 4.
 EFFECT OF MOISTURE ON pH OF
 MORTAR CONTAINING SEA-SALT.

pH values of two moistened samples of pulverized mortar from the bridge were determined. Increments of sea-salt were added to sample R and the actual contents of chlorides were determined. The results are shown graphically in Figure 4. The plotted points are for moisture contents of 8 percent (about 75 percent saturation) and higher. 8 percent was the lowest moisture content at which pH could be measured with a glass electrode. The curves have been extrapolated into the region of lower moisture. Sample I presumably has lost more alkalis through leaching than has sample R and therefore has a lower pH for the same salt content.

samples were then sealed in chemically resistant glass bottles. pH readings were made after 2, 4 and 8 days and appeared to be stable at the latter date. Each recorded value was the average of several trials. The values used in plotting Figure 4 are the averages of the 4 and 8-day readings. Considerable difficulty was experienced in obtaining reproducible readings and smooth curves could not be fitted to include all of the plotted points. Nevertheless the trend is unmistakable and it is believed that the curves as drawn are fair representations of true conditions.

The data indicates the probability of pH values as low as 10 to 11 in unsaturated concrete containing sea-salts in the amounts found to be present in samples from the bridge. (Refer to Table X.)

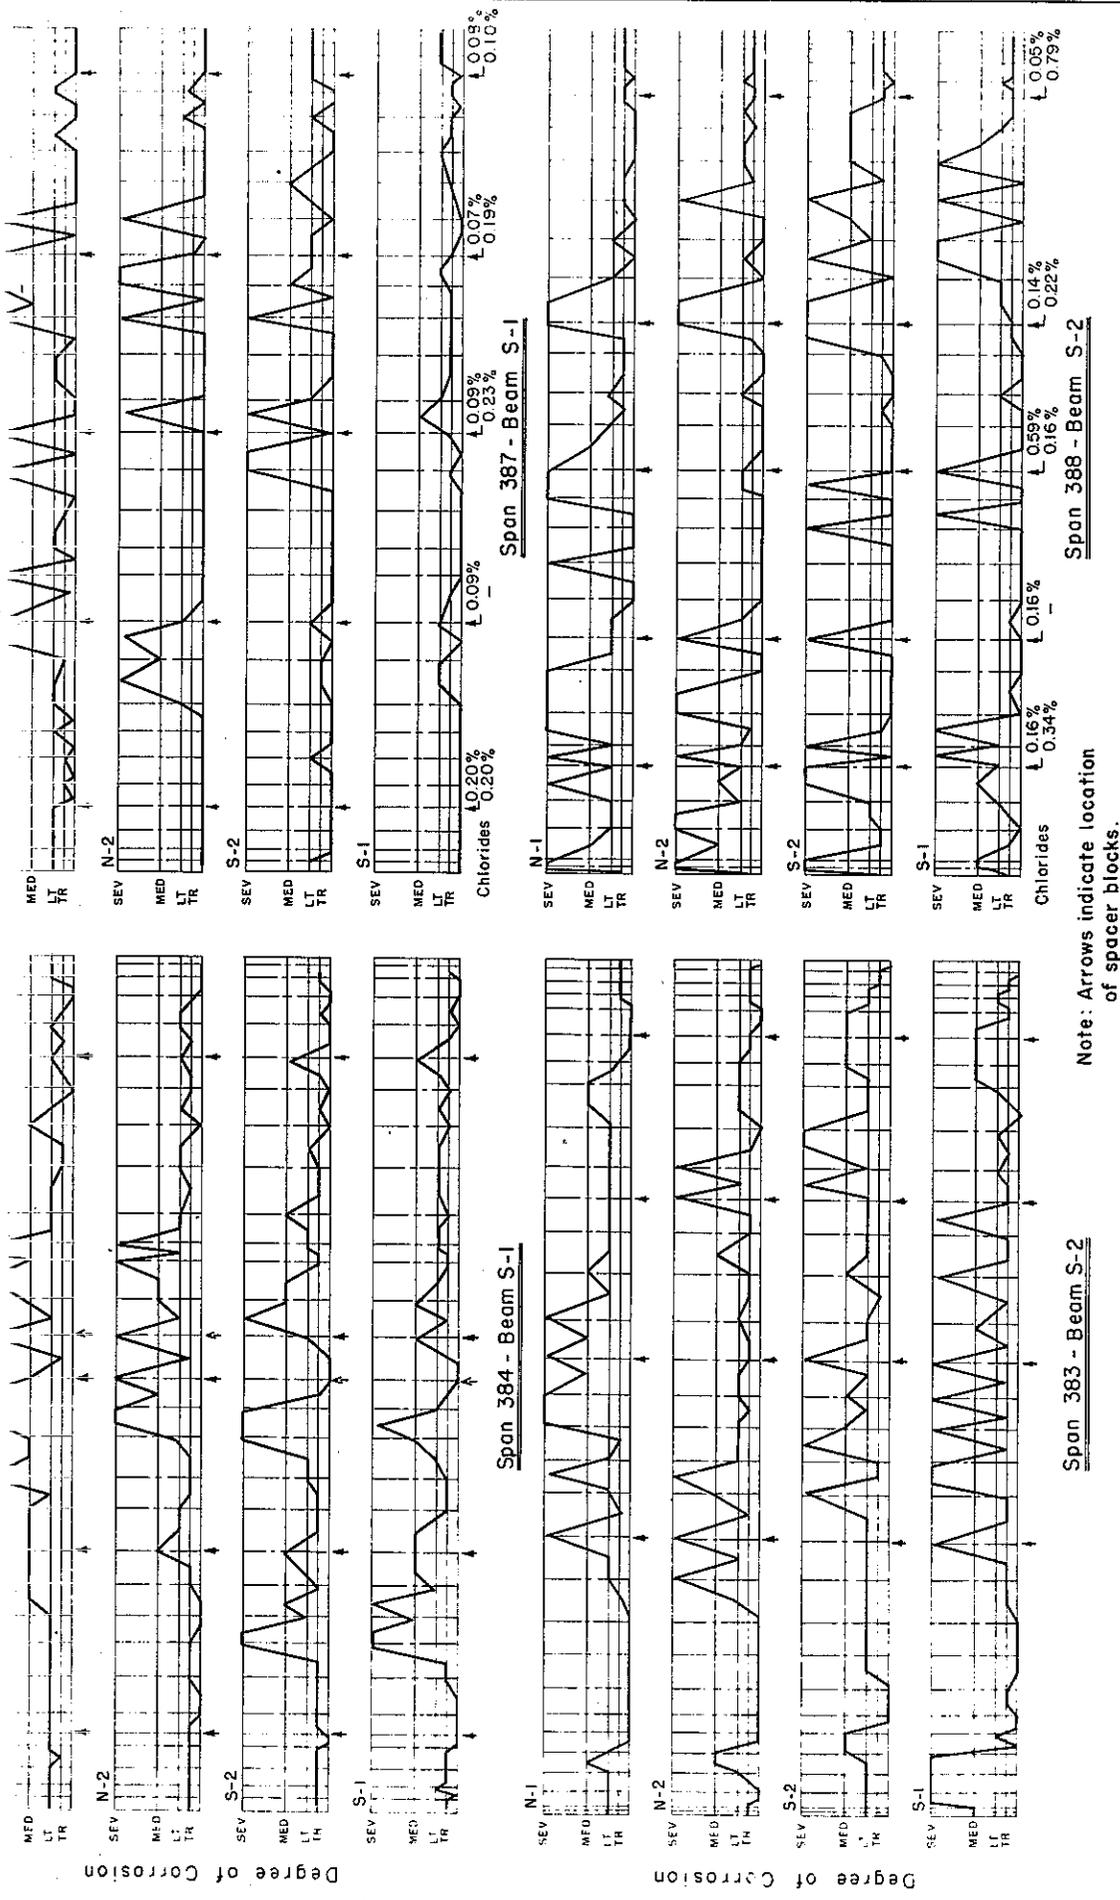
FIGURE 5
DISTRIBUTION OF CORROSION
ON LOWER BARS OF BEAMS

The data of these notes have been plotted in Figure 5. The condition in Span 387, Beam S-1 (upper right of figure) shows particularly well that corrosion is more severe in the vicinity of the spacer blocks and suggests that it may have started at these locations and later spread in one or both directions from these points. In other beams where corrosion is more advanced the relation to the spacer blocks is less clearly defined.

Taken as a whole, the frequency at which severe or medium corrosion has occurred within 1 foot of a spacer block is about 60 per cent greater than over the entire length of the bars.

In the four beams there were 18 pairs of spacer blocks each supporting stirrups which in turn supported four longitudinal bars. There were thus 72 points of "contact" between bars and spacer blocks. At 19 points the corrosion was at a low level at the block and for several feet each side. Of the remaining 53 points the following relationship obtained:

Corrosion severe at or within 1 foot of spacer block	34 points or 64 percent
Corrosion medium and definitely higher at spacer block than in interval of several feet each side	7 points or 13 percent
Corrosion less at spacer block than in adjoining spaces	12 points or 23 percent

The evidence is therefore quite strong that the spacer blocks introduced points of weakness with respect to the prevention of corrosion.

Chloride determinations of the blocks in two beams are indicated on the diagrams. Relatively low percentages of chloride were found in the blocks nearest the west end of the beams and corrosion in this vicinity was of low order. Over the remaining portion of the beams there appears to be little relationship between the percentage of chlorides and the degree of corrosion.
