Final Report on Protective Coatings Used in the Experimental Painting of the Leffingwell Creek Bridge

Final Report

LEFFINGWELL CREEK BRIDGE

January, 1959

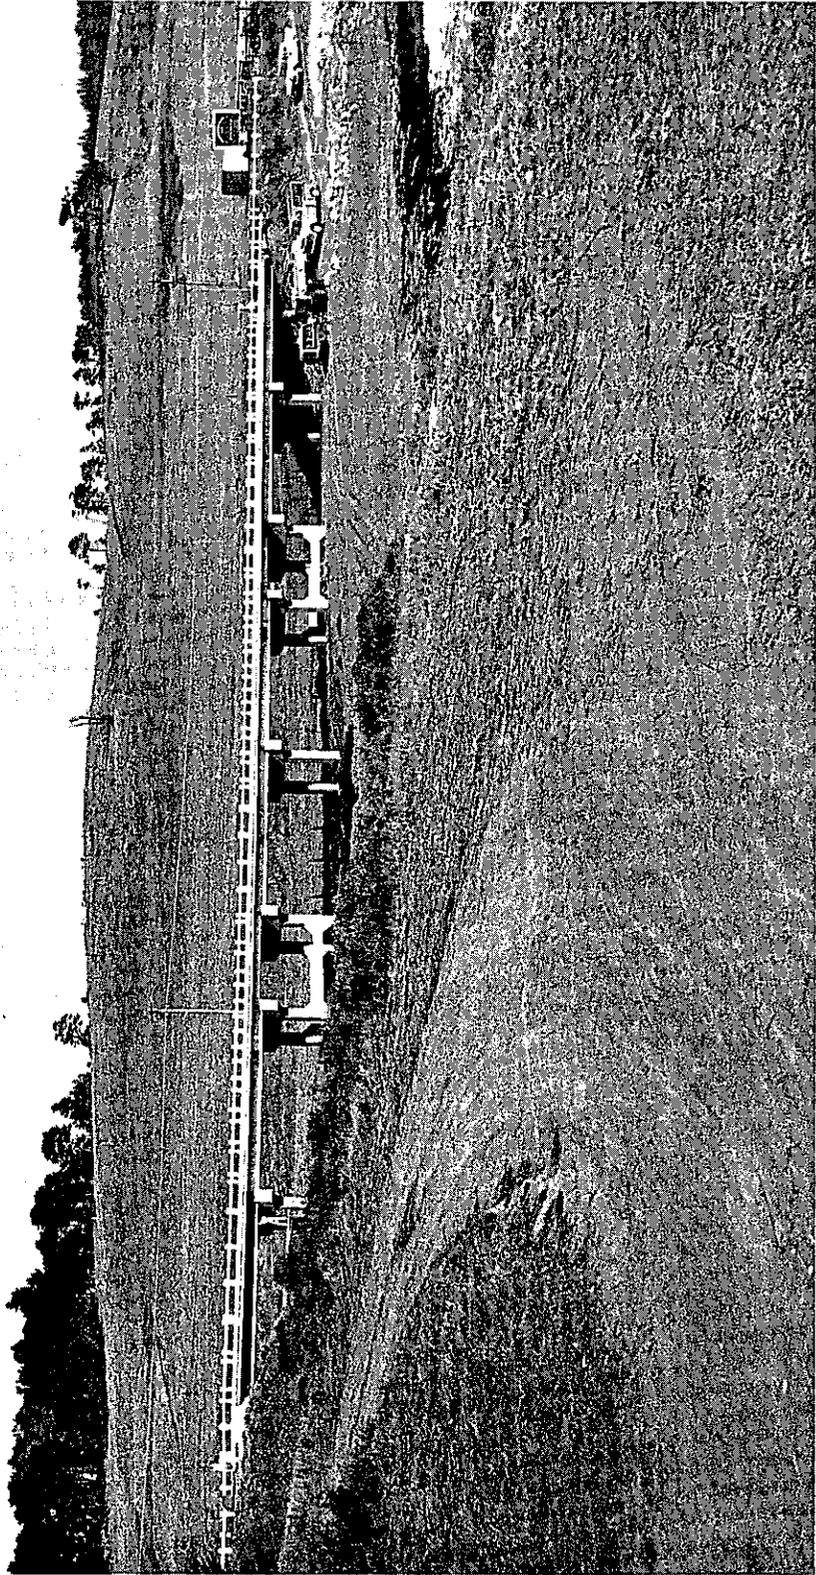
Fig. 1. Leffingwell Creek Bridge as viewed from near the Pacific Ocean surf line. This picture was taken in October 1958, just at the beginning of sandblasting operations for repainting.

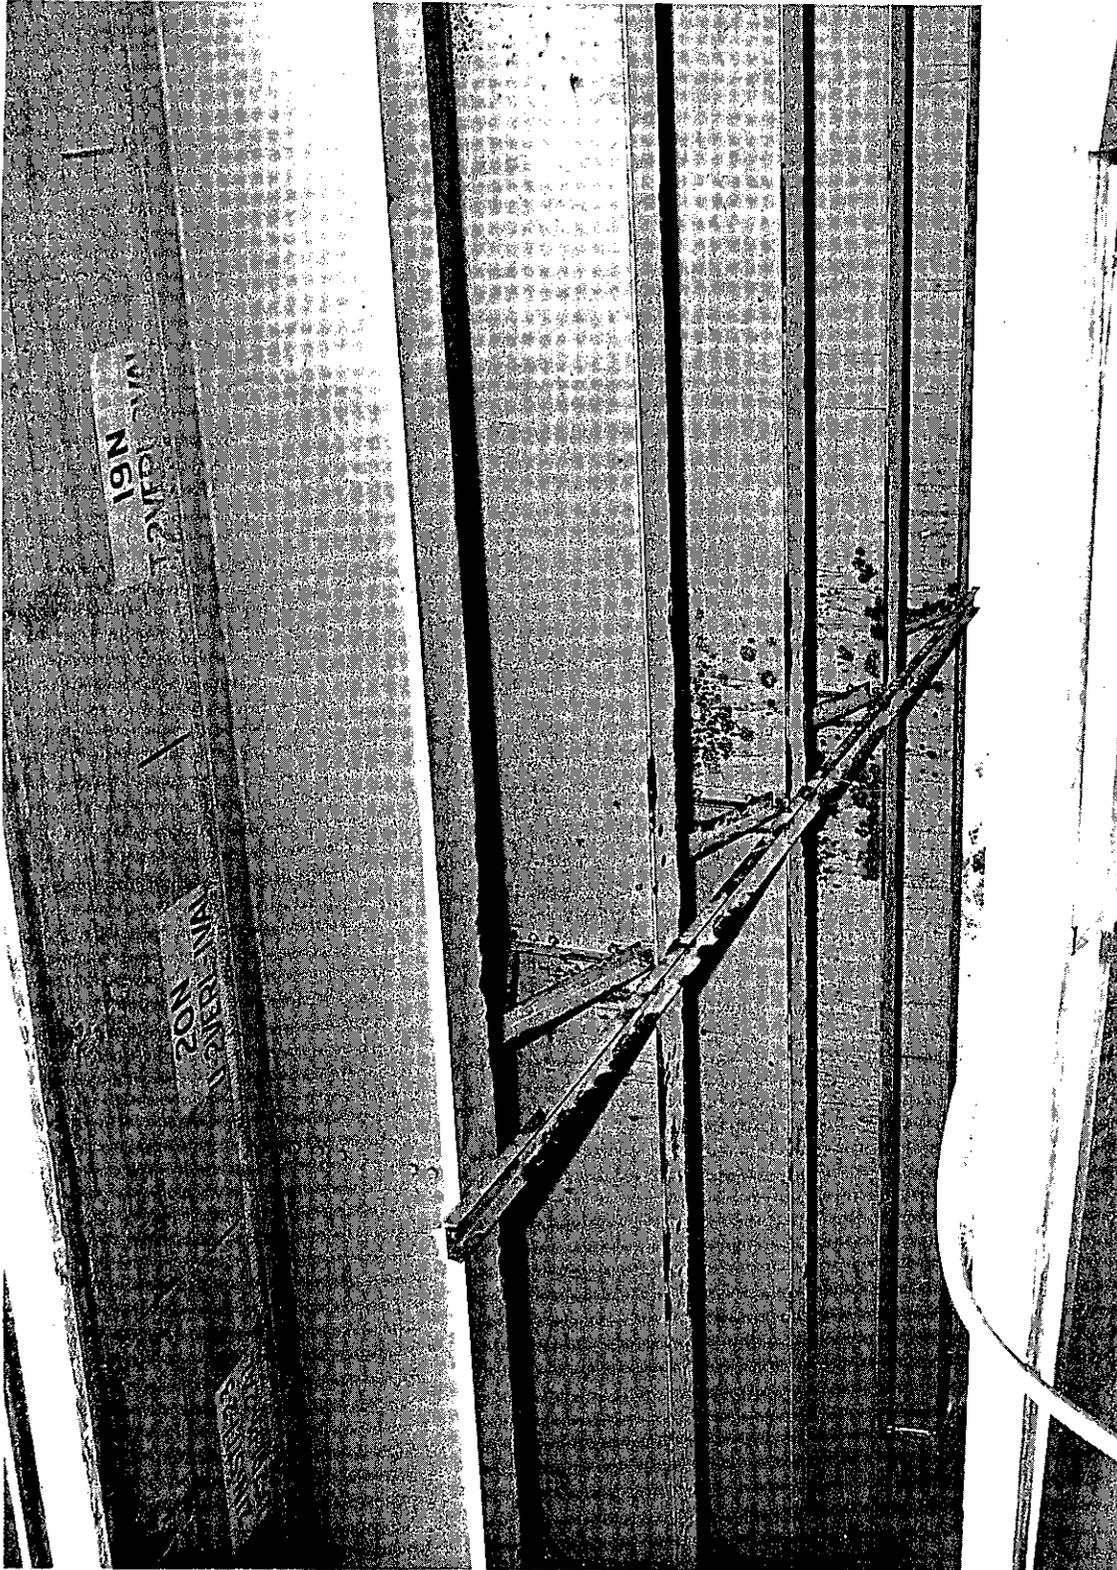
feature of the effects. Panels 4H, Fig. 14 and 20H, Fig. 17, 18, are badly corroded on the left of the brace; Panel 4N, Fig. 8 and 9, corrosion is mostly on the right side of the brace, while that of Panel 20N, Fig. 2 and 3, is pretty evenly distributed on each side of the brace. These inconsistencies within the individual panels are not so readily discernible from the photographs as they were from direct inspection where angular viewing could be eliminated.

The Red Lead Phenolic used on Panel 21N, Stringers 1,2,3, Fig. 2, and on Panel 22H, Stringers 1,2,3, Fig. 19, should have been labeled RLPPh - X6. This formulation is a variation of the coating frequently used by the San Francisco-Oakland Bay Bridge and consists of Red Lead in linseed oil reinforced with the State Specification Aluminum Varnish. The vehicle is not greatly different from that used in the other RLPPh series but the performance — so far as we can judge from its limited trial — seems to be better. Of course, the location in each instance cited is recognized as more favorable generally than most of the RLPPh series of panels.

Fig. 2. The legend shown on the underside of the bridge deck describes the coating and whether steel was treated or not, e.g., Panel 20N indicates bare sandblasted steel was painted with two coats of Vinyl Epoxy Red Lead and one coat Vinyl Aluminum. Panel 19N steel treated with phosphoric acid, two coats of Vinyl Epoxy Red Lead - two coats Vinyl Aluminum.

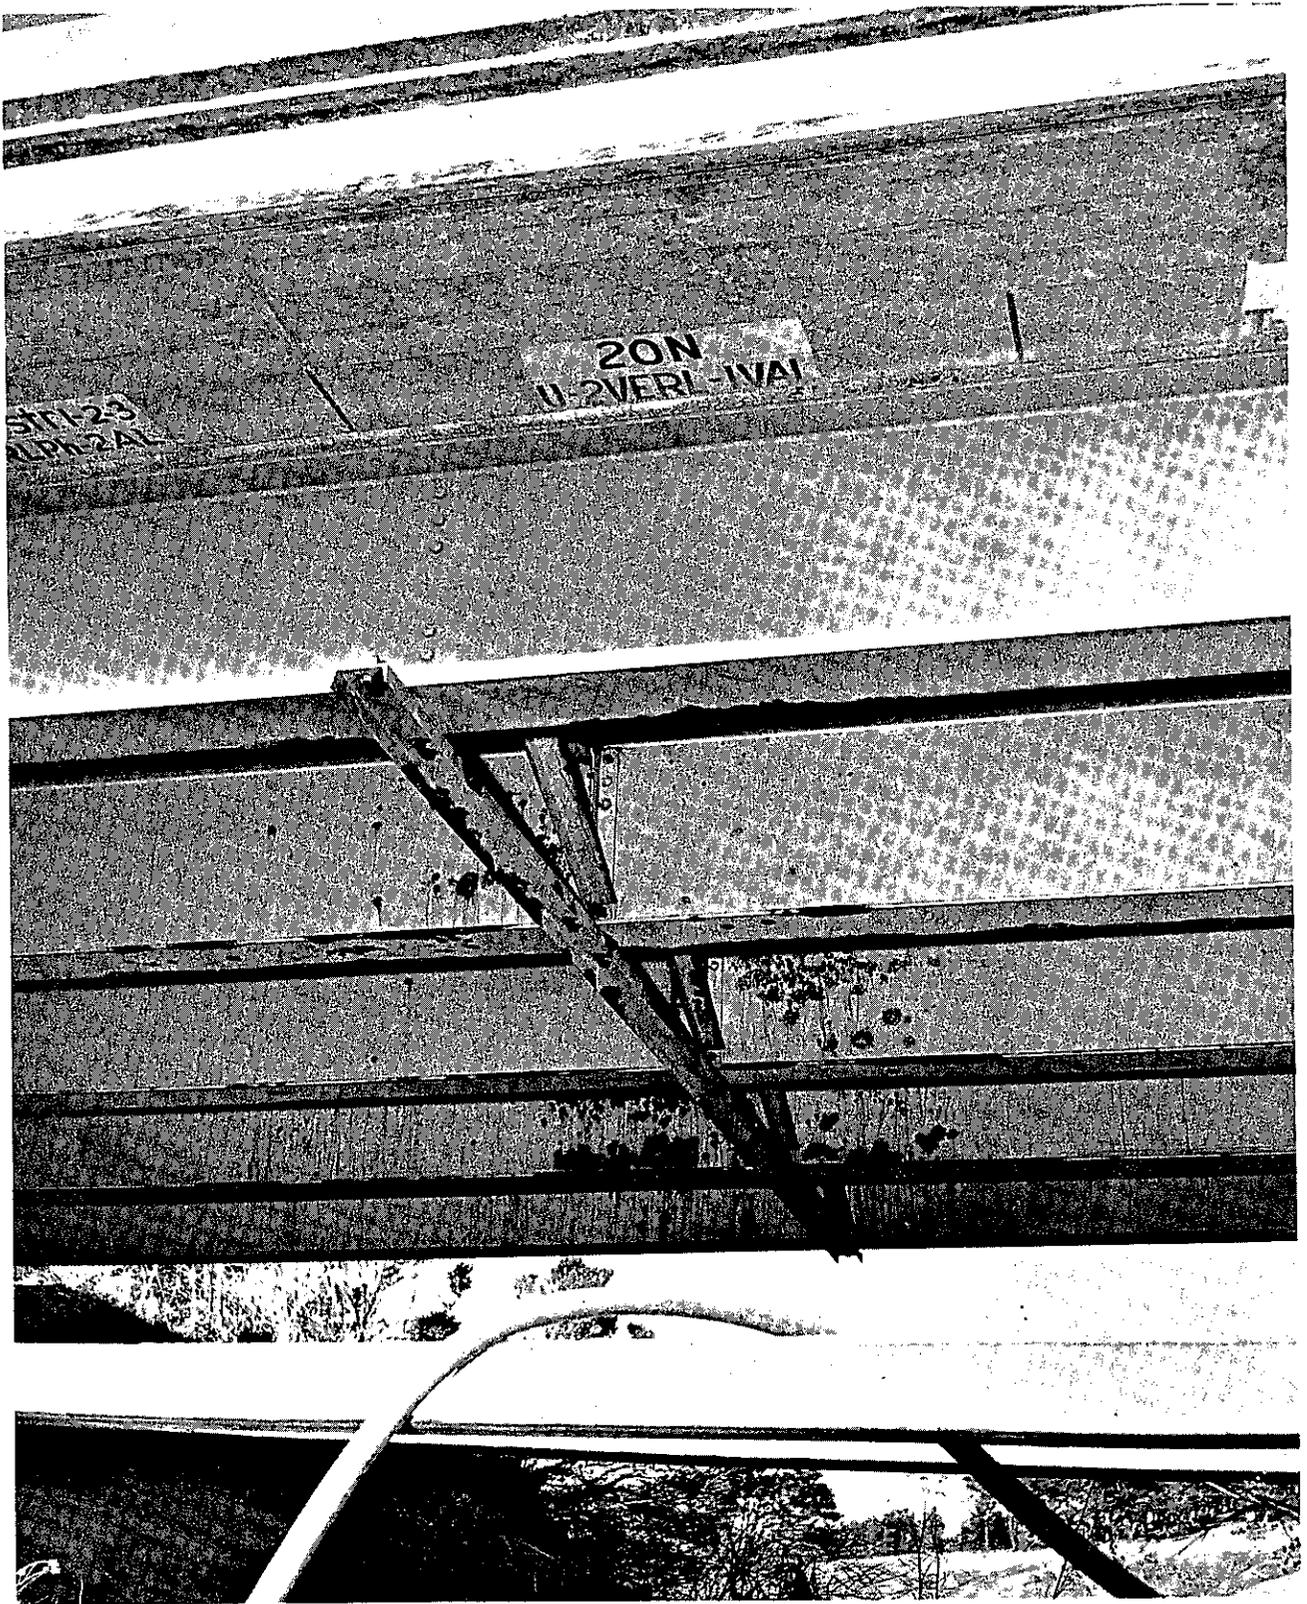
Fig. 3. A somewhat enlarged view of Panel 20N. Notice the apparent effect of the brace on the corrosion.

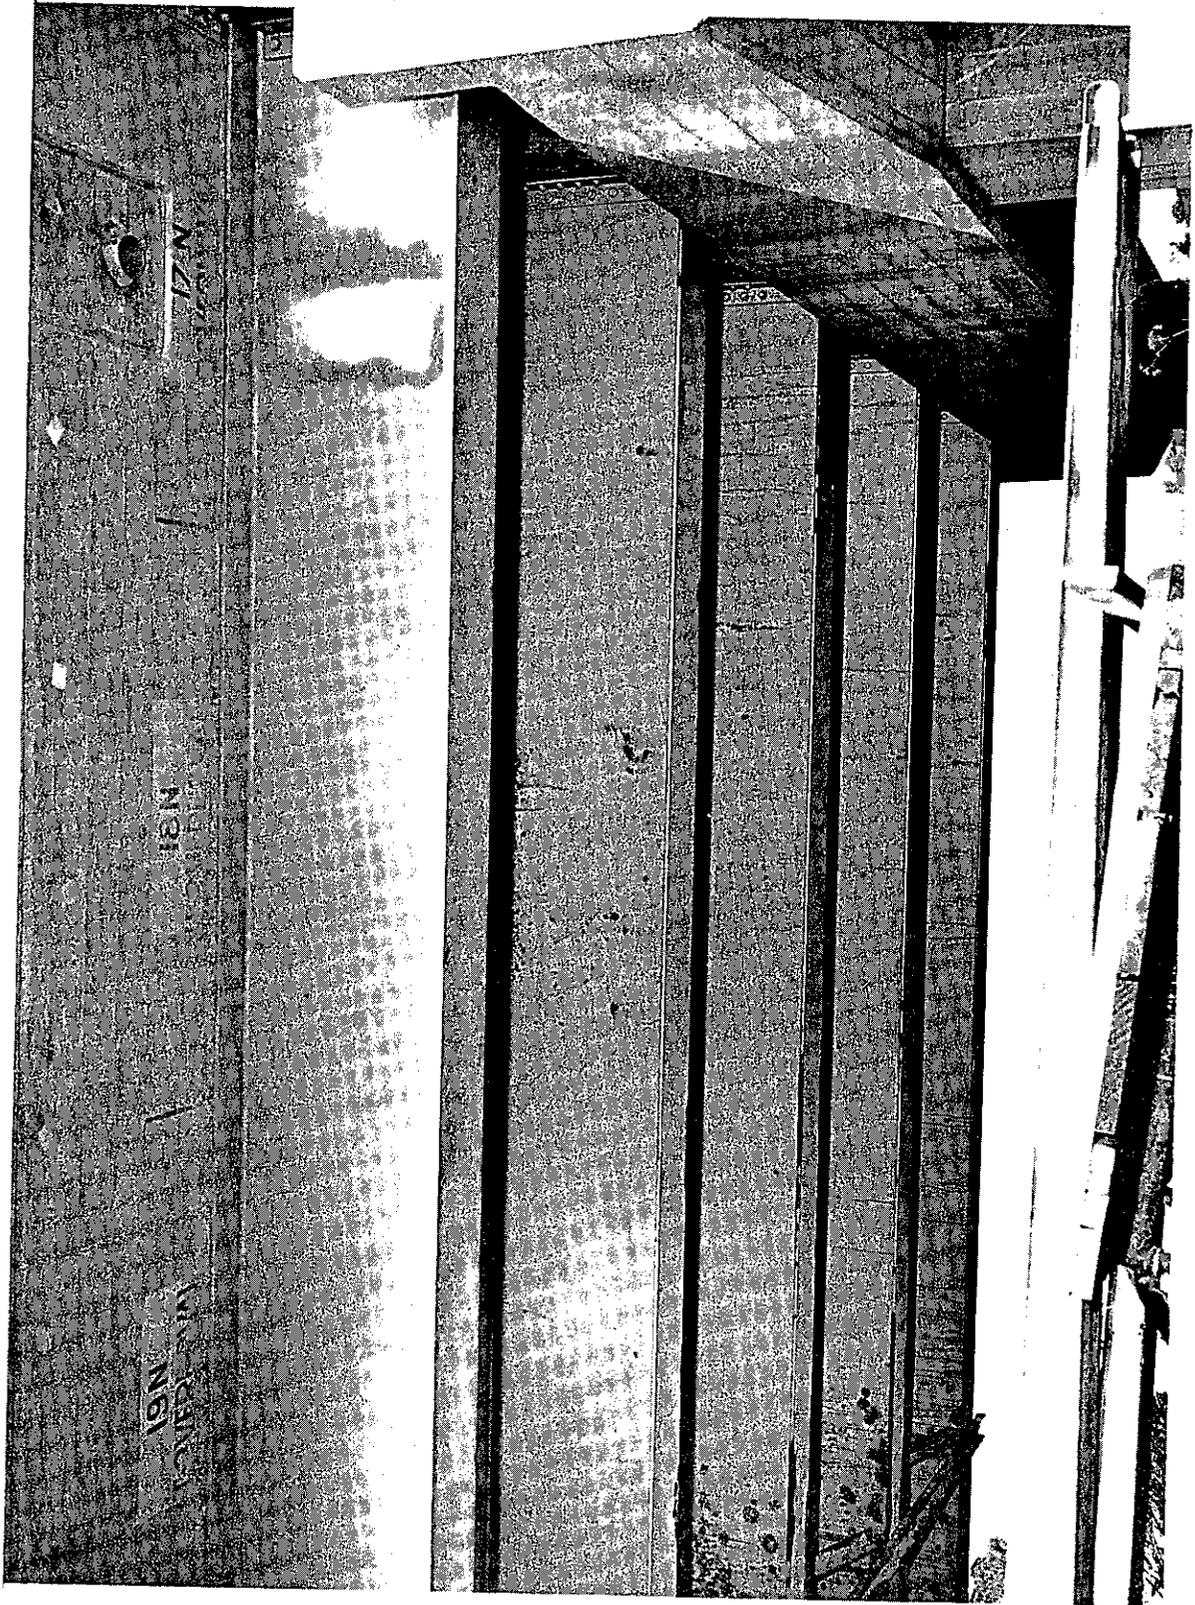
Fig. 4. Panels 19N and 18N were presumably given identical coatings except that 19N had the acid treatment, 18N none. Note the general better appearance of 19N.

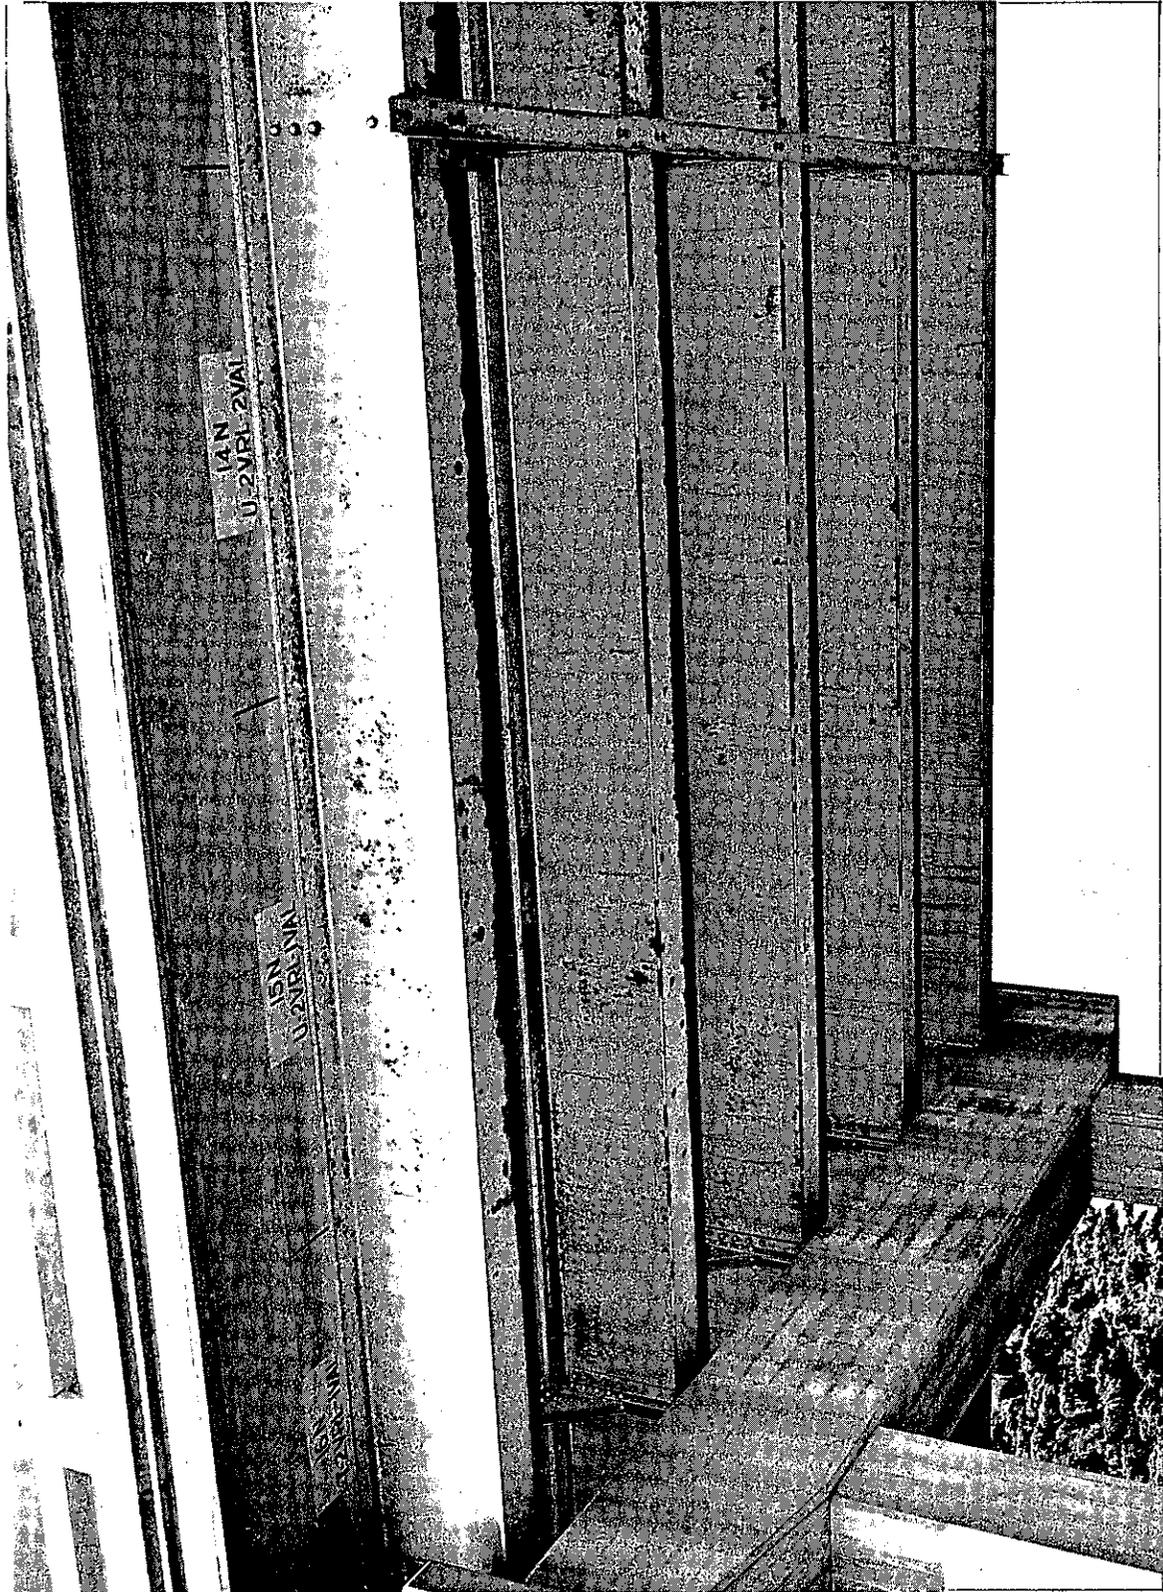
Fig. 5. The effect of the pier and brace in this section has probably been predominate.

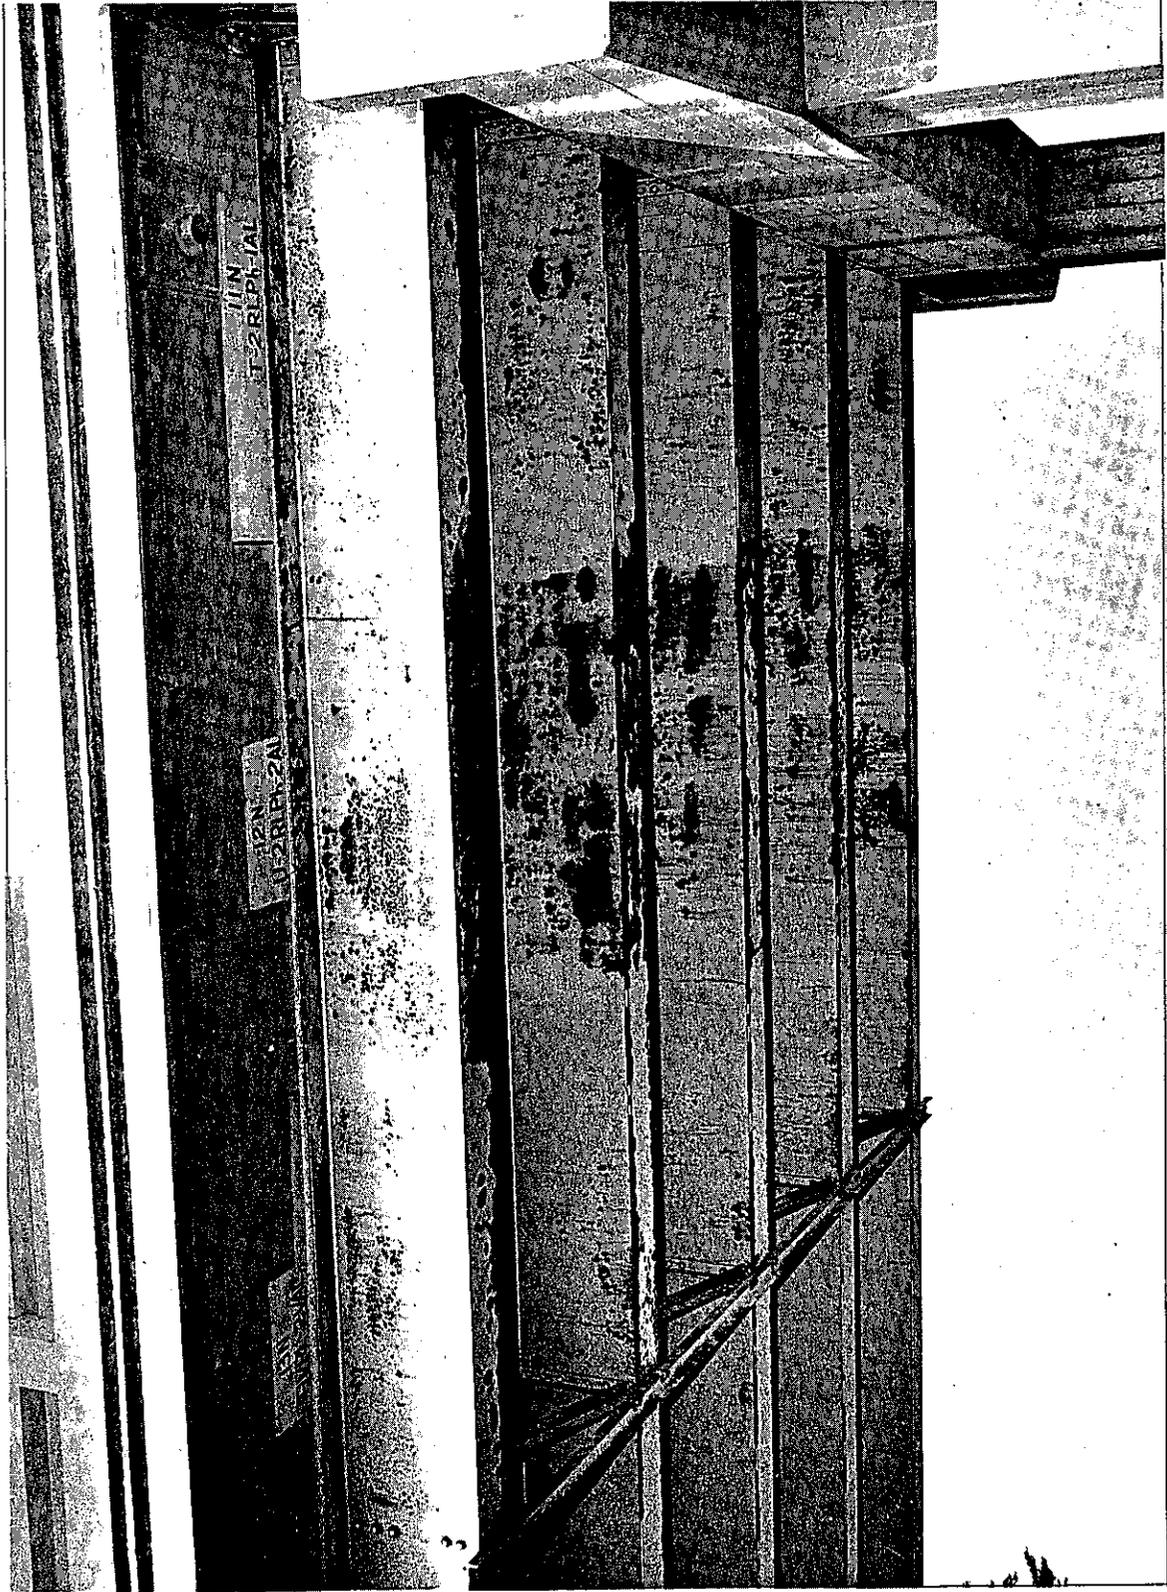
Fig. 6. The effect of acid treatment of the steel seems to be very evident here in Panel 11N compared to untreated 12N, even with an extra coat of Aluminum.

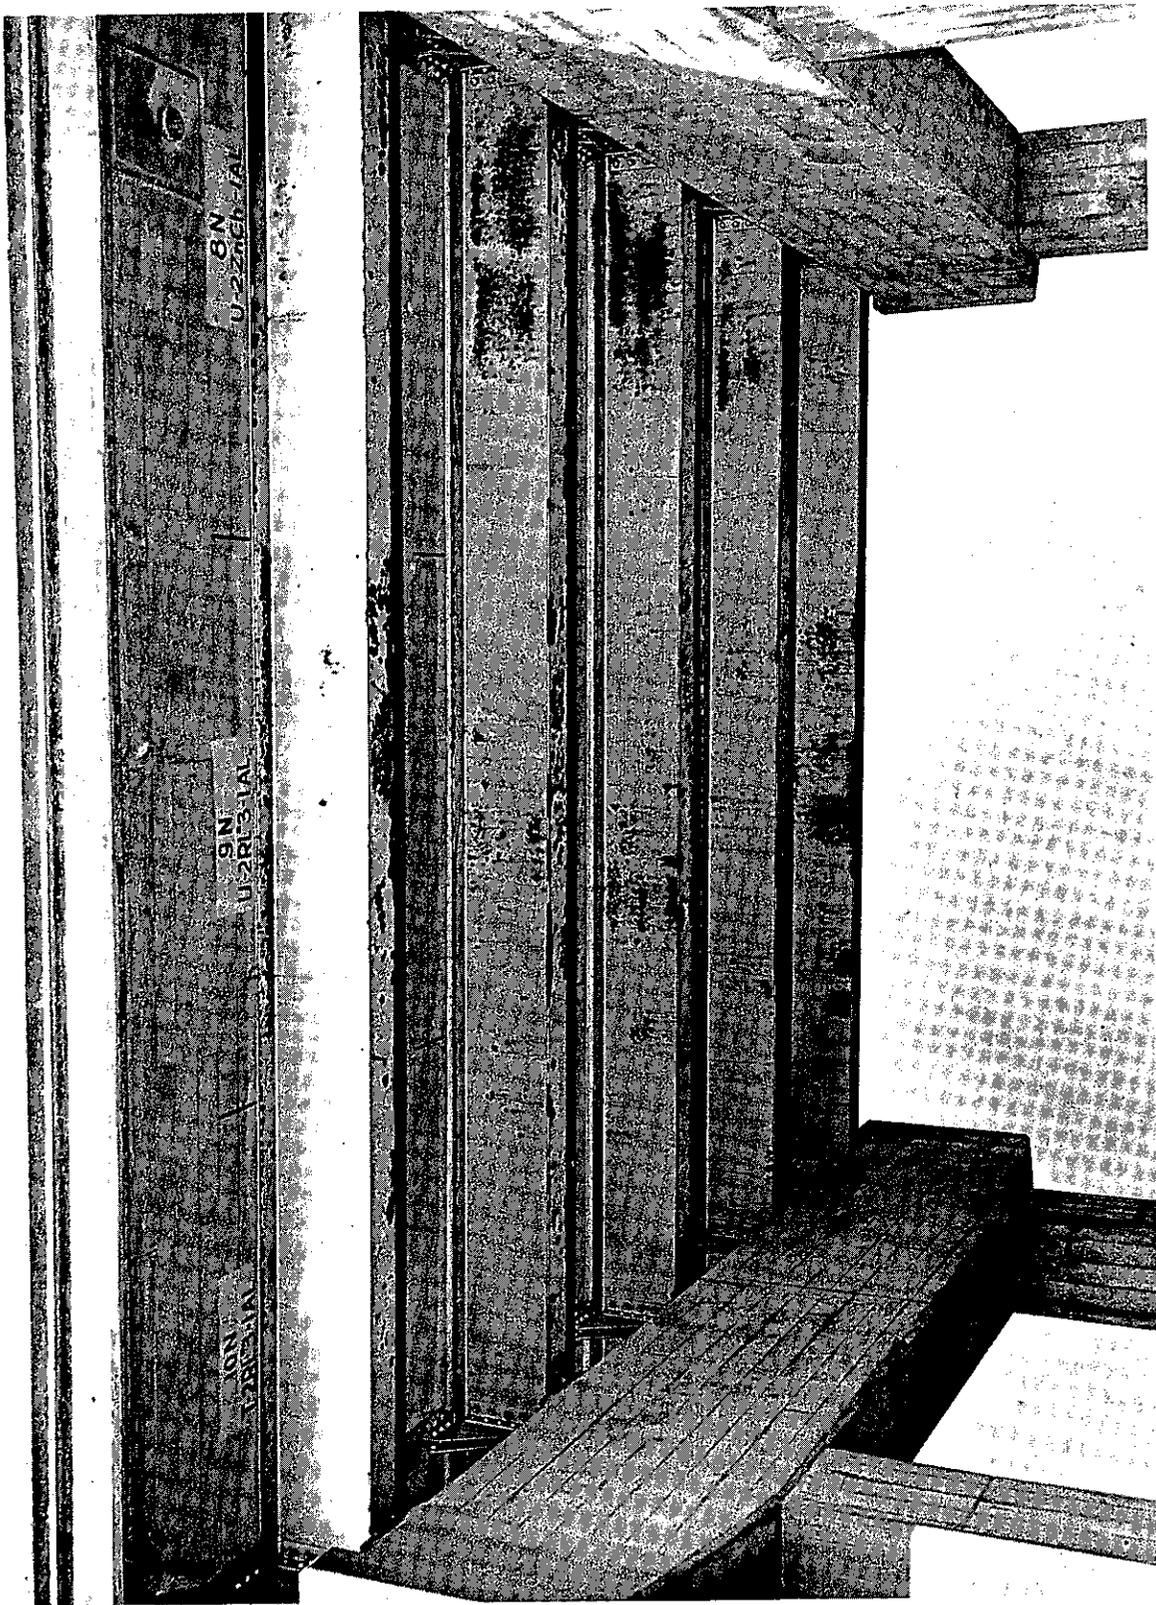
Fig. 7. Panels 10N and 9N seem to show the benefit of treatment in Panel 10N, although the effect of the pier alongside this panel is unknown.

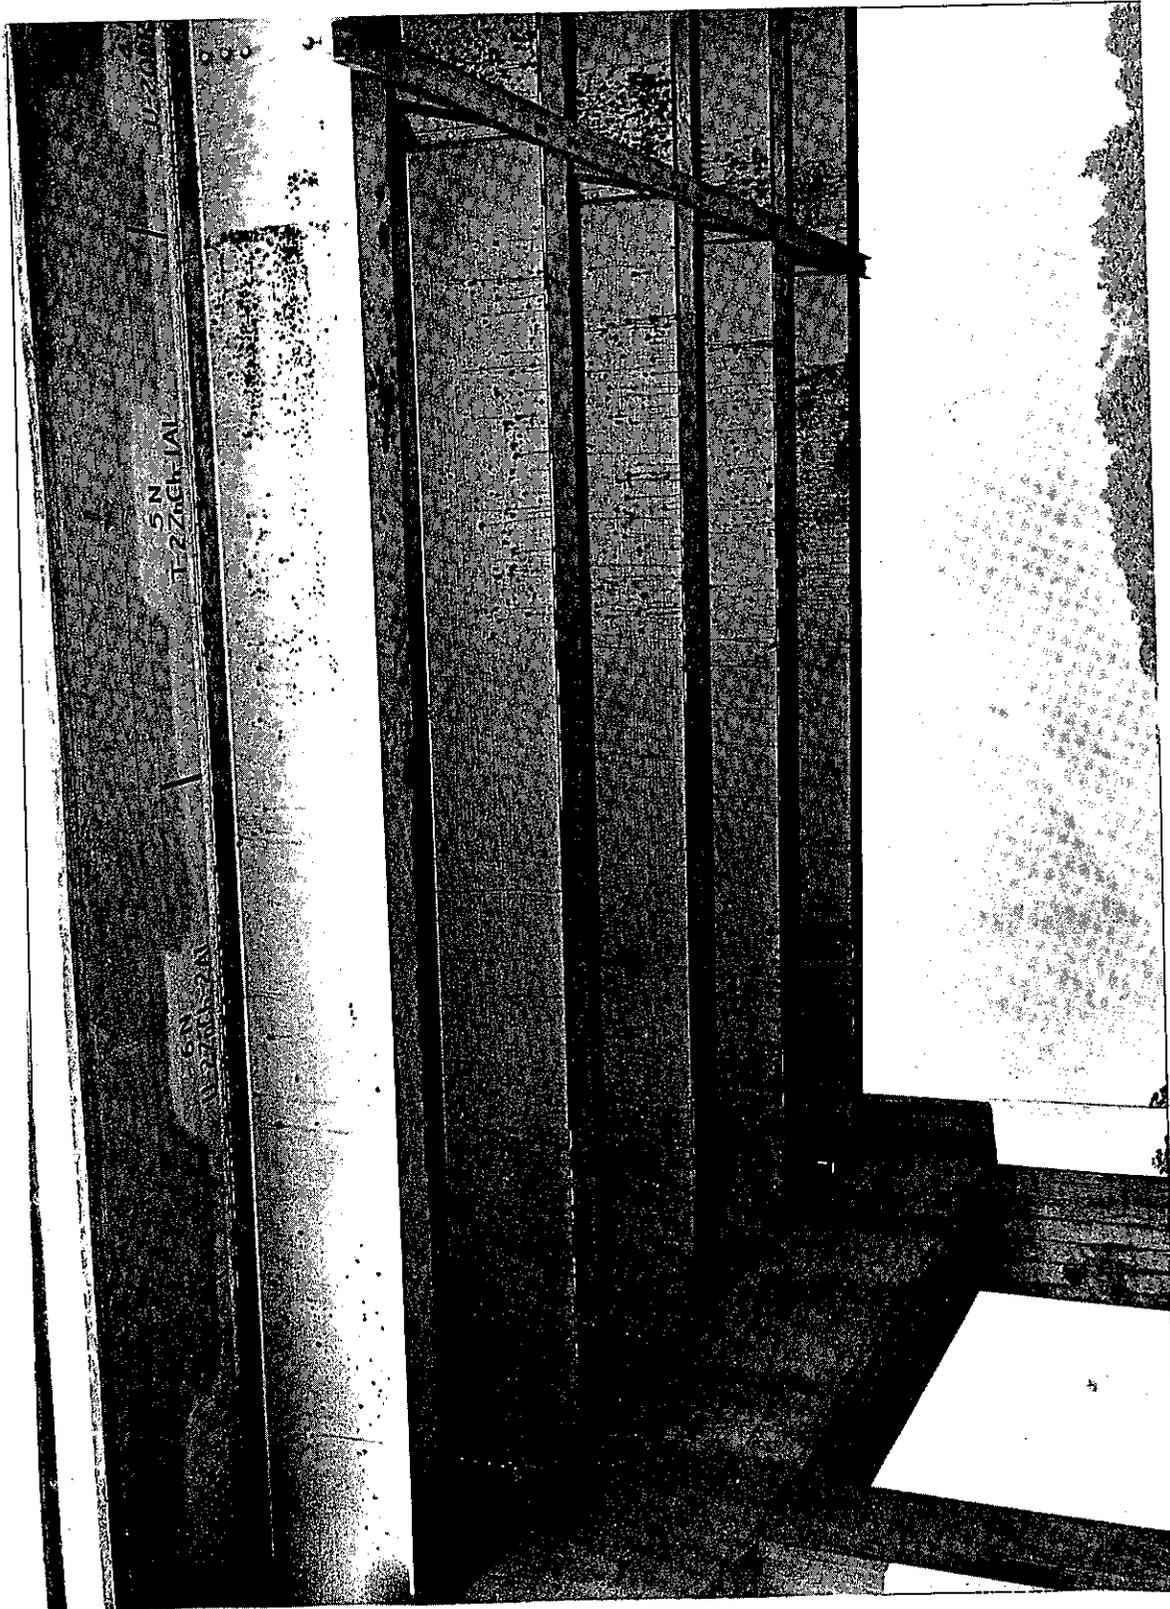
Fig. 8. Here is a reversal from result noted in Fig. 7. Treated Panel 7N is in poor shape compared to untreated 6N, probably due to pier effect on wind currents.

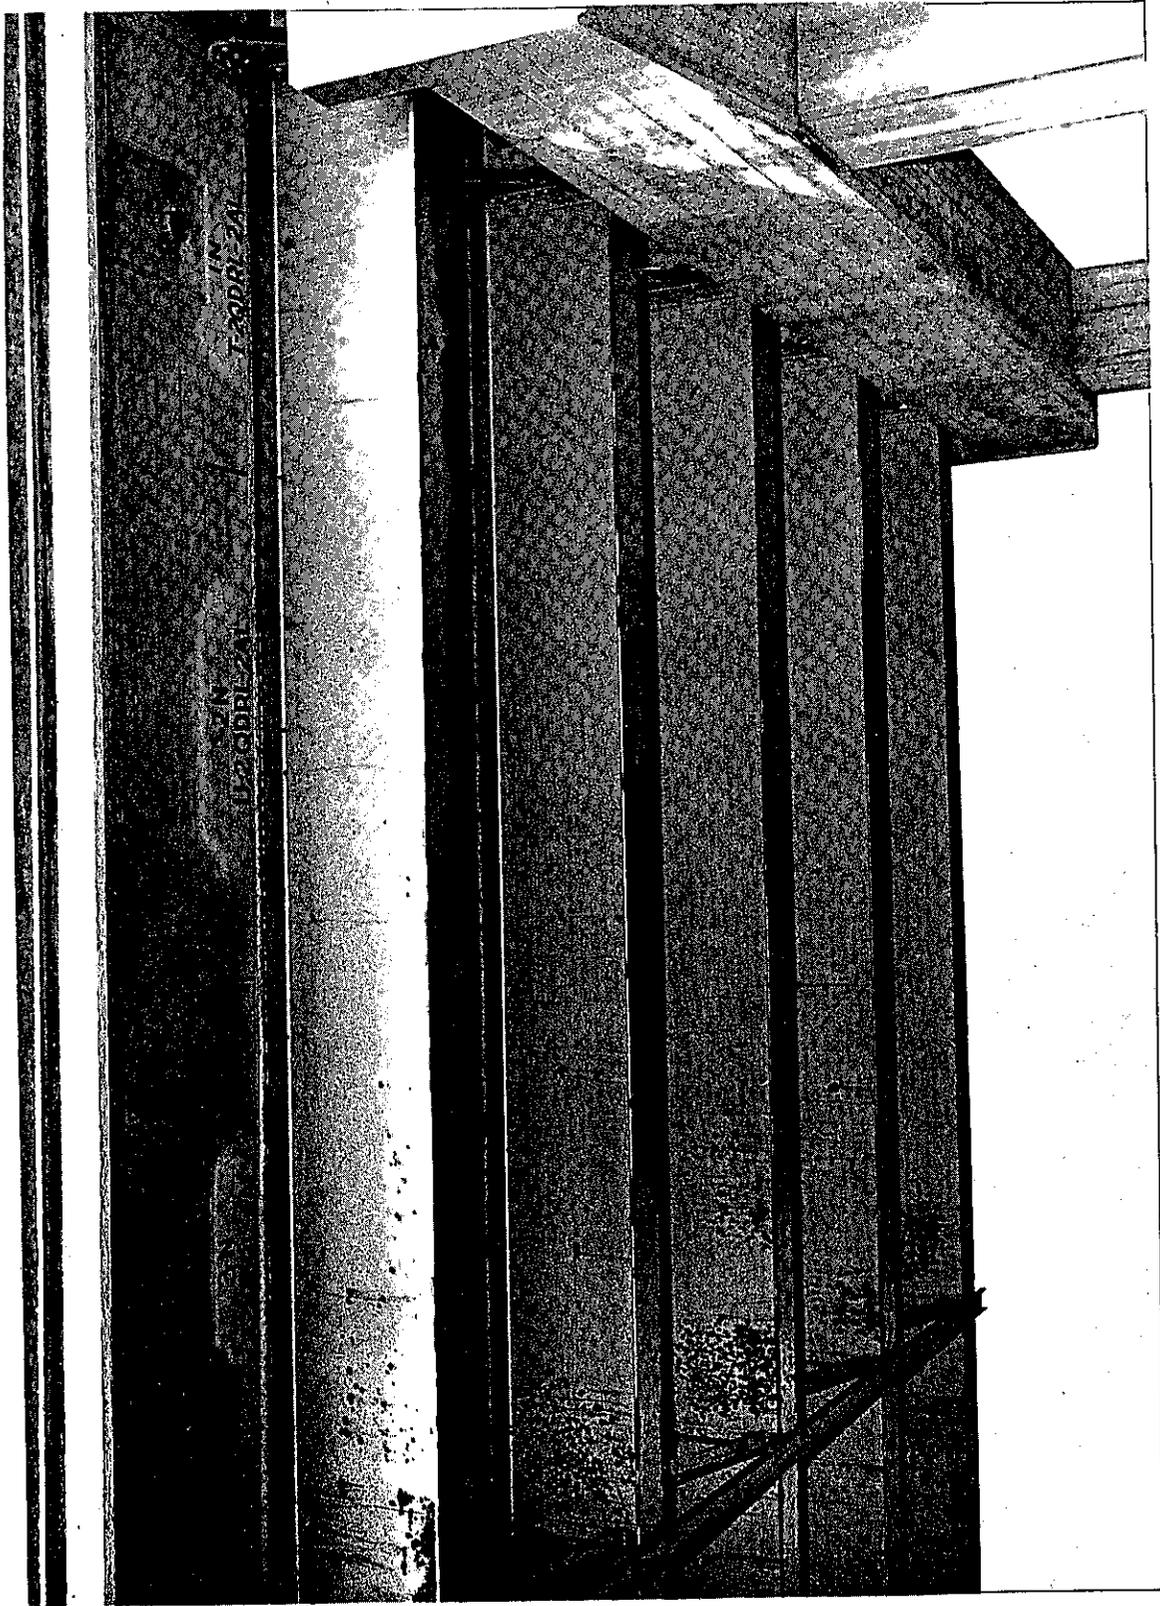
Fig. 9. Flanges in Panels 2N and 1N are badly corroded but there is little evidence of difference between the treated and untreated sections.

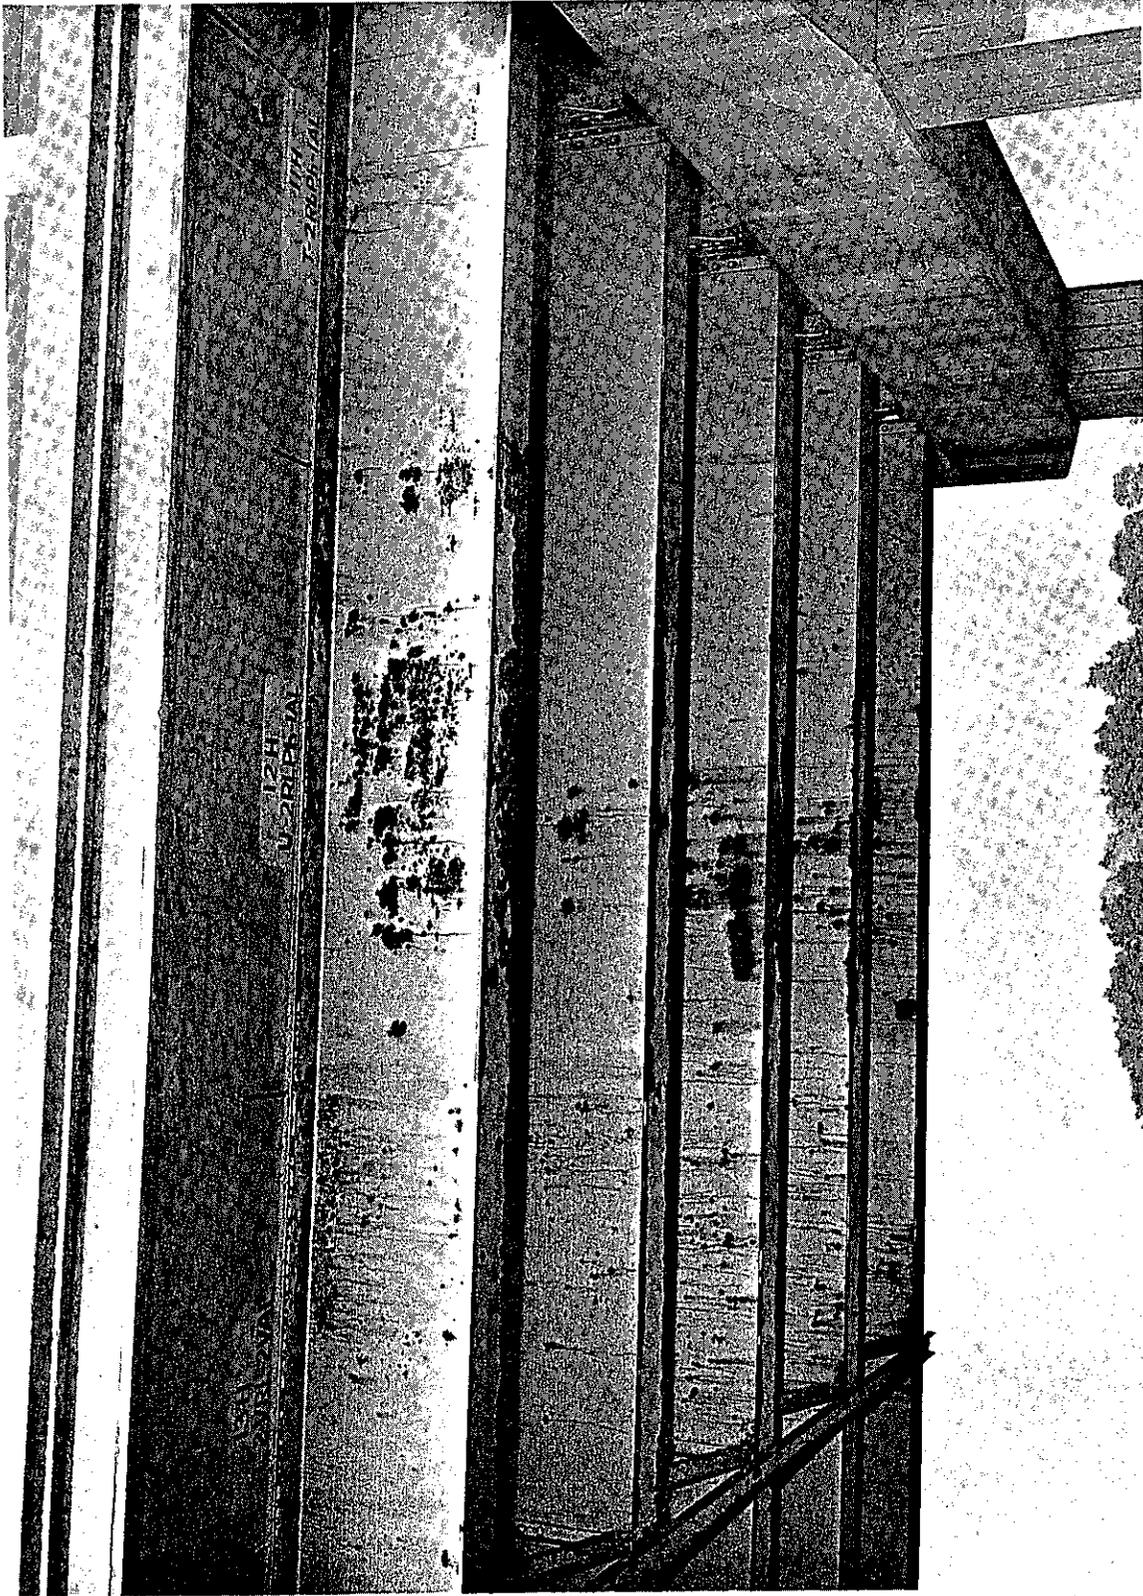
Fig. 11. Treated Panel 13H is in poor condition compared to Panel 14H, untreated. The virtue of the wash primer MIL-P-15328 has been well established but does not overcome the apparent adverse effect of the brace.

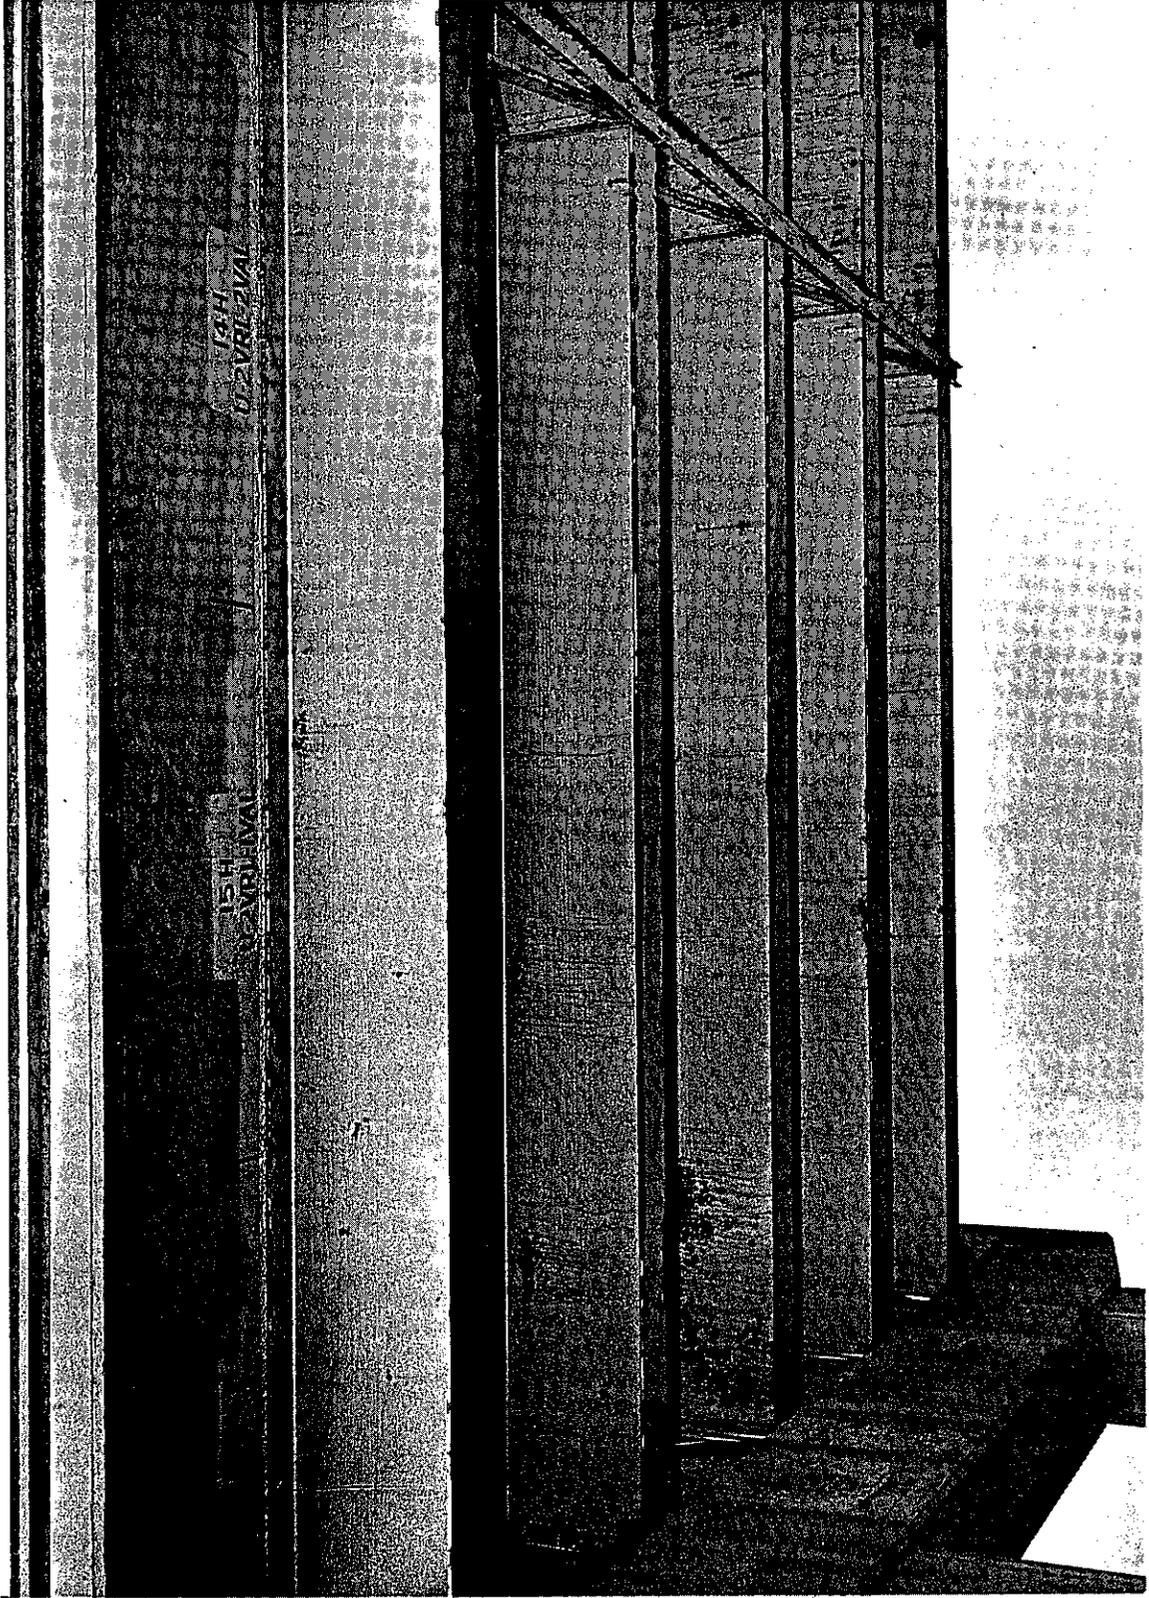
Fig. 10. The pretreatment of Panel 16H does not show to advantage here. The advantage appears to lie in the extra coat of Aluminum Finish in Panel 14H. Pier and brace probably alter the course of corrosion.

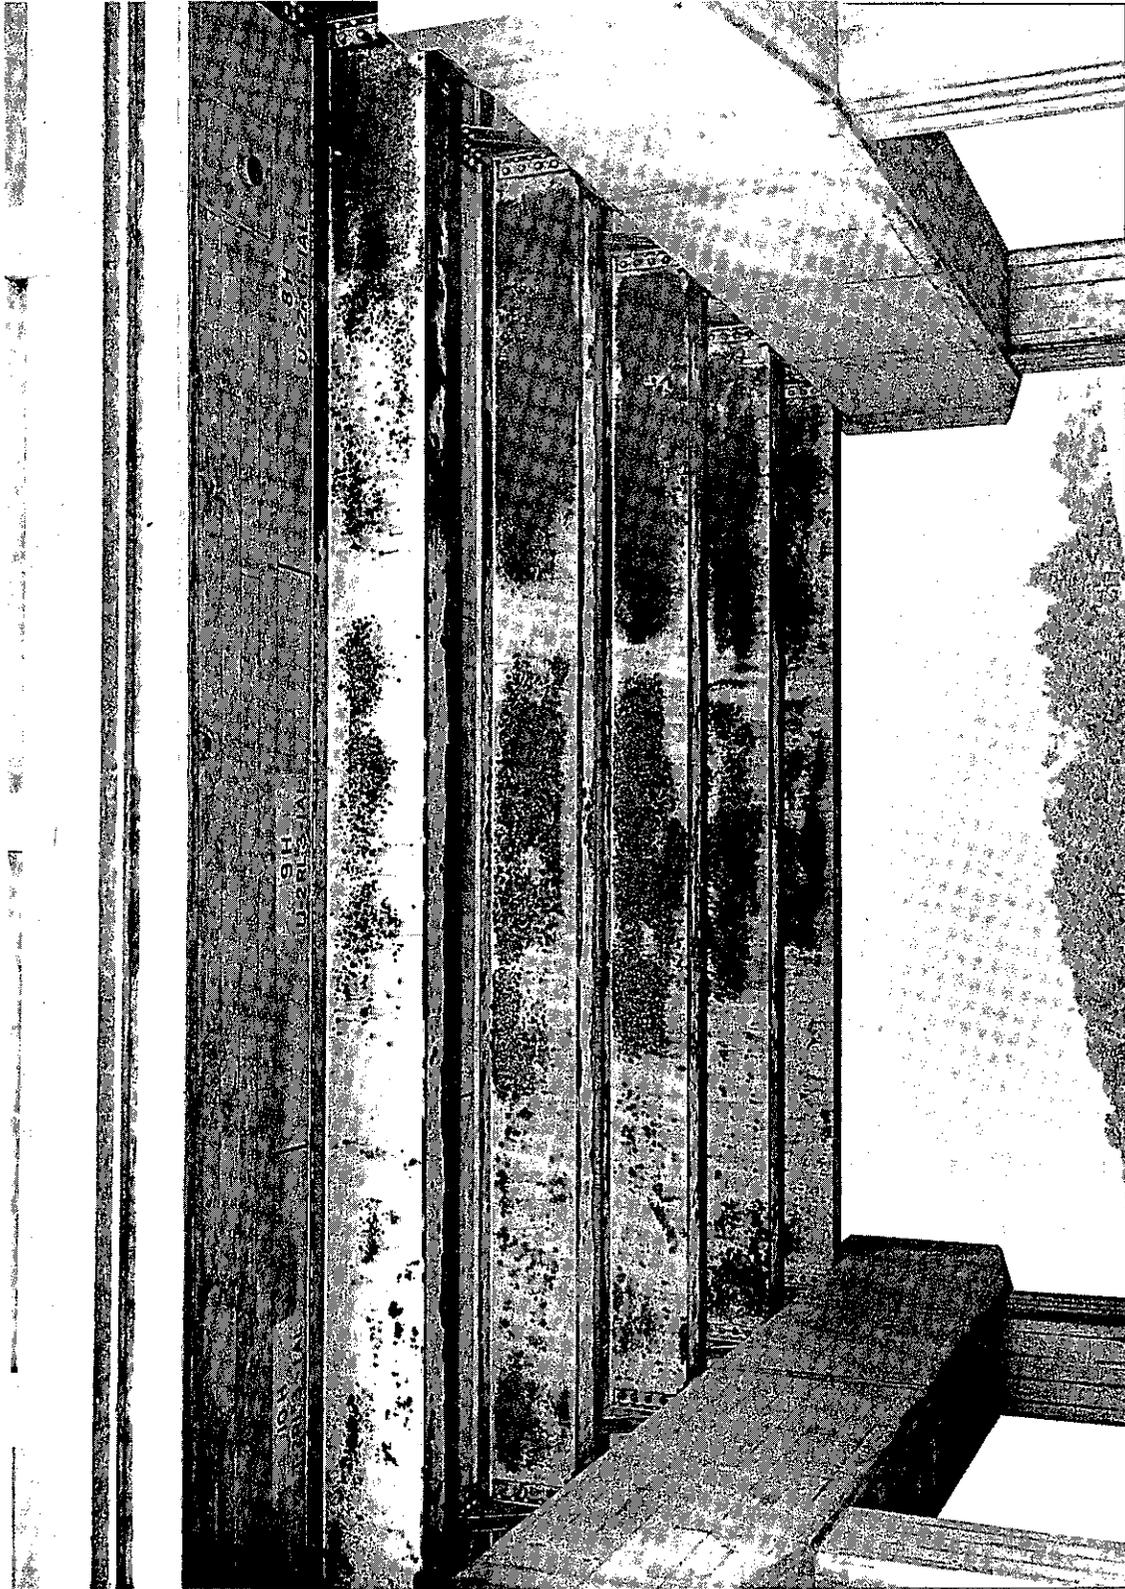
He may notice, also, some features which are very revealing. Specifically, examine Panels 8H and 9H, Fig. 12 — the boundary between them. Note that an area six or eight inches in width extending across the entire span is relatively well protected. This must be due to overlapping of the two coatings. Individually,

both of these coatings have failed miserably, but where they have been piled up on each other extra coats and probably extra thickness have afforded protection. Other panels may show a similar effect.

Fig. 12. Eliminating the first stringer which is subject to fresh rain and little of pier's wind diversion, note the regressing width of heavy corrosion on successive stringers. Probably due to sustained diversion by pier of salt carrying winds.
