Final Report on Protective Coatings Used in the Experimental Painting of the Leffingwell Creek Bridge

Final Report

LEFFINGWELL CREEK BRIDGE

January, 1959

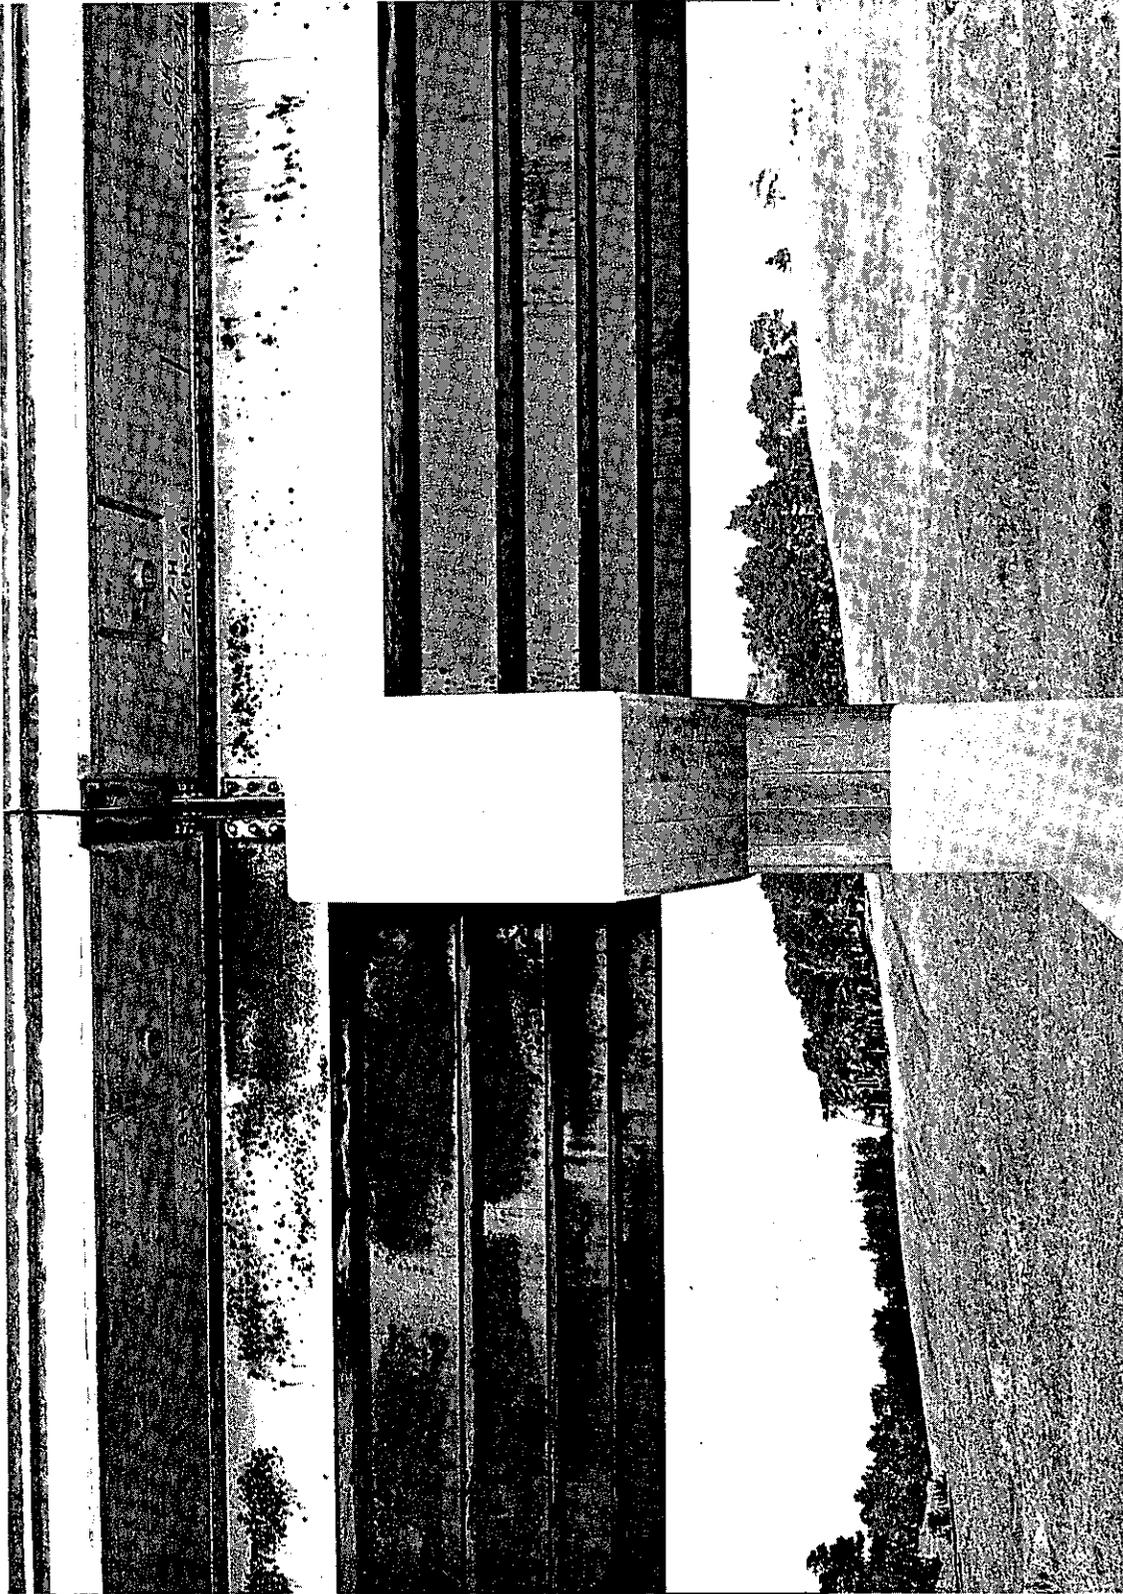
Fig. 13. Panels 8H, 7H and 6H, all given two coats of Zinc Chromate have performed here in accordance with what would be predicted, qualitatively.

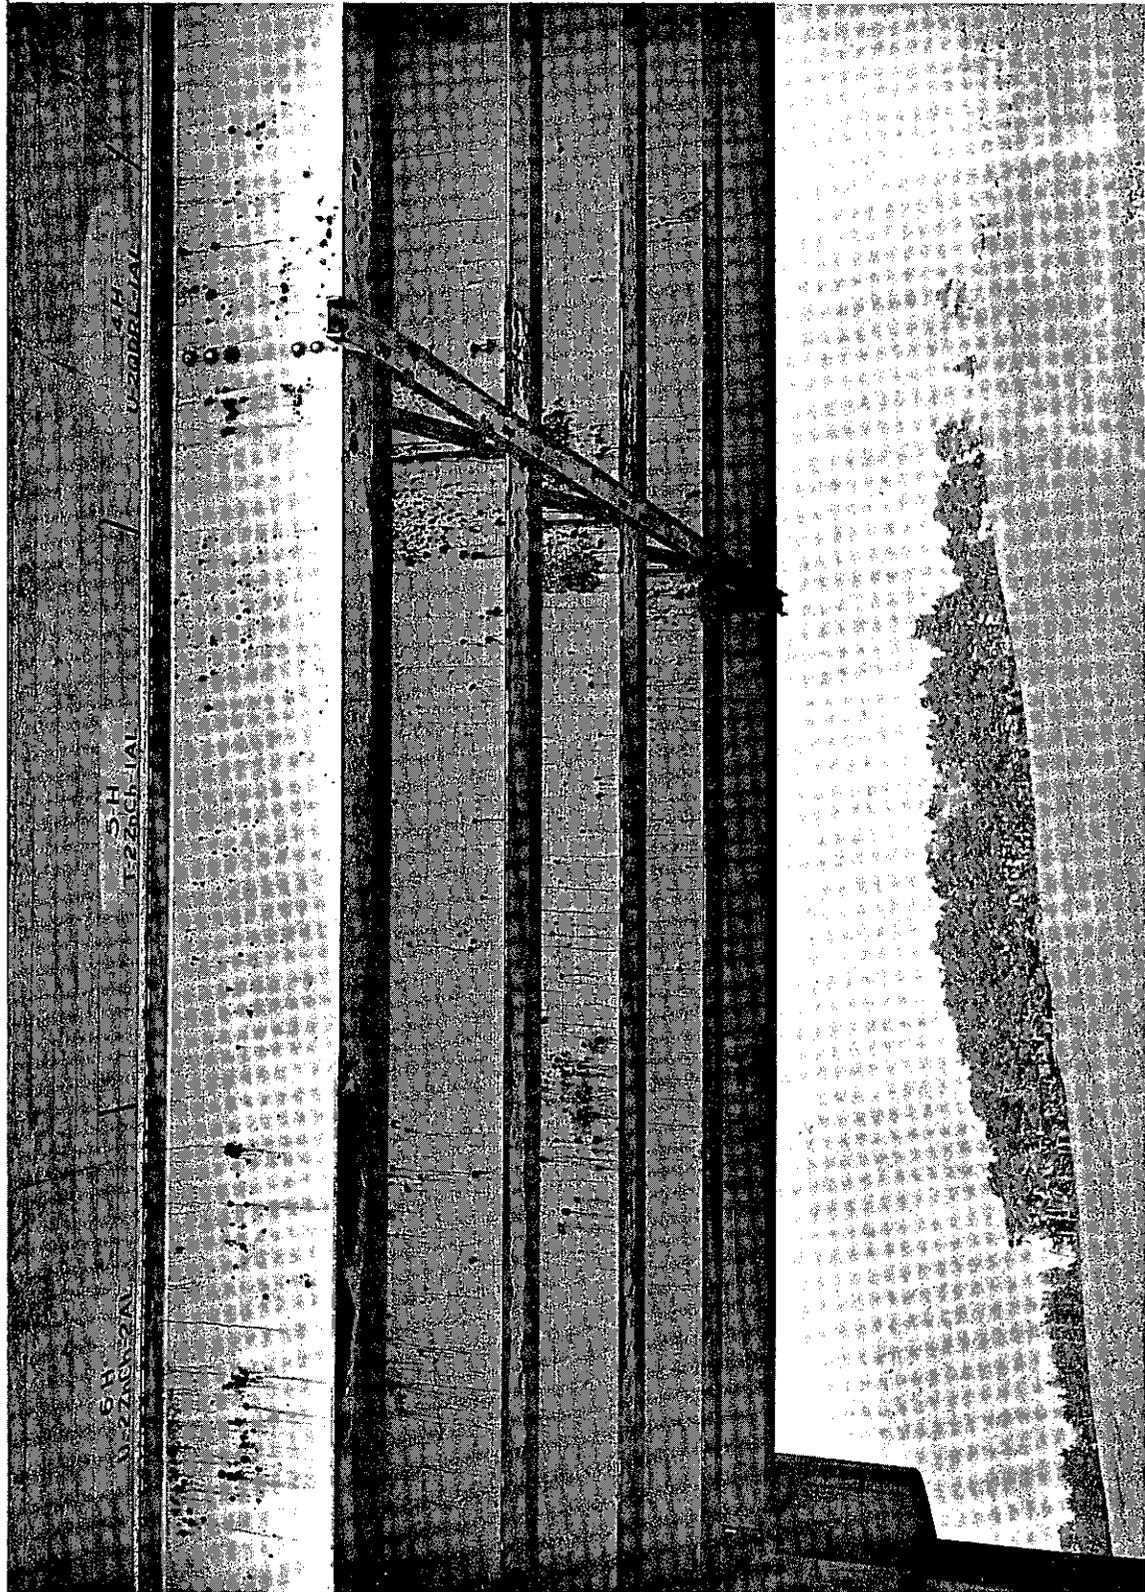
Fig. 14. Normal expectancy continues into Panel 5H. This treated panel with one coat of Aluminum Finish is about a stand-off with Panel 6H, untreated but with two coats of Aluminum Finish.

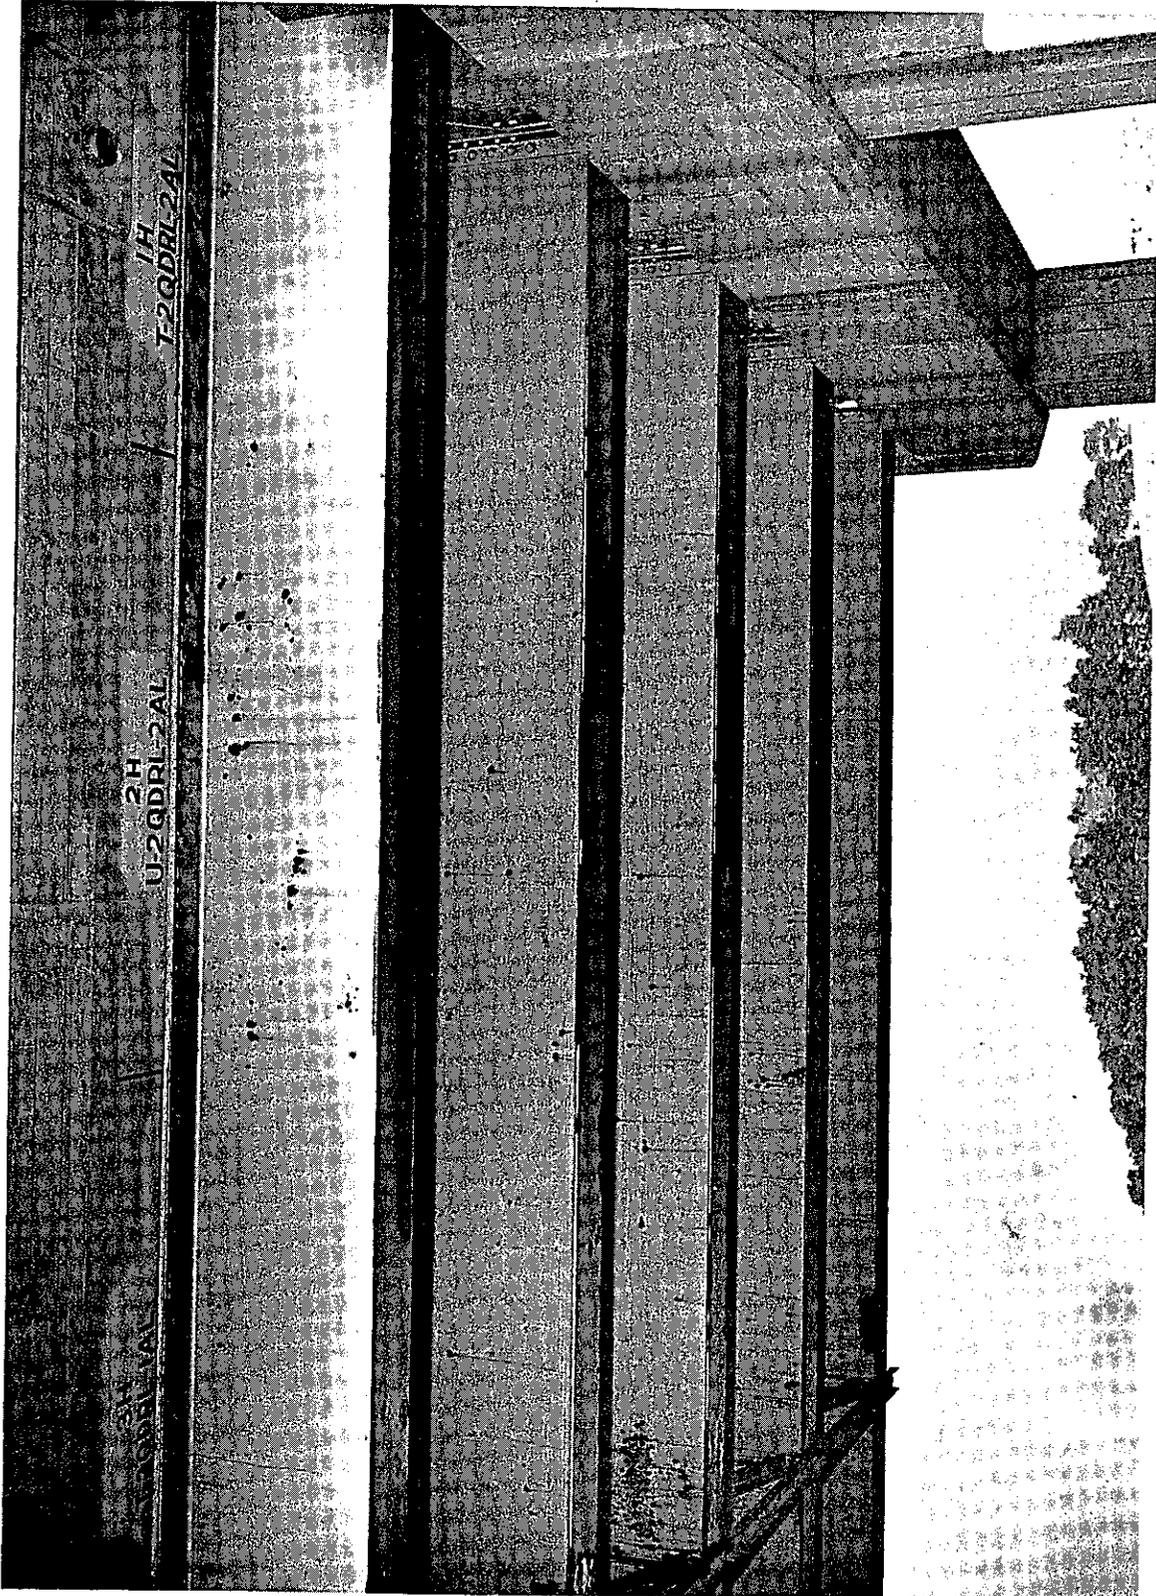
Fig. 15. This series of Semi-Quick Dry Red Lead also follows normal performance expectancy. Panel 3H, pretreated with one coat of Aluminum Finish seems to have an edge over Panel 2H with two coats of Aluminum Finish.

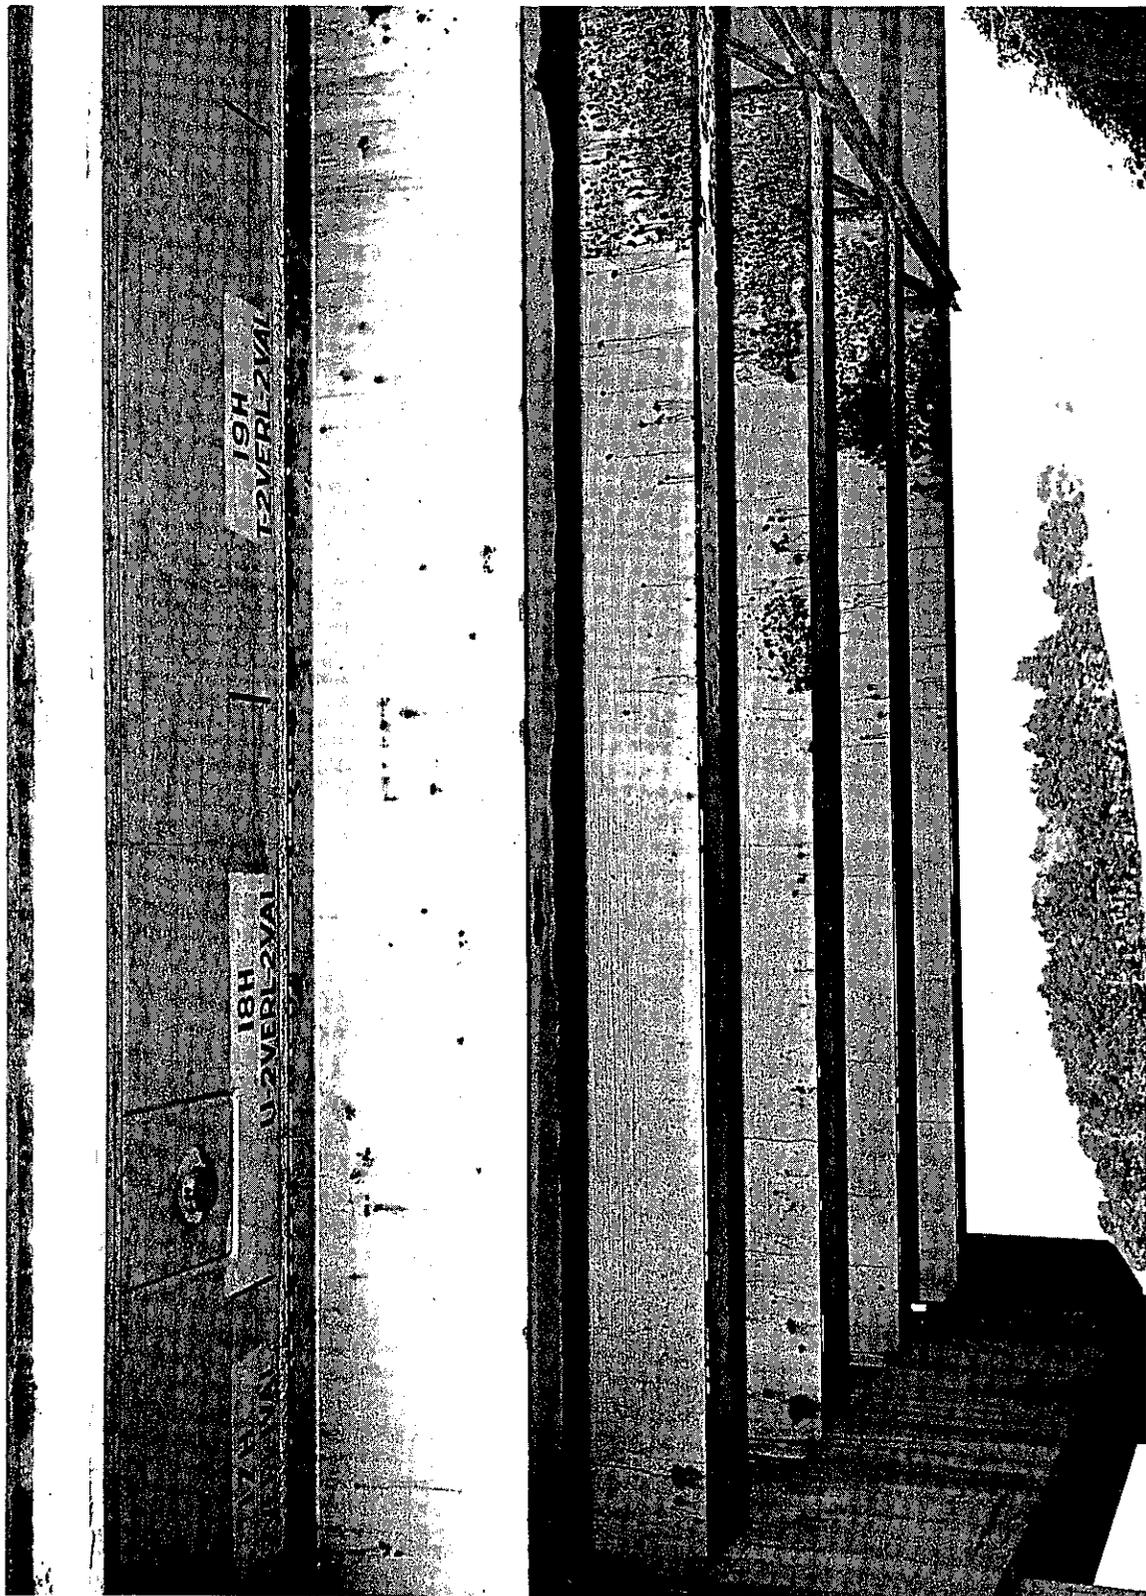
Fig. 16. This series of Vinyl Epoxy Red Lead coatings does not entirely conform to expected results. However, note the vast superiority of Panel 19H over 20H as indicated by the sharp dividing line between the two.

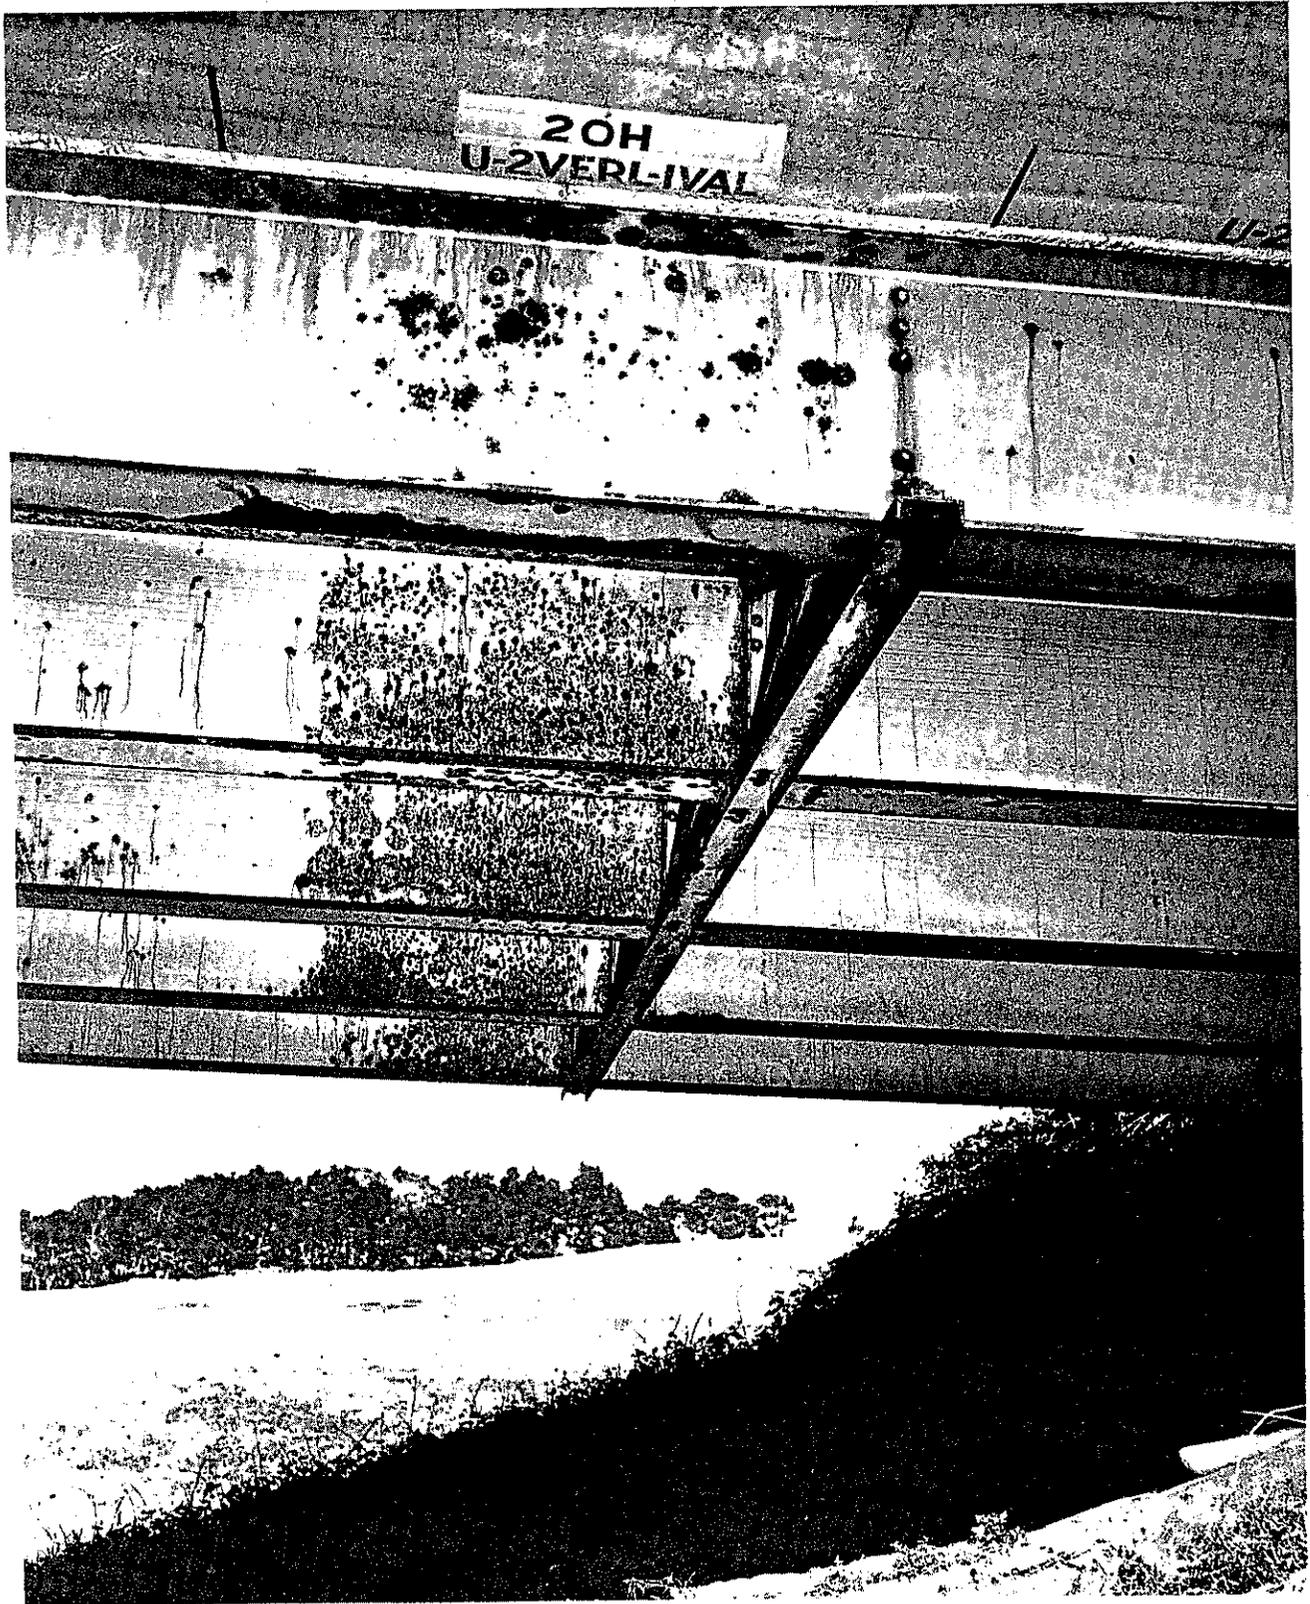
Fig. 17. The effect of the brace on corrosion areas is very marked in Panel 20H.

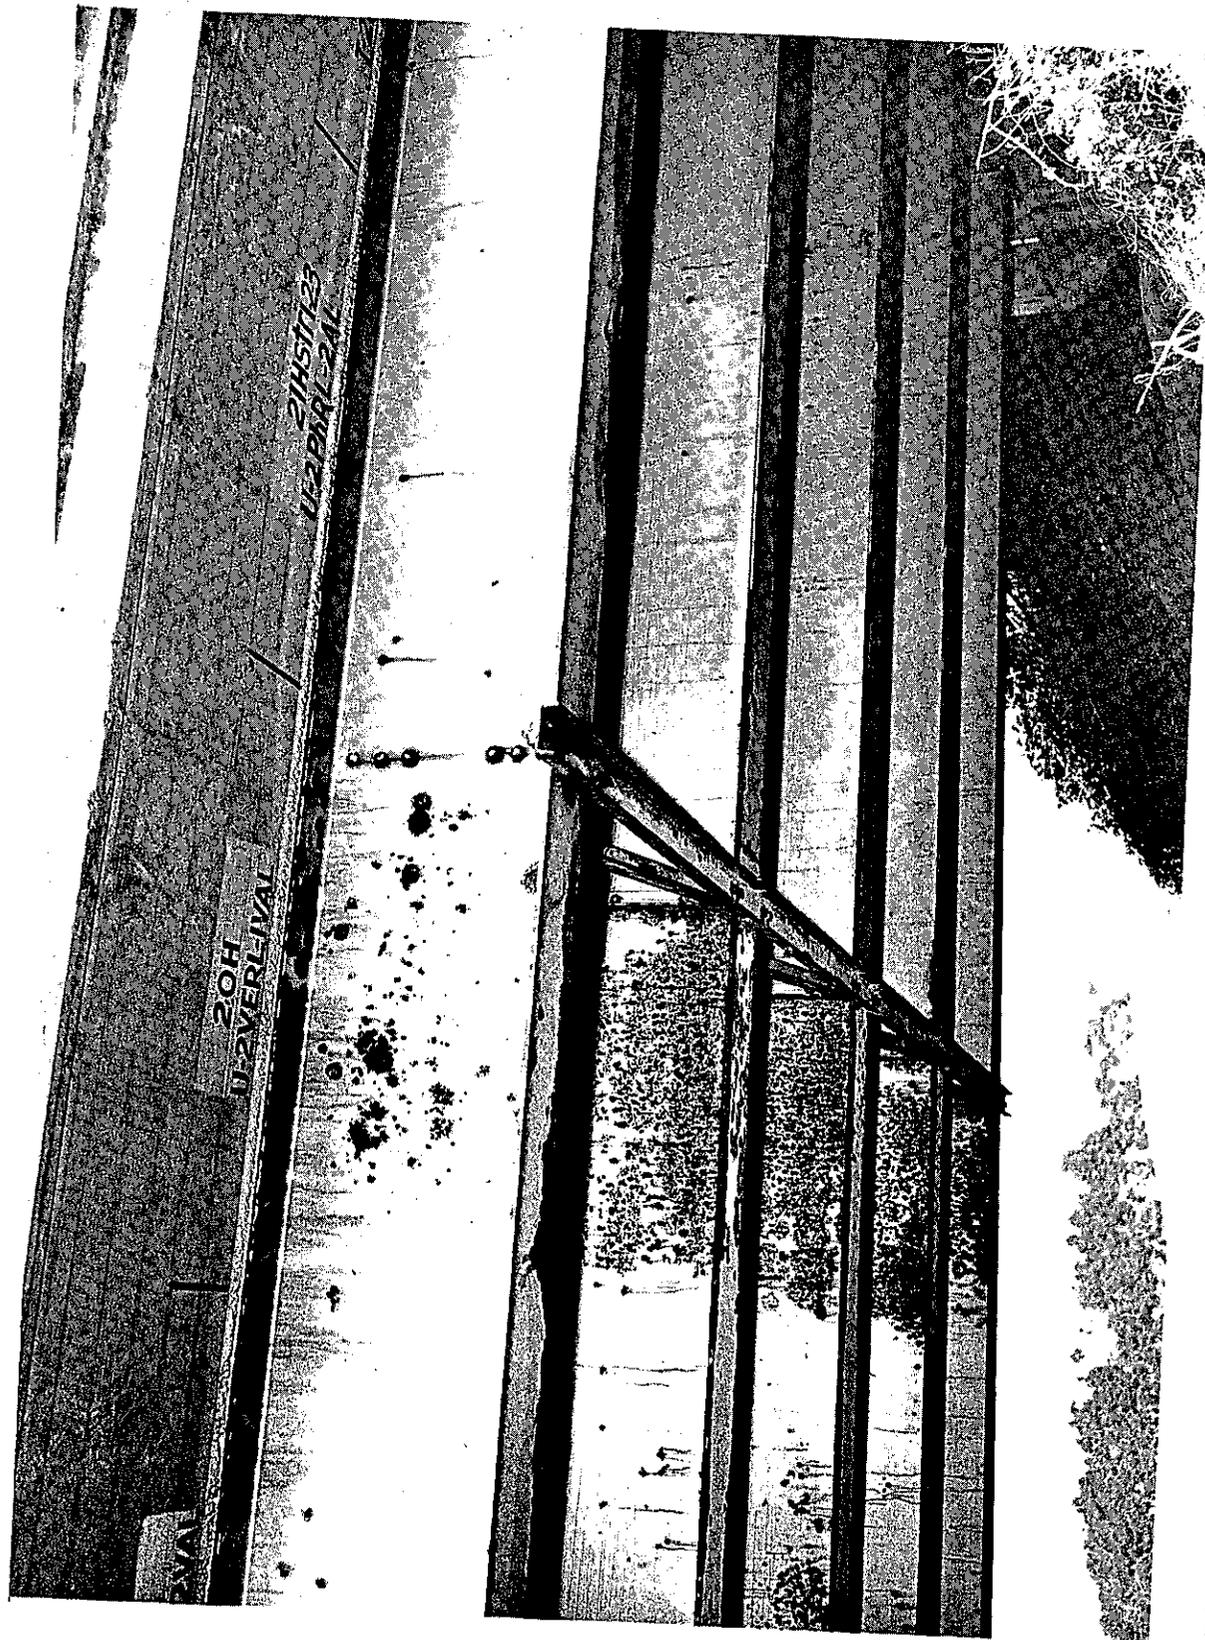
Fig. 18. Notice the vast improvement of the Red Lead Phenolic in Panel 21H over that shown in Fig. 11.

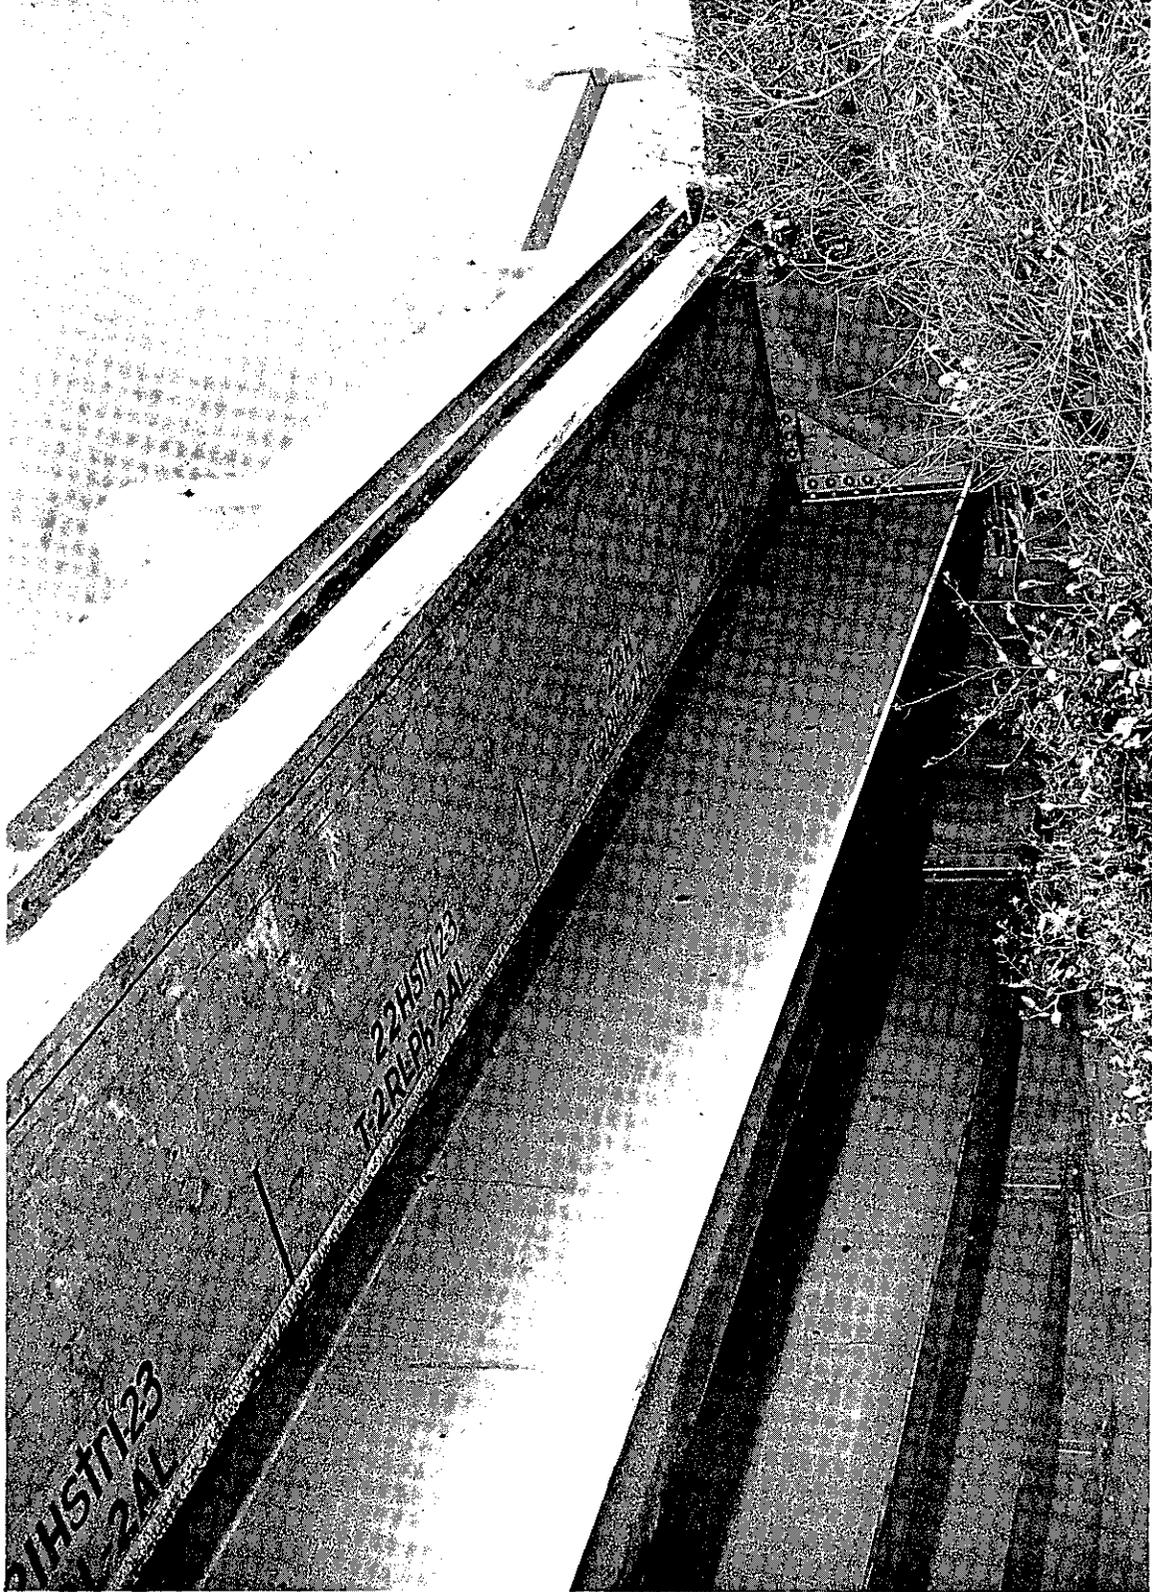
The Red Lead Phenolic used on Panel 21N, Stringers 1,2,3, Fig. 2, and on Panel 22H, Stringers 1,2,3, Fig. 19, should have been labeled RLPPh - X6. This formulation is a variation of the coating frequently used by the San Francisco-Oakland Bay Bridge and consists of Red Lead in linseed oil reinforced with the State Specification Aluminum Varnish. The vehicle is not greatly different from that used in the other RLPPh series but the performance — so far as we can judge from its limited trial — seems to be better. Of course, the location in each instance cited is recognized as more favorable generally than most of the RLPPh series of panels.

Fig. 19. The Red Lead Phenolics shown here in Panels 21H and 22H seem to have performed better than the old Red Lead and Metallic Lead formulation.
