An Investigation of the Subsurface and Surface Drainage Conditions on Road I-Men-1-D, E between 4.1 Mi. North of Forsythe Creek and Ridgewood Summit

June 1960

State of California
Department of Public Works
Division of Highways
Materials and Research Department

I-Men-1-D,E
Lab Auth 2196-20-S

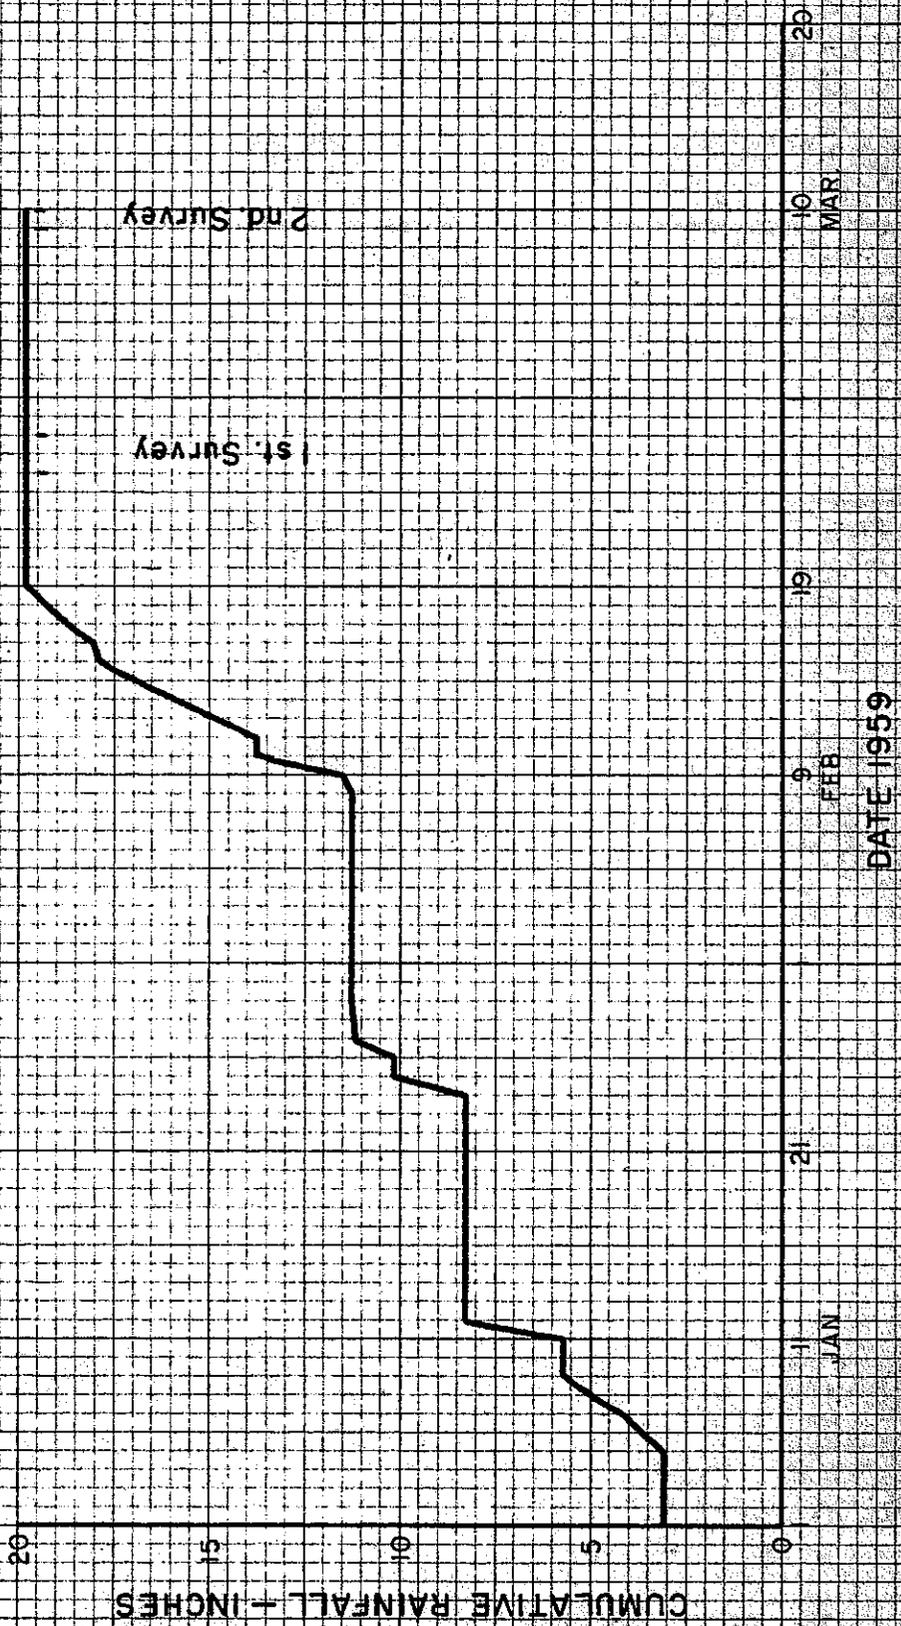
RAINFALL MEASURED AT
WILLITS HOWARD FOREST RANGER STATION
RIDGEWOOD SUMMIT
IT-MEN-I-D, E

The average annual rainfall for the Ridgewood Summit area is fifty inches. Figure No. 1 shows the rainfall for the period January 1, 1959, to March 10, 1959. Most of the rainfall occurs during heavy storms, causing periodic high runoffs. The CMP's and RCB's are of sufficient size to take the runoff. There are two locations, right of Station "D" 209+50 and right of Station "D" 368+50, where the headwall or inlet of the pipe is not properly situated for the large flow that must be handled and some of the water bypasses the headwall and spills out onto the pavement.
