CUT SLOPE DESIGN AND LANDSLIDES
SOME CASE HISTORIES

T. W. Smith and H. R. Cedergren

Prepared for
A.S.T.M. Meeting
Los Angeles

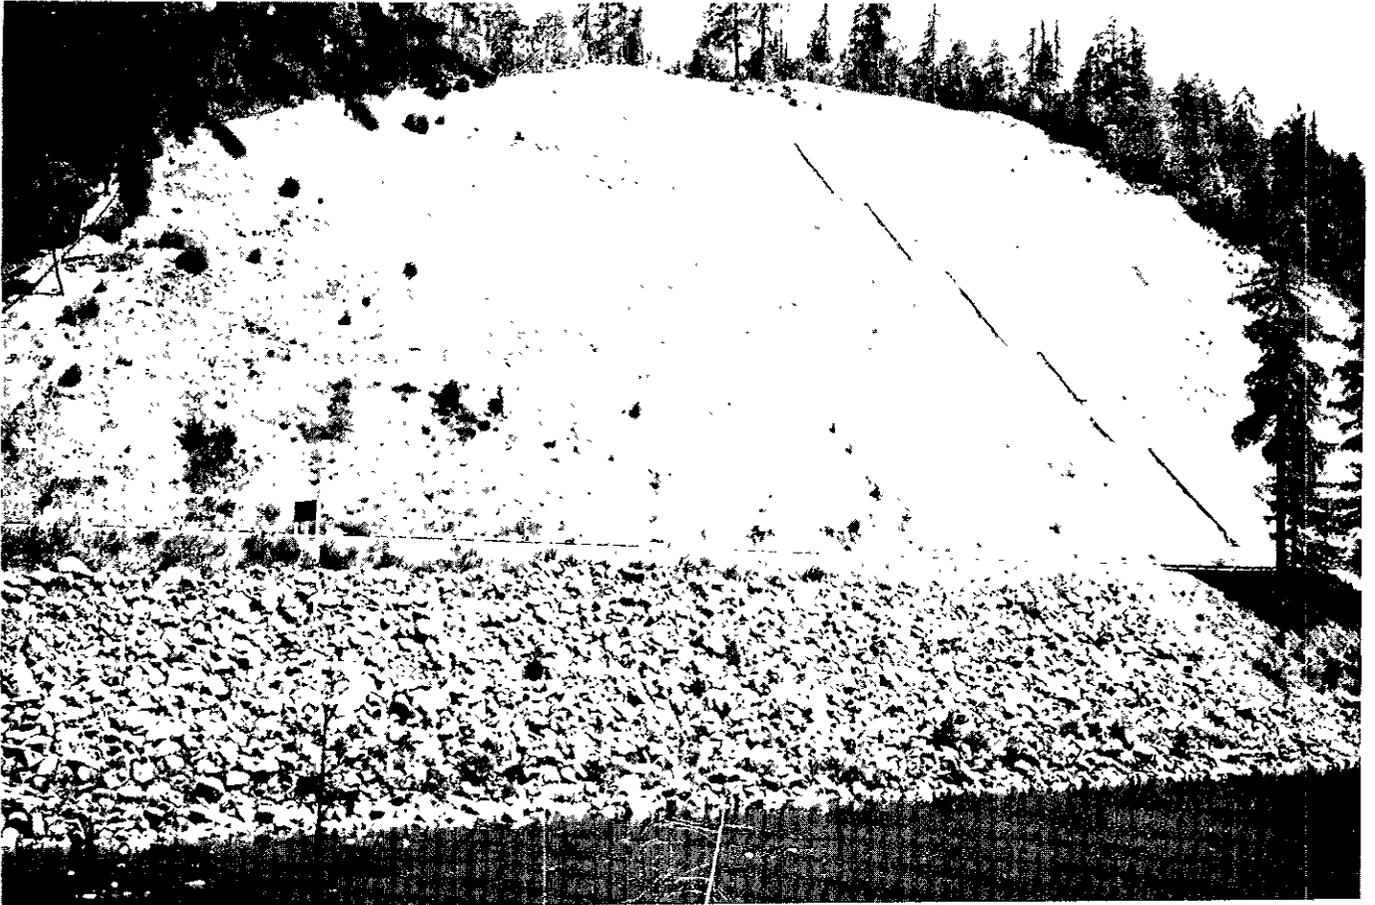
This cut was constructed according to plans and the job was accepted as complete on November 12, 1958. It has passed through four winter seasons without any signs of instability. Considering the great height of this cut, this project has been very satisfactory. The exploratory borings indicated that there would be no significant changes in material except for the top soil and degree of weathering for the depth that was to be removed, and that the new slope would be in the same kind of

Fig. 1 - View of Completed Dyerville Cut

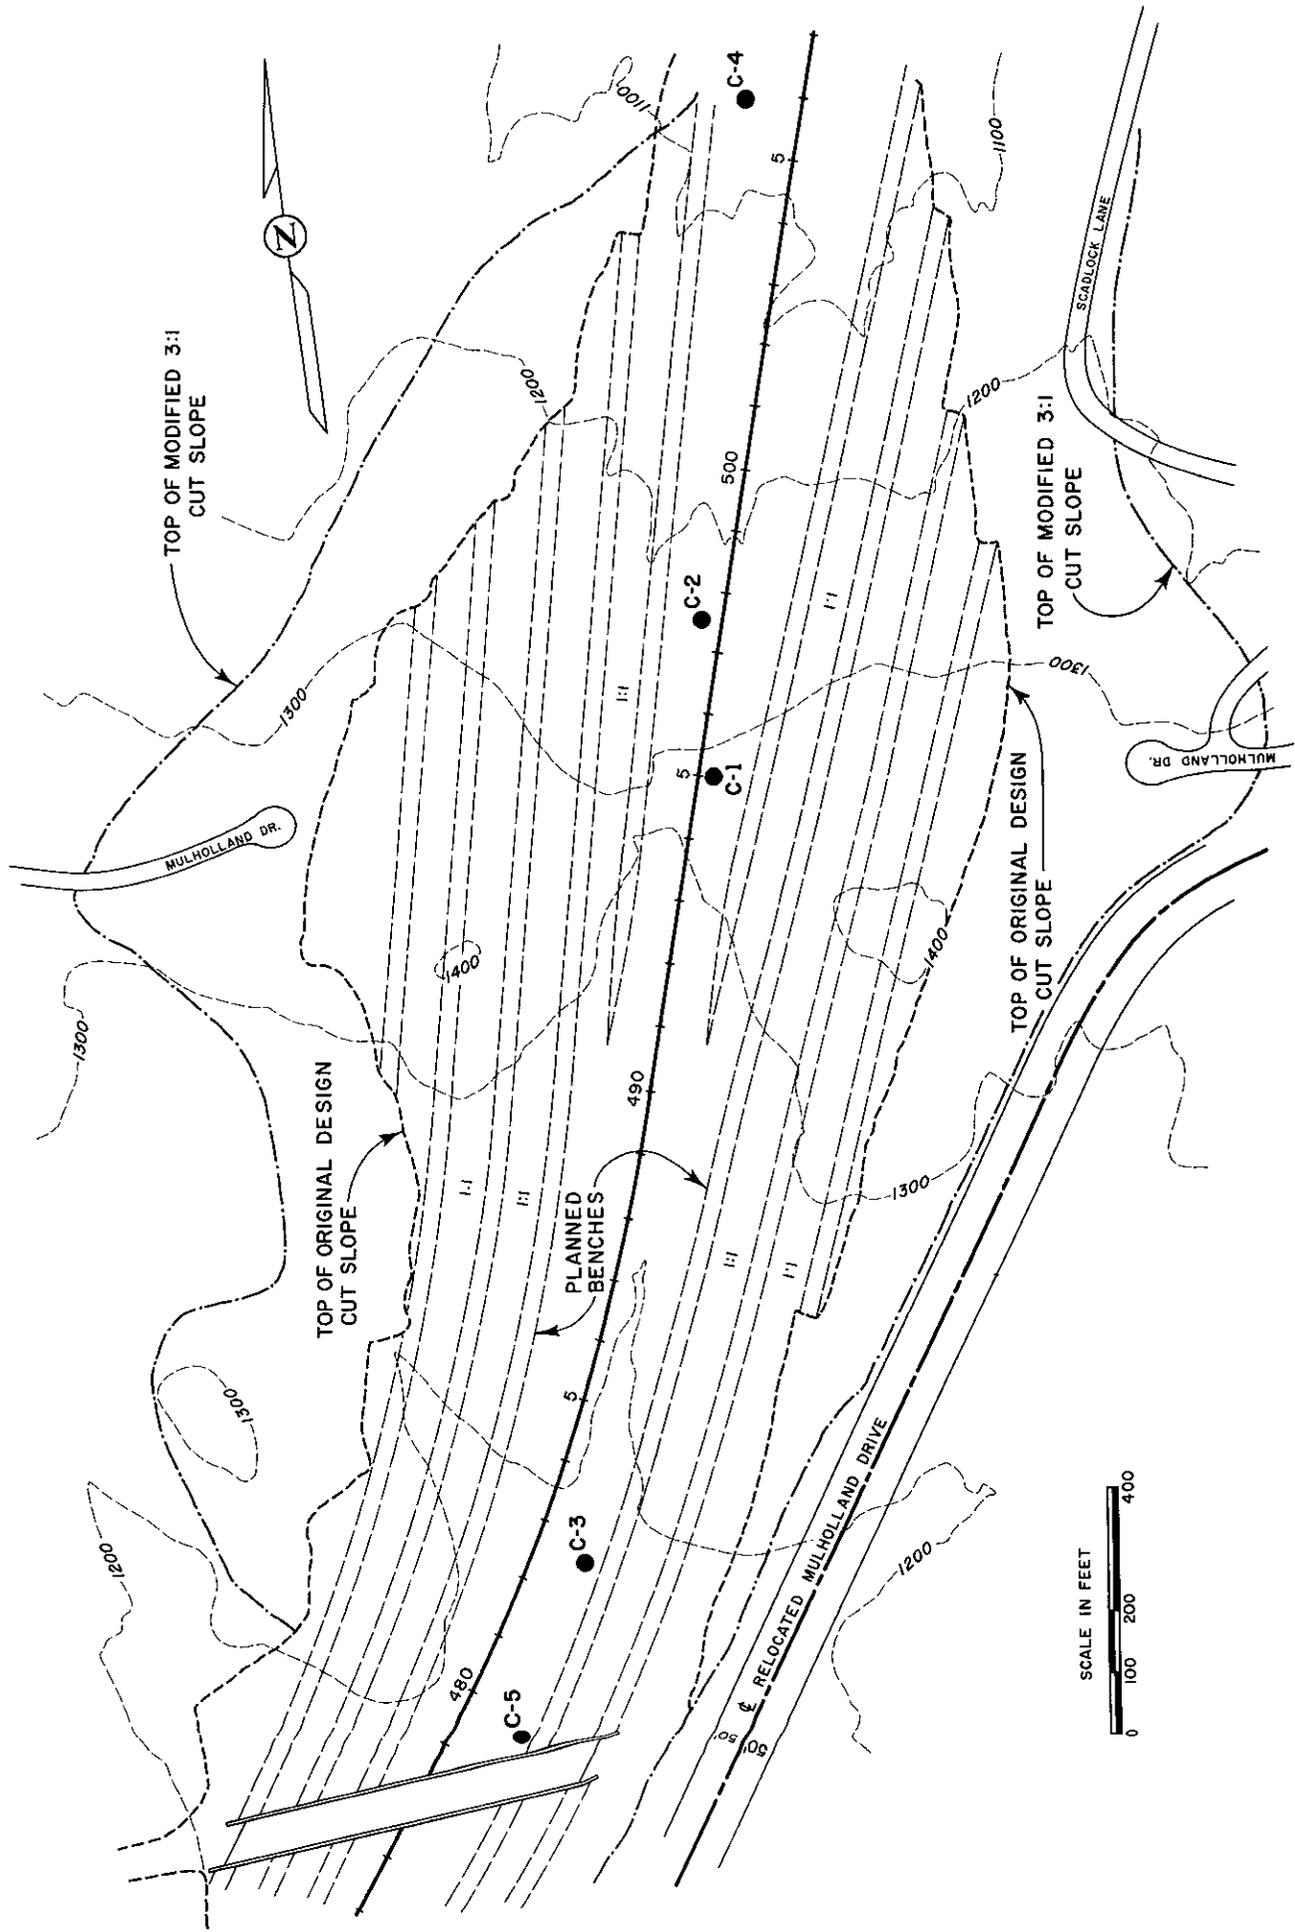
FIG. 10 PLAN SHOWING ORIGINAL AND MODIFIED SLOPE DESIGN OF MULHOLLAND CUT

After a review of the boring logs and the geological history of the area, it was recommended that this cut be constructed with $1\frac{1}{2}:1$ slopes with 30-foot benches at 60-foot vertical intervals. Subsequently a large excavation was made in this area to obtain borrow for another highway project. This excavation stood on a 1:1 slope without any serious failures. It was then decided that the Mulholland cut could be designed on 1:1 cut slopes benched at 60-foot vertical intervals.

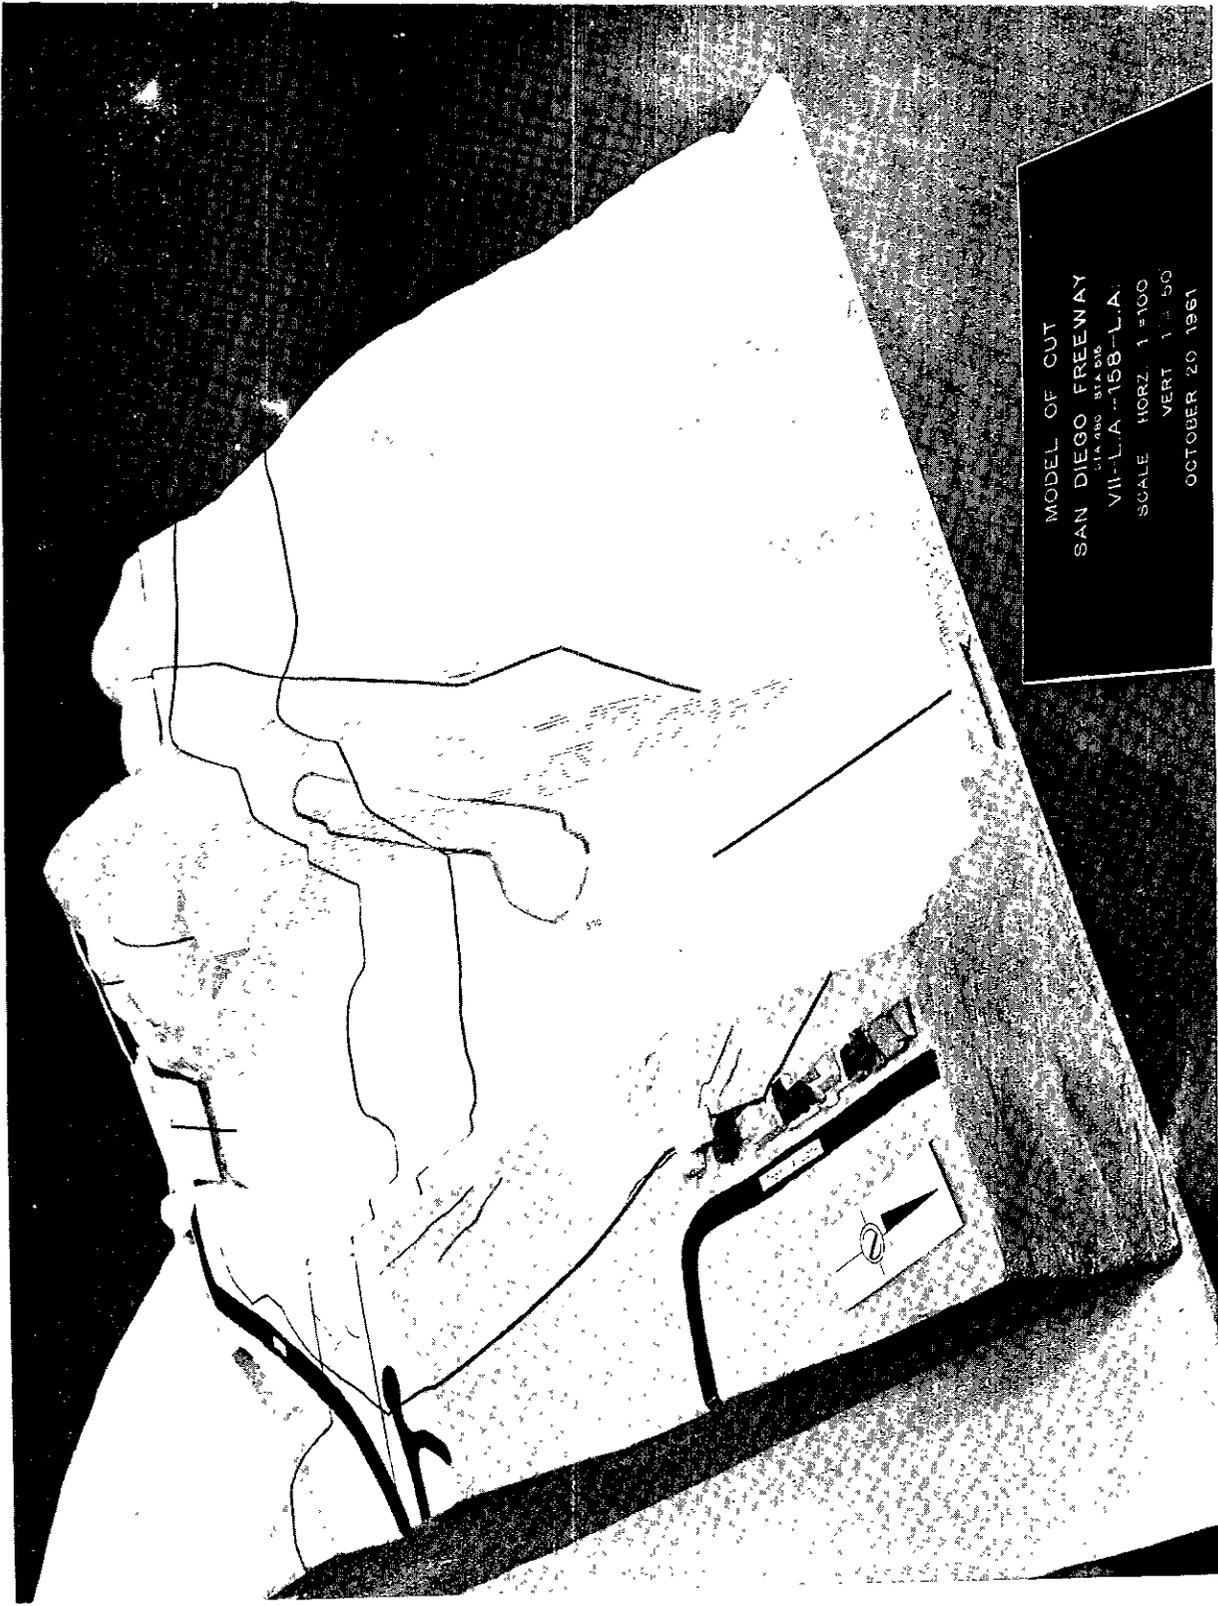
Minor cracking had occurred in the east side of the cut as early as July 1961, but this was not considered serious until early in October when cracks began to develop in the floor slabs of the private dwellings on Scadlock Lane, as noted above, and more definite cracking occurred through the contractor's yard and in the pavement of old Mulholland Drive. The extent of the slide may be seen in the photograph in Fig. 12. To aid in analyzing the geological conditions and the slide movement, a geological model was constructed (See Figs. 13 and 14).

Fig. 14 - Photograph of Mulholland Cut Model Showing Status of Excavation at Time of Failure

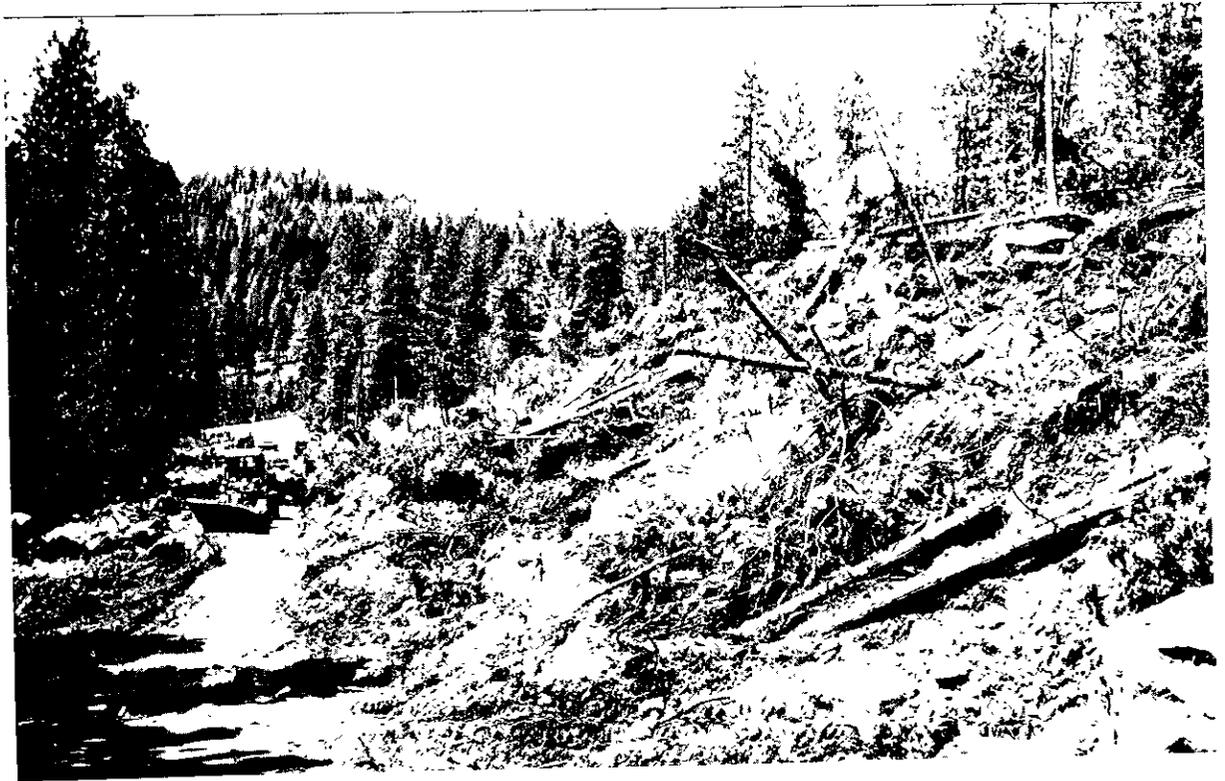
Fig. 16 - View Looking West Along Highway at Toe of Towle Slide

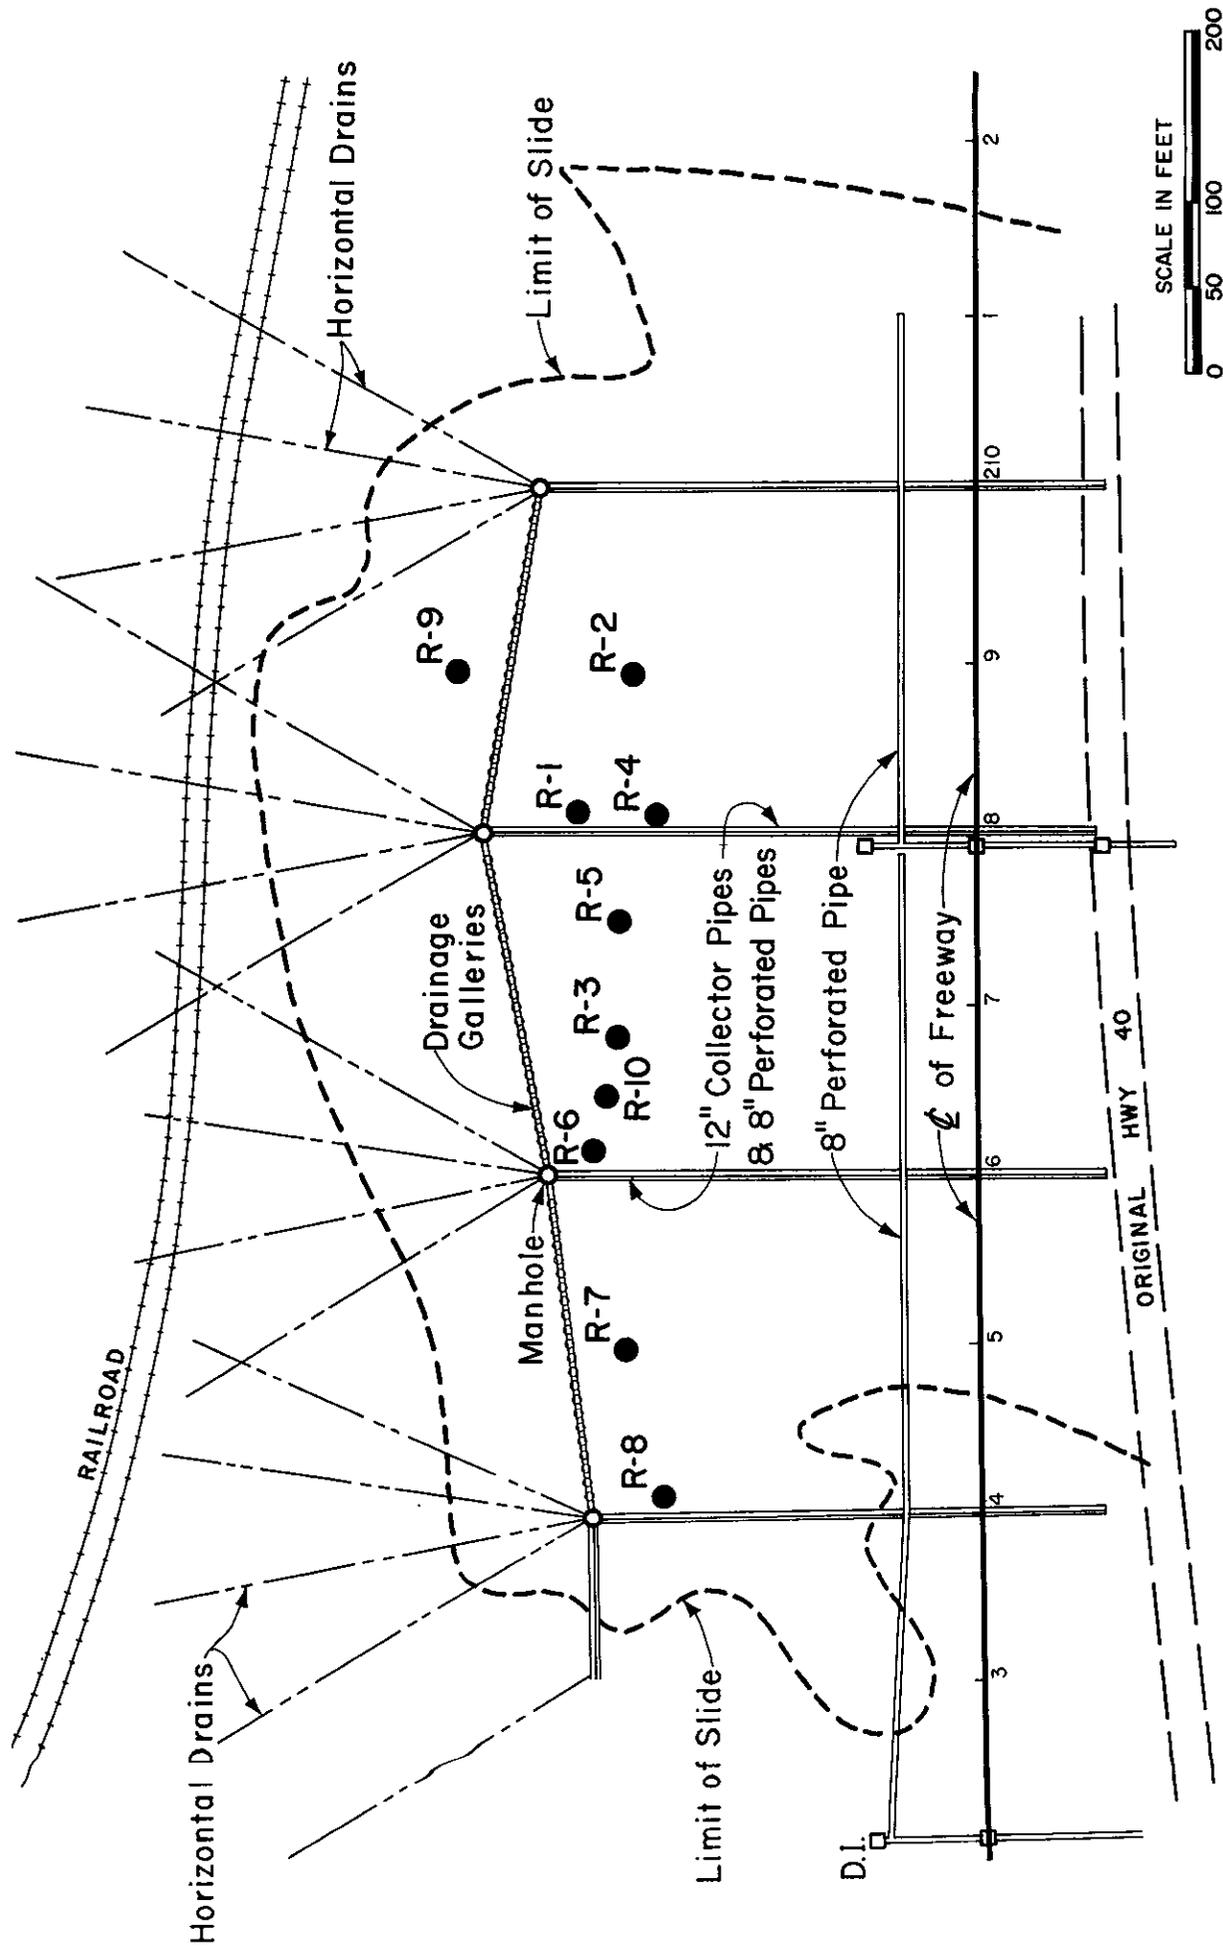
FIG. 18 PLAN SHOWING STABILIZATION DETAILS AND BORING LOCATIONS AT TOWLE SLIDE

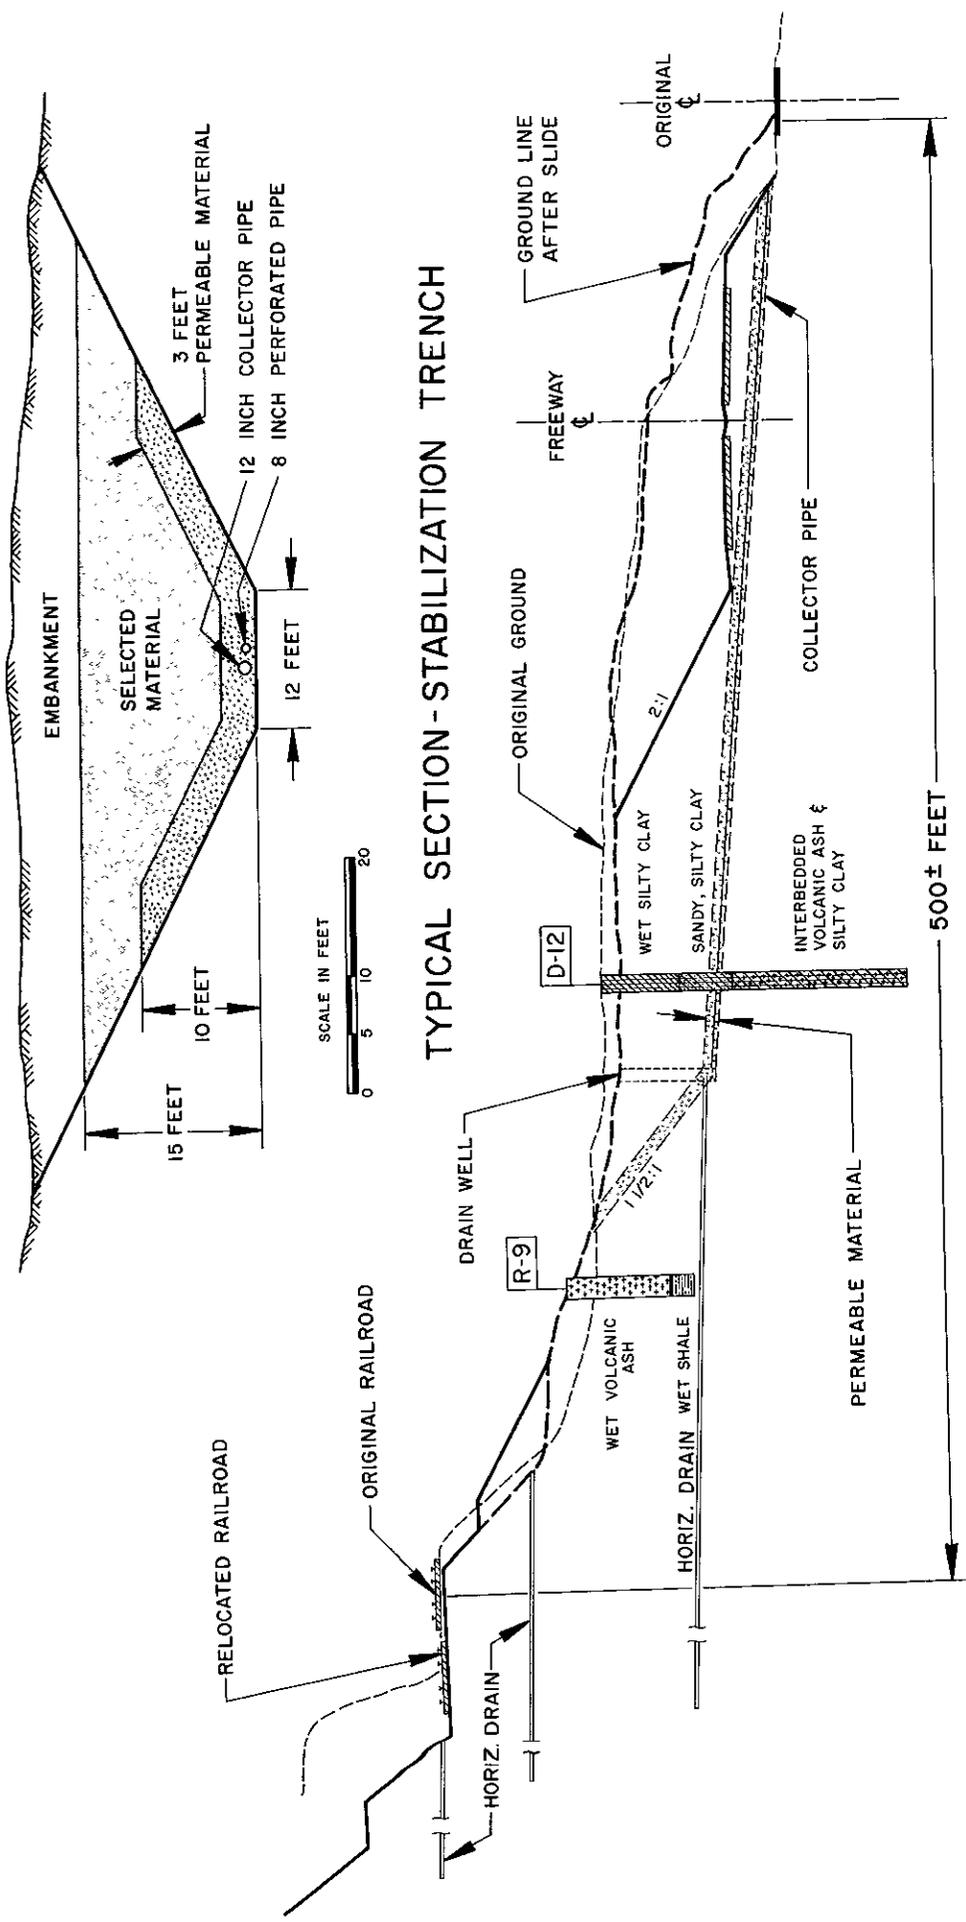
FIG. 19 PROFILE AND TYPICAL SECTION OF STABILIZATION TRENCH AT TOWLE SLIDE

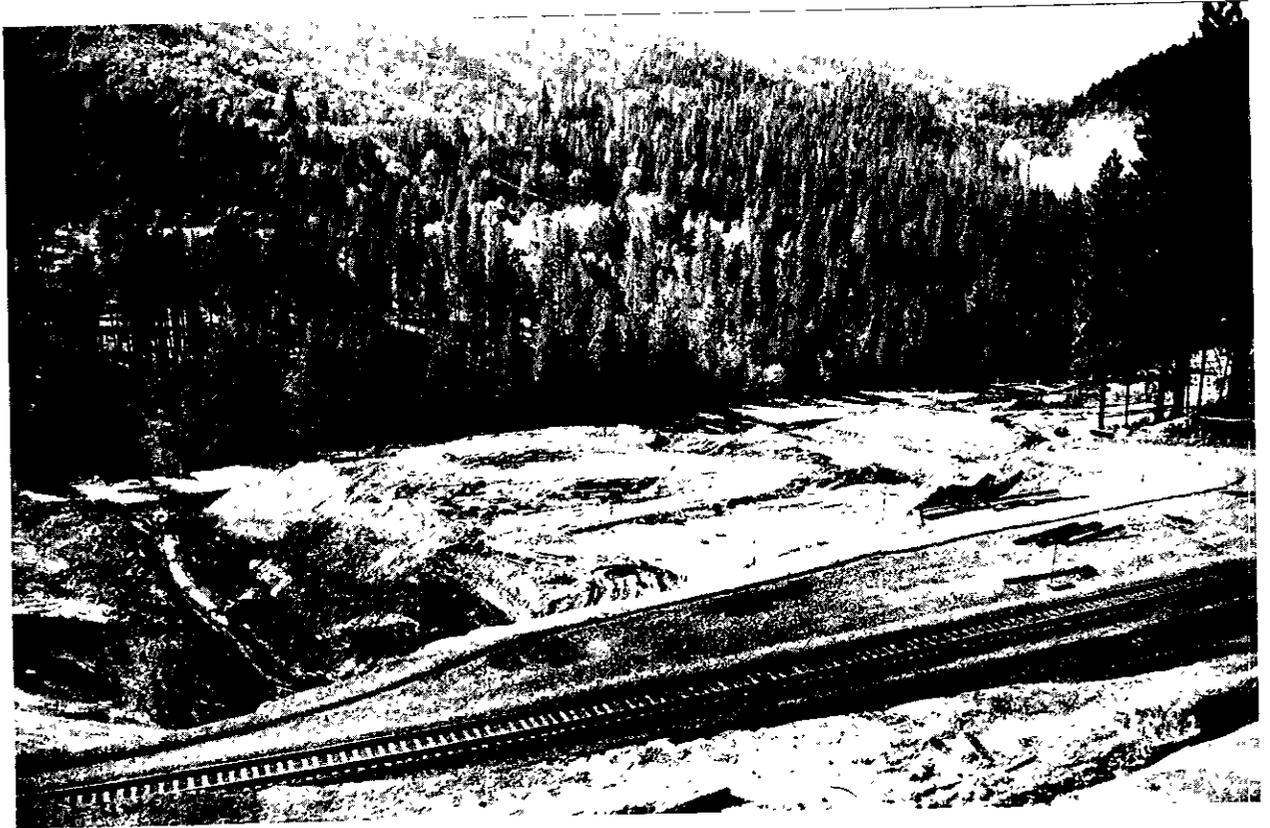
Fig. 20 - View Showing Stabilization Trench at Towle

After completion of these stabilization trenches and a winter shutdown on construction operations, borings were made to determine whether the trenches had been effective in removing the ground water from the entire area. It should be noted that the construction of the trenches removed less than one-third of the slide mass in the area of the trenches. Any increase in stability of the mass remaining in place was dependent upon decreasing moisture contents and hydrostatic pressures by drainage. It was found that the ground water was standing quite high in the area between the trenches, and it was decided that further drainage facilities would be necessary.
