M&R 636392

Dynamic Tests of Corrugated Metal Beam Guardrail

State of California
Department of Public Works
Division of Highways

Presented at the 46th Annual Meeting of the Highway Research Board

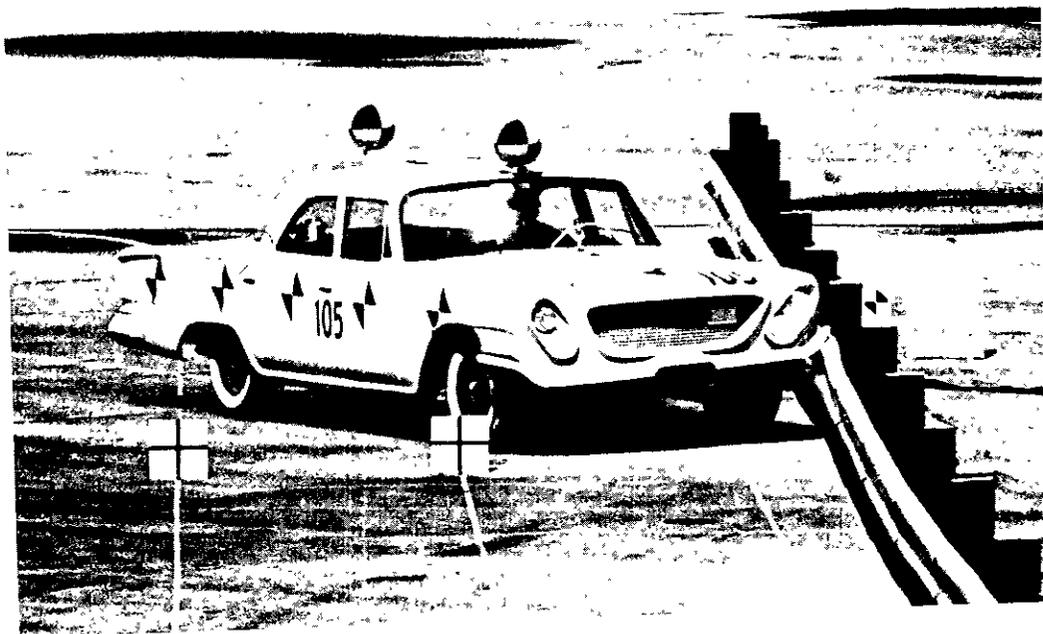
Figure 3

Analysis of the data from Test 105 indicated that the vaulting problem on the 24-in-high blocked-out corrugated steel beam guardrail was compounded by the front bumper geometrics of the 1962 Chrysler test vehicle (see Figure 3).

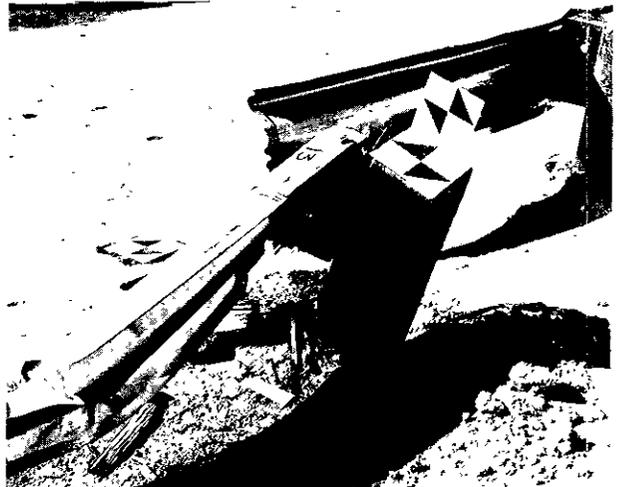
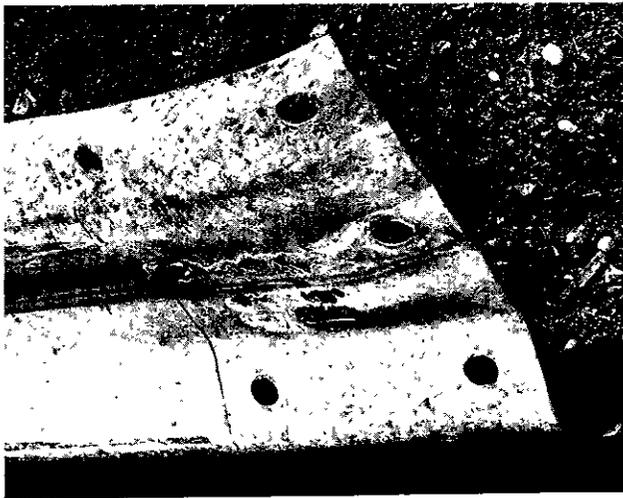
Typical Failures of
Steel and Aluminum Beams

This difference can be observed by comparing the examples (a., b., and c.) of deformed steel beams that were successful in redirecting the vehicle with the examples of aluminum failures (d., e., and f.) shown on Plate 3.

Due to the unpredictable manner of load application by the various vehicle components, a barrier beam must have the capability of accepting large plastic deformations without failure or it must operate within its elastic limit and resist local deformations such as is done by most bridge rails⁽⁸⁾. Steel exhibited this plastic capability and performed satisfactorily with no failures that affected the effectiveness of the guard-rail (see Plate 3).

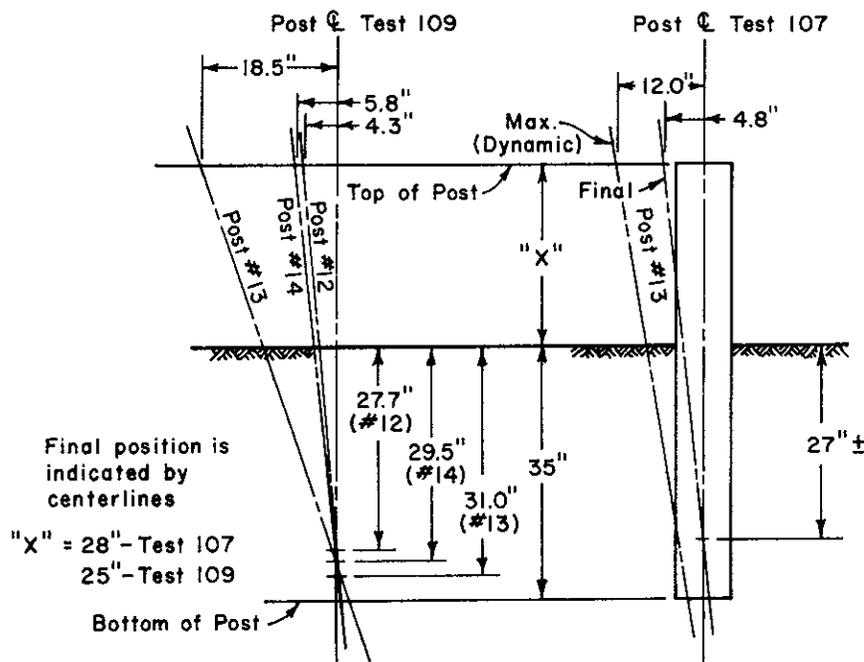
Figure 7

vertical axes. As the lateral deflections of the post tops increased, the centers of rotation moved down along the post axes. For very large deflections the rotation center appeared to be very near the bottom of the post, which is in agreement with previous findings⁽¹⁴⁾ for rigid posts (see Figure 7).

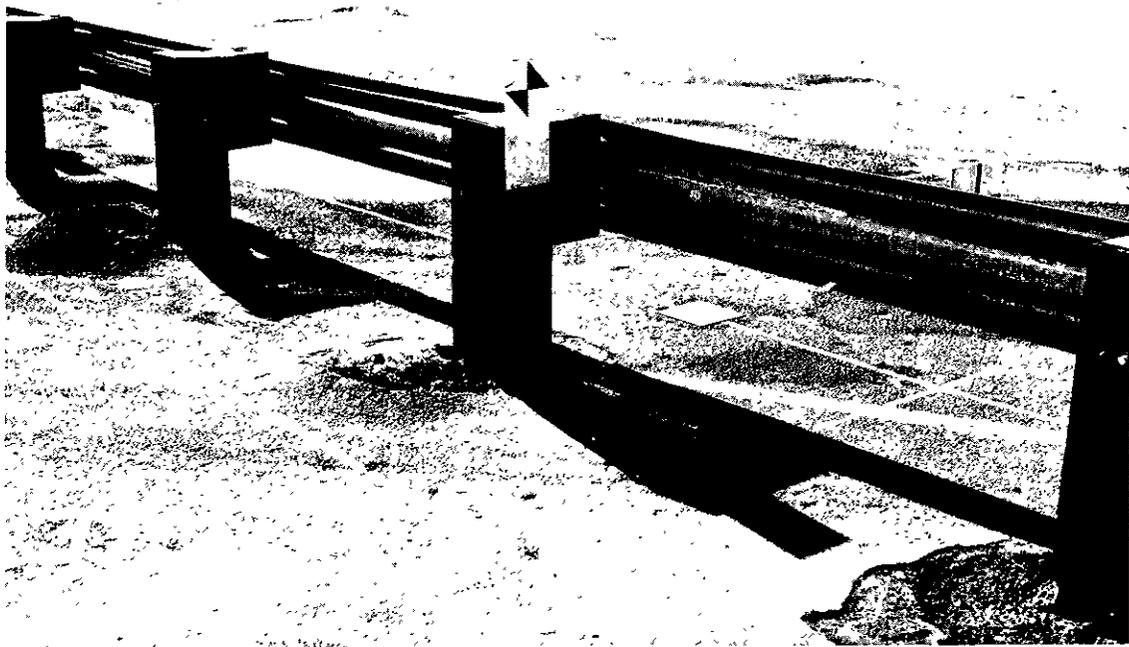
Figure 8 shows soil heave after one of the latter tests and illustrates the need for adequate set-back from the hinge-point, or deeper post embedment, for guardrail installations on fill slopes.

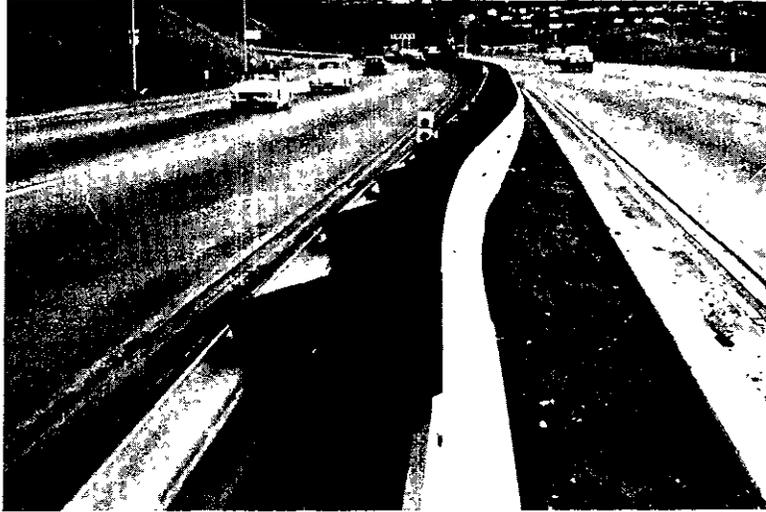
Figure 9

median barriers have performed exceptionally well as illustrated by Figures 9 and 10.

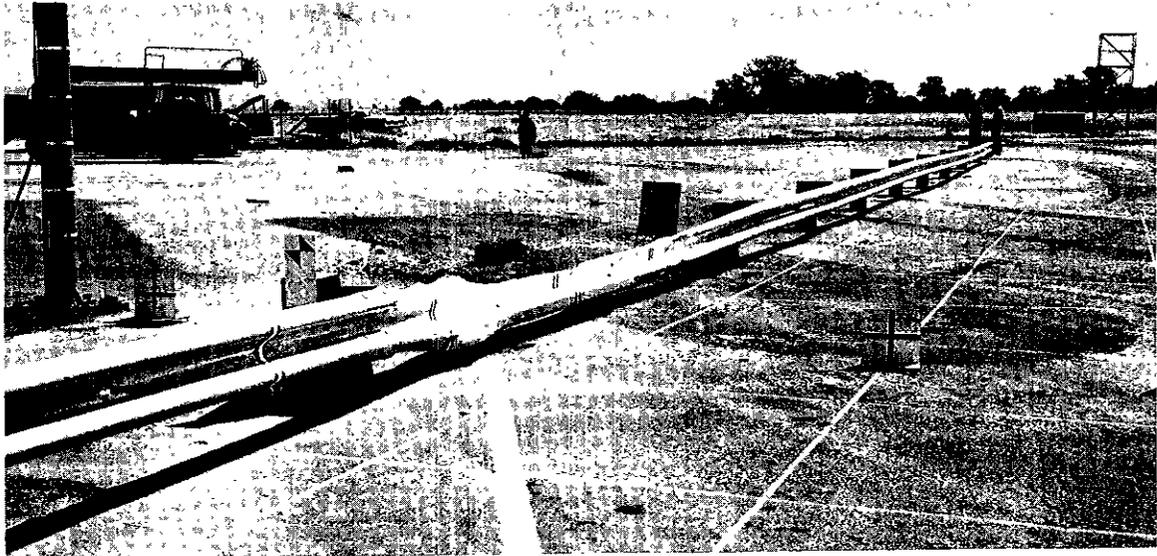
TEST 105 PLATE A

BARRIER DAMAGE: Two sections of beam were damaged. Three posts were knocked out of alignment, one of which was shattered. One block-out block was splintered and one was split.

VEHICLE DAMAGE: The vehicle sustained moderate front end damage. This vehicle was repaired for \$250 and used as the impact vehicle in Test 109.

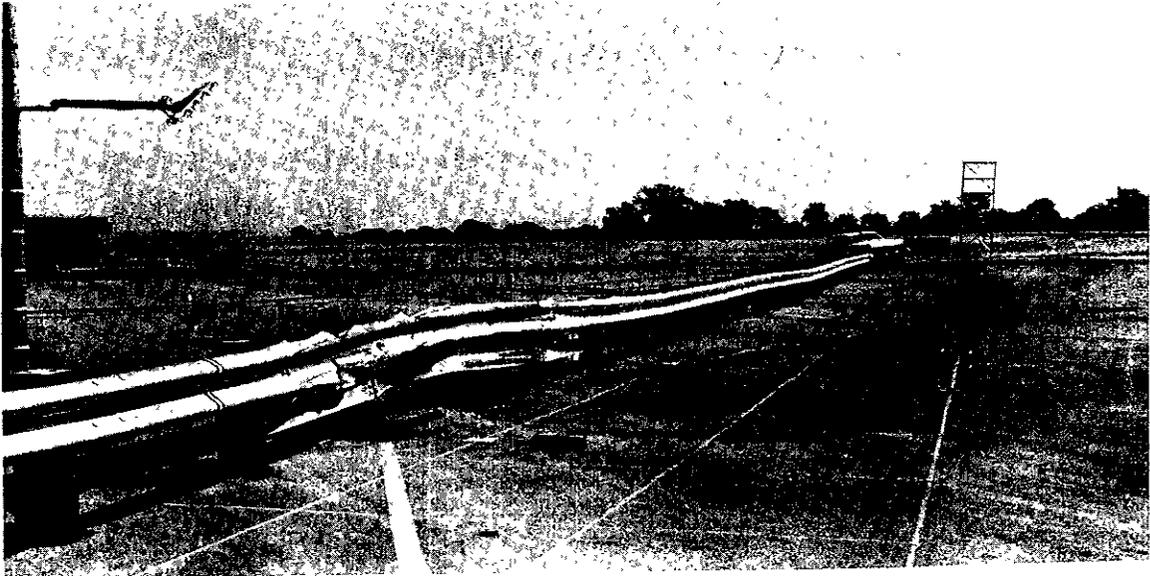
TEST 106 PLATE A

BARRIER DAMAGE: Three sections of beam and two sections of rubbing rail were damaged. Six posts were knocked out of alignment, one of which was broken and one was split. Three block-out blocks were splintered, and two were split.

VEHICLE DAMAGE: The vehicle sustained major front end damage and was considered a total loss.

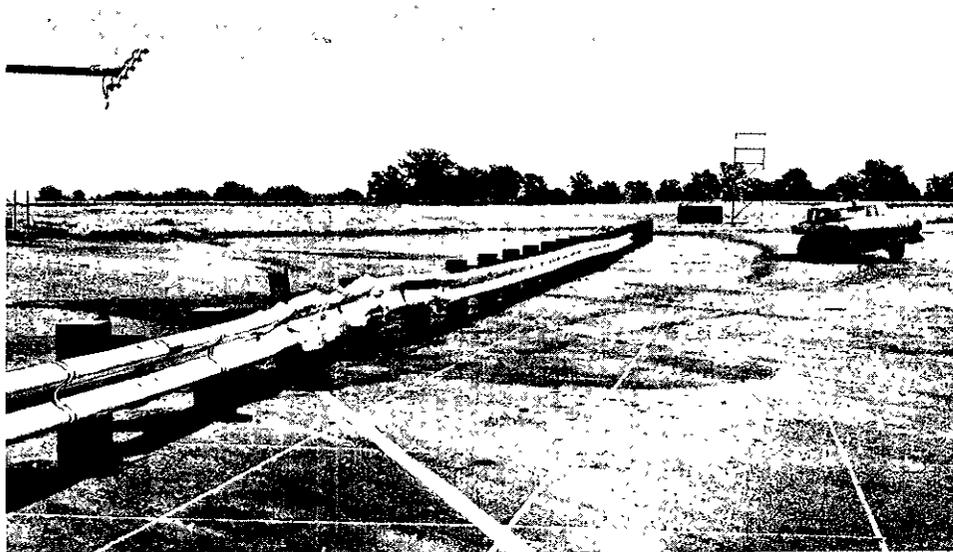
TEST 107 PLATE A

BARRIER DAMAGE: Three sections of beam were damaged. Four posts were knocked out of alignment and two were split. Two block-out blocks were splintered and three were split.

VEHICLE DAMAGE: The vehicle sustained major front end damage and was considered a total loss.

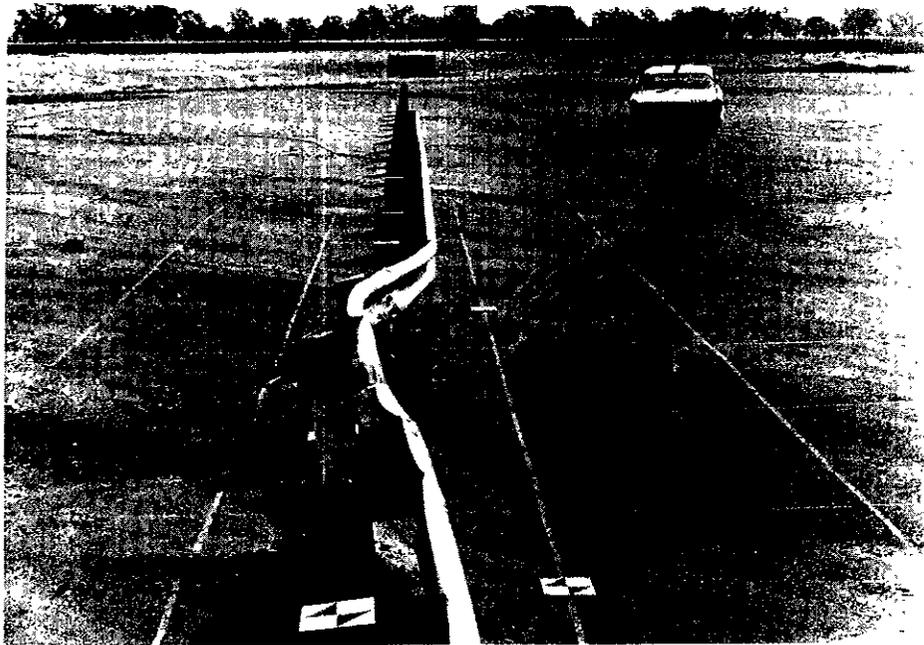
TEST 108 PLATE A

BARRIER DAMAGE: Three sections of beam were damaged. Five posts were knocked out of alignment and five were split. Two block-out blocks were splintered and four were split.

VEHICLE DAMAGE: The vehicle sustained major front end damage and was considered a total loss.

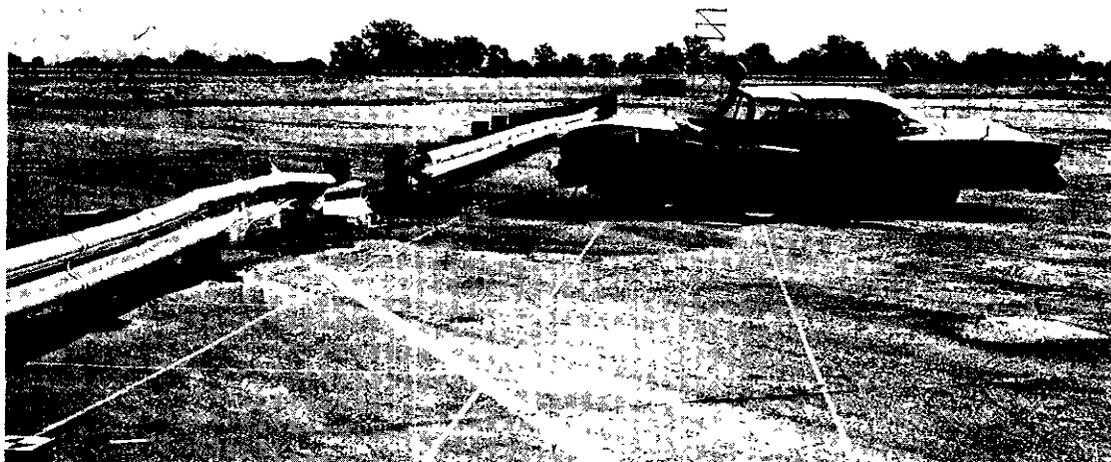
TEST 109 PLATE A

PERFORMANCE: The vehicle impacted the guardrail between posts at a speed of 60-mph and remained in contact for approximately 12-ft before the beam separated. The vehicle snagged the separated beam, resulting in a violent 100° spin-out. The vehicle's momentum, as it snagged, caused the failed beam to penetrate the wheel well and floor boards and impale the dummy. As the vehicle spun-out, 8-ft of the beam broke off near the wheel well and remained in the vehicle.

BARRIER DAMAGE: Two sections of beam were destroyed. The beam failed completely in three places. Five posts were knocked out of alignment, three of which were split. Three block-out blocks were splintered and six were split.

VEHICLE DAMAGE: The vehicle sustained major front end, dash-board, and passenger compartment damage and was considered a total loss.

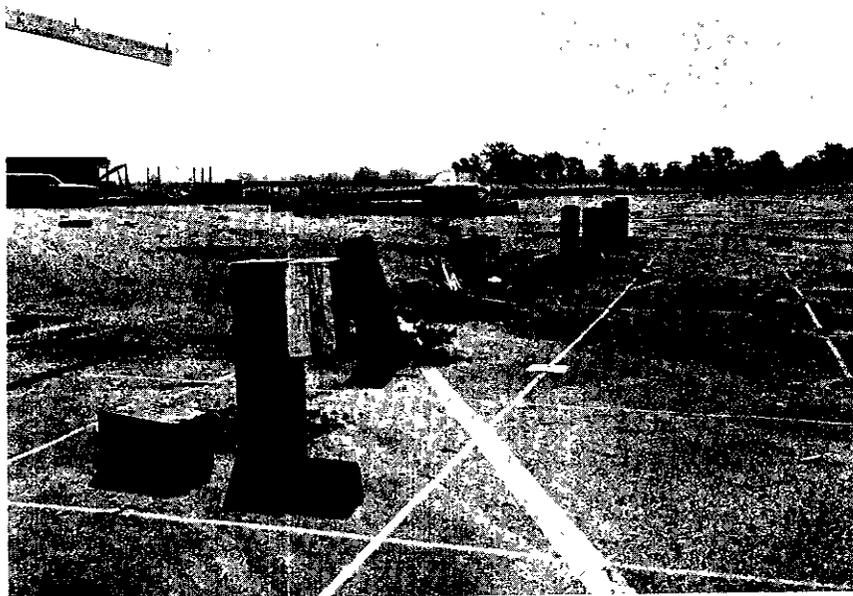
TEST 132 PLATE A

BARRIER DAMAGE: All five beam sections, ten of eleven posts and eight of nine blocks were damaged. Posts one, three, five, nine, ten, and eleven were split as the bolts were pulled through the posts by the beam. Posts six and seven were shattered to ground level. Posts two, four, and eight retained the bolt causing it to pull through the beam. Extreme bending caused three cracks to occur in the beam. There was no indication of failure at the beam splices.

VEHICLE DAMAGE: The vehicle sustained major front end damage and was considered a total loss.
