DYNAMIC TESTS OF WOOD POST AND TIMBER POLE SIGN SUPPORTS SERIES XV

MATERIALS AND RESEARCH DEPARTMENT
RESEARCH REPORT
NO. M & R 636398

December - 1967
Final Report
No. M & R 636398

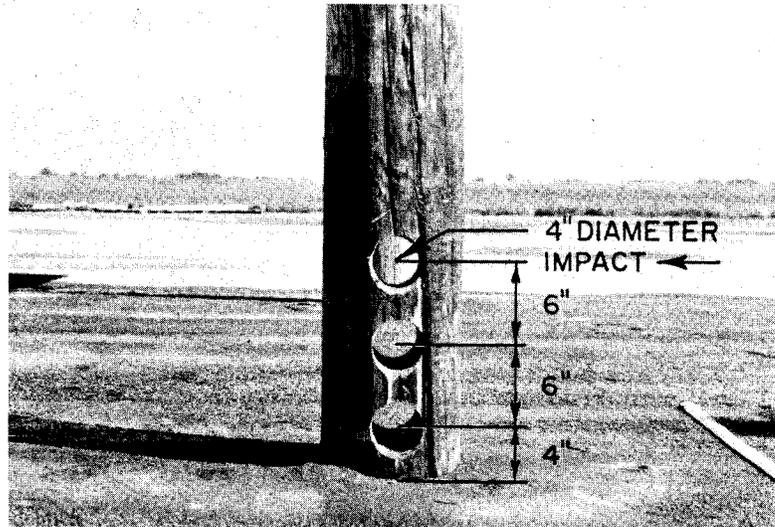
FIGURE 2

To produce this weakened plane, three 4" diameter holes were bored horizontally through the neutral axis of the Class 2 timber pole parallel to the sign face as detailed in Figure 2.

Theoretical calculations indicated that this 45.4% reduction in cross sectional area would significantly reduce the shear capacity of the pole without materially

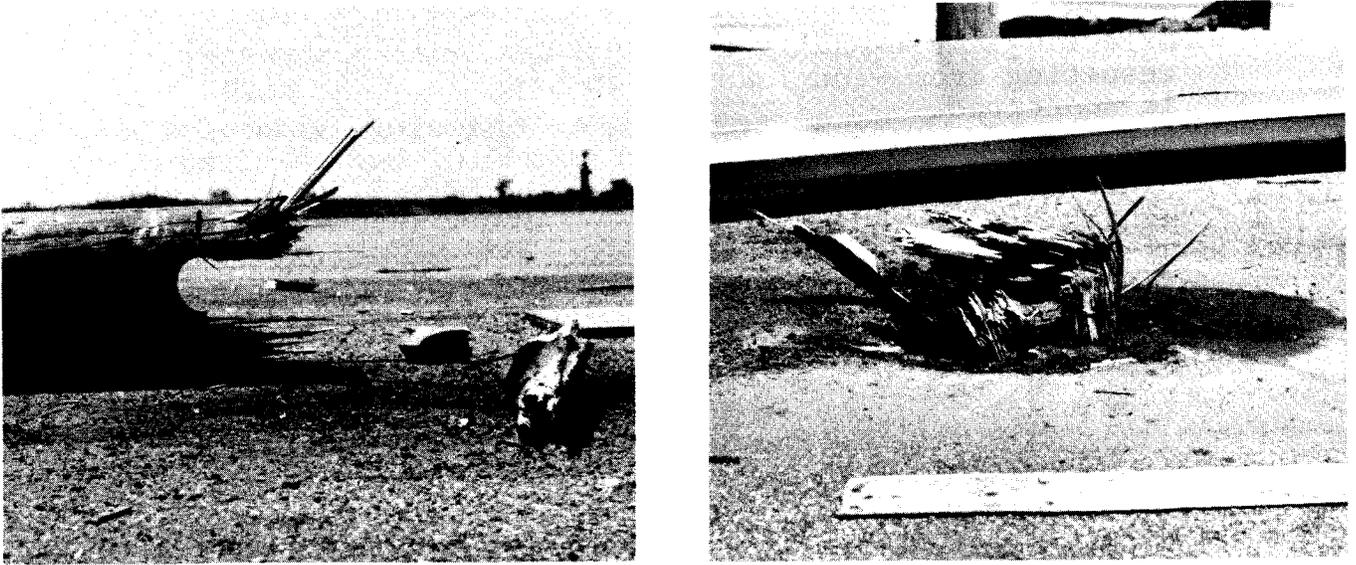
FIGURE 3

The results of the impact test indicated that this modification was effective in reducing the impact severity. However, analysis of the high speed data film of the impact and evaluation of the appearance of the fractured pole revealed that the type of failure which occurred in the pole was not what had been anticipated.

Prior to this test it was felt that failure would result primarily from excessive shear stress and produce a clean break through one of the weakened planes where the cross sectional area had been reduced. However, the high speed data film revealed that a beam type failure occurred with the wood material splitting between the holes, thus allowing vertical slippage. This let the two sides of the pole break independently of one another. Sequence pictures illustrating this failure are shown in Plate A, Test No. 153, of the Appendix. The appearance of the broken pole after impact is shown in Figure 3.

Although failure was not necessarily the result of excessive shear stress, this test did prove that this particular pole modification was effective in reducing the safety hazard presented by a Class 2 pole.

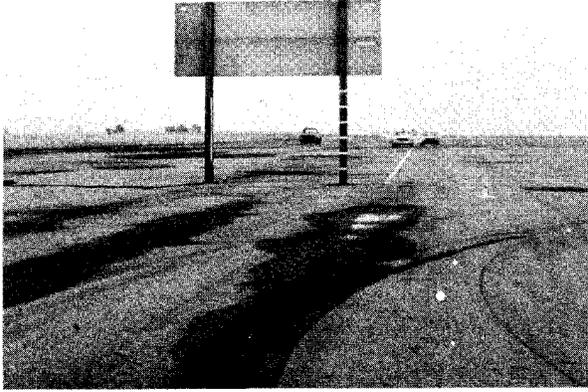
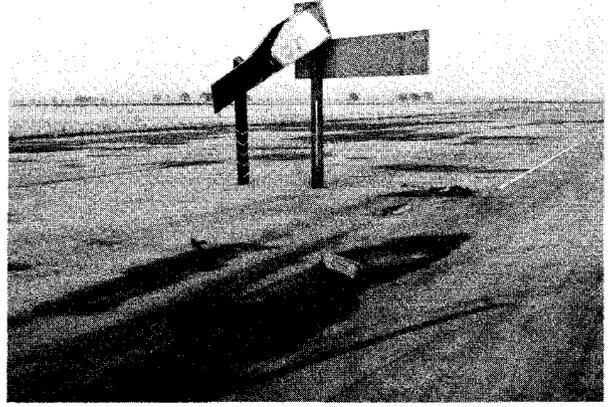
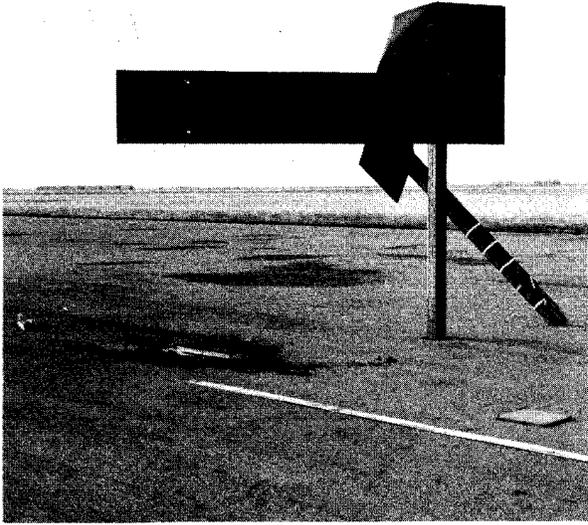
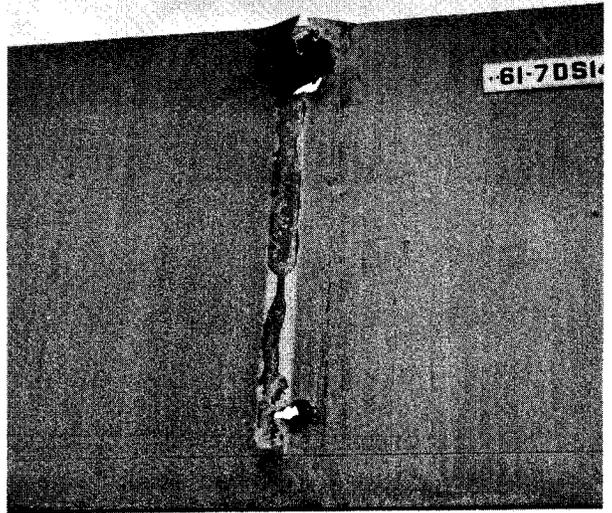
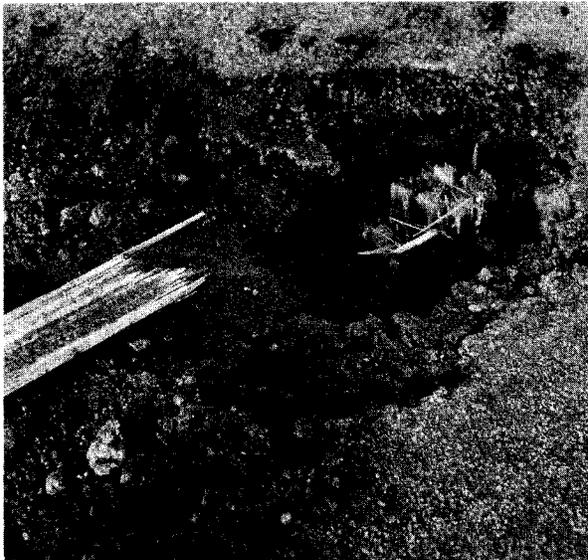
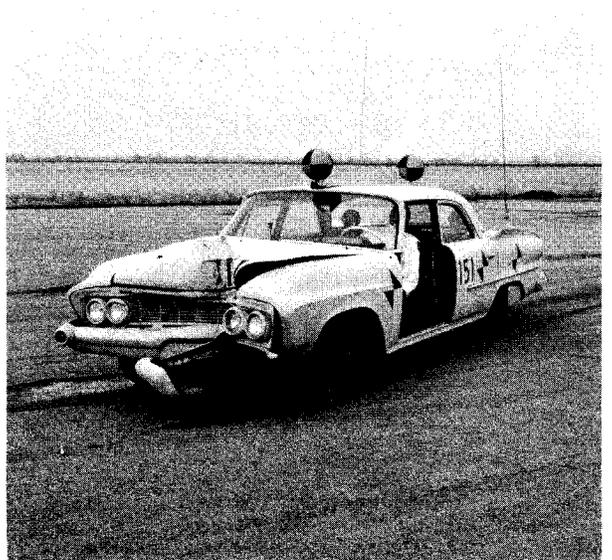
The impacted post sheared at ground level and was propelled upward and to the right by the force of impact. The pole tore loose from the lower panel, pulling the mounting bolts through the sign panel, but remained attached to the upper panel which it twisted and bent as it swung in an arc down and to the right of the right support post. Neither sign panel could be salvaged.

The vehicle sustained moderate front end damage.

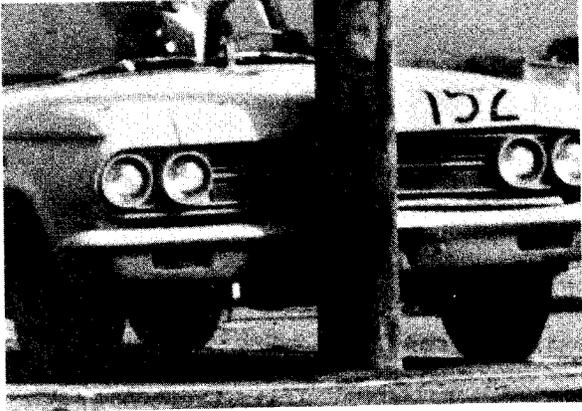
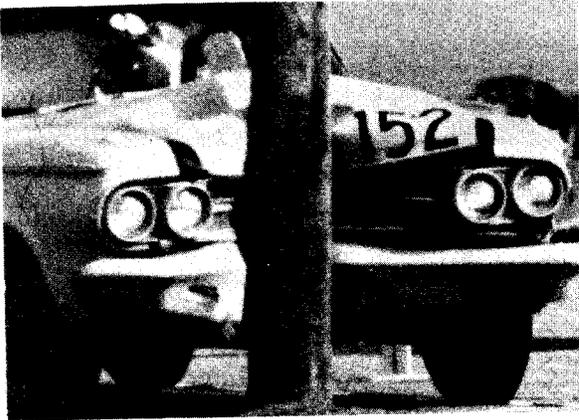
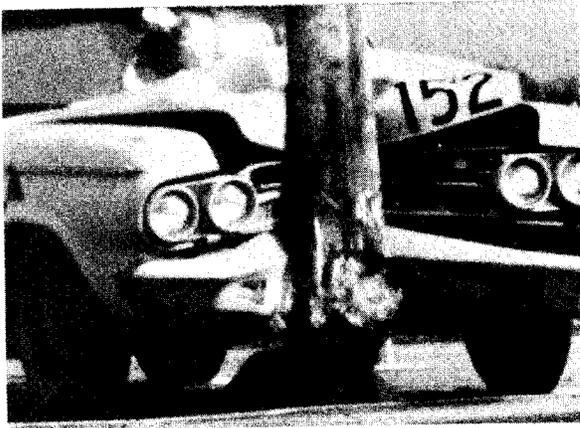
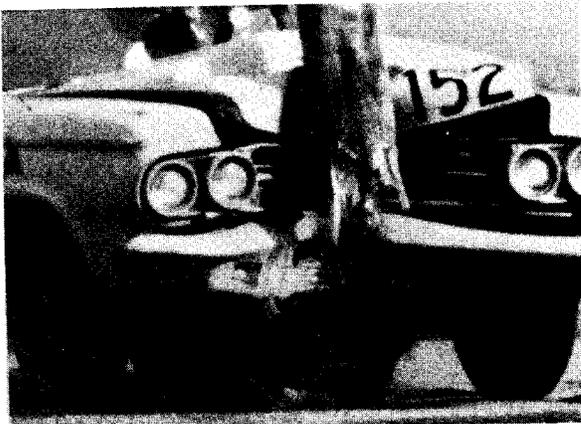
TEST 152 PLATE A

A review of the high speed data film indicated that the pole failure resulted primarily from excessive bending

stresses rather than from the direct shear force of the vehicle impact. See Test 152, Plate A of the Appendix.

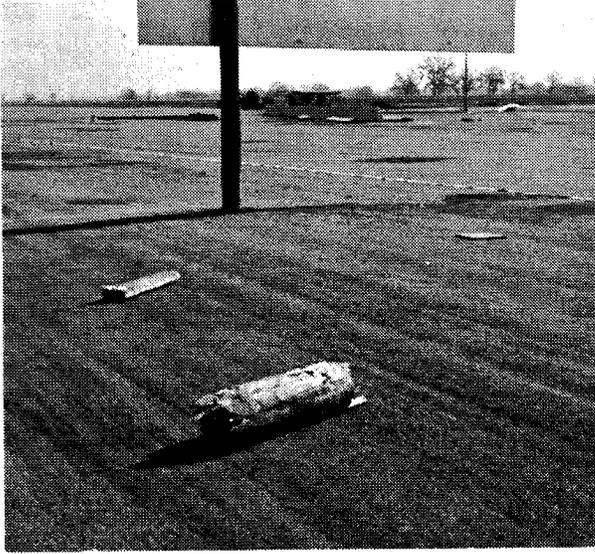
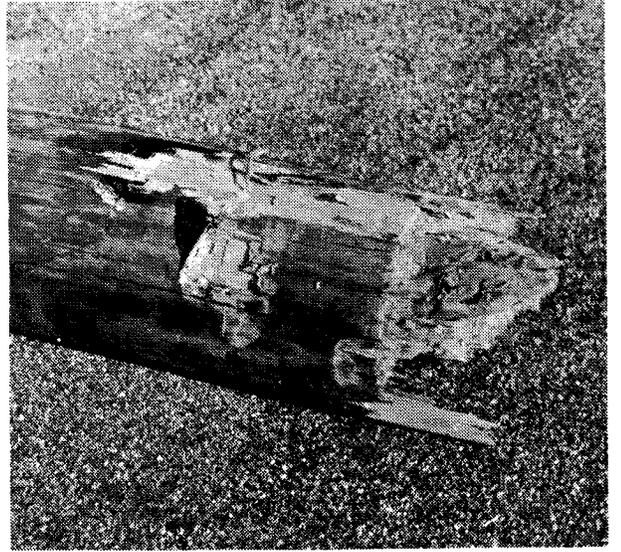
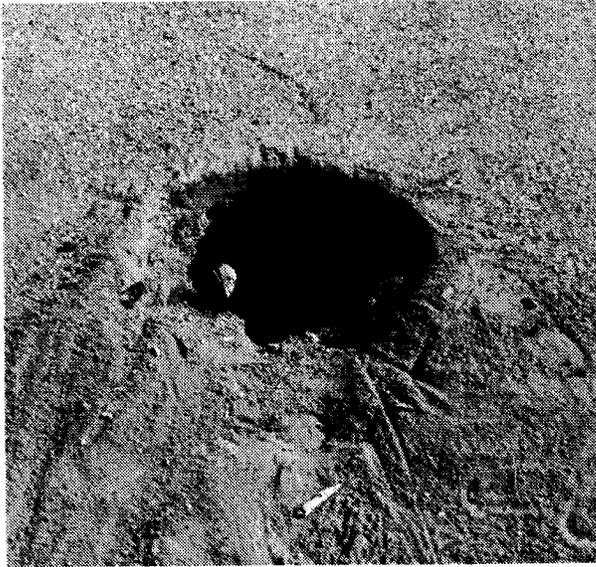
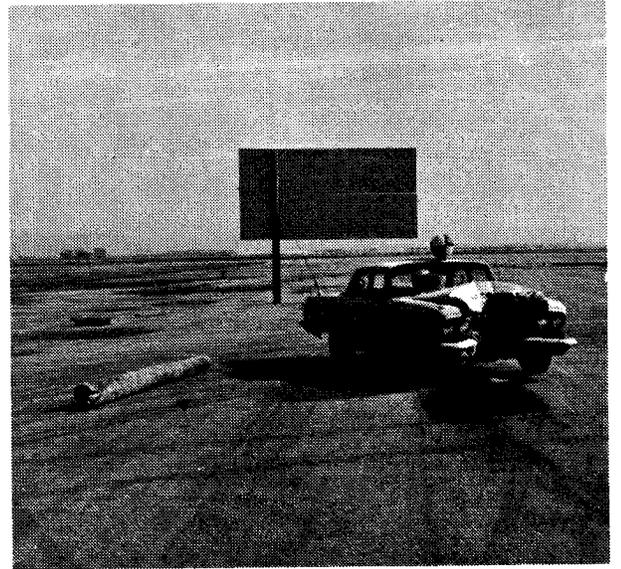
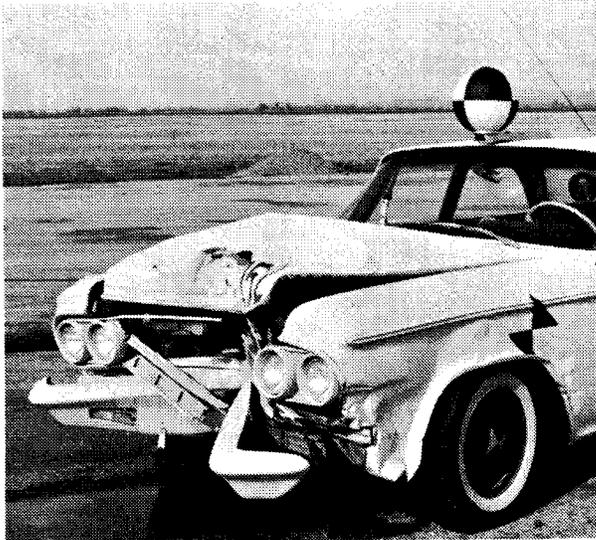
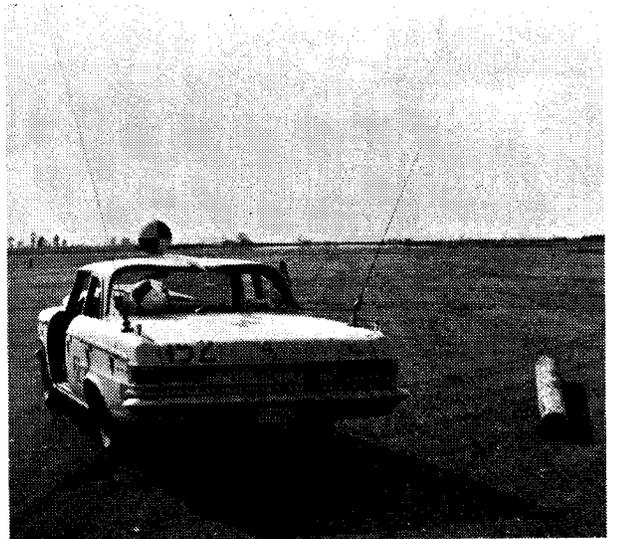
TEST 152 PLATE C

Upon impact the pole broke off 11 in. below ground level and 24 in. above the ground. The upper 15 ft. section of pole tore loose from both sign panels, was flipped up and came down on the crash vehicle deforming the roof and shattering the rear window. The four lag bolts, attaching the sign panels to the pole, pulled out of the impacted pole without damaging the sign panels. The panels remained attached to the right support pole and were used in the subsequent test without repairs.

The vehicle sustained moderately severe front end sheet metal damage in addition to the aforementioned deformed roof and shattered rear window.

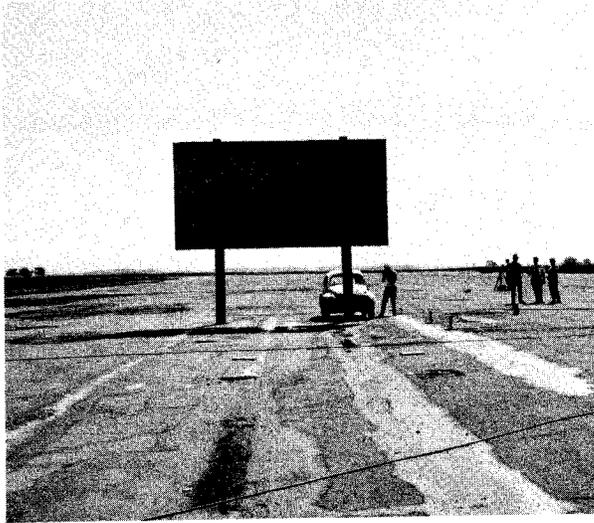
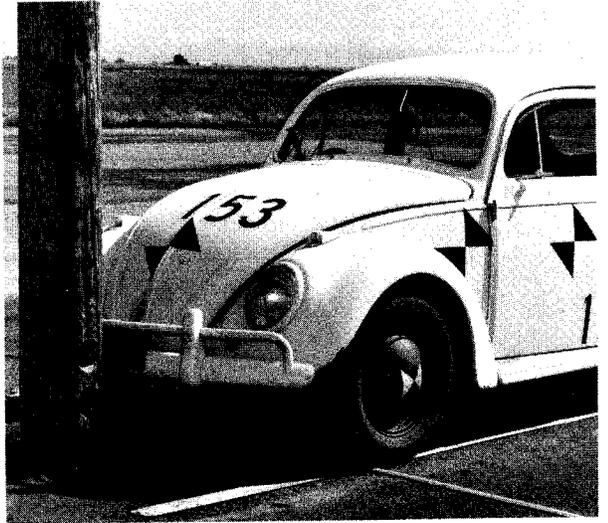
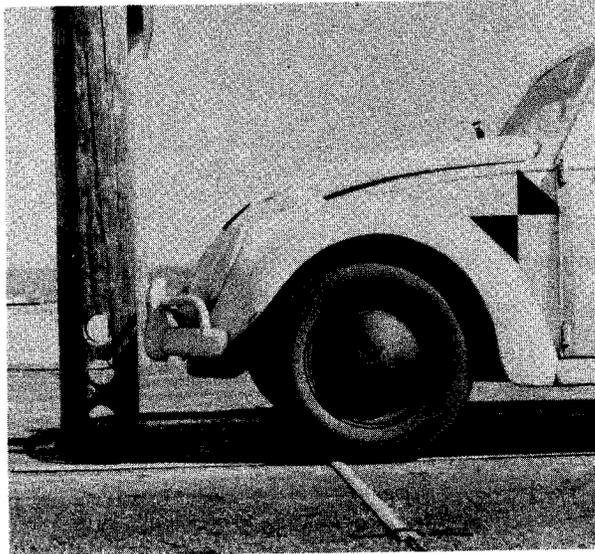
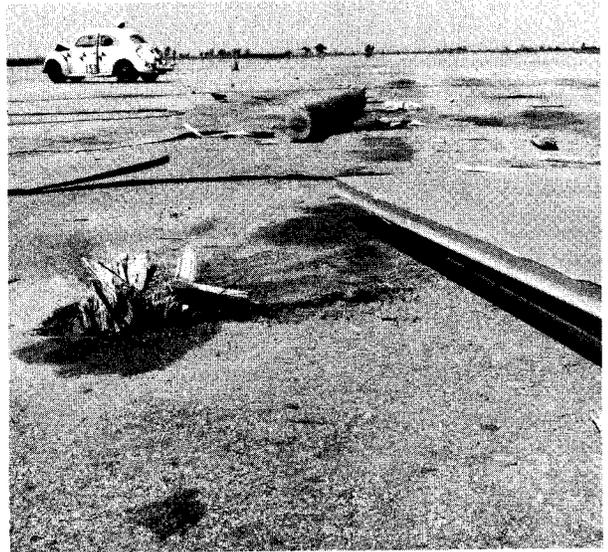
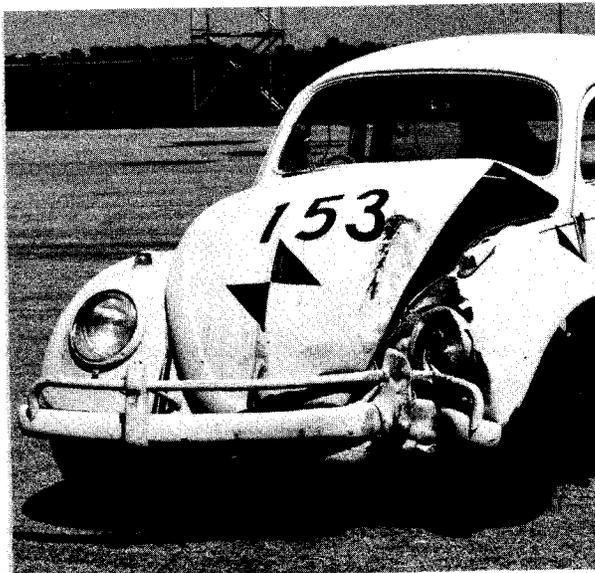
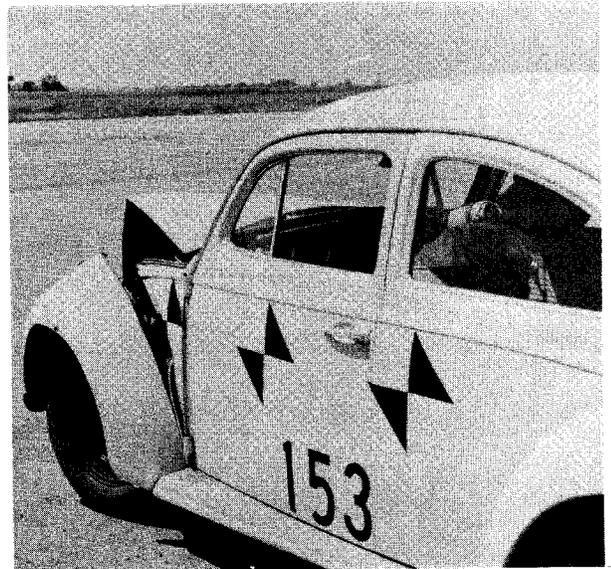
TEST 153 PLATE D

The test vehicle impacted "head-on" into the modified post, at a speed of 39 mph. The vehicle's exit speed was 27 mph. The vehicle was redirected approximately 5 degrees to the left, probably as the result of impact being approximately 1.5 ft. to the left of the vehicle center. The impacted pole fractured at the bottom hole approximately 2 in. above the ground and the section

containing the three holes split in two and was crushed by the force of impact. The remaining 15 ft. of pole was kicked ahead and up, and it tore loose from the sign panels. Had the vehicle not been redirected slightly, it is probable that this section, as it fell, would have struck the vehicle top as in the previous test. The sign panels pulled loose from the other support post and fell to the ground directly below.

The vehicle sustained moderate front end and under-carriage damage with the left front wheel pushed back approximately 6" and the steering column 3". Repair costs were estimated at \$250.
