Pinole Slide I-80, California

1970

Materials and Research Department
Division of Highways
Sacramento, California

PINOLE SLIDE
I-80, CALIFORNIA

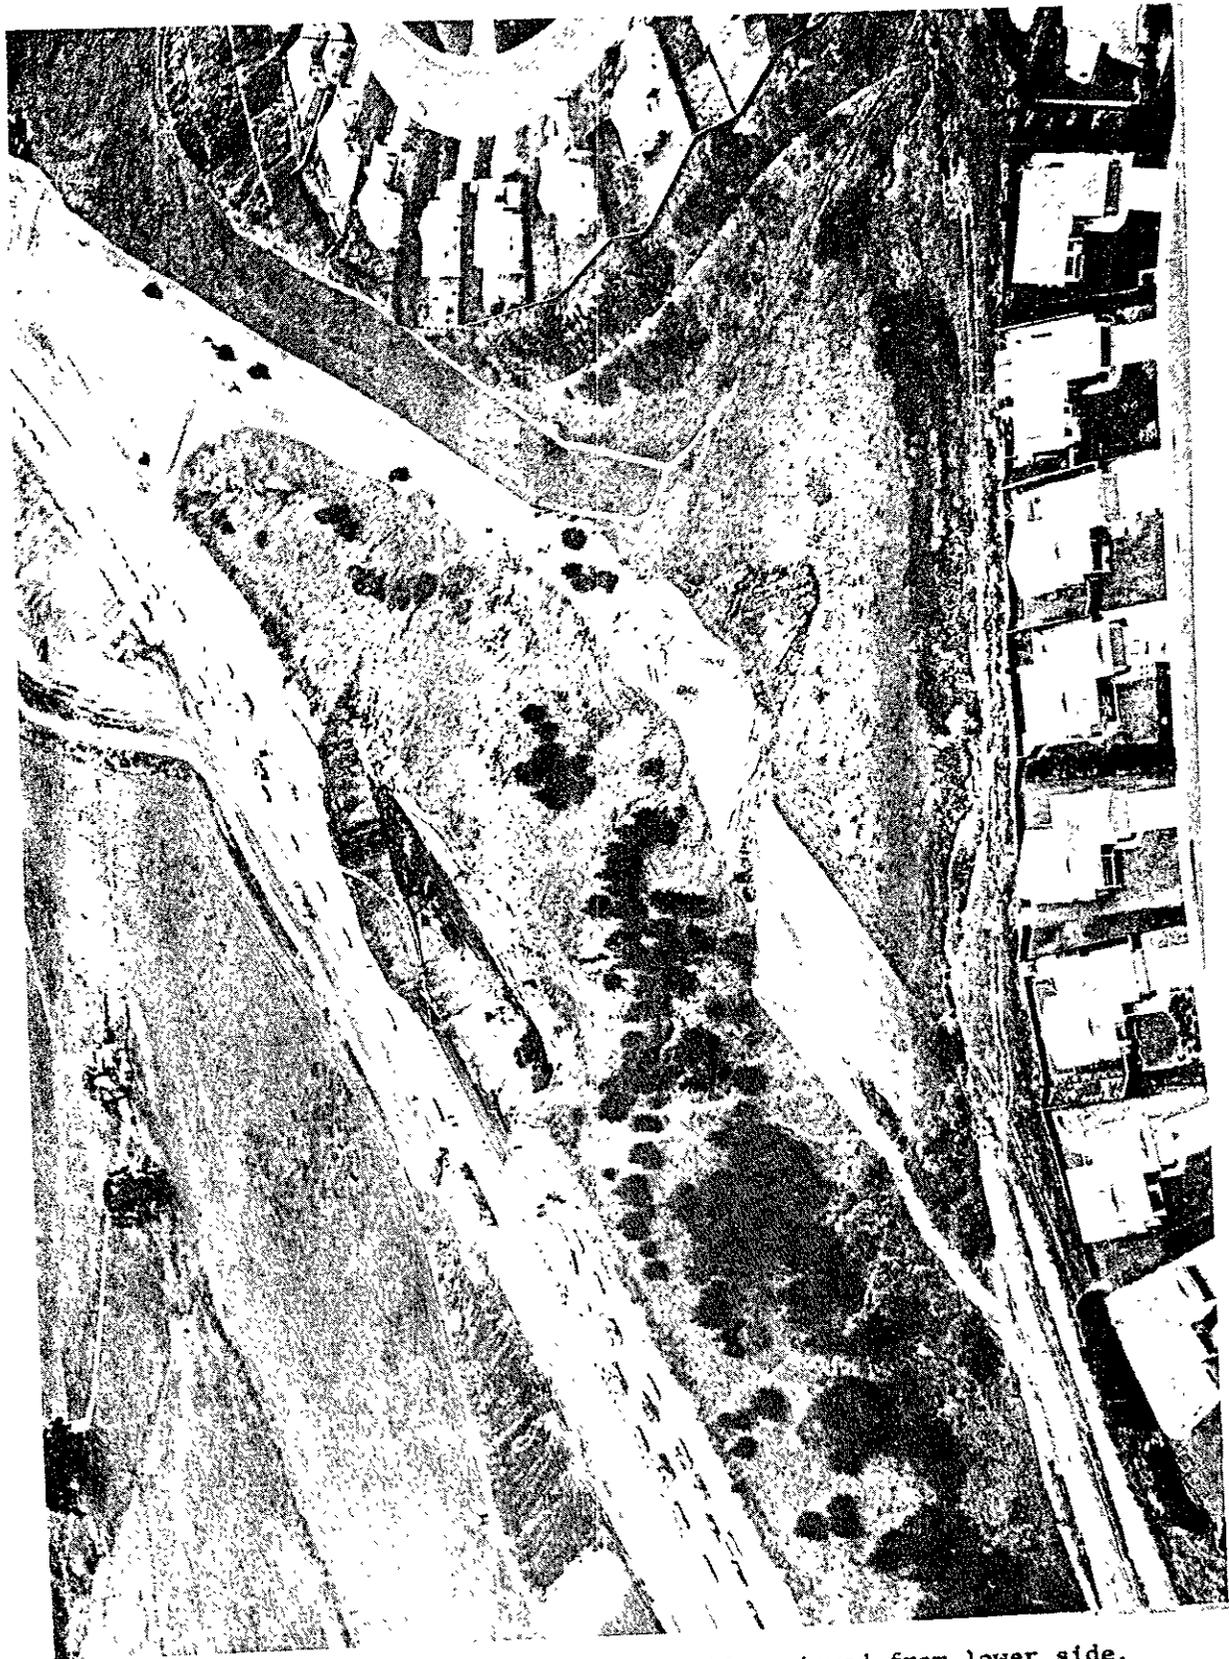
On Tuesday, May 6, 1969, indications of distress in the form of cracking and settlement appeared on a portion of the pavement of Interstate Route 80 near Pinole, California. Efforts to restore the damaged surface of the heavily traveled freeway during the next few days were ineffective as the deterioration of the roadway progressively worsened. It soon became apparent that the distress reflected an unstable condition within the embankment or its underlying foundation, and by Sunday morning, May 11, the prospect of a massive failure appeared imminent. It was therefore decided to close the road at midday in the interest of public safety. The Highway Patrol was notified, traffic was diverted, and police forces in nearby cities were alerted to prepare for unusual traffic over alternate routes. A few hours after these precautions were taken, over 400 feet of embankment slid out leaving a single lane of the roadway in place, as shown in Photographs 1 and 2.

Photograph No. 1 - Aerial photo of slide, looking westerly

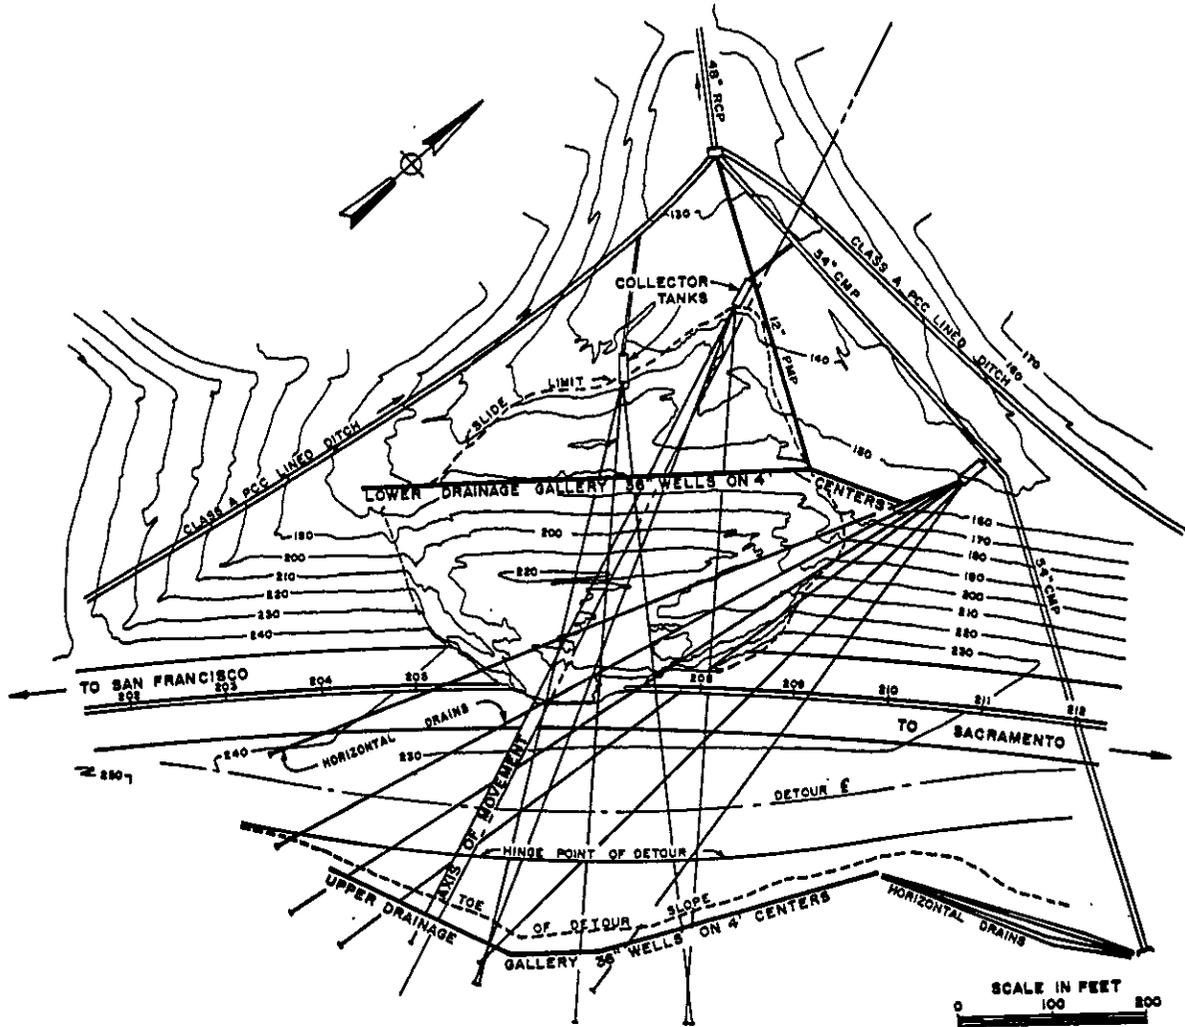
PLAN OF FAILED AREA
STA. 202 TO STA. 212

Figure 2 - Plan of failure area showing drainage system and detour

gallery on the high side of the fill is drained laterally to a collecting basin at ground surface by means of a 6-inch steel pipe supplemented by a group of three short horizontal drains. From this point the cumulative flow is conducted beneath the embankment to the drainage disposal area through a 54-inch by 990-foot CMP. A 12-inch by 350-foot perforated metal pipe laid in an excavated trench bedded with gravel drains the lower gallery to the master drain junction box (see Figure 2).

The 12 horizontal drains installed to relieve ground water pressure were incorporated into the permanent drainage system. Three 32-foot lengths of 120-inch multiplate pipe fitted with concrete ends to form tanks were utilized to collect flows from the three groups of drains. Water collected in the tanks exited through small conduits into the large 54-inch pipe drain and into the open PCC lined ditches that function as surface drains along the toes of the embankments (see Figure 2).

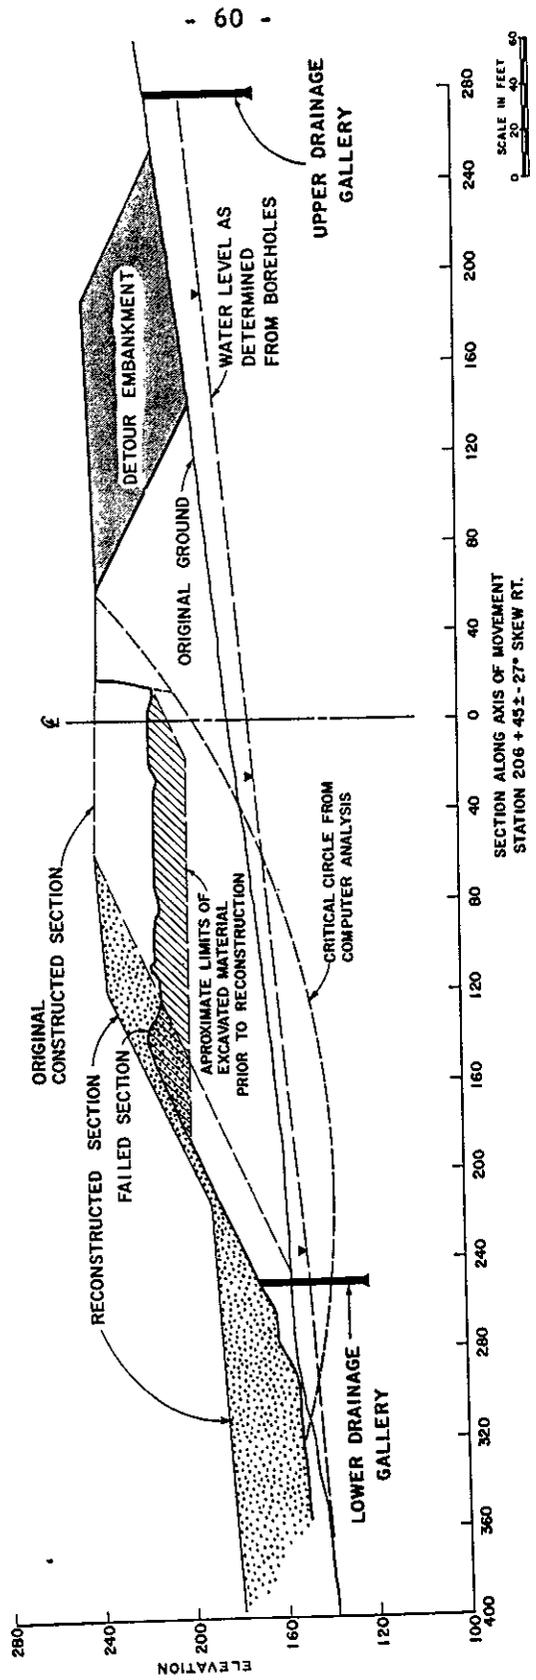
factor. For the conditions analyzed, a minimum safety factor of 1.01 was obtained for the circle shown on Figure 3.

The mode of failure appears to have been more of the translational type than circular, especially through the lower area of movement. The use of a circular failure surface as an approximation is believed to have been justified since the critical circle was fairly flat through the zone of original ground and conformed reasonably well to the available inclinometer data. Also the safety factor of unity attested to the reasonableness of strength values used in the analysis.

Figure 3 - Cross section along axis of movement, Station 206+45 ±, showing failure plane, reconstruction features and detour embankment

Increased stability of the embankment was provided by the placement of a 25-foot high berm downhill of the roadway, extending laterally 50 feet beyond the downhill limit of movement (see Figure 3). This berm was keyed into the existing subdivision embankments northerly of the original embankment toe. A factor of safety in the order of 1.4 was obtained through employment of the berm.
