Landslide Investigation Near Forest Glen

January 1976

R.H. Prysock

State of California
Department of Transportation
Division of Structures & Engineering Services
Office of Transportation Laboratory

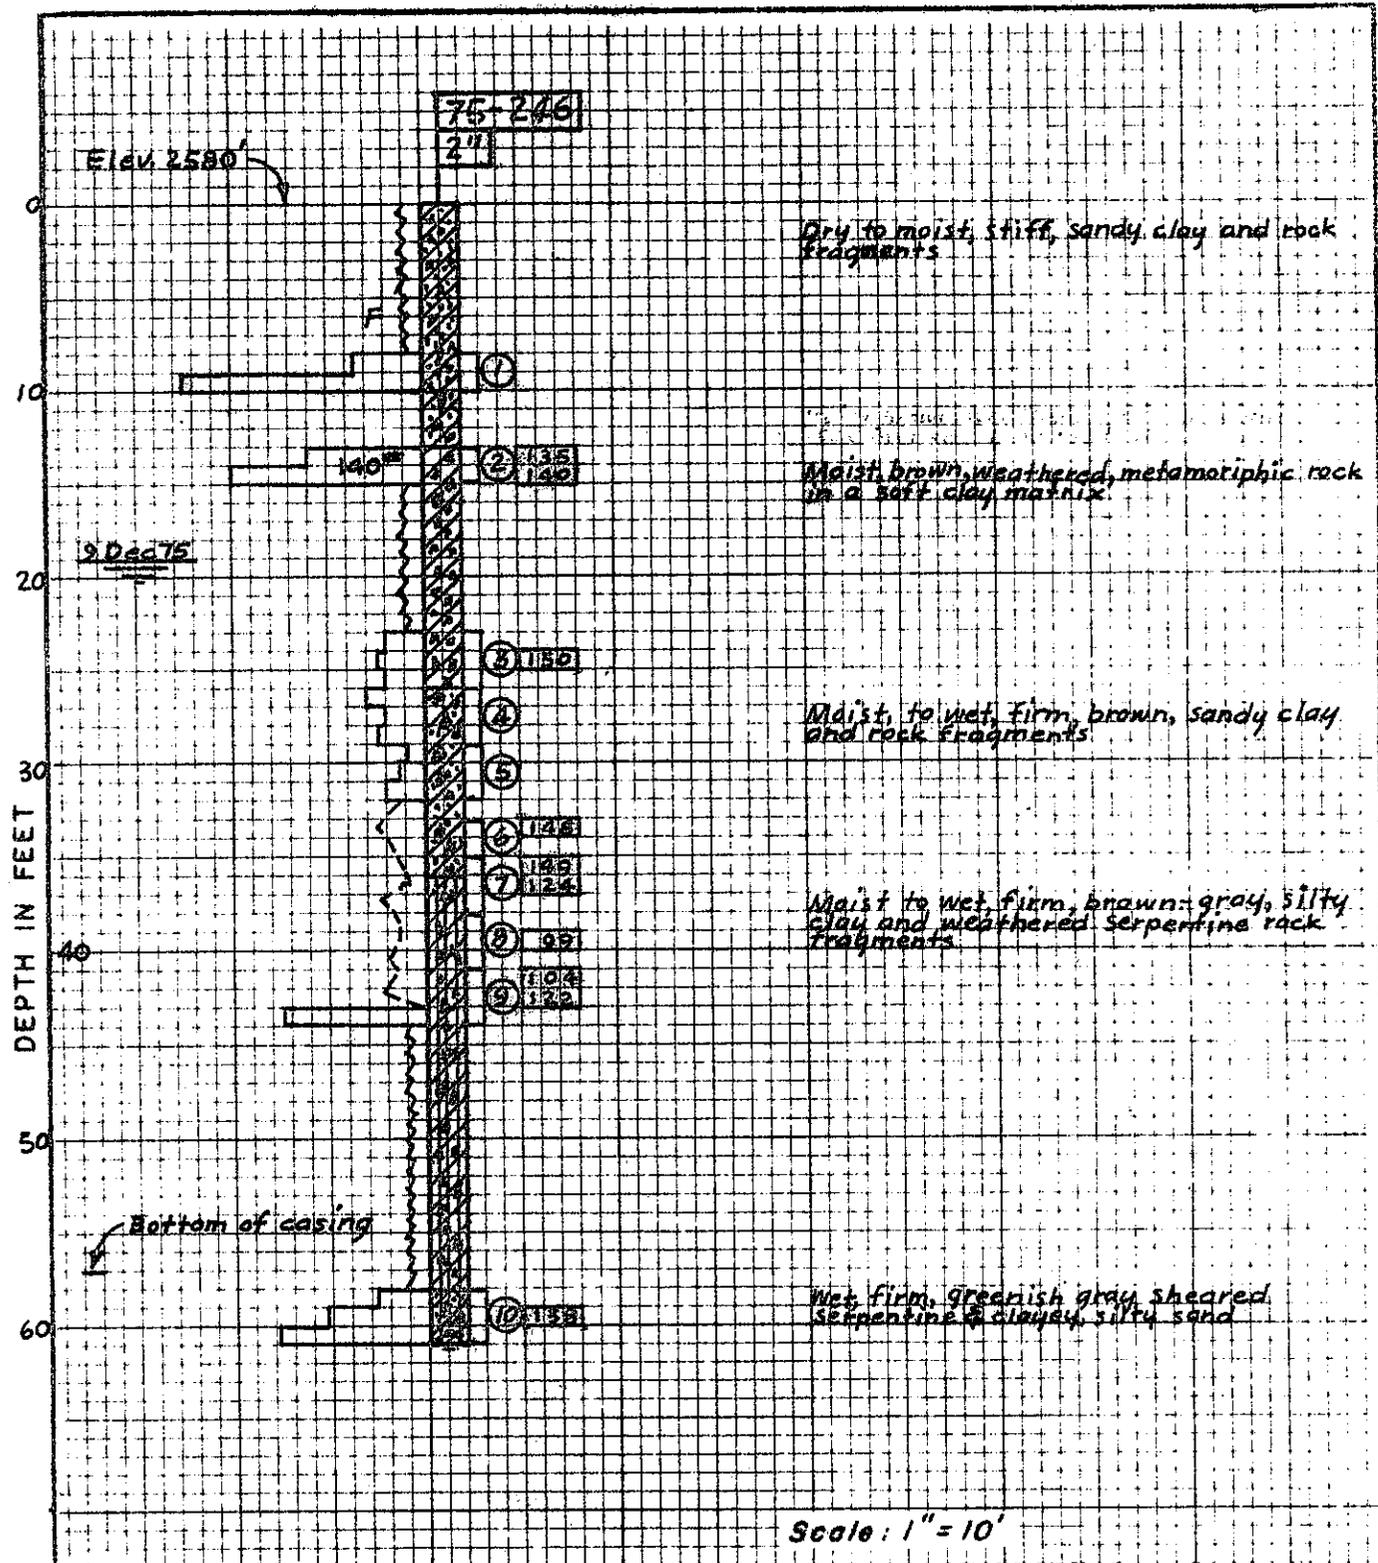
TRANSPORTATION LABORATORY LANDSLIDE INVESTIGATION							
NEAR FOREST GLEN							
Profile of Boring 75-246							
DATE	DIST.	COUNTY	ROUTE	POST MILE	DWG. NO.	TOTAL SHEETS	
1-28-76	01	Tri	36		2798	4 of 19

During October 7-15, 1975, a drill crew from District 01 made four borings (Nos. 246-249) through the slide mass to depths of 61, 63, 72 and 73 feet. Tube samples were taken at various depths for laboratory testing and then the boreholes were used for slope indicator installation. Examination of samples revealed the subsoils to consist primarily of brown and gray sandy clayey silt with a high percentage of rock fragments comprised of weathered gneiss, schist, quartz, and serpentine. Hard rock, as indicated by auger refusal, was found in three of the four borings at bottom depths of 63 to 73 feet. No well-defined stratification was evident and no reliable generalized soil profile could be developed, especially in view of the probable folds and distortions in the substrata.

Free groundwater was encountered during drilling at depths of 23, 43, 51 and 57 feet, respectively, as noted on the boring logs, Figures 4-7.

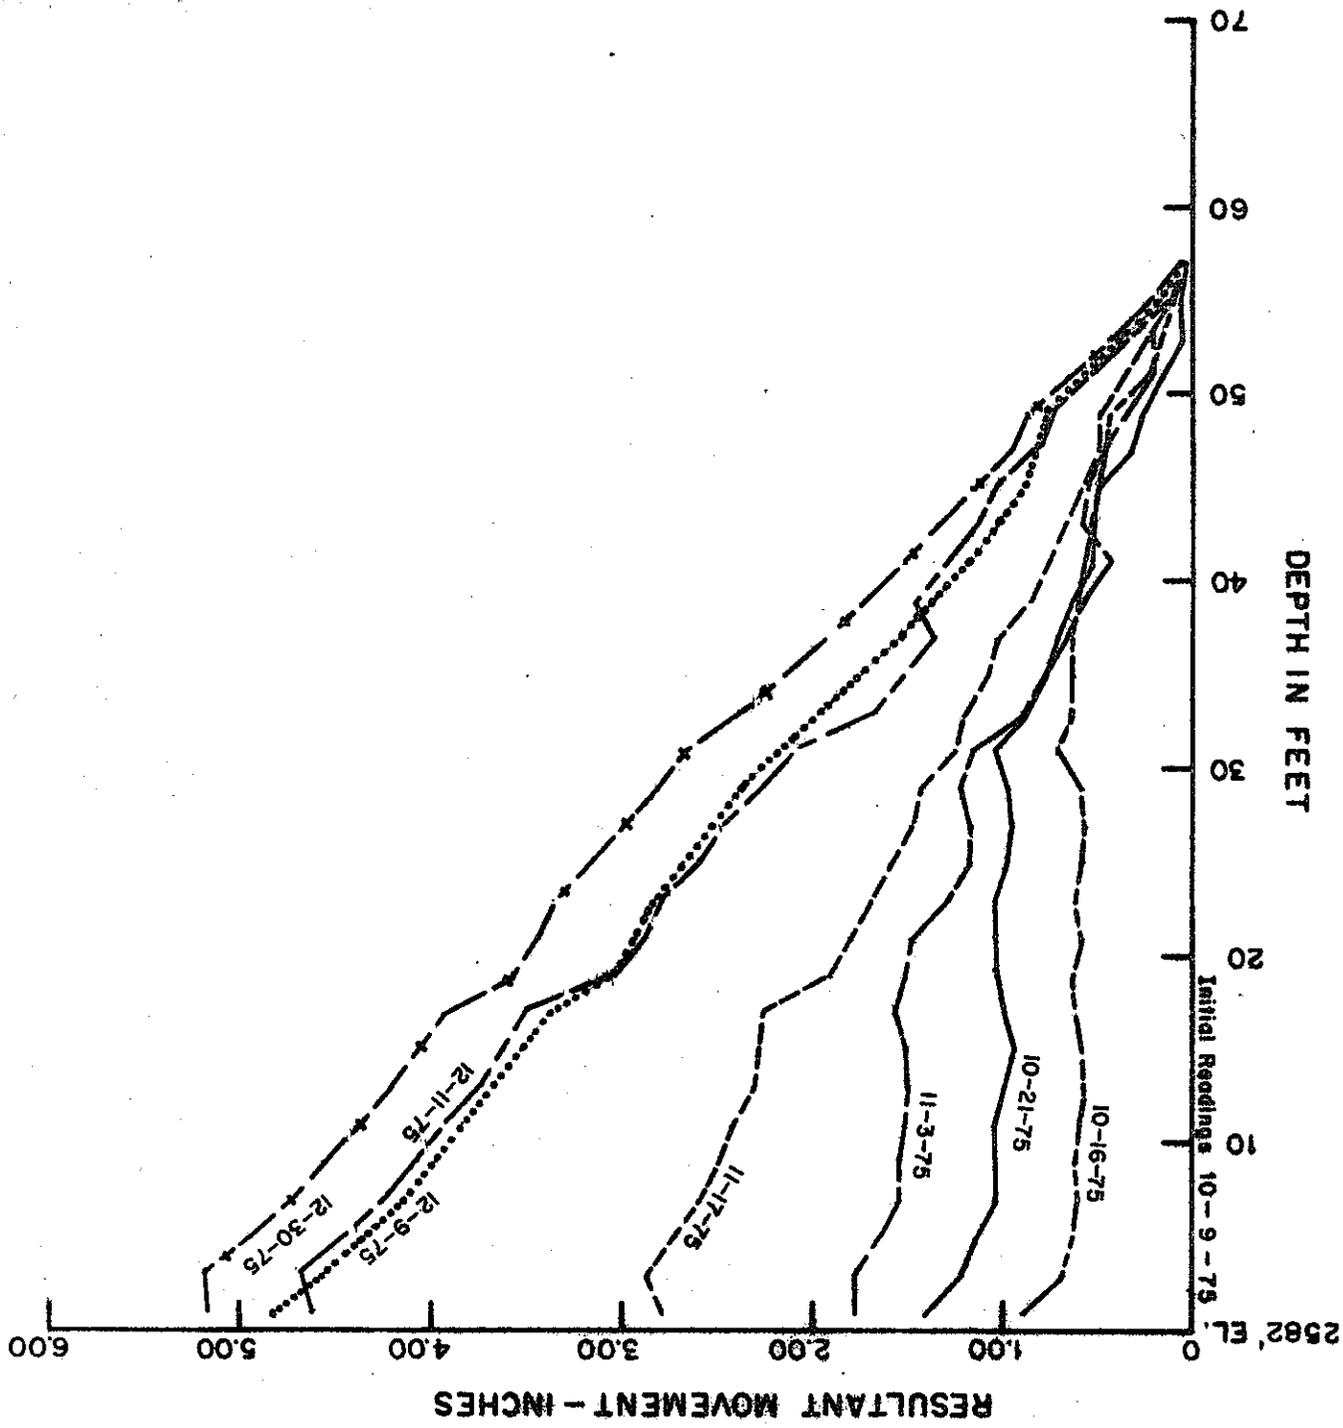
Figure 8

The pattern of slide movement as shown by slope indicator data, noted on Figure 2, substantiates visual observations of ground surface cracks. SI-1, for example, shows a resultant movement in a westerly direction almost 90 degrees from the direction of overall movement. This localized movement toward a free surface (the natural slope down to the drainage course) probably results from a pinching or squeezing action as the overall slide mass rides over or around firmer material. Indicators SI-2, -3, and -4 show resultant movements in the general direction of overall

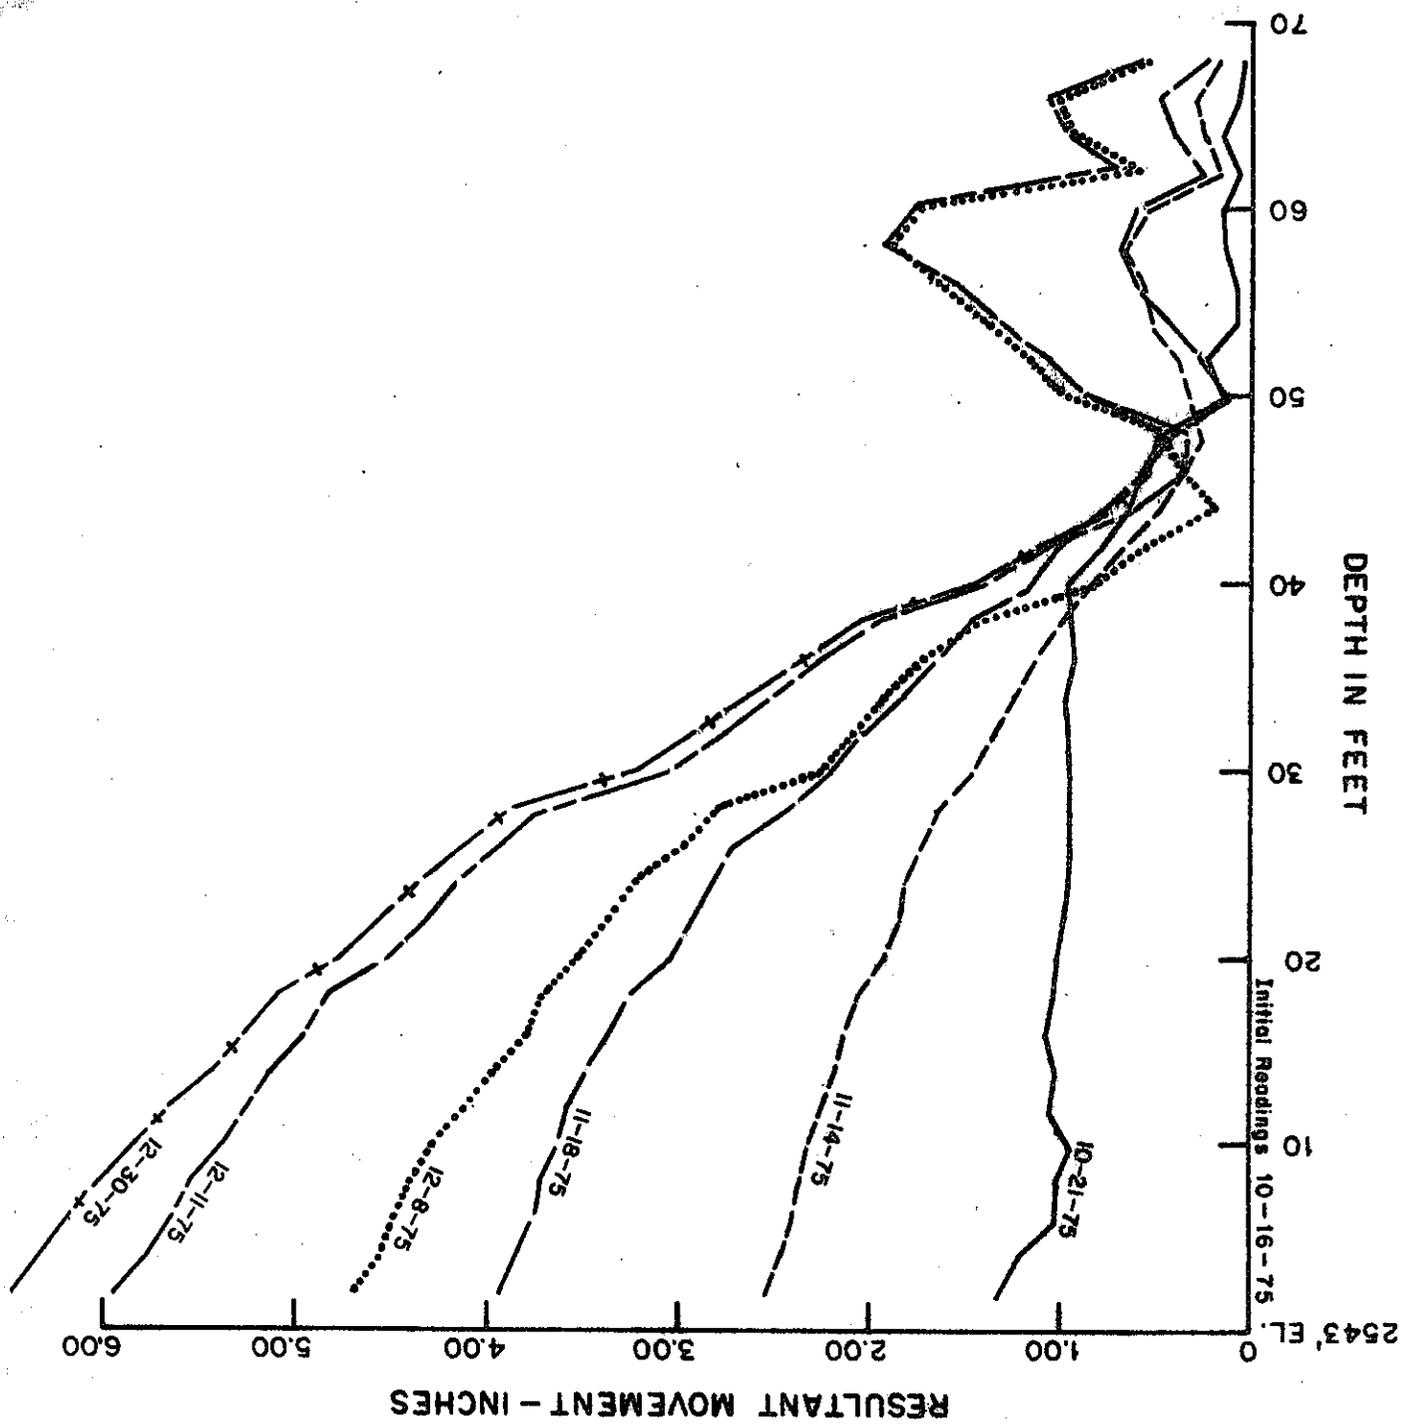
Figure 10

slide movement. SI-3 shows an interesting pattern in that from ground surface to a depth of about 52 feet, the resultant movement is in an easterly direction toward a free surface, whereas overall movement (below 52 feet) is in a southerly direction toward the new road alignment and slide pushup area. The seemingly erratic pattern of slide movement is believed to result from the subsurface twisting, squeezing, and overriding caused by a complex stratigraphy that probably is reflected by the topography.

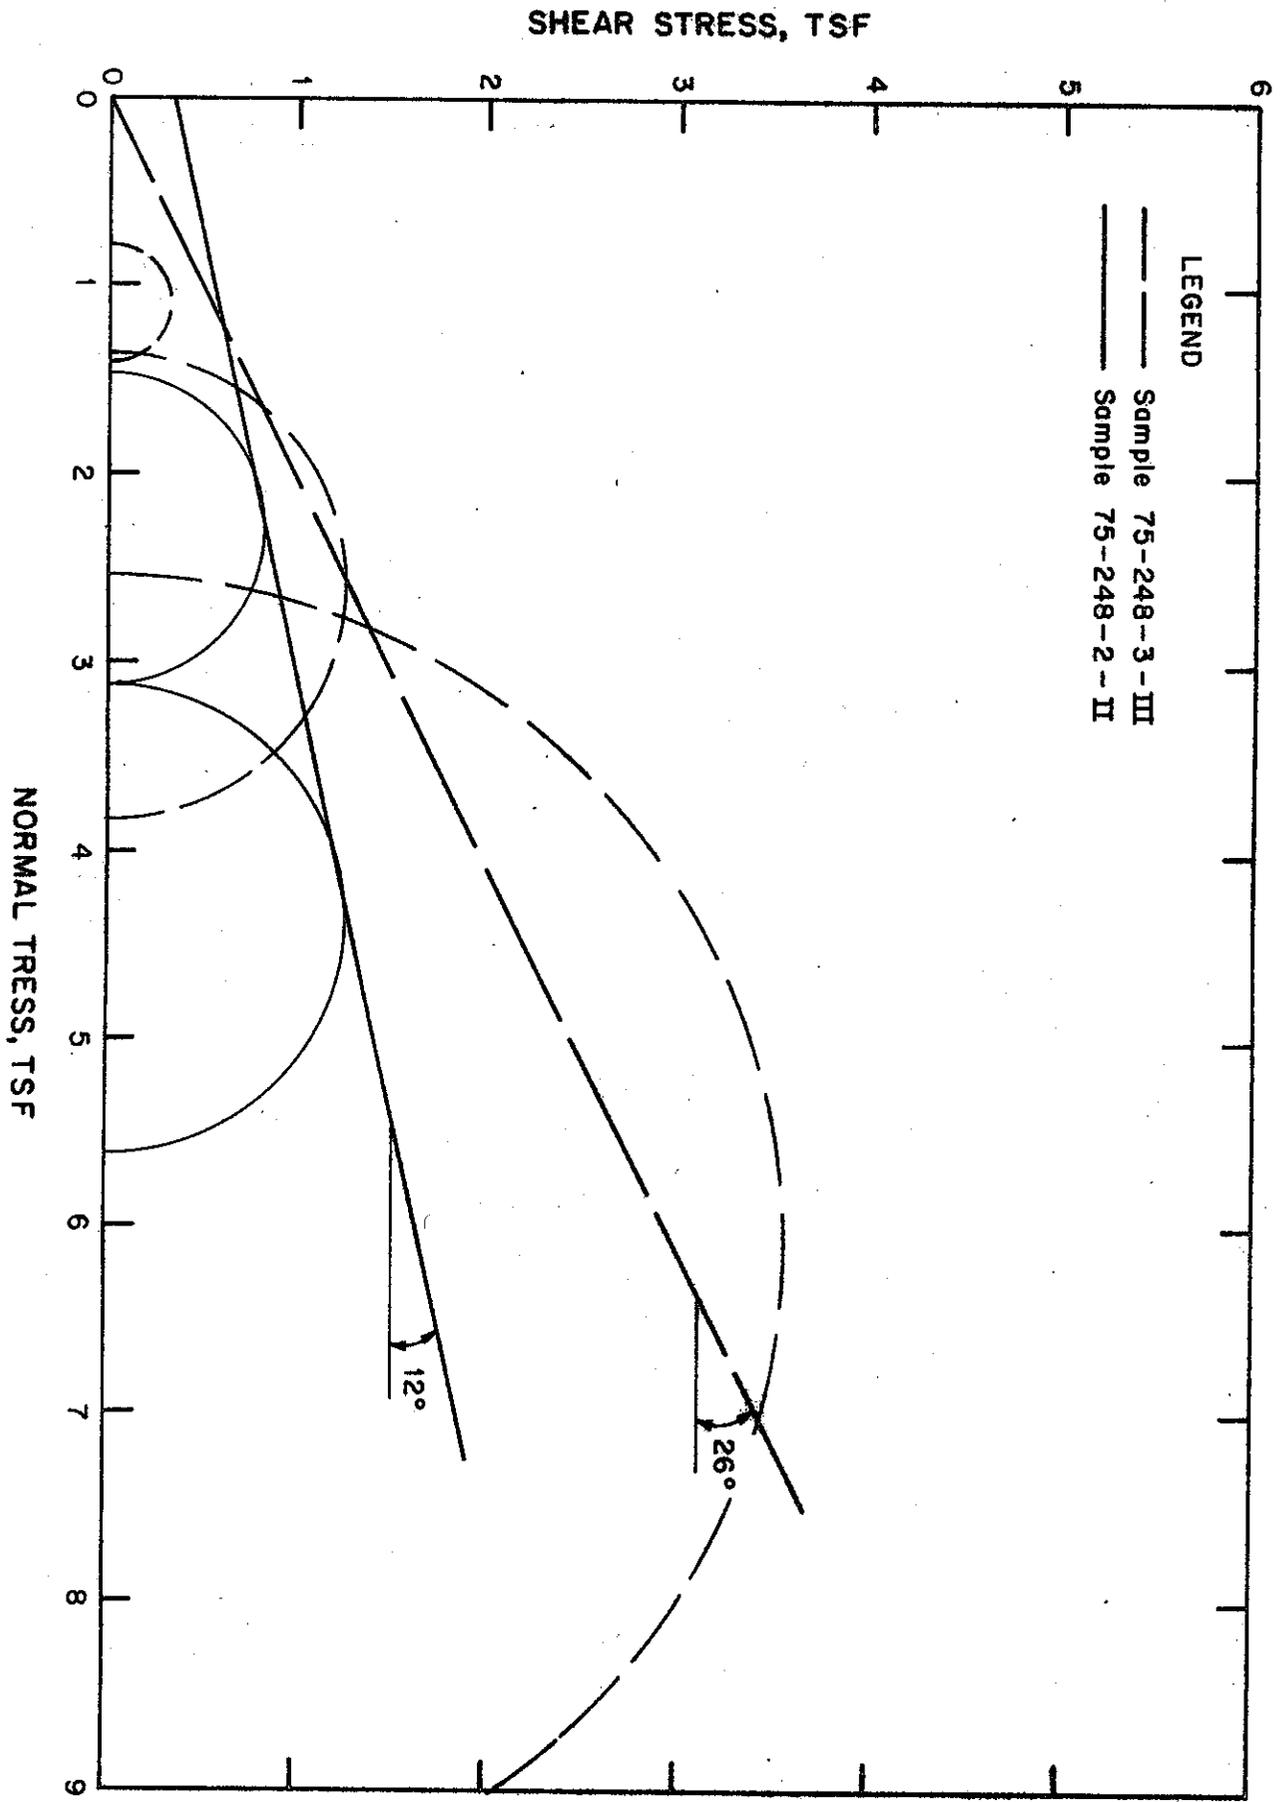
Figure 16

Two series of direct shear tests were run by repeatedly shearing the specimens along the same failure plane to determine residual strength values. One of the series did exhibit strength loss with repeated shearing and gave residual values of 700 psf and 12° for unit cohesion and friction angle, respectively. The remaining series did not show appreciable strength loss and resulted in strength values of $C=0$ and $\phi=26^\circ$. These results are plotted on Figure 16.

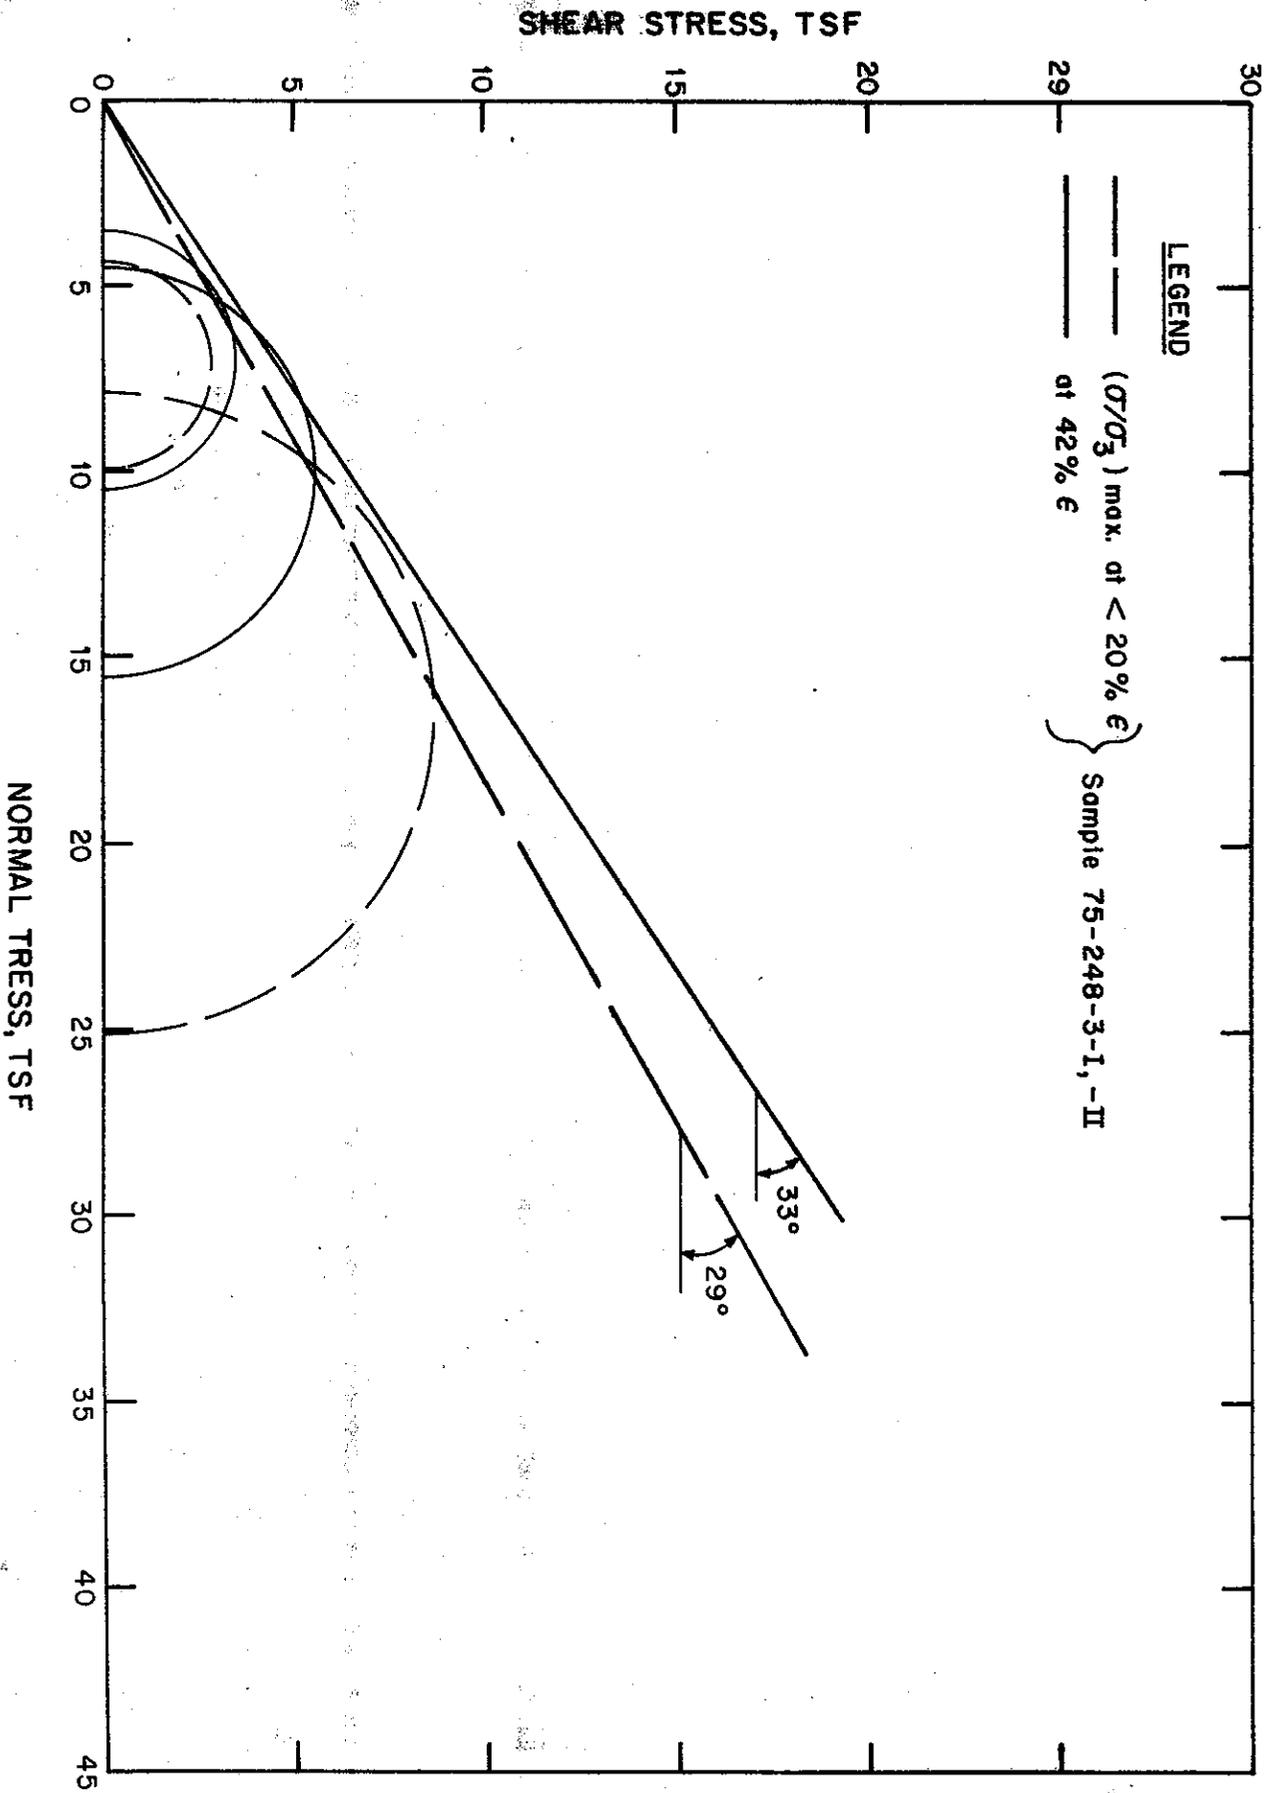
The results, shown plotted as a Mohr diagram in Figure 17 demonstrate that no appreciable loss of strength occurred. The common failure criterion of maximum principle effective stress ratio, which occurred at less than 20 percent strain, yielded a ϕ - angle of 33° whereas 42% strain values produced a ϕ - angle of 29° .

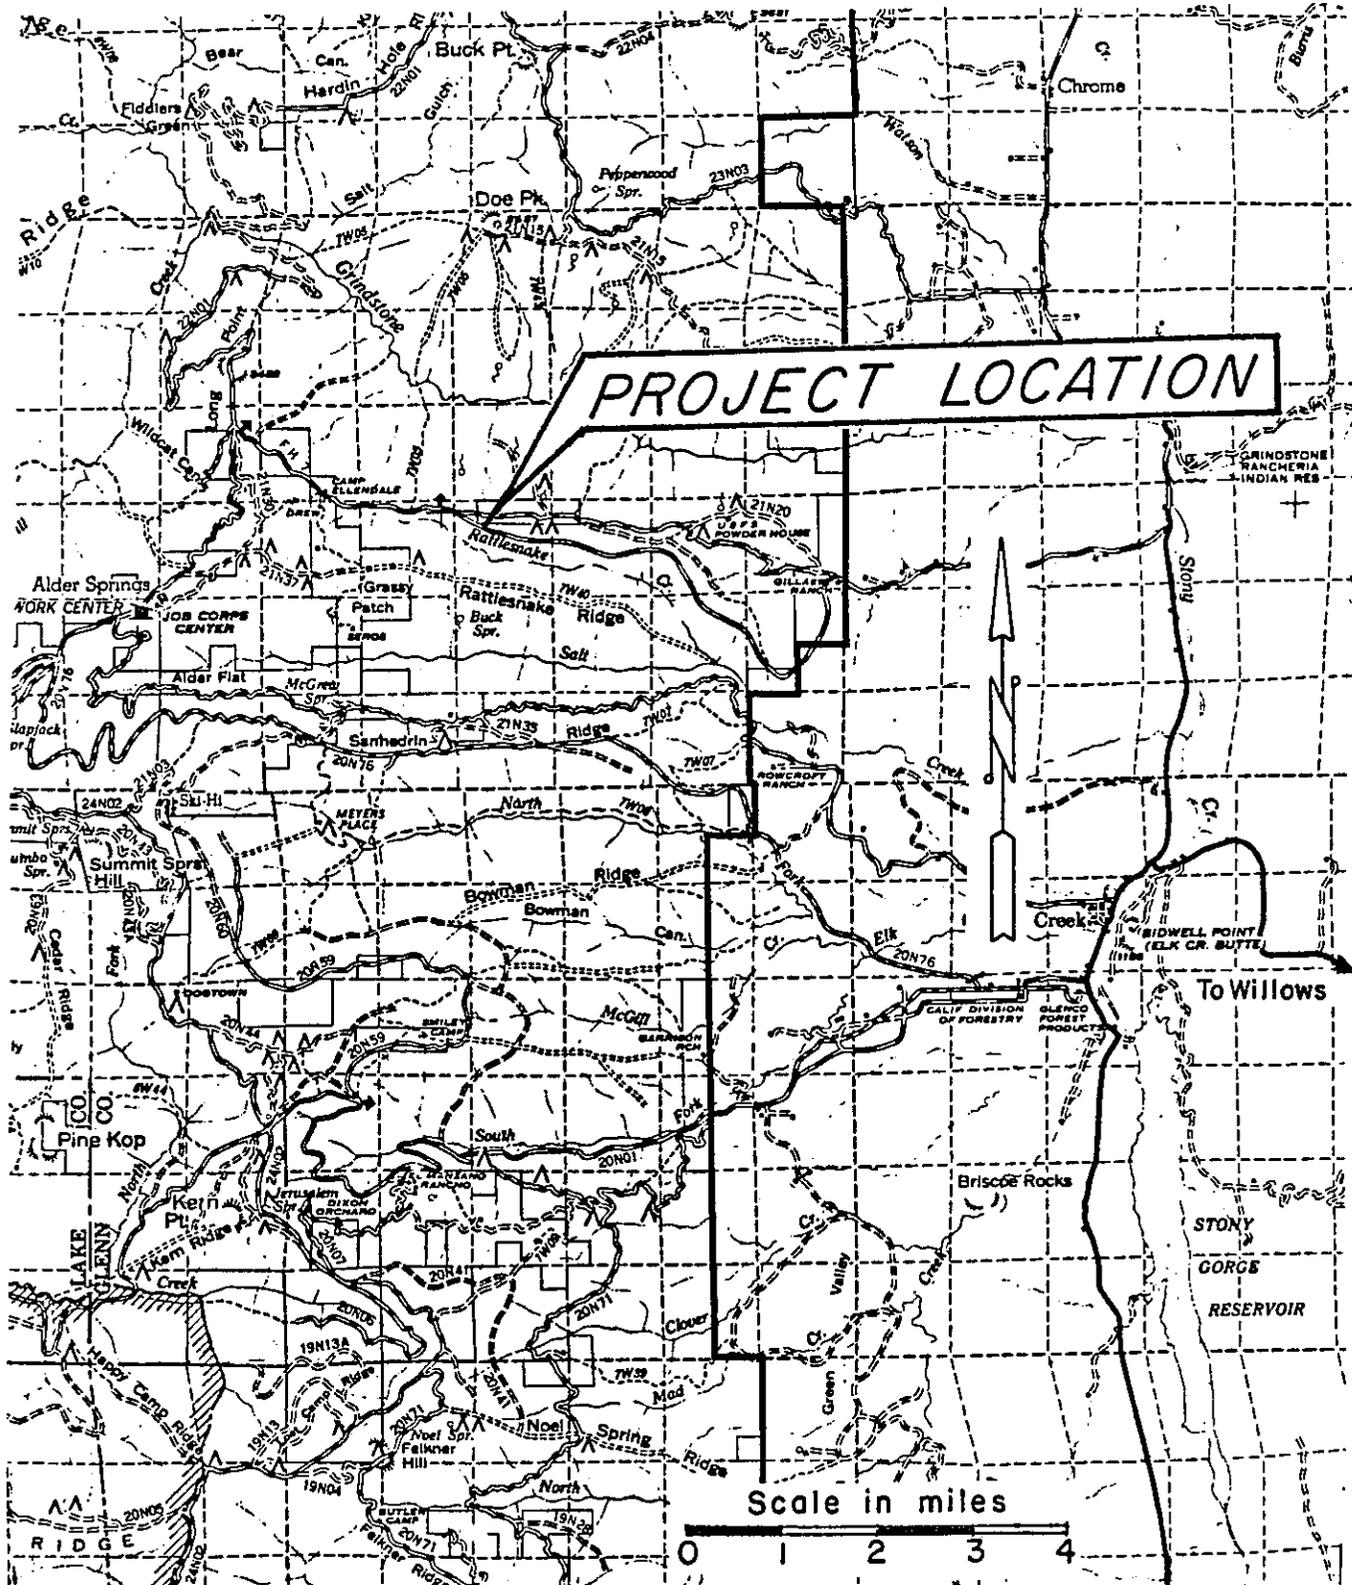
STATE OF CALIFORNIA
 DEPARTMENT OF TRANSPORTATION
 DIVISION OF STRUCTURES & ENGINEERING SERVICES
 TRANSPORTATION LABORATORY
**LANDSLIDE INVESTIGATION
 NEAR STA. 273±**

Renewed movement occurred during the wet season of 1973. Cracks progressed up the cut slope and into the dense brush for a total distance of approximately 160 ft. right of centerline. The main, arcuate shaped scarp is 5 to 6 ft. high with some cracking above it.

Movement on the downhill side also occurred with subsequent displacement of the roadway and sidehill embankment. Cracking and push outs of loose material can be observed for a distance of approximately 200 ft. down slope (see attached plan, Sheet 3).

It appears that failure was precipitated by saturation of old, loose slide debris forming the 20 to 30 ft. high cut slope and the embankment foundation. Removal of lateral support by cutting undoubtedly contributed to the renewed instability.

and sealed to improve drainage and prevent saturation and erosion at the toe. The effect of the unloading as indicated by the stability analysis referred to earlier increased the factor of safety from unity (F.S. = 1.0) to F.S. = 1.18. When the water table is lowered to the July 23, 1976 level by dewatering and is combined with unloading, the factor of safety increases to 1.24. No additional instability is anticipated on the cut slope, if all loose material from previous movement is removed by unloading. This alternate would probably be the most economical of the three.

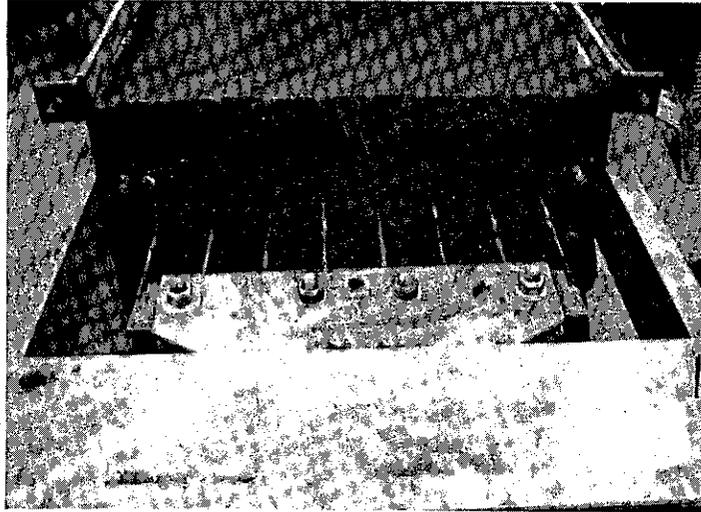
PHOTO 4: Failure Mode exhibited in specimen with 8-longitudinal bar (Test Run No. 5).

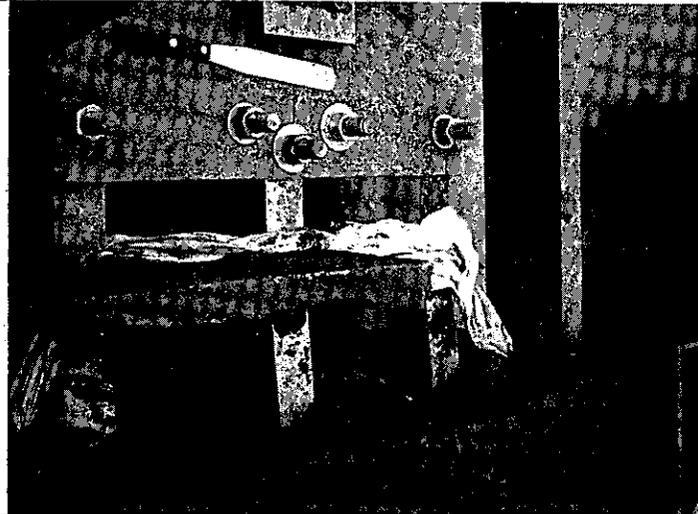
PHOTO 5: View of failure mode in specimen with three steel strips (Test Run No. 10).

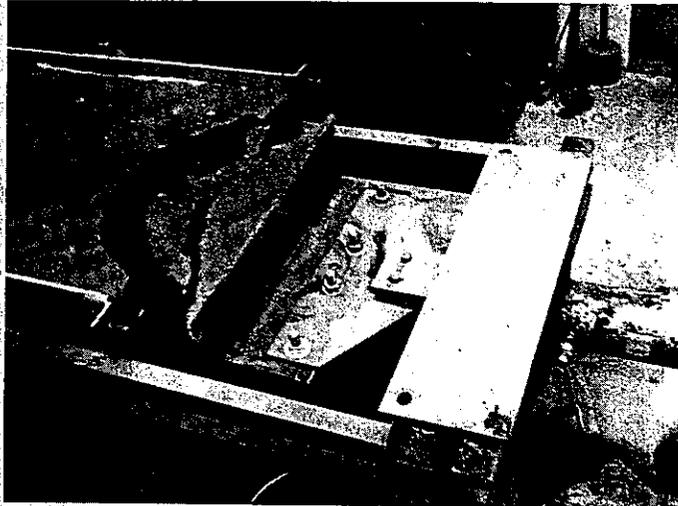
PHOTO 6: Cone-shaped failure mode exhibited in specimen with solid steel plate (Test Run No. 7).
