CA/TL-86/04

Rapid Pavement Repair Using Polyurethane

February 1986

RAPID PAVEMENT REPAIR
USING POLYURETHANE

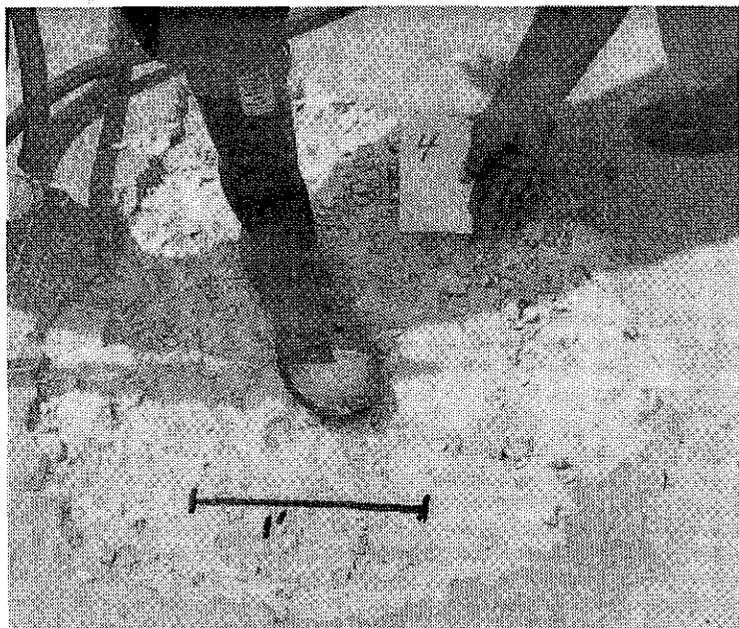
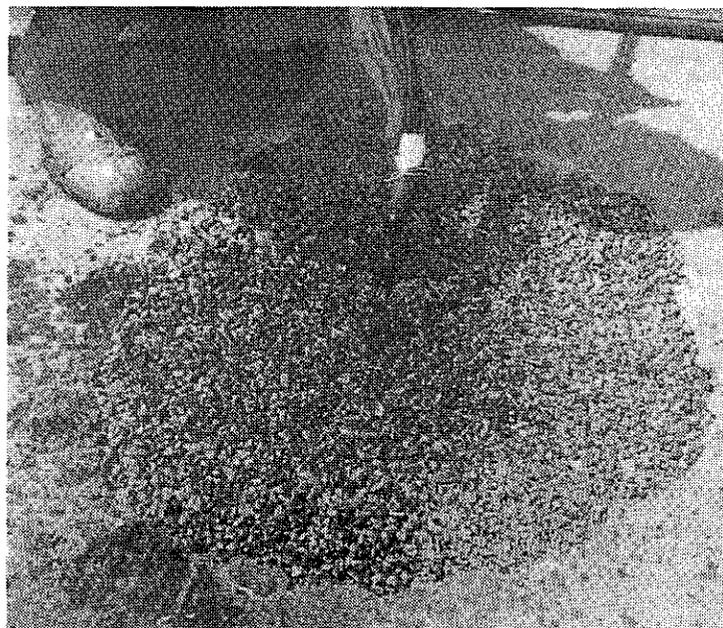
PCC PAVEMENT
07-VEN-118-28.7/29 APRIL 4, 1985

On April 4, 1985, TransLab personnel and Moorpark Maintenance Station personnel placed the material. The outside air temperature was approximately 75°F. Five craters, numbered 1 through 5 from east to west, 75'-150' apart, between PM 28.7 and 29.0 on the westbound #3 lane, were patched. Also, a 15'x10' section of pavement in the #3 lane about 25' west of hole #5 was flood treated with polyurethane resin in an attempt to penetrate and seal the alligator cracks and prevent future damage. This section was chosen because of the extensive cracking and the loose material on the top surface. The interlock of the pieces

seemed to be the only thing holding the surface together (see Plate A2). As heavy trucks went by, some 1"-diameter pieces could be seen moving independently of the slab, a sign the interlock was beginning to break down.

The potholes were inspected by the maintenance crew and loose concrete and debris were removed by hand. Holes #2 and #5 had been previously patched with AC, and although the AC was removed, a thin layer of asphalt still coated the surface of the holes. The potholes were first filled with uniformly graded 3/8" aggregate and then resin was added until level with the top of the pavement. Holes #2 and #5 showed visual signs that the asphalt coating was dissolved by the resin and percolating to the surface. However, this did not seem to cause any deleterious effects. The patches supported traffic within five minutes of the flooding with resin (see Plate A1).

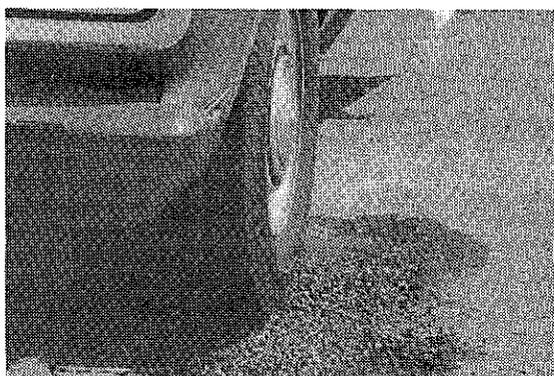
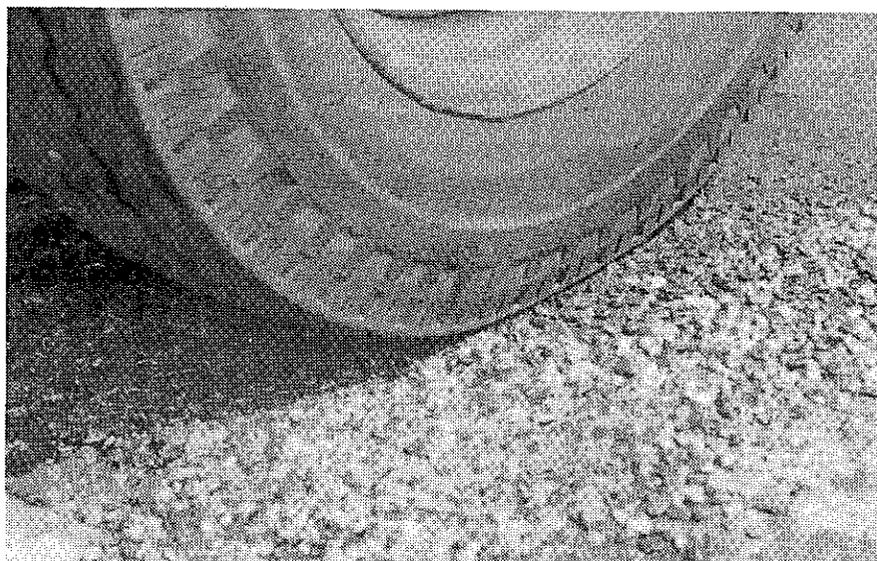
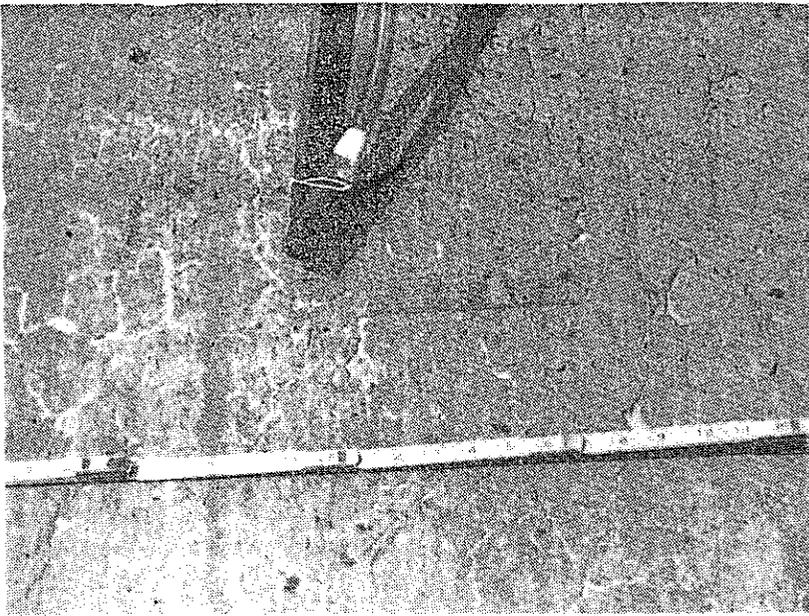
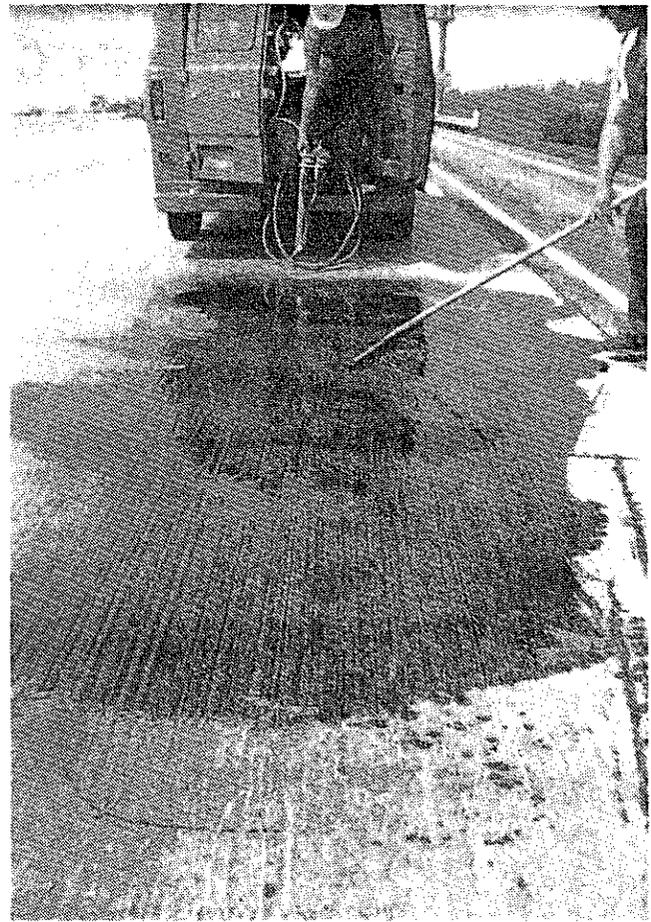
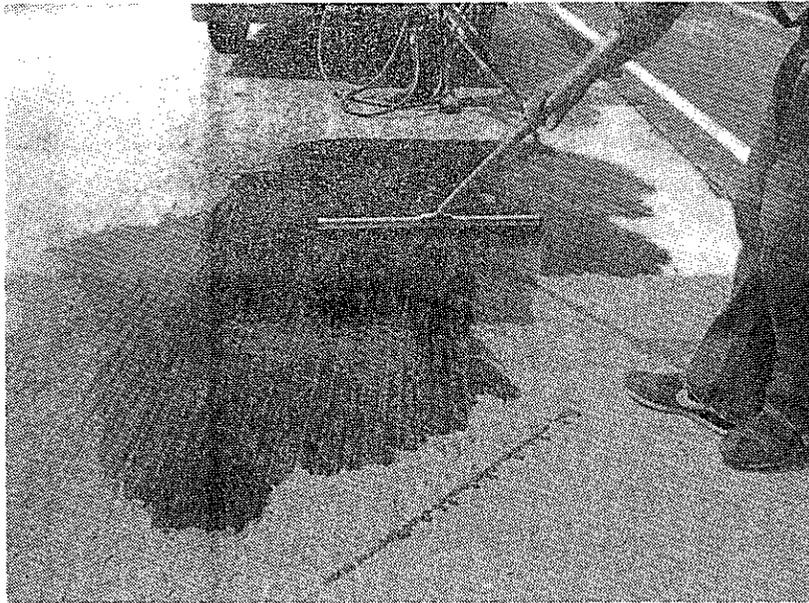
REPAIRING TYPICALLY DAMAGED PAVEMENT

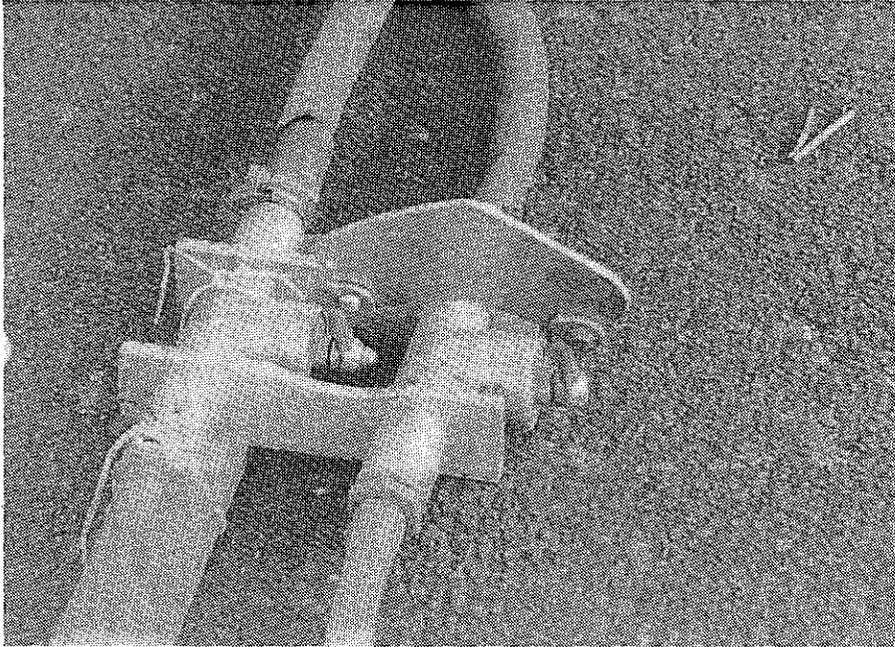
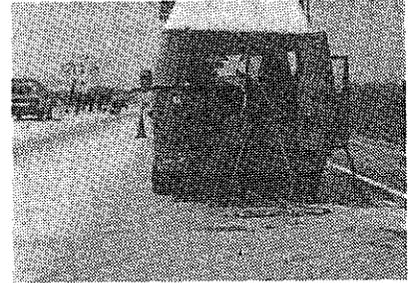
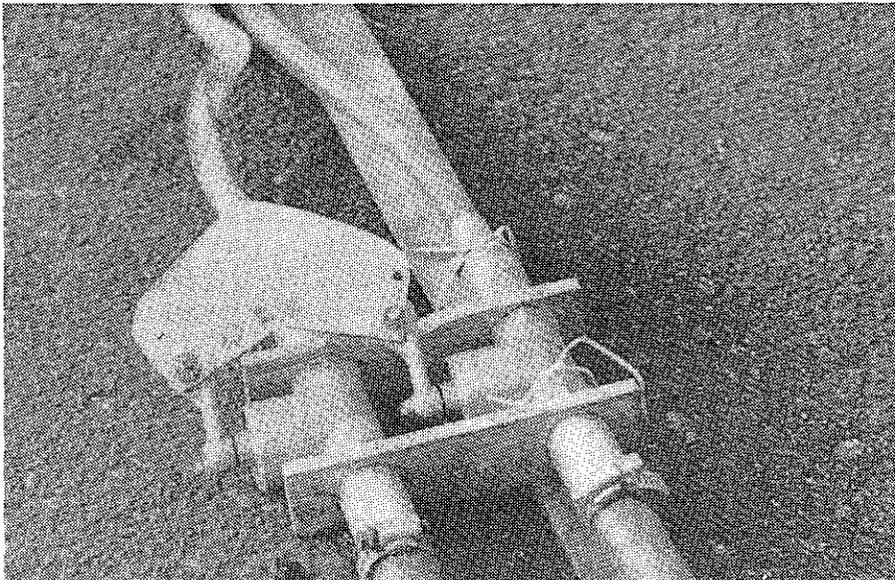
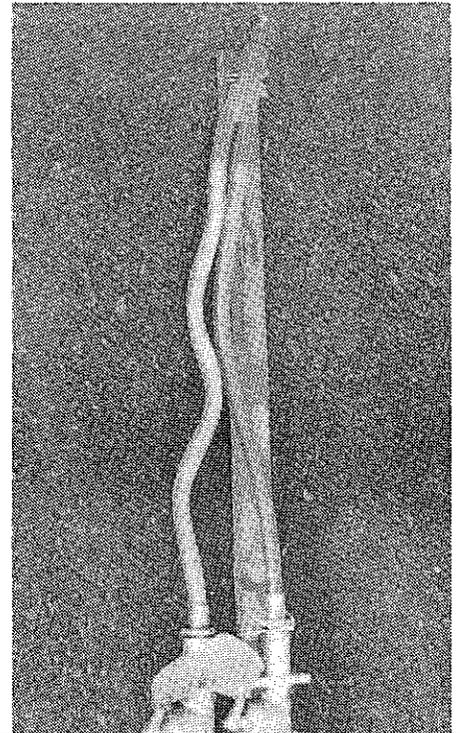
**FLOOD TREATMENT
OF PCC PAVEMENT
WITH URETHANE**
VEN-118-29 APRIL 4, 1985

DISTRIBUTOR & CLOSE-UP OF VALVE SYSTEM USED ON PCC PAVEMENT

For this field test, a system was devised so that the two components could be continuously mixed as needed. The drums of resin were pressurized between 5 and 10 psi to force the resin to flow through attached hoses. The two hoses, one from each drum, converged into a single hose. Globe valves were installed on each hose before they converged. The valve system was constructed so that both valves could be turned on or off simultaneously. The valve handles were also spring loaded so that the valves were either completely open or shut. The hoses immediately after the valves were transparent so that the resin flow could be observed. This was to ensure that both components were flowing through the valves (see Plate A3).

There was no surface preparation on the flood treated 10'x15' area. The resin was pumped through the hoses attached to the drums sitting in the back of a van moving forward at 3-5 mph. A crew followed the vehicle squeegeeing the resin for a uniform application and broadcasting sand on it to increase the coefficient of friction (see Plate A2). Though the resin appeared to penetrate the cracks and bond the surface back together, cores will be taken to determine if the flood treatment was effective.

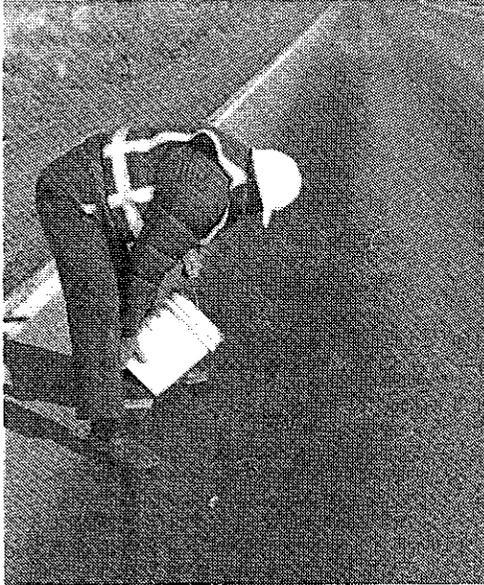
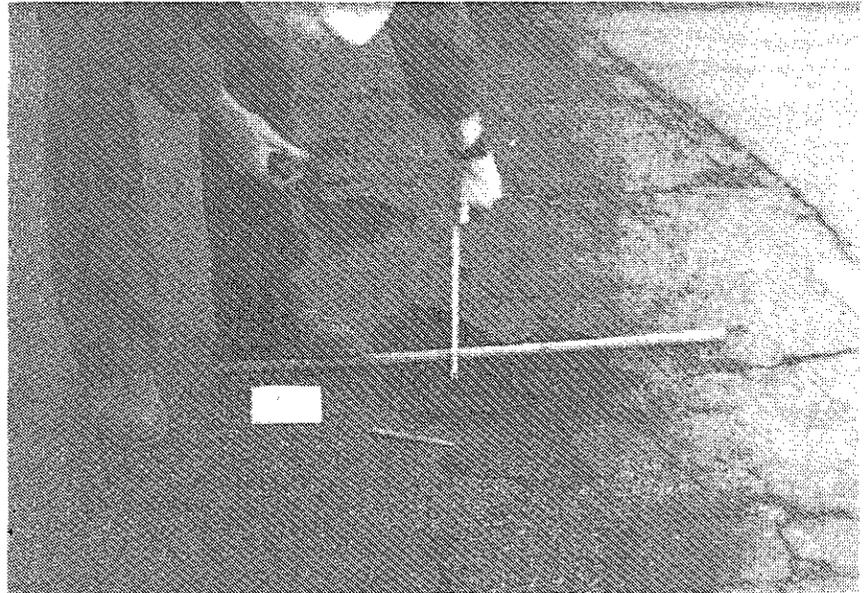
02-SIS-97-41/43

A.C. PAVEMENT POTHOLES

There was no preliminary preparation of the damaged pavement. The rut and holes were filled with 5/16" rock and then flooded with activated polyurethane resin. A 10'x3' section of the depression was also filled with the 5/16" rock and then flooded with resin (see Plate B₃). The two-part polyurethane was formulated at a 1:1 ratio, by volume. Calibrated five gallon mixing buckets were used to mix the resin. The repaired road sections supported heavy truck traffic within 20 minutes.

FLOODING WITH ACTIVATED
POLYURETHANE HOLES
FILLED WITH 5/16" CHIPS

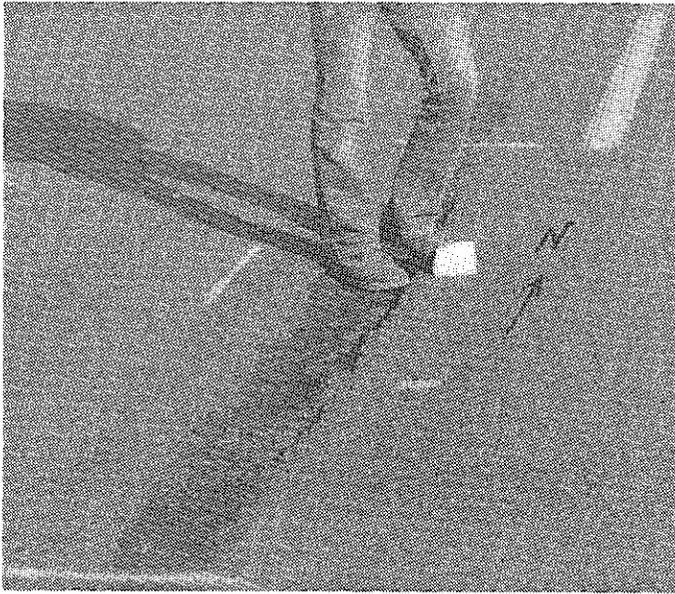
A.C. PAVEMENT 8" x 10' RUT
02-SIS-97-46.9

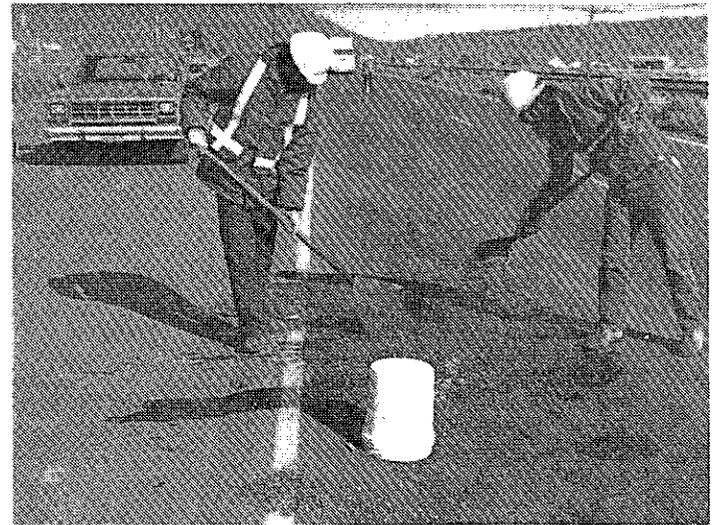
REPAIRING THE DEPRESSION
JANUARY 24, 1985

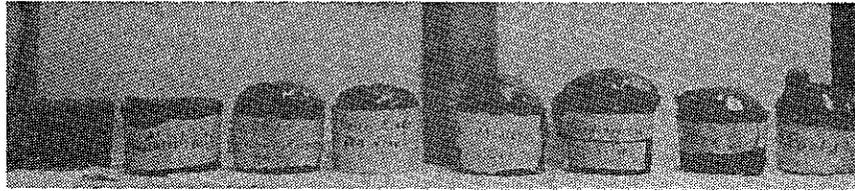
1.) SAMPLES ORIGINAL HEIGHT AT TOP OF MOLD

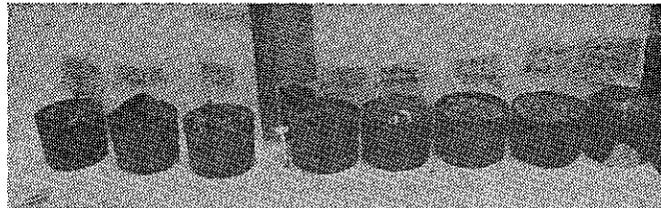
Since the type of aggregate did not significantly affect the resin's expansion, various chemical defoaming agents were tried with sand. Large quantities of baking soda had no observable effect on the foaming. Silane caused the expansion to increase. However, "NDW" and "NXZ" defoaming agents, generally used in paints, did seem to reduce the expansion (see Plate C, Figure 2).

2.) SAMPLES ORIGINAL HEIGHT AT STRING LINE

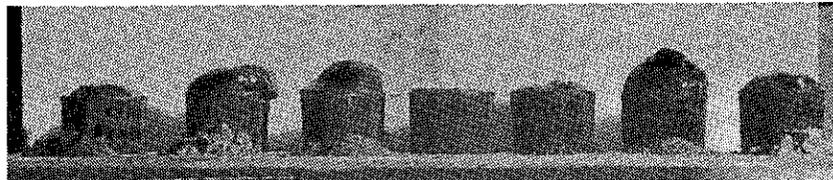
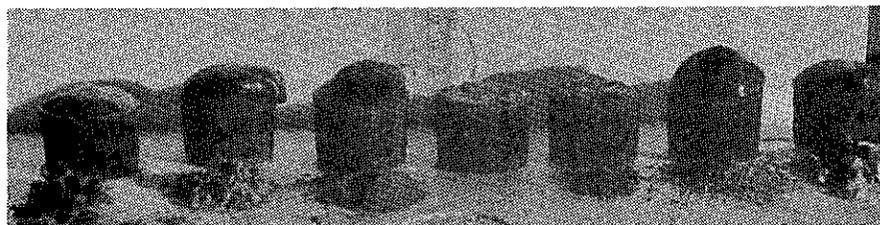
3.) SAMPLES SHOWING AGGREGATES. ORIGINAL HEIGHTS OF THOSE LABELED "URETHANE AGGRE.", "STEEL SHOT", AND "LIMESTONE" WERE AT STRING LINE AS SHOWN IN FIGURE 2. ALL OTHERS WERE AT TOP OF MOLD.
