1. REPORT NUMBER  CA/TL-87/06	2. GOVERNMENT ASSOCIATION NUMBER	3. RECIPIENT'S CATALOG NUMBER	
4. TITLE AND SUBTITLE A Seat Belt Efficacy Demonstration: A Large Angle Moderate Speed Impact Into a Concrete Median Barrier		5. REPORT DATE April 1987

A SEAT BELT EFFICACY DEMONSTRATION:  
A LARGE ANGLE MODERATE SPEED IMPACT  
INTO A CONCRETE MEDIAN BARRIER

STATE OF CALIFORNIA  
DEPARTMENT OF TRANSPORTATION  
DIVISION OF FACILITIES CONSTRUCTION  
OFFICE OF TRANSPORTATION LABORATORY

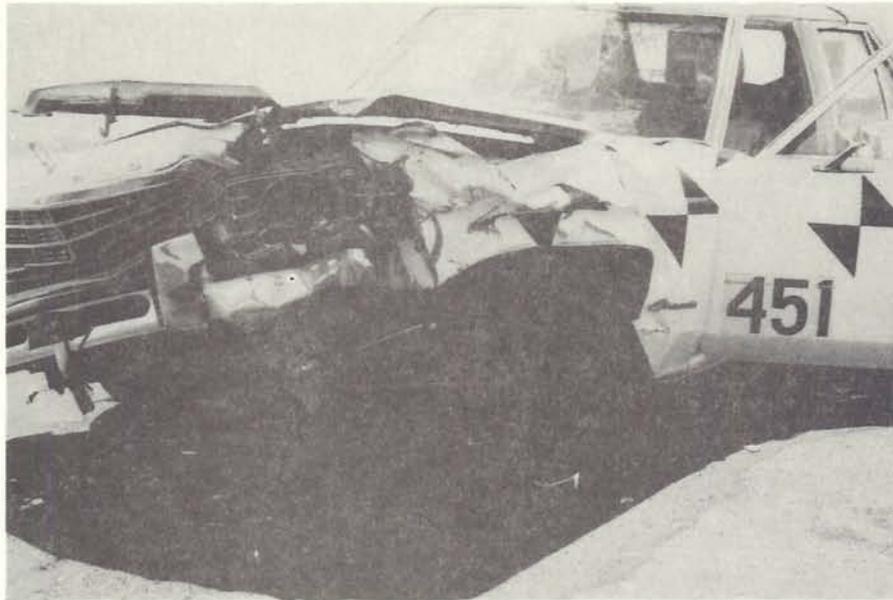
Figure 6. Close-Up of Damaged Bumper, Fender and Wheel

The left front corner of the car made first contact with the barrier. This caused the entire left front corner of the vehicle to be crushed back to approximately the original position of the front tire. The left front wheel was deformed and the tire flattened (Figure 6). The fender was pushed back and contacted the front door so that it was very difficult to open. The left front corner of the hood was bent due to contact with the barrier. Crush of the front extended across about 3/4 of the width; the right head light was not broken (Figure 7). The radiator was pushed into the fan and bent the fan shaft. The engine was moved. The front bumper was pushed to the right 9 inches and the rear bumper was pushed to the right 2 inches.

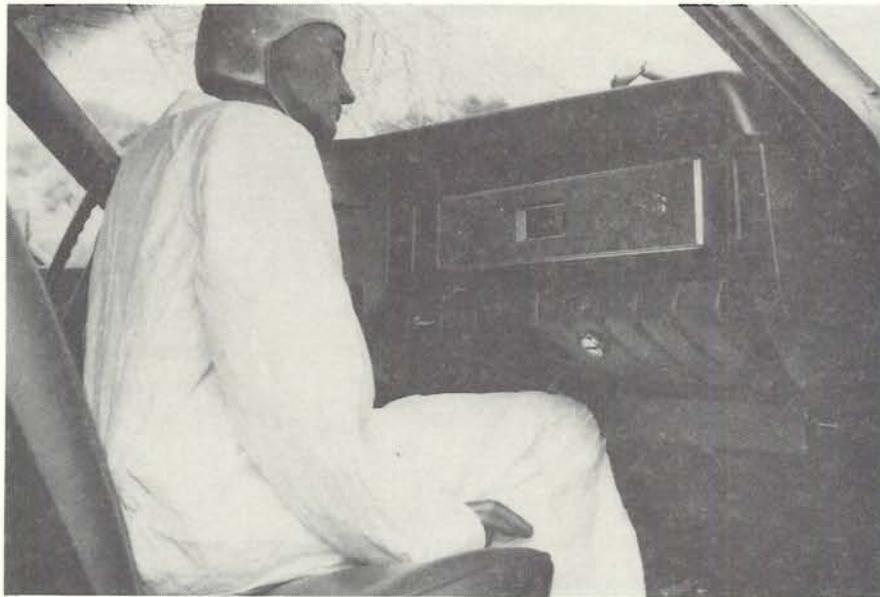
Figure 8. Interior Damage Caused by Dummy

The vehicle interior and windshield were damaged by the two dummies. The passenger dummy's knees were forced into the lower dash fracturing the plastic in the area of the left side of the glove compartment and below the heater/air conditioner controls (Figure 8). The same dummy's head contacted and fractured the windshield. The driver dummy contacted the left front door bending a part of the interior door panel. The steering column was pushed down 1 inch and left 3/4 inch, measured at the dash board, by the passenger dummy.

Willie's knees broke the plastic of the lower dash causing the glove compartment to be unusable.

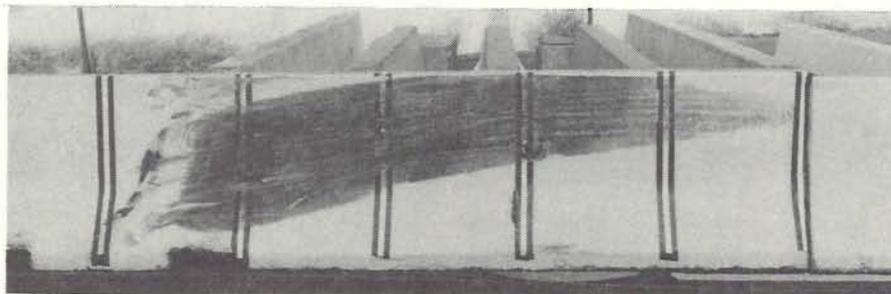
Figure 9. Tire Marks and Gouge Show Clearly on Face of Barrier

The face of the barrier received black tire marks, surface scraping from hood and front sheet metal and gouging from the frame of the car (see Figure 9). The tire marks started 3 inches upstream of the center of the barrier and extended to 10 feet downstream of the center. Surface scraping started 7 inches downstream from the center and extended to 5 feet downstream. Gouging was confined to an area 10 inches and 18 inches above the ground about 18 inches long 27 inches downstream from the center of the barrier.

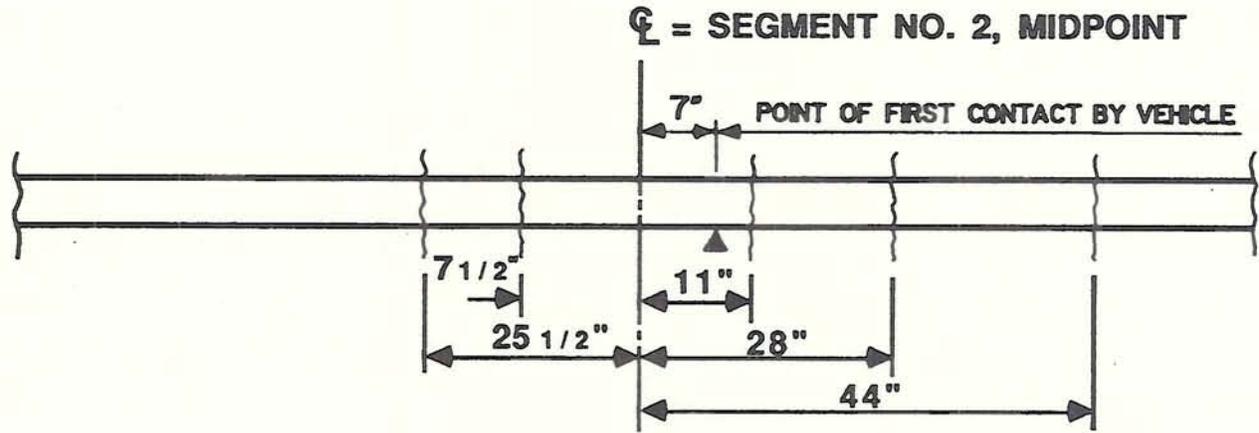
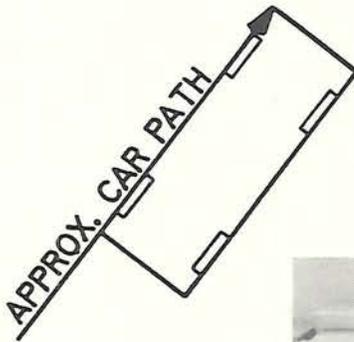
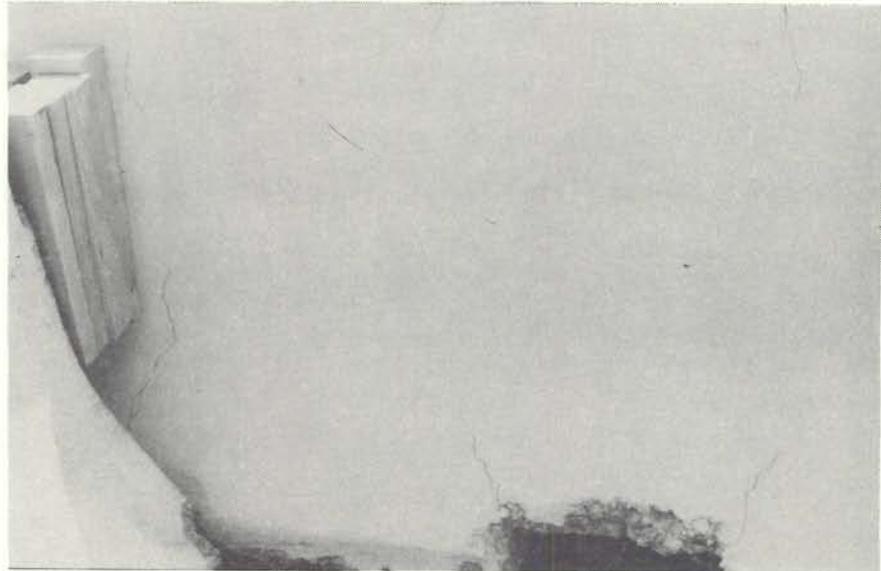
Figure 10. Location of Cracks on Back Side of Barrier  
Cracks in photo enhanced for visibility

The backside of the barrier in the region of impact developed 5 cracks spaced 16 inches to 18 inches apart over a length of 70 inches (Figure 10).

In this test, the structural strength of the barrier was used to the limit. This was evidenced by several vertical cracks on the backside of the barrier in the region of impact as shown in Figure 10. These cracks are indicative of bending failure. Under more severe impact conditions, a more spectacular failure might be expected.

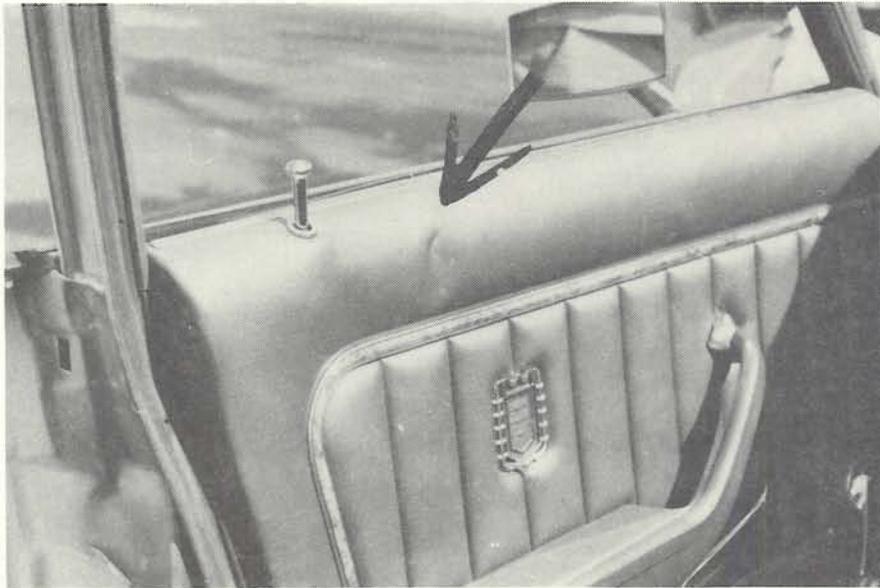
Figure 11. Dent in Left Front Door Panel from Dummy's Arm

Upon impact Rex Karrs, the restrained driver dummy, was thrust forward and caused the shoulder strap to extend about 10 inches, as evidenced by fraying of the edge due to the loop it passes through near the ceiling. This dummy was restrained from impacting the interior in the forward direction. As the vehicle was redirected the left door forcefully hit the dummy, causing slight indentation of the interior door panel (Figure 11) and caused the dummy to bend at the neck allowing its head to penetrate the plane of the (open) door window. Rex Karrs' final position was seated face forward with both feet on the left side of the foot well.

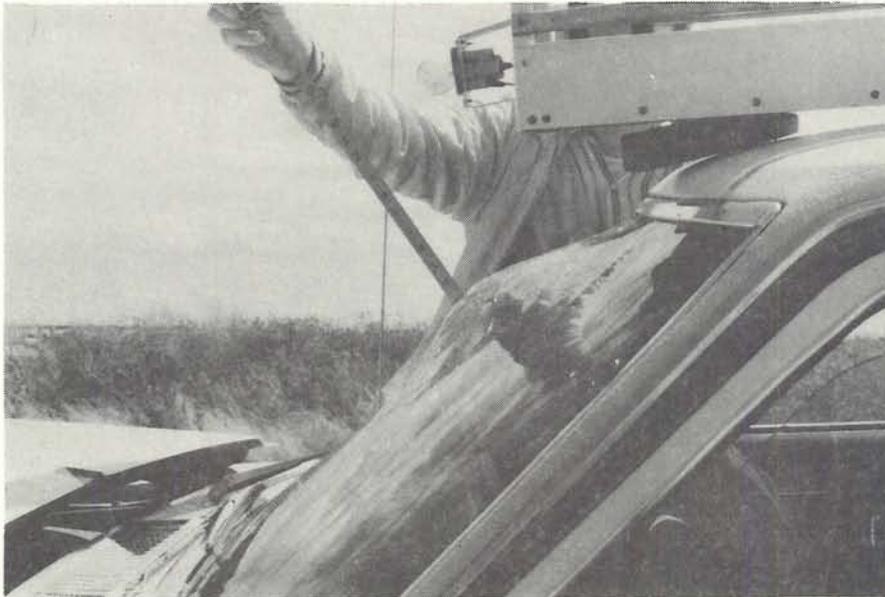
Figure 12. The Windshield Bulged 1-3/4 Inch  
After Vehicle Came to Rest

Upon impact Willie Makit, the unrestrained passenger dummy, was thrust forward. Before its head hit the windshield, the vehicle began redirecting. The dummy's head hit the rearview mirror and knocked it off the windshield mount, cracking the window. Its head continued forward and toward the left of the car breaking the windshield, bulging it out a maximum of about 3 inches. The head was deflected downward and the chin hit and broke the top of the dashboard in front of the right side of the steering wheel. This dummy's knees firmly impacted the lower dash and fractured the plastic. The left side of the glove box and the area below the heater controls (center) were damaged. The upper torso of Willie Makit pushed hard against the steering wheel and shift lever causing a movement of the steering column downward and to the left. Willie Makit's final position was: feet in the passenger foot well, knees in the lower dash, upper torso leaning against the dash and shift lever and head wedged between the windshield and dash, chin imbedded in dash. The windshield continued to bulge out about 1 3/4 inch (Figure 12).

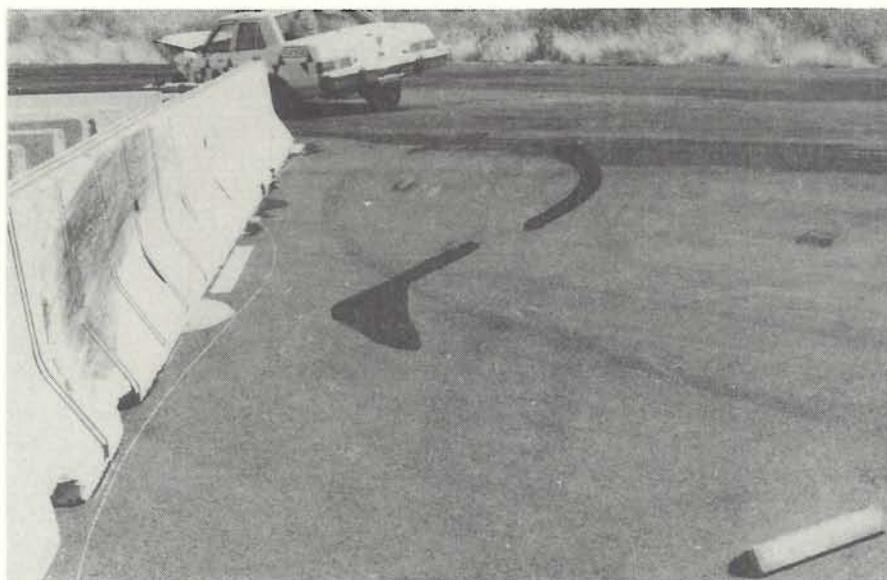
Figure 13. Skid Marks of Right Front Tire

The vehicle trajectory would be considered acceptable when compared against the standards. The final stopping position was across the line of the barrier. If the barrier had extended farther downstream, the vehicle would have made secondary contact with it, and probably would have stopped adjacent to the barrier. After the redirection, the maximum distance the vehicle traveled away from the barrier was 9 feet at the right front corner, as evidenced by tire marks. Figure 13 shows the right front tire skid marks enhanced.

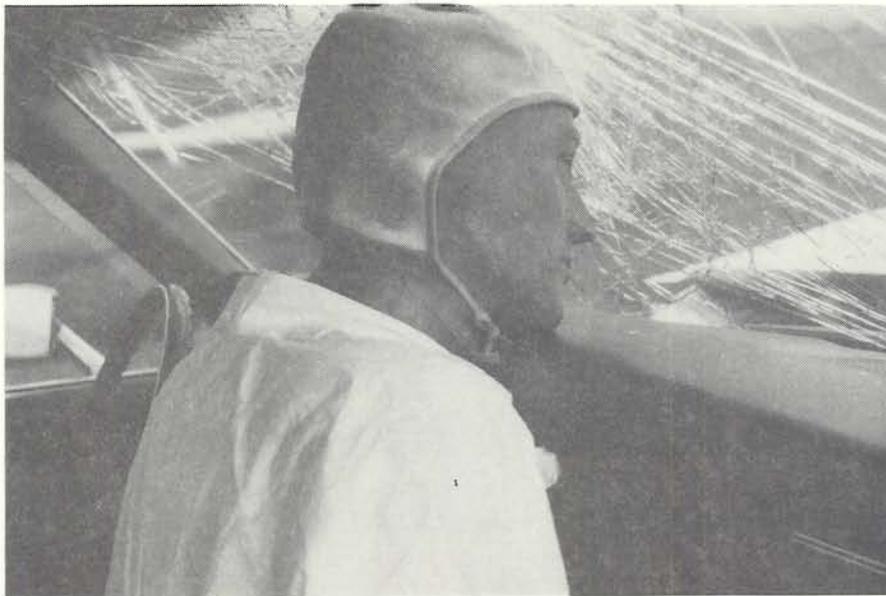
Figure 15. The Dummy's Head Wedged Between the Dash and Windshield

The key difference in the behavior of the two dummies was the magnitude of forward motion. Rex Karrs, the driver dummy, was restrained by a lap belt/shoulder strap, while Willie Makit, the passenger dummy was not restrained. Rex Karrs' forward motion was halted by the lap belt/shoulder strap. The strap extended about 10 inches from the normal rest position allowing nominal forward motion while preventing any impact by the head, knee, or torso. Willie Makit's forward motion was halted when its head struck the windshield and its knees struck the lower dash. The windshield was broken by Willie's head and bulged out about 3 inches during redirection. Figure 14 shows the windshield bulging and glass spraying away in a sequence taken from one of the high-speed cameras. After the vehicle came to rest, the windshield still bulged 1 3/4 inches (Figure 12) while Willie's head was wedged between the dash and wind shield in Figure 15.

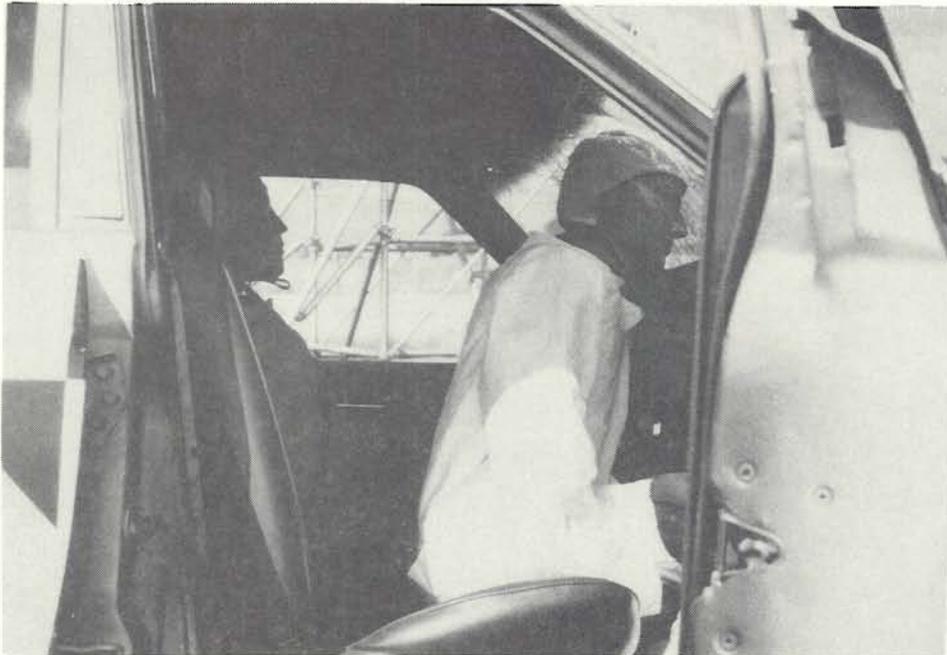
Figure 17. Final Position of The Two Dummies

After forward and lateral movement relative to the car reached a maximum, Rex Karrs bounced back into the driver's seat, slightly to the right of the center of the seat, and then shook in the seat. Willie Makit remained in contact with the windshield, dash and steering wheel until the vehicle came to rest. The left shoulder and arm were stuck in front of the steering wheel. Figure 16 shows the dummies' motions as viewed by the interior high-speed camera. Figure 17 shows the final position of the two dummies.
