FHWA/CA/TL-87/07

Guidelines for Using Recycled Tire Carcasses in Highway Maintenance

May 1987

FINAL REPORT # FHWA/CA/TL-87/07

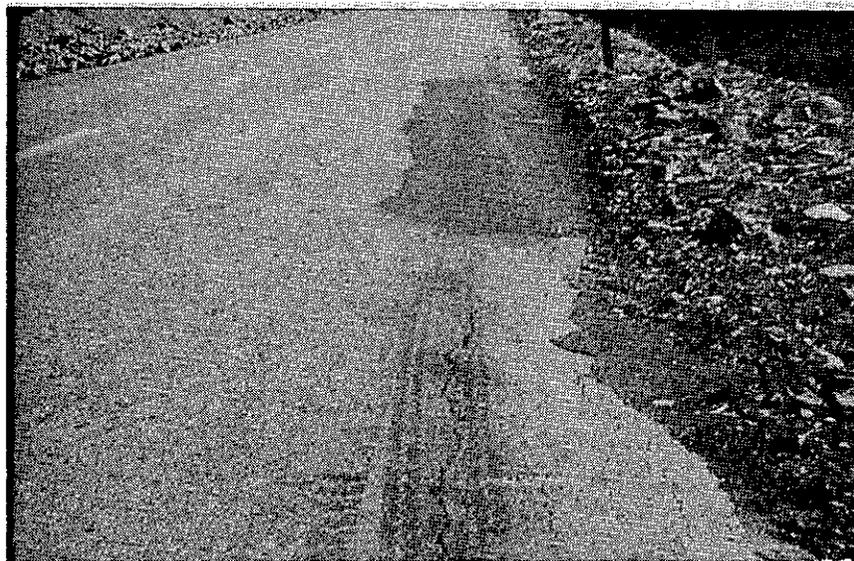
Photo 7.14 - Shoulder Cracking

Several small cracks developed immediately after installation of the tires in Unit "A". Subsequent to patching by maintenance forces no further cracking or significant movement in the tires or pavement in either the test sites "A" and "B" occurred (Photo 7.14).

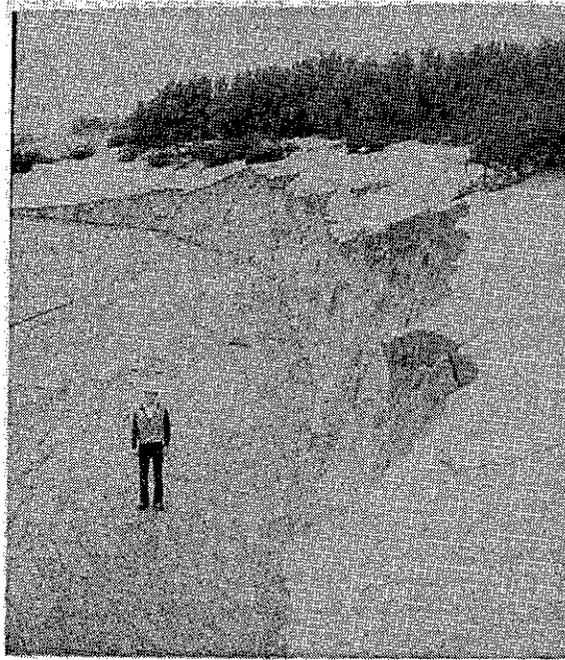
Photo 9.19 - Before Unit 5 Was Installed

One indirect benefit provided by the contained tire installation was the protection of the highway embankment by tire Unit 5. Photo 9.19 shows the Unit 5 site before the installation and the force of the sheet flow eroding the protective slope. Photo 9.20 shows the area three months after the installation of the tire barrier. The impoundment of sand has replaced the material removed by erosion before installation of Unit 5. The unit now protects the slope from further erosion as well as impounding sand before it reaches the tree row.
