1. REPORT NUMBER CA12-1200 A	2. GOVERNMENT ASSOCIATION NUMBER	3. RECIPIENT'S CATALOG NUMBER
4. TITLE AND SUBTITLE Quieter Pavement Research: Concrete Pavement Tire Noise	5. REPORT DATE 05/30/2011

7. AUTHOR John T. Harvey and Erwin Kohler		6. PERFORMING ORGANIZATION CODE
9. PERFORMING ORGANIZATION NAME AND ADDRESS University of California, Davis & Berkeley Partnered Pavement Research Center 1353 S. 46th Street, Bldg. 452 Richmond, CA 94804		8. PERFORMING ORGANIZATION REPORT NO. UCPRC-RR-2010-03

Quieter Pavement Research: Concrete Pavement Tire Noise

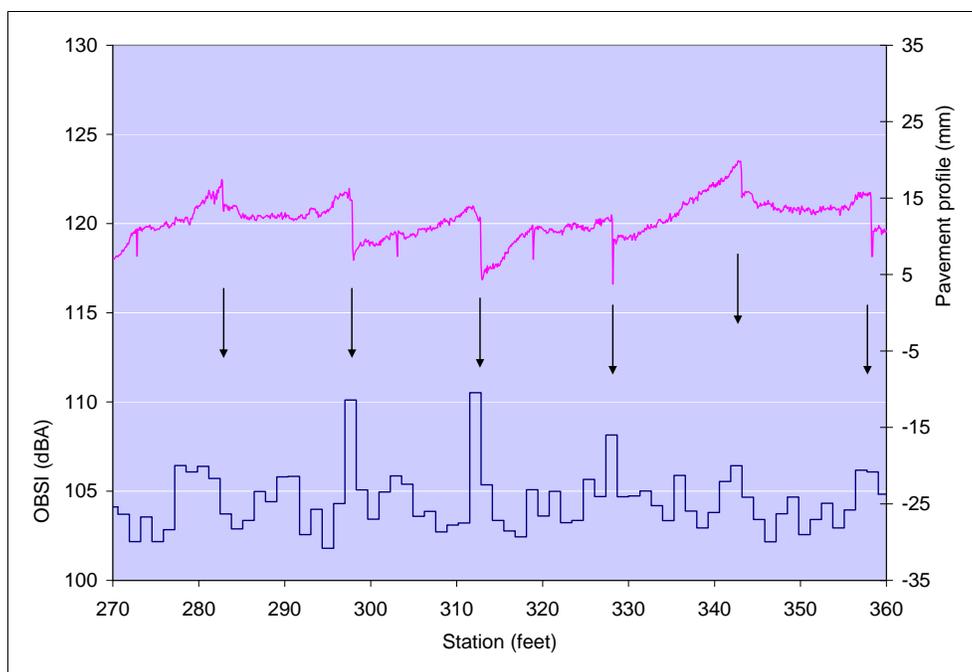
Figure 3.40: Noise level spikes and correspondence to joint faulting.

Similar effects have been identified previously, and some preliminary data indicating the added effects of joint faulting, joint groove cross-sectional area, and joint sealant recess depth on overall OBSI for concrete pavement surfaces has been developed by Purdue University and the American Concrete Pavement Association using the Purdue Tire Pavement Test Apparatus in the laboratory with some field validation at the MnROAD test track in Minnesota (8).

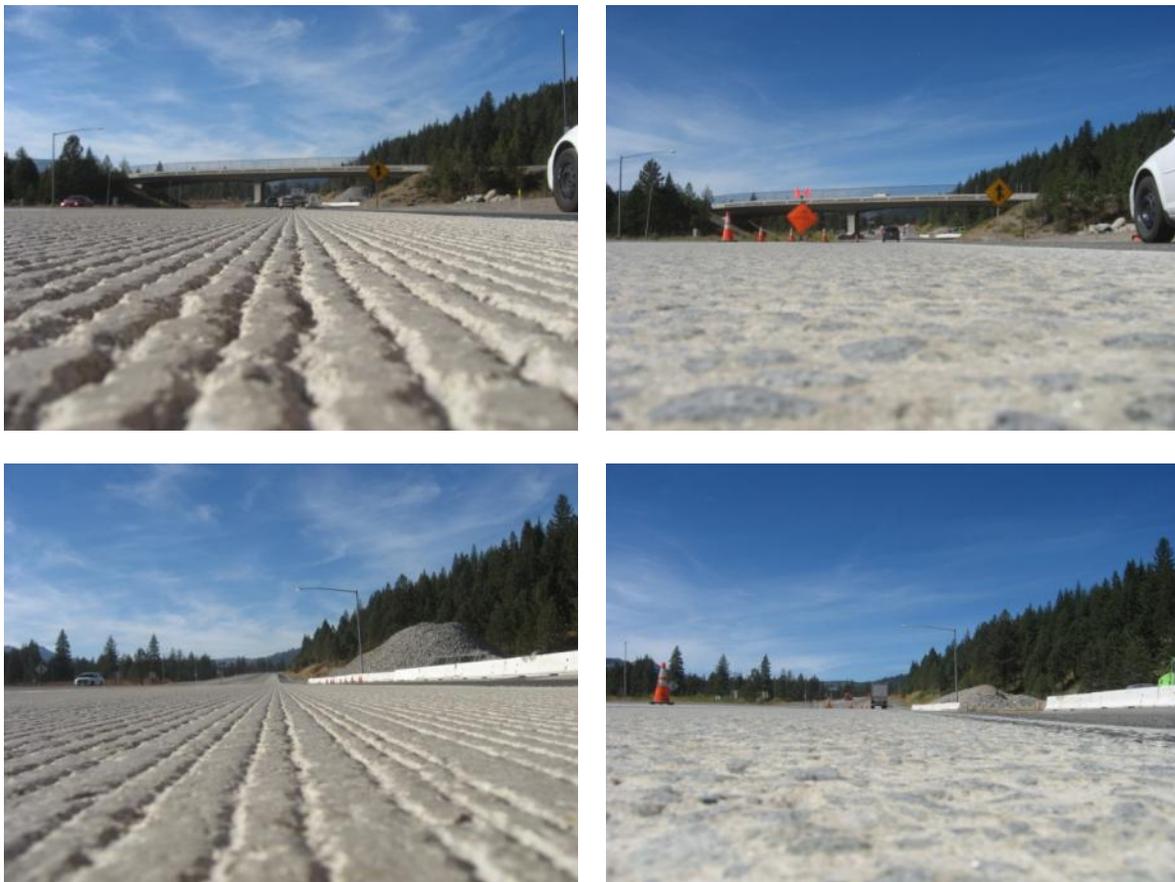
Figure C.1: Change in texture after one year at Sections QP-142.1 (top) and QP-142.3 (bottom).

Images of the surface texture of Sections QP-142.1 and QP-142.3 at approximately the same spots are shown in Appendix D, with the pictures on the left taken in November 2008 and the ones on the right in September 2009. This pavement was new—it had been opened to traffic in the summer of 2008—and is located at 5,900 feet above sea level, where it was subjected to chain wear during snow season. Appendix D shows that the longitudinal tining remains outside the wheelpath, while it has been completely obliterated in the wheelpaths by the chains.
