30 YEAR REPORT
ON THE
EXPERIMENTAL TREATMENT OF THE SUBSOIL
UNDER A PORTLAND CEMENT CONCRETE PAVEMENT
IN
SOLANO COUNT - BETWEEN DENVERTON AND RIO VISTA
III-SOL-53-B

Reported by T. E. Stanton, Materials and Research Engineer
May, 1951

TO: T. E. Stanton
FROM: C. W. Clawson
SUBJECT: Cores from X-sol-53-B

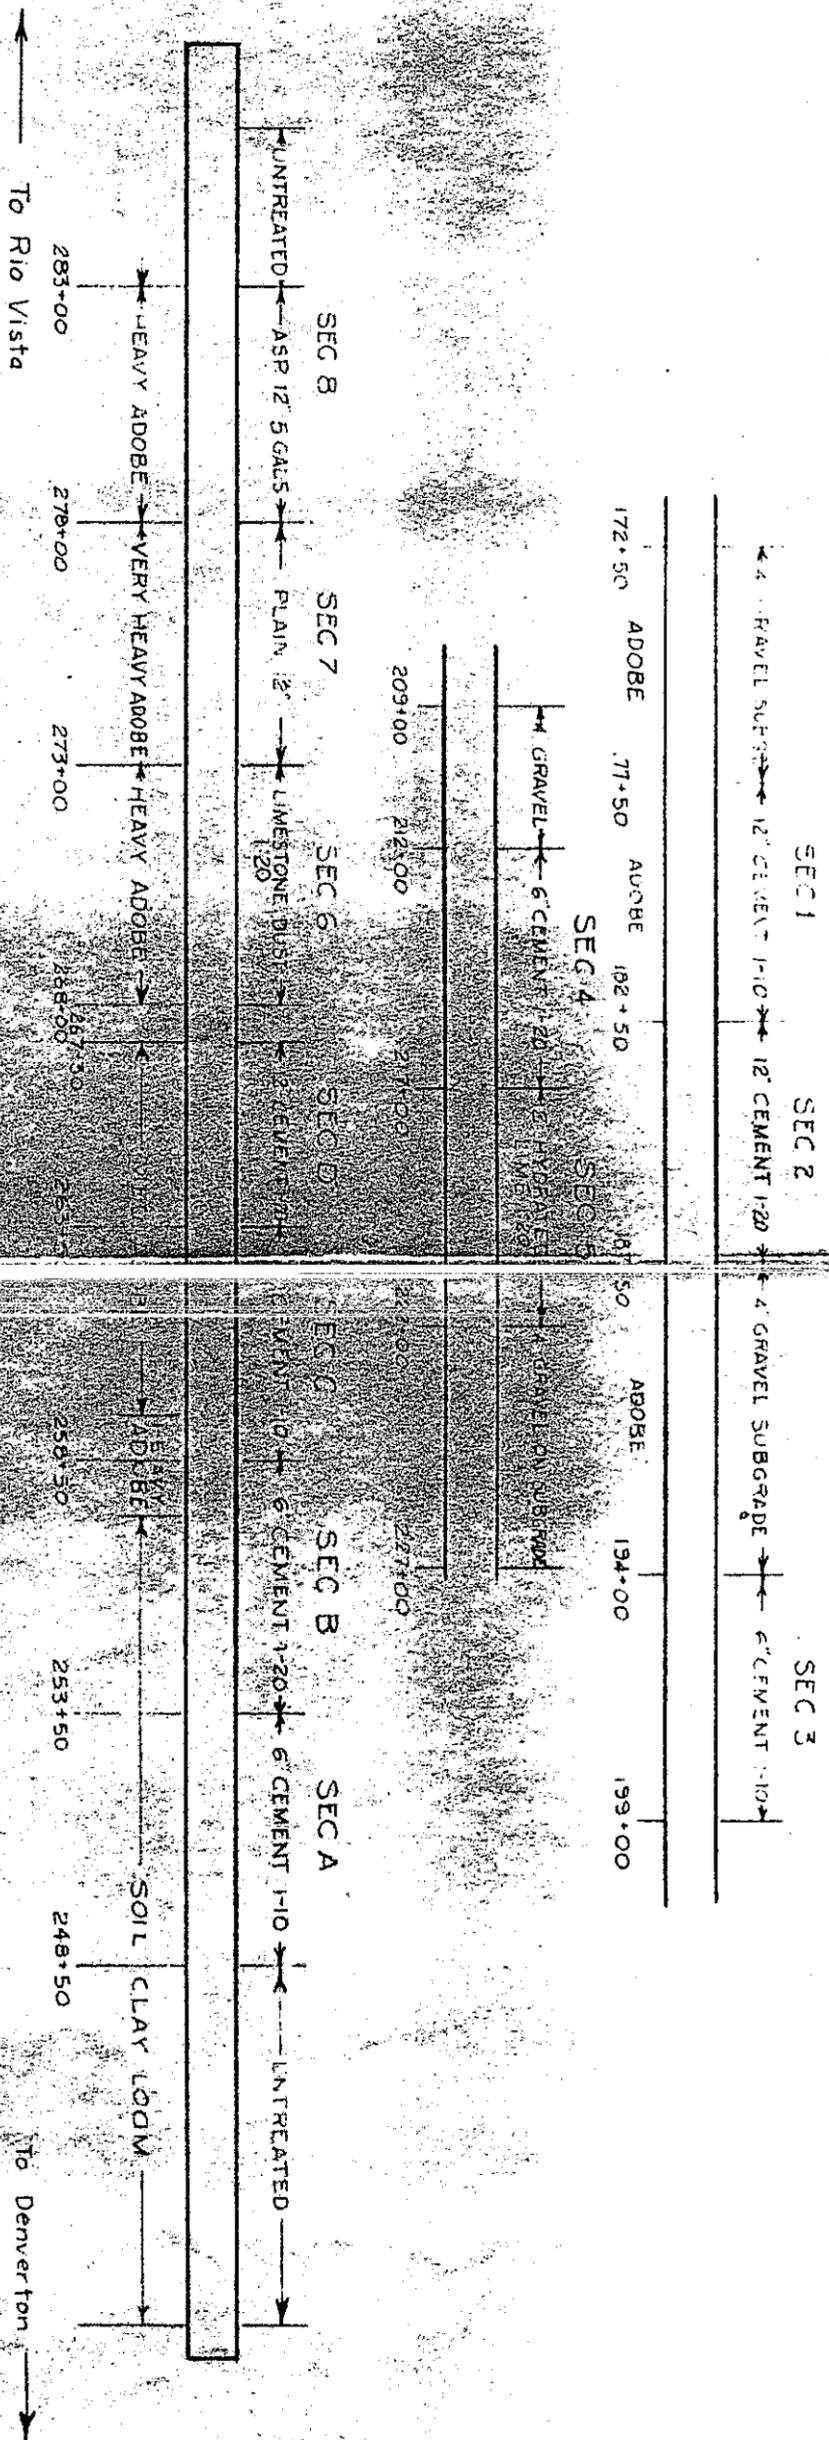
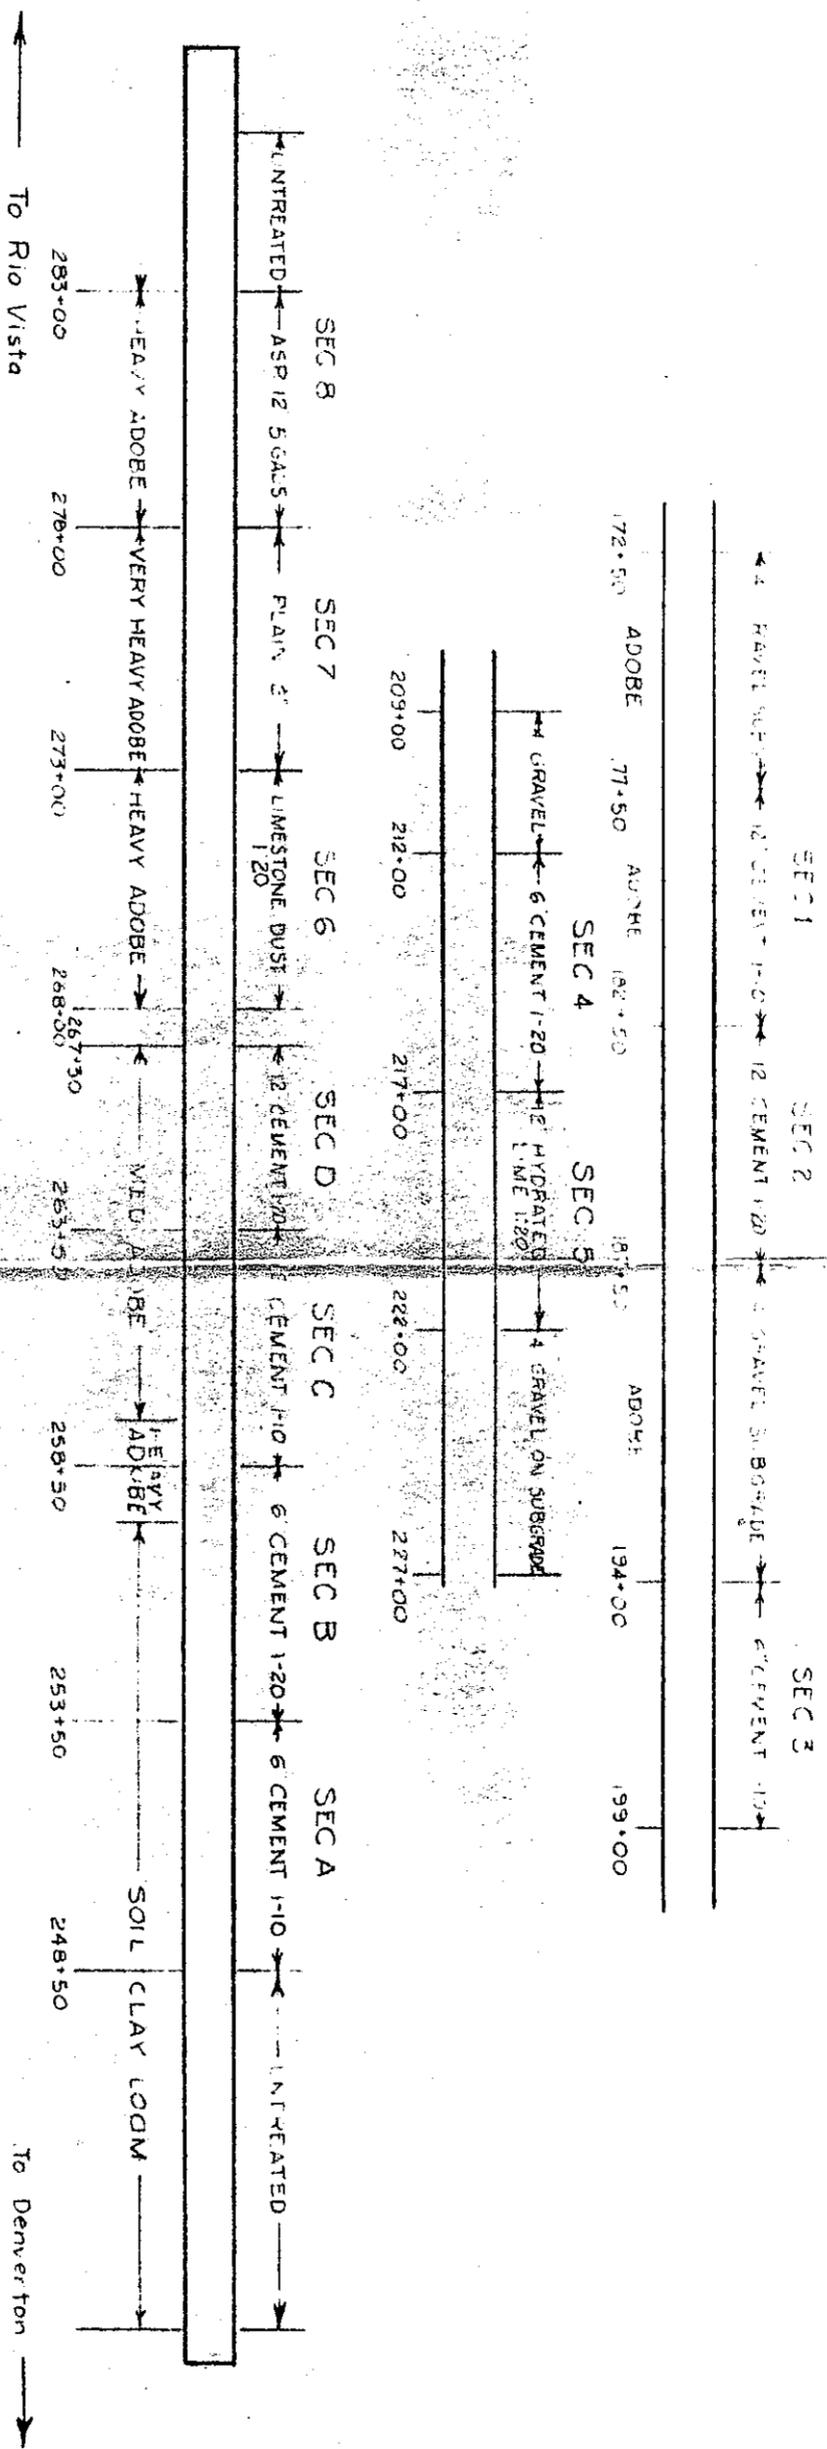
FIGURE I

STATE OF CALIFORNIA
 CALIFORNIA HIGHWAY COMMISSION
 EXPERIMENTAL SECTION
 RIO VISTA LATERAL
 SOL-53-B
 CONSTRUCTED 1924
