An Investigation of the Causes of Distress Appearing in A Bituminous Surfaced Road in Yolo County

April 1957

III-Yol-90-B

III-Yol-90-B
Between 2.7 Miles to 6.7 Miles
North of Madison

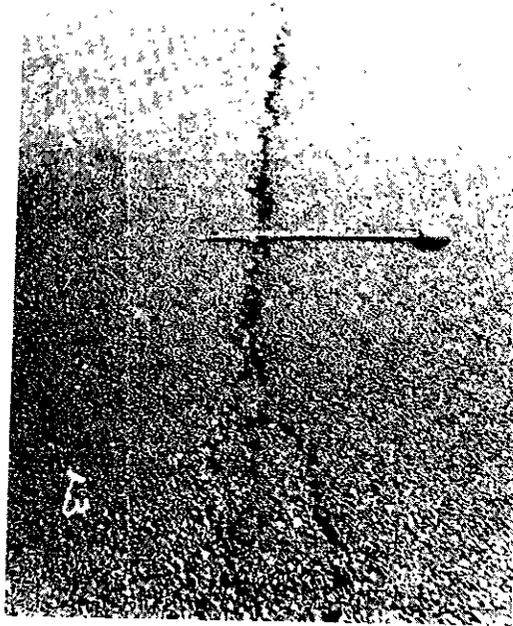
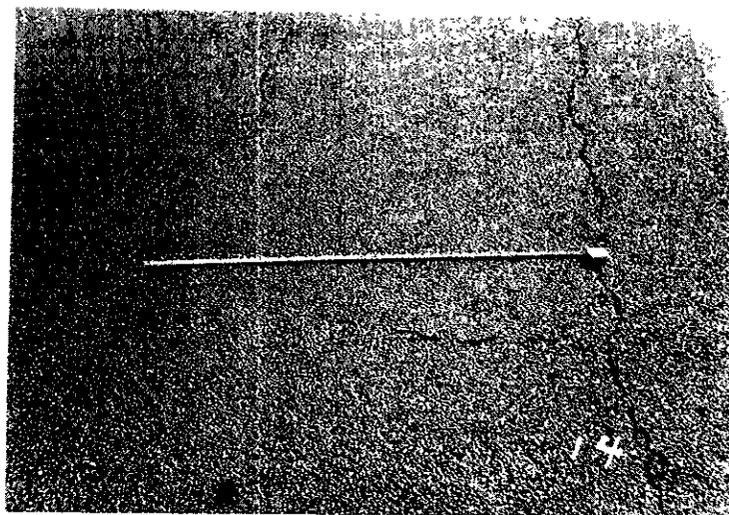
All cracks are wider at the surface than at depth. This is due to the tendency of the 1/2" open graded mix to spall or chip away at the crack. The crack trace through the underlying dense graded PMS and the cement treated base become finer and are sometimes difficult to see.

This "nonflexible" surfacing is unable to bridge across the normal contraction or shrinkage cracks that develop in all cement treated bases. The tendency of the 1/2" open graded surfacing to spall along the cracks has accentuated the appearance of distress. Therefore, we believe that the extreme brittleness of the PMS is one of the major contributing causes of distress on this road.

Typical Cracks Showing Spalling in Open Graded Mix

It is believed that the life of the road can be greatly extended by comparatively minor surface repairs. It is the recommendation of this department that any badly spalled areas be filled in with plant mixed surfacing and that a double seal coat be placed or preferably a rich open graded plant mix blanket of say, 3/4" thickness. This would help fill up existing cracks, serve as a barrier to further oxidation and prevent the entrance of water through the existing dry open graded mixture. It is our opinion that any slight movement in the cement treated base will result in reflection cracking of any relatively thin dense graded blanket. The seal coat or open graded mix should provide somewhat more flexibility and retard the further appearance of reflection cracks.

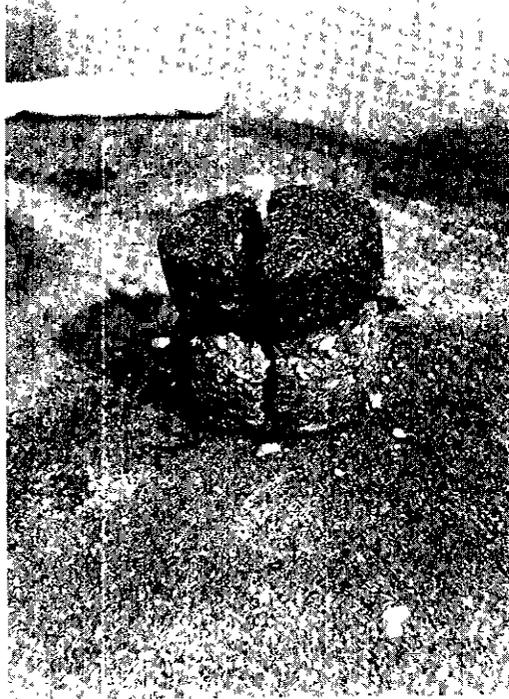
The samples of the treated base were typical of cement treated base with a moderate cement content. The cylinders break during the coring and were recovered as partial cores rather than a coherent unit.

In all cases the lower portion of the cement treated base sample was softer, less dense and contained less cement.

Core as Recovered
