Progress Report on Median Barrier Test Program

November 1958

F.N. Hveem

Subject: Progress Report on Median Barrier Test Program

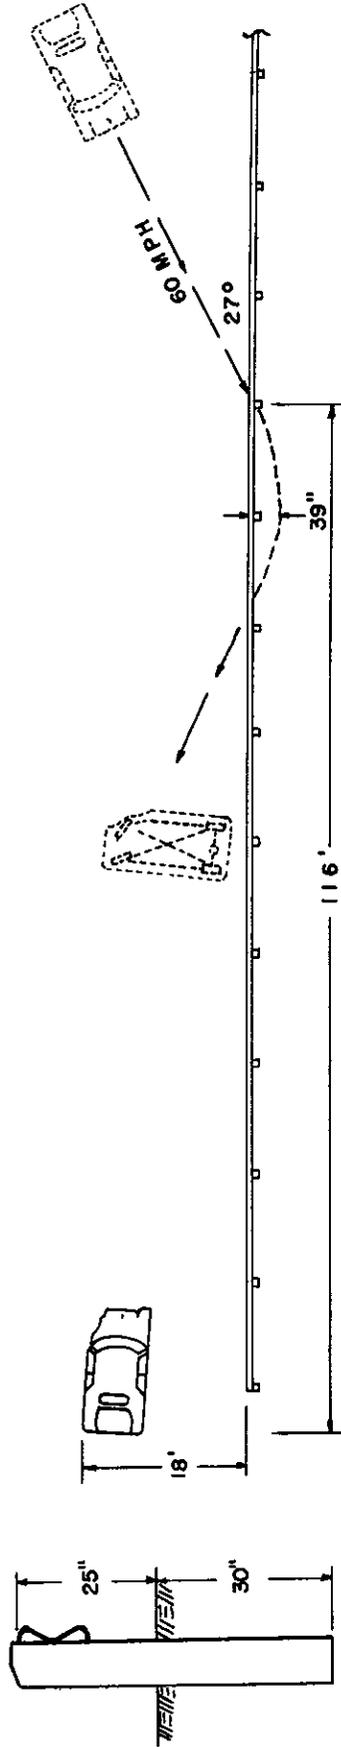
GUARDRAIL.....	W Section	DUMMY INJURY.....	Multiple scalp lacerations.	TEST NO.....	1
BRACKET	None	GUARDRAIL DAMAGE	3 Sections damaged beyond repair.	DATE	7-10-58
POST	8x8 D.F.	POST DAMAGE	2 Posts damaged beyond repair.	VEHICLE	Chev. 52 Sedan
POST SPACING	12'-6" O.C.	VEHICLE DAMAGE	12 Posts out of alignment.	SPEED	60 MPH
LENGTH OF INSTALLATION...	212.5'	MAX. DYNAMIC DEFLECTION OF RAIL....	48"	IMPACT ANGLE.....	27°
GROUND CONDITION	Dry	VEHICLE DECELERATION (PEAK).....	Long.	VEHICLE WEIGHT.....	3980
				(W/DUMMY & INSTRUMENTATION)

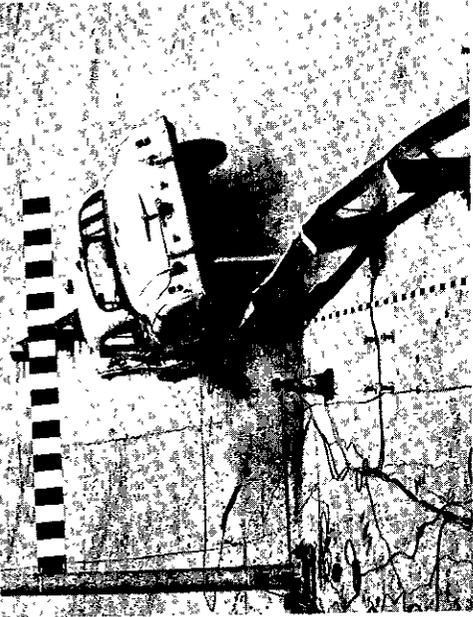
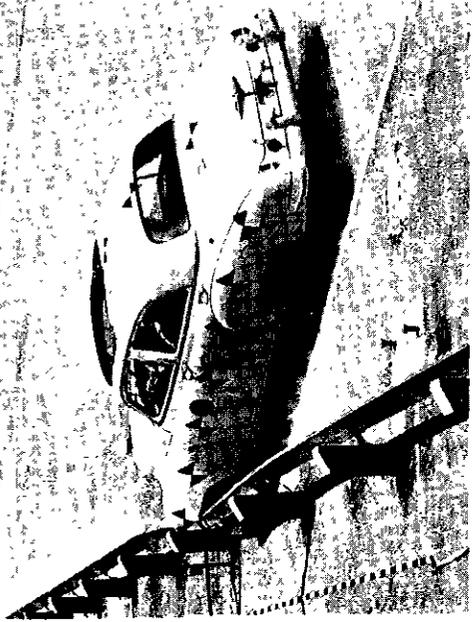
GUARDRAIL Tuthill
 BRACKET HG15N
 POST 8x8 D.F.
 POST SPACING 10' O.C.
 LENGTH OF INSTALLATION ... 200'
 GROUND CONDITION Dry

DUMMY INJURY Severe scalp lacerations. Possible minor concussion. TEST NO. 2
 GUARDRAIL DAMAGE 4 Sections damaged beyond repair. DATE 7-23-58
 POST DAMAGE 5 Posts damaged beyond repair. VEHICLE Chev. 50 Sedan
 VEHICLE DAMAGE 10 Posts out of alignment. SPEED 59 MPH
 MA X. DYNAMIC DEFLECTION OF RAIL ... 55 1/2" IMPACT ANGLE 32 °
 VEHICLE DECELERATION (PEAK) Long. ... Transv. ... (W/DUMMY & INSTRUMENTATION)
 Total loss

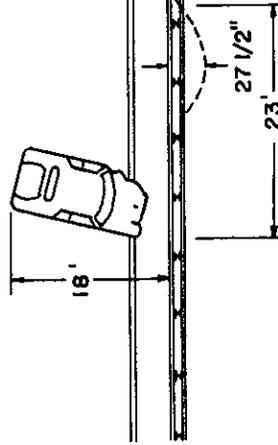
DUMMY INJURY Possible neck injury & concussion.
 GUARDRAIL DAMAGE 4 Sections damaged beyond repair.
 POST DAMAGE 3 Posts knocked out.
 VEHICLE DAMAGE 2 Posts out of alignment.
 MAX. DYNAMIC DEFLECTION OF RAIL ... 36"
 VEHICLE DECELERATION (PEAK) Long. Transv.

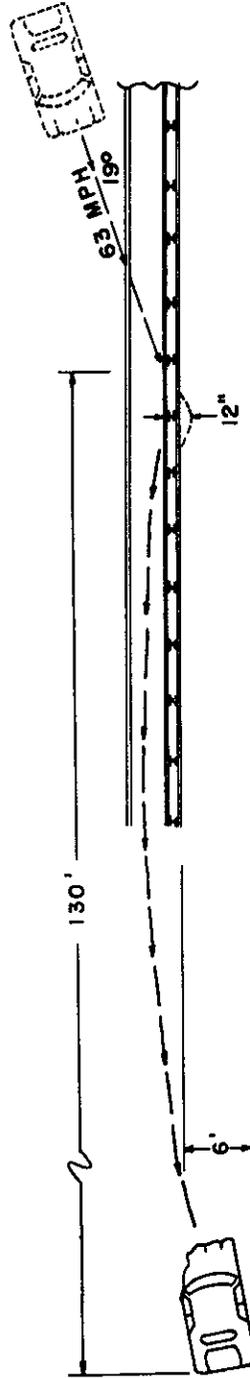
DUMMY INJURY..... Multiple scalp lacerations. Possible internal injury. TEST NO.....7
 GUARDRAIL DAMAGE 2 Sections damaged beyond repair. DATE 9-18-58
 POST DAMAGE 2 Posts damaged beyond repair. VEHICLE Chev. 54 Sedan
 VEHICLE DAMAGE 2 Posts out of alignment. SPEED 63 M P H
 MAX. DYNAMIC DEFLECTION OF RAIL...19" IMPACT ANGLE.....19°
 VEHICLE DECELERATION (PEAK) Long.Transv. (W/DUMMY & INSTRUMENTATION)
 Total loss. VEHICLE WEIGHT.....4050

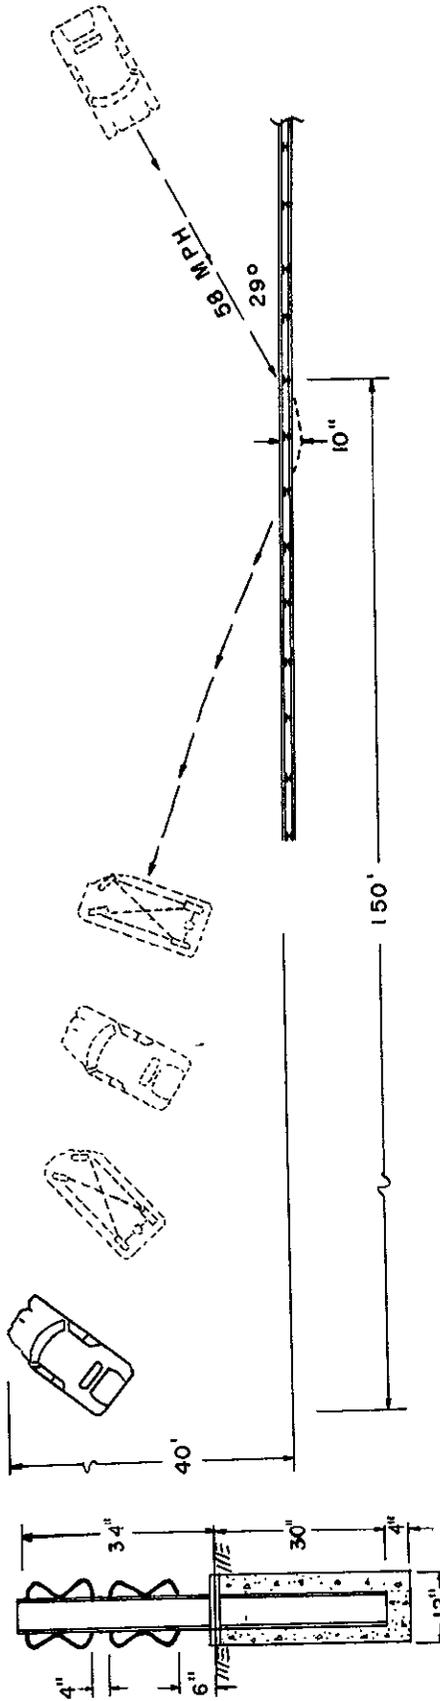
GUARDRAIL..... W Section
 BRACKET..... None
 POST..... 6" WF Beam
 POST SPACING..... 6'-3" O.C.
 LENGTH OF INSTALLATION... 100'
 GROUND CONDITION..... Dry

DUMMY INJURY..... Scalp lacerations. Possible concussion.
 GUARDRAIL DAMAGE..... 2 Sections damaged beyond repair.
 POST DAMAGE..... All can be repaired.
 VEHICLE DAMAGE..... 5 Posts out of alignment.
 MAX. DYNAMIC DEFLECTION OF RAIL... 15"
 VEHICLE DECELERATION (PEAK)..... Long. Transv.

TEST NO..... 8
 DATE..... 10-2-58
 VEHICLE..... Chev. 52 Sedan
 SPEED..... 58 M.P.H
 IMPACT ANGLE..... 29°
 VEHICLE WEIGHT... 4050
 (W/DUMMY & INSTRUMENTATION)

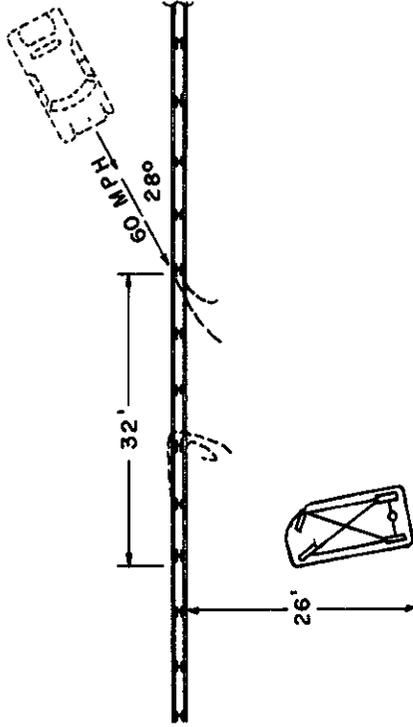
In general it appears that the closer the post spacing the more rigid the over-all barrier system. As was illustrated, however, by Test No. 9, care must be used in the over-all design. The lack of distribution of loading to many posts is one of the results of a rigid system, so the beam in a rigid system must be stronger than with flexible posts so as to resist the concentration of loading that occurs due to the relatively short span in which the loading is absorbed. This loading is a tensile load rather than a beam load and tends to snap the rail at the joint.

DUMMY INJURY Possible chest and internal injuries.
 GUARDRAIL DAMAGE 4 Sections damaged beyond repair.
 POST DAMAGE Both rails failed.
 VEHICLE DAMAGE 2 Posts damaged beyond repair.
 MAX. DYNAMIC DEFLECTION OF RAIL... 15" Before failure.
 VEHICLE DECELERATION (PEAK)..... Long. Transv.

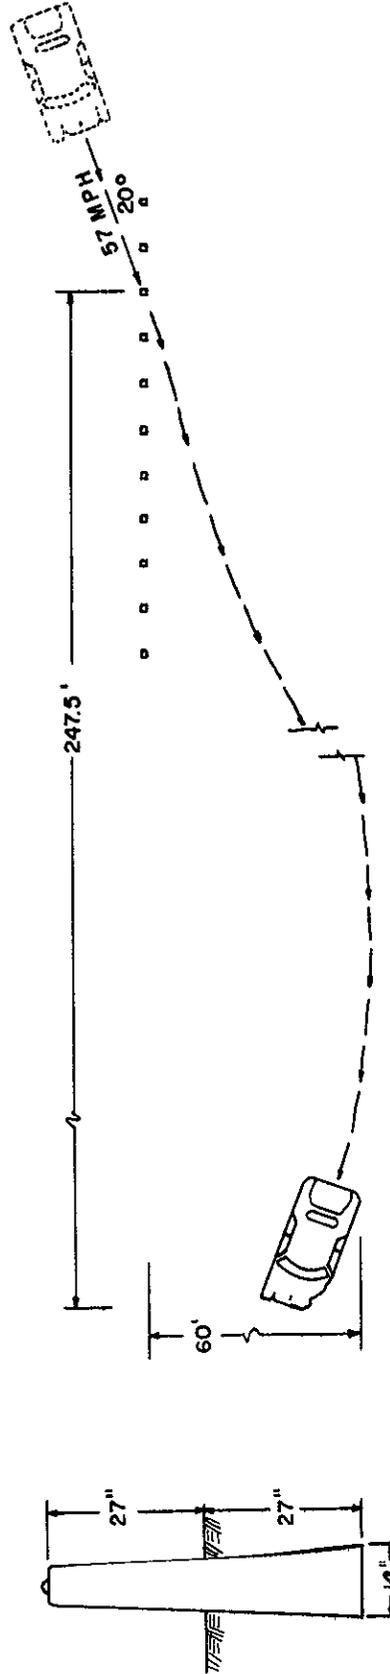
GUARDRAIL.....None
 BRACKET.....None
 POST.....P.C.C.
 POST SPACING.....5' O.C.
 LENGTH OF INSTALLATION...60'
 GROUND CONDITION.....Dry

DUMMY INJURY.....No apparent injuries.
 GUARDRAIL DAMAGE.....No rail.
 POST DAMAGE.....3 Posts demolished.
 VEHICLE DAMAGE.....Est. \$ 200.
 MAX. DYNAMIC DEFLECTION OF RAIL...No rail.
 VEHICLE DECELERATION (PEAK).....Long.....Transv.

TEST NO.10
 DATE10-23-58
 VEHICLEChev. 53 Sedan
 SPEED57 MPH
 IMPACT ANGLE.....20°
 VEHICLE WEIGHT...3970
 (W/DUMMY & INSTRUMENTATION)

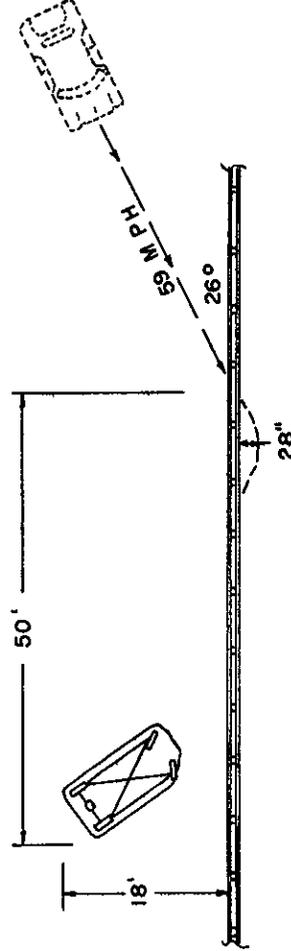
GUARDRAIL W Section
 BRACKET None
 POST 8x8 DF.
 POST SPACING 6'-3" O.C.
 LENGTH OF INSTALLATION... 200'
 GROUND CONDITION Dry

DUMMY INJURY Scalp lacerations. Possible internal injuries.
 GUARDRAIL DAMAGE 6 Sections damaged beyond repair.
 POST DAMAGE 3 Posts damaged beyond repair.
 VEHICLE DAMAGE Total loss.
 MAX. DYNAMIC DEFLECTION OF RAIL... 40"
 VEHICLE DECELERATION (PEAK) Long. Transv.

TEST NO. 11
 DATE 10-30-58
 VEHICLE Ford 55 Sedan
 SPEED 59 MPH
 IMPACT ANGLE 26°
 VEHICLE WEIGHT... 4050
 (W/DUMMY & INSTRUMENTATION)

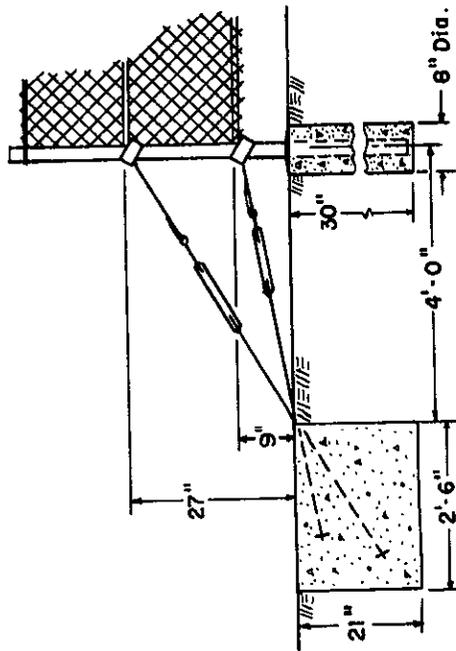
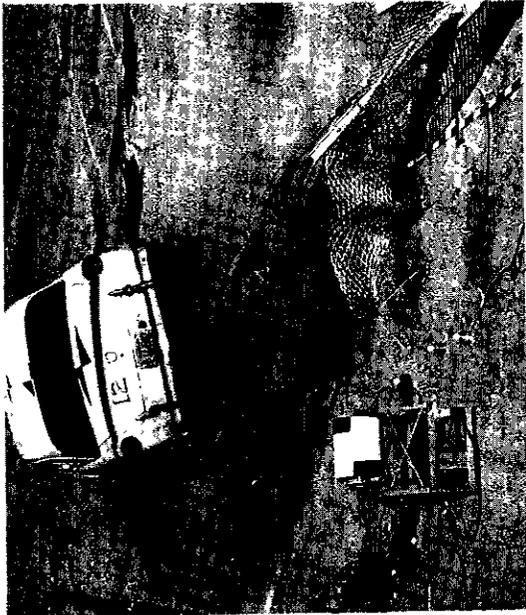
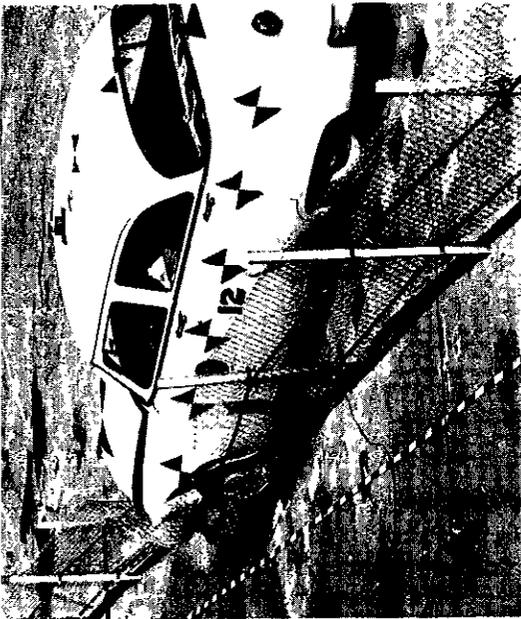
Since writing the above, Test No. 12 has been performed but not analyzed. This unit is a 3 foot high chain link fence on standard steel H posts with two 3/4" anchored cables serving as snubbers.

Based on observations in the field, this test resulted in snubbing of the car into the system at a deceleration tolerable to human occupants and at minor damage to the vehicle. The collision was at the standard 30° angle of approach at a speed of 60 mph.

Further study must be made to be sure that all factors are considered, but at this time it appears that this cable and chain link fence barrier system is one of the more promising barriers tested to date.

GUARDRAIL 36" Chain Link
 Fence w/ 3/4" cables 9" & 27" above Pvmt.
 POST 2 1/4" - 4.1 #
 H Section Fence Post.
 POST SPACING 8' O.C.
 LENGTH OF INSTALLATION ... 96'
 GROUND CONDITION Dry

DUMMY INJURY No Visible Injury.
 GUARDRAIL DAMAGE 50' of Fence knocked out. No damage to Cable.
 POST DAMAGE 7 Posts damaged beyond repair. 6 Posts Bent.
 VEHICLE DAMAGE \$ 400.
 MAX. DYNAMIC DEFLECTION OF RAIL ... 7' - 2"
 VEHICLE DECELERATION (PEAK) Long. Transv.

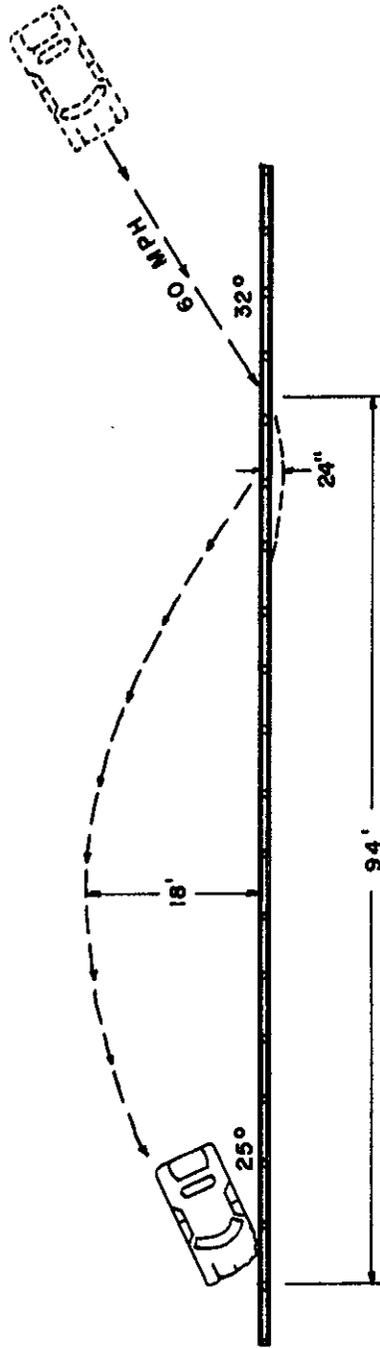
GUARDRAIL W Section
 CHANNEL 6" Γ 8.2 #
 BRACKET 8x8x12DF Block
 POST 8x6 D.F.
 POST SPACING 6'-3" O.C.
 LENGTH OF INSTALLATION ... 125'
 GROUND CONDITION Dry

DUMMY INJURY Minor head injury.
 GUARDRAIL DAMAGE 4 Sections damaged beyond repair.
 CHANNEL DAMAGE 4 Sections damaged beyond repair.
 POST DAMAGE 3 Posts damaged beyond repair.

VEHICLE DAMAGE Total Loss
 MAX. DYNAMIC DEFLECTION OF RAIL ... 37"
 VEHICLE DECELERATION (PEAK) Long. ... Transv.

TEST NO. 13
 DATE 12-18-58
 VEHICLE Chev. 53 Sedan
 SPEED 60 MPH
 IMPACT ANGLE 32°
 VEHICLE WEIGHT ... 4000
 (W/DUMMY & INSTRUMENTATION)

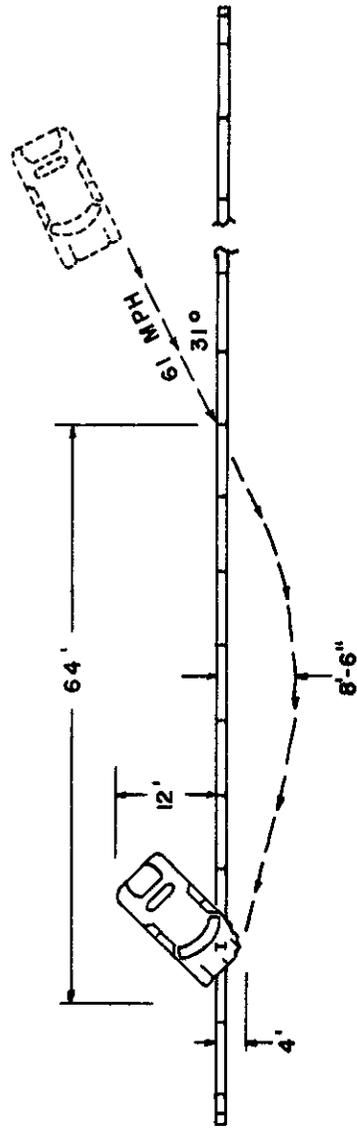
GUARDRAIL 36" Chain Link
 Fence w/ 3/4" cables 9" @ 30" above Pymt.
 POST 2 1/4" - 4.1 #
 H Section Fence Post.
 POST SPACING 8' O.C.
 LENGTH OF INSTALLATION ... 192'
 GROUND CONDITION Dry

DUMMY INJURY Minor Bruises
 GUARDRAIL DAMAGE 80' of Fence knocked out. No damage to Cables.
 POST DAMAGE 11 Posts damaged beyond repair.
 VEHICLE DAMAGE \$400.
 MAX. DYNAMIC DEFLECTION OF RAIL ... 8'-6"
 VEHICLE DECELERATION PEAK Long Transv.

TEST NO. 14
 DATE 12-26-58
 VEHICLE Chev. 53 Sedan
 SPEED 61 MPH
 IMPACT ANGLE 31°
 VEHICLE WEIGHT ... 4000
 (W/DUMMY & INSTRUMENTATION)
