Snohomish River Bridge Report

By
Paul G. Jonas
and
Charles B. Kendrick

SNOHOMISH RIVER BRIDGE REPORT

Our Proj. W. O.
M 63299

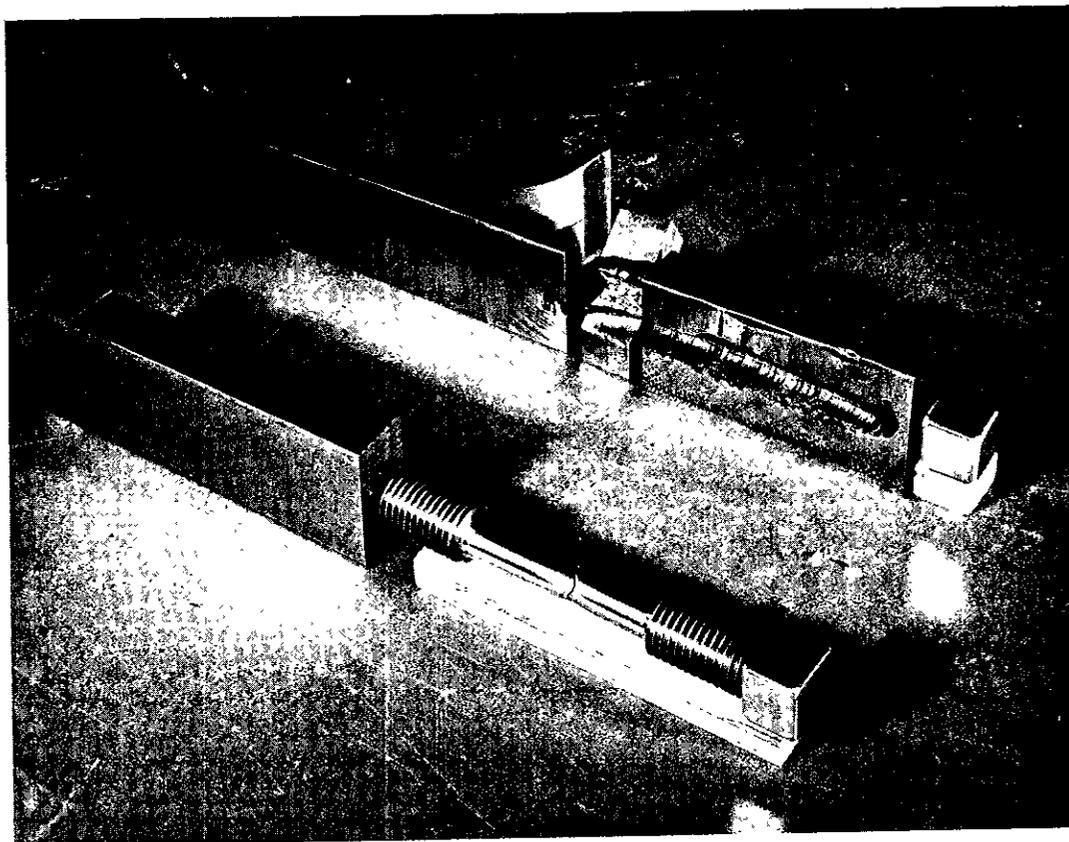
FIGURE 1. Bottom flange sample in foreground - Top flange sample in background - showing how pieces were removed from samples for examination and test.

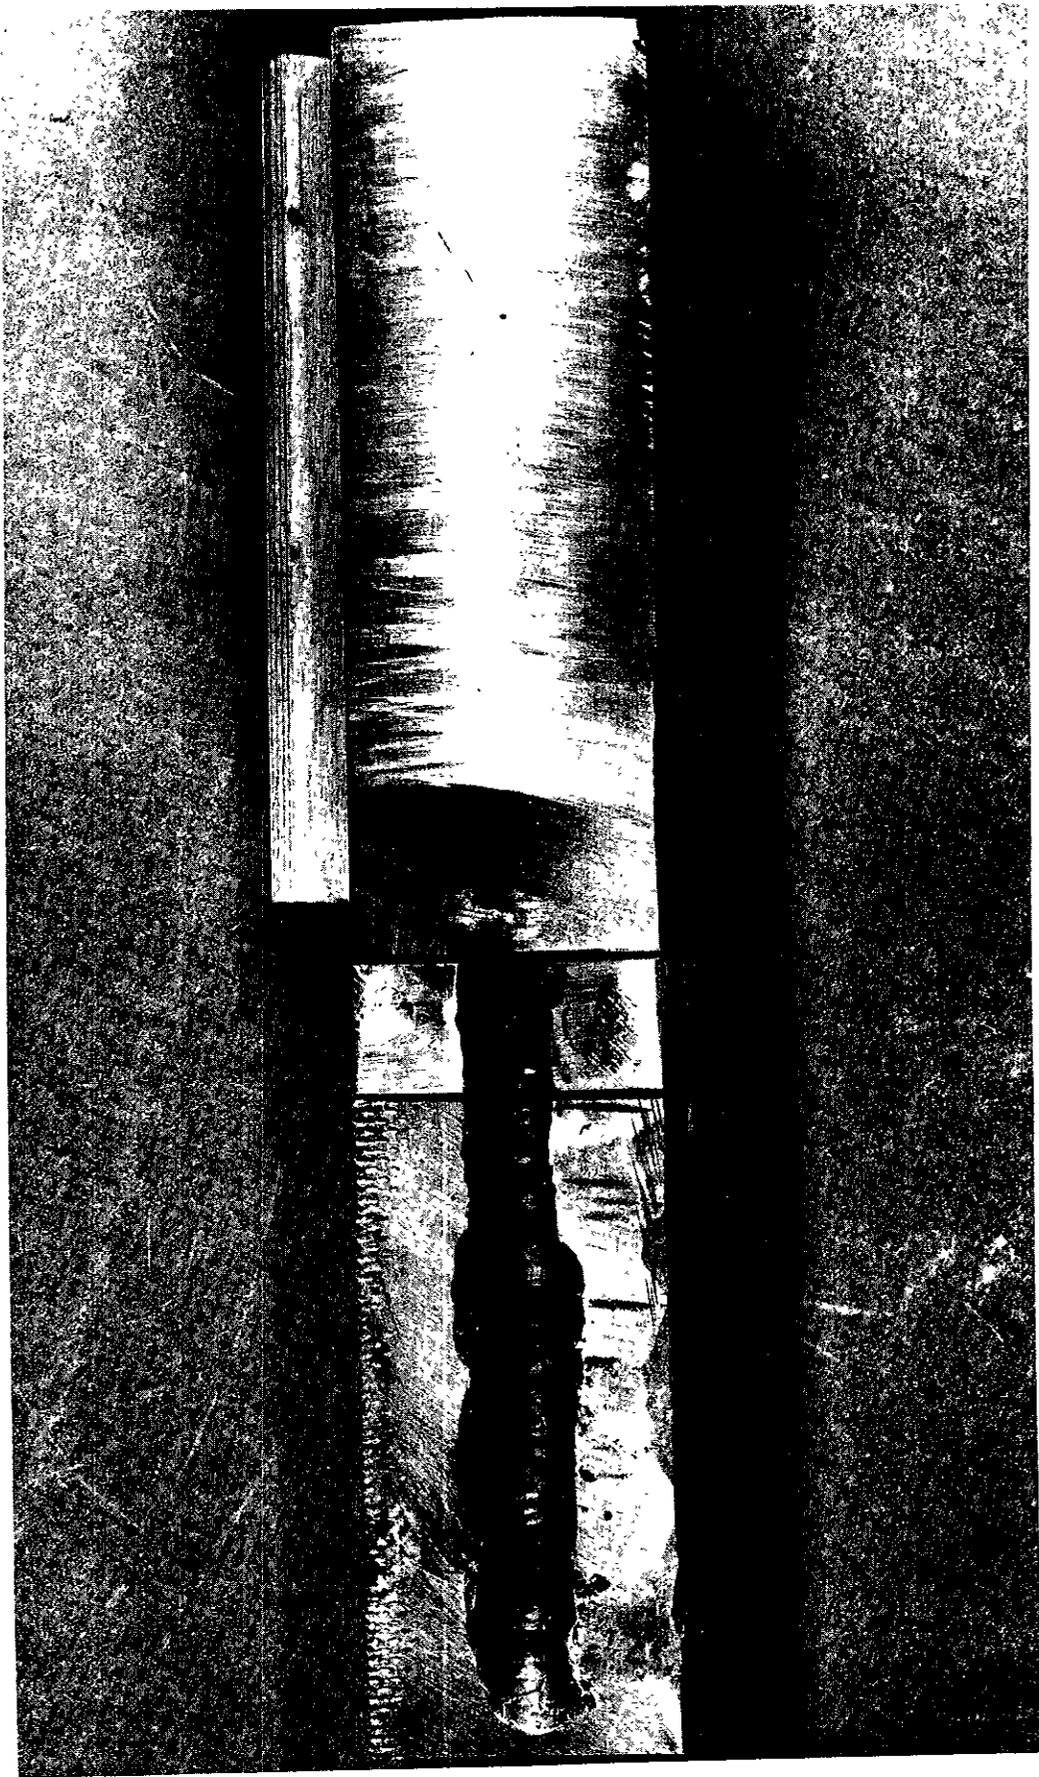
FIGURE 2. Pieces from the top flange sample laid out according to their respective positions in the sample and viewed from the ground flame-cut outside edge of the flange from which the sample was removed. Simple visual inspection of the line of layered inclusion materials visible in the photograph showed it to be virtually continuous throughout the sample. (A fact confirmed by ultrasonic testing.)

It is recommended that the steel containing defects of the extent and nature represented by the top flange sample should be removed from the member if continuous into the width of the flange plate and especially if this condition enters into the butt weld area.

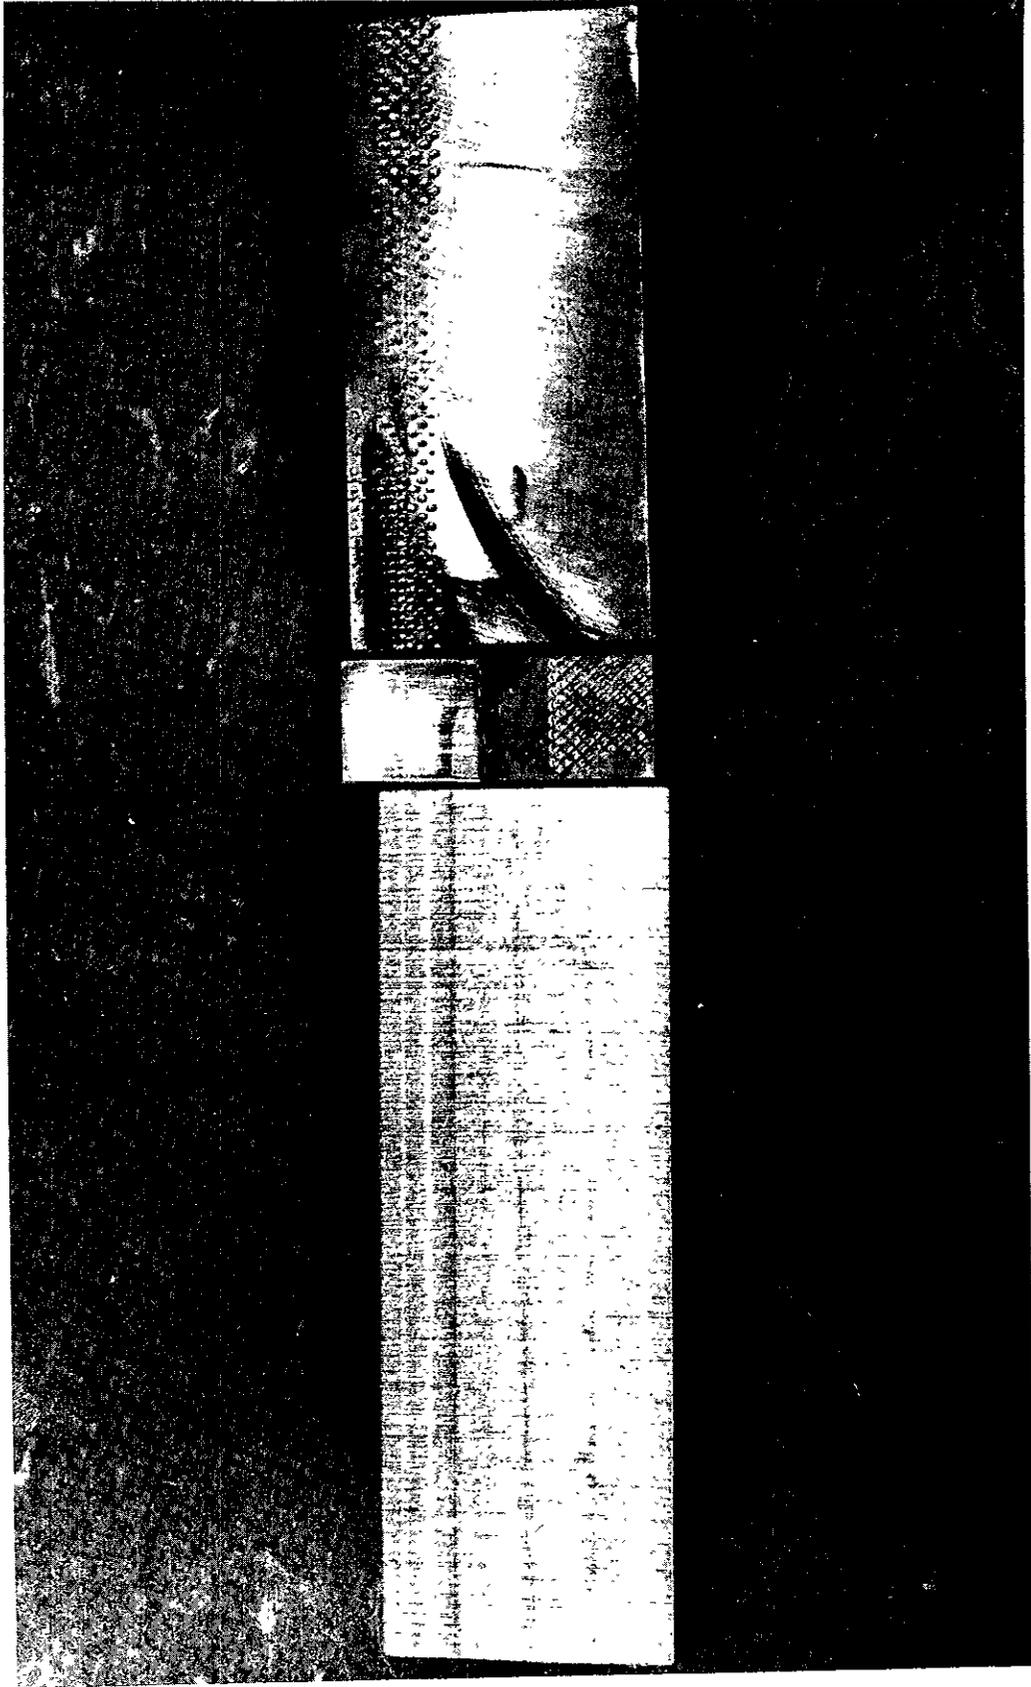
FIGURE 3. Pieces from the top flange sample laid out according to their respective positions in the sample and viewed from the side closest to the web and opposite the flame-cut edge of the flange. Notice that the layers of non-metallic inclusions are visible without magnification or etching on both the band-sawed and the ground surfaces.

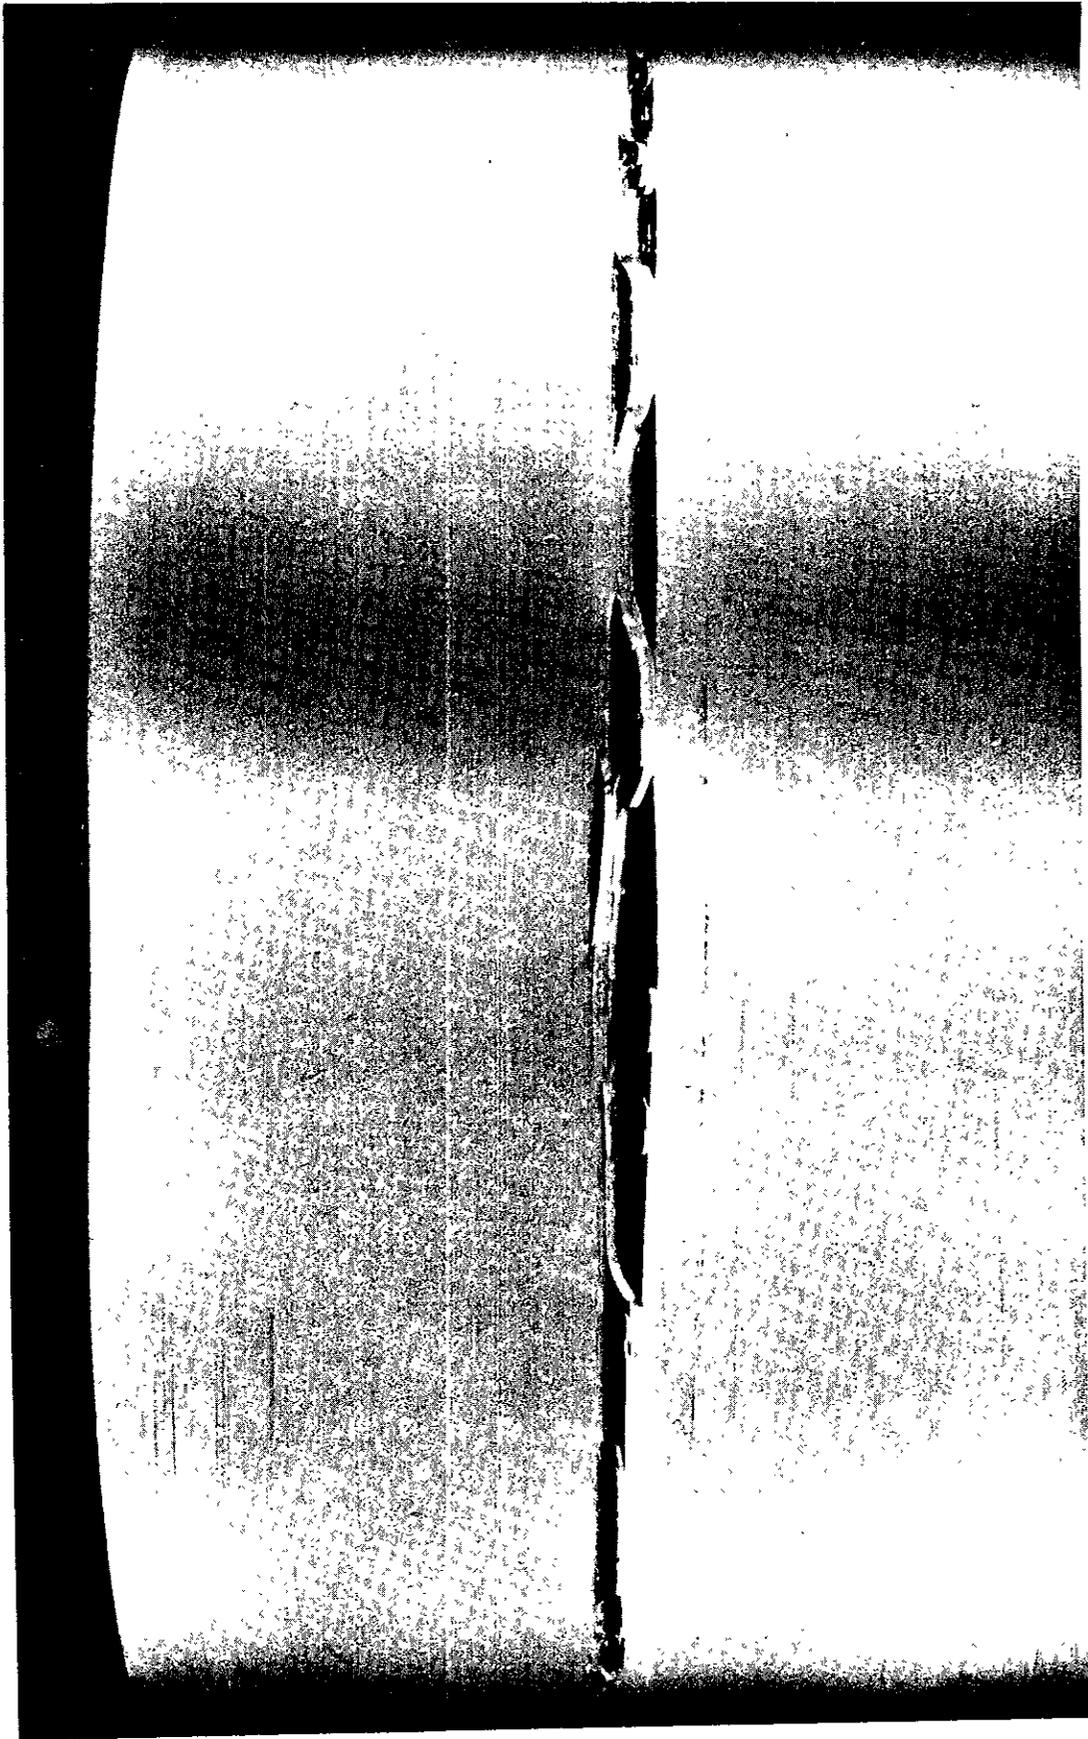
- A. The guided bend test (13% elongation) failed at less than 1% elongation. It separated almost completely

at 13% elongation at a plane of layered inclusion material parallel to and half way between the plate surfaces (see Figures 4 and 5).

FIGURE 4. 3X Face of Guided Bend Test of Top Flange at 13% elongation. This surface, developed from a band sawed face, has been shaped, ground, and polished on 4/0 paper.

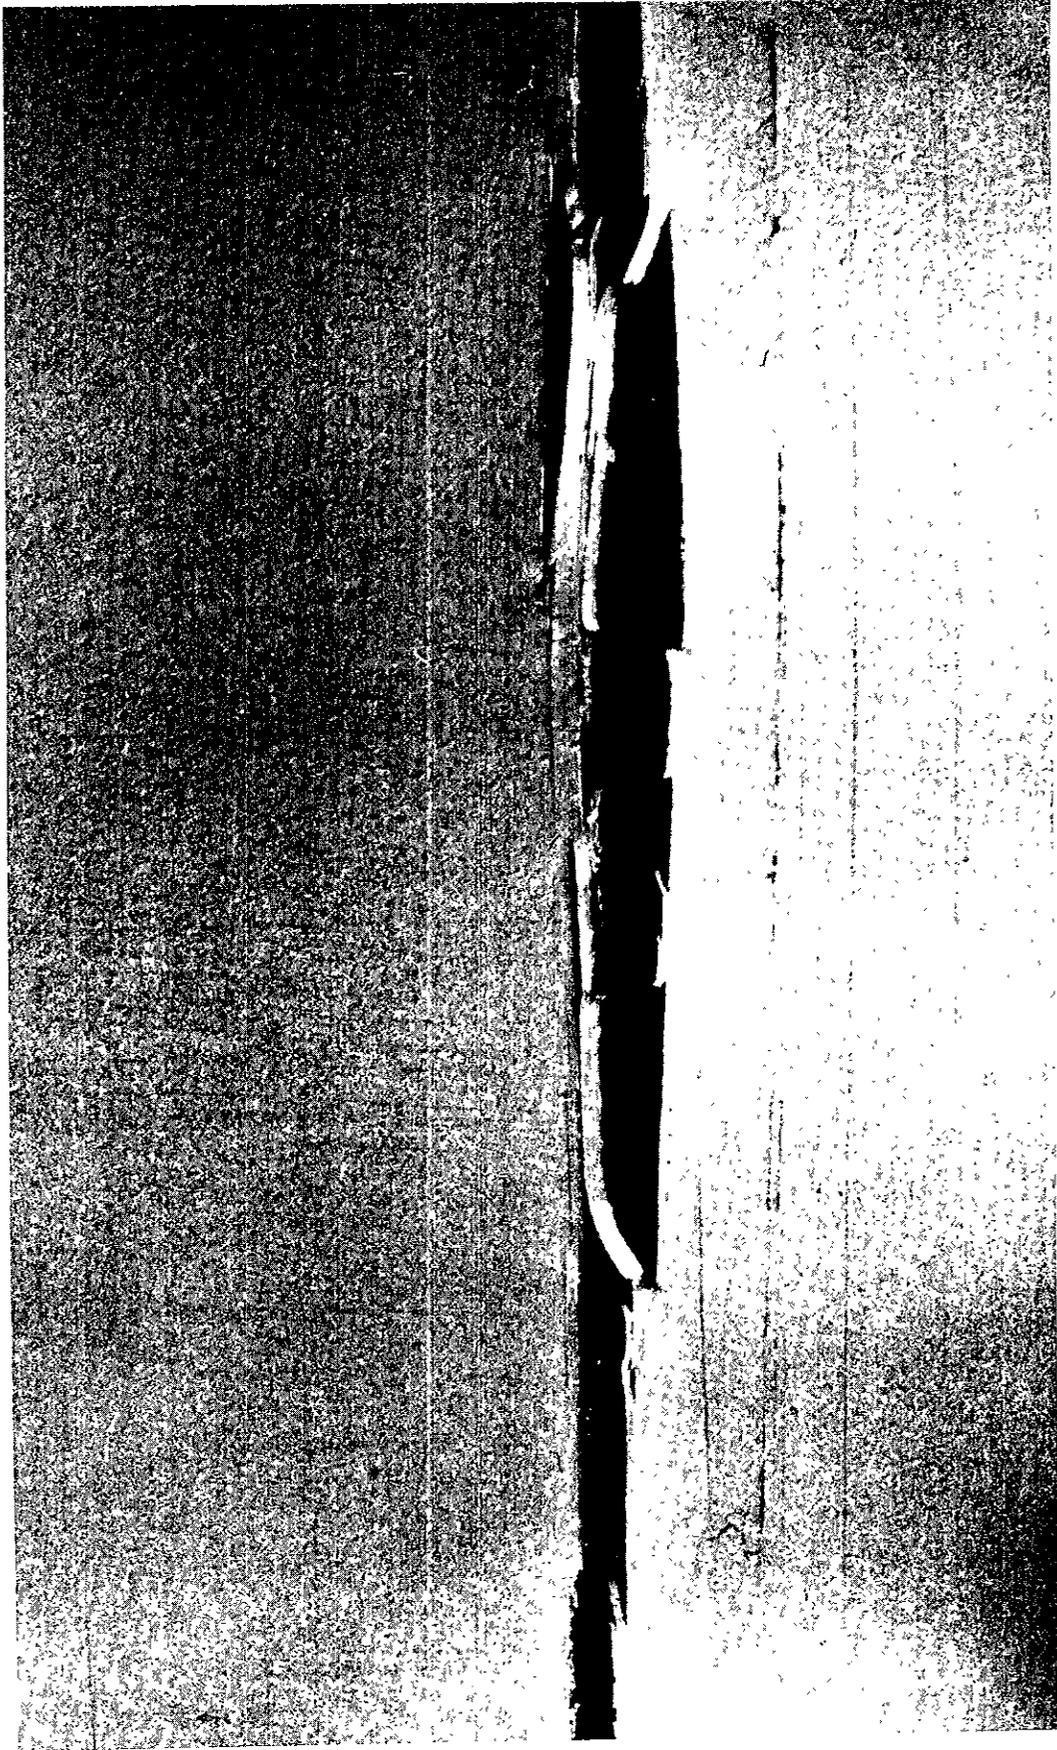
FIGURE 5. 6X Face of Guided Bend Test Top Flange at 13% elongation. Openings began to appear along the line of lamination as soon as bending became noticeable to the eye.

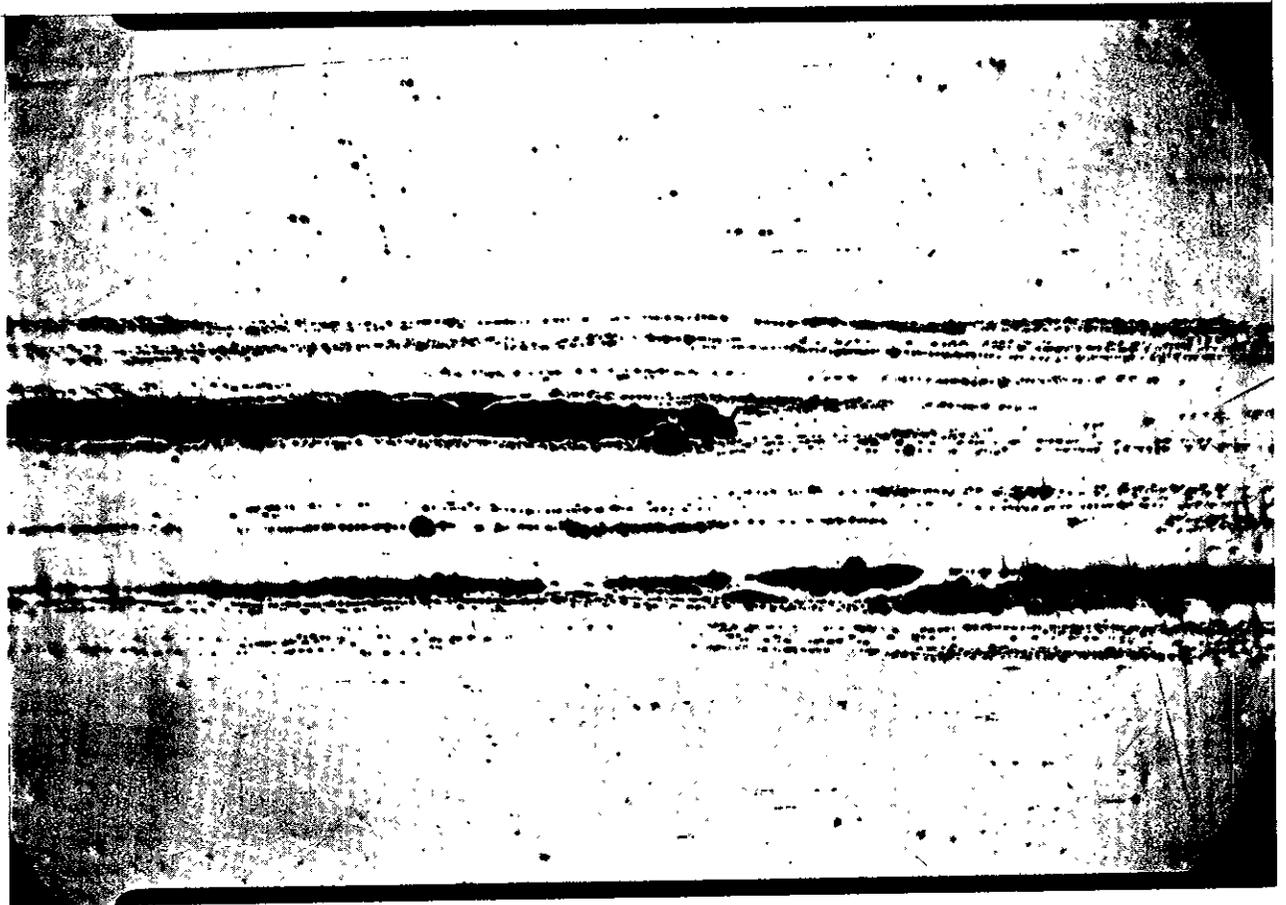
FIGURE 9. 50X polished unetched face of metallographic specimen taken from the top flange sample showing clearly the lines of layered material next to the flame cut edge of the flange from which the sample was taken. These layers of material extended to form a lamination that separated the top flange sample over 50% to 70% of its area.

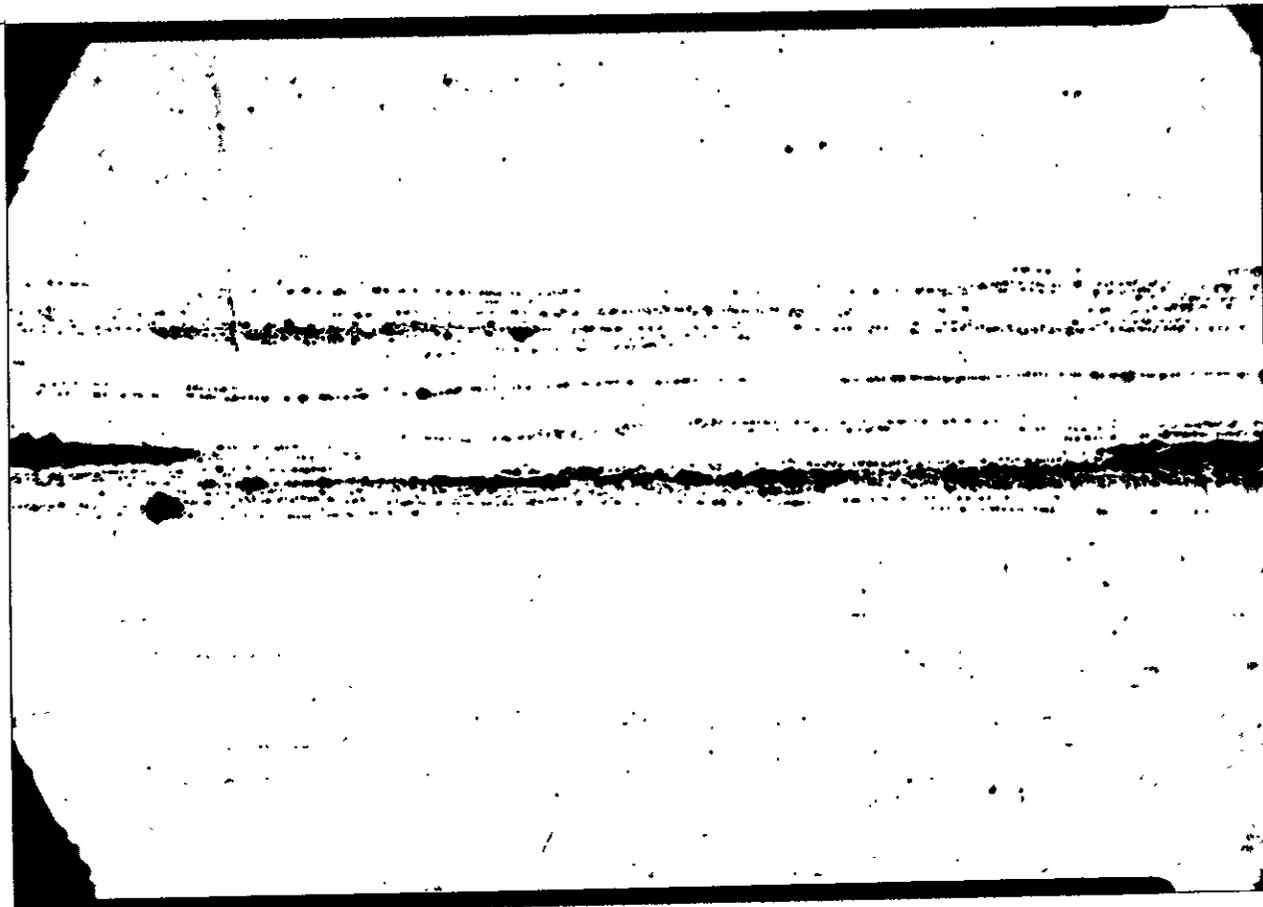
FIGURE 10. 50X polished unetched face of metallographic specimen taken from the top flange sample showing clearly the lines of layered material next to the flame cut edge of the flange from which the sample was taken. These layers of material extended to form a lamination that separated the top flange sample over 50% to 70% of its area.

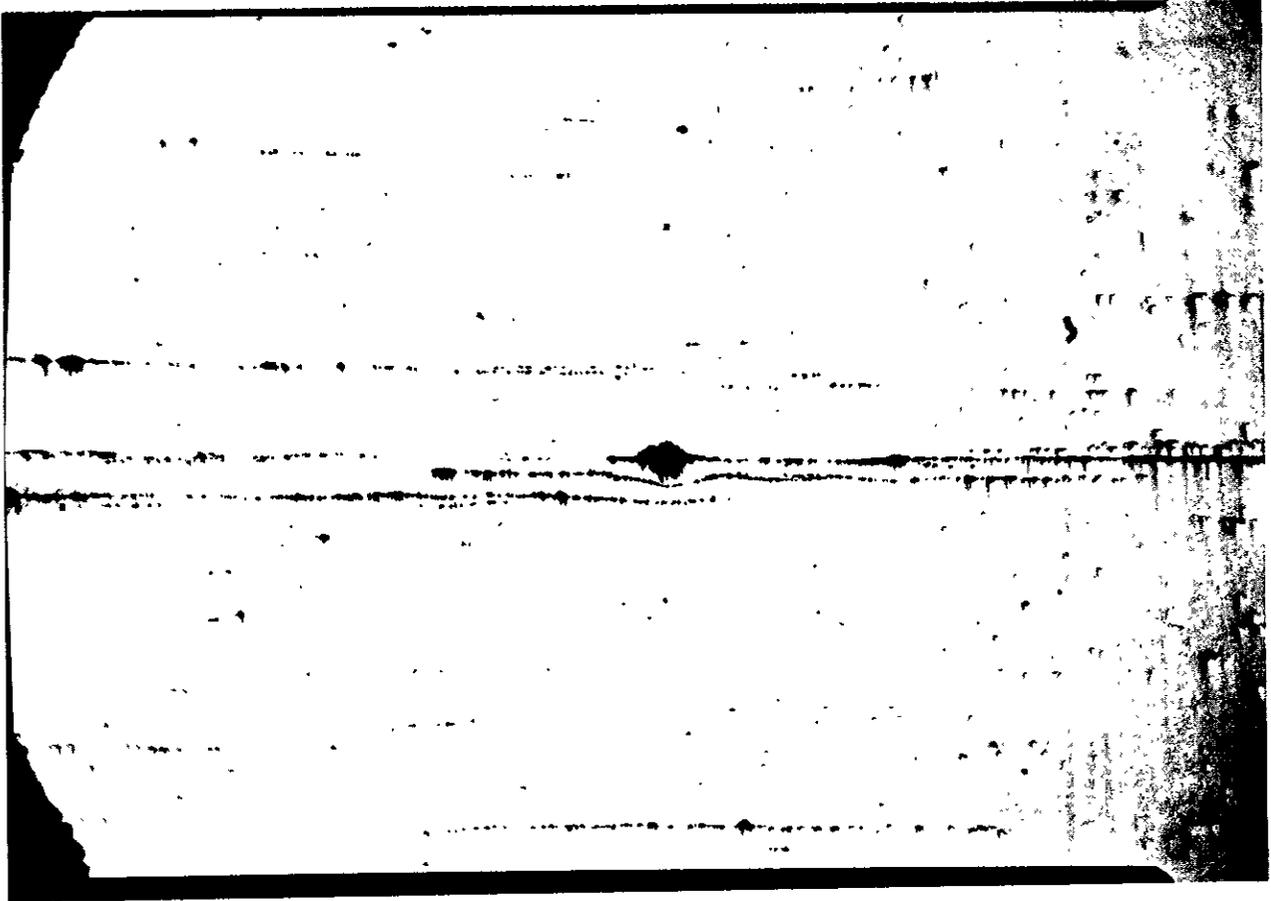
FIGURE 11. 50X polished unetched face of metallographic specimen taken from the top flange sample showing clearly the lines of layered material next to the flame cut edge of the flange from which the sample was taken. These layers of material extended to form a lamination that separated the top flange sample over 50% to 70% of its area.

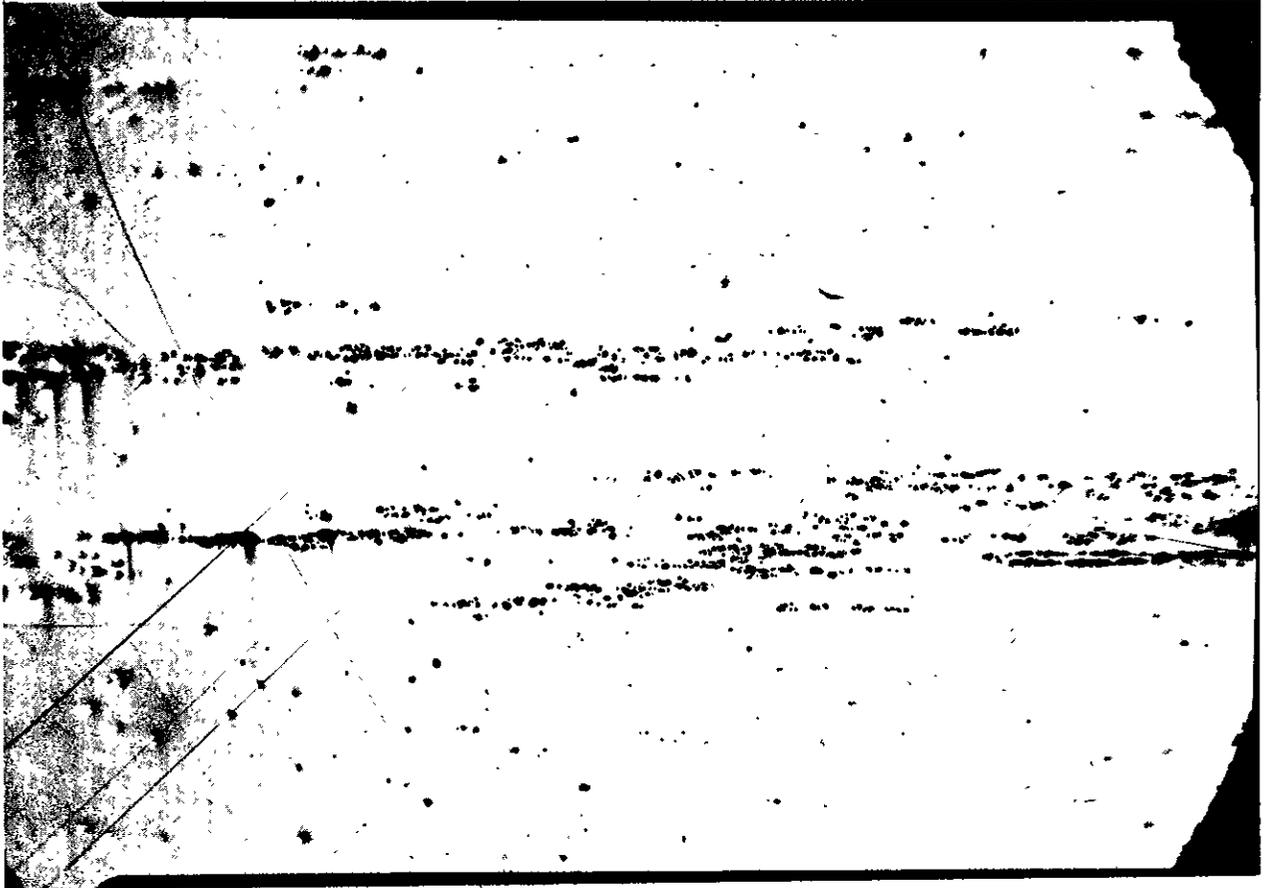
FIGURE 12. 50X polished and unetched surface of metallographic specimen taken from the top flange sample. This shows a section of steel in the beam at a point $5/8$ " away from and transverse to the flame cut edge of the flange from which the sample was removed.

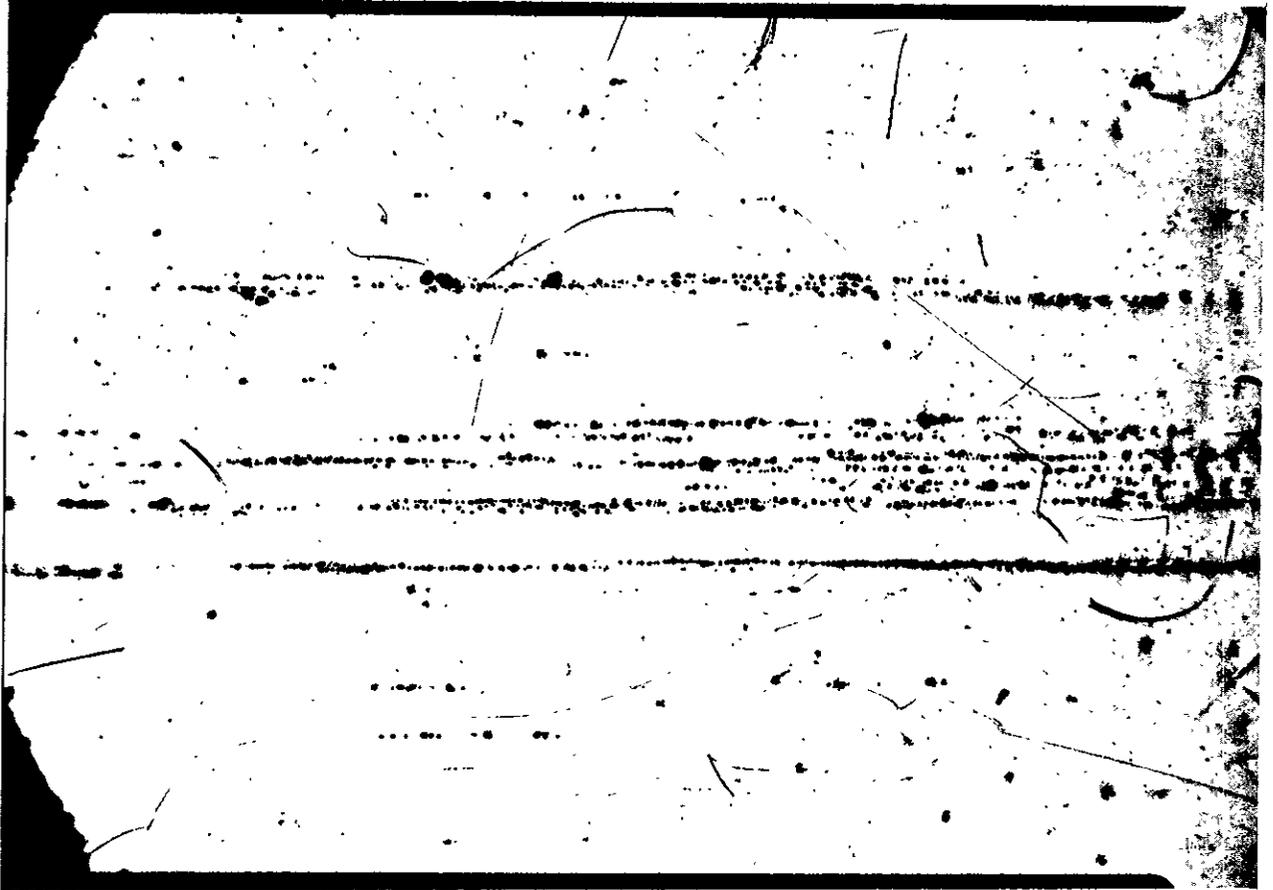
FIGURE 13. 50 X polished and unetched surface of metallographic specimen taken from the top flange sample showing the layered inclusion material in a surface $13/16$ " away from and parallel to the flame cut edge of the flange from which the sample was removed. Layers of inclusion material of this nature appeared to be typical of those found through the specimen and presumably throughout the top flange sample as it was received.

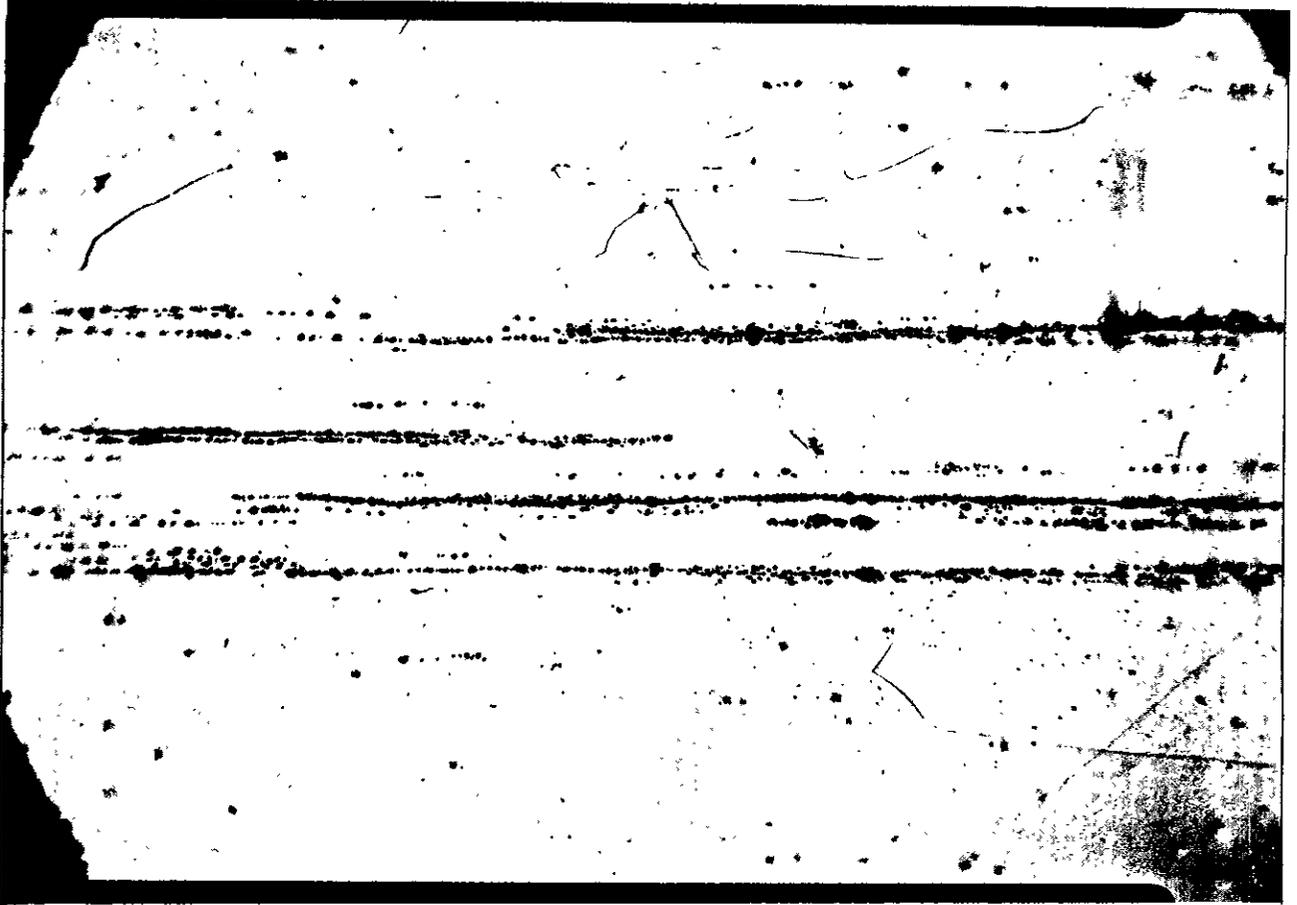
FIGURE 14. 50X polished and unetched surface of metallographic specimen taken from the top flange sample showing the layered inclusion material in a surface $13/16''$ away from and parallel to the flame cut edge of the flange from which the sample was removed. Layers of inclusion material of this nature appeared to be typical of those found through the specimen and presumably throughout the top flange sample as it was received.

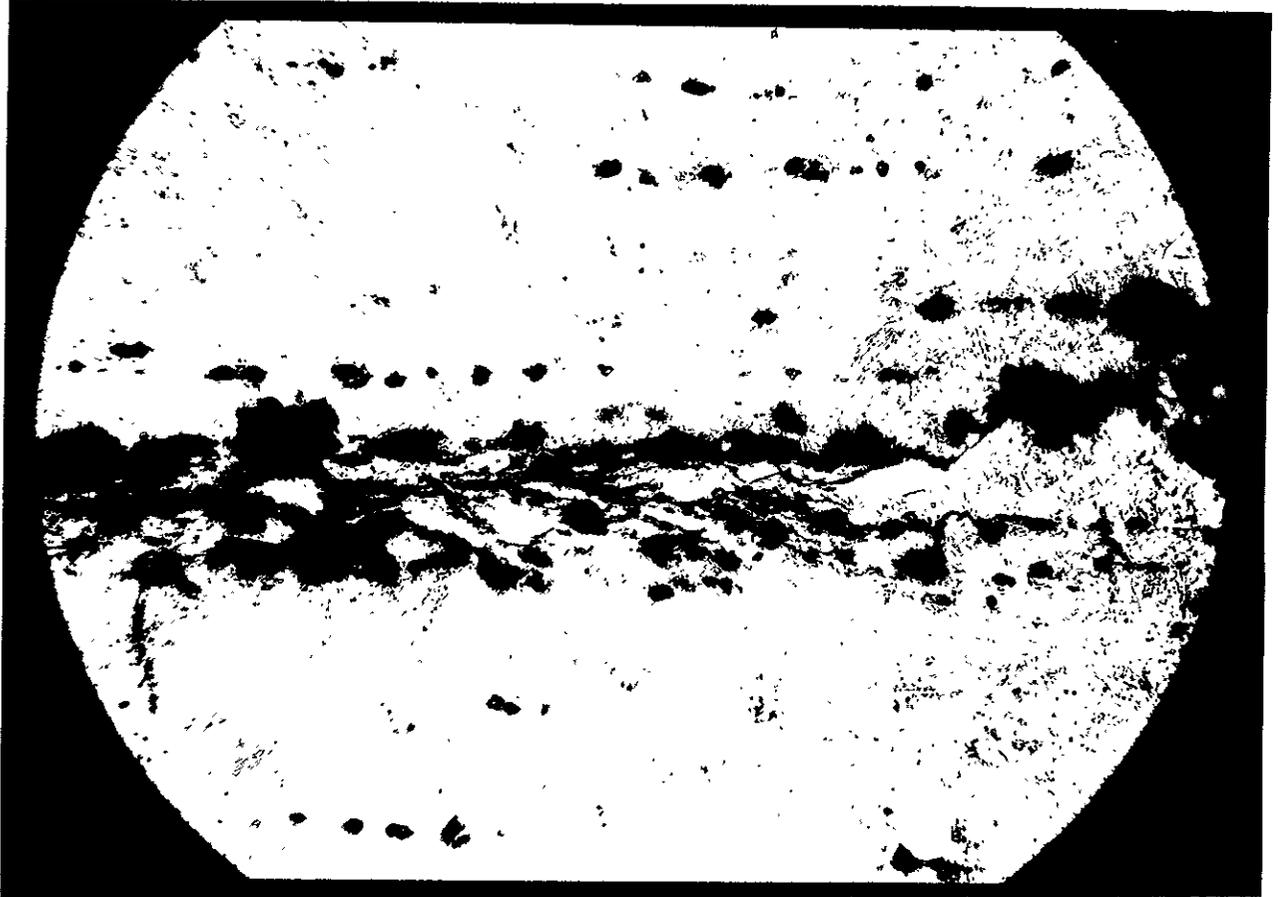
FIGURE 15. 500X Nital etch showing lines of inclusions next to flame cut surface connected by cracks to form a continuous separation in metallographic specimen from top flange.

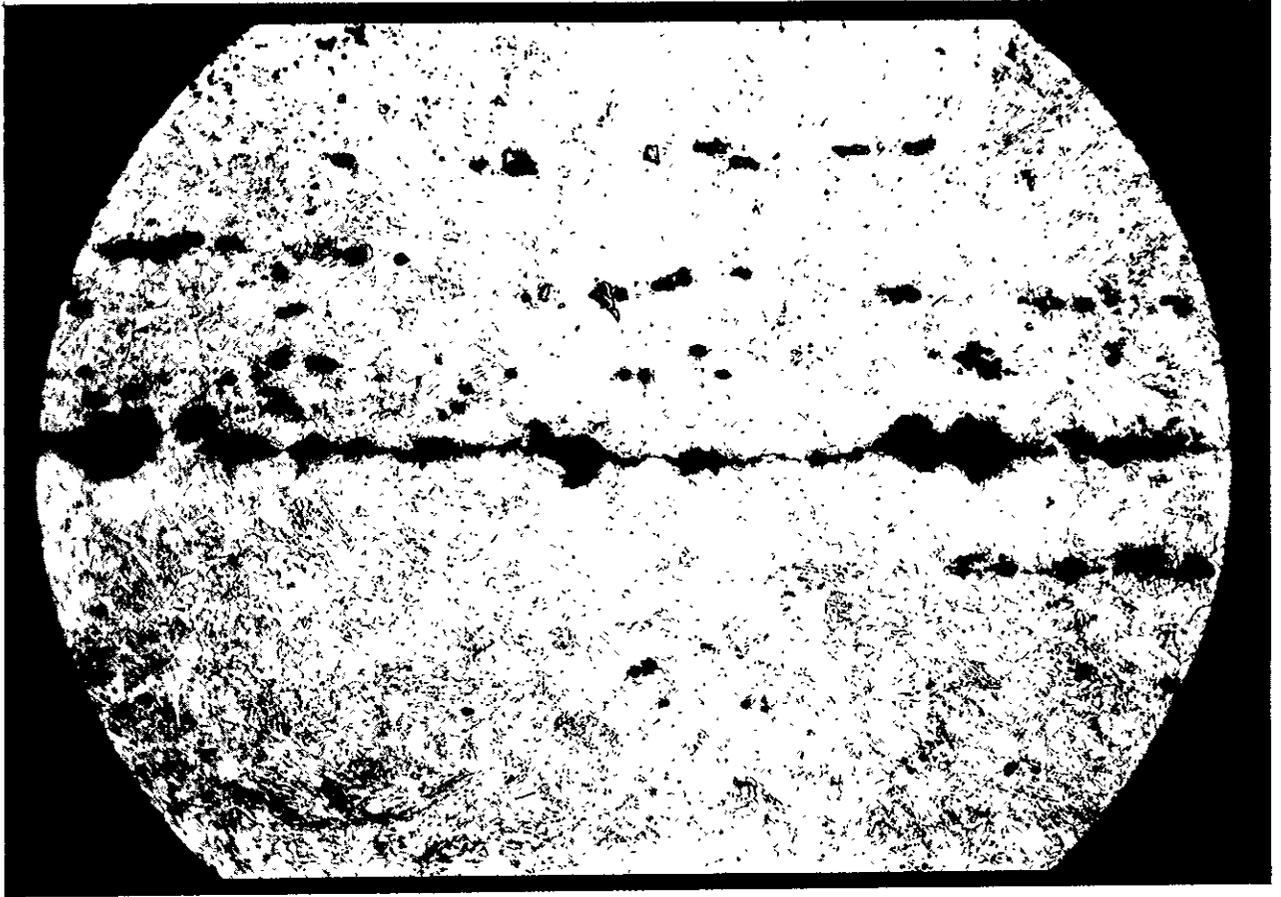
FIGURE 16. 500X Nital etch showing lines of inclusions next to flame cut surface connected by cracks to form a continuous separation in metallographic specimen from top flange.

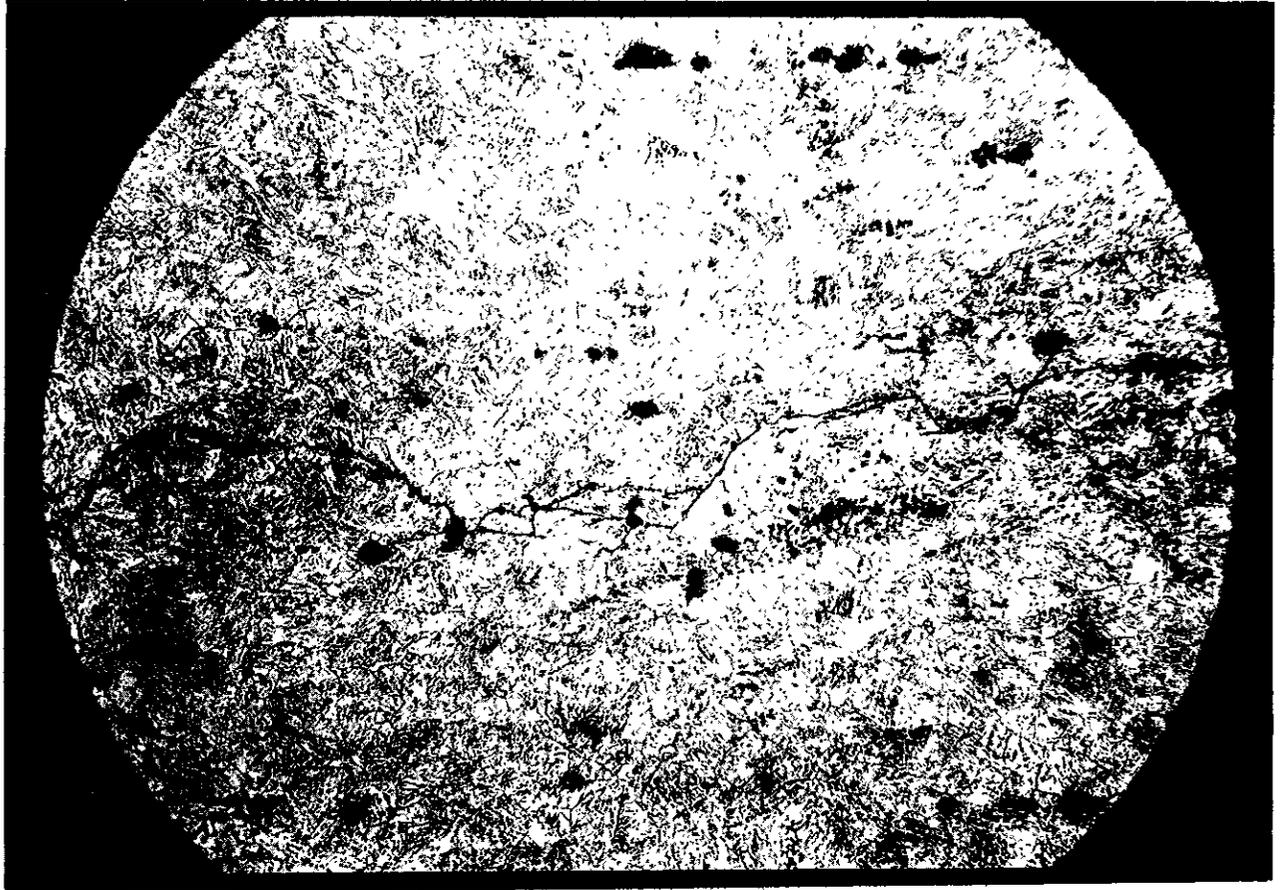
FIGURE 17. 500X Nital etch showing satellite cracks running parallel to and out from the principal layer of nonmetallic inclusion material at the flame cut surface in metallographic specimen from top flange.

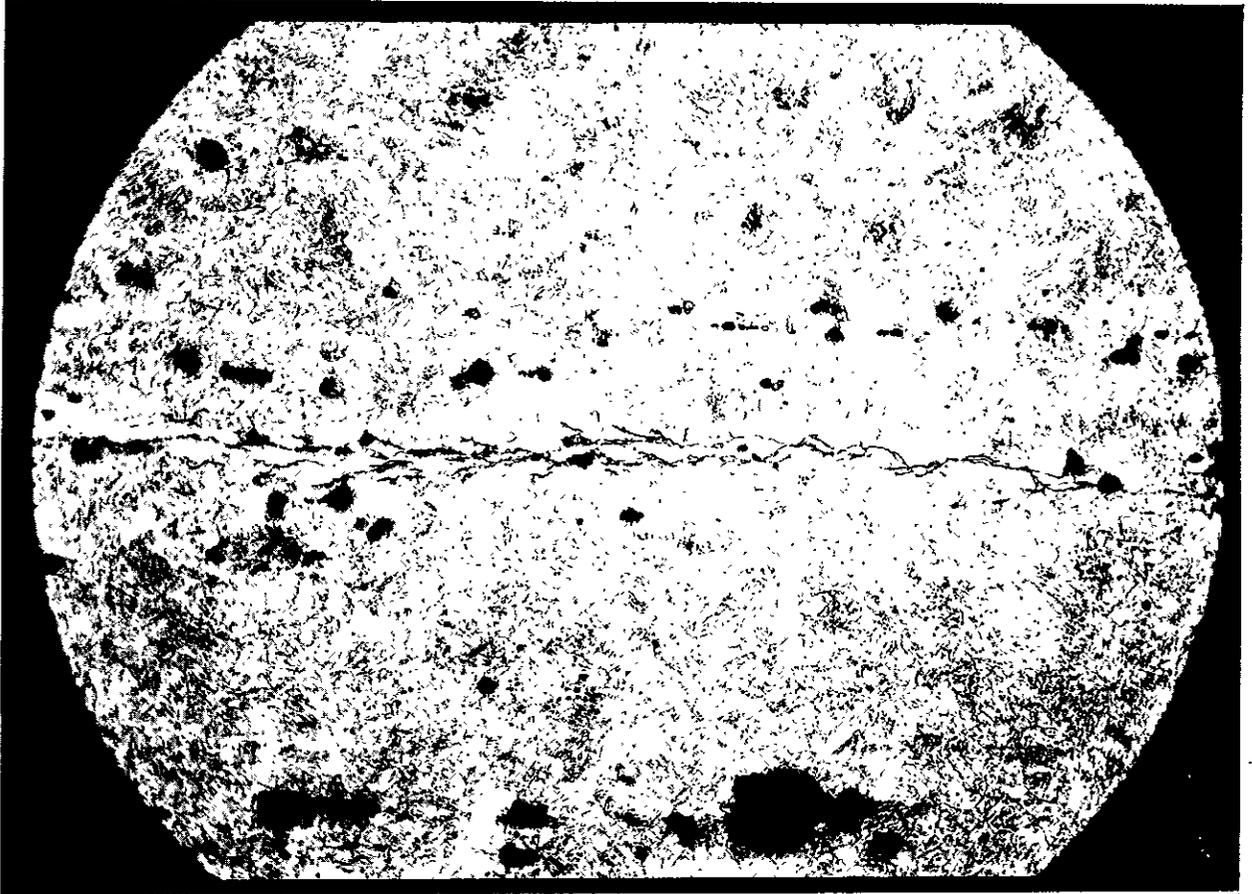
FIGURE 18. 500X Nital etch showing satellite cracks running parallel to and out from the principal layer of nonmetallic inclusion material at the flame cut surface in metallographic specimen from top flange.

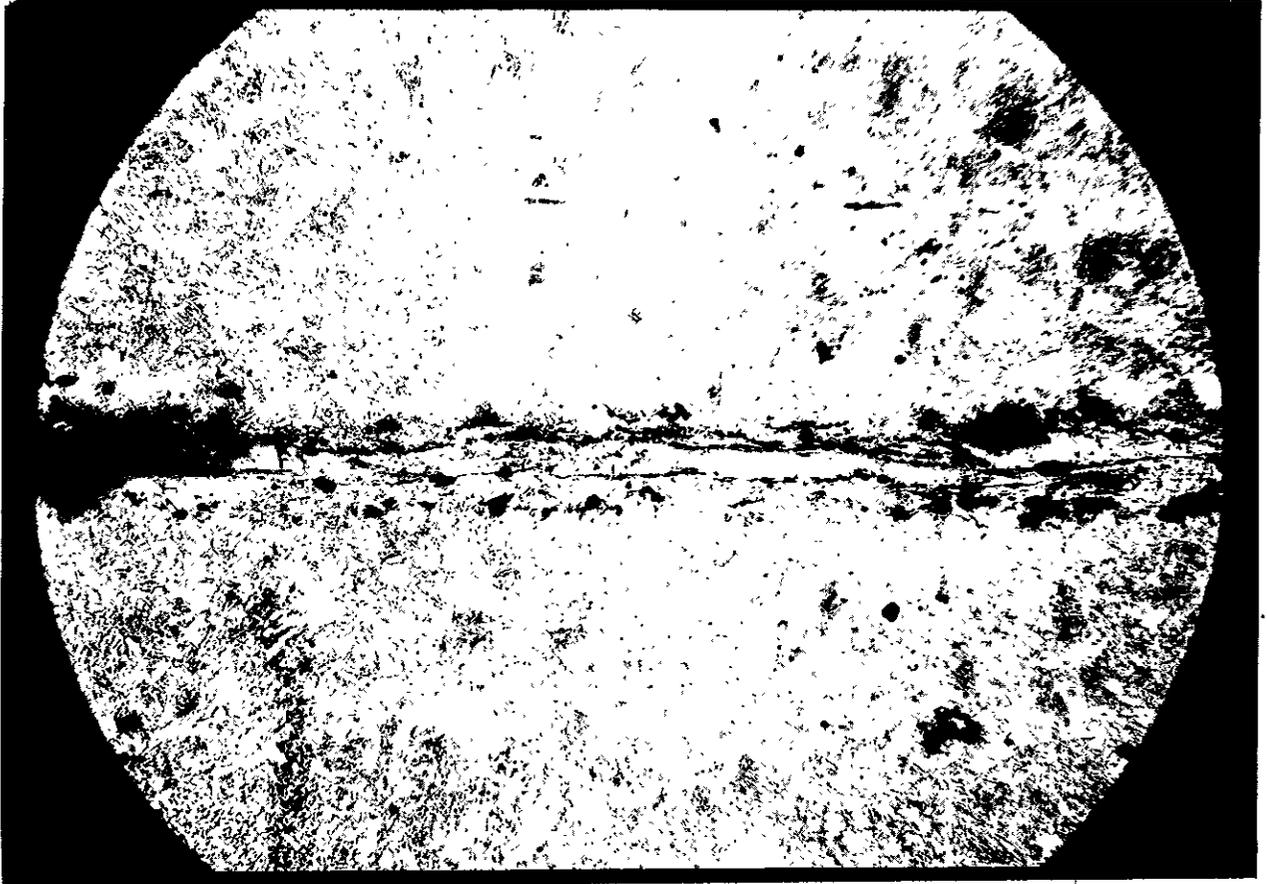
FIGURE 19. 500X Nital etch showing layered metal structure parallel to principal layer of nonmetallic inclusion material of the flame cut surface of the top flange specimen.
