Snohomish River Bridge Report

By
Paul G. Jonas
and
Charles B. Kendrick

SNOHOMISH RIVER BRIDGE REPORT

Our Proj. W. O.
M 63299

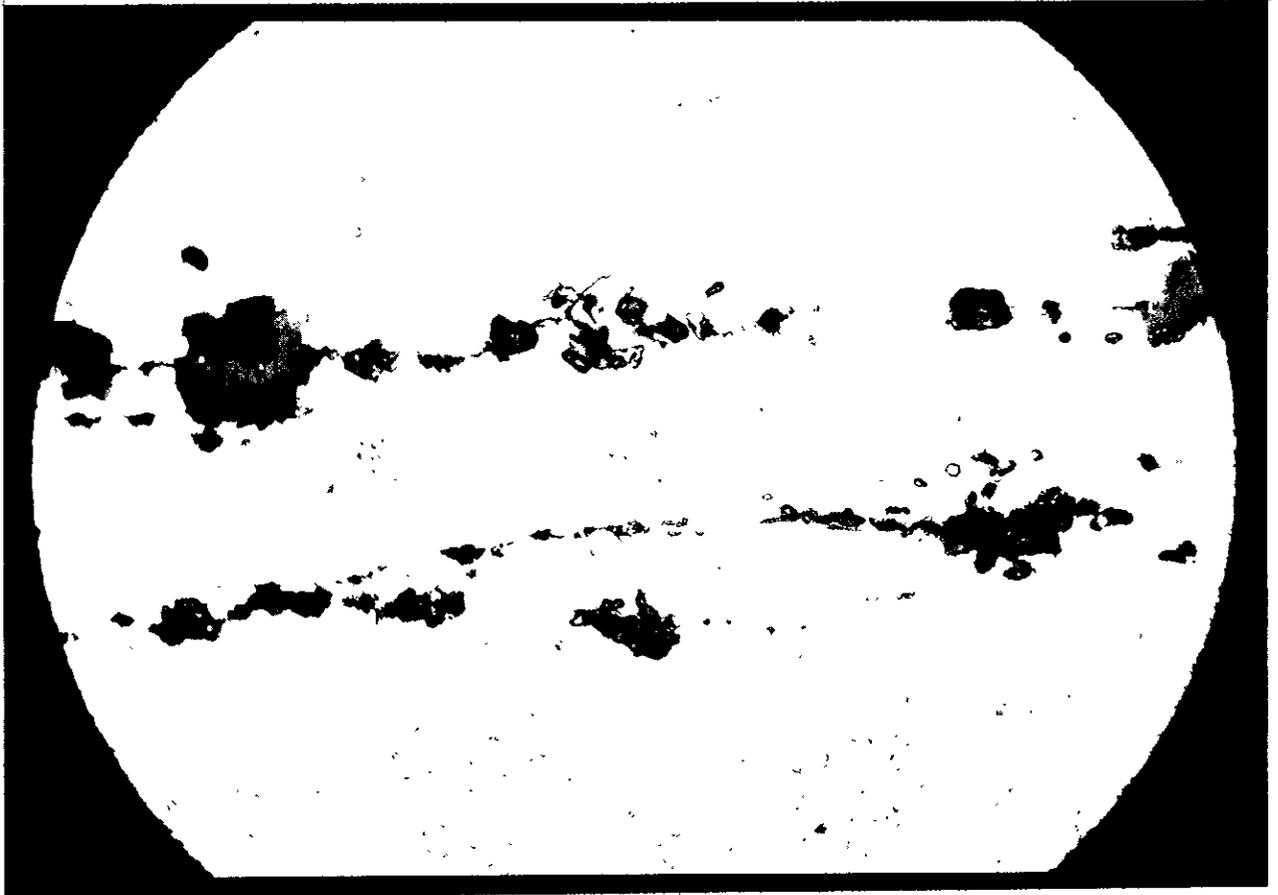
FIGURE 20. 500X Nital etch showing nature of inclusion material. Linear clusters of nonmetallics not plastic at rolling temperature appear to be alumina type, whereas in the material in the larger contiguous inclusions appear to be an iron rich type. Crystals of TiN (?) are scattered extensively in the region of the layers of nonmetallics but these do not appear to contribute significantly to the laminating effect associated with iron and alumina type inclusions.

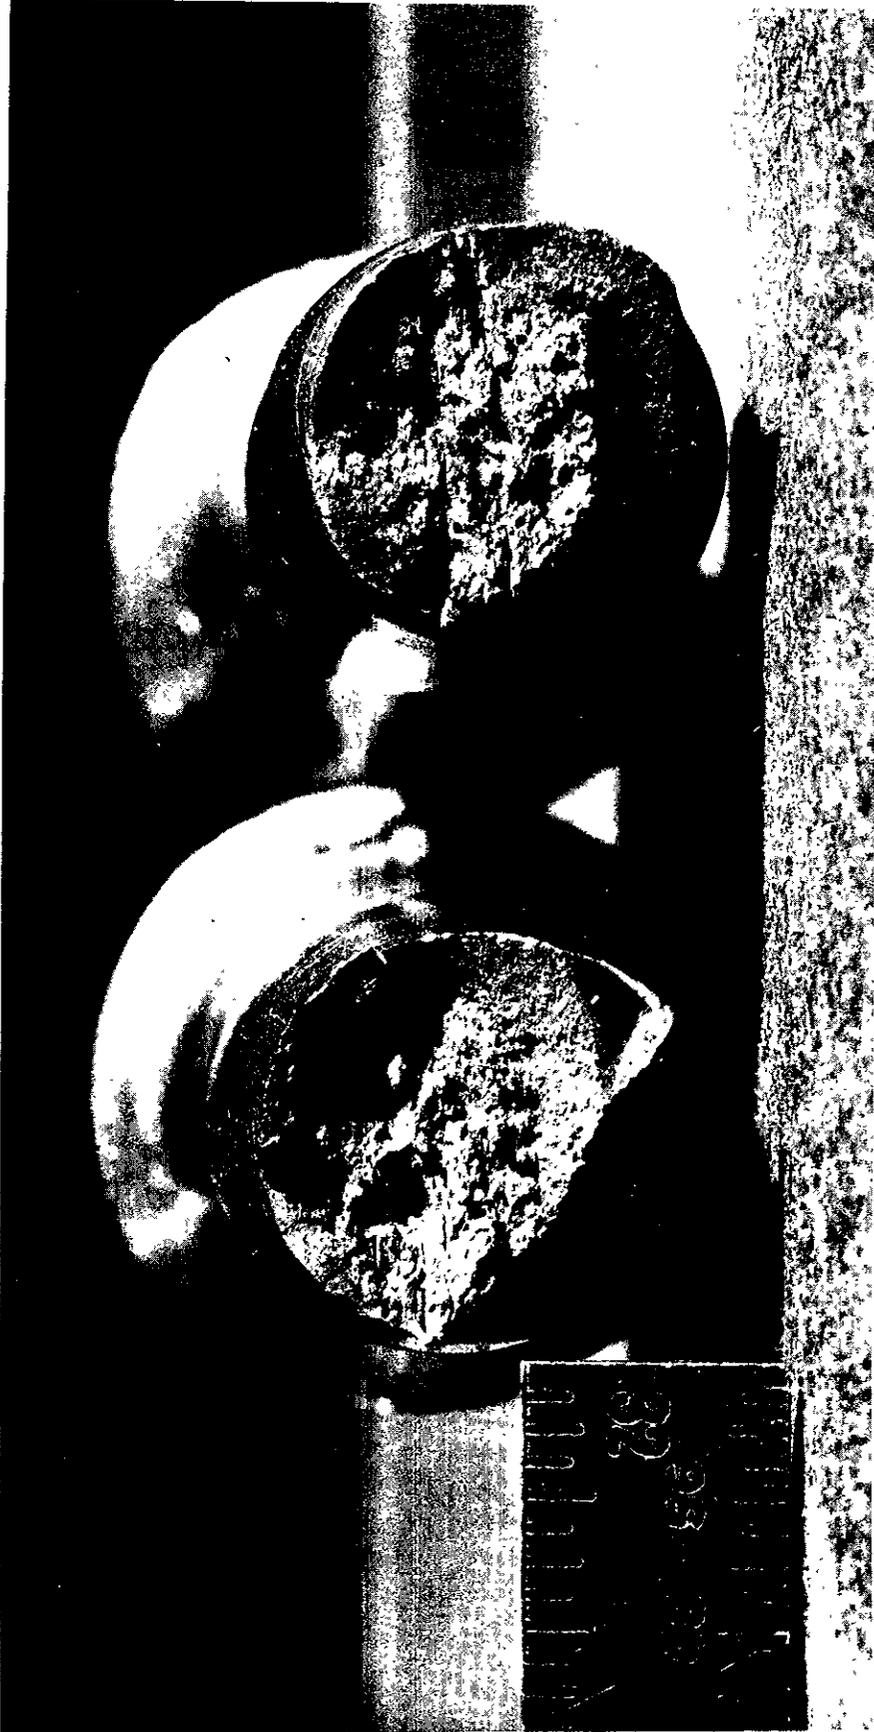
The specimen exhibited sufficient length of visible seams on the side and through the fractured ends to cause the bottom flange plate to be rejected as firebox quality steel on the basis of the homogeneity requirements under specification ASTM A20-59. See Figure 23. During the machining of this specimen, it was believed advisable to provide more than normal support for the piece in order to counter any tendency of the machine tool to dig into the line of inclusion material that became visible as the piece was being prepared.

FIGURE 23. Fractured ends of the tensile specimens cut from the central portion on the bottom flange sample. (See Figure 1 for location.) The laminar type of separation visible here would probably be sufficient to cause the plate to fail the homogeneity test required of firebox steel. Machining this piece was complicated by the tendency of the machining tool to catch in these defects during the turning operation. (Ultimate 114,000 psi; yield 105,500 psi; 15% elong. @ 2"; 43% reduction of area.

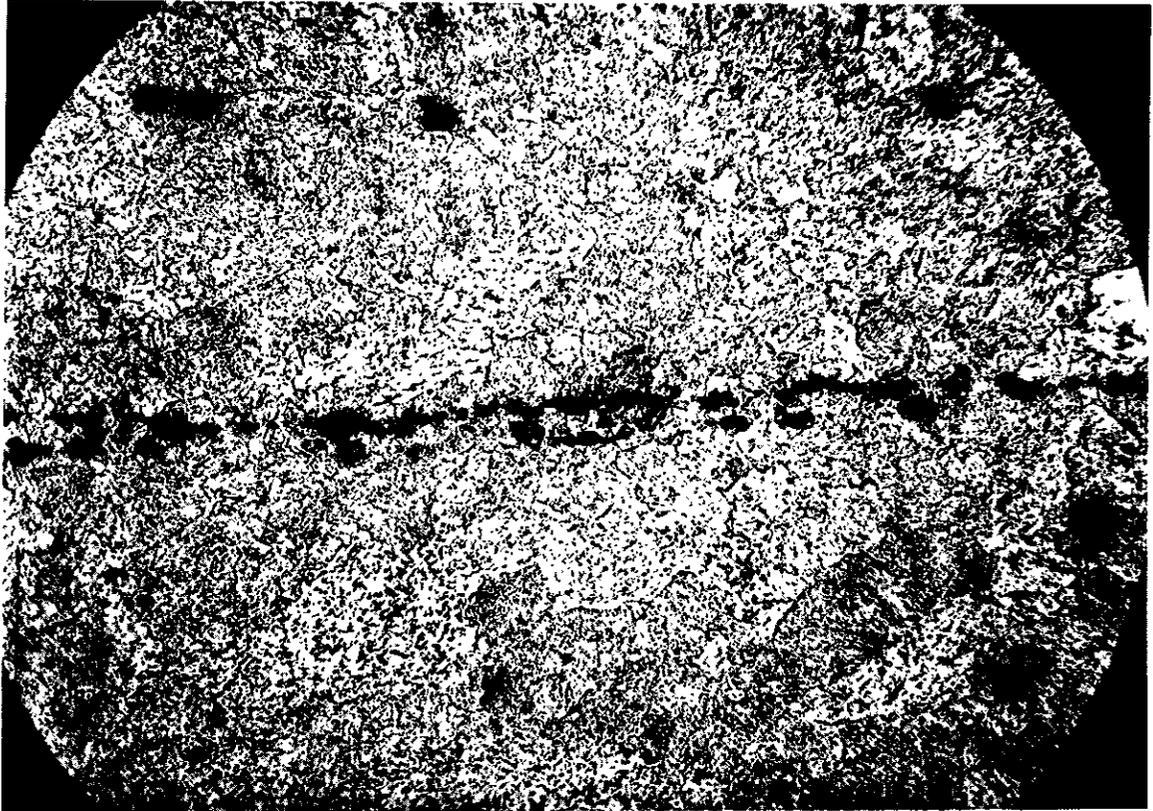
- D. The metallographic specimen showed some layers of nonmetallic inclusion material (see Figures 24 through 27). Ultrasonic testing confirmed the existence of these layers of inclusions by micro and macro examination and indicated that they were distributed in a discontinuous and disconnected fashion so that about 5 to 15% of the section area was judged separated in a laminated fashion.

FIGURE 26. 500X polished and etched surface of metallographic specimen taken from the bottom flange sample showing a line of inclusion material in a surface $13/16''$ away from and parallel to the flame cut edge of the flange from which the sample was removed.

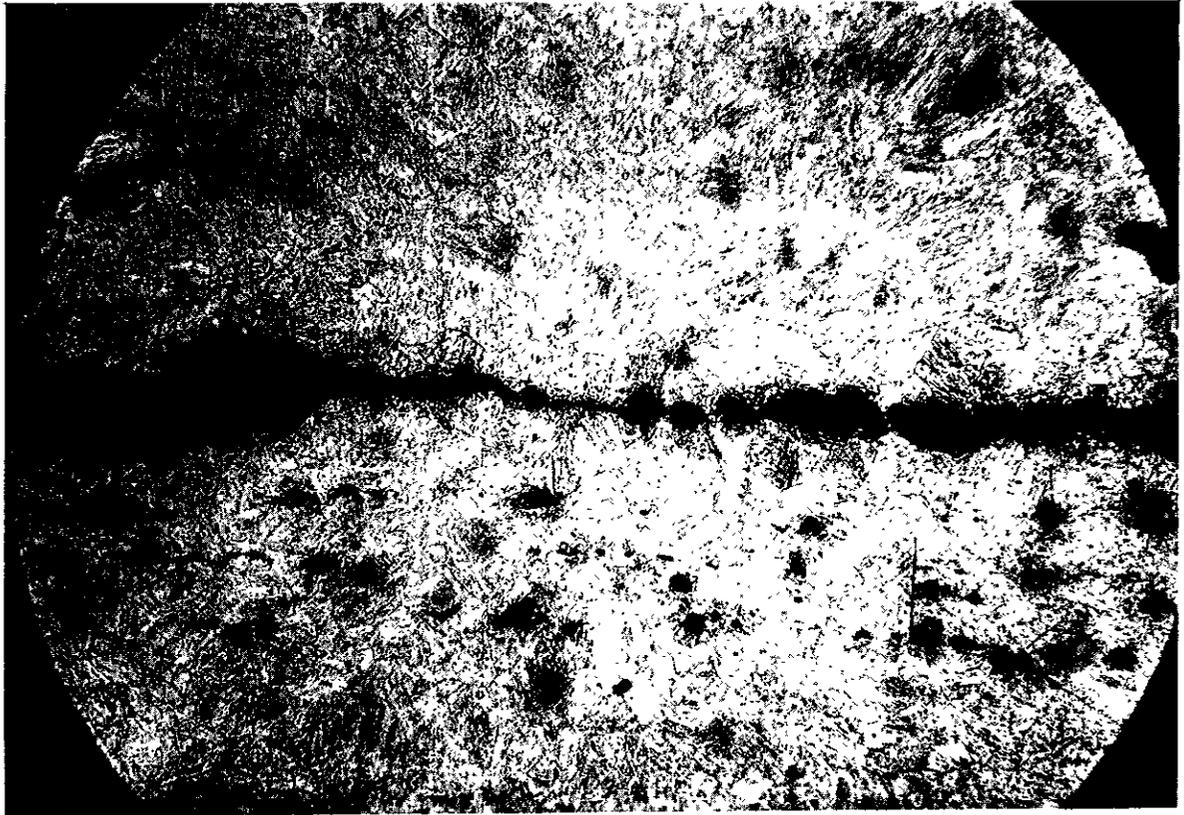
FIGURE 27. 500X polished and etched surface of metallographic specimen taken from the bottom flange sample showing line of inclusion material next to the flame cut and ground outside edge of the flange from which the sample was removed.
