Evaluation Tests Of Defiant Self Rectifying Safety Steel Post
Manufactured By Defiant International, Inc.

August 1969

Eric F. Nordlin

California Division of Highways
Sacramento, California

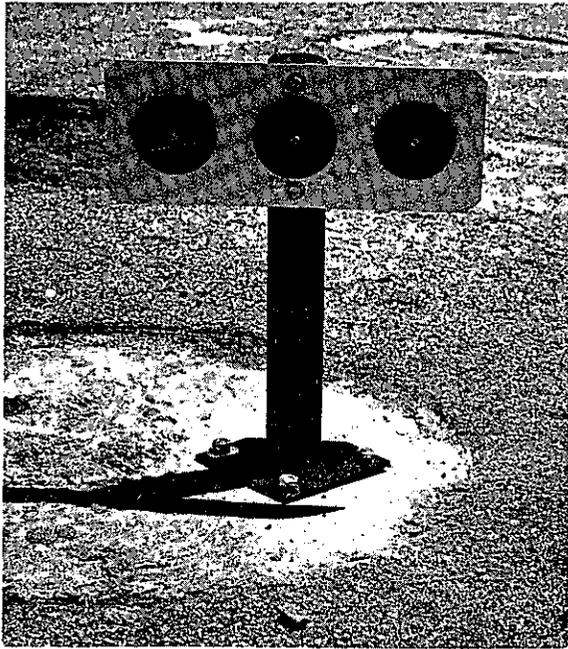
FIGURE 1

Two models of the Defiant Safety Post were tested. They were identically constructed differing only in the over-all height of the post which was 18 in. and 48 in. (Figures 1 and 2). A standard 30 in. height is also available. The manufacturer also indicated they can adapt this same principle to a wide range of heights and sizes.

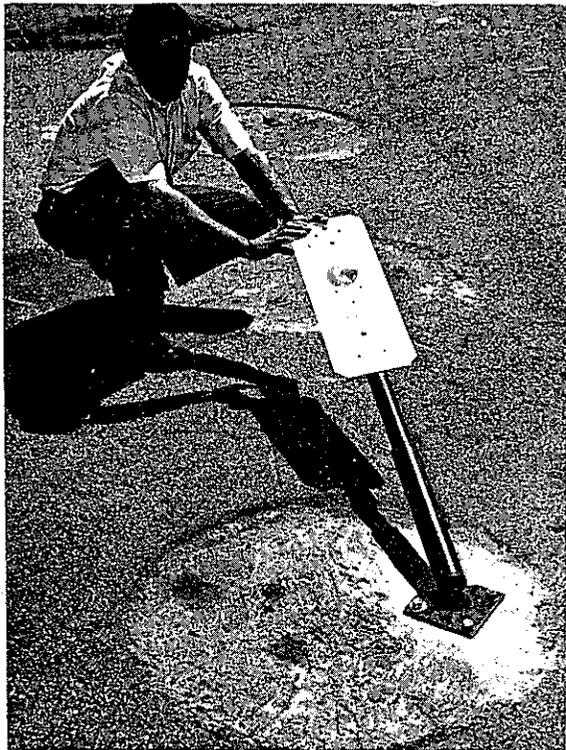
FIGURE 3

The functional part of this device consists of a 2-in. dia. steel pipe post secured to a semi-triangular $\frac{1}{4}$ " thick steel base plate by a strong coil spring. The spring is attached to a hook welded to the base plate at one end and to a steel plug welded inside the post, approximately 12-in. up from the base plate, at the other. The principle is that when force is applied to the post the spring stretches allowing the post to lay over. When the force is removed the tensioned spring restores the post to the upright position (Figures 3 and 4).

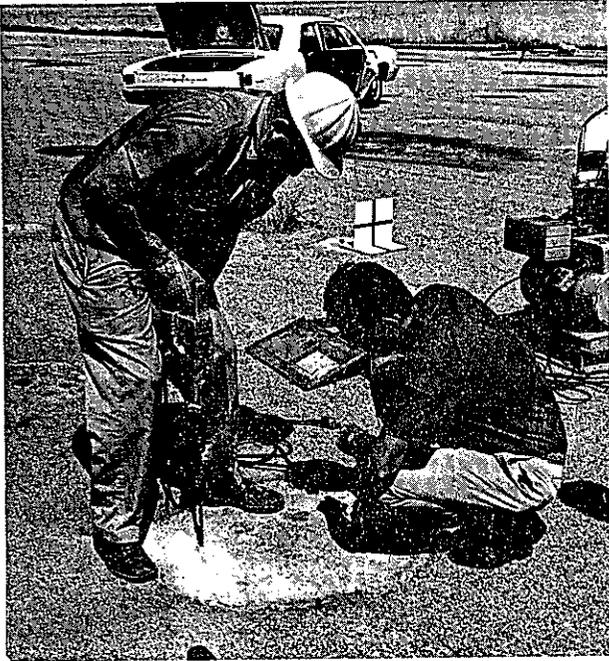
FIGURE 5

The units tested were installed on the day of the test at our Lincoln airport test facility. The base was bolted down to an existing concrete footing with $\frac{1}{2}$ " diameter "red head" bolt studs (Figures 5 and 6). The same studs were utilized for all impact tests on both units.

Although care was taken to drill the concrete and install the "red heads" to match the base mounting holes, difficulty was encountered in the alignment and the base mounting holes required reaming to obtain proper alignment. However, larger dimensional tolerances between the holes and bolts and the use of plate washers will facilitate installation and this is not considered a serious problem. On both units $\frac{1}{4}$ " diameter bolts were used for mounting the warning signs. A W60R guide plate was installed on the 48-in. post and a W61R horizontal reflector plate on the 18-in. post.

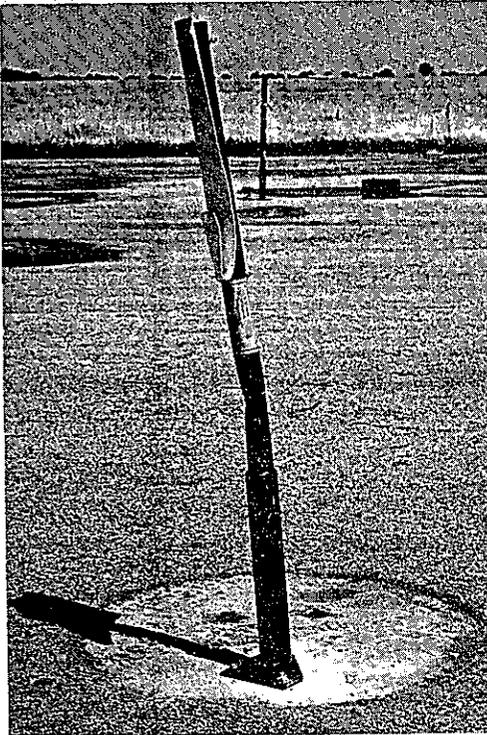
FIGURE 7

Test No. 1 was a 60 mph head-on impact into the 48-in. high unit. The test driver reported no significant physical and only a slight audible indication of impact. The device deflected down on impact and rebounded immediately to the upright position after passage of the vehicle over it. Although permanent damage to the post appeared to consist only of a slight final bend (approximately 6°) at the point of impact with the bumper (Figure 7), high speed film analysis showed the unit initially bent approximately 20° upon impact. The slapping of the post against the ground took much of the initial bend out. The guide plate was deformed with all three center-mount reflectors stripped off. There was no damage to the base, but the return spring did appear to lose some of its tension. Operation of the device was unaffected although a noticeable "wobble" was evident. Damage to the vehicle was very minor and consisted only of a ½" deep concave dent in the leading edge of the bumper and hood (Figure 8).

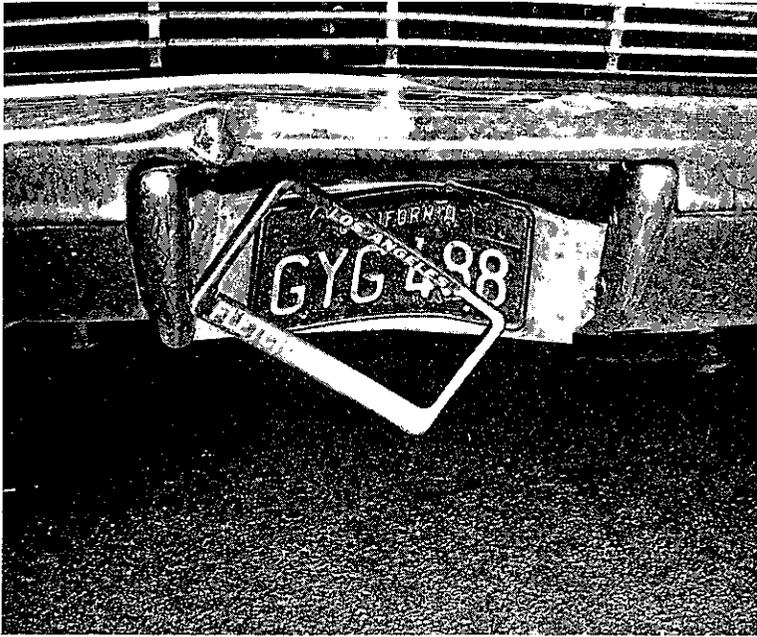
FIGURE 9

Test No. 3 was a 60 mph head-on impact into the 18-in. horizontal unit. Collision into this shorter unit produced a slightly more physical and audible indication of impact. This was primarily attributed to the fact that the point of impact on the vehicle was at a less rigid point on the front bumper, deforming it approximately 4-in. (Figure 9). There was no damage to the post which rebounded immediately to the upright position. There did not appear to be any loss of spring tension as observed on the 48-in. unit. The guide plate was deformed beyond repair with all three reflectors either stripped off or badly damaged (Figure 10).

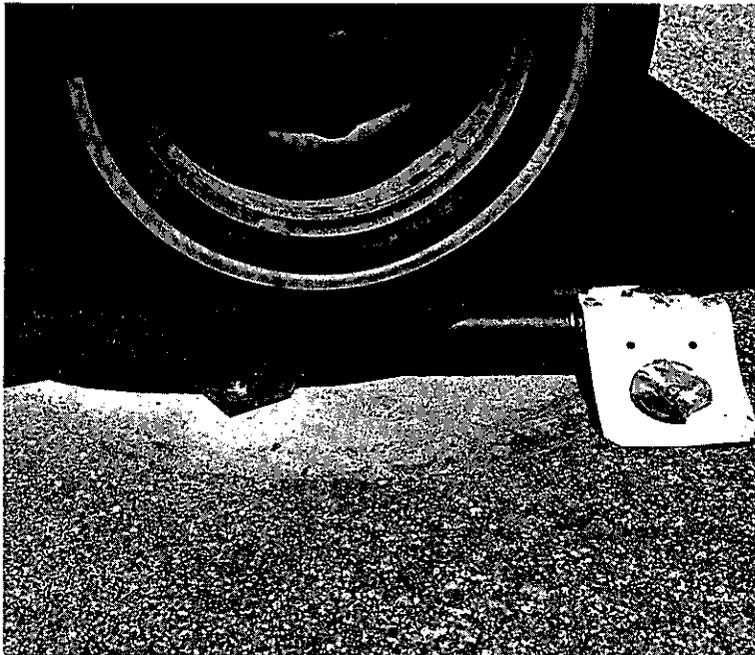
FIGURE 11

Test No. 4 was a non-impact test where the vehicle wheel was driven directly onto post of the 18-in. unit, deflecting it flat against the pavement. As the wheel was driven off, the post snapped back to the upright with no apparent damage (Figure 11).
