Slide Investigation And Geological Review 03-Gle-Forest Highway 7

September 1976

ERFO 781(1)  
03-G13-Forest Highway 7  
(Mendocino Pass Road)  
Lab. Auth. 662797

REPORT OF SLIDE INVESTIGATION  
AND GEOLOGICAL REVIEW NEAR STATION 273±  
03-GLE-FOREST HIGHWAY 7  
WEST OF WILLOWS, CALIFORNIA

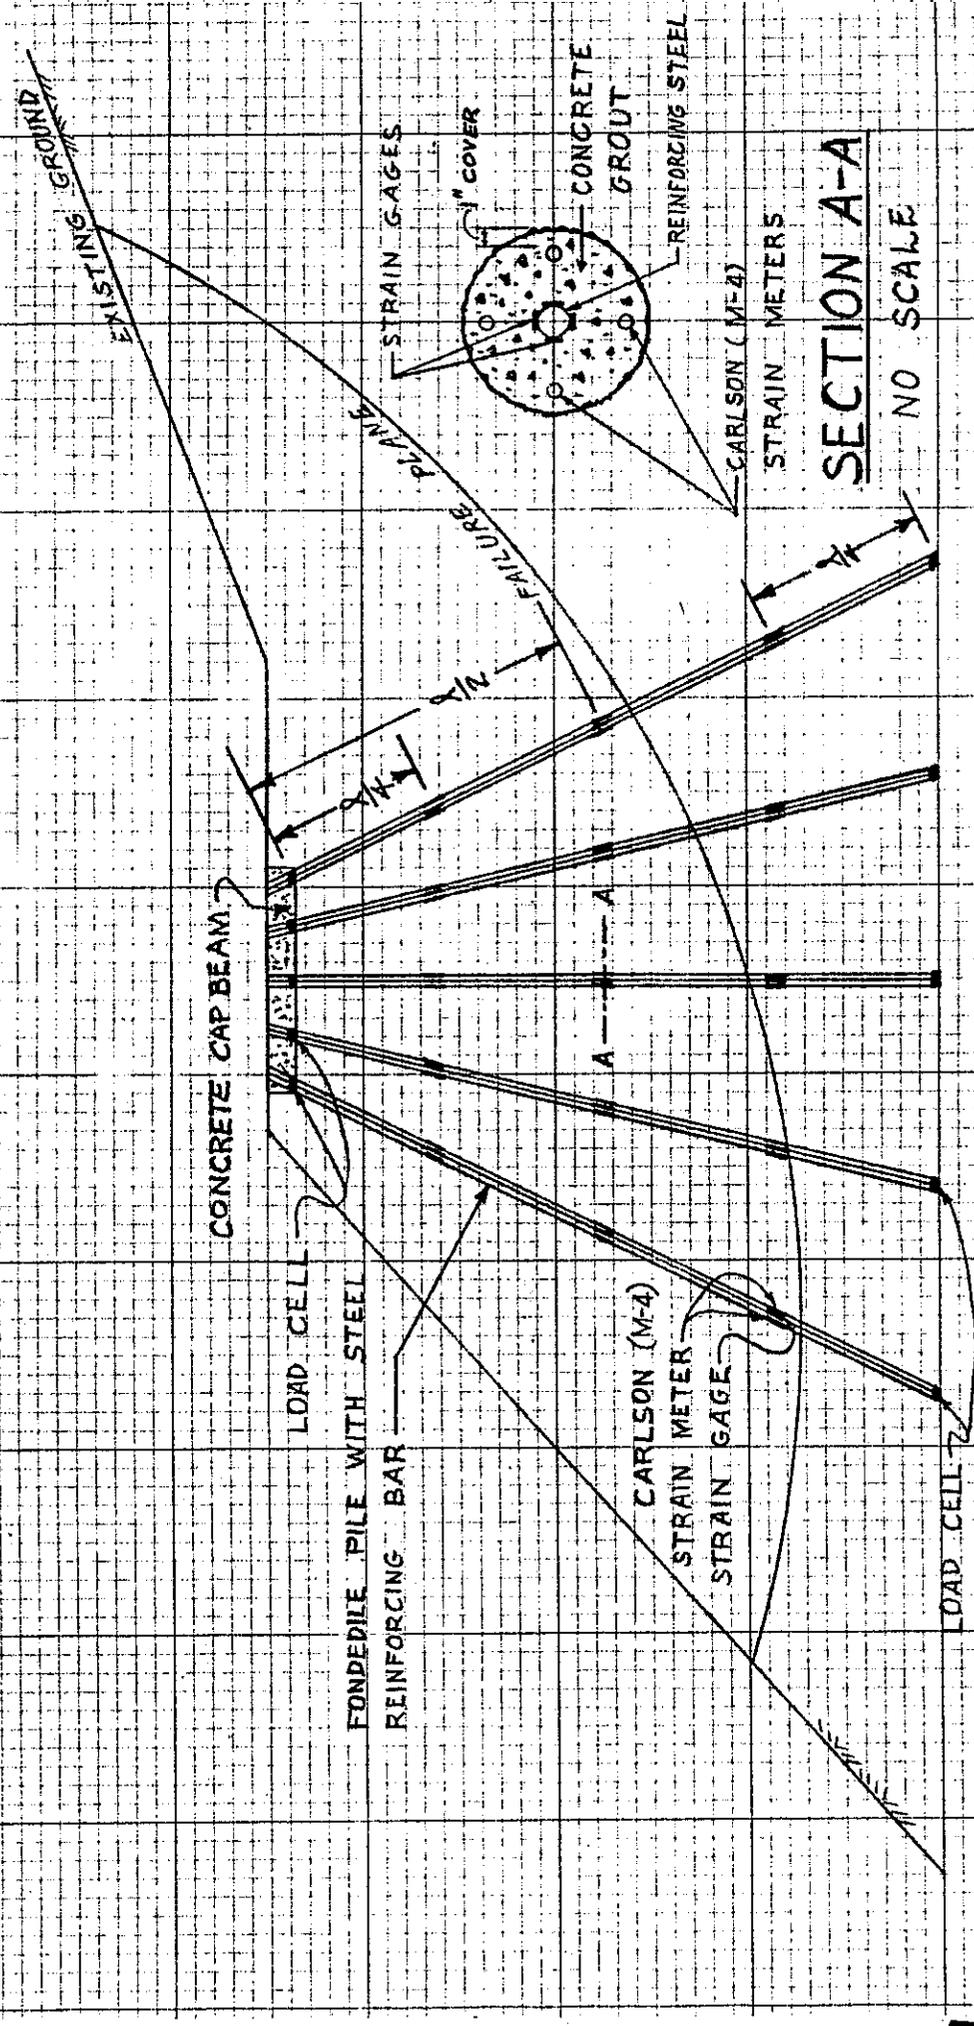
# SCHEMATIC OF PROPOSED INSTRUMENTATION FOR FIVE PILES

The proposed instrumentation plan for construction control consists of instrumenting five (5) preselected piles and providing

additional slope indicator monitoring locations and both horizontal and vertical survey points. Four (4) strain gages will be installed on the circumference at the 90 degree points on the reinforcing steel bar of each test pile at three elevation levels. Carlson M-4 Strain Meters will also be installed at the same levels and locations by means of a special jig attached to the reinforcing bar. These special jigs will hold the strain meters in position at a distance sufficient to provide approximately 1-inch of concrete cover between the outer nominal pile diameter and the strain meter. Load cells will also be welded to the bottom of each reinforcing bar of the five (5) test piles. The instrumented bars will be installed prior to concrete placement.

Load cells will be installed at the top of each instrumented reinforcing bar by means of a special attachment and grouted into the cap beam. All instrumentation wires will be routed to an instrumentation readout facility. A schematic of the proposed instrumentation plan is attached.

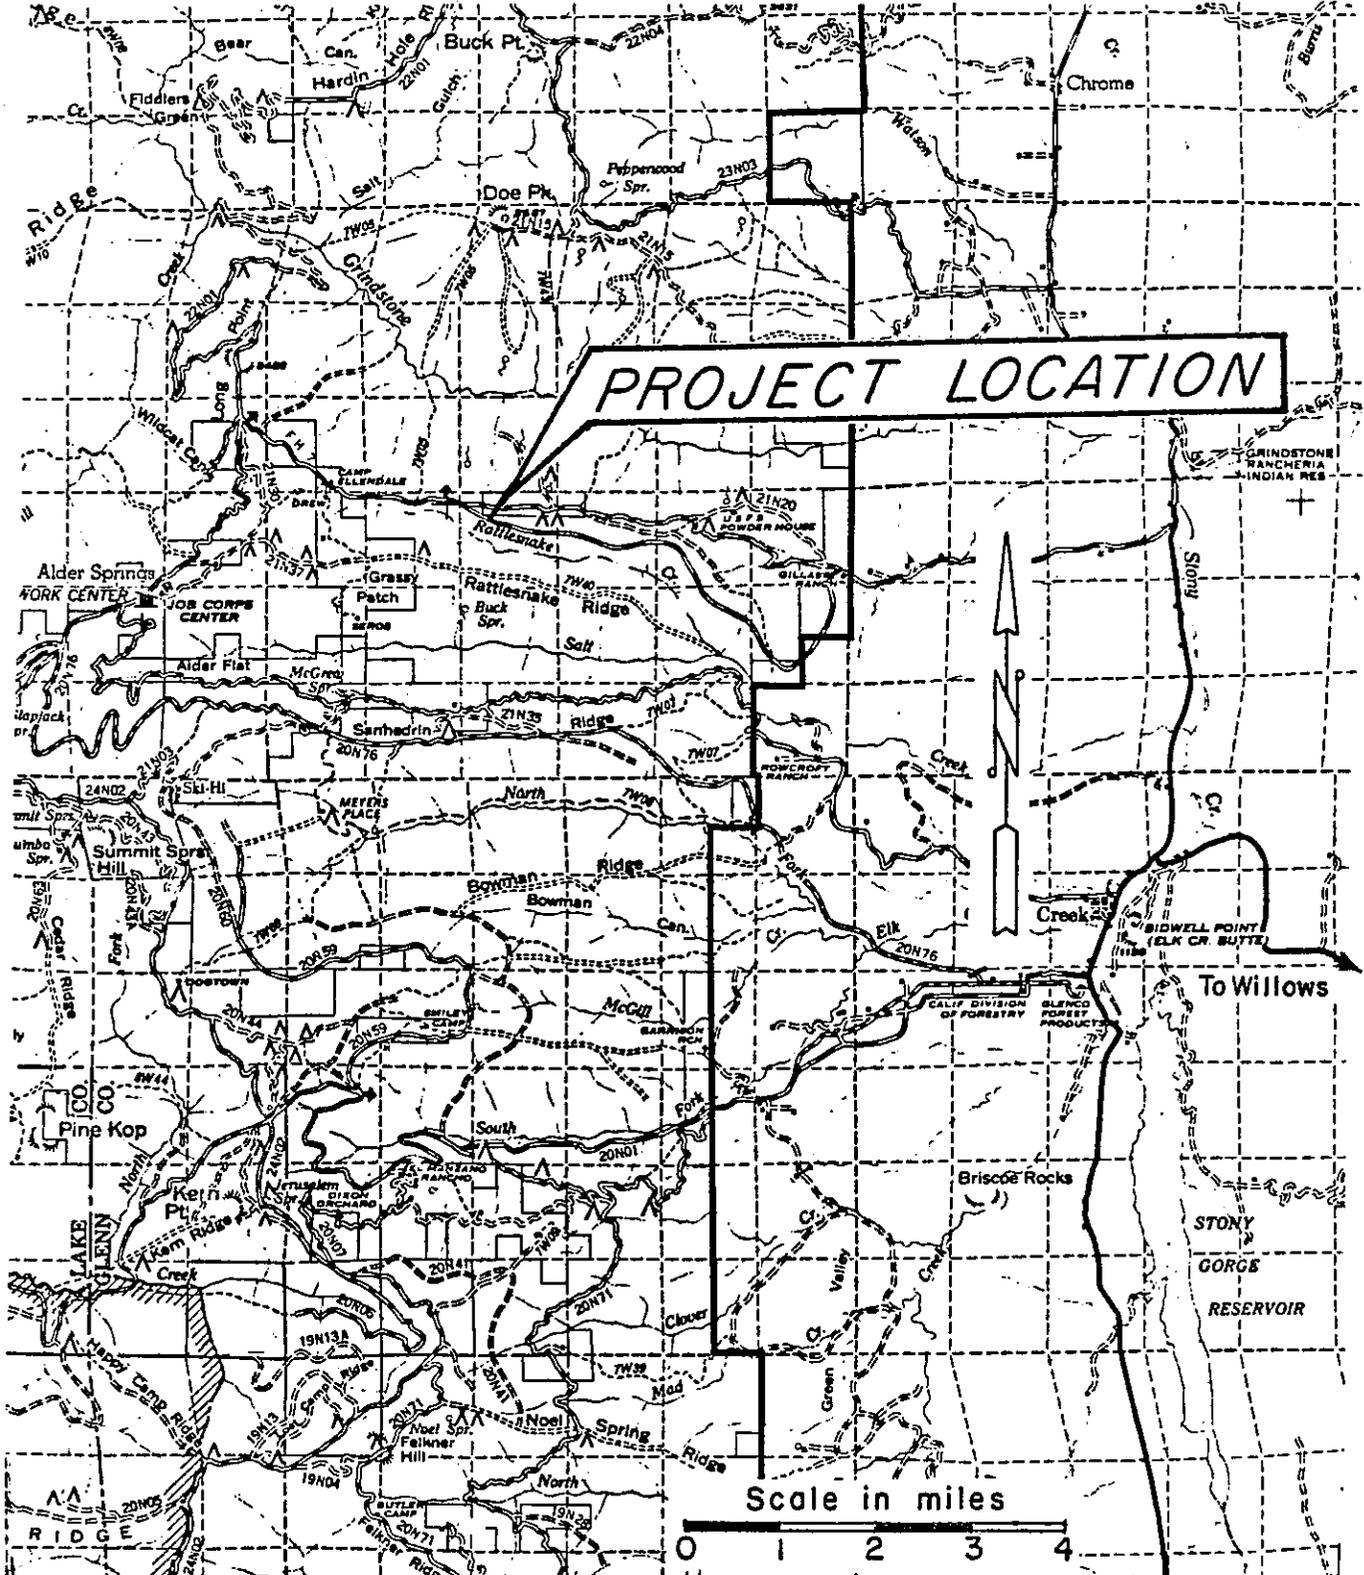
STATE OF CALIFORNIA  
 DEPARTMENT OF TRANSPORTATION  
 DIVISION OF STRUCTURES & ENGINEERING SERVICES  
 TRANSPORTATION LABORATORY  
**LANDSLIDE INVESTIGATION  
 NEAR STA. 273±**

This report is the first of a series of three that will present the results of geological review and slide investigations performed at various sites on Forest Highway 7 (Mendocino Pass Road) located in Glenn County, west of Willows, California (Refer to Sheet 2). Their common purpose is to determine the feasibility of utilizing Fondedile Root Piles to correct the slope instability problems that exist on this facility and to consider other alternatives for correction. These locations were selected on April 8, 1976, during a field review conducted by personnel representing both FHWA and the Caltrans Laboratory. It was tentatively agreed that Caltrans would investigate these sites for feasibility of a Fondedile correction under an amended version of a previous agreement.
