Evaluation of Cold Planers For Grinding PCC Pavements

September 1978

B.F. Neal and J.H. Woodstrom

EVALUATION OF COLD PLANERS FOR GRINDING PCC PAVEMENTS

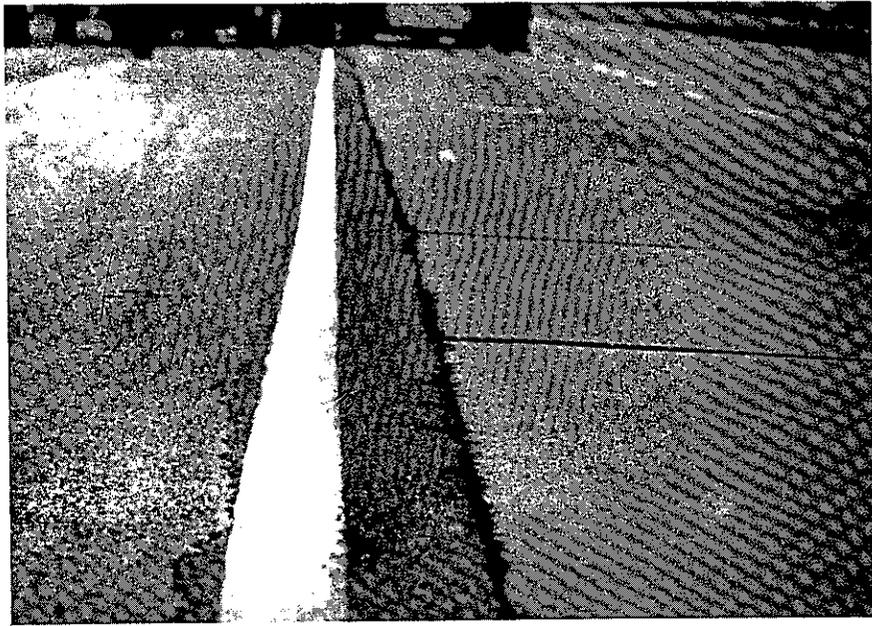
Fig. 2
Typical Pavement Condition

The equipment used by PR Systems was a CMI Rotomill PR-375 (see Figure 1) with a cutting head length of 9 ft 2 in. (2.8 m) which was equipped with new cutting points before the test began. The location was on the outside, or number 3 lane, of westbound I-80 at approximately Post Mile 4.0 in Yolo County. The pavement in this area was faulted only about 0.13 inch (3.3 mm) but was considered to be suitable for a fair trial of the equipment (see Figure 2).

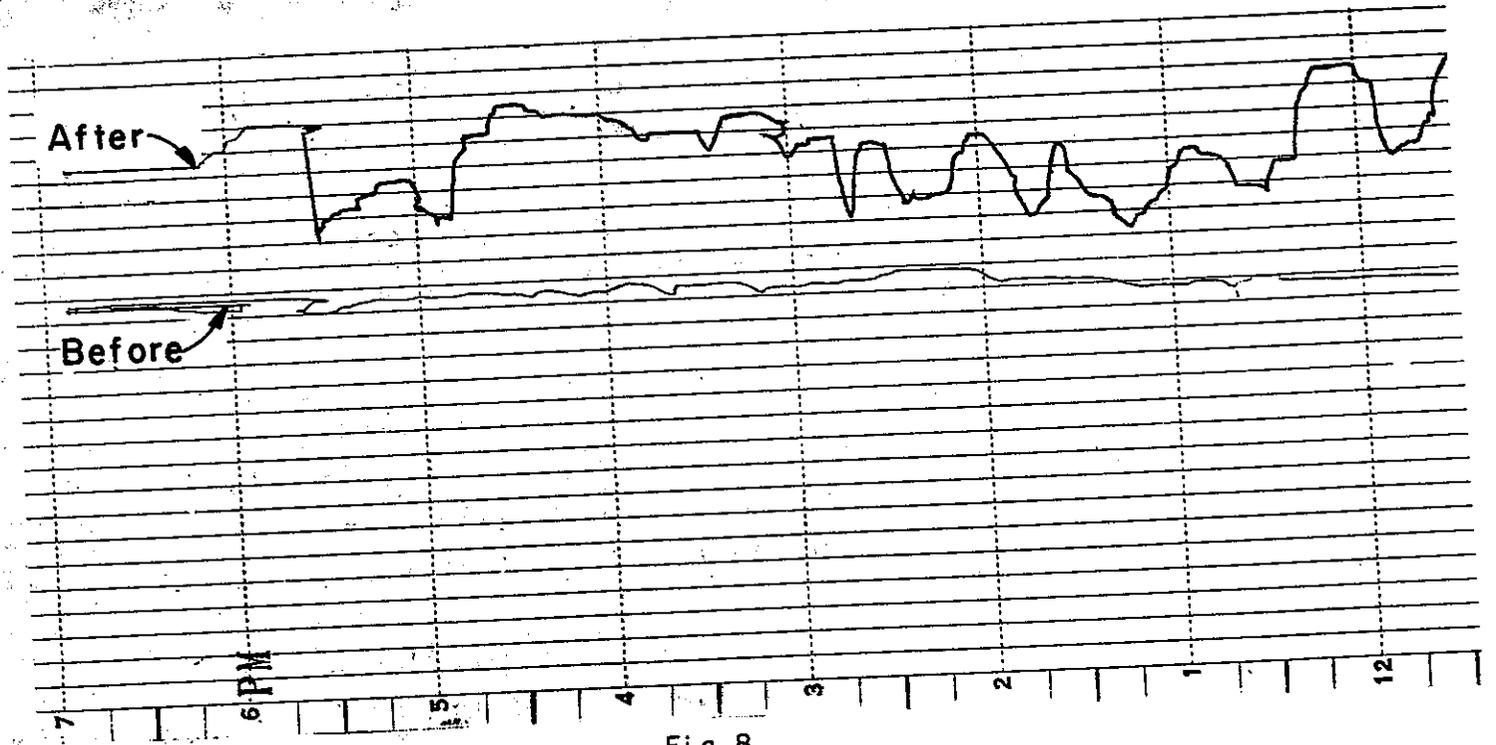
Fig 8

Figure 8 shows before and after transverse profiles of the texture made with a laboratory developed texture profilometer.

BEFORE AND AFTER TEXTURE PROFILES (TRANSVERSE)
CMI PROJECT
03-YOL-80-4.0

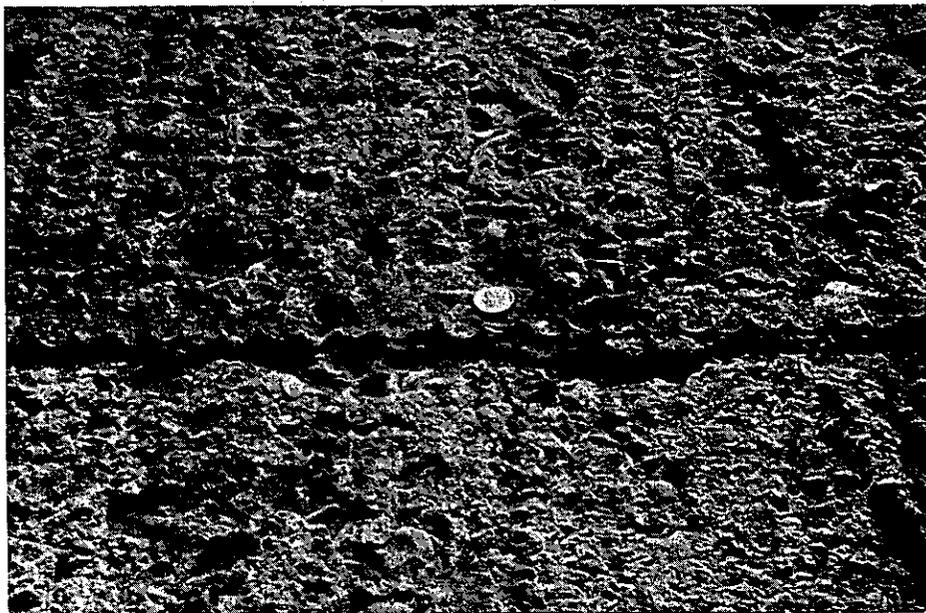
Fig. 11
Steel Joint Insert After Milling

strips placed to form weakened planes at every fourth joint (see Figure 11) did break off a few of the cutting tips. About 1200 lineal ft (366 m) of pavement (approximately full lane width) was milled.

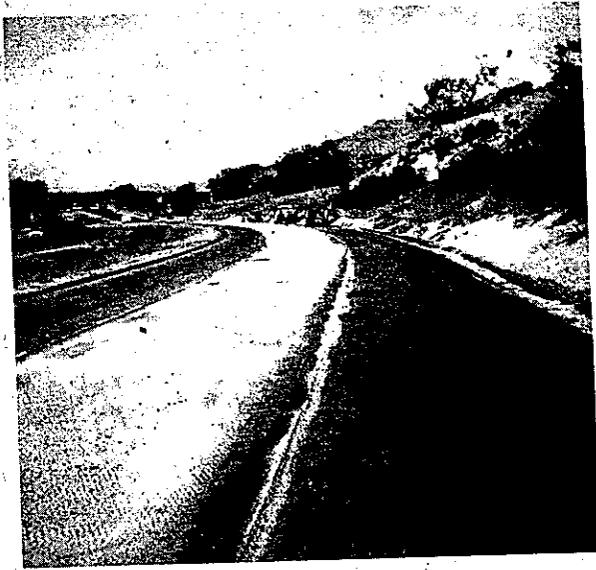
Fig. 12
Milled Pavement Texture

The appearance of the texture was similar to that seen at Davis (see Figure 12). Again, the untreated joints were badly spalled, and the treated joints fared only slightly better. A few of the joints, which were considered to have been sealed satisfactorily, appeared to be only slightly affected.

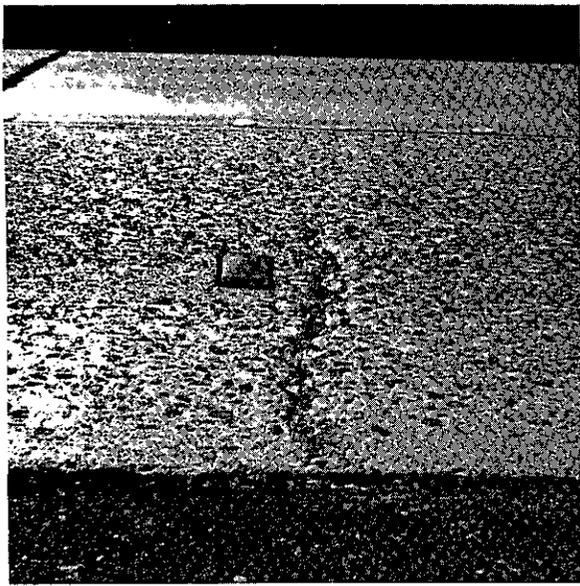
Fig. 18
Random Crack After Milling

Results of the milling were approximately the same as the previous tests. While the filled joints show less damage than those unfilled, it is still considered that damage is too severe. Figures 14 through 21 show prepared joints and one random crack before and after milling. Figure 22 shows a diamond grinding operation, with no damage being incurred at the joint edges.
