CA-TL-78-30

Tests of Flexible Plastic Guide Marker and Clearance Marker Posts

September 1978

Office of Transportation Laboratory
California Department of Transportation
Sacramento, California 95819

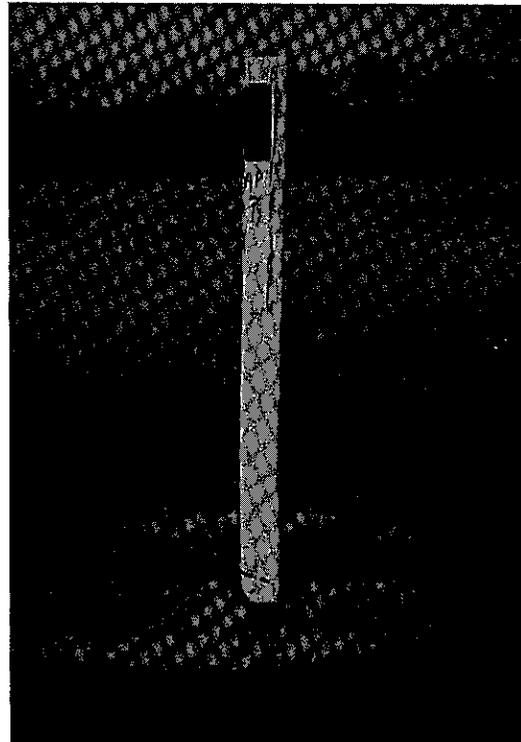
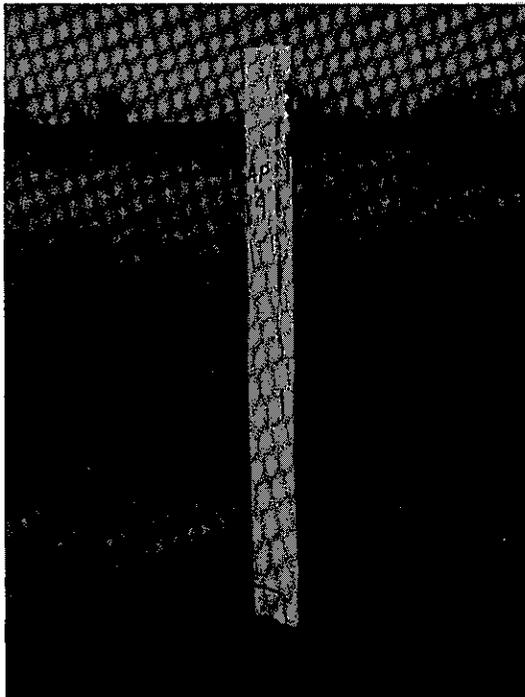
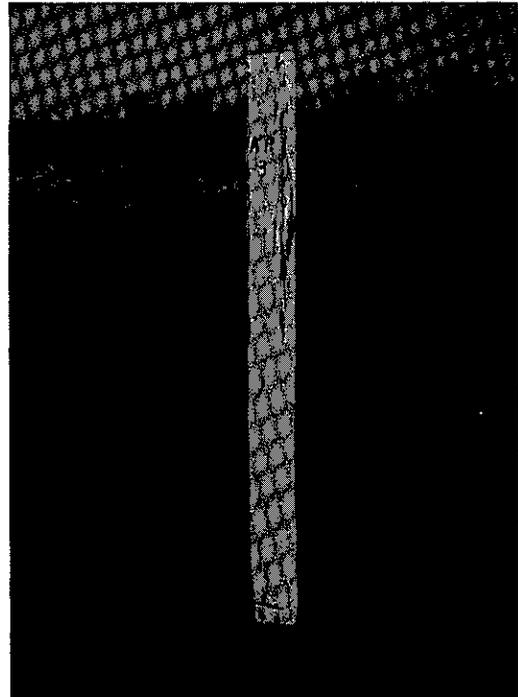
Figure 3

Both shapes of these guide marker posts were pulled out of the ground 1 to 3 inches after the 10 vehicular impacts. It is considered, however, that the anchoring system is adequate in restricting the pullout to the degree observed. The photos in Figures 2 and 4 show the amount of pullout as the distance the black line has been raised above the ground level.

No vehicular damage was detected after striking these guide markers at 55 mph. The damage to the three posts tested for each shape was considered minimal.

The photo in the upper left corner of each of Figures 2 and 4 shows one post before the first impact and the other three photos on the page show all three posts after 10 vehicular impacts. The reflective sheeting (Reflexite) on the post is damaged from the vehicular impacts and allowances must be made for replacement after a few impacts, even though in some cases the reflective sheeting lasted for the entire ten vehicular impacts.

Even though our second test series showed that the circular section guide marker would perform adequately with the omission of the bottom foam plug or other interior backfill, the manufacturer has not recommended installation without the backfill or foam. It is recommended that the Autopost be considered acceptable on an interim basis. They are capable of complying with the requirements of the present specification for non-drivable flexible plastic guide markers.

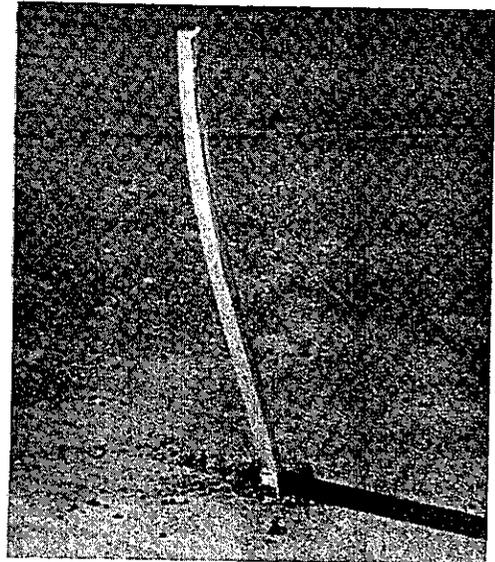
There was little or no damage to the vehicle from any of the 55 mph impact tests. The guide marker post tended to return to an approximate vertical position after each impact with a pullout of 0 to 1/2" from the ground. After the first vehicular impact the marker canted 5 to 20° from the vertical. After 10 impacts the post approached a canted position of 30° from the vertical. During the vehicular impacts the post developed an S-shaped curve as can be seen in one of the photos. It is considered that this shape and appearance would not be acceptable even though the marker returned to a semi-upright position. Due to this deformed shape, this marker is not considered acceptable.

Side View of Post
After 10 Impacts

It is recommended that no further testing be performed with the LDP-8 Lanco T-post design as a flexible guide marker post. Its performance does not compare with the other flexible guide marker posts being evaluated.

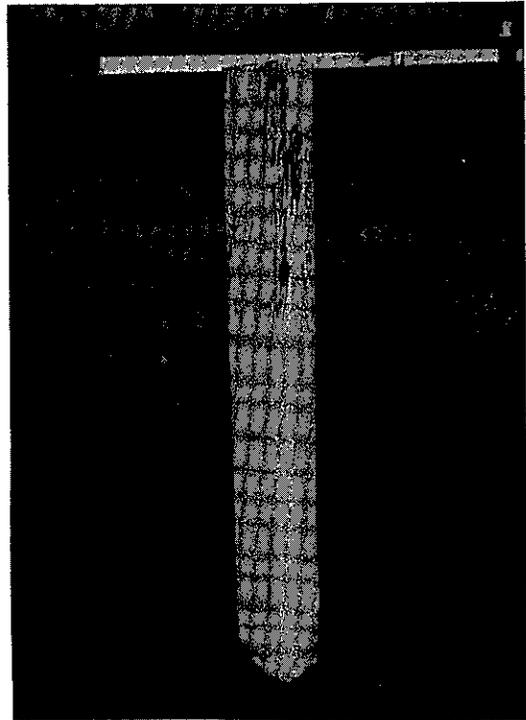
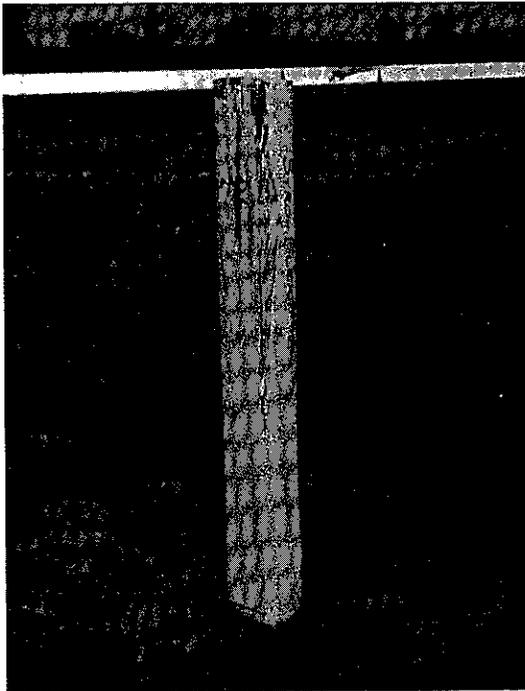
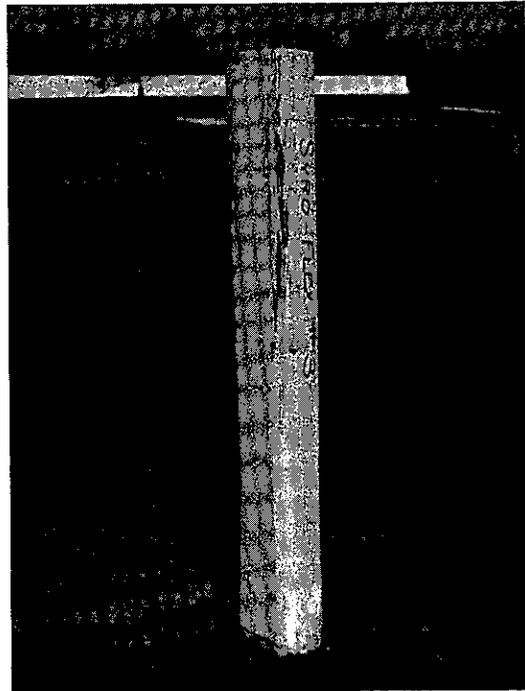
This guide marker post was able to withstand the 10 vehicular impacts at 55 mph and satisfactorily return to a vertical position, as was found in earlier tests and evaluations. The black cap cover on the top of the post was knocked off on the first vehicular impact. The upper left photo in Figure 8 shows one of the three posts before the first vehicular impact and the other three photos show all three posts after the 10 impacts. The damage to the vehicle from the impact was minimal. The damage to the posts was also considered minimal. The anchoring system for this guide marker was satisfactory with only 1/2" to 1" pullout from the ground after the 10 vehicular impacts.

It is recommended that further installations of this marker post be deferred until suitable evidence is developed or obtained which would attest to its long term serviceability.

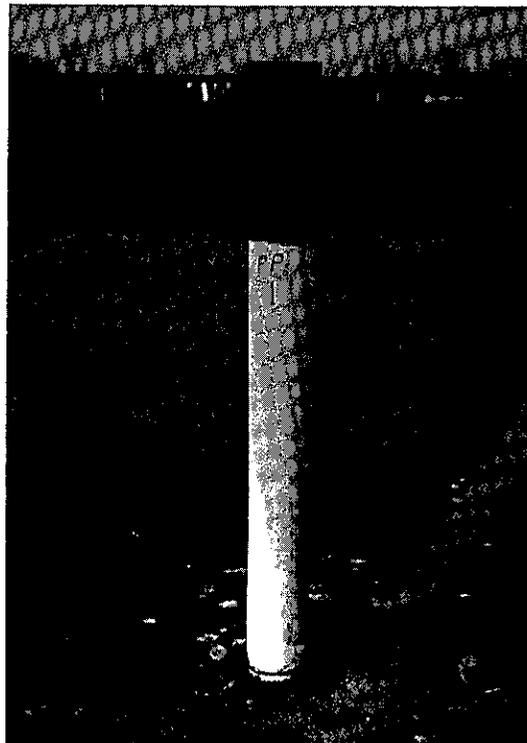
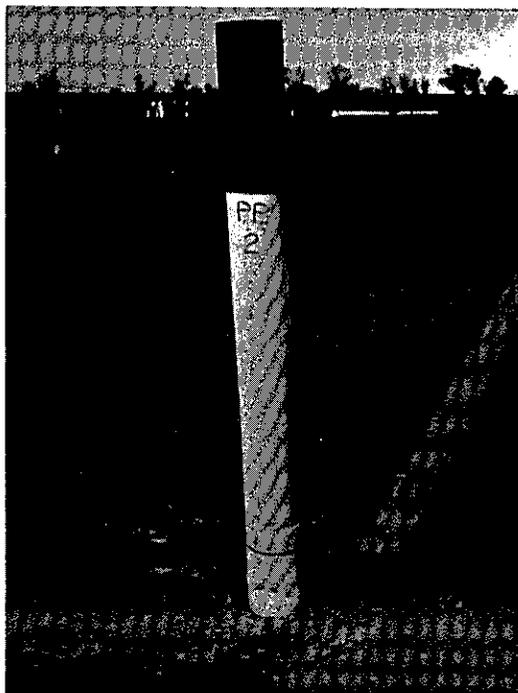
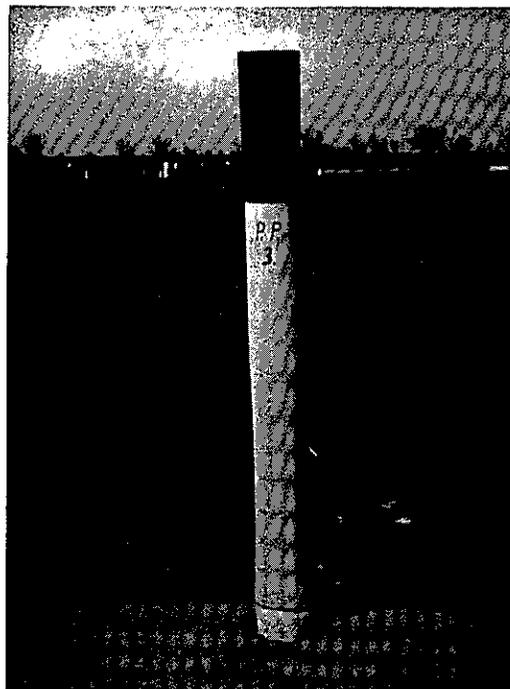
There was slight or no damage to the vehicle from the 55 mph impact with this backfilled guide marker post. The post was able to withstand the 10 vehicular impacts and return to a vertical position with little or no apparent damage. Care must be taken to insure that the backfill for this post is tightly compacted as anchorage depends entirely on friction between the post and the soil. Two of the three posts pulled out of the ground 4" to 6" from the impacts. The third post pullout was very minimal - approximately 1/2" or so.

The second series of tests was conducted to verify the manufacturer's claim that the post would perform satisfactorily without interior backfilling. This installation was not successful. The guide marker post failed to return to vertical when the interior backfill was omitted.

It is recommended that this post with interior backfilling be considered acceptable at this time. Further evaluation of long term serviceability and general performance by trial field installations should be monitored. Our present specification for non-driveable flexible guide markers is appropriate and should be used in specifying the Polypost guide marker post.

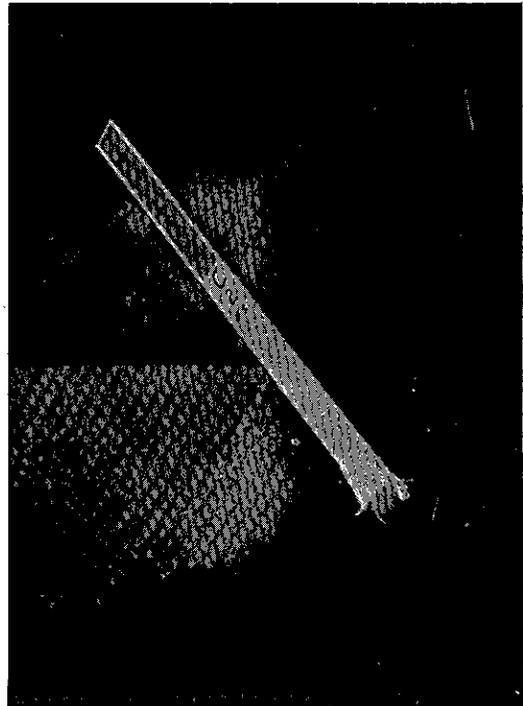
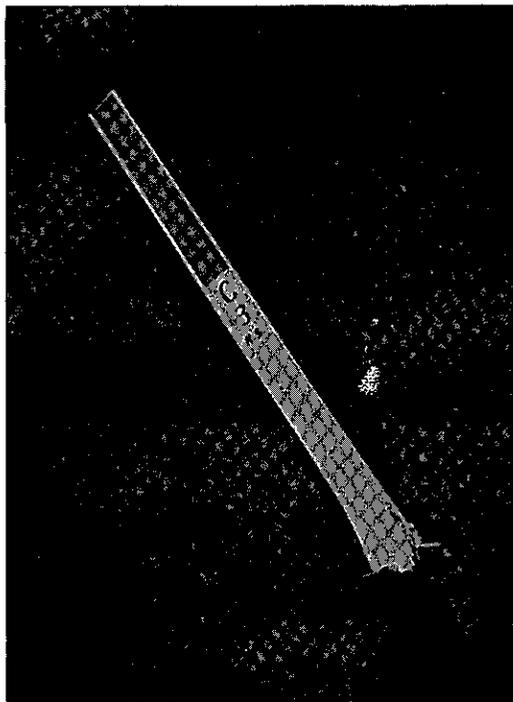
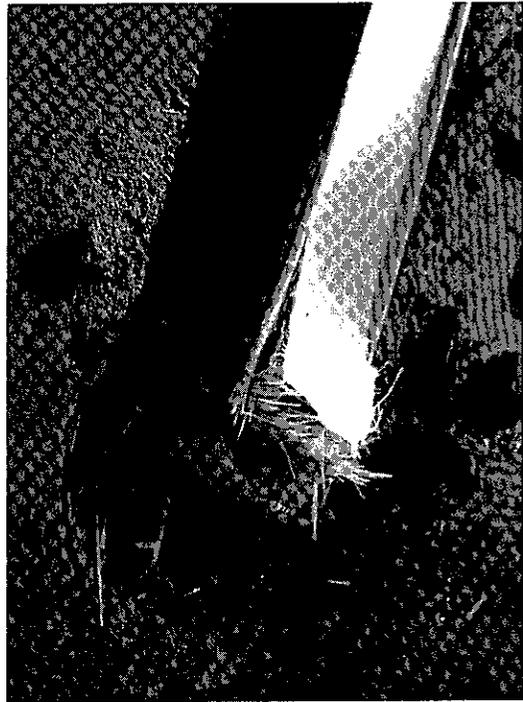
The initial test on the 2 1/2" wide ribbed flexible guide marker post, which the manufacturer claimed could withstand the higher impact speed of up to 55 mph, resulted in a post failure at that speed. The impact sheared the post off at the ground level as shown in photos in Figure 17. However, when the test was rerun at a slower speed of 35 mph, this ribbed post withstood the impact and returned to a vertical position. Once a plastic hinge formed at the base of the post from the first slower vehicular impact, the post was able to withstand much higher speeds, up to 55 mph in subsequent tests, and return to an upright position immediately following impact. The posts withstood about 5 impacts without showing any significant damage. During the next 5 impacts, however, the top of the posts began to delaminate and fray with this damage progressing upon each additional impact. Delamination of the posts also occurred in the region of the plastic hinge with the magnitude of delamination increasing with each impact. After a total of ten hits, the tops of all posts impacted were severely delaminated and ragged in appearance.

speed of 35 mph without any failures. Then the impact speed was increased to 55 mph which the posts also withstood. As in the tests on the 2 1/2-inch wide ribbed post, the tops of these posts also started to show significant damage after about 5 impacts with the damage progressing perceptibly during the next 5 impacts. The fraying of the post tops after 10 impacts was about the same as noted for the 2 1/2-inch wide post. Delamination also occurred in the region of the plastic hinge.
