1. REPORT NUMBER CA08-0766	2. GOVERNMENT ASSOCIATION NUMBER	3. RECIPIENT'S CATALOG NUMBER
4. TITLE AND SUBTITLE Development and Crash Testing of an Aesthetic, See-Through Bridge Rail, Type 92 "		5. REPORT DATE December 2008
		6. PERFORMING ORGANIZATION CODE
7. AUTHOR David Whitesel, John Jewell, Robert Meline		8. PERFORMING ORGANIZATION REPORT NO. FHWA/CA08-0766
9. PERFORMING ORGANIZATION NAME AND ADDRESS Roadside Safety Research Group California Department of Transportation 5900 Folsom Blvd., Sacramento, CA. 95819		10. WORK UNIT NUMBER
		11. CONTRACT OR GRANT NUMBER In-house H Y C ICA08-0766
12. SPONSORING AGENCY AND ADDRESS California Department of Transportation 5900 Folsom Blvd., Sacramento CA. 95819		13. TYPE OF REPORT AND PERIOD COVERED Final Tgr qt v< 29 B 4226 "q" 28 52 422: "
		14. SPONSORING AGENCY CODE

**DEVELOPMENT AND CRASH TESTING OF AN AESTHETIC,
SEE-THROUGH BRIDGE RAIL, TYPE 90**

DEPARTMENT OF TRANSPORTATION
DIVISION OF RESEARCH AND INNOVATION
OFFICE OF SAFETY INNOVATION AND COOPERATIVE RESEARCH

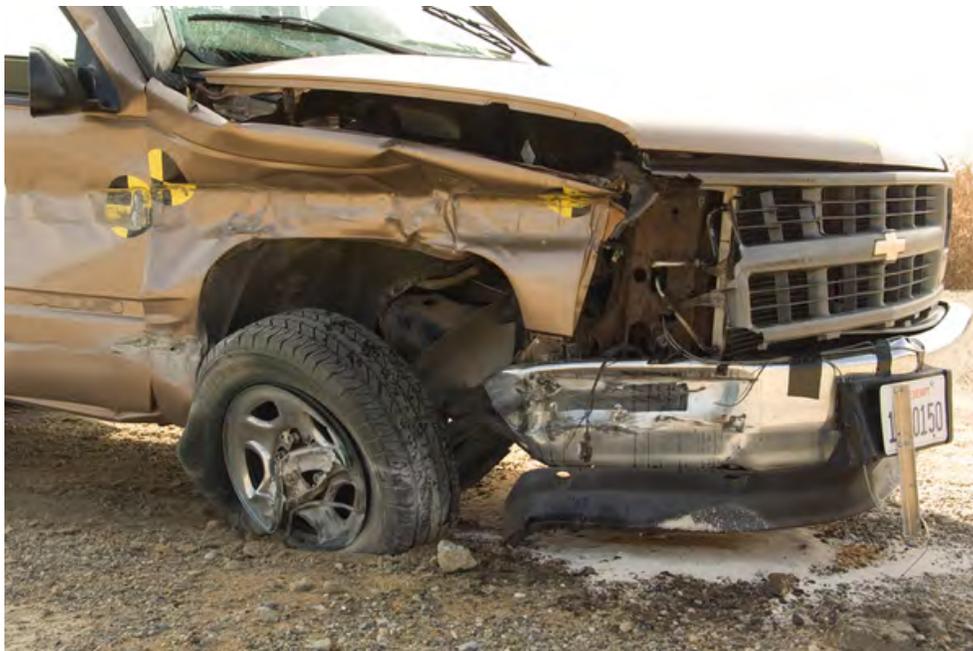
Figure 2-8 – Right front corner of test vehicle after Test 631

The right front corner of the vehicle was moderately damaged in the initial impact with the barrier. The right front fender, hood, bumper, headlamp area, grille, and suspension components were all affected. The passenger side doorframe was deformed outward but the door remained latched. The right front tire was also ruptured. The steel rail caused denting along the entire length of the passenger side as the vehicle continued to contact the barrier after the initial impact. The right front tire was pushed rearward and slightly into the passenger side foot well area. The maximum amount of passenger compartment deformation was 124 mm¹, which occurred in the floorboard². The entire windshield spider-cracked but did not separate or enter the occupant compartment. However, this cracking was not caused entirely by the test. The windshield was inadvertently damaged (see Figure 2-10) on the impact side shortly before the test was run and it was decided that the damage was not significant enough to warrant postponing the test. Post-crash photos show the initial crack to be the weak point and the source of future cracking.

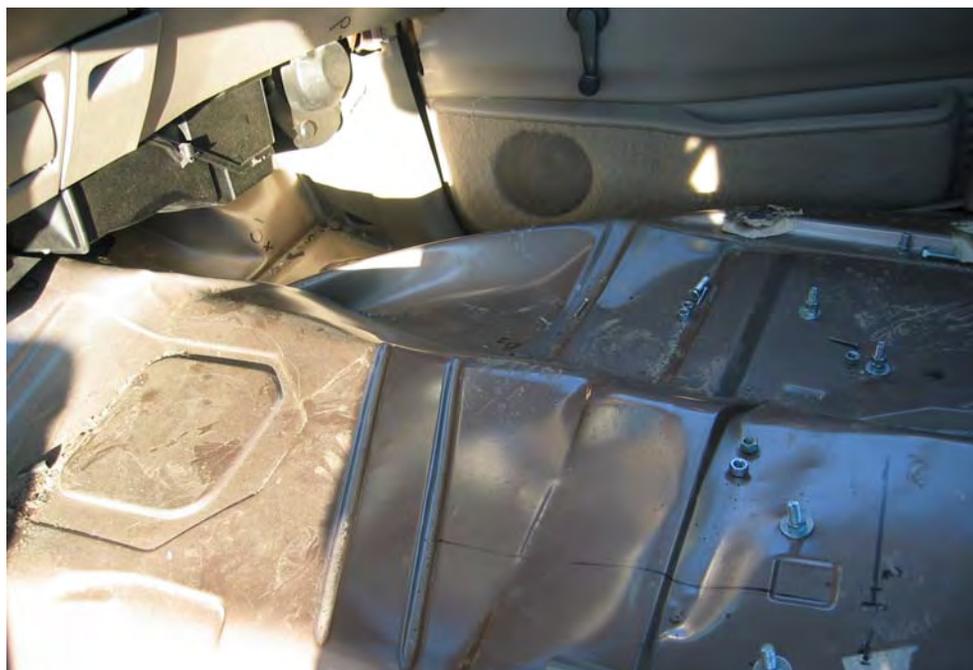
Figure 2-9 – Floorboard deformation of test vehicle after Test 631

¹ It was discovered after the test that there was significant corrosion of some non-structural components of the front grill above the bumper, which may have adversely affected the occupant compartment deformation.

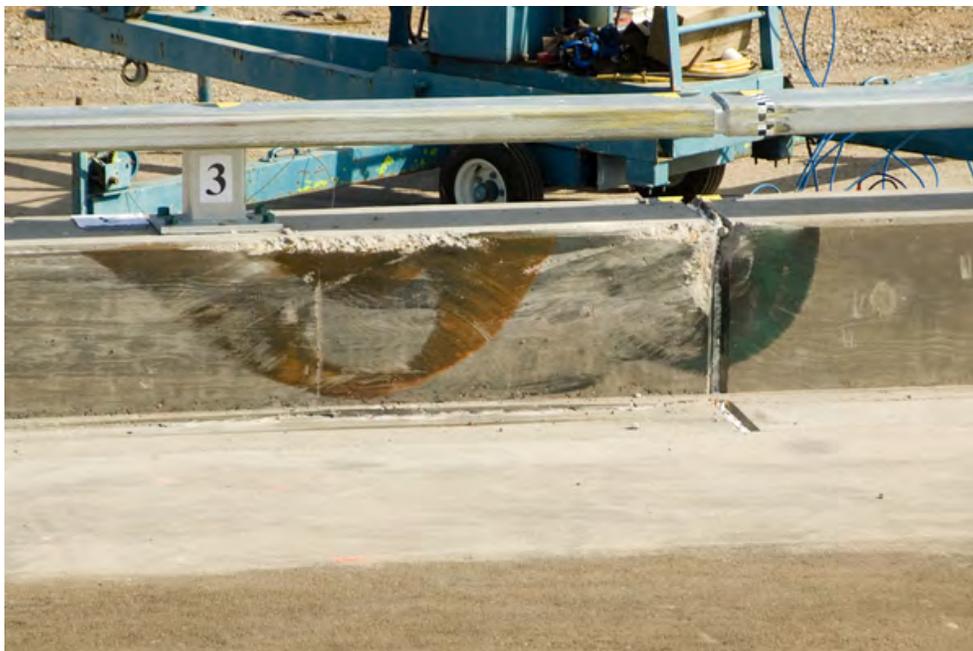
Figure 2-13 – Type 90 barrier face after Test 631

Barrier Damage: Maximum dynamic deflection in steel rail of 38 mm, superficial concrete spalling, and no permanent lateral deflection.

There was only minimal permanent damage to the barrier during Test 631. The steel rail scraped a small amount of paint off the vehicle along the length of contact. The vehicle caused some minor concrete spalling at the downstream vertical face of the expansion joint near the impact point and along the top of the curb for approximately 1.5 m. No rebar was exposed so there was no structural damage to warrant immediate repair. For aesthetic reasons and because the concrete cover over the rebar has been compromised, the damage should be repaired by maintenance crews.

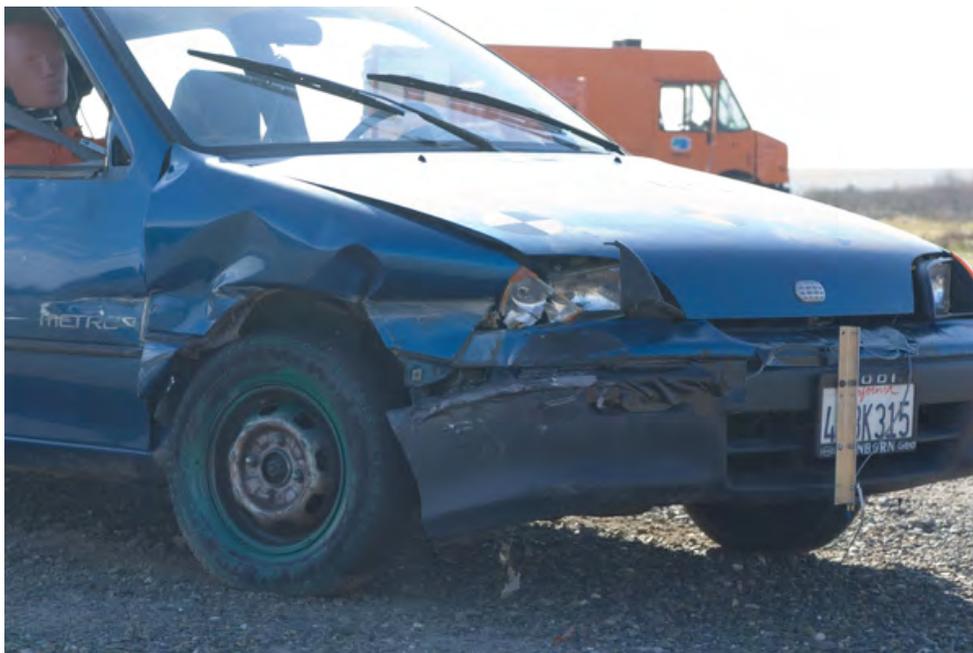
Figure 2-18 – Front right corner of test vehicle after Test 632

The right front corner of the vehicle was moderately damaged. The right front bumper and right fender were pushed rearward. The right front tire and wheel assembly were pushed rearward about 146 mm into wheel well, deforming it. The entire right side of the vehicle was moderately damaged. There was no significant passenger compartment or floorboard deformation. The passenger-side mirror was broken off.

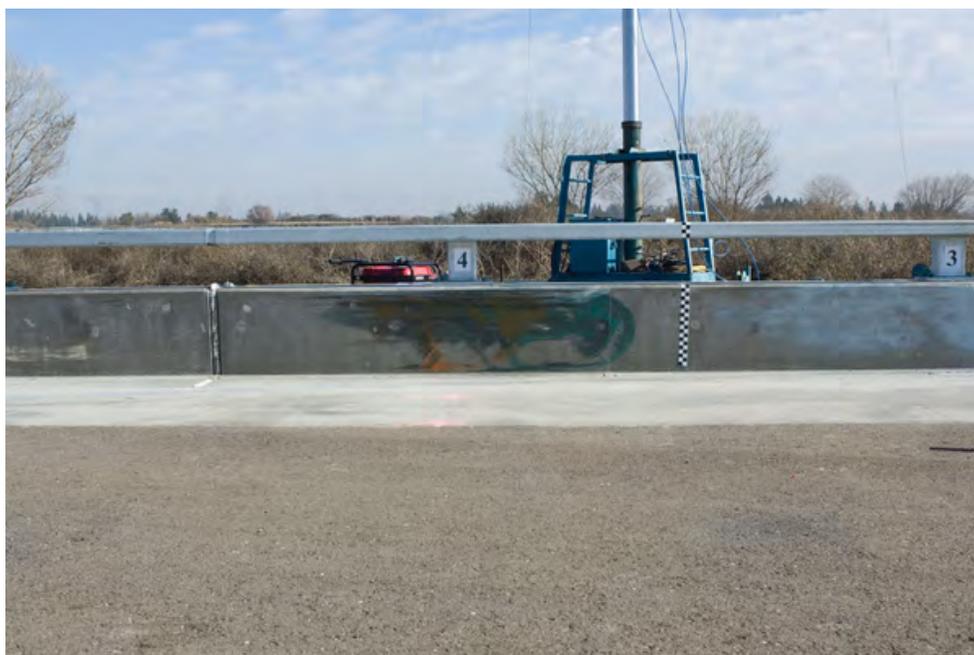
Figure 2-20 – Type 90 bridge rail face after Test 632

Barrier Damage: No dynamic deflection in steel rail, minor superficial concrete spalling.

There was essentially no permanent damage to the barrier during Test 632. The steel rail scraped a small amount of paint off the vehicle along the length of contact. There was a negligible amount of concrete spalling on the concrete curb. There would be no need for repair by a maintenance crews.

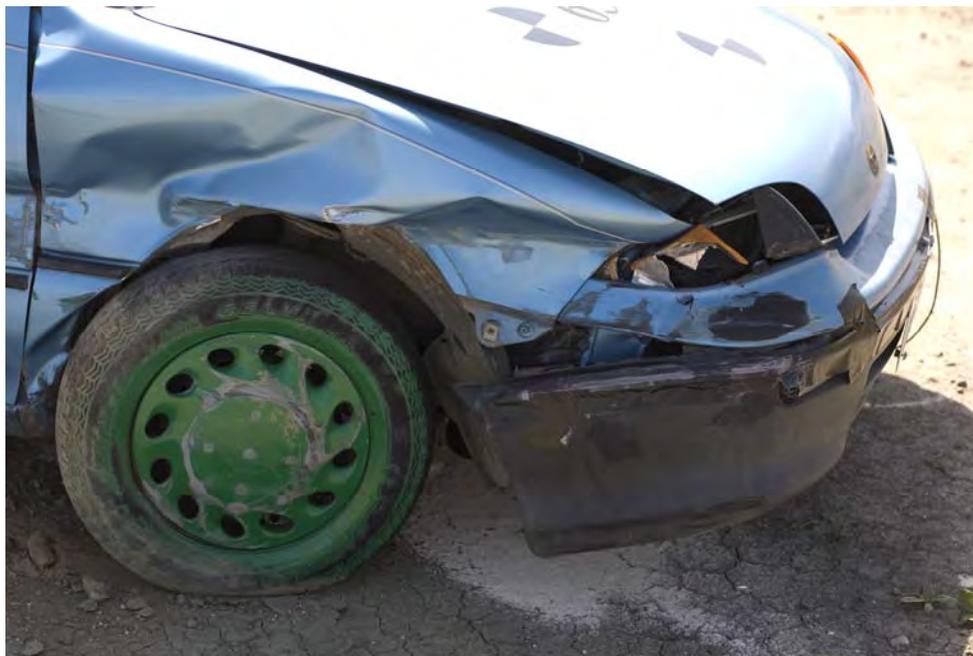
Figure 2-27 – Front right corner of test vehicle after Test 633

The right front corner of the vehicle was moderately damaged in the initial impact with the concrete curb. The right front bumper and right fender were pushed rearward. The right front tire and wheel assembly was pushed rearward about 130 mm into wheel well, deforming it. The entire right side of the vehicle was moderately damaged. There was no significant passenger compartment or floorboard deformation.

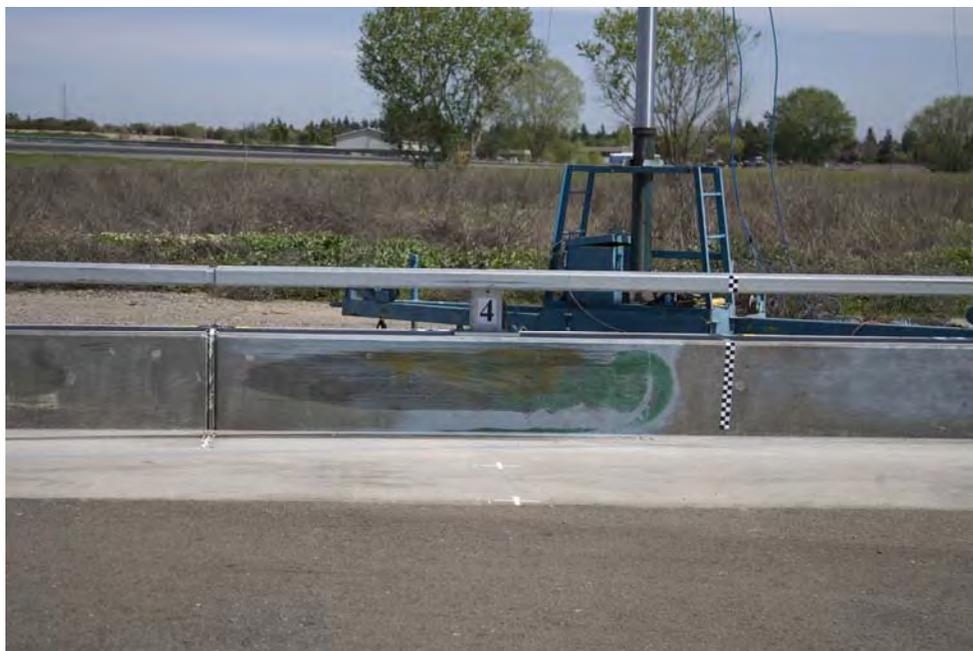
Figure 2-28 – Type 90 bridge rail face after Test 633

Barrier Damage: No dynamic deflection in steel rail, minor superficial concrete spalling.

As in Test 632, there was essentially no permanent damage to the barrier during Test 633. The steel rail scraped a small amount of paint off the vehicle along the length of contact. There was a negligible amount of concrete spalling on the concrete curb. There would be no need for repair by a maintenance crews.

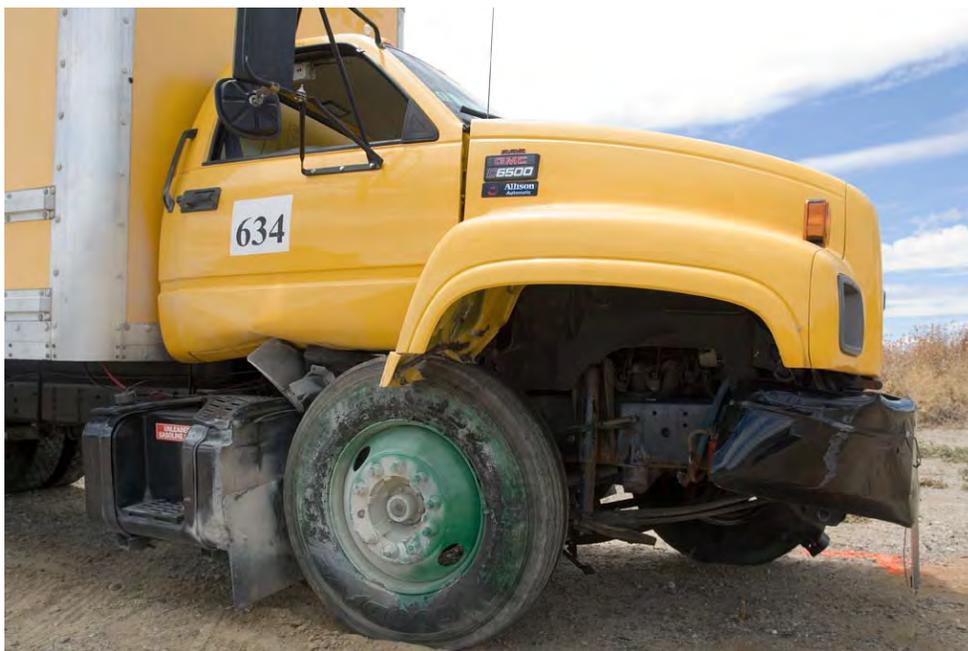
Figure 2-34 – Right side of test vehicle after Test 634

The impact of the right front tire with the barrier caused failure of several suspension components, including the right-side U-bolts which secure the axle to the leaf springs as well the end of the leaf spring on the right side. The axle shifted rearward 650 mm on the impact side and forward 160 mm on the driver side. When the front passenger side wheel was driven rearward, it crushed the battery box, the OEM fuel tank, the fender, and the door. Additionally, the front passenger side shock mounting bolt was sheared, a wheel stud on the front passenger tire sheared off, the passenger side of the front bumper was bent rearward, the rear passenger side wheel was damaged, and the bottom of the cargo bed was scraped at support locations from scraping the top of the steel rail. The passenger-side door remained latched even though the battery box was pushed upward into the bottom of the door, causing significant deformation. There was no significant passenger compartment or floorboard deformation. Additionally, all tires were still fully inflated after the test, despite the impact-side rims being bent and/or scraped during impact.

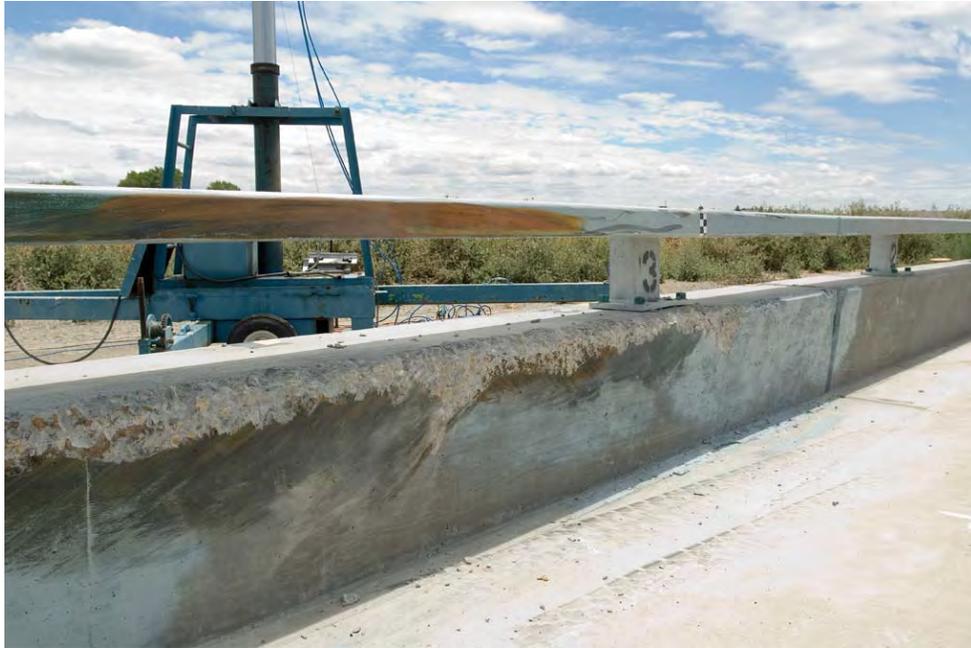
Figure 2-37 – Type 90 barrier face after Test 634

Barrier Damage: Maximum dynamic deflection in steel rail of <50 mm and <15 mm of permanent lateral deflection, moderate concrete spalling from vehicle lug nuts scraping, and <15 mm of permanent lateral deflection.

Unlike the previous tests, there was some permanent damage to the barrier. The vehicle lug nuts and rims caused gouging and spalling of the top of the concrete curb from just upstream of the initial impact point to where the rear tire lost contact with the rail, about 4.5 meter downstream of the impact point. At posts 3 and 4 the spalling extended to the front edge of the post base plate. As in Test 631, the gouging and spalling were superficial and not structural as evidenced by the lack of exposed rebar¹. More significantly, there was minor weld cracking at Post 3 (the post nearest the impact location) where the post was attached to the base plate. The welds were cracked approximately 6 mm on each side of all four corners, with a 0.05-mm gap at the crack locations. The center of the base plate was also bent upwards on the traffic and upstream sides, with the maximum deformation of 5 mm occurring on the traffic side. Additionally, the steel rail had a permanent lateral deflection of less than 15 mm. Because the weld cracking was minor, it is unlikely that damage to the steel rail would pose a safety concern to other vehicles before maintenance crews could repair the damage.

¹ The damage to the concrete, although not aesthetically pleasing, would not likely have an adverse affect on the crashworthiness of the barrier.
