FINAL
WILDLIFE CORRIDOR ASSESSMENT REPORT

VENTURA STATE ROUTE 118

May 27, 2004

LSA Associates, Inc.
1650 Spruce Street, Suite 500
Riverside, California 92507
(909) 781-9310

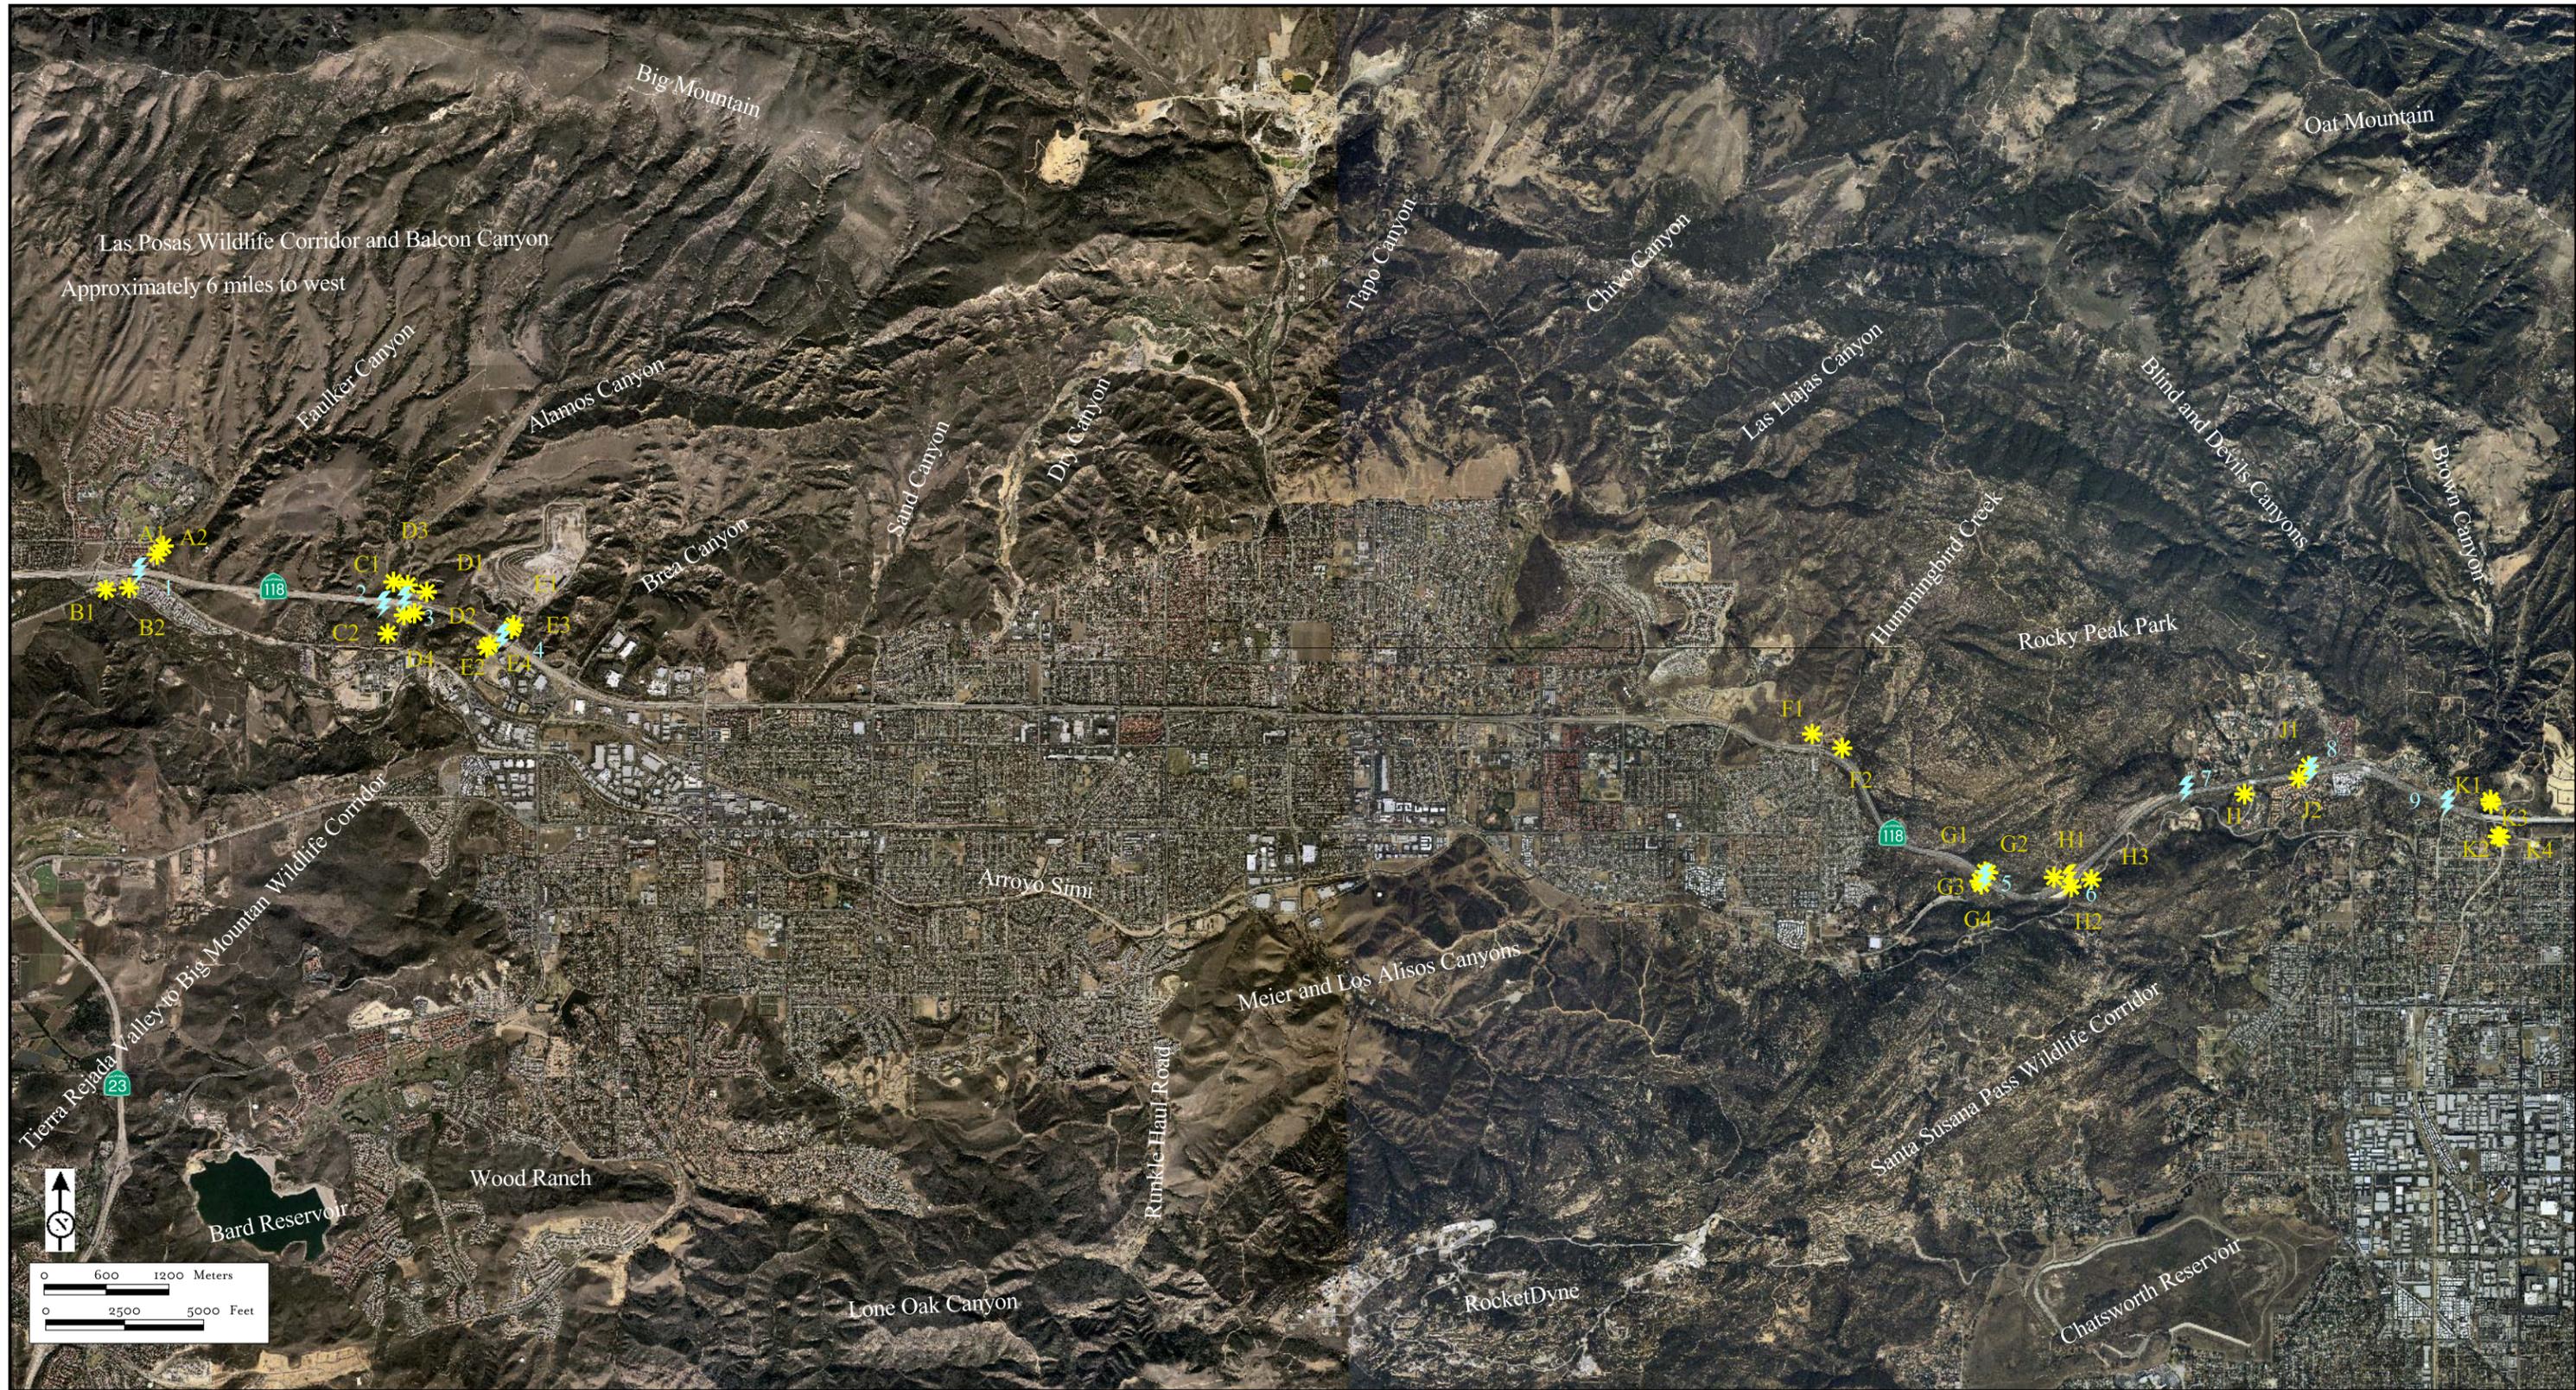
FIGURE A2

⚡ CAMERA STATIONS

Scent station locations are approximate and are for illustrative purposes only.
 Source: Photos - 2000 Digital OrthoMosaic'd Air Photos, SCAG/Emerge Inc.
 3/24/04 (I:\CDT230\gis\finalreportfigures.apr)

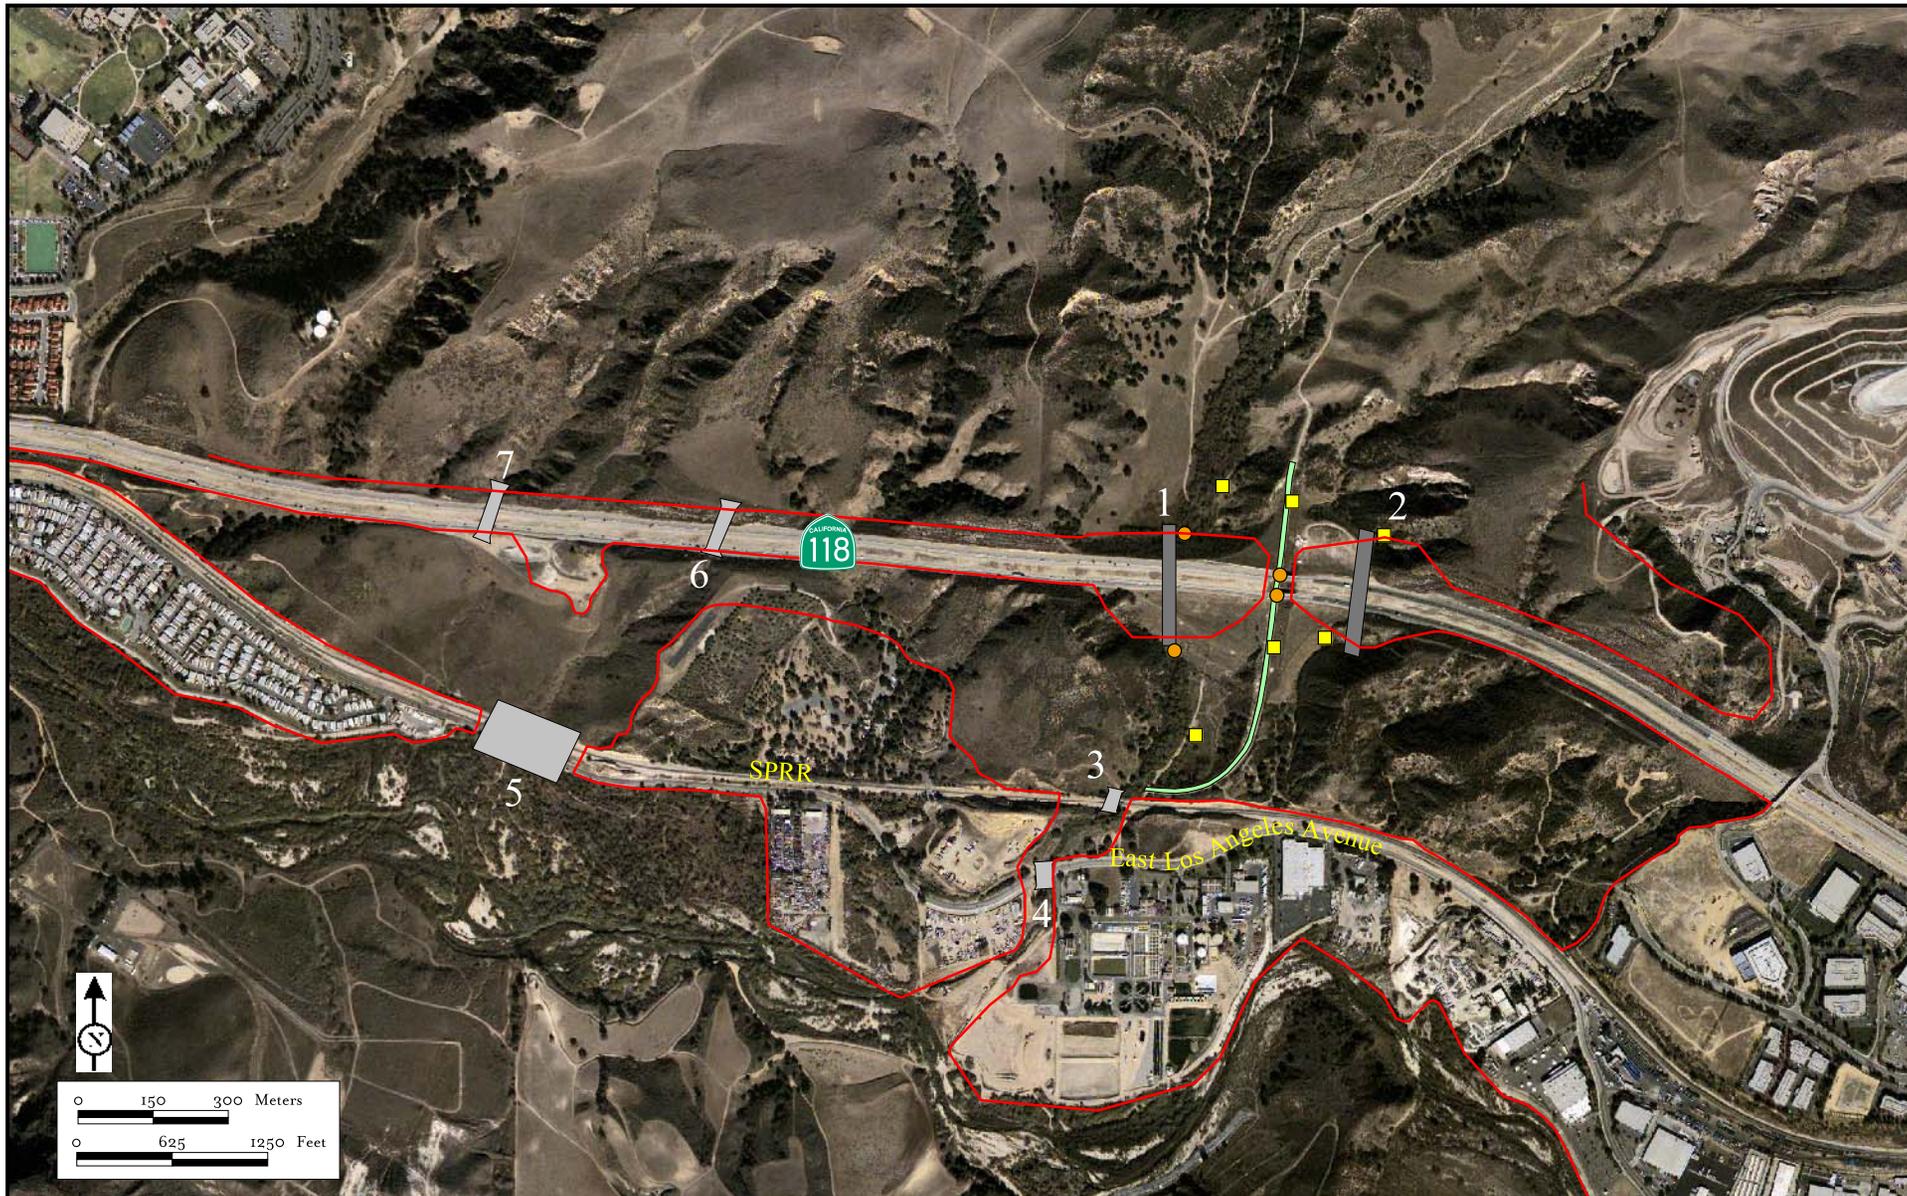
Figure A4

Alamos Canyon Wildlife
Linkage Enhancements

Recommended Enhancement Proposals. The enhancement proposals listed below would be used in combination to direct wildlife through the open space between SR-118 and Los Angeles Avenue. Wildlife movement would be facilitated by large mammal passageways under the railroad tracks and Los Angeles Avenue located west of Oak Park Campground (Figure A4).

Proposal 2. One or more of the existing culverts should be replaced with more suitable wildlife passageway structures. Trenchless culvert replacement or “tunnel jacking” technology could be used to install a 10-foot by 10-foot or larger box culvert in a location west of Oak Park (Figure A4, tunnels #6 and #7).

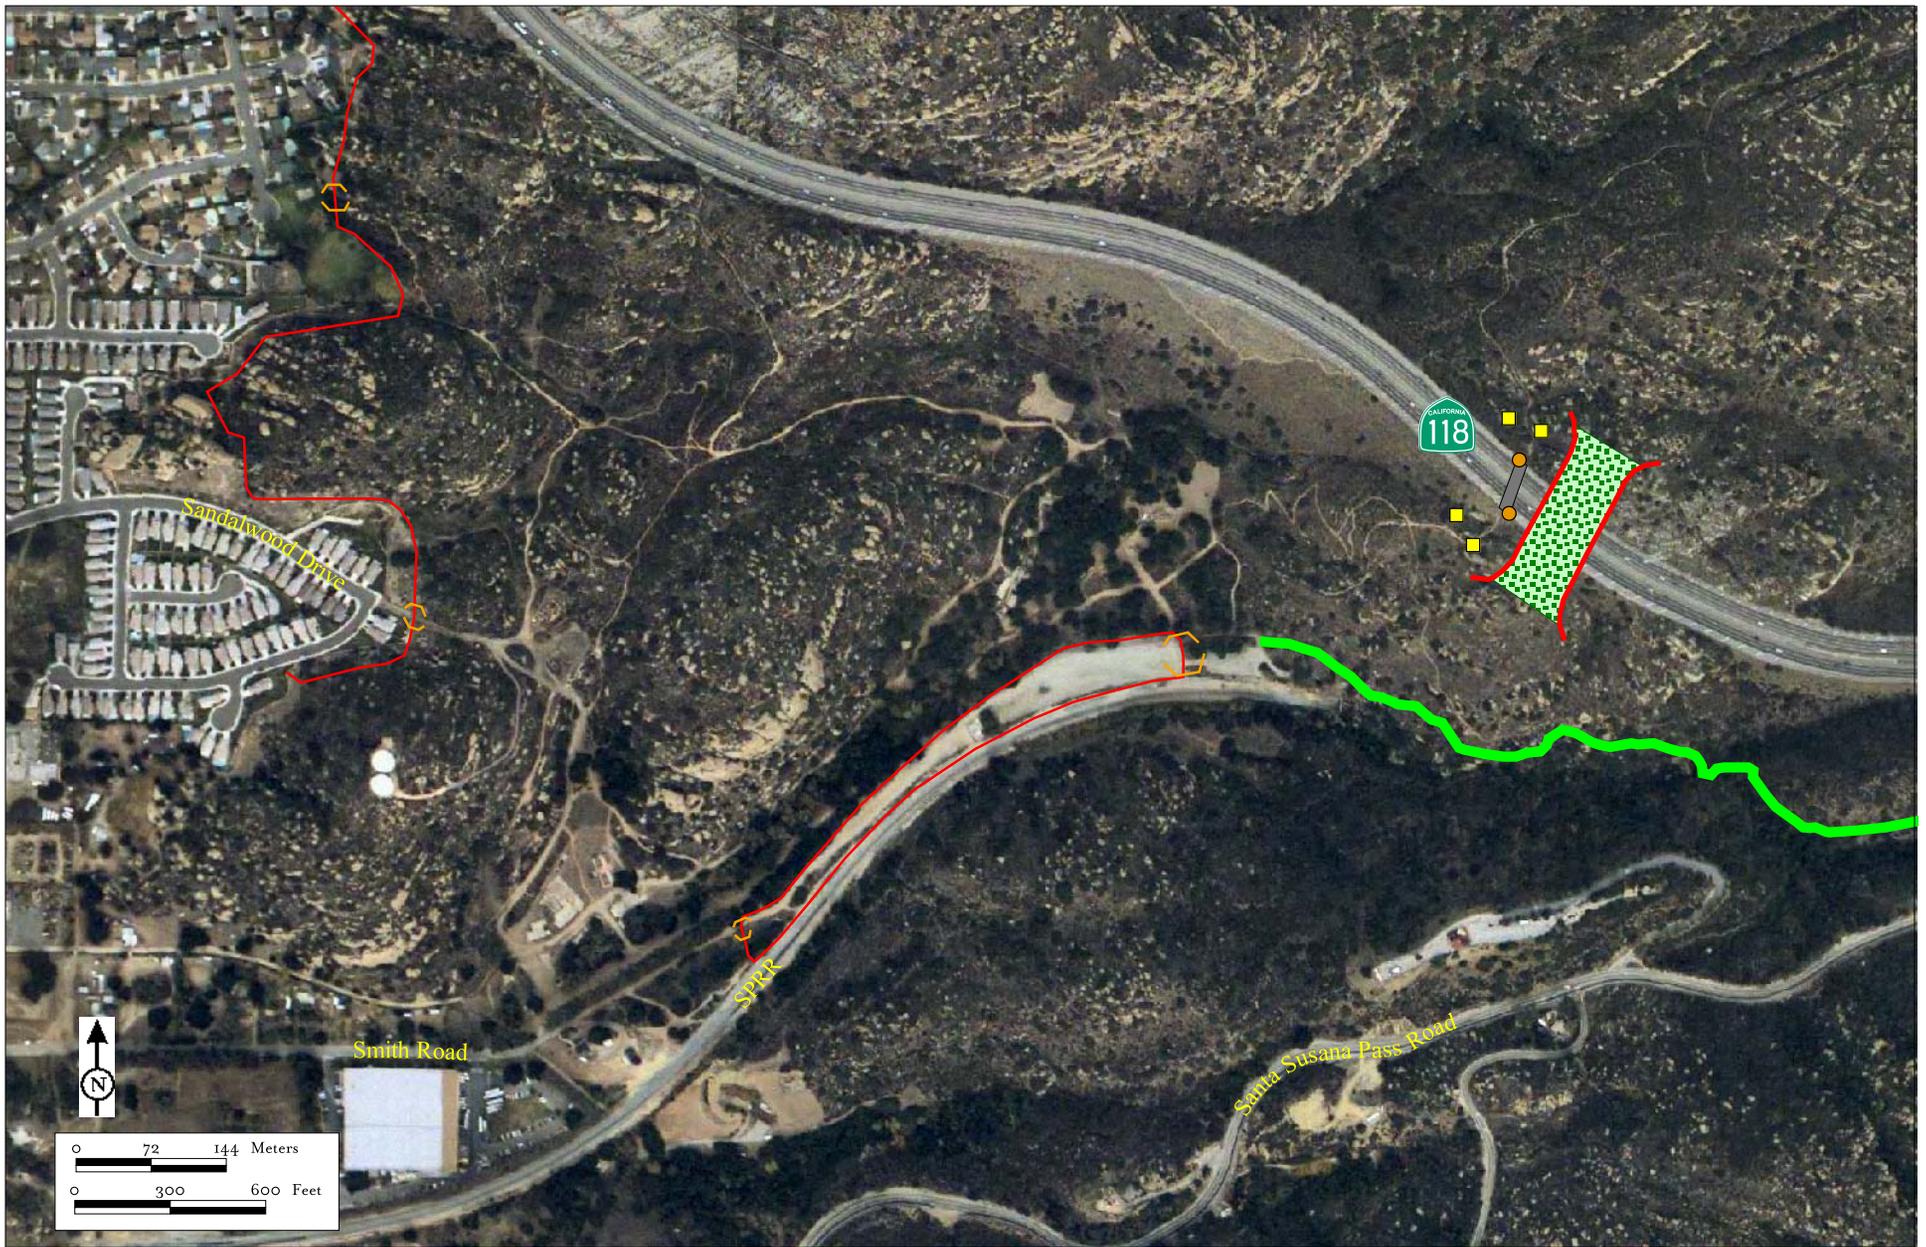
FIGURE A5

Corriganville Tunnel Wildlife
Linkage Enhancements

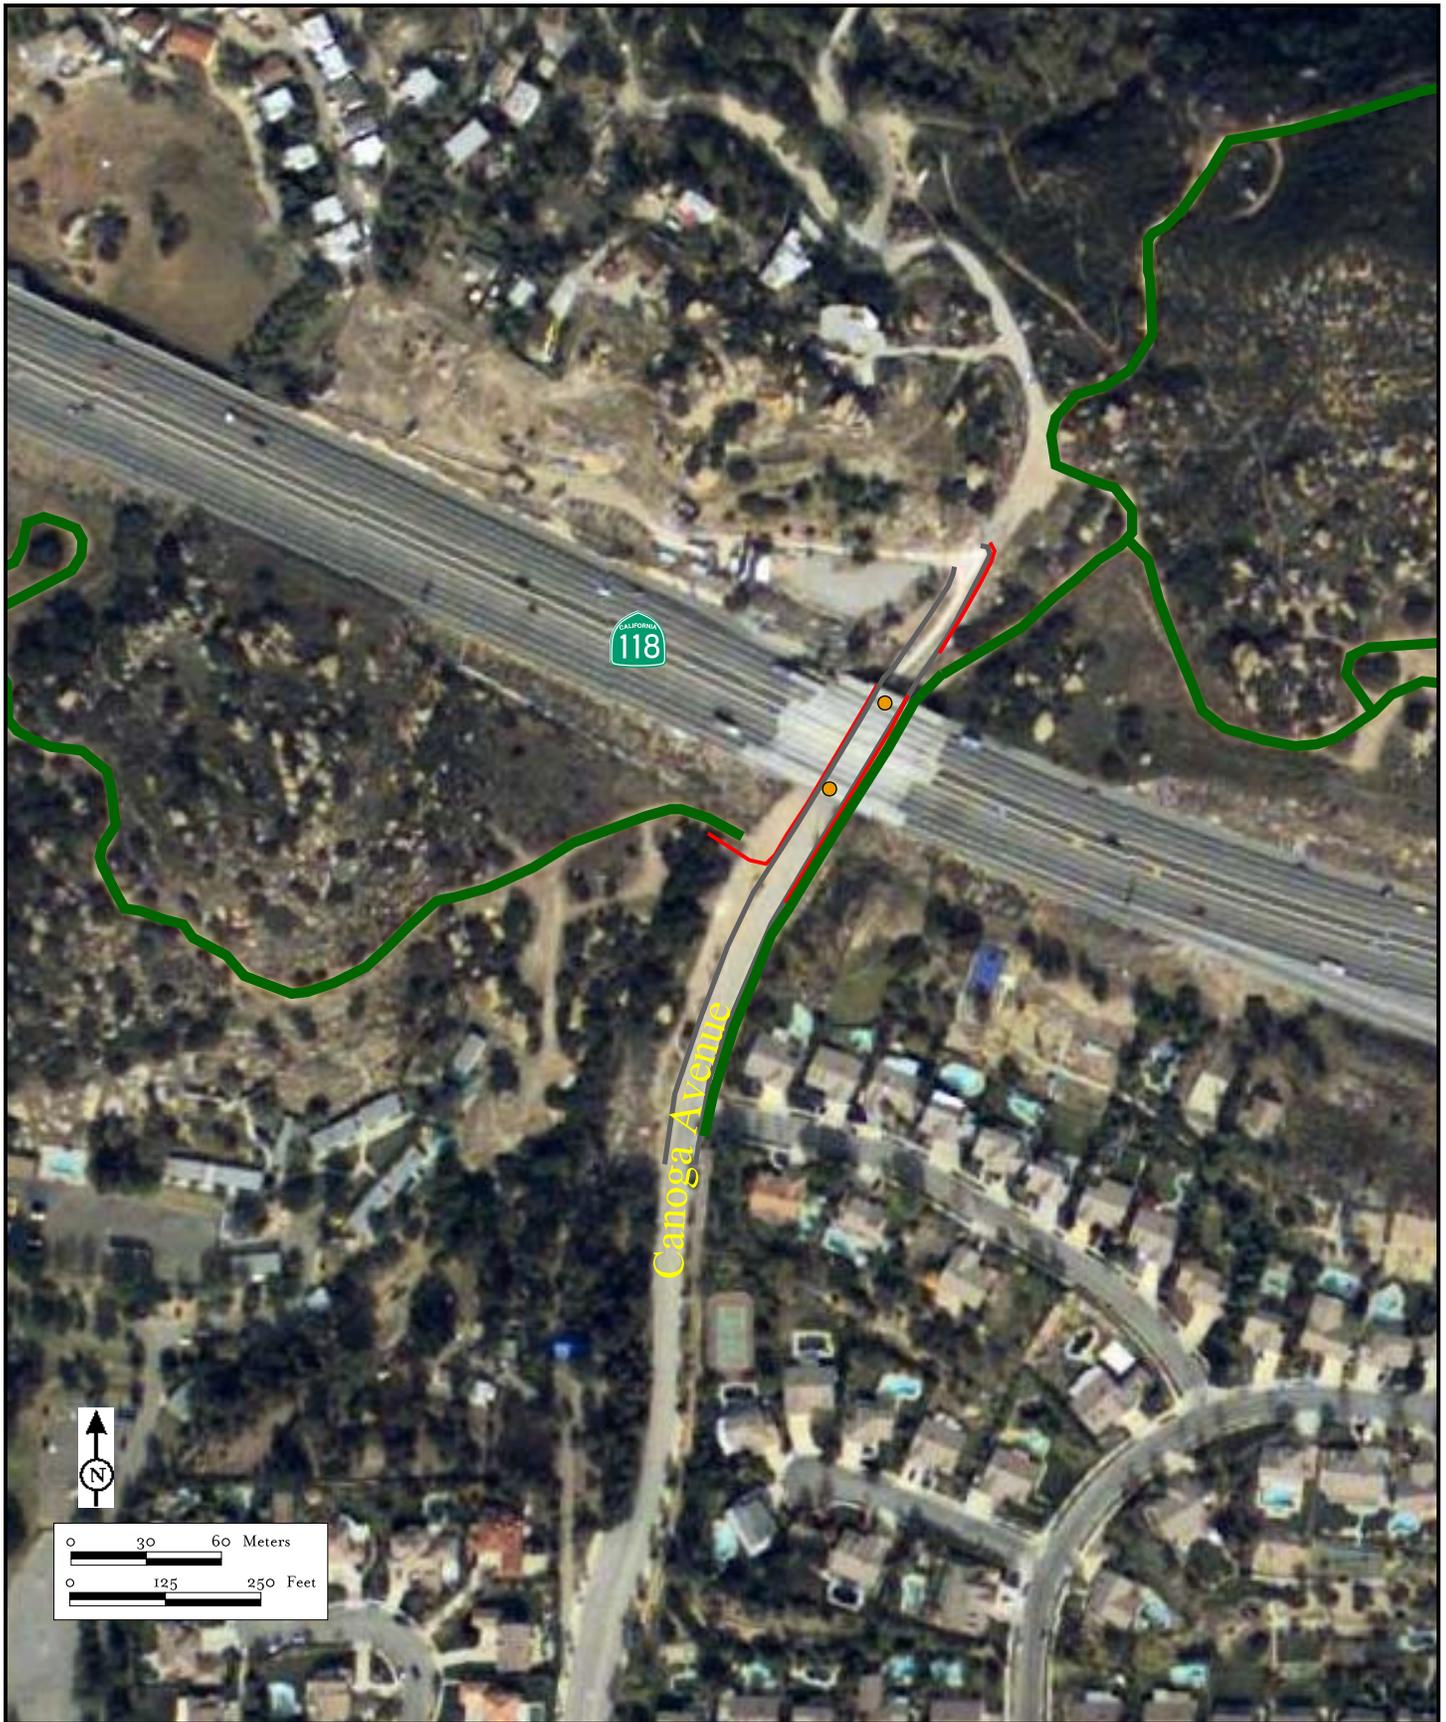
- PHOTO STATION LOCATIONS
- SCENT STATION LOCATIONS

Canoga Avenue Wildlife
Linkage Enhancements

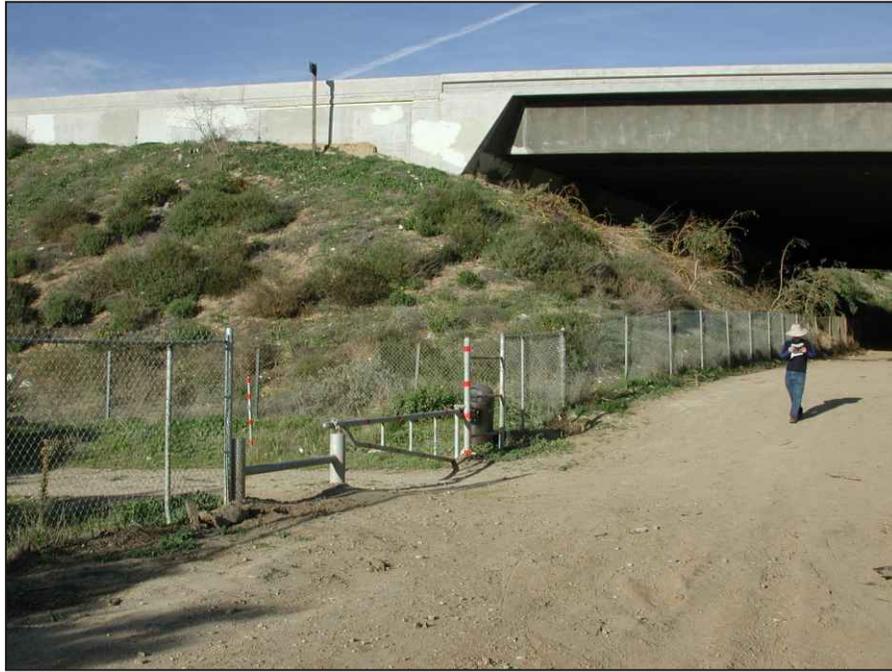
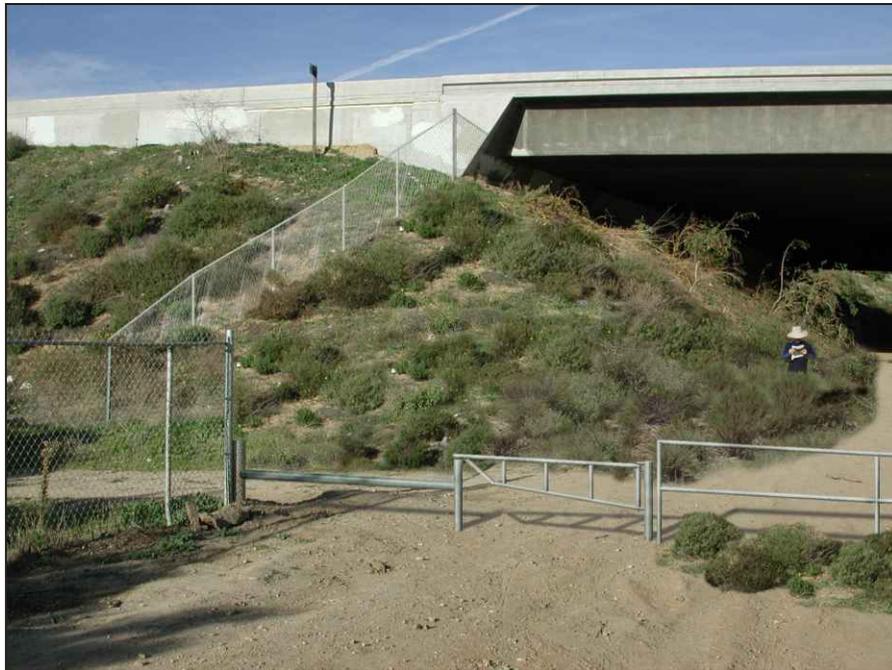
FIGURE A7A

Before

After

Ventura 118 Wildlife Study
Final Report
Canoga Avenue
Wildlife Linkage Enhancement

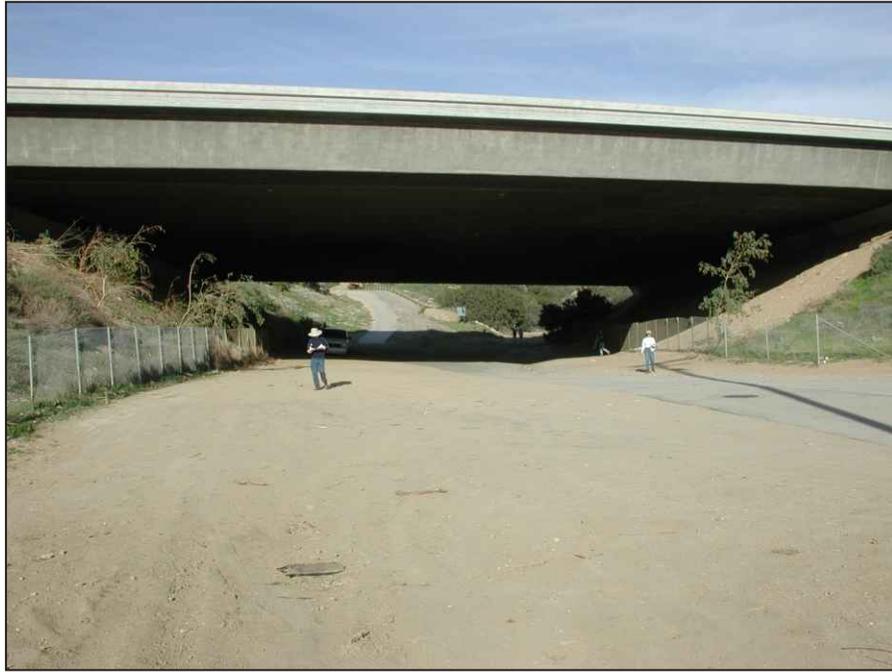
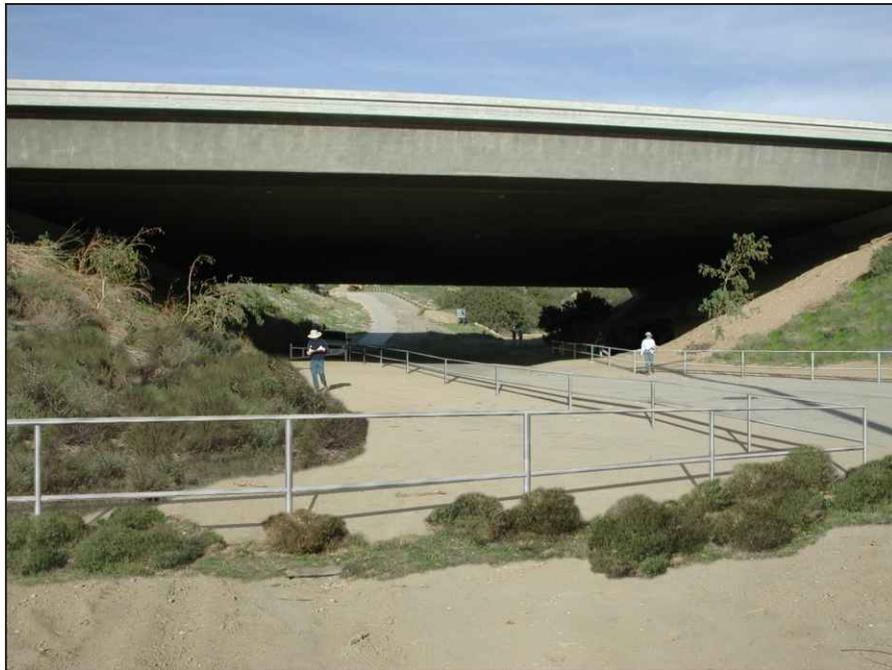
FIGURE A7_B

Before

After

Ventura 118 Wildlife Study
Final Report
Canoga Avenue
Wildlife Linkage Enhancement

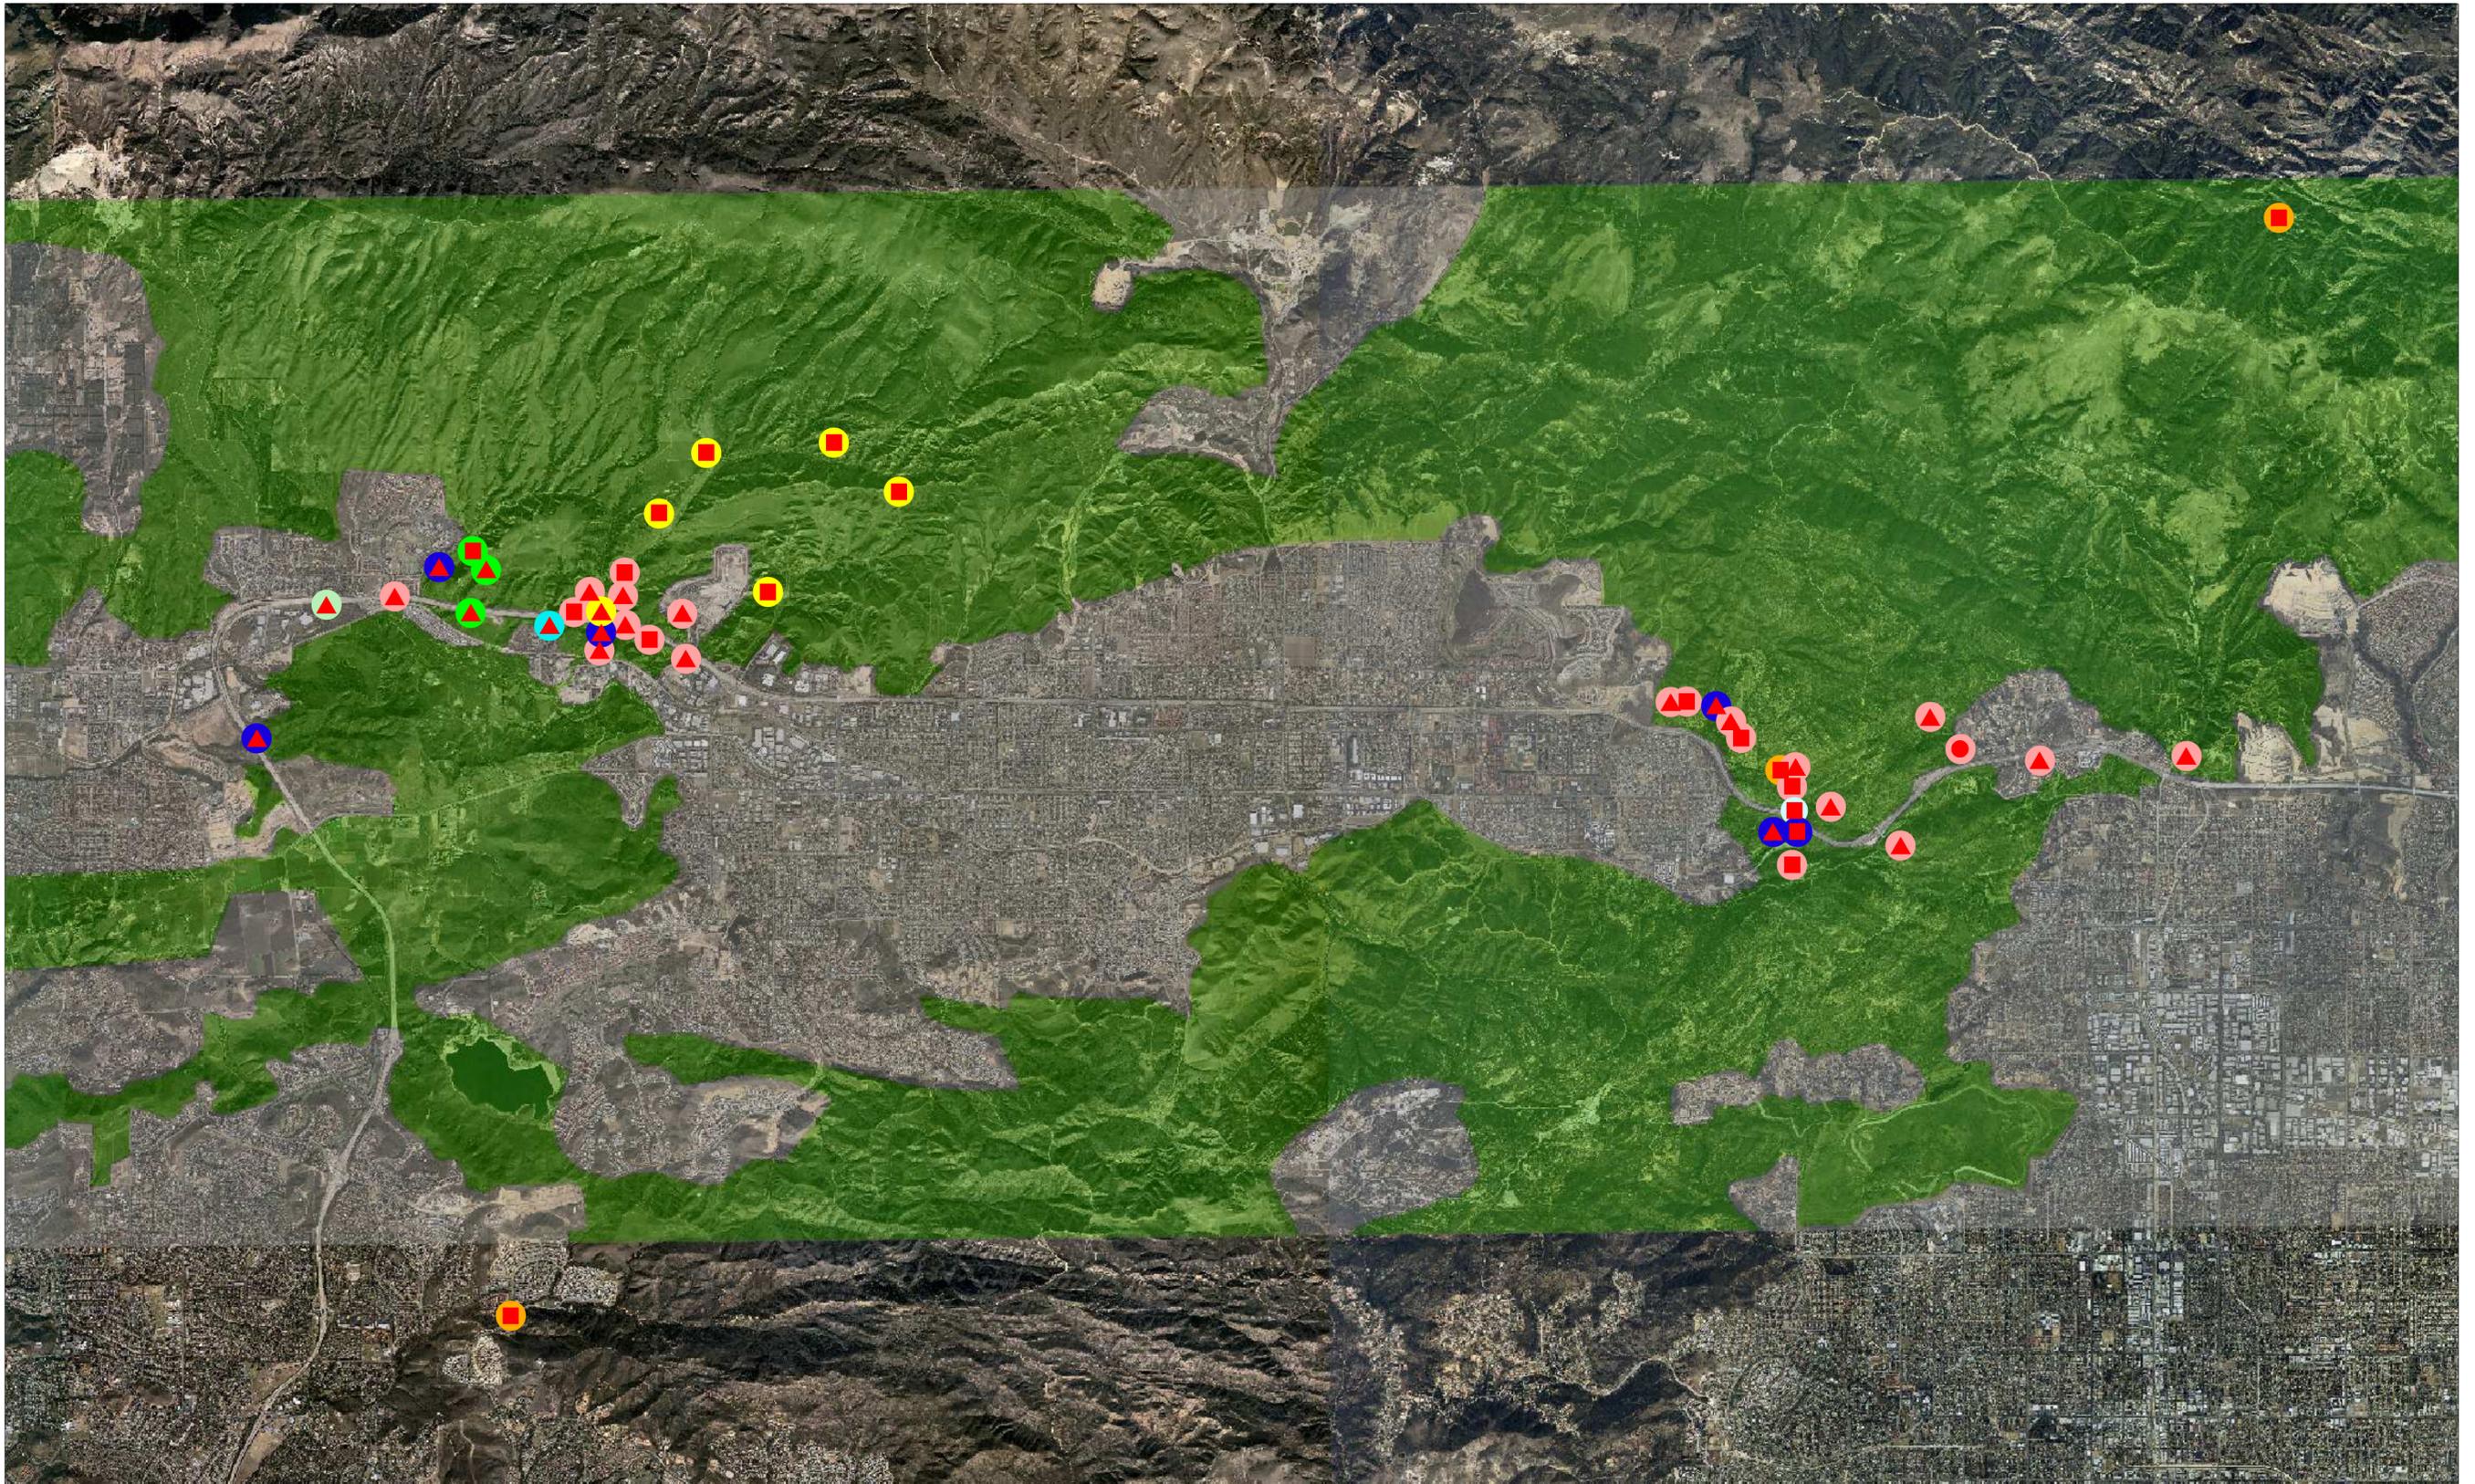
FIGURE B1

Wildlife Observation Map

Note: Wildlife observation locations are approximate and are for illustrative purposes only
SOURCE: Photo-2000 Digital Orthomosaic'd Air Photos, SCAG/Emerge Inc; Wildlife Data-Santa Monica Mountains Conservancy-1991, Michael Brandon & Associates Inc.-1993, Ng, Sandra-2000, Psomas-2002, BonTerra Consulting-2003, National Park Service-2004
5/26/04 (l:cdt230)gis/wildobs.mxd
