# Bats and the Rebuilding of the Interstate 5/ Santa Clara River Bridge

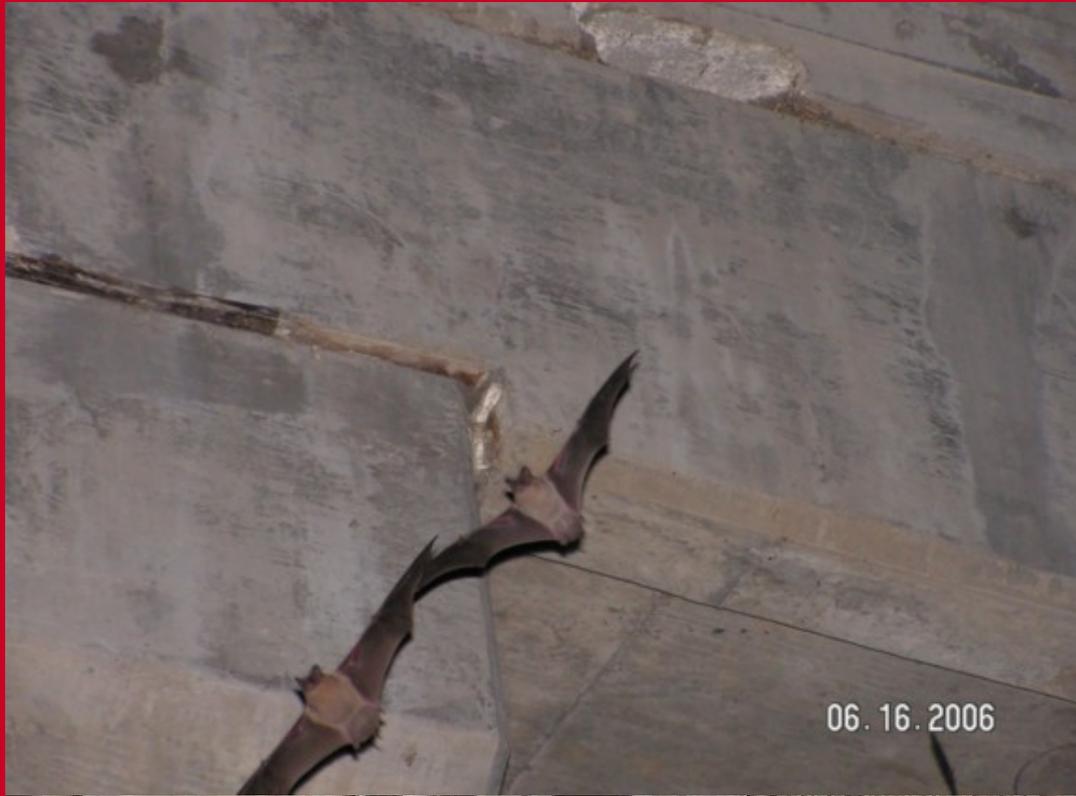
# I-5/Santa Clara River Bridge

Before the bridge demolition:

- Approximately 3000 to 3500 bats roosted within joints beneath the bridge.
- A large colony of day-roosting Mexican freetail (*Tadarida brasiliensis*) had built up over decades.

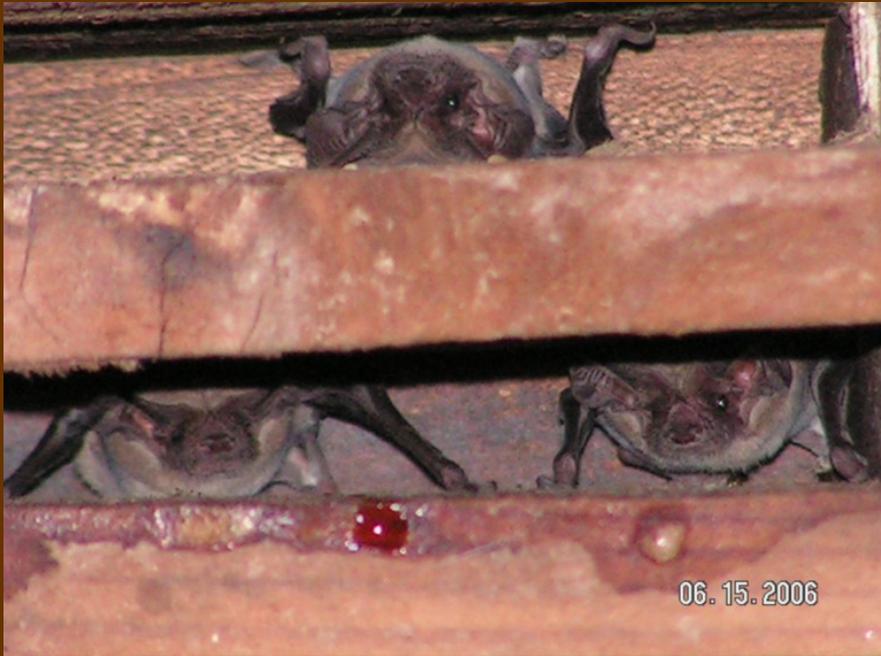
# Bridge Demolition

Before demolition a qualified biologist determined that there was bat presence based upon:

- Large amounts of bat guano on the top of the bent below the joints.
- The distinct sound of bats vocalizing within the joints of the bridge.

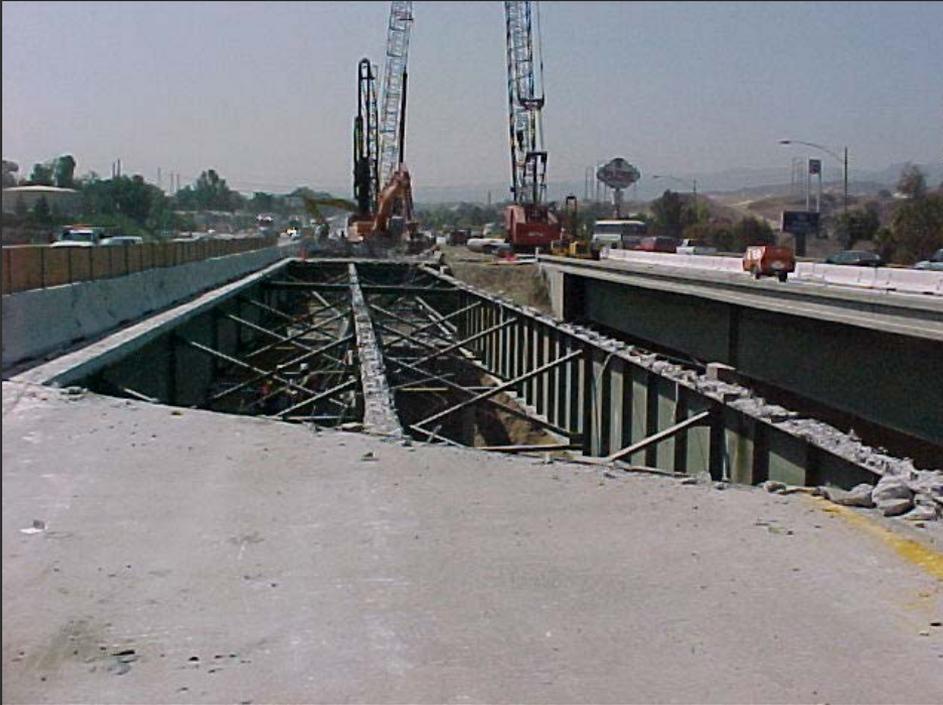
# Demolition of I-5/Santa Clara River Bridge 8/1/02

- Unfortunately, due to structural restrictions, visual identification of bats was not readily feasible, and work was not stopped.
- Removal of the bridge deck exposed the area within the bridge used as bat roosts.

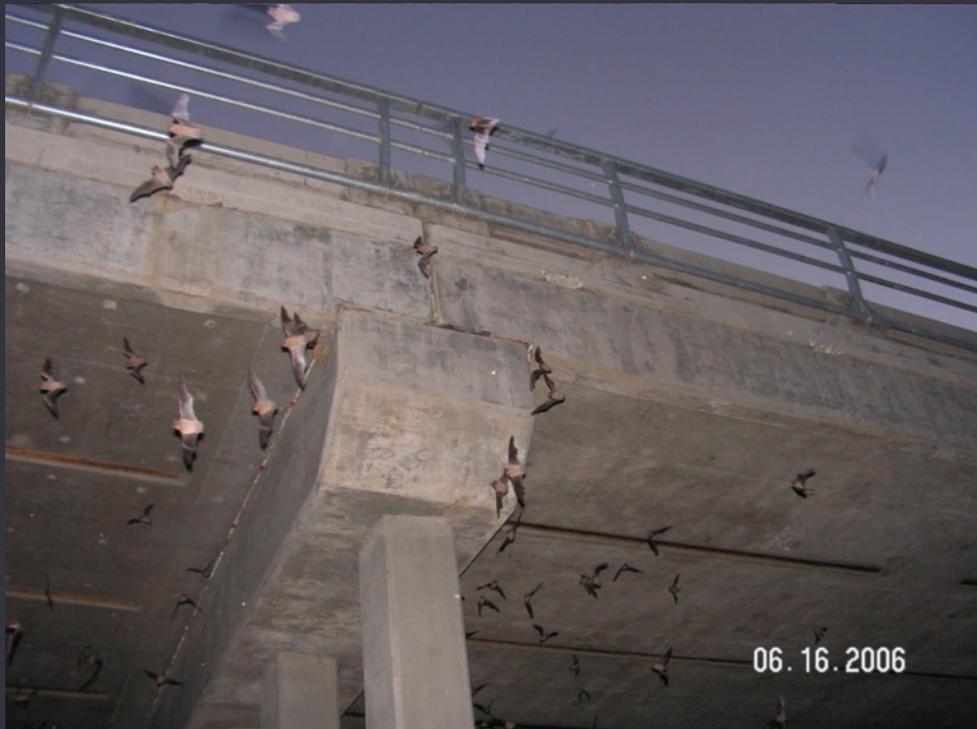
- Temporary wooden bat houses were installed on the Old Road Bridge during construction, approximately 300 feet downstream.
- Wooden bat houses attracted big brown bats at a ratio of approximately 3:1.
- A much greater number of Mexican freetail than big brown occupied the original bridge.

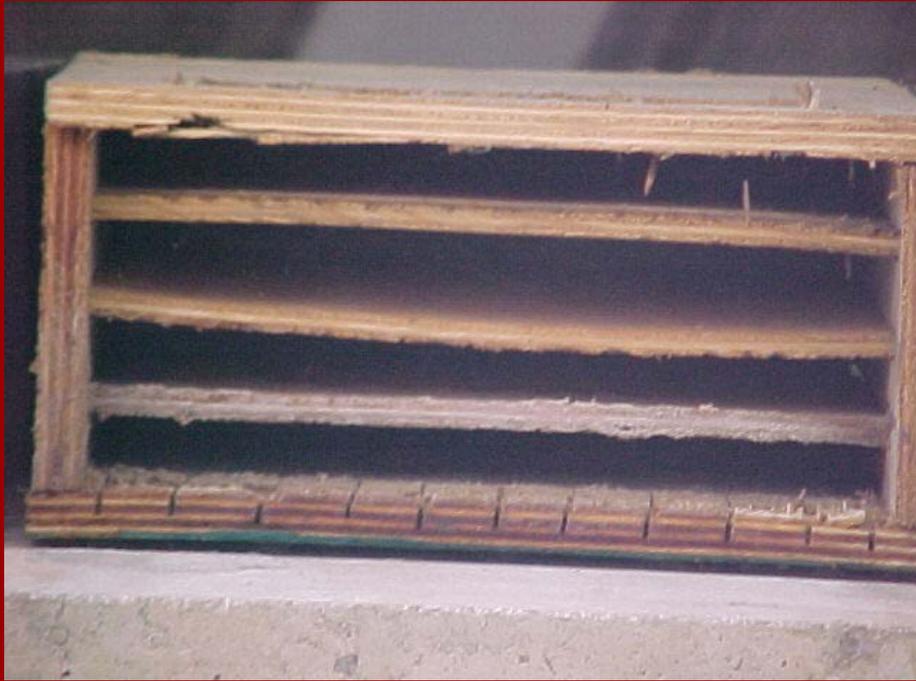
- Mexican freetail was the bat that needed the greatest mitigation.
- Mexican freetail bats may prefer concrete, like the permanent habitat, which more closely resembles their natural rock habitat, to wood, which resembles big brown's habitat in trees.

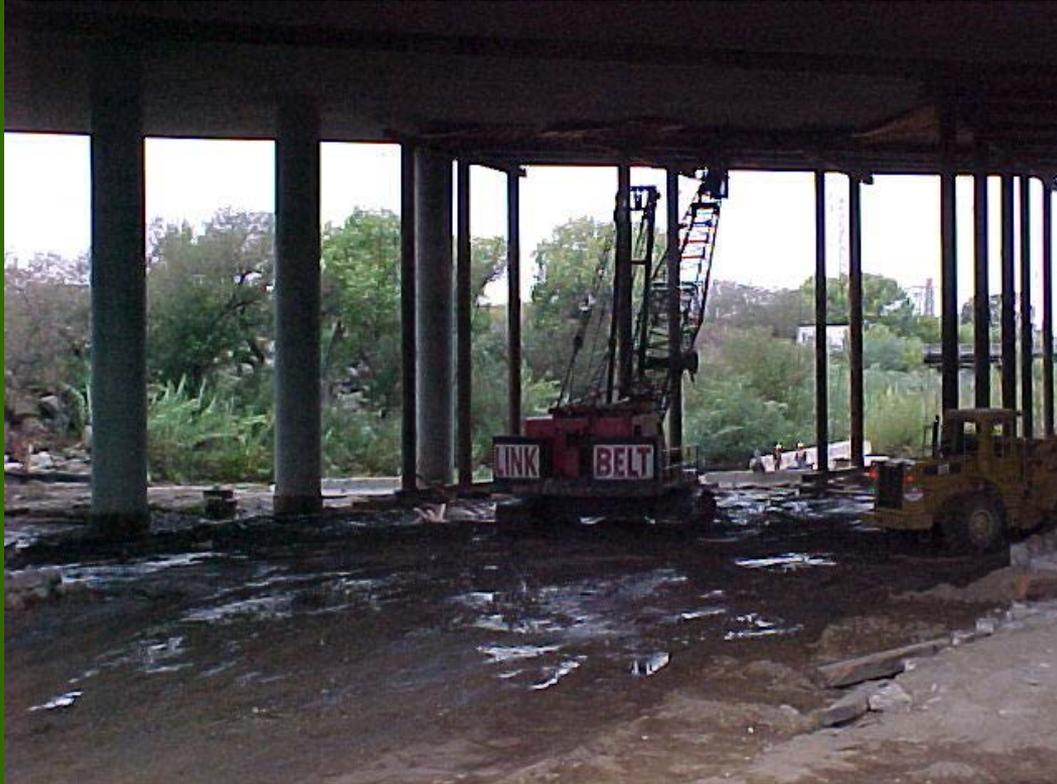
- When false-work for the new bridge was installed, bats returning to their home for years would find gaps in the false-work to roost within.

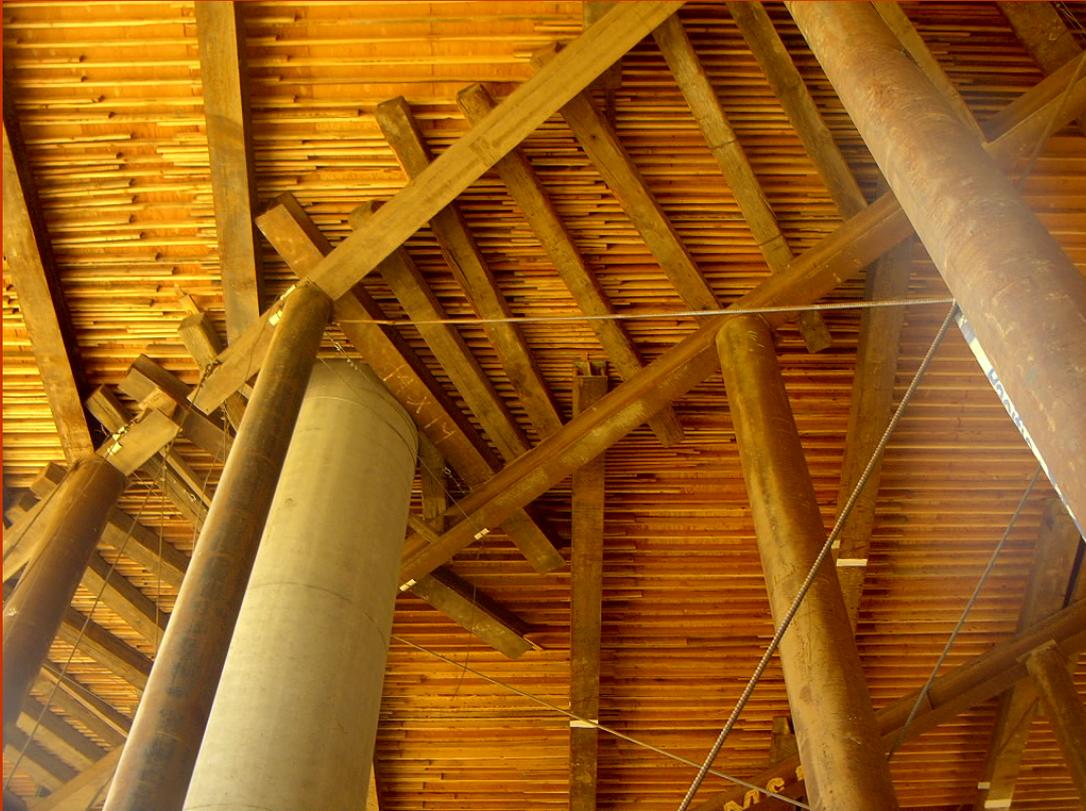
# Bats in Falsework

- The situation required constant monitoring and coordination to protect the bats.

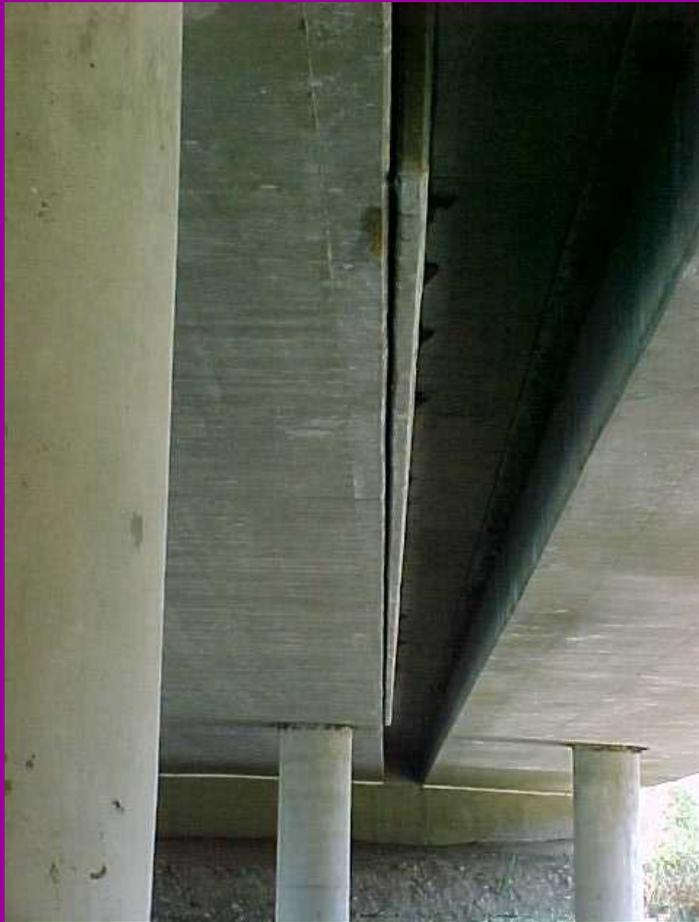
- After demolition and building of the new bridge, 2 concrete panels were installed within the S/B and N/B midrib to create bat habitat.

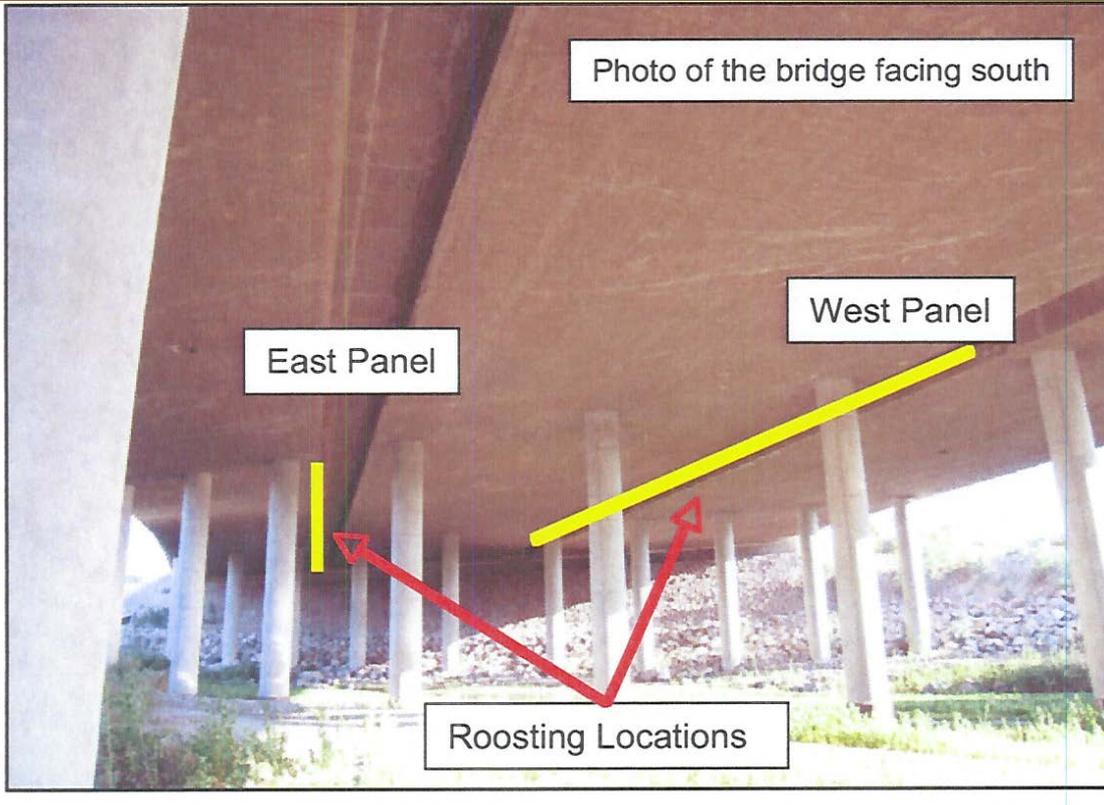
Underside of the bridge facing south showing:

- The location of the east and west bat habitat panels
- Roosting locations.

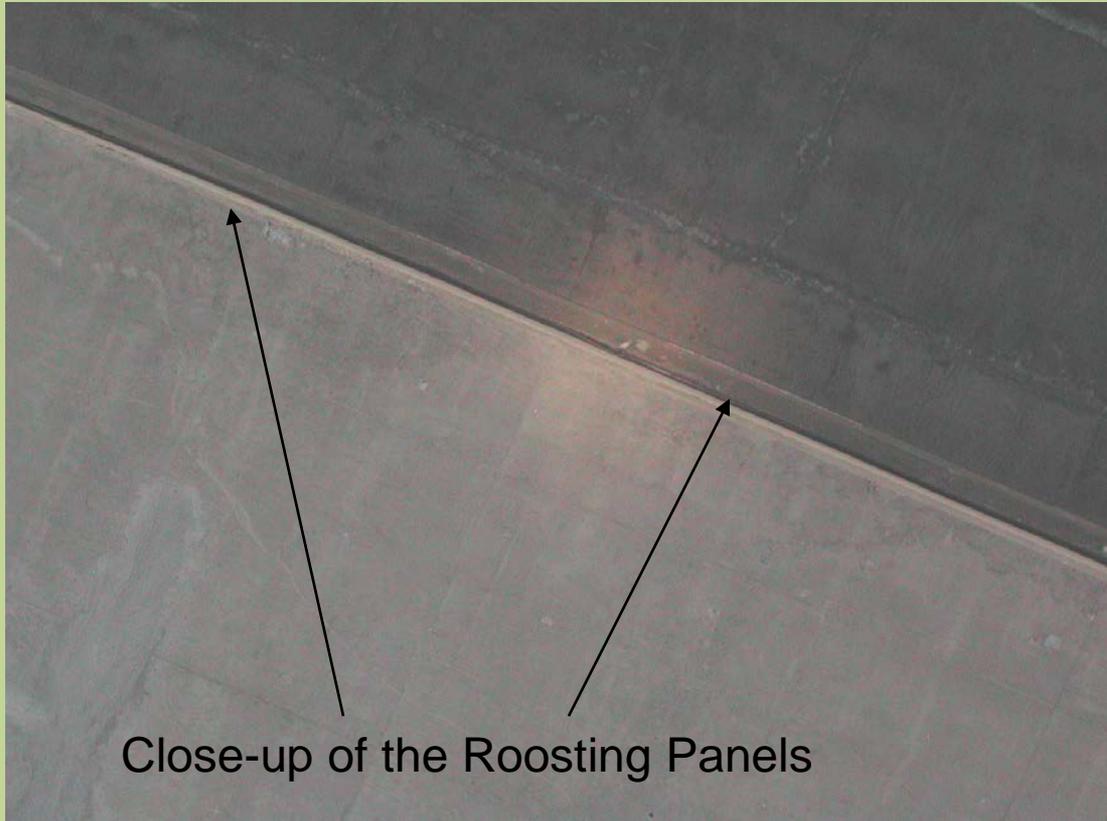
The roosting panels:

- Have a 1 inch wide crevice.
- Are 20 inches deep to provide a thermal gradient.
- Are 75 feet long.

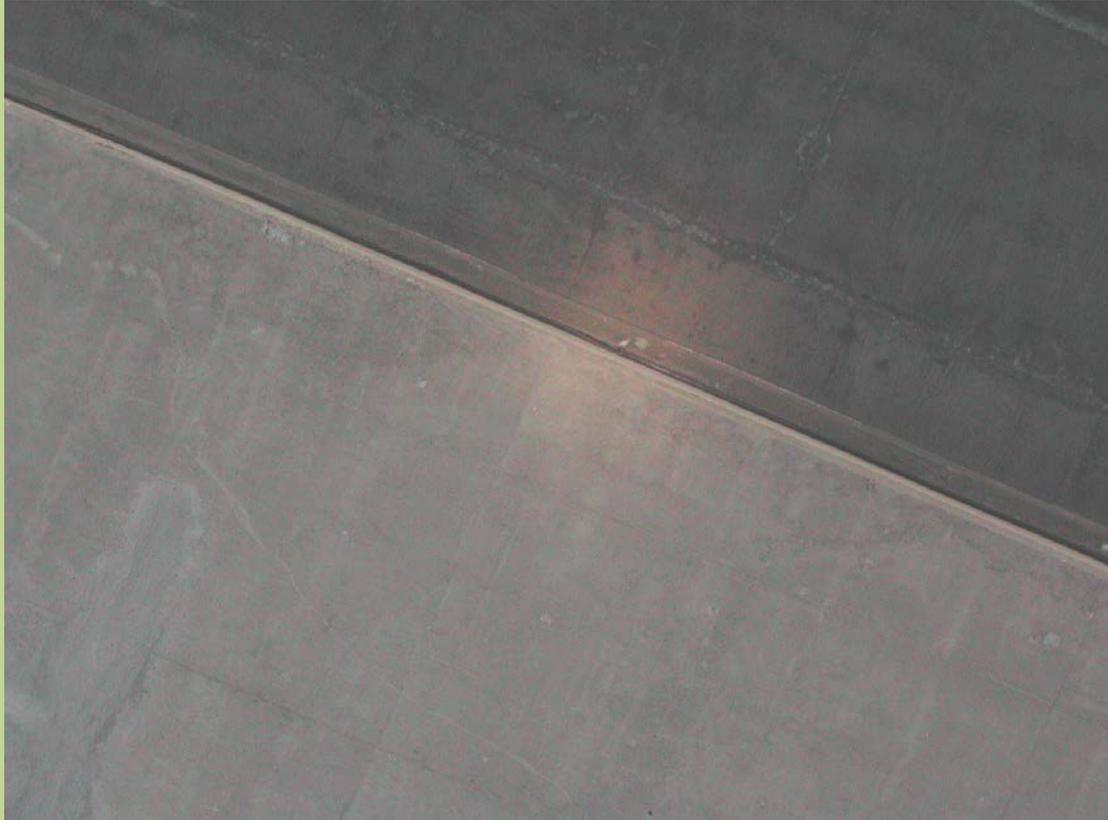
- Allow access to portions of the habitat within which there is a range of temperatures both vertically and horizontally.
- Important both diurnally and seasonally to maintain proper temperature.

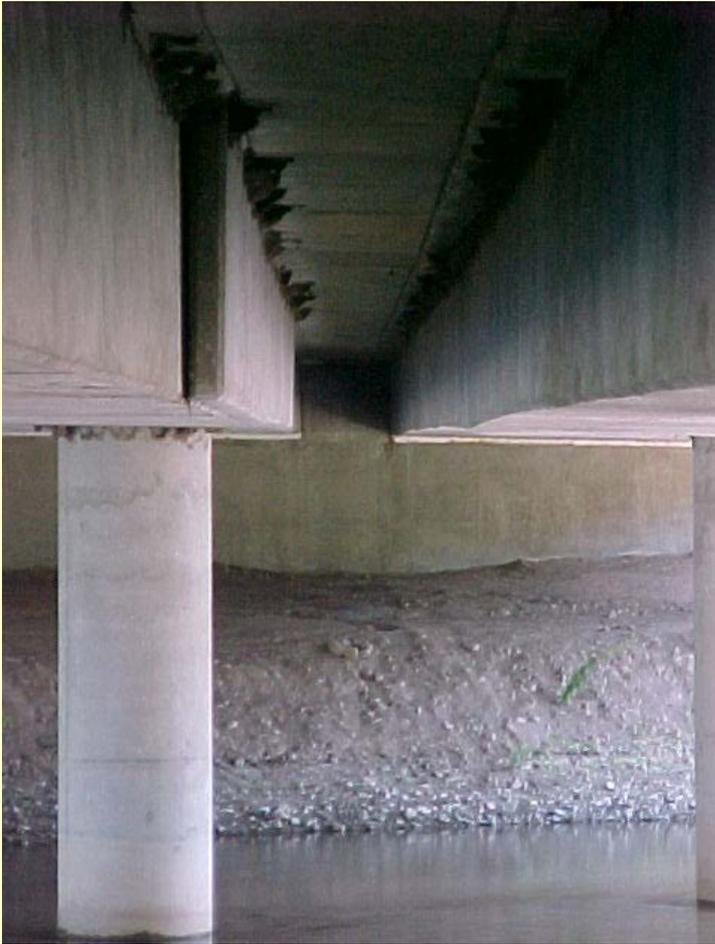
# Innovative Engineering, Design and Construction

- Designed to not interfere with maintenance and inspection.
- Total cost was \$50,000- only 0.4% of the bridge cost.
- Good success to date.
- Bat population preserved in the area.

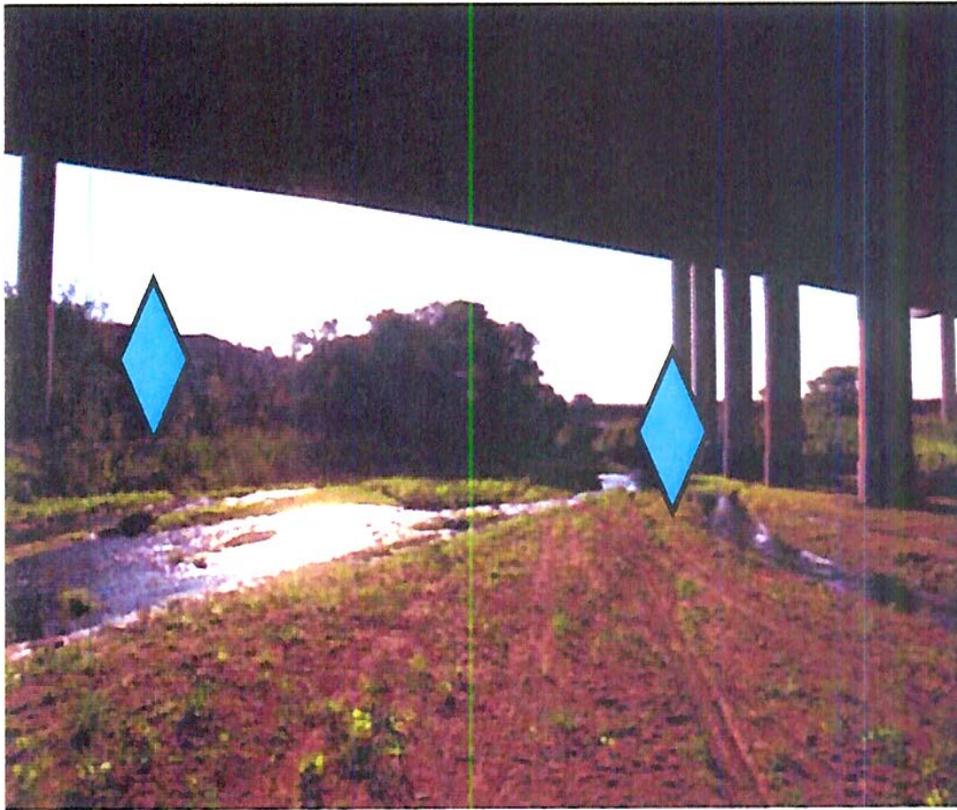
- View of underside of bridge facing east and west.
- During the evening exit counts, bat surveyors stood in the areas identified with blue diamonds.

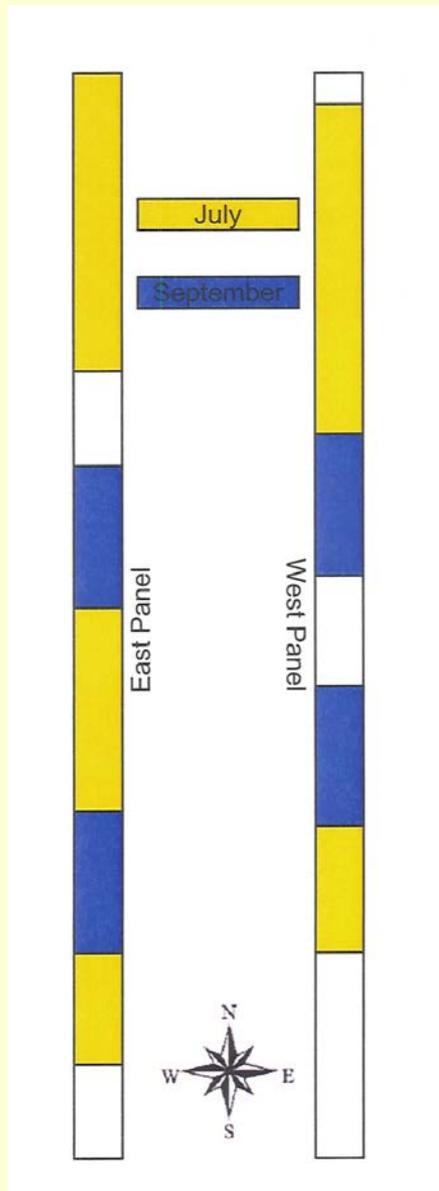
During summer 2007 surveys, bats occupied different sections of the habitat:

- The yellow sections indicate distribution of bats during the July survey, clumped throughout the east and west panels.

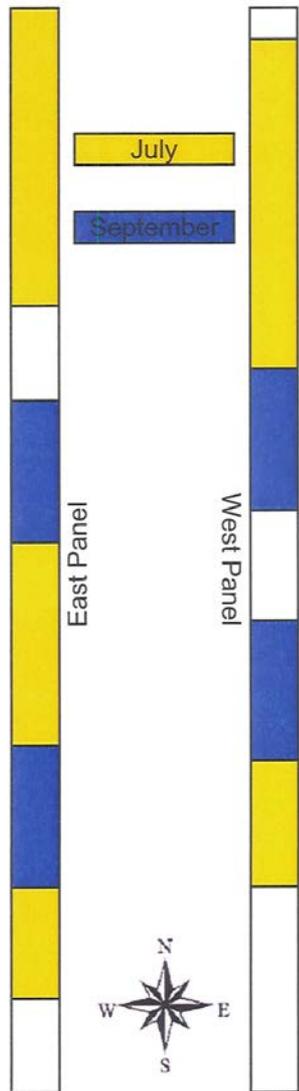
- The blue sections indicate distribution of bats during the September survey.
- The population was roosting more towards the middle of the east and west roosting panels.

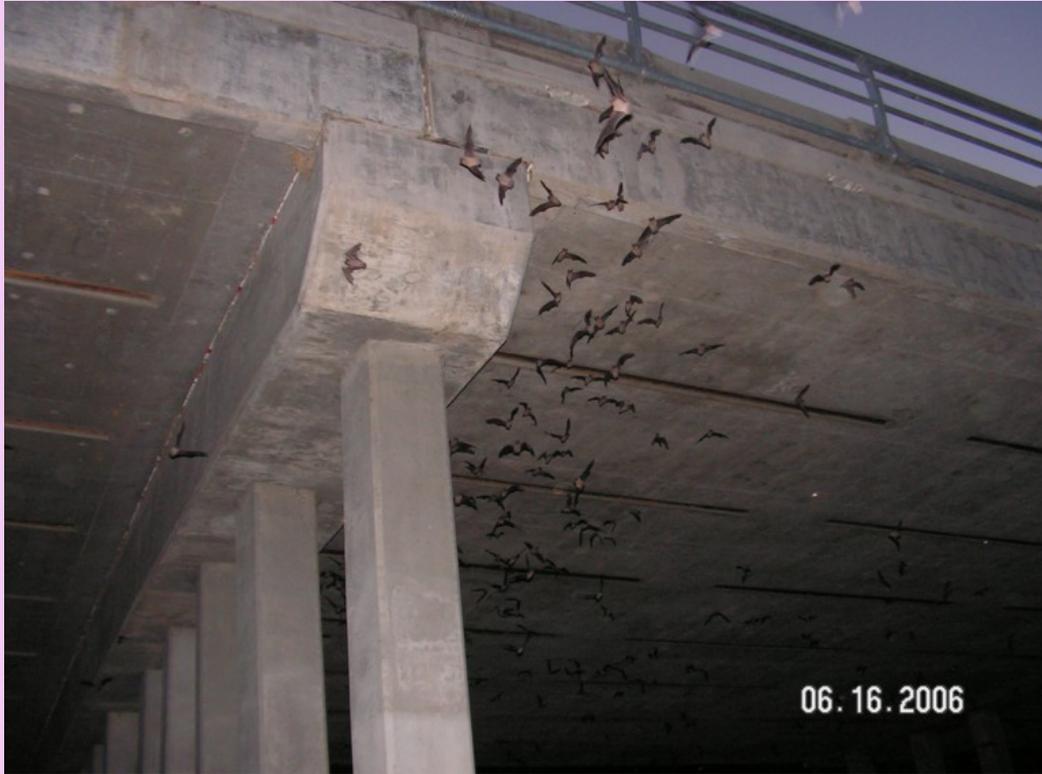
# Exit Survey Estimated Results

<u>Date</u>	<u>Population</u>
• 8/23/05	200-300
• 7/31/06	730
• 8/24/06	1000
• 7/3/07	2450
• 9/17/07	385
• 6/18/08	2000
• 8/18/08	4000

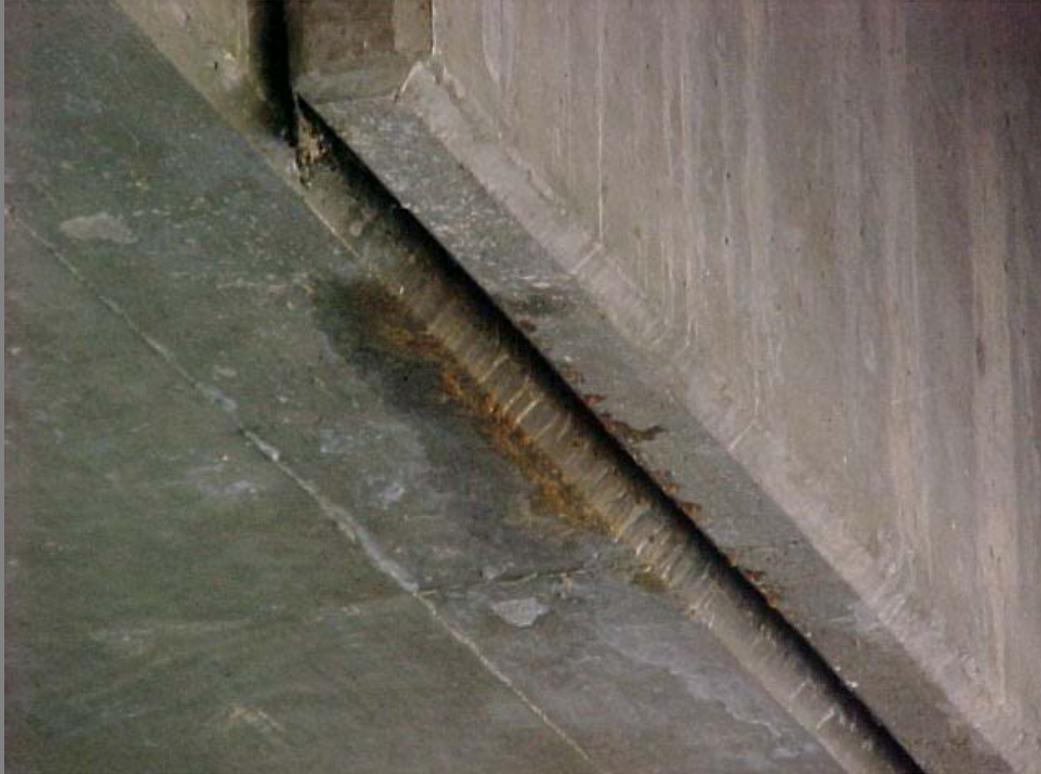
- If funding can be secured, another bat habitat panel of the same or variable dimensions should be added to the existing panel, doubling the capacity of the habitat.
