Successful Control of Invasive Spanish Broom (*Spartium junceum*)

Robert A. James

Caltrans, District 11

Broom Control on SR-67 in Ramona, San Diego Co.

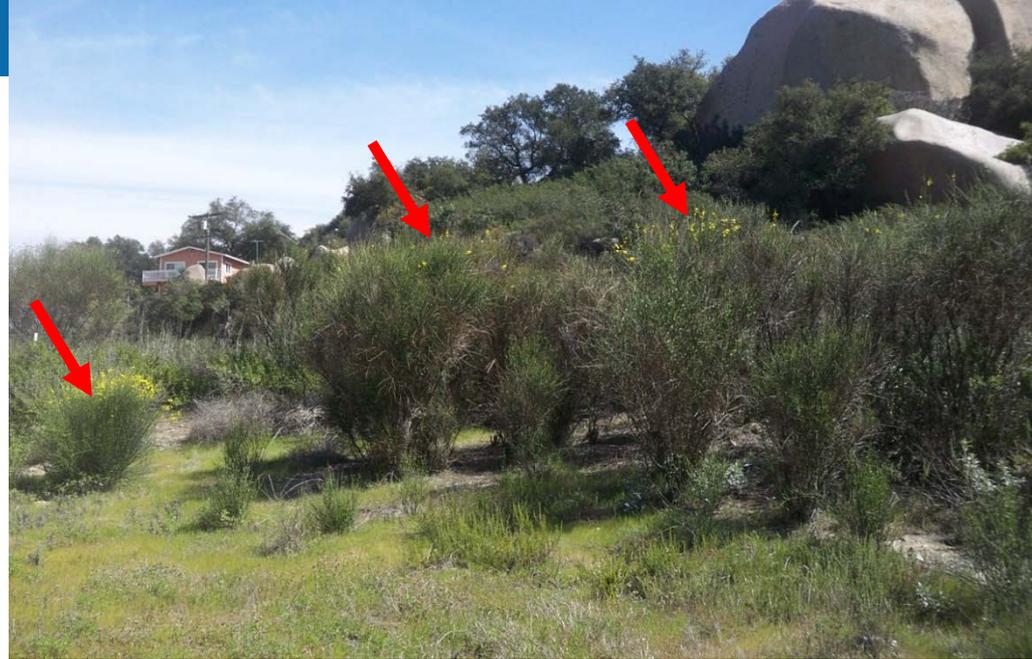
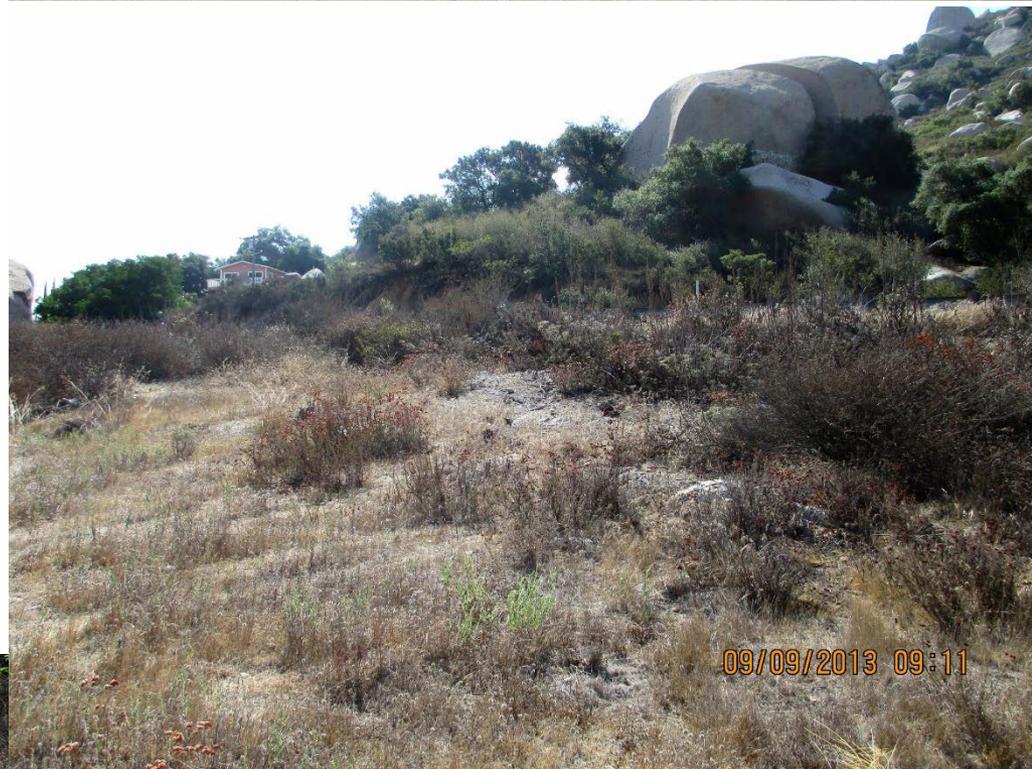
- About 300 shrubs along and near highway needing control
- Stump cutting / application of herbicide triclopyr (Garlon) by Caltrans Maintenance initially ~95% effective (summer, when active growth). Glyphosate not!
- Little follow up control required in next 3 yrs for stump resprouts and new plants (<1% cover returned)
- Native vegetation replacing broom, such as California buckwheat, forbs, and grasses
- Integrated Pest Management (IPM) approach let natives return
- Similar results observed in efforts by San Diego County and USFS

This was a successful effort that can be applied to other Spanish broom populations, different broom species, and other invasive shrubs. Careful planning, implementation, and multi-year follow up are keys to success!

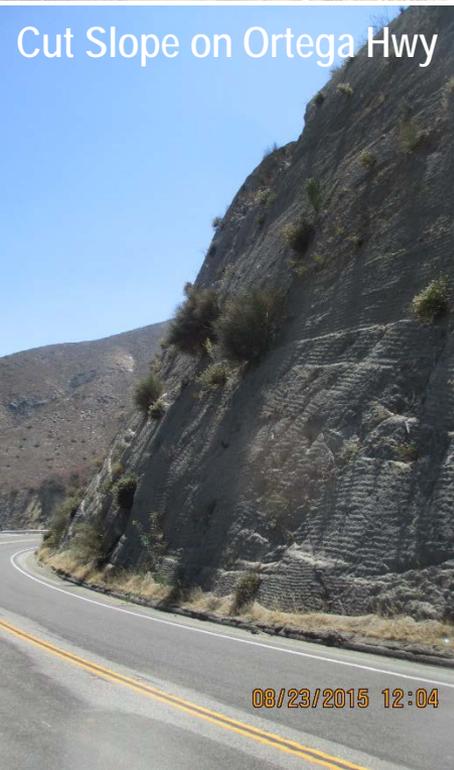
Cut Slope on Ortega Hwy

Other Broom Locations Needing Control
(Riverside, Orange and San Diego Counties)
