# **INFORMATION HANDOUT**

**For Contract No. 03-1F9904**

# AERIALY DEPOSITED LEAD AND TRAFFIC STRIPE PAINT SITE INVESTIGATION REPORT

State Route 32  
Post Mile 9.54 to 10.22  
Butte County, California

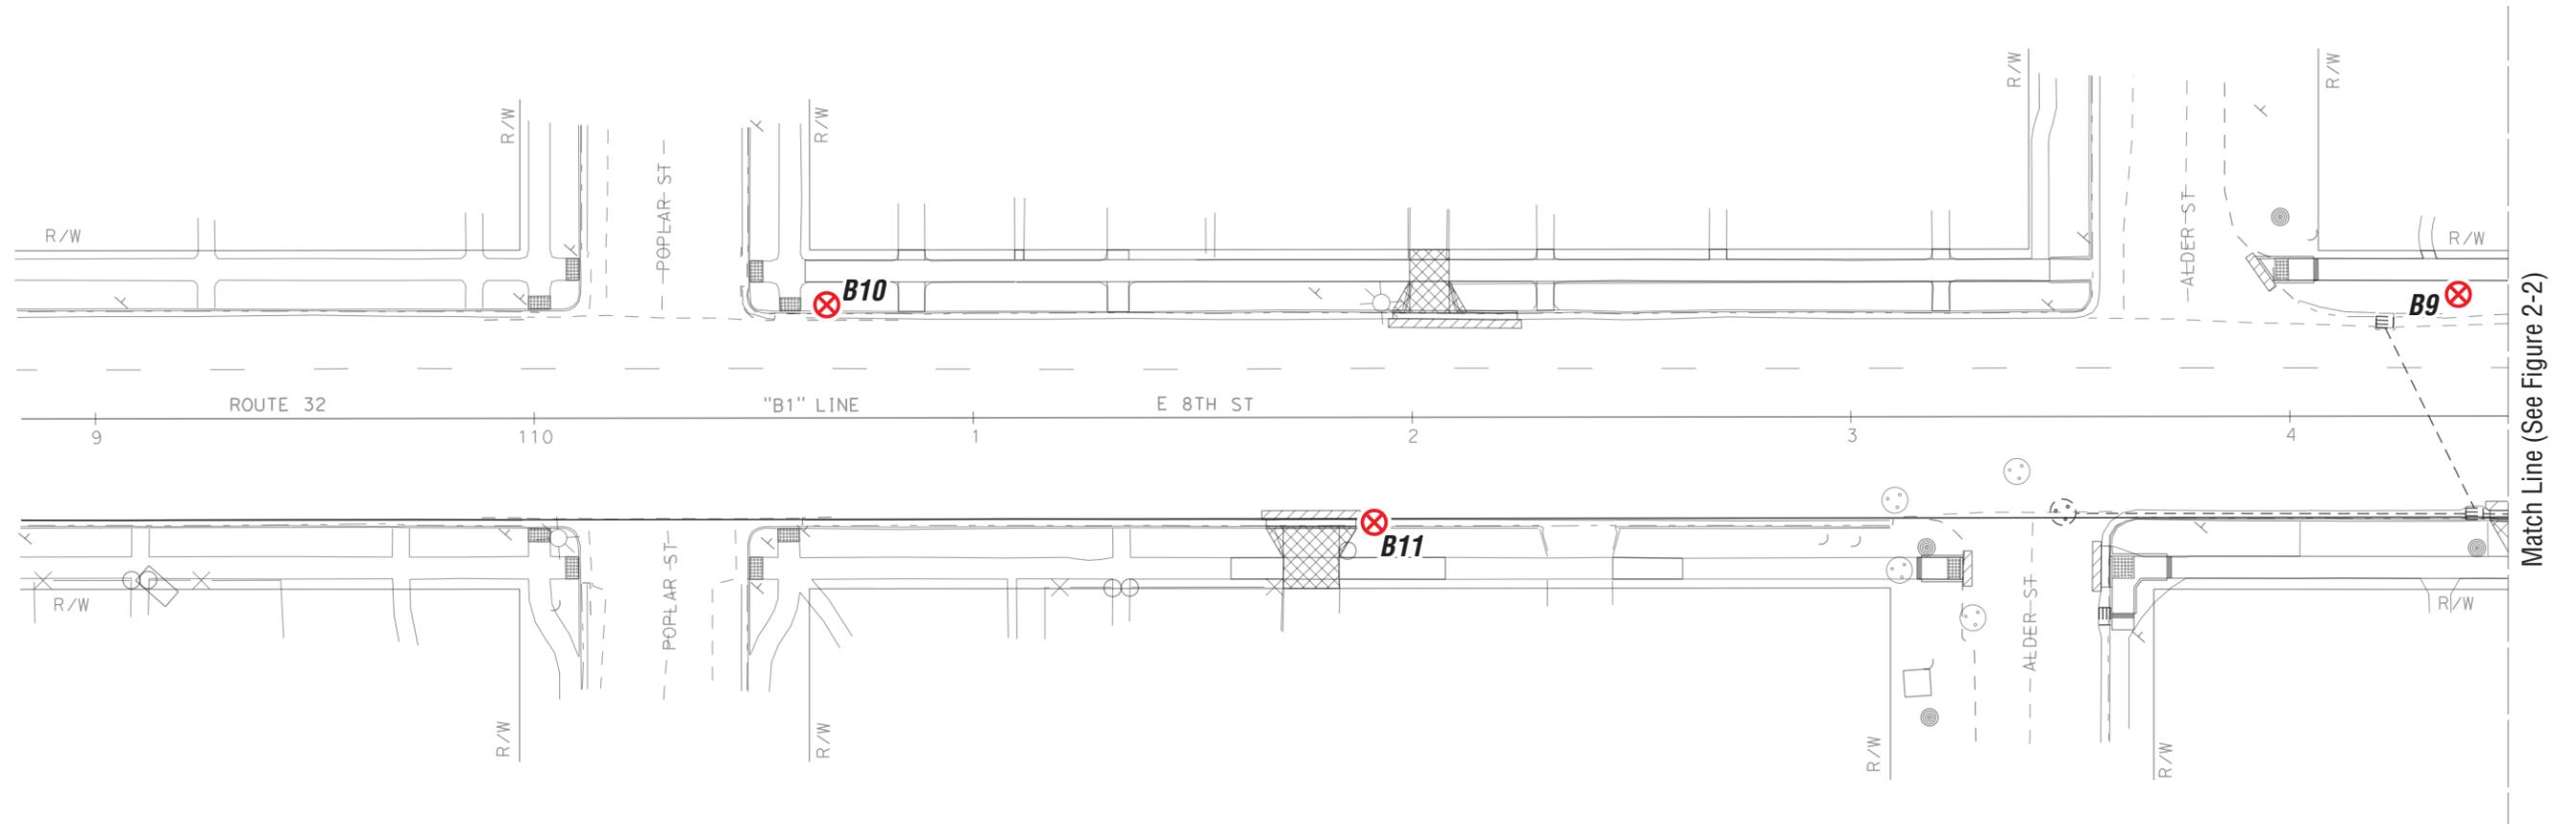
October 2015 Figure 2-1

**SITE PLAN**  
**WB SR-32**  
**(E. 8th Street)**

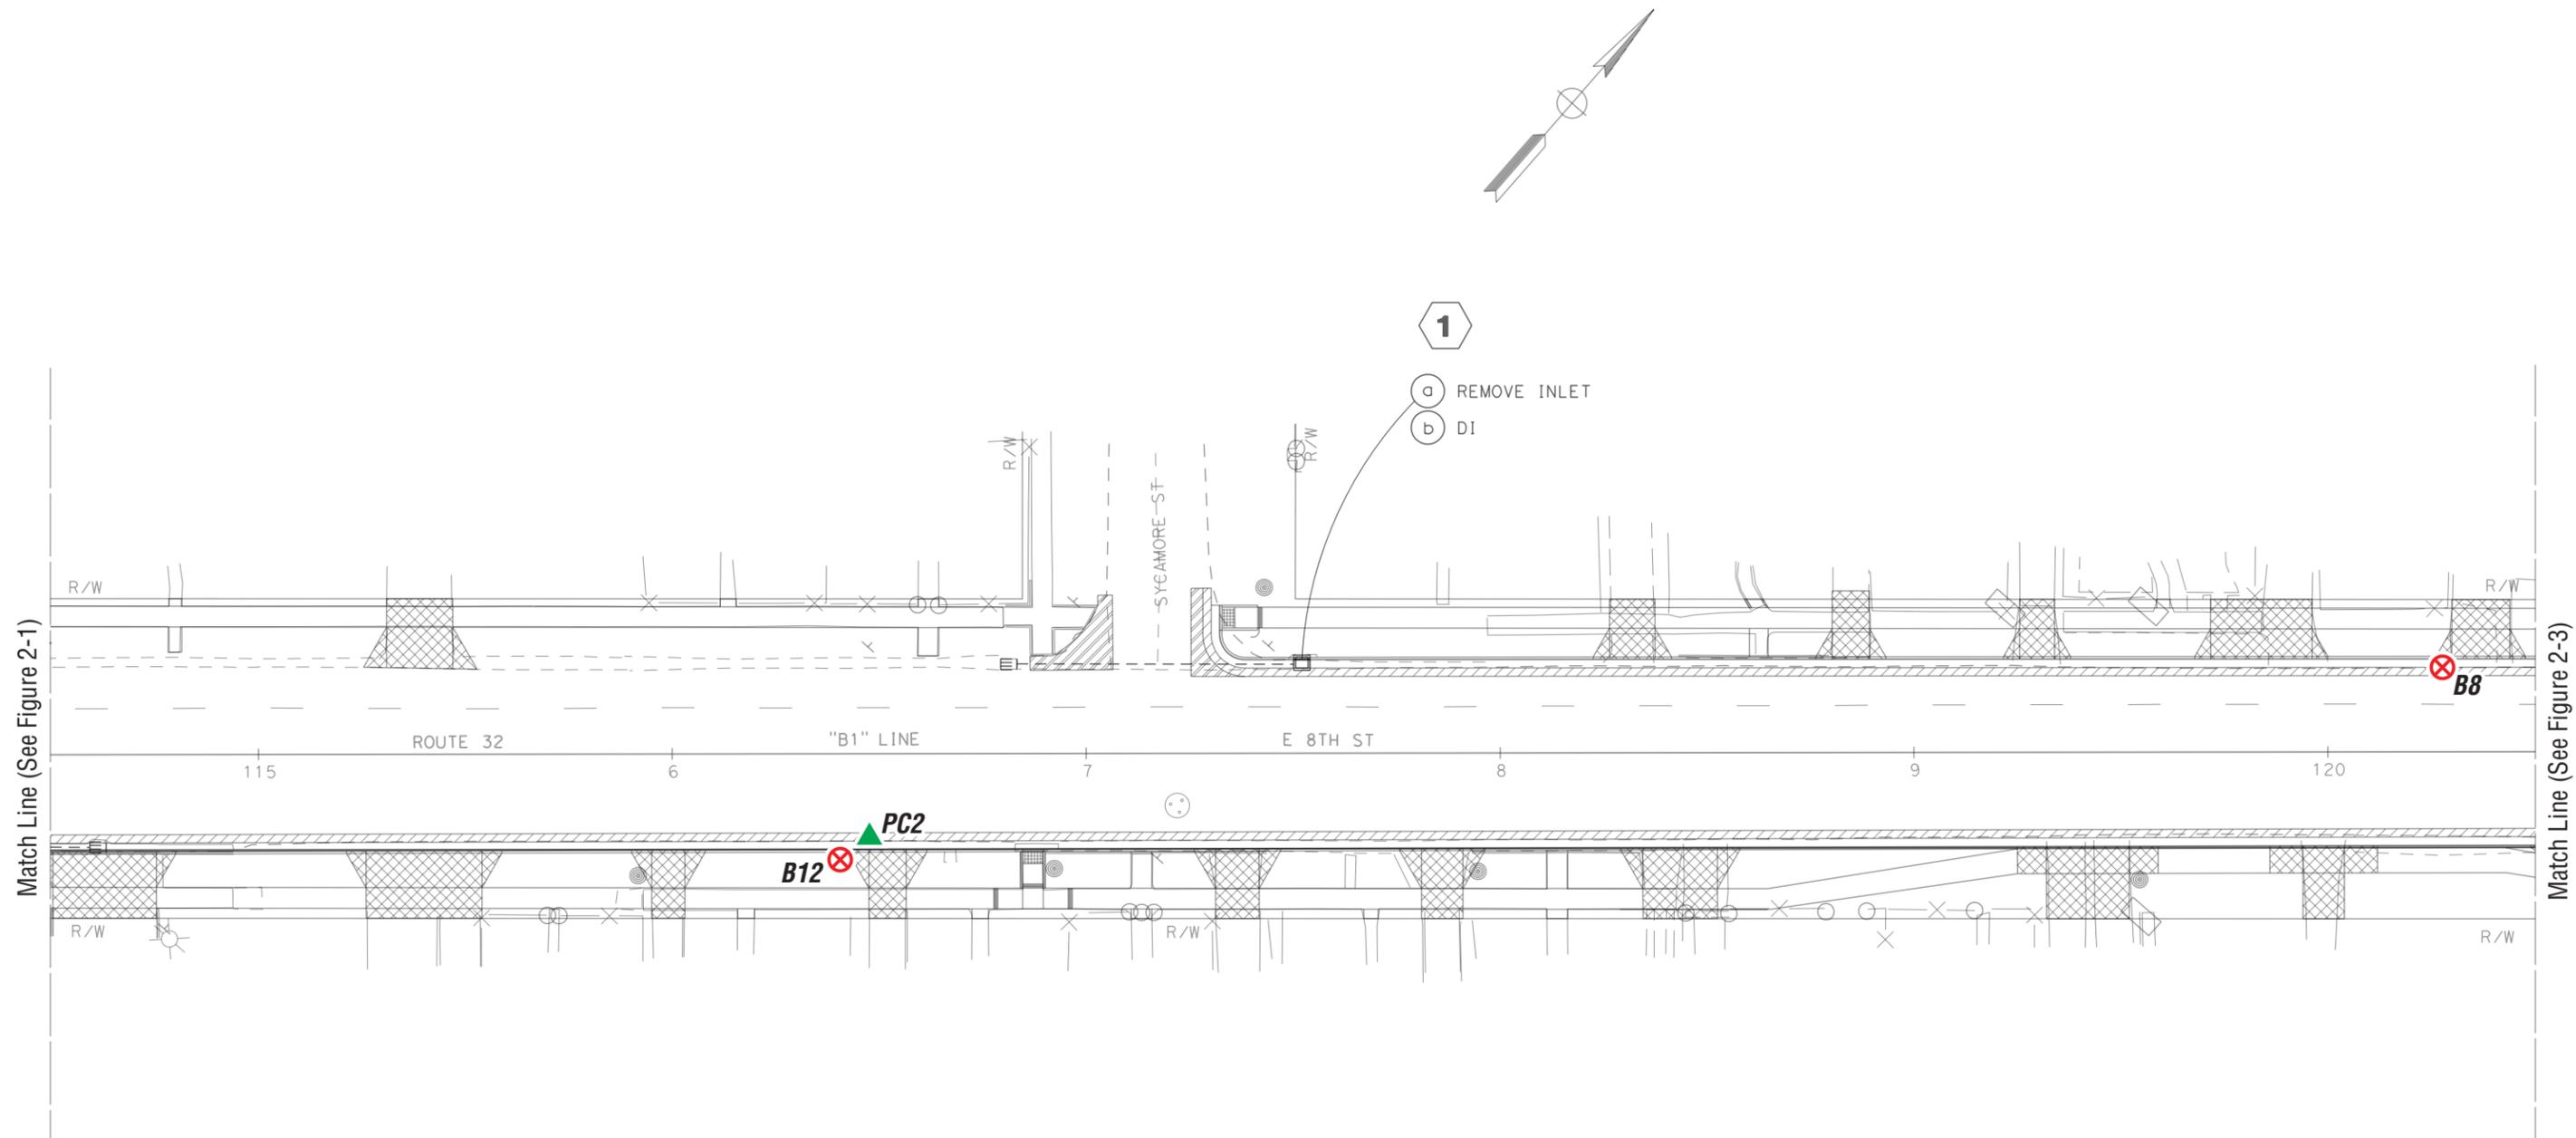
October 2015 | Figure 2-2

We collected yellow traffic stripe paint samples PC1 and PC2 along WB SR-32 (E 8<sup>th</sup> Street), and samples PC3 and PC4 along EB SR-32 (E 9<sup>th</sup> Street). The traffic stripe paint samples were collected using a hammer to break a chip off the traffic stripe paint, then the samples were placed in Ziploc<sup>®</sup> re-sealable plastic bags, labeled, and delivered to ATL under standard COC documentation. The approximate traffic stripe paint sample locations are depicted on Figures 2-2, 2-3, 3-2, and 3-5.

**SITE PLAN**  
**WB SR-32**  
**(E. 8th Street)**

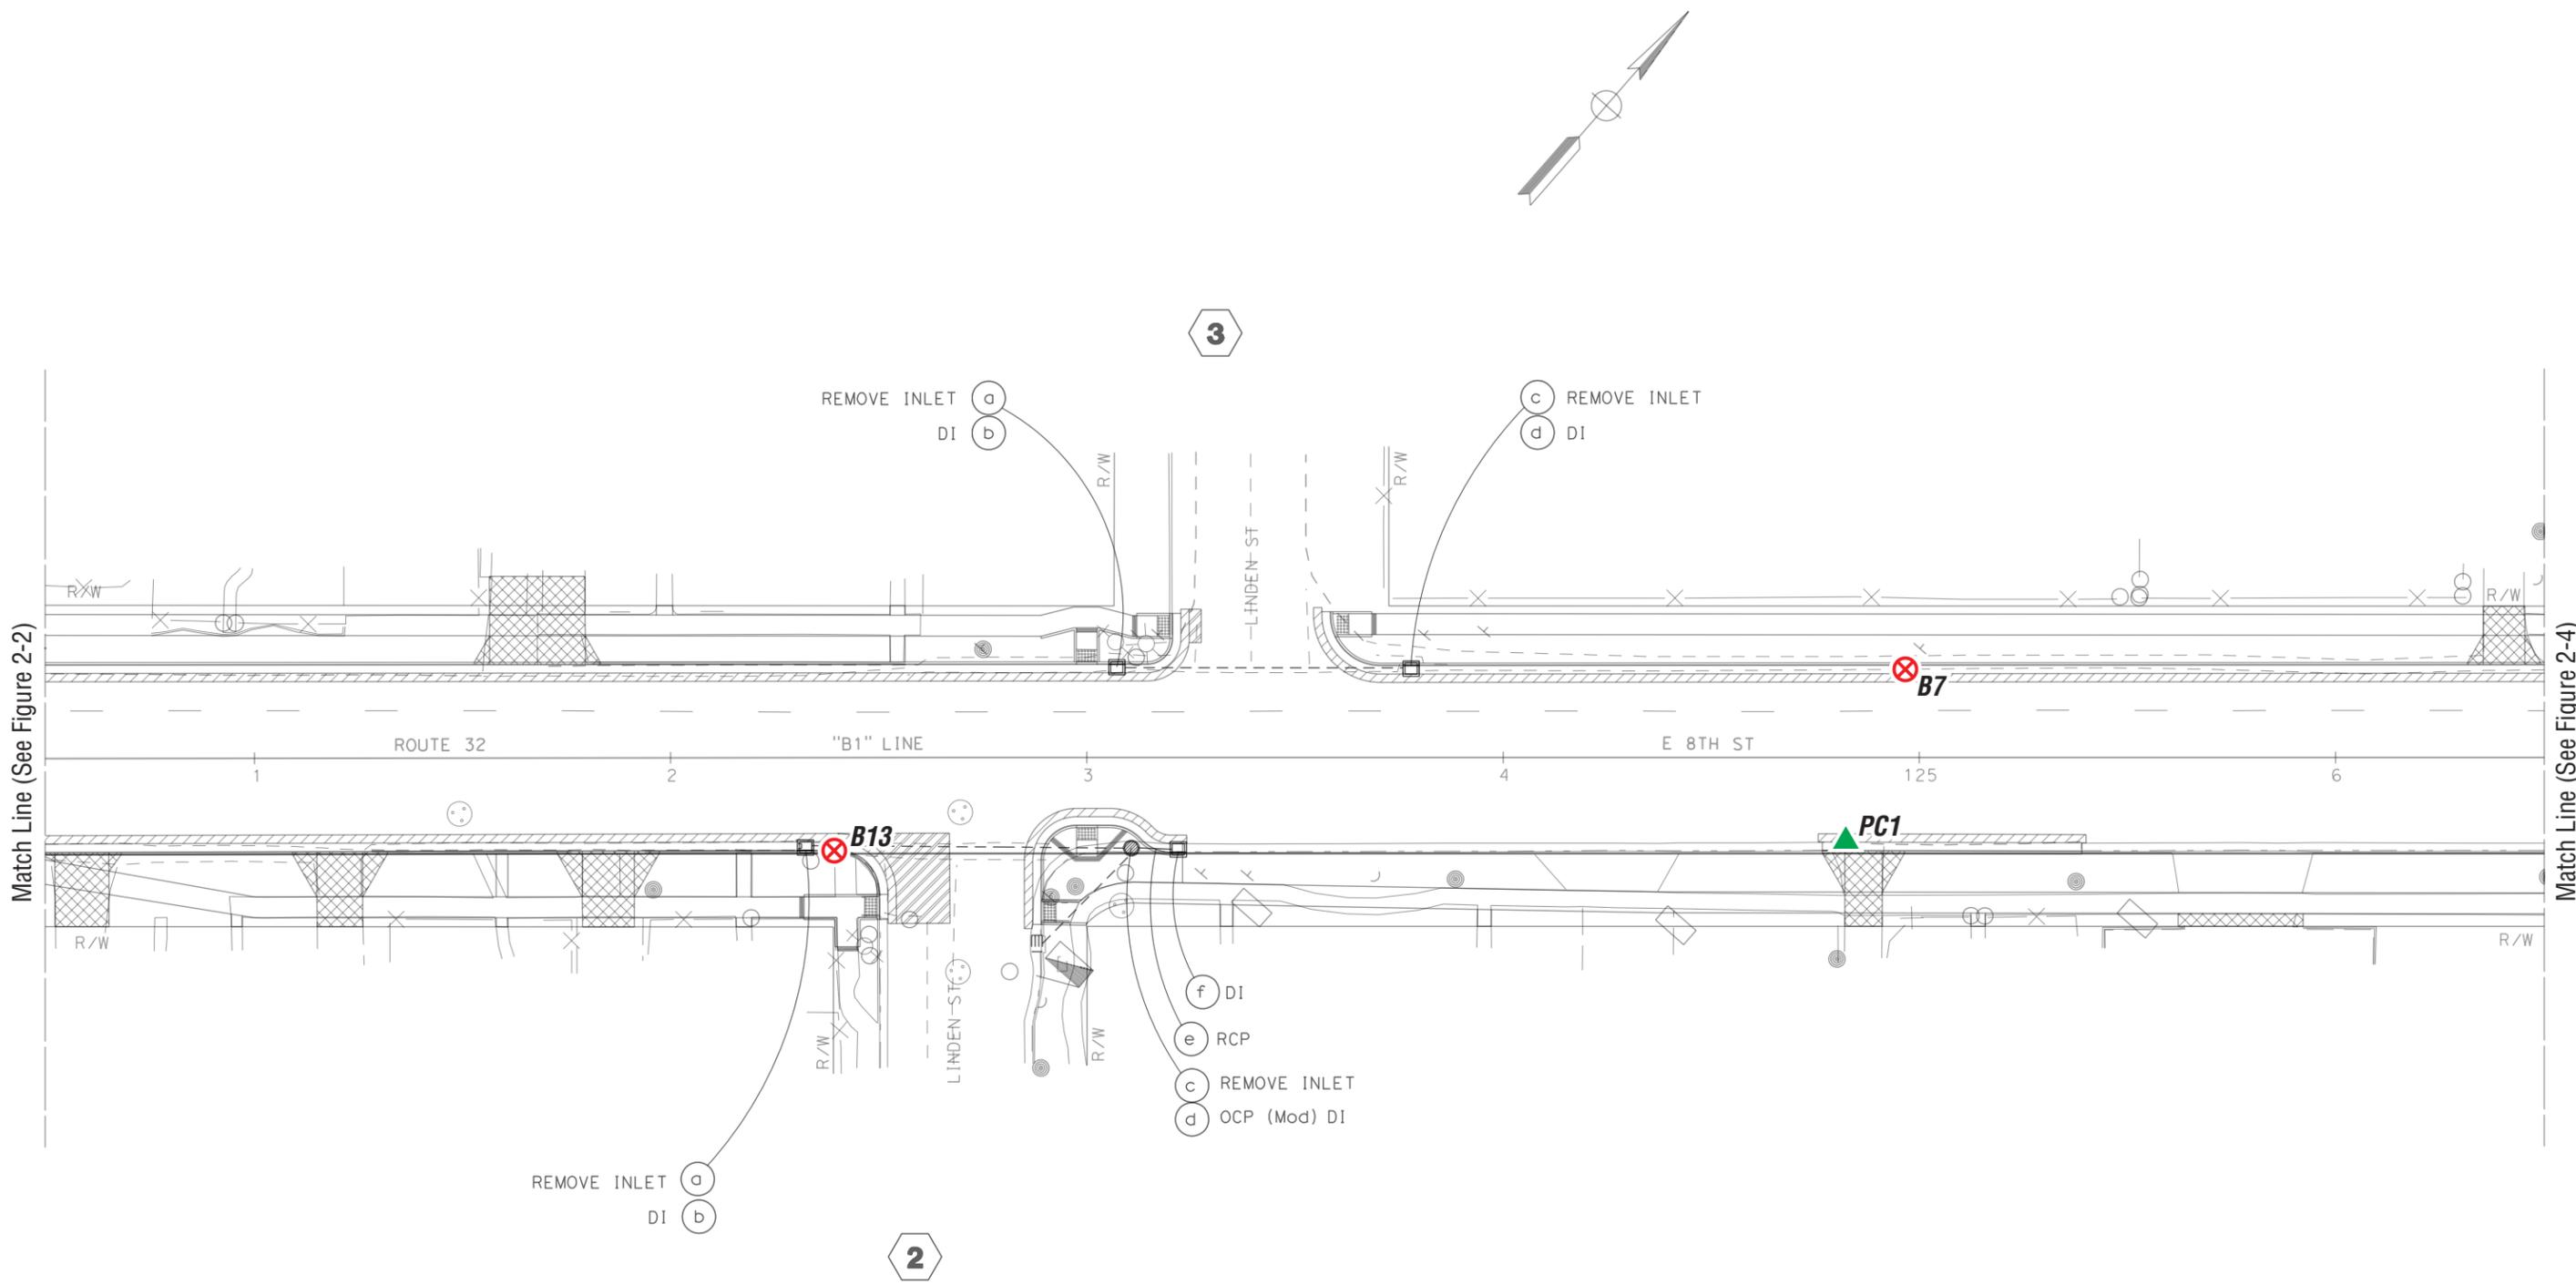
<b>GEOCON</b> CONSULTANTS, INC. <small>3160 GOLD VALLEY DR - SUITE 800 - RANCHO CORDOVA, CA 95742          PHONE 916.852.9118 - FAX 916.852.9132</small>	
<b>State Route 32 Post Miles 9.54 to 10.22</b>	
GEOCON Proj. No. S9805-01-54 TO No. 54 Contract 03A2132 E-FIS 03-00020426-1 EA 03-1F9901	<b>SITE PLAN</b> <b>WB SR-32</b> <b>(E. 8th Street)</b>
	October 2015   Figure 2-3

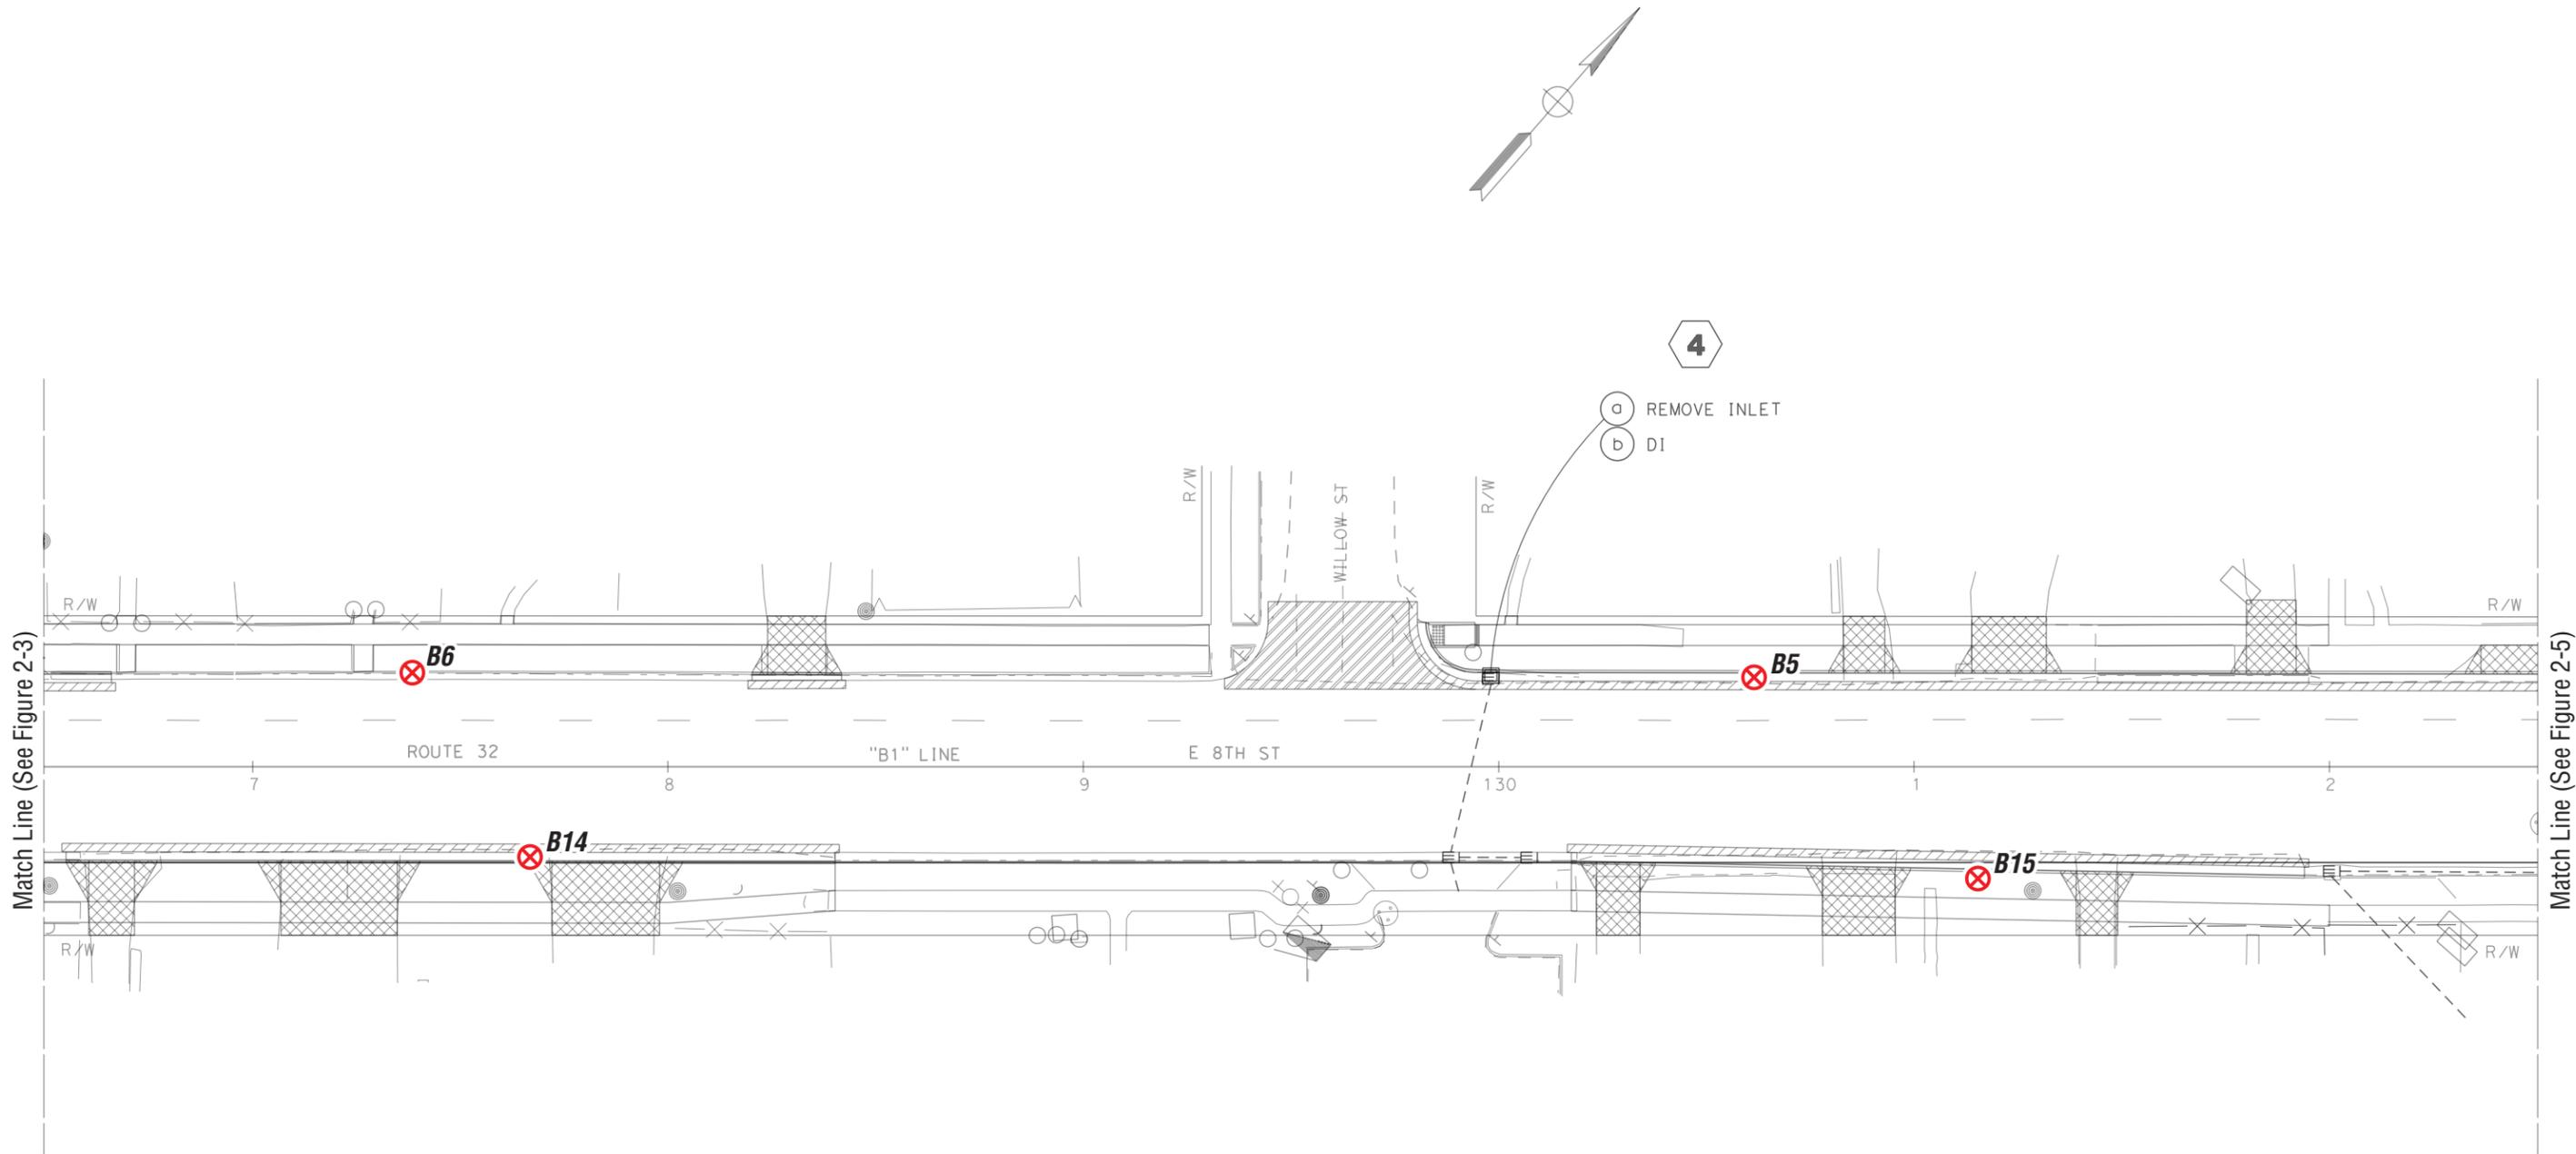
October 2015 Figure 2-4

**SITE PLAN**  
**WB SR-32**  
**(E. 8th Street)**

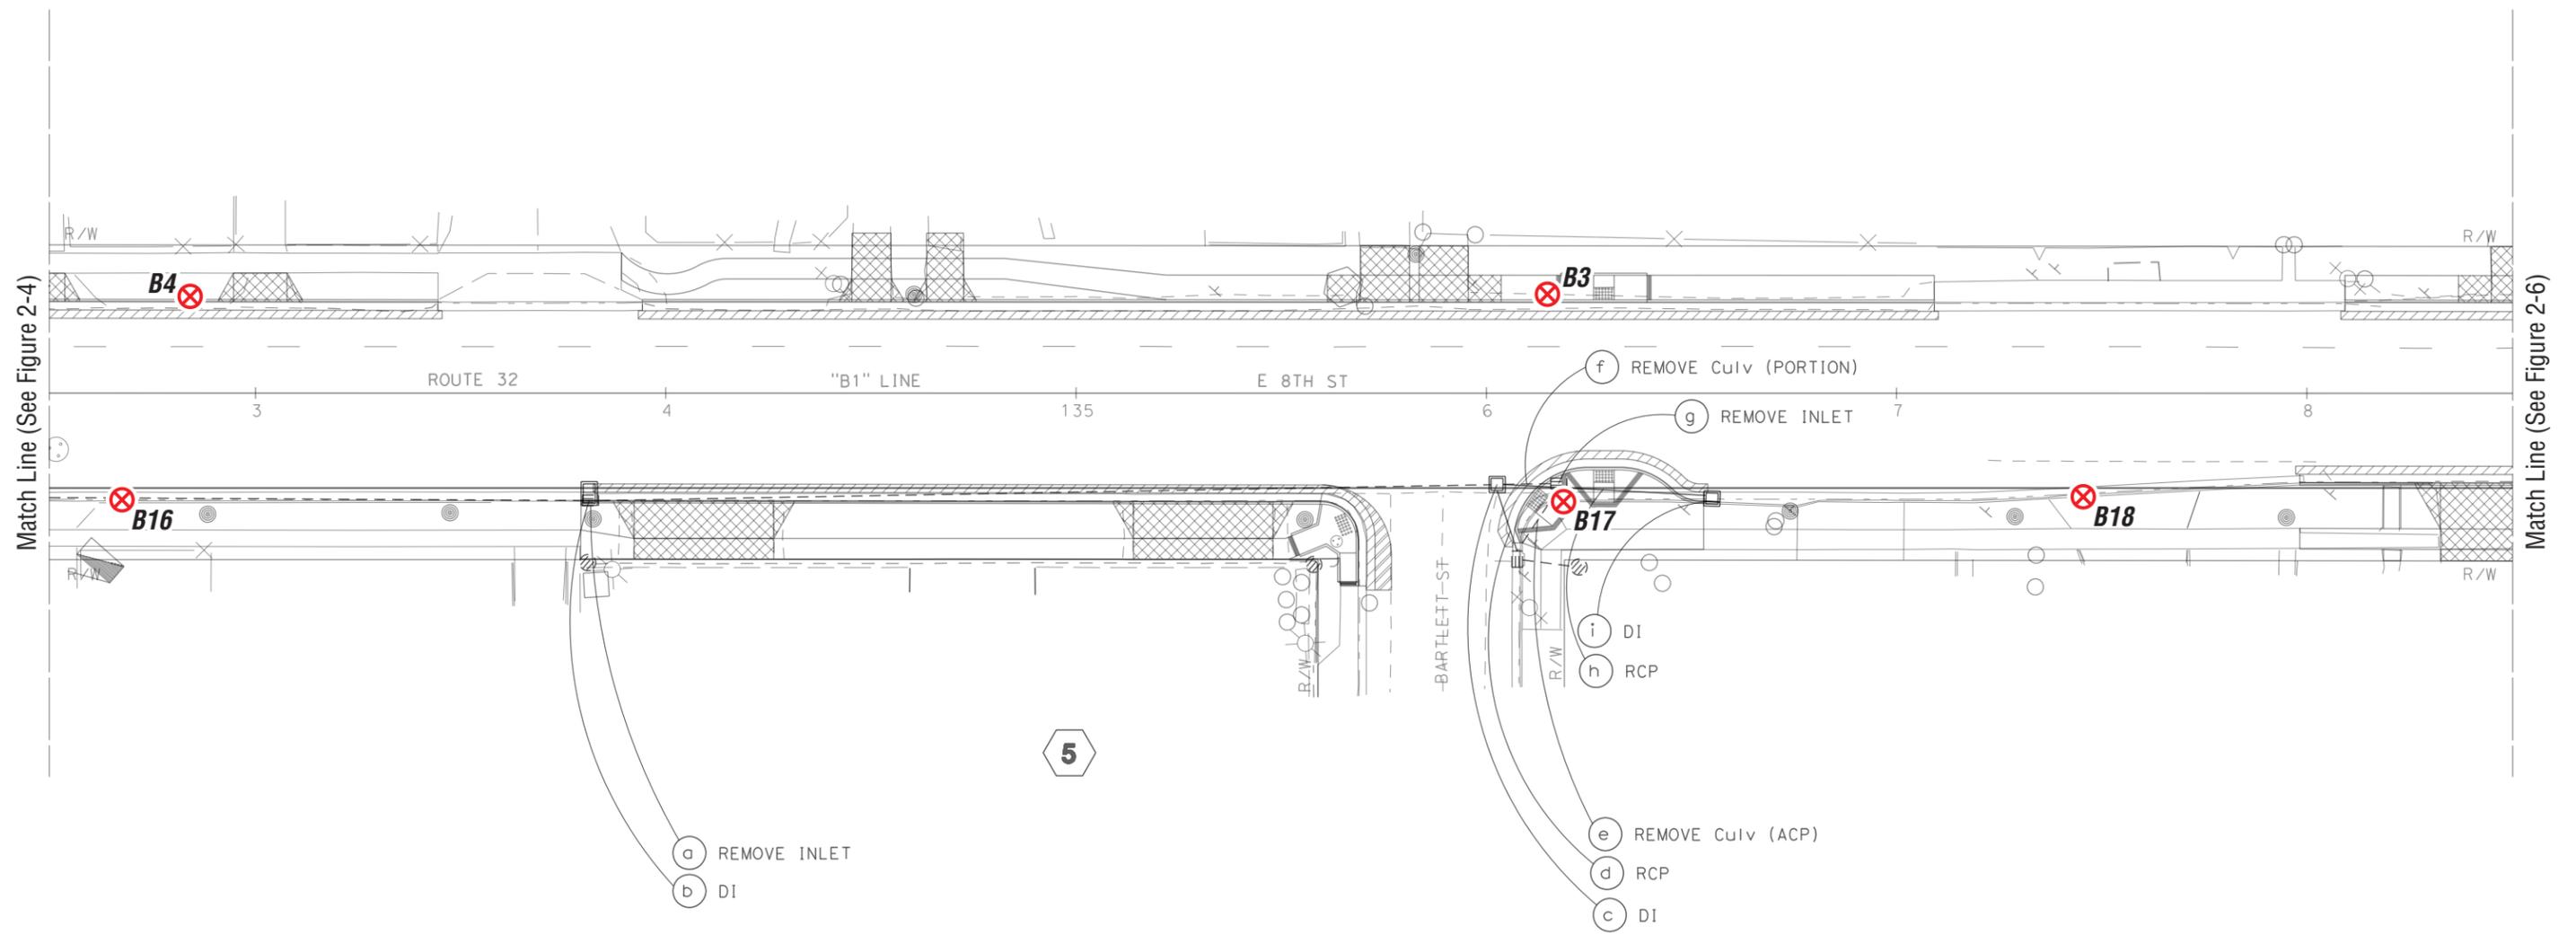
October 2015 | Figure 2-5

**SITE PLAN**  
**WB SR-32**  
**(E. 8th Street)**

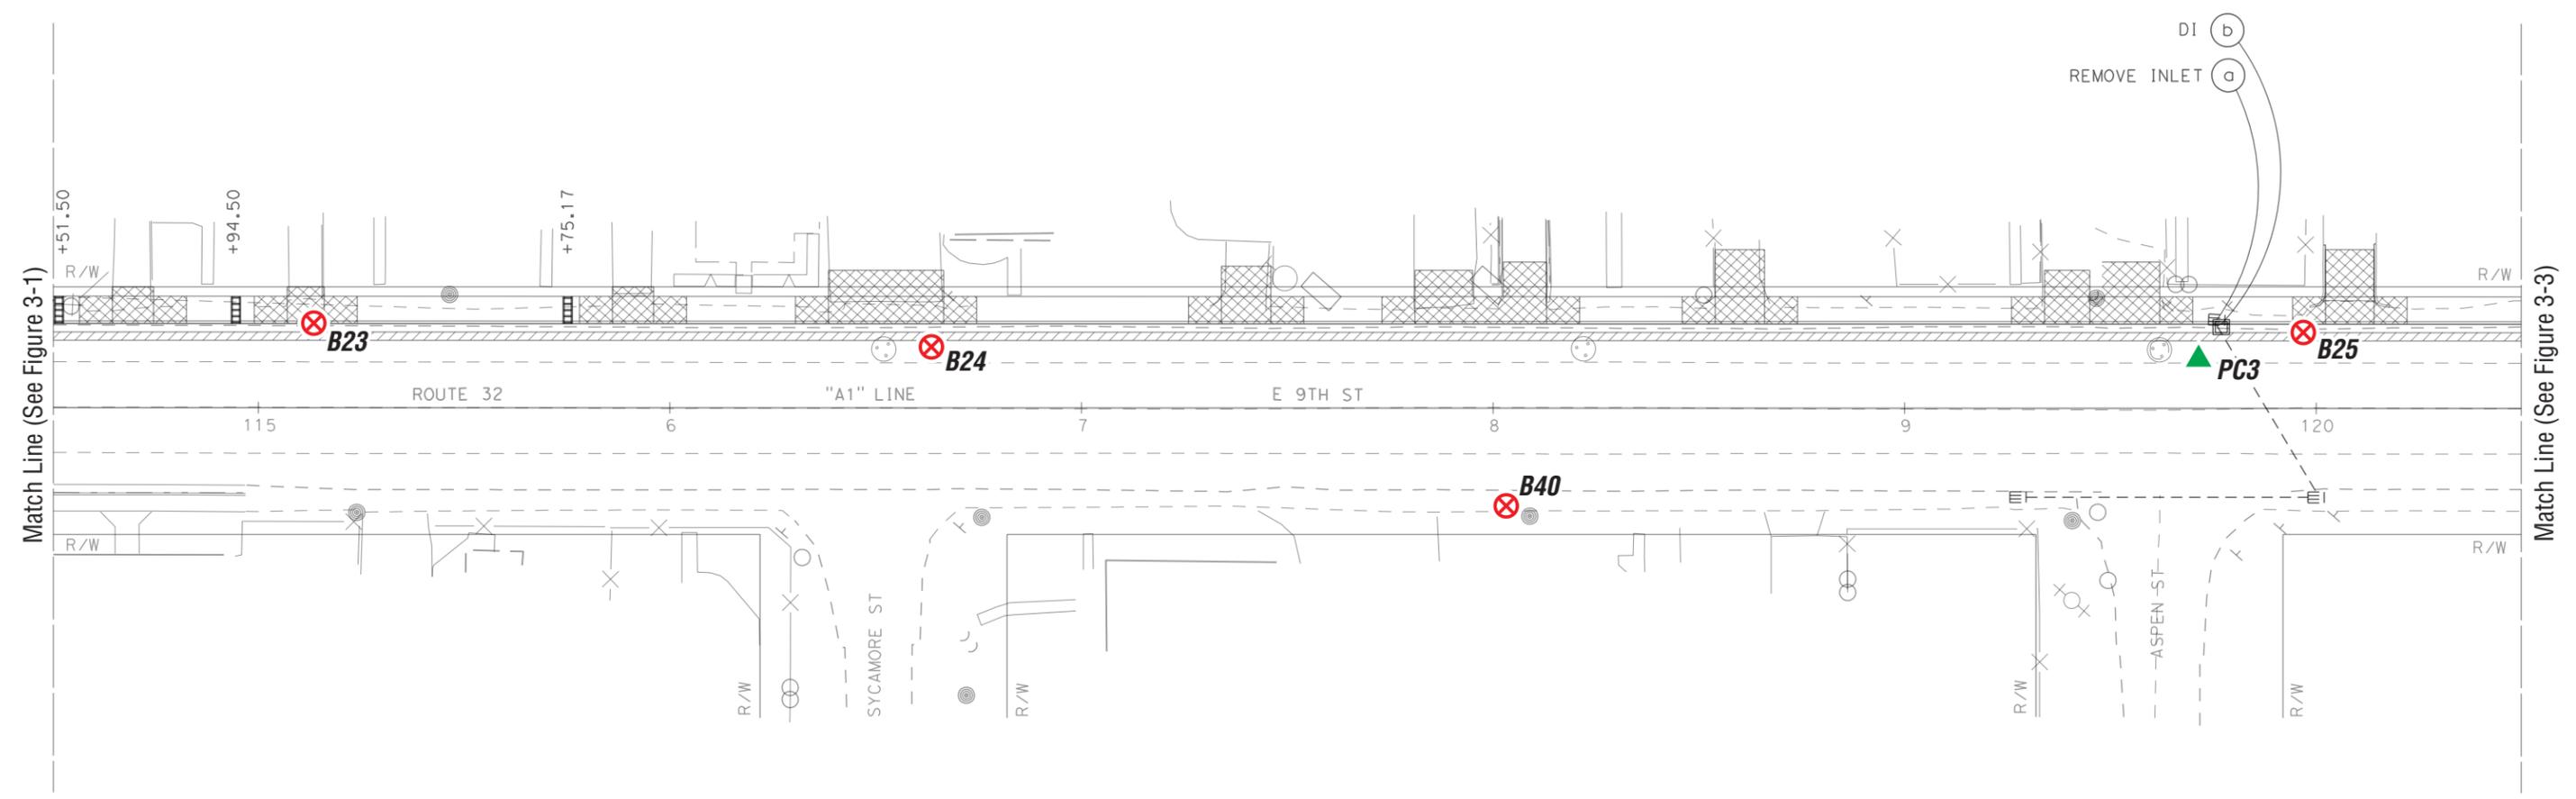
State Route 32 Post Miles 9.54 to 10.22	
GEOCON Proj. No. S9805-01-54 TO No. 54 Contract 03A2132 E-FIS 03-00020426-1 EA 03-1F9901	<b>SITE PLAN</b> <b>EB SR-32</b> <b>(E. 9th Street)</b>
October 2015	Figure 3-2

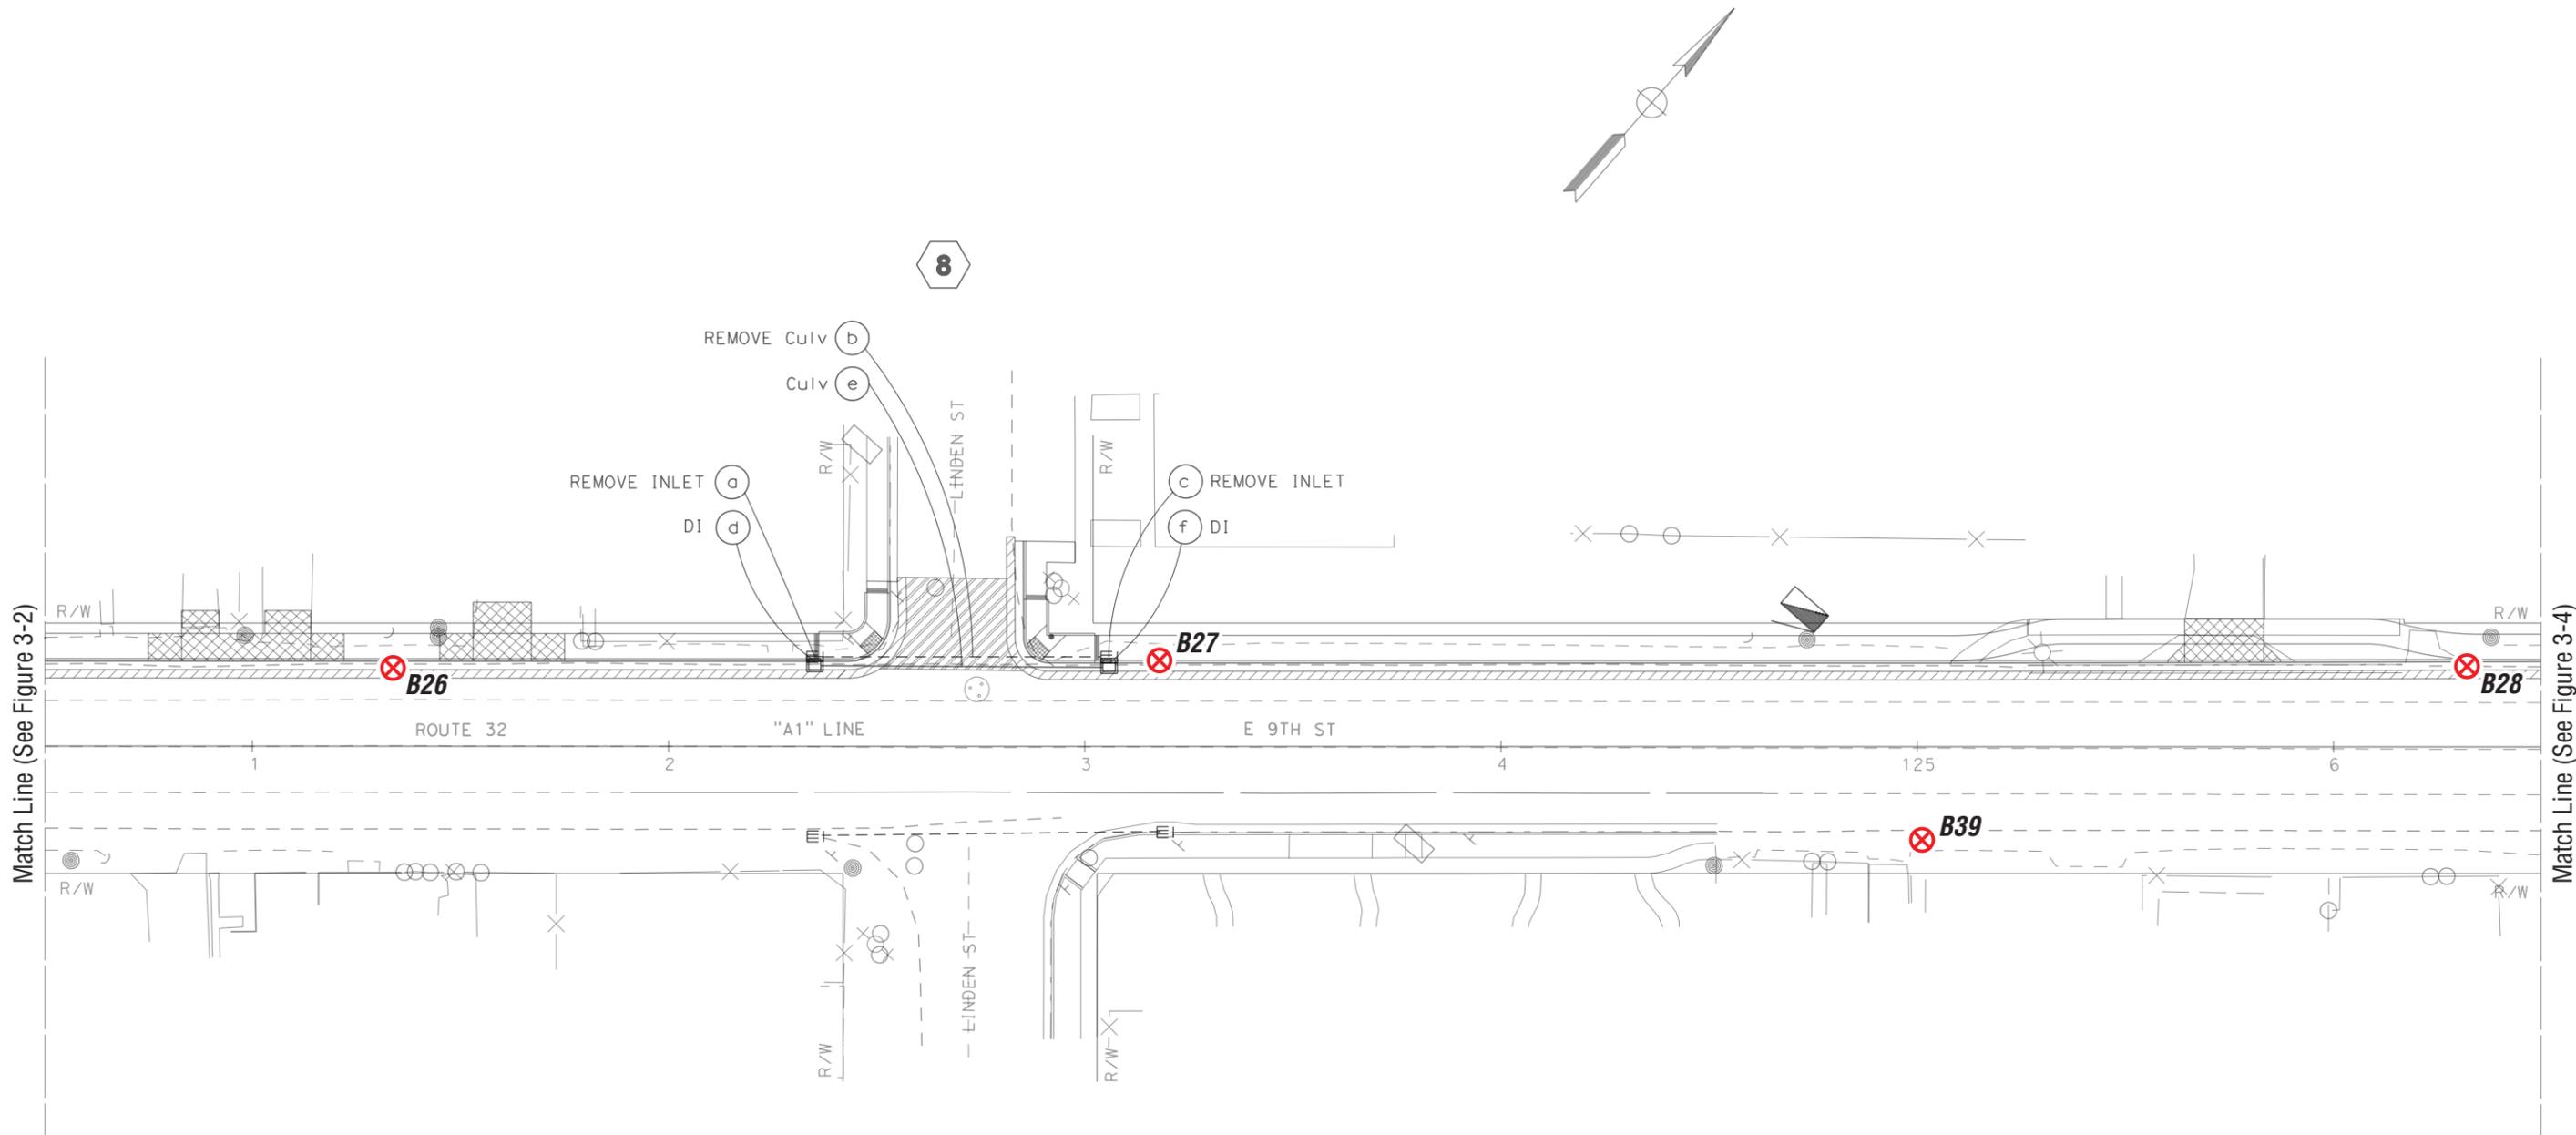
State Route 32 Post Miles 9.54 to 10.22	
GEOCON Proj. No. S9805-01-54 TO No. 54 Contract 03A2132 E-FIS 03-00020426-1 EA 03-1F9901	<b>SITE PLAN</b> <b>EB SR-32</b> <b>(E. 9th Street)</b>
October 2015	Figure 3-3

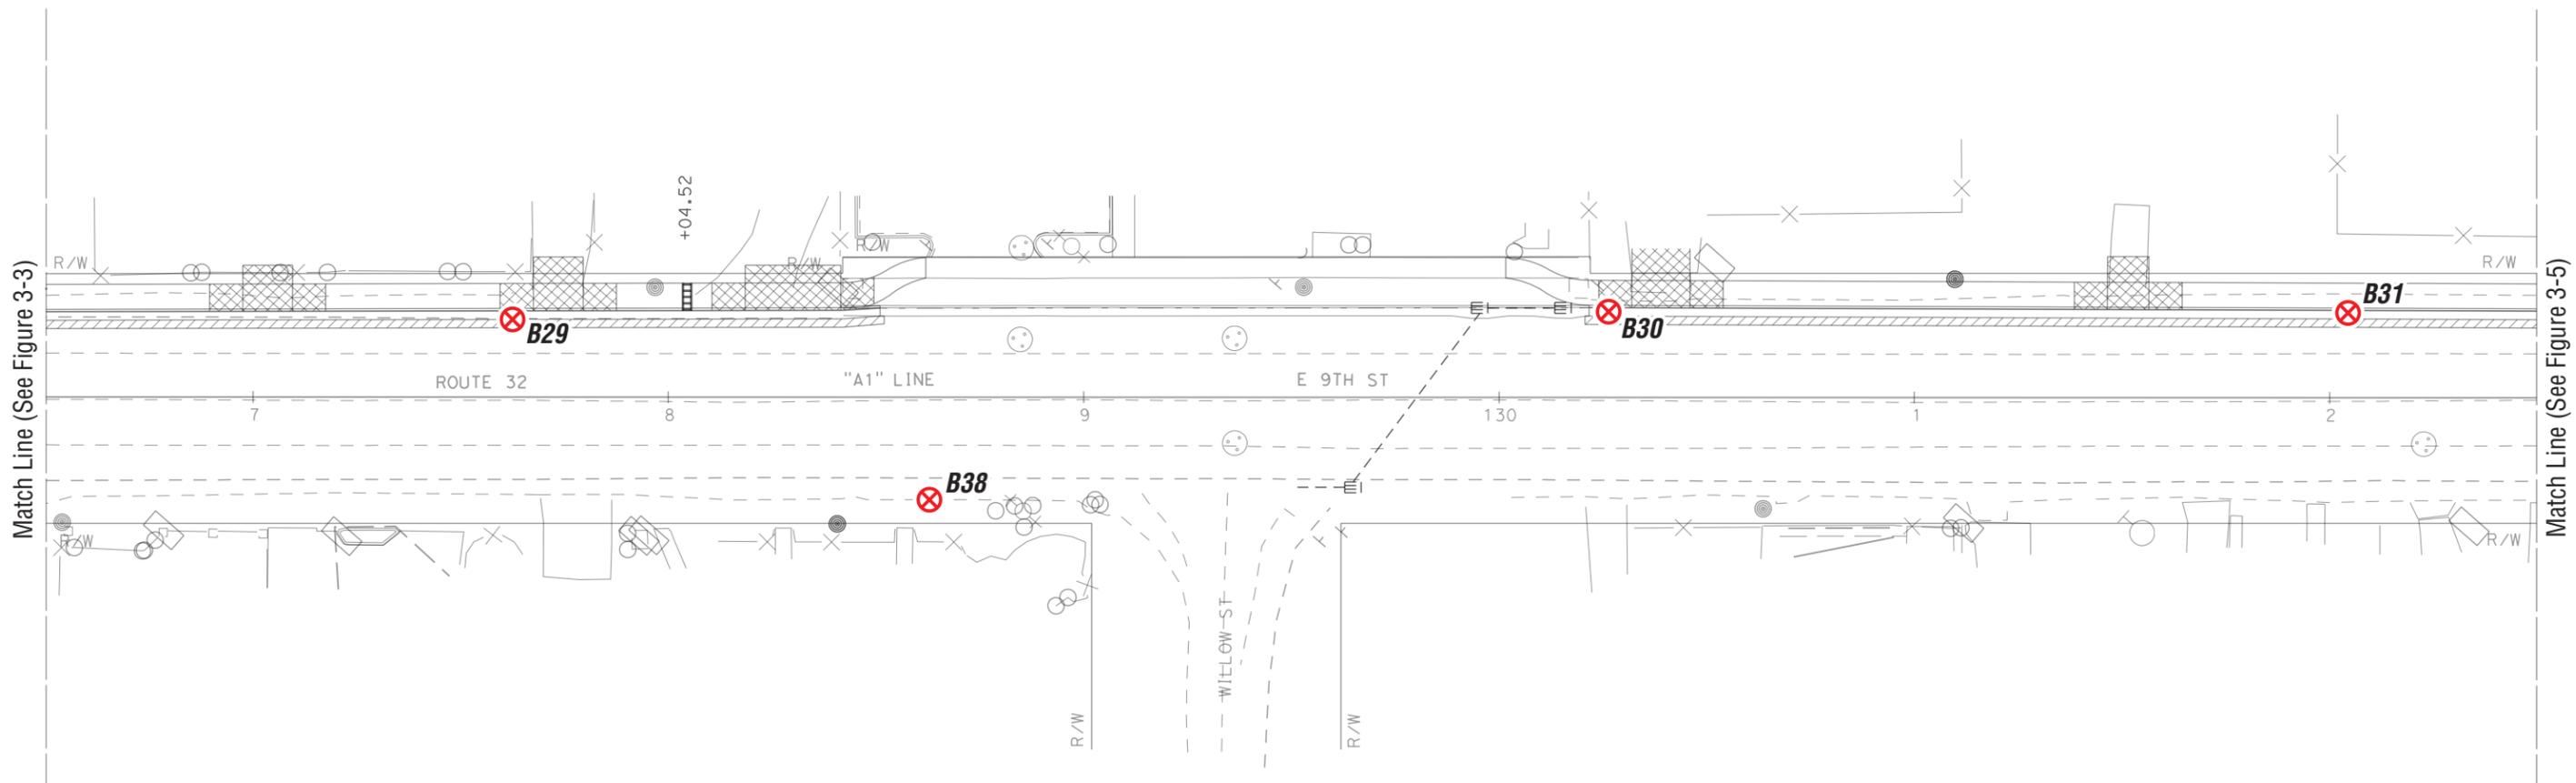
State Route 32 Post Miles 9.54 to 10.22	
GEOCON Proj. No. S9805-01-54 TO No. 54 Contract 03A2132 E-FIS 03-00020426-1 EA 03-1F9901	<b>SITE PLAN</b> <b>EB SR-32</b> <b>(E. 9th Street)</b>
October 2015	Figure 3-4
