# **INFORMATION HANDOUT**

**For Contract No. 03-1F9904**

# AERIALY DEPOSITED LEAD AND TRAFFIC STRIPE PAINT SITE INVESTIGATION REPORT

State Route 32  
Post Mile 9.54 to 10.22  
Butte County, California

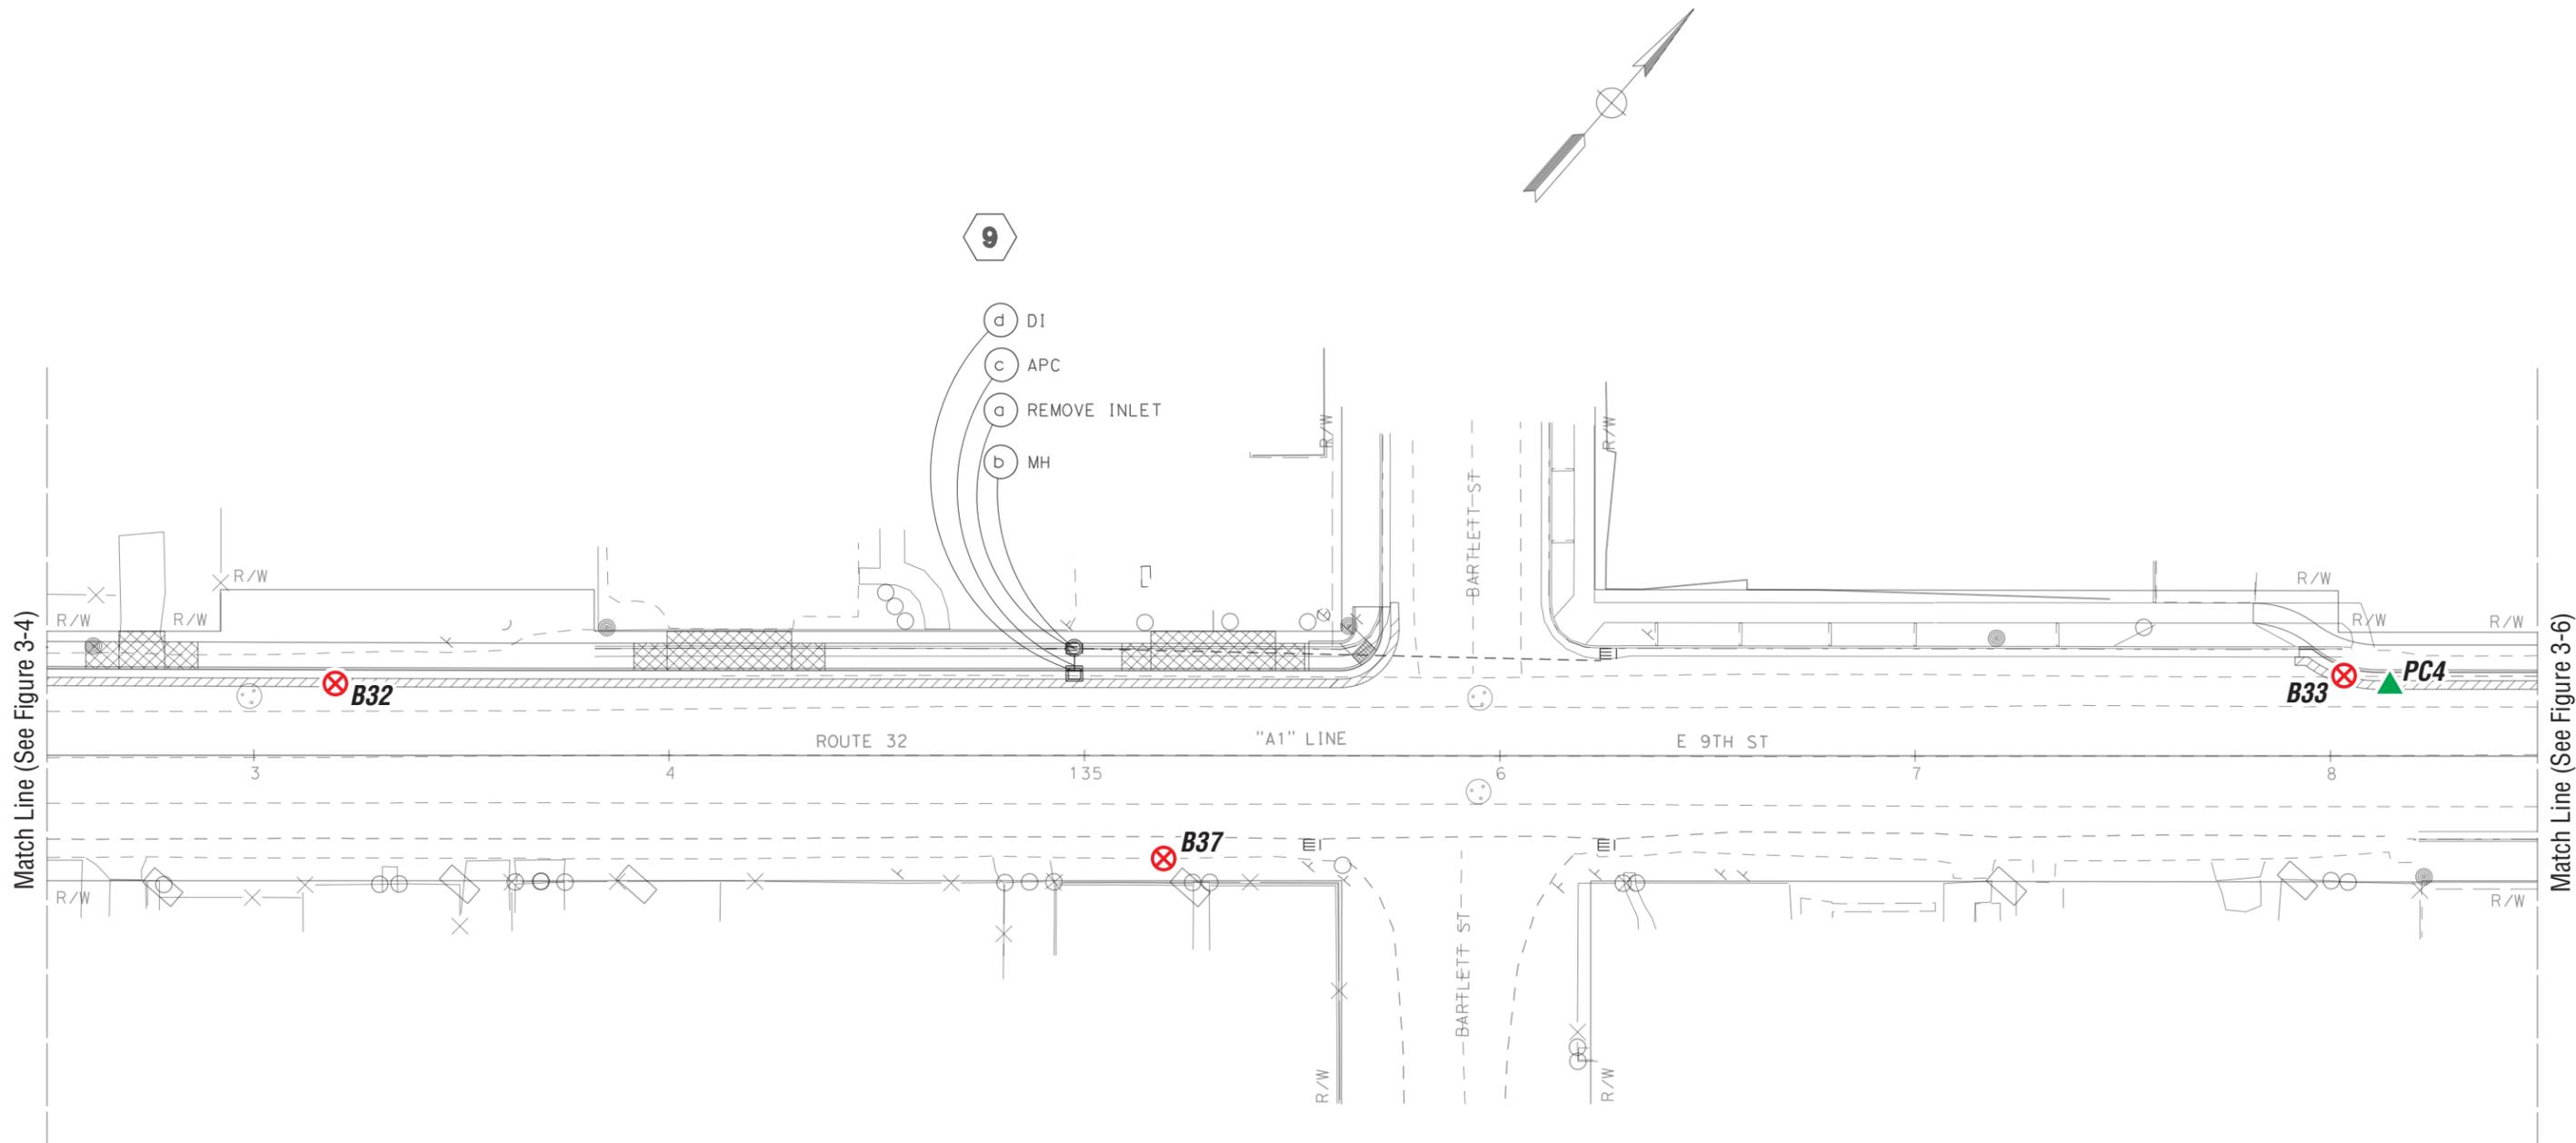
October 2015 | Figure 3-5

We collected yellow traffic stripe paint samples PC1 and PC2 along WB SR-32 (E 8<sup>th</sup> Street), and samples PC3 and PC4 along EB SR-32 (E 9<sup>th</sup> Street). The traffic stripe paint samples were collected using a hammer to break a chip off the traffic stripe paint, then the samples were placed in Ziploc<sup>®</sup> re-sealable plastic bags, labeled, and delivered to ATL under standard COC documentation. The approximate traffic stripe paint sample locations are depicted on Figures 2-2, 2-3, 3-2, and 3-5.

**SITE PLAN**  
**EB SR-32**  
**(E. 9th Street)**

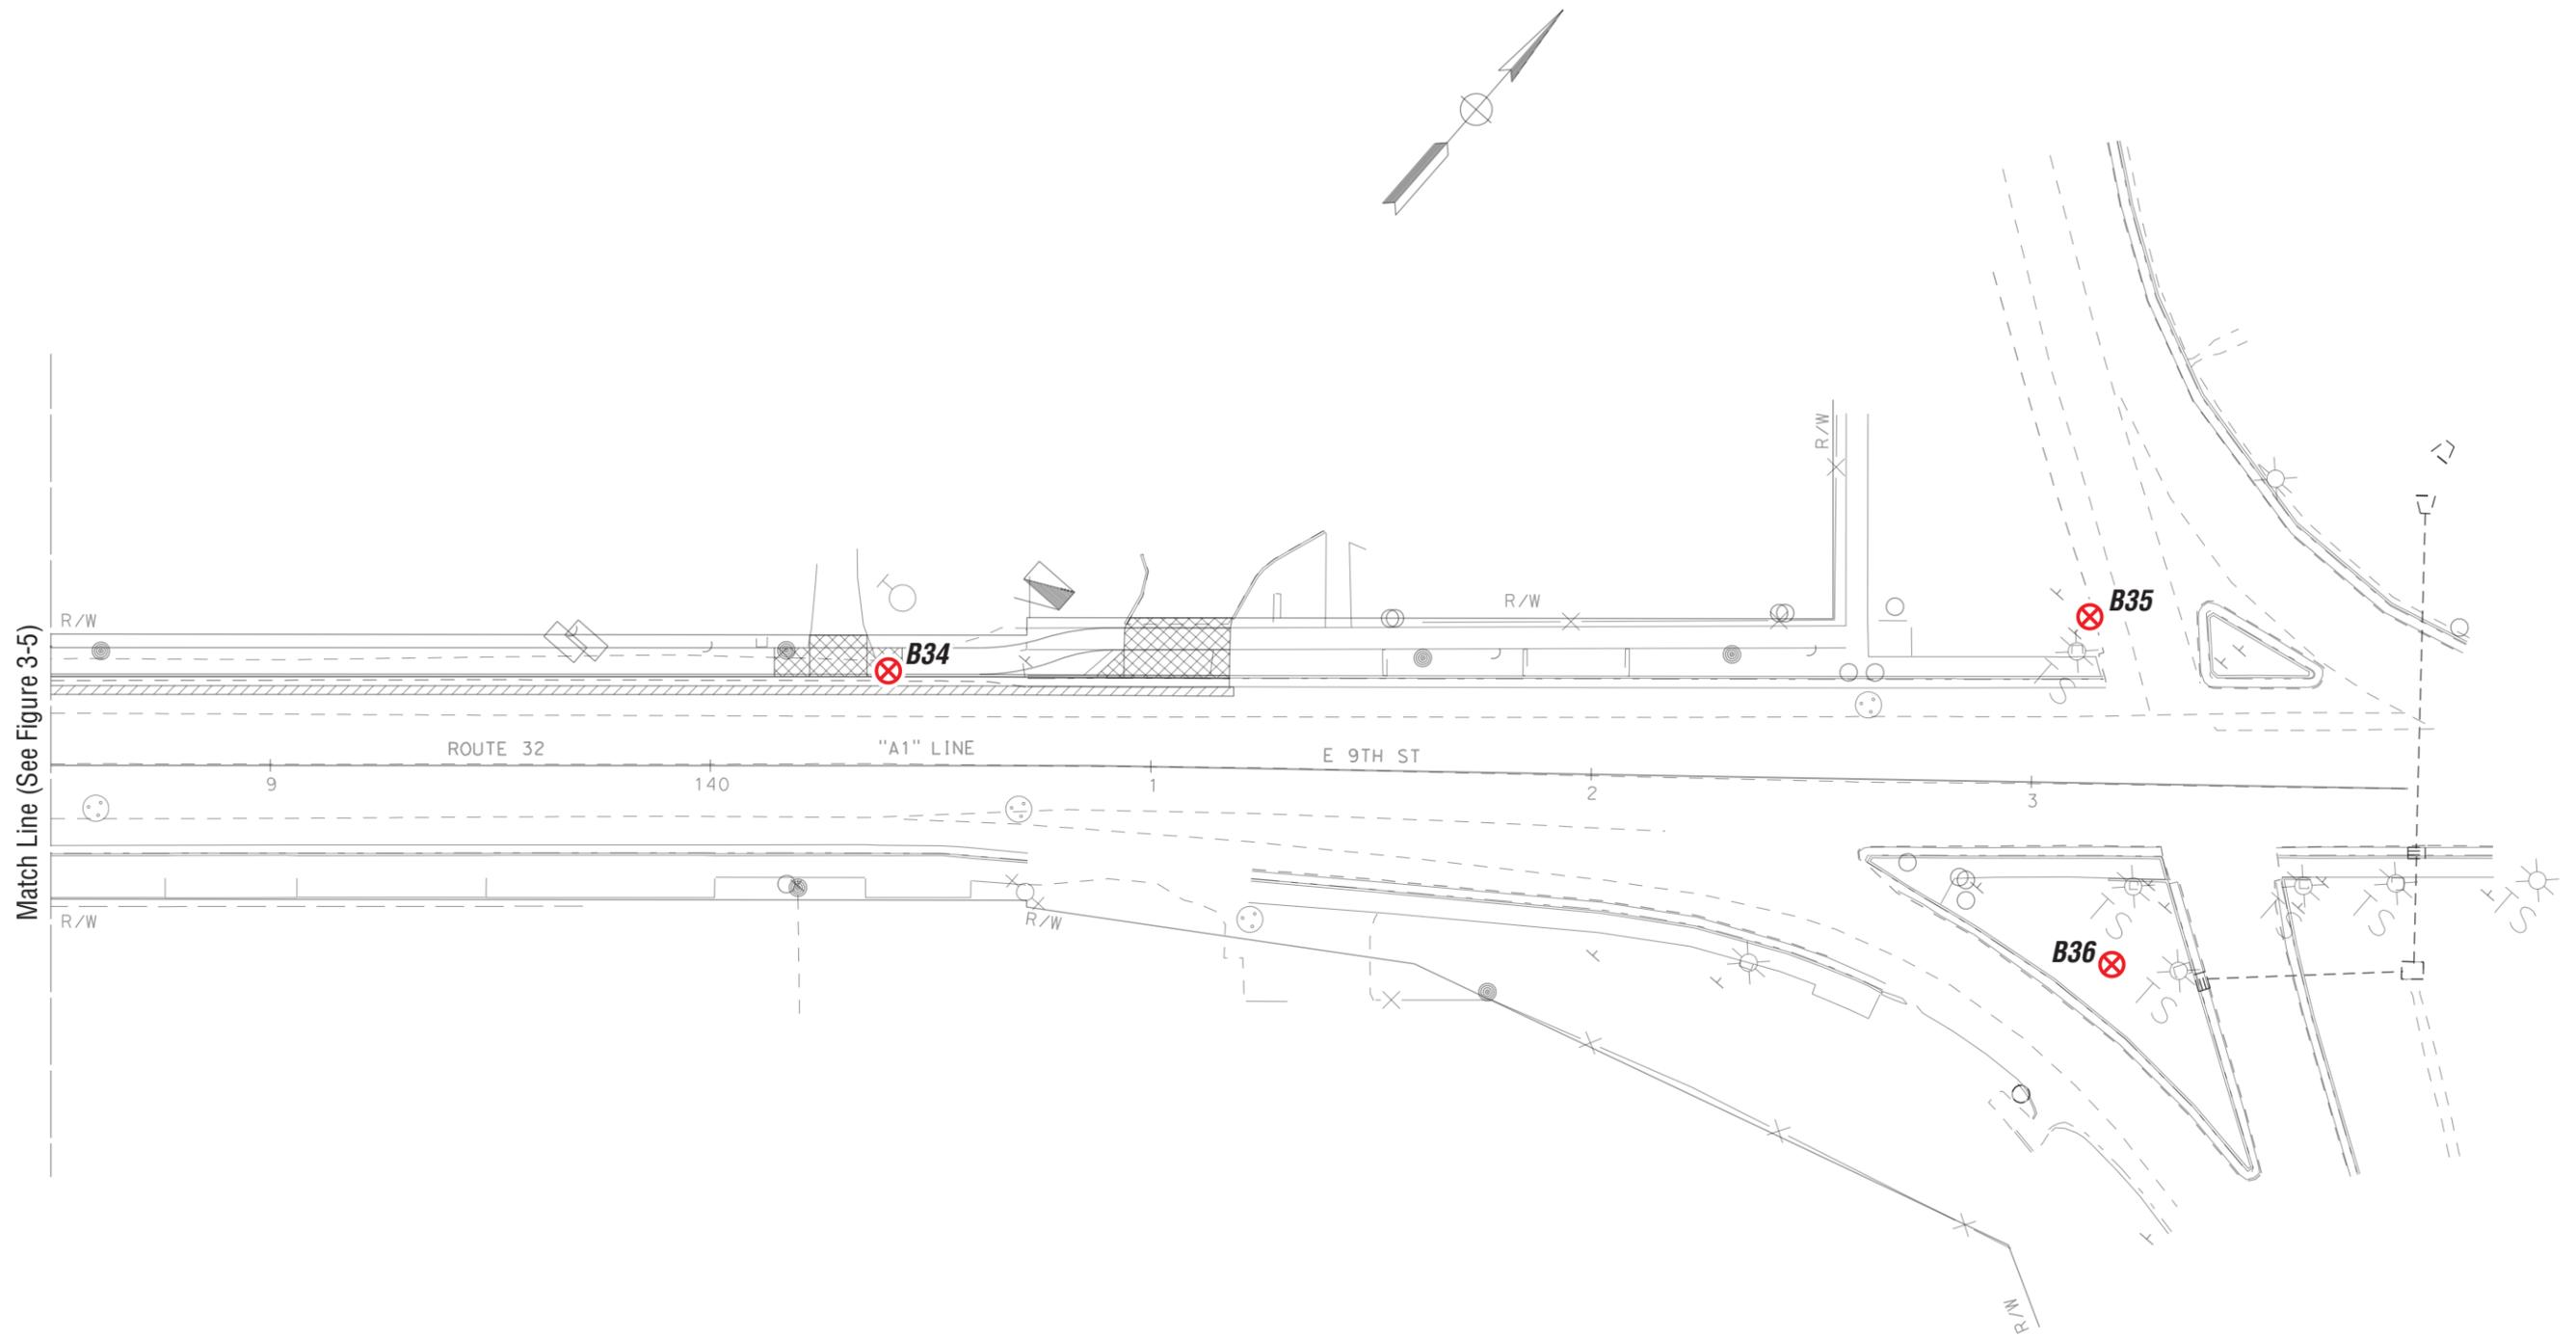
October 2015 | Figure 3-6

**SITE PLAN**  
**EB SR-32**  
**(E. 9th Street)**

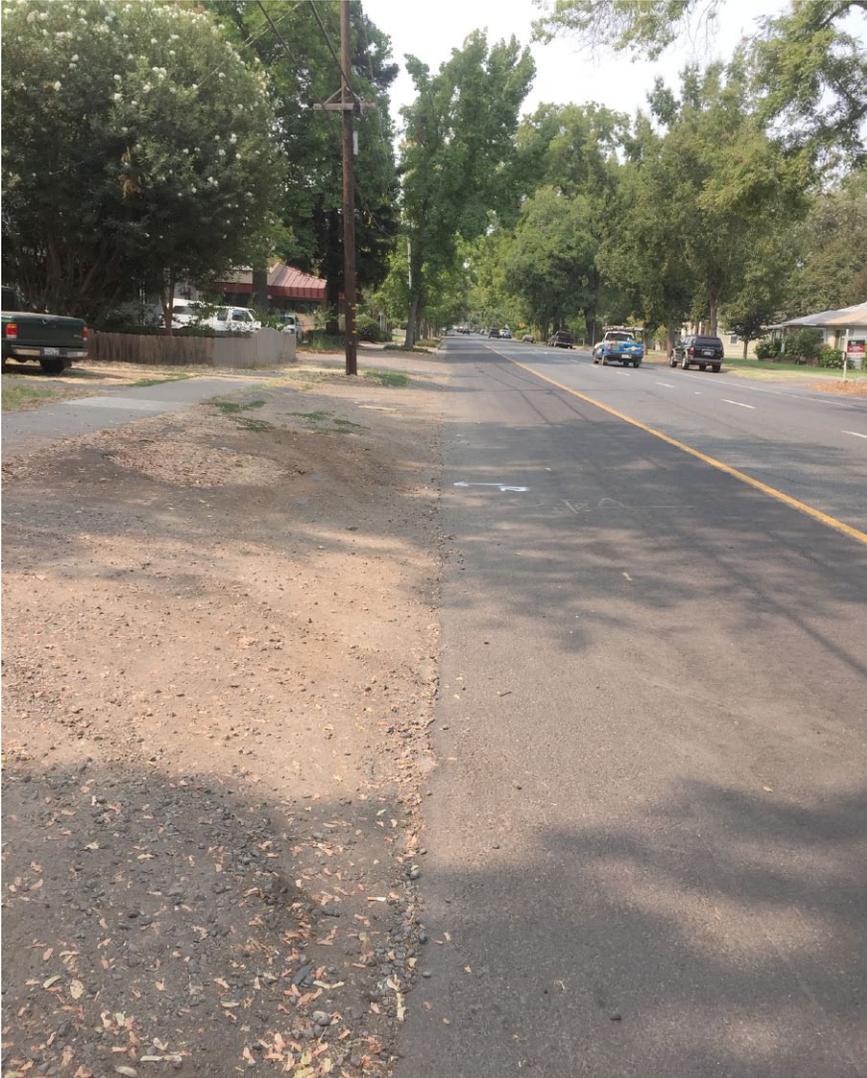
Photo No. 1 Typical sampling location on the south side of westbound SR-32 (E. 8th Street) in the vicinity of Boring B12

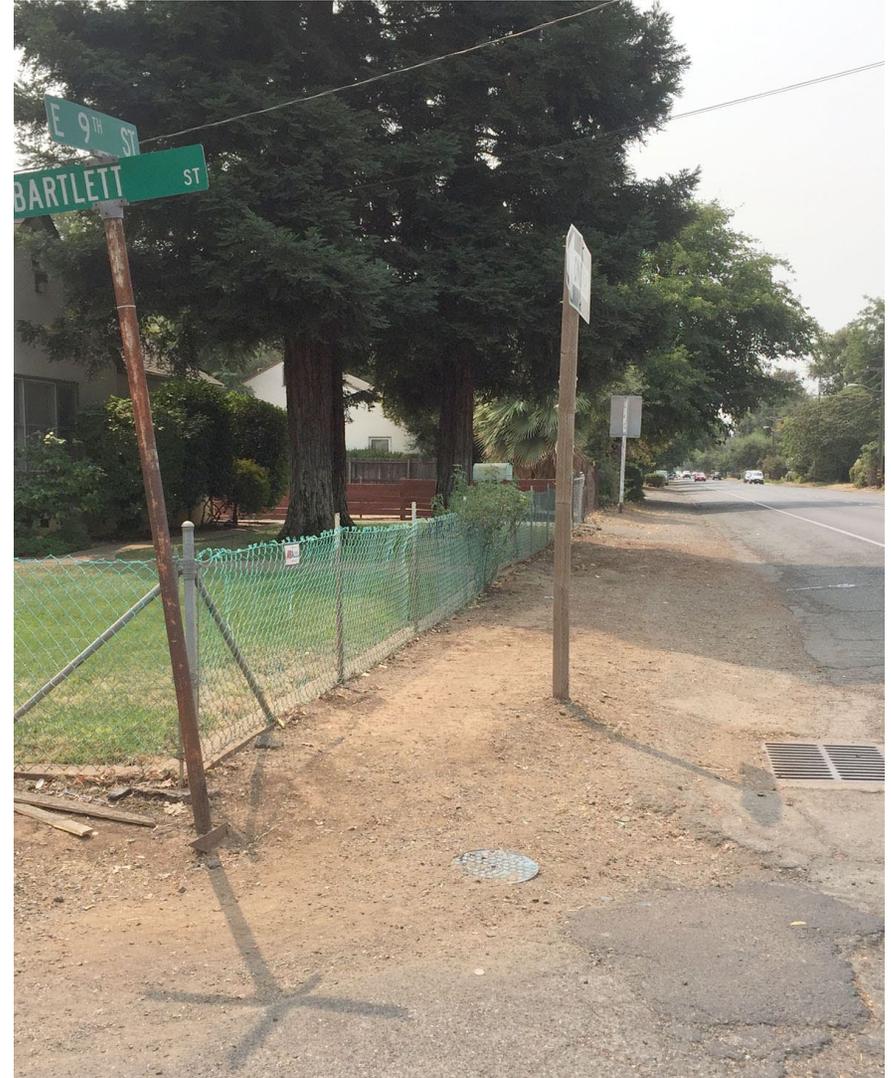
Photo No. 2 Typical sampling location on the south side of eastbound SR-32 (E. 9th Street) in the vicinity of Boring B37
