Asbestos and Lead-Containing Paint Survey Report

Subject: ASBESTOS AND LEAD-CONTAINING PAINT SURVEY REPORT
03-PLA-80, PM 31.8, ILLINOISTOWN OVERCROSSING (BRIDGE NO. 19-0085)
PLACER COUNTY, CALIFORNIA
CONTRACT NO. 03A2132, E-FIS 03 1400 0243 1, EA 03-4F7001
TASK ORDER NO. 29

Illinoistown Overcrossing (Bridge No. 19-0085) 03-PLA-80 PM 31.8

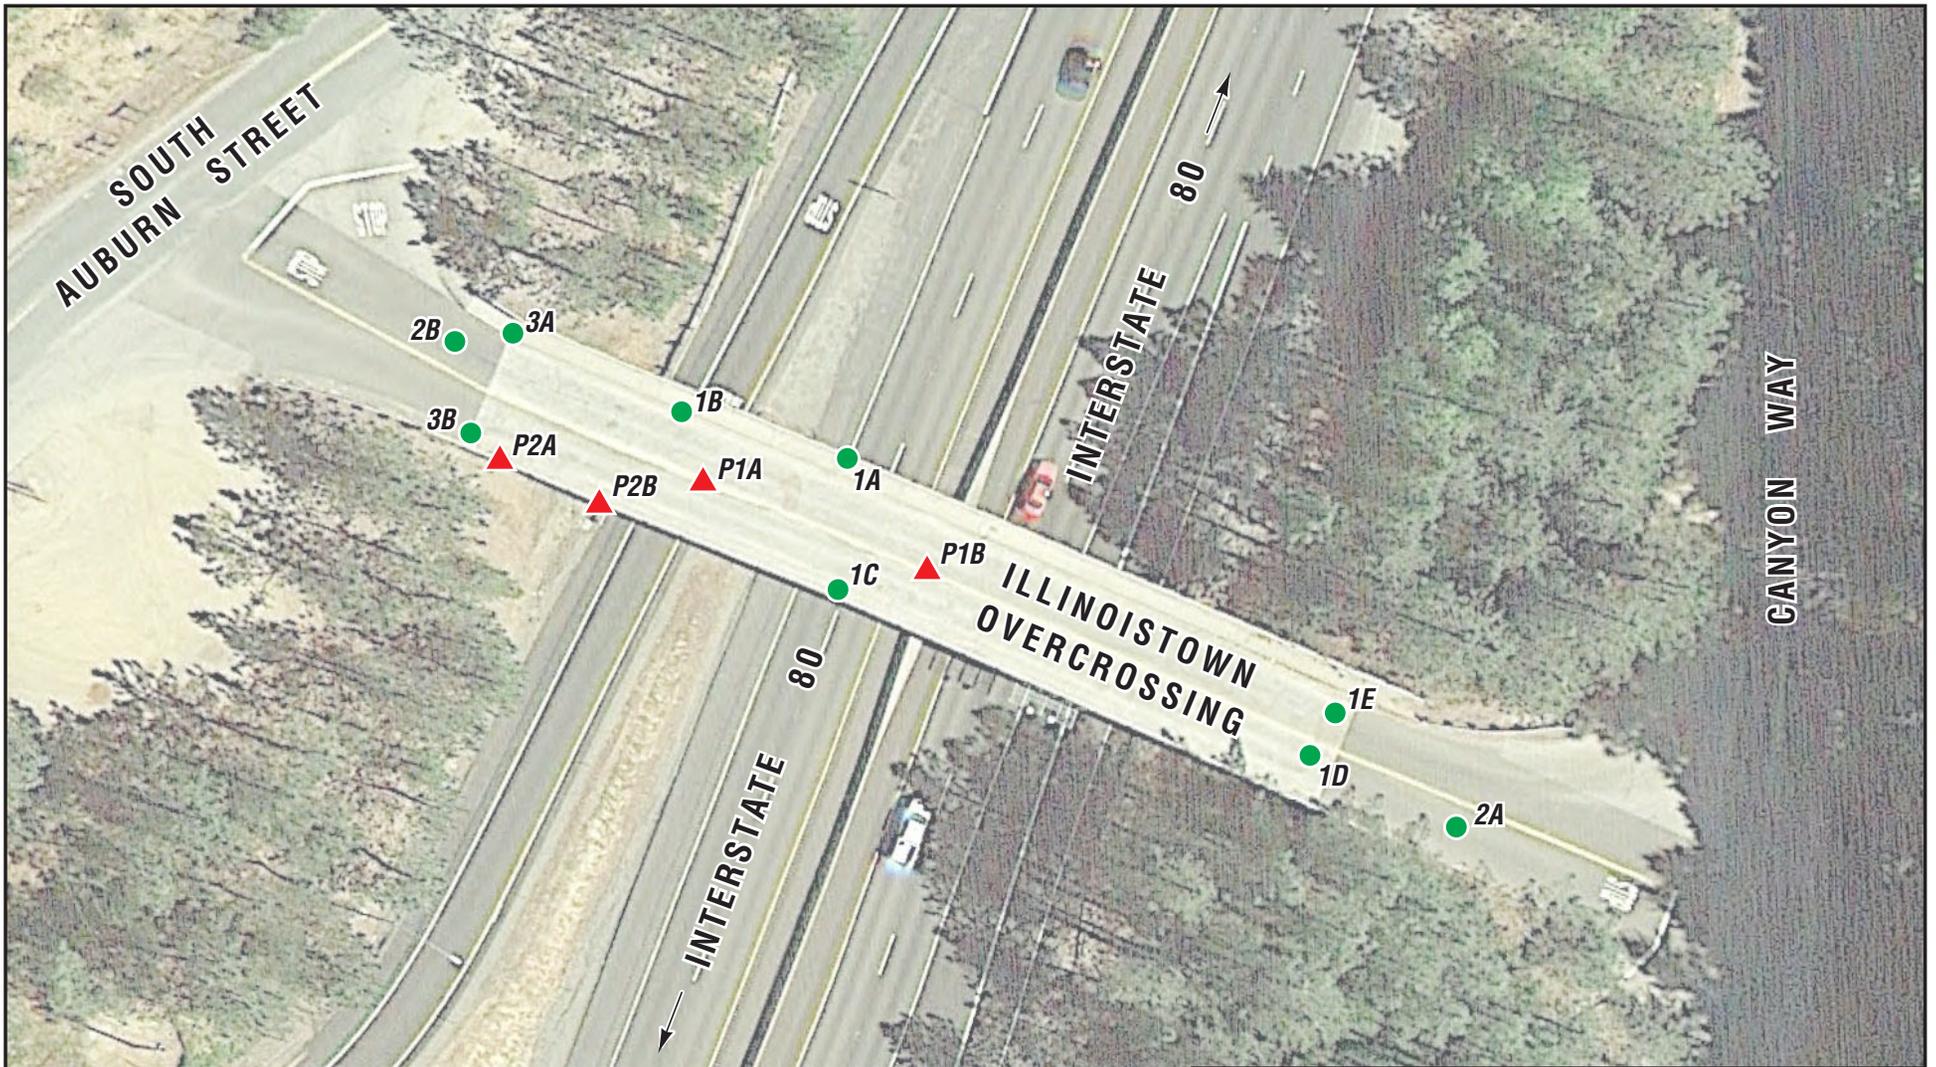
Figure 2

- Approximate Asbestos Sample Location
- ▲ Approximate Paint Sample Location

SITE PLAN

Sample group identification numbers, material descriptions, approximate quantities, friability assessments, and photo references are summarized on Table 1. Approximate sample locations are presented on Figure 2. Materials represented by the samples collected are shown in the attached photographs.

Paint sample identification numbers, descriptions, peeling and flaking quantities, and photo references are summarized on Table 2. Approximate sample locations are presented on Figure 2. Materials represented by the samples collected are shown in the attached photographs.

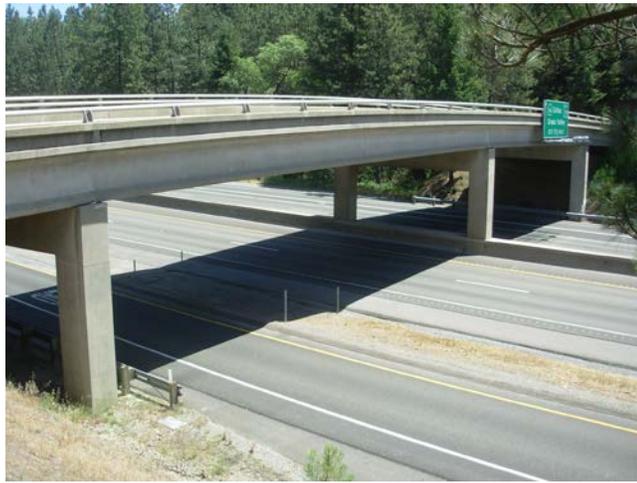
Photo 1 – Illinois town Overcrossing (Bridge 19-0085) at PM 31.8 on Interstate 80 in Placer County, California

Sample Group No.	Description of Material	Approximate Quantity	Friable	Site Photo	Asbestos Content
1	Concrete	NA	NA	1 through 6	ND
2	Asphalt	NA	NA	2	ND
3	Joint fill material	NA	NA	3 and 4	ND

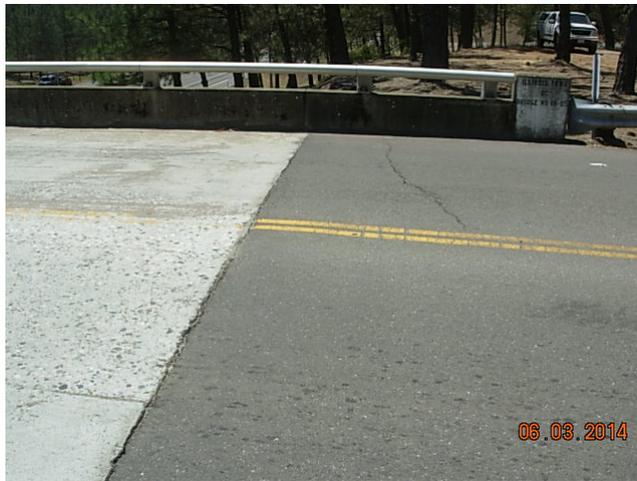
Photo 2 – Bridge deck

A sample representing intact yellow traffic striping exhibited a representative total lead concentration of 2.7 mg/kg.

Paint Sample No.	Paint Description	Approximate Quantity Peeling/Flaking	Site Photos	Total Lead (mg/kg)
P1A/B	Yellow traffic striping	Intact	2	2.7
P2A/B	Gray paint (graffiti abatement)	Intact	6	32

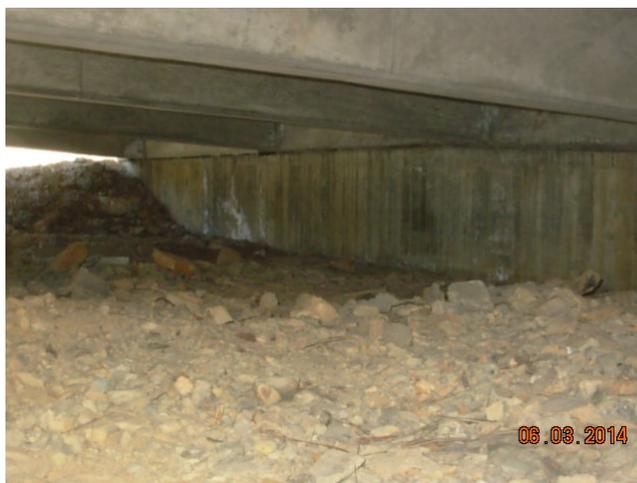
Photo 3 – West abutment and concrete girder system

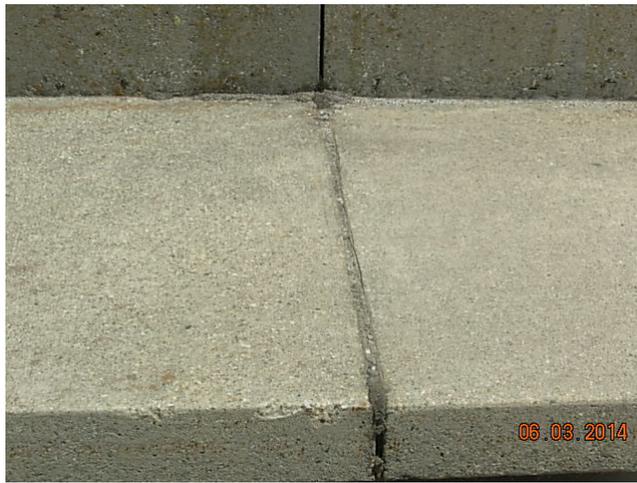
Photo 4 – Bridge expansion joint and fill material

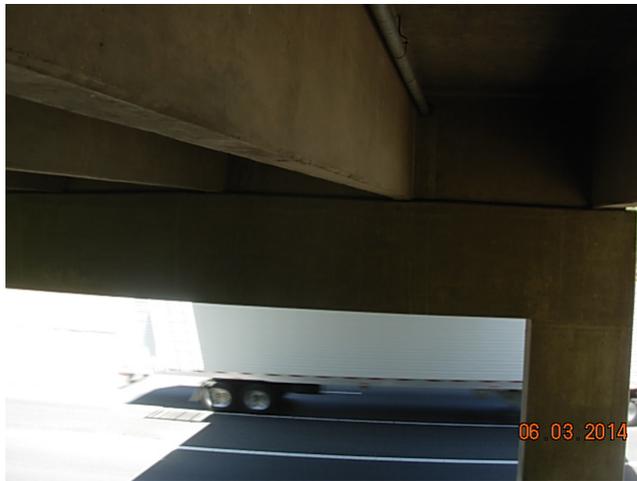
Photo 5 – Bridge columns

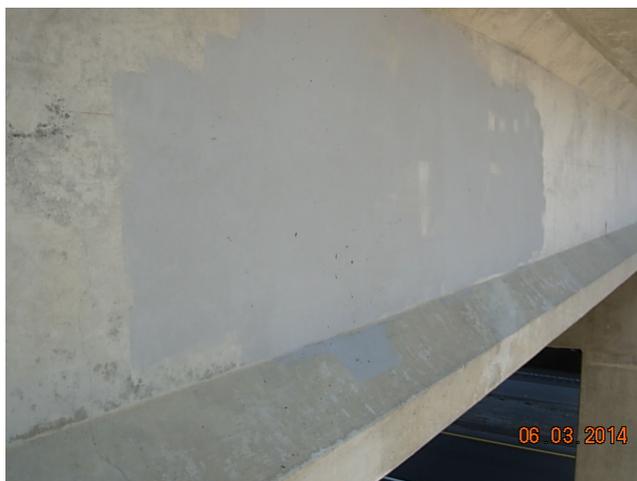
Photo 6 – Graffiti abatement near west abutment

A sample representing intact gray graffiti abatement exhibited a representative total lead concentration of 32 mg/kg.
