## APPENDIX B

### GUIDELINES FOR IDENTIFYING AND REPAIRING LOCALIZED AREAS OF DISTRESS IN AC PAVEMENTS PRIOR TO CAPITAL PREVENTIVE MAINTENANCE OR REHABILITATION REPAIRS

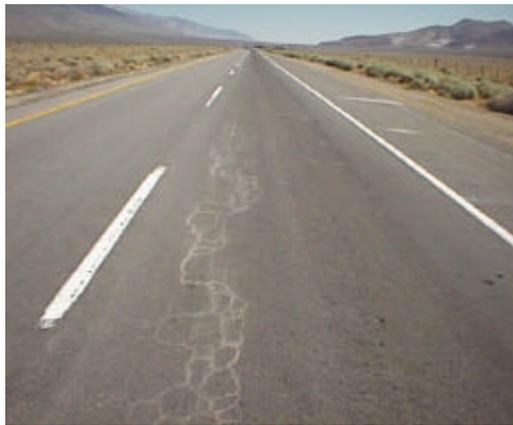
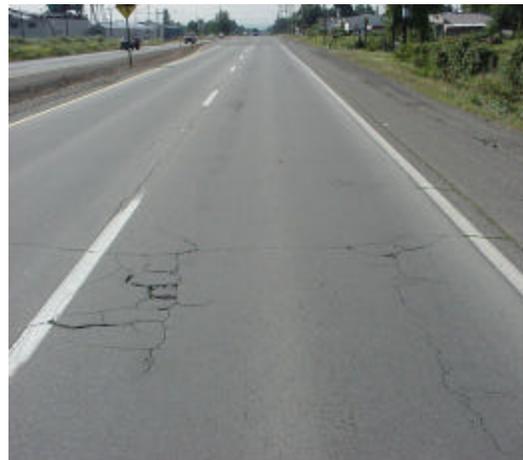
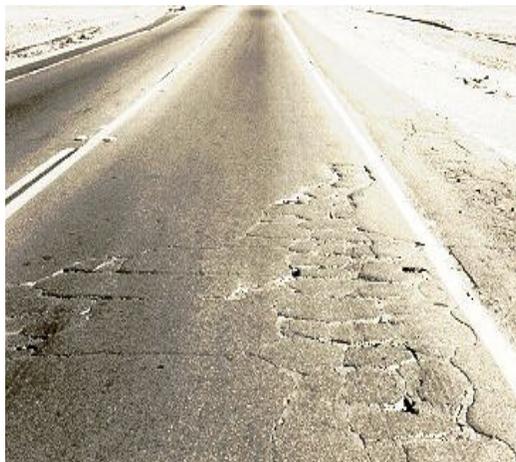
###### a) Alligator Cracks

Alligator cracking is characterized by interconnected or interlaced cracks in the wheel path, forming a series of small polygons, (generally less than 1 foot on each side). The cracking resembles the appearance of alligator skin, thus the term alligator cracking. Alligator cracking is a load-related distress and occurs when the wheel loads exceed the design of the roadbed.

Alligator cracking is probably caused by a saturated base or subgrade. Therefore, correction should include removal of the wet material and installation of needed drainage. When water is a factor in the cracking, drainage should first be corrected.

Recommended Repair: Permanent repair is made by constructing a deep patch that completely removes the affected area and replaces it with new

AC and base materials, as necessary. Hot mix asphalt placed full-depth provides a strong patch and can be done expeditiously. If hot mix asphalt is unavailable or is not needed to quickly complete the repair or not needed for constructibility purposes, new aggregate base material compacted in layers and capped with AC pavement may be used.

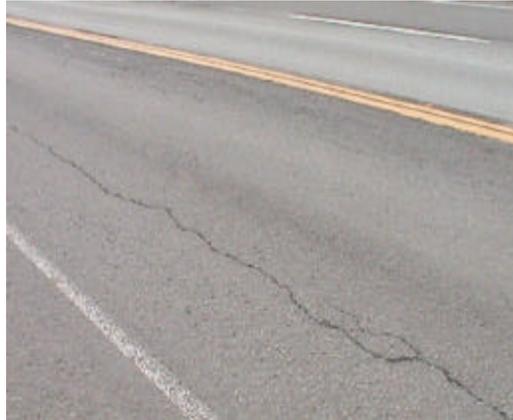
b) Longitudinal Cracks

[Shrinkage Cracks, Reflection Cracks, Joint Cracks, Edge Cracks and Slippage Cracks]

Longitudinal cracks are non-load-associated cracks. Longitudinal cracks are single cracks approximately parallel to the centerline. These cracks are primarily due to the contraction and shrinkage of the surface course, reflection from underlying pavement joints, poorly constructed paving joints, or roadbed settlement.

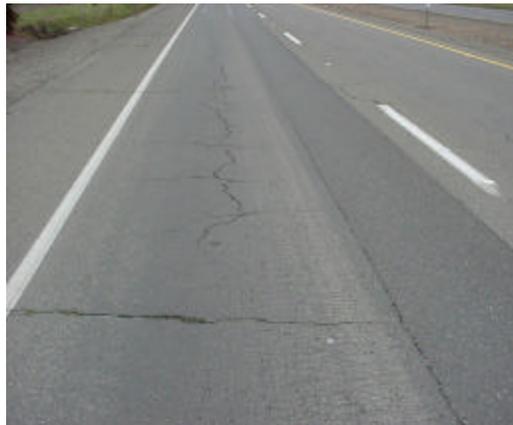
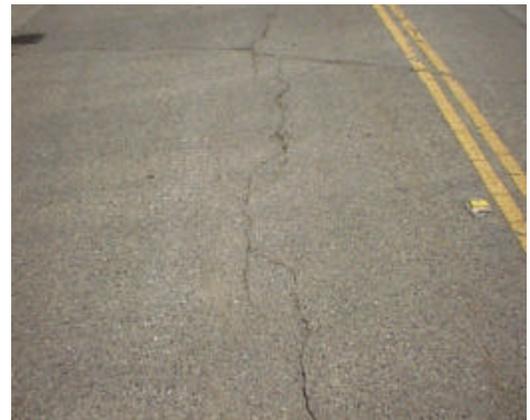
c) Transverse Cracks

Transverse cracks are non-load-associated cracks. Transverse cracks appear approximately at right angles to the centerline. These cracks are primarily due to the contraction and shrinkage of the surface course or reflection from underlying pavement joints.

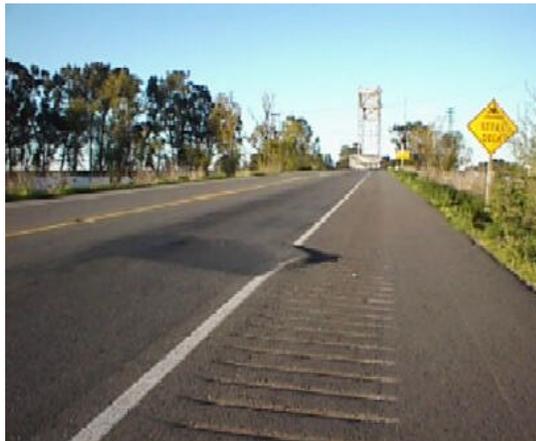
### c) Settlement

Settlement is a noticeable or abrupt vertical distortion from the original pavement profile or cross-slope. Settlement is often associated with fill areas. This condition may also have associated cracking, Settlement Cracking.

Settlement in localized areas of limited size is sometimes accompanied by cracking. When water collects in these depressions, they become not only a source of pavement deterioration but also a hazard to motorists.

Depressions are caused by traffic loads heavier than that for which the pavement was designed, by poor construction methods, or by consolidation deep within the subgrade. Edge cracks and depressions can also be caused by the lack of lateral or shoulder support for the asphalt pavement.

Recommended Repair: When water is a factor in causing the depression, drainage should first be corrected. The depressions should then be removed, repaired by constructing a deep patch that completely removes the affected area and replaces it with new AC and base materials, as necessary, and then compacted to restore the area to the same grade as the surrounding pavement. Hot mix asphalt placed full-depth provides a strong patch and can be done expeditiously. If hot mix asphalt is unavailable or is not needed to quickly complete the repair or not needed for constructibility purposes, new aggregate base material compacted in layers and capped with AC pavement may be used.

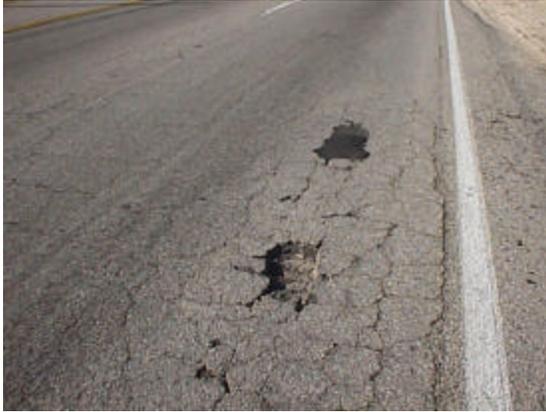
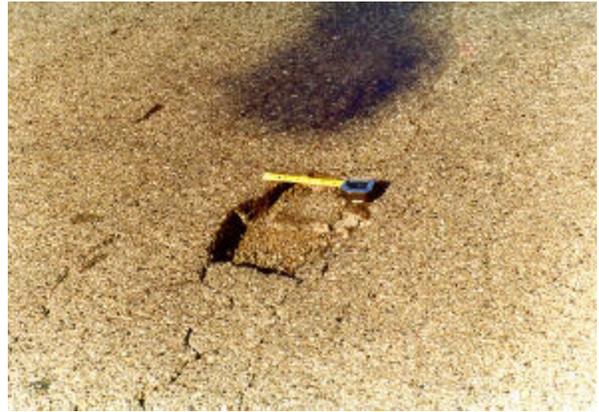
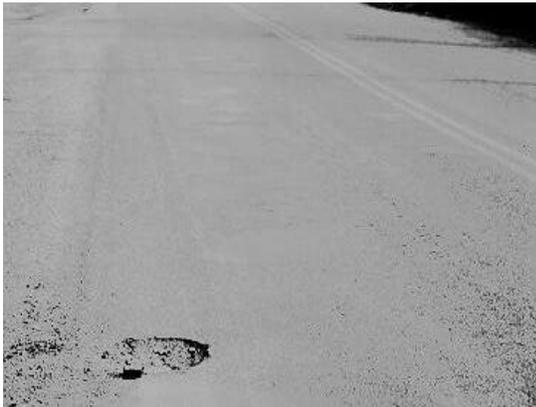
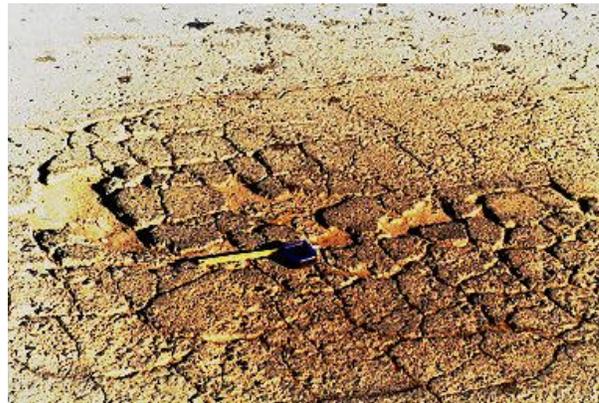
#### a) Pot Holes

Potholes are isolated, bowl-shaped holes in the pavement of various sizes. Generally, potholes are a result of the loss of alligatored pavement and, if so, they can be irregular in shape due the adjacent alligatored pavement. They frequently appear when maintenance is not promptly applied once the distress that is causing them appears.

Potholes typically are the result of localized asphalt disintegration under traffic. A pothole is usually caused by weakness in the pavement resulting from too little asphalt, too thin an asphalt surface, too many fines, too few fines, or poor drainage. Potholes frequently appear when it is difficult, because of inclement weather, to make permanent repairs. Temporary repairs usually involve cleaning out the hole and filling it with a premixed asphalt patching material.

Recommended Repair: Permanent repair is made by constructing a partial depth or deep patch that completely removes the affected area and replaces it with new AC and base materials, as necessary.
