Progress Report of Performance of Experimental Bridge Approach Slabs in District VII

State of California
Department of Public Works
Division of Highways
Materials and Research Department

PROGRESS REPORT
of
PERFORMANCE OF EXPERIMENTAL
BRIDGE APPROACH SLABS
in
DISTRICT VII

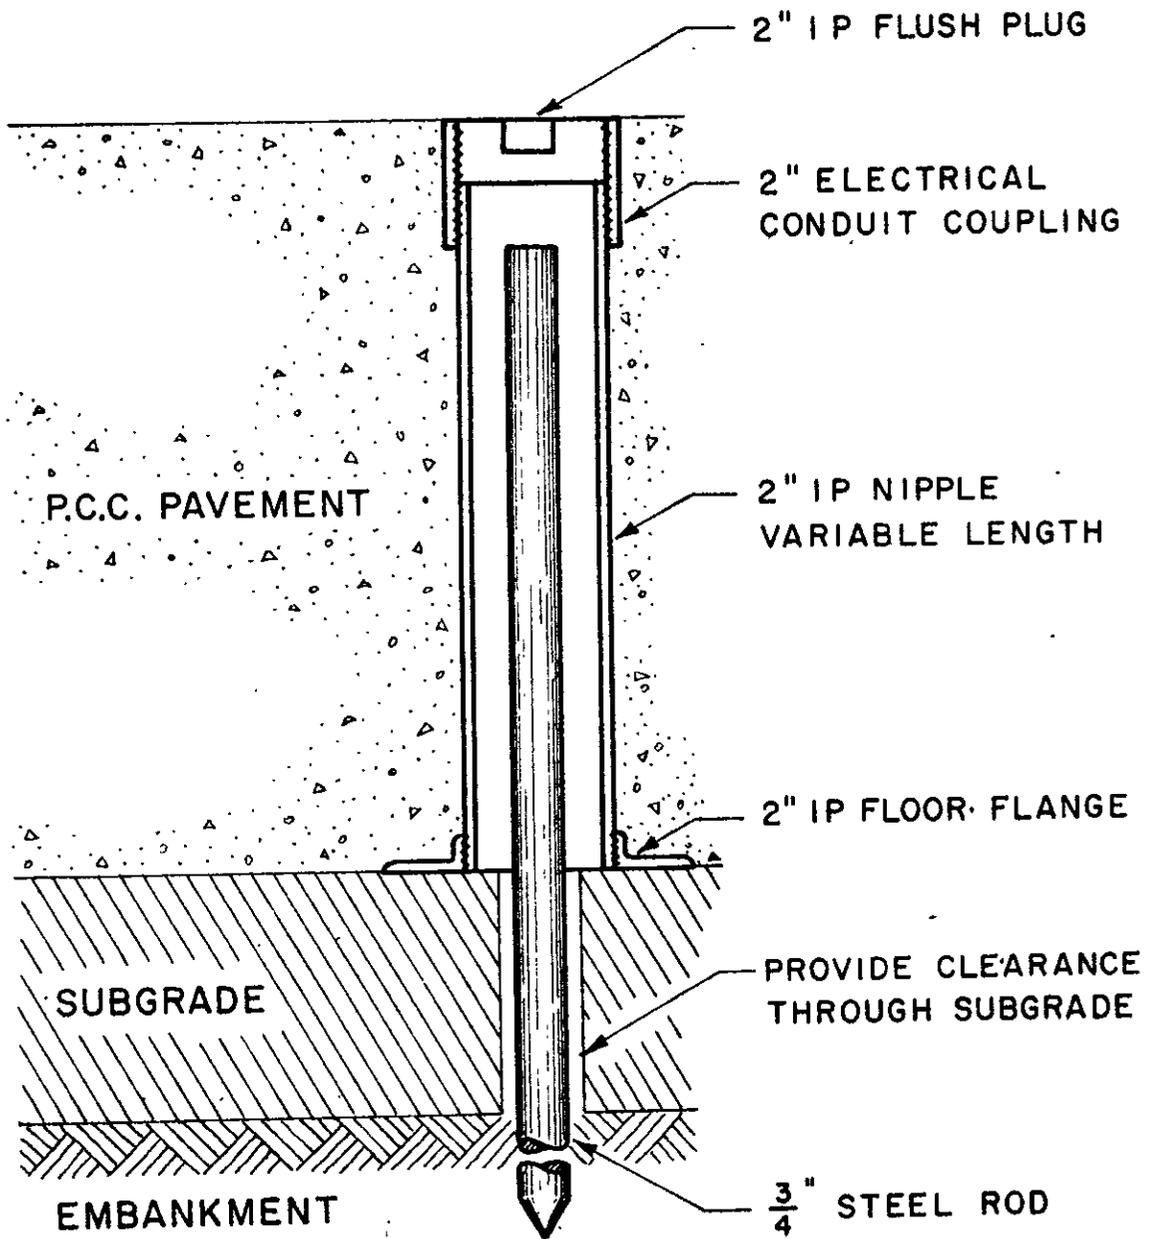
Fig I

The ability of a pavement slab to span areas of nonsupport cannot be appraised where settlement of the underlying support does not occur, i.e., where the support remains in full contact with the slab. To reveal the separation between the pavement and the subgrade devices of the type illustrated in Figure I were placed in each of the special design slabs. The initial elevations of the pavement surface and the top of the center steel rod, and the differential between these values is determined at the time of placement. Comparison with the differentials determined by periodic check readings throughout the life of the project reveals the magnitude of the separation.

SUBGRADE SETTLEMENT DEVICE

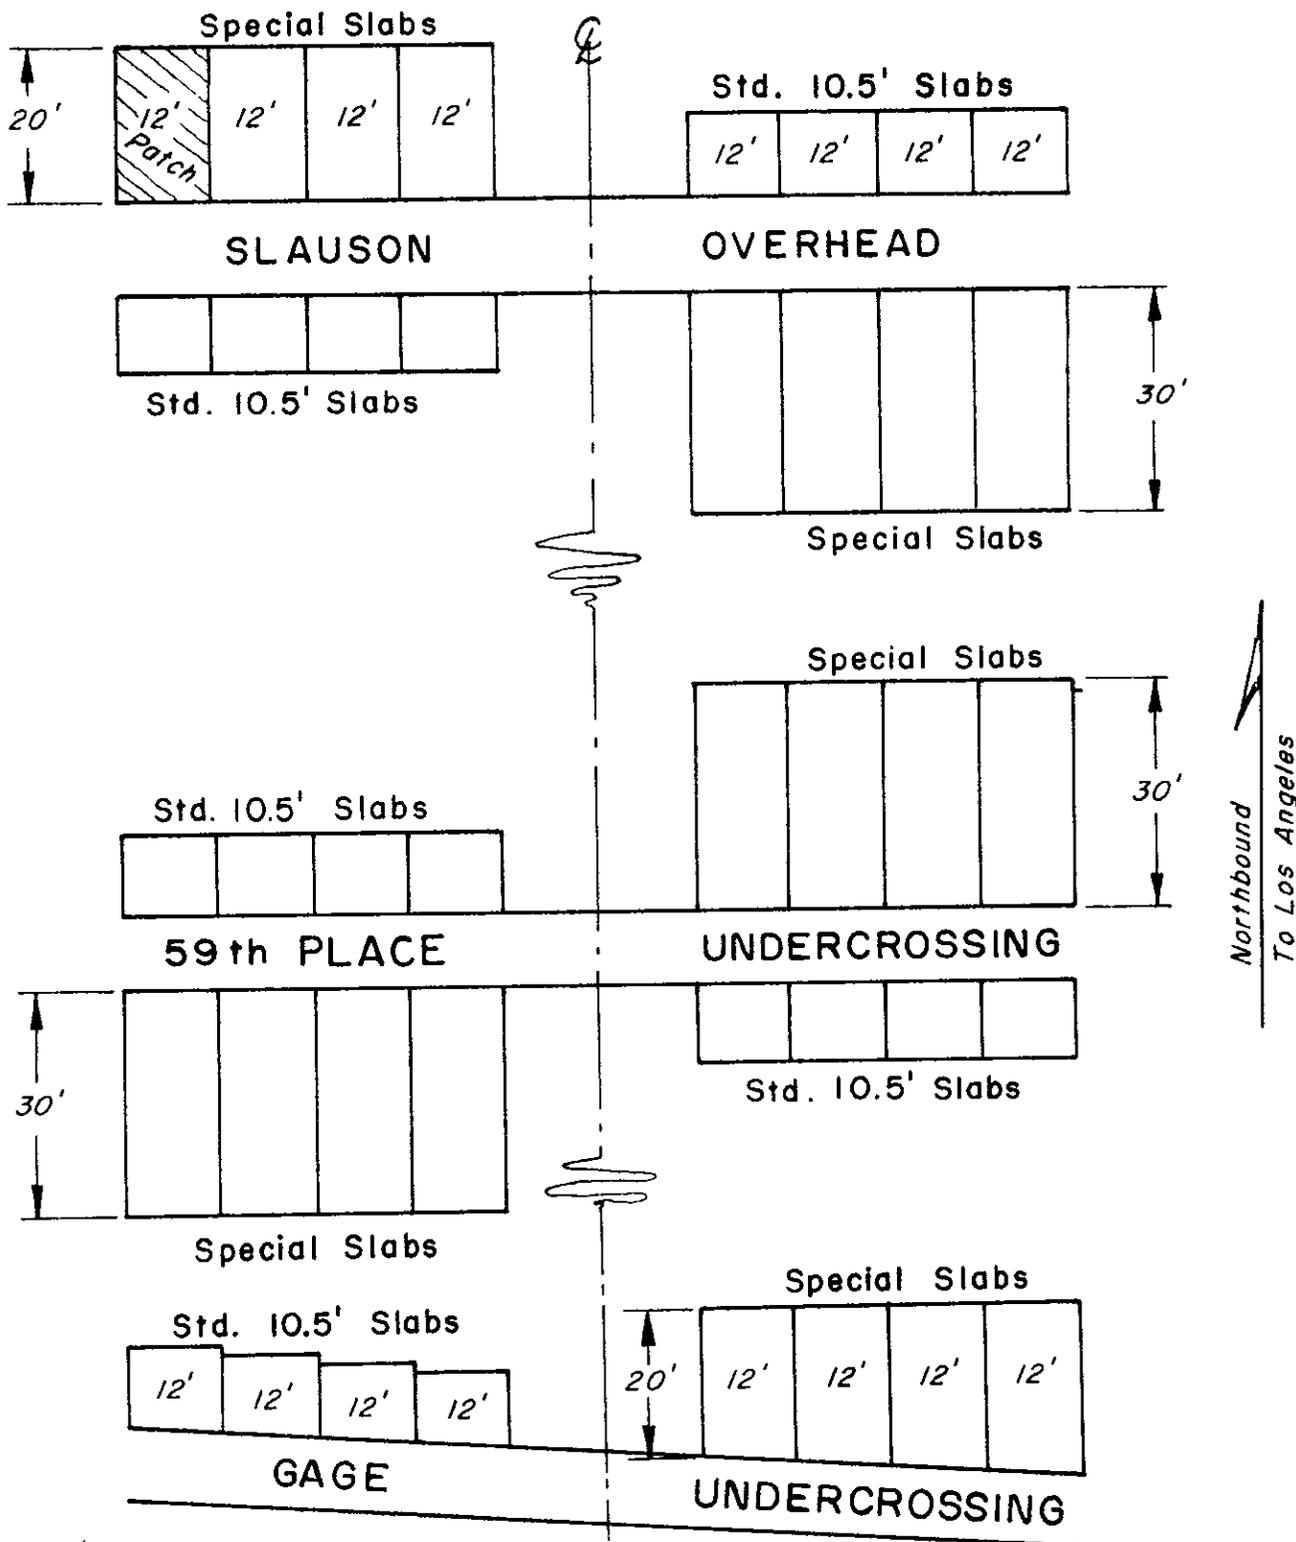
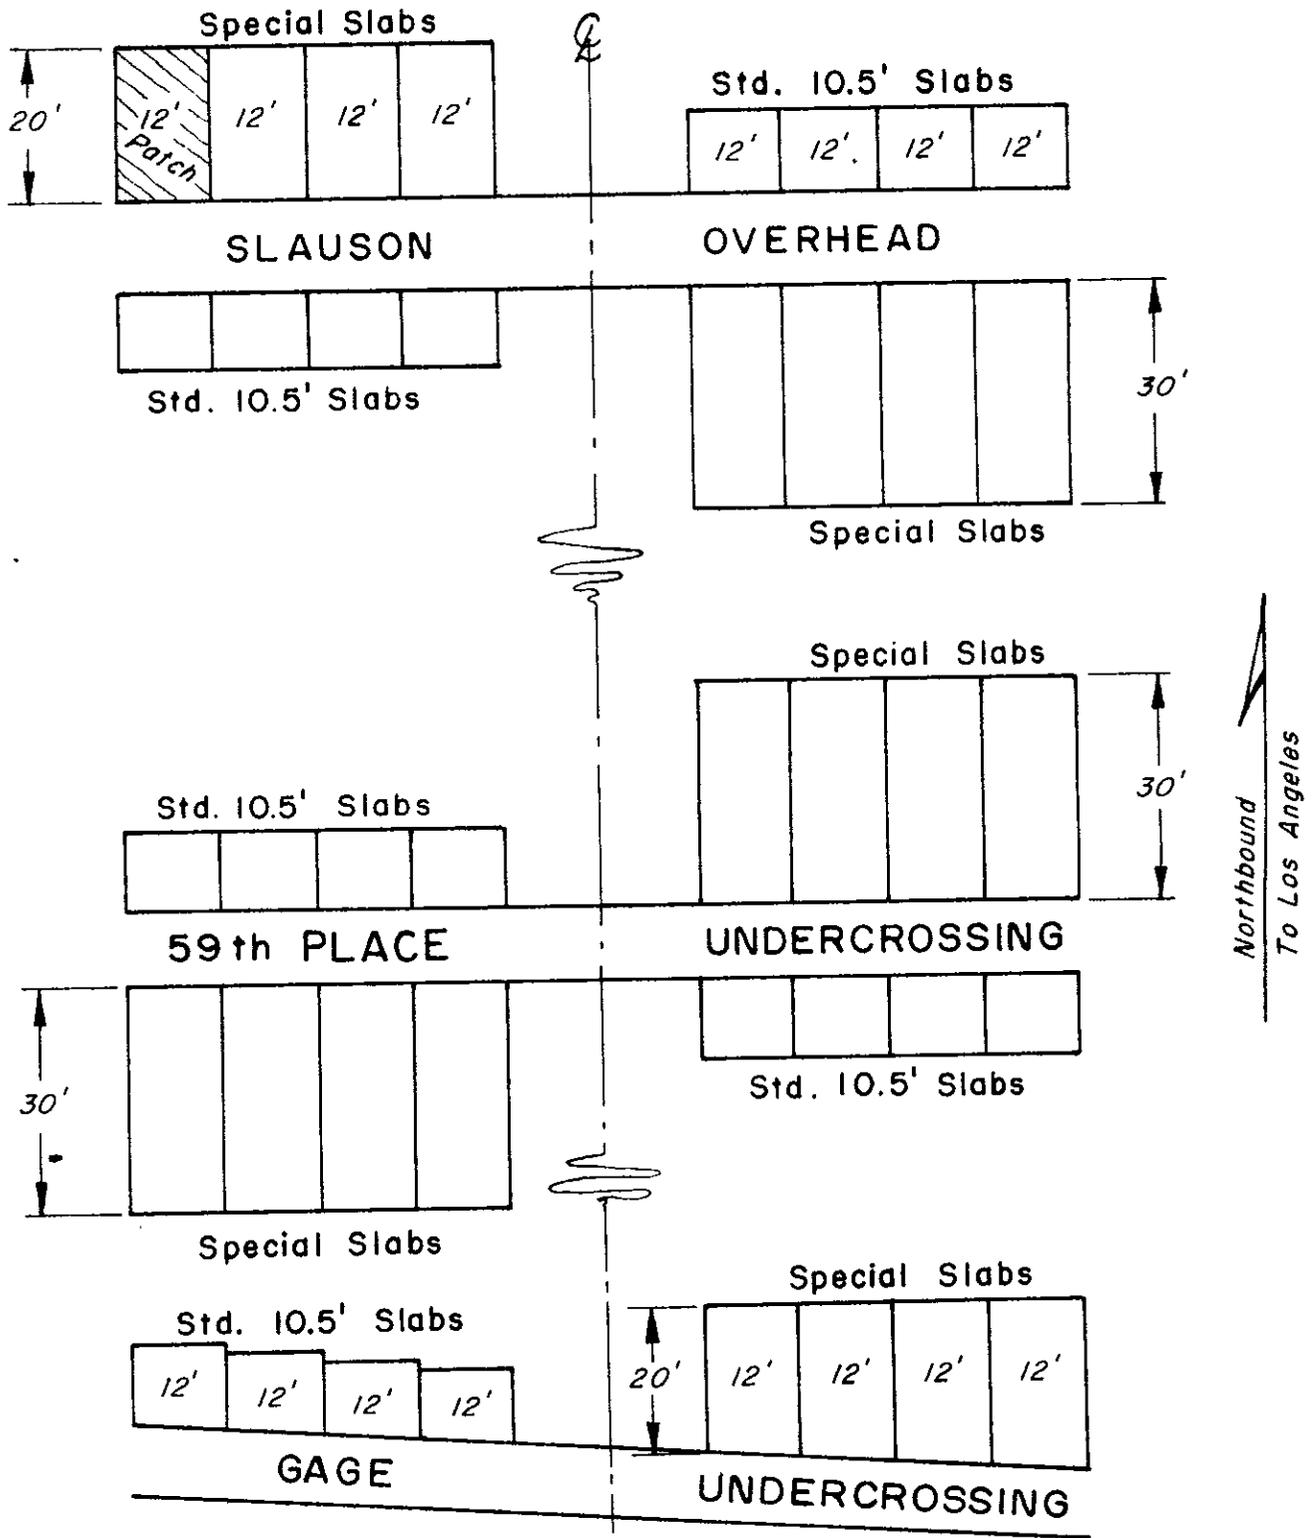
FIG. IV

The three special study locations on the Harbor Freeway are sketched in Figure IV. Completion date for the contract was May 16, 1957. Inspection periods at these locations coincided with those on the San Bernardino Freeway, i.e., July 1958, July 1960, March 1961, and with similar findings. Except for a patched area on the special design slab at Slauson Avenue Overhead, as marked in Figure IV, both special and standard slabs remain free of visually discernible distress. The patch at Slauson Avenue O.H. was placed between the times of the July 1958 and July 1960 inspections, and is at a location where a large volume of truck traffic uses the off ramp to reach the nearby industrial area. This patch extends completely over the ramp lane as well as the outside travel lane.

While there has occurred minor cracking and other defects as noted in Figures III and IV, there are only two instances of patching, one on each of the freeways. One patch appears on a standard slab and one on a special slab. There are no indications of mudjacking or other major maintenance operations.

INVESTIGATION of EXPERIMENTAL
BRIDGE APPROACH SLABS
HARBOR FREEWAY

Because the cost of periodic visual inspections is not excessive it is recommended that such inspections be scheduled on an annual basis, to observe the performance of the slabs over a longer service period.
