Dynamic Tests Of An Energy Absorbing Barrier Employing Steel Drums

Nordlin, E.F.; Woodstrom, J.H.; and Doty, R.N.

State of California
Department of Public Works
Division of Highways
Materials and Research Department

MATERIALS AND RESEARCH DEPARTMENT
RESEARCH REPORT
NO. M & R HRB 636405-2

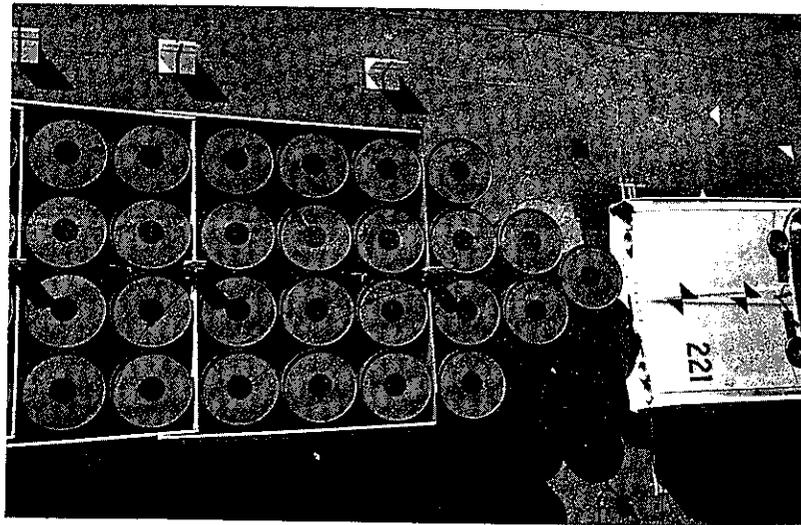
FIGURE 1

The primary energy absorbing media used for the test barrier were 55 gallon tight-head steel drums. Forty-one of these drums, which were approximately 24" in diameter and weighed 38 pounds each, were used for each barrier. The drums contained 18 gage tops and bottoms and 20 gage sides. The tops and bottoms each contained one 7" diameter hole to decrease the magnitude of the force required to crush the drum (see Figure 1 below). The barrier design procedure used was developed and reported by the Texas Transportation Institute³. The design calculations are included as Appendix A of Reference 6.

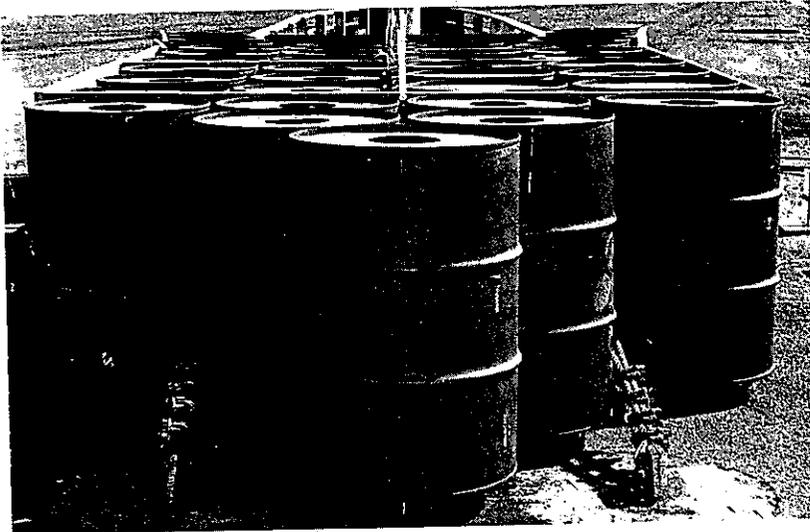
FIGURE 2

The test barrier was placed in front of a California Type 8 Bridge Approach Guardrail (BAGR) to simulate a gore installation (Exhibit 2). Two concrete anchor blocks were cast in place in front of the barrier. Four 3/4 inch wire ropes were attached to fabricated steel "T" sections embedded in these concrete anchors (see Figure 2 below). The wire rope was threaded between the drums so that the drums would be free to slide backward during impact and then attached to the BAGR using swaged fittings. A slight pre-impact tensile force was placed on the cables. The cables were aligned in a straight line to minimize the cable slack, and subsequent lateral movement, that develops during an oblique angle impact. Figure 3 below shows the cables sloping up from the front anchor block. The anchor block and sloping cables were located such that the front drums would receive as much lateral support as possible while still keeping the cables low enough to minimize the possibility of snagging the impacting vehicle.

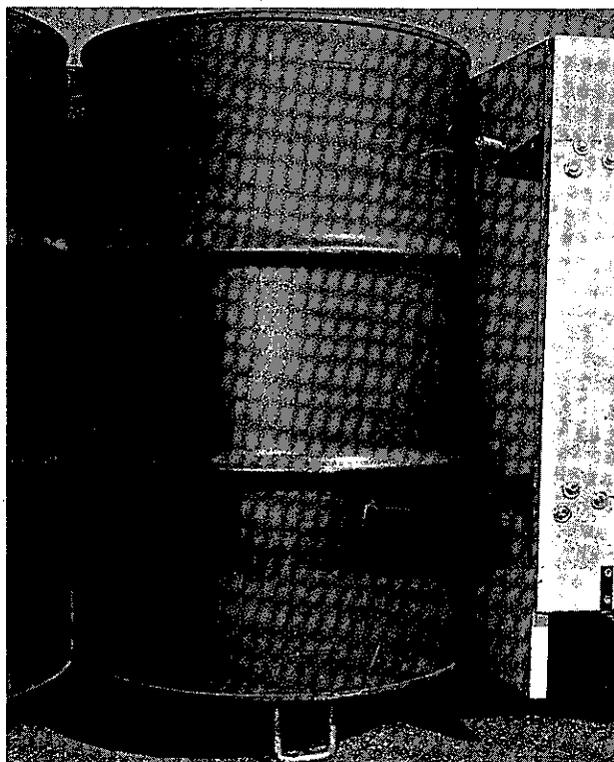
FIGURE 4

The barrier was elevated four inches above the ground with one "U" bolt chair bolted to the bottom of each drum. The drums were attached together at all points of contact with 5/8 inch bolts and washers. For Test 221, bolts were placed 2" below the drum tops and 2" above the drum bottoms; wood spacer blocks were used between drums (see Figure 4 below). For Tests 222 and 223, the bolts were located at the two rolling hoops and a steel washer was placed between the drums so that the cable could be threaded between the drums more easily. Since the drums were bolted together, in a relatively rigid assembly, some of the "U" bolt chairs were not in contact with the slightly irregular ground surface at all times.

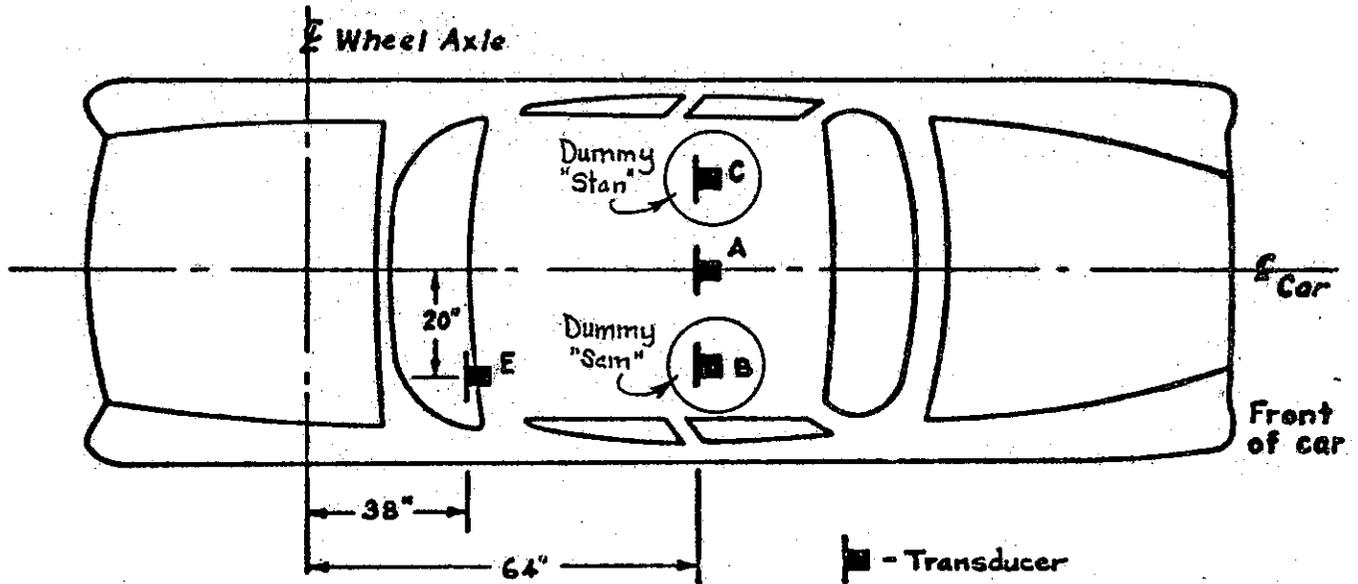
VEHICLE INSTRUMENTATION

CHANNEL NO.	LOCATION ¹	DESCRIPTION ²
1	A	100 "G" longitudinal accelerometer (T)
2	E	100 "G" longitudinal accelerometer (T)
3	C	50 "G" longitudinal accelerometer (T)
4	C	50 "G" lateral accelerometer (T)
5	C	50 "G" vertical accelerometer (T)
6	C	Force meter in "Stan's" chest (T)
7	C	Lap belt tension transducer, "Stan" (T)

- ¹ A and E on vehicle floor; B and C on back of dummy's chest cavity.
- ² (T) = FM telemetry, (U) = umbilical cord.

For Tests 221 and 222, a telemetry instrumentation system on loan from the Federal Highway Administration was used⁸. It consisted of seven channels of FM telemetry for use in the crash vehicle and/or dummies and seven hardwire channels for use on the test barrier and back-up bridge approach guardrail. The system included seven accelerometers and two seat belt force transducers and all the necessary signal conditioning equipment. The dynamic data from these transducers was recorded on a 14 channel analog magnetic tape recorder. For Tests 222 (partial) and 223, data from instrumentation on the test vehicle was transmitted through an umbilical cord (hardwire) system. All the accelerometers in the test vehicle and the dummies were of the unbonded strain gage type. Those used with the telemetry system were Statham Model A514TC accelerometers. Those used with the hardwire system were Statham Model A400TC accelerometers. Additional data regarding the vehicular and barrier instrumentation is included on Plates 1 and 2, pages 11 and 12.

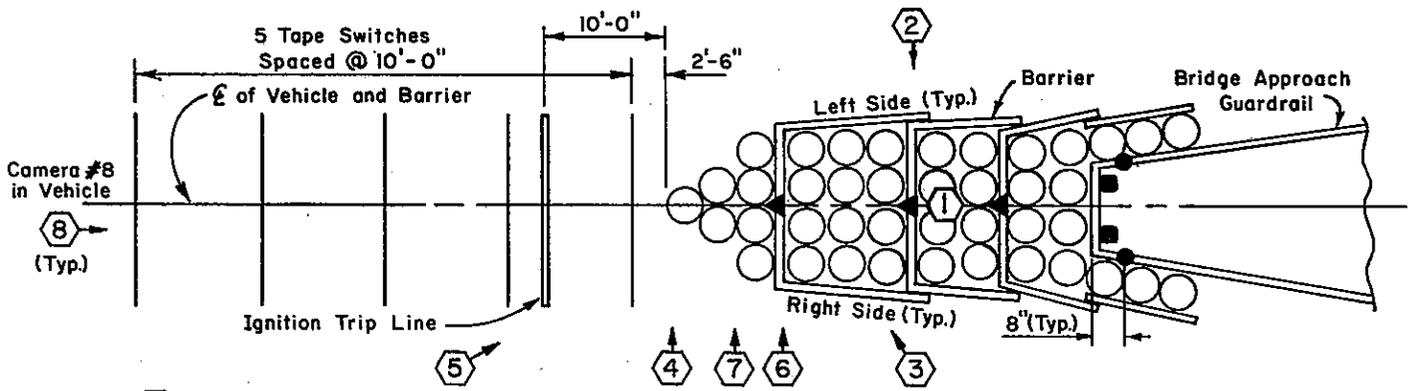
TEST 221

- ▶ Accelerometer (200 G's) Total 3.
- Load cell (50 Kip min. capacity) Total 4.
- Strain gage (ℓ top surface, upper & lower rails, ℓ 8" behind nose of steel barrier) Total 4.

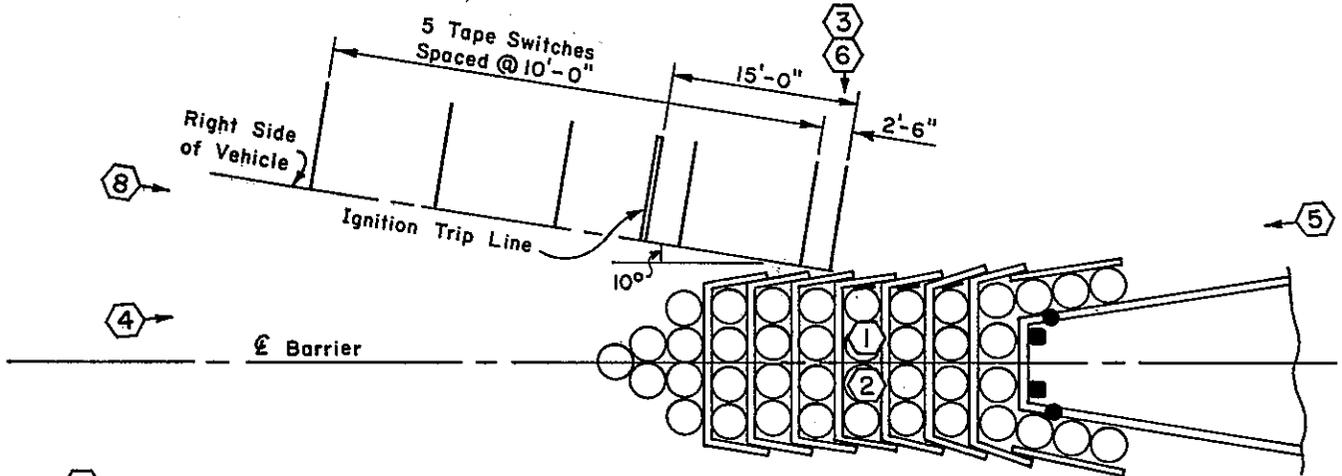
TEST 222

- Load cell (50 Kip min. capacity) Total 4.
- Strain gage (ℓ top surface, upper & lower rails, ℓ 8" behind nose of steel barrier) Total 4.
- Strain gage on Fender Panel, Total 3.

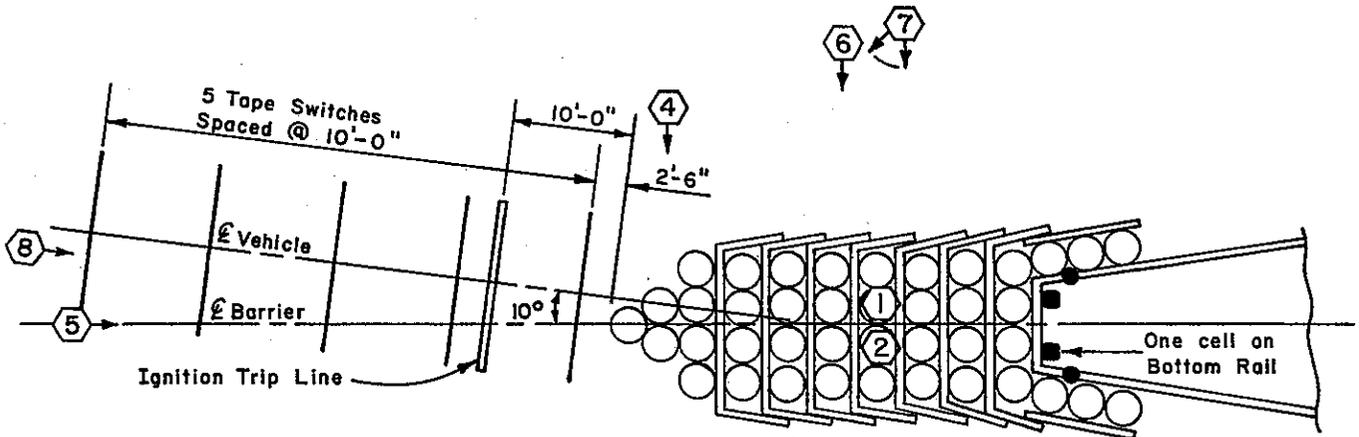
TEST 223

- Load cell (50 Kip min. capacity) Total 3.
- Strain gage (ℓ top surface, upper & lower rails, ℓ 8" behind nose of steel barrier) Total 4.

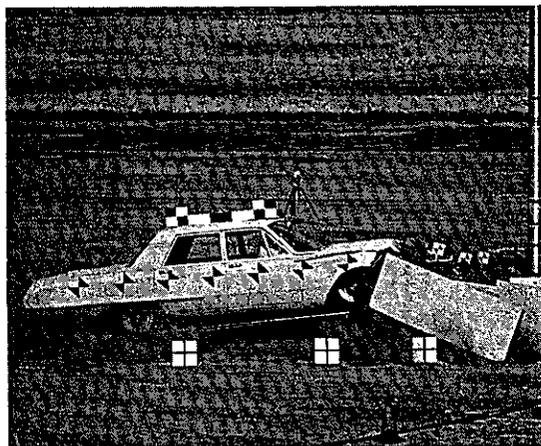
FIGURE 5

There was a noticeable vertical force imparted to the vehicle as shown by the vehicular rise in Figure 5, below. The rise was caused, at least in part, by the right front wheel riding up on the cable. There was virtually no vehicular "rebound".

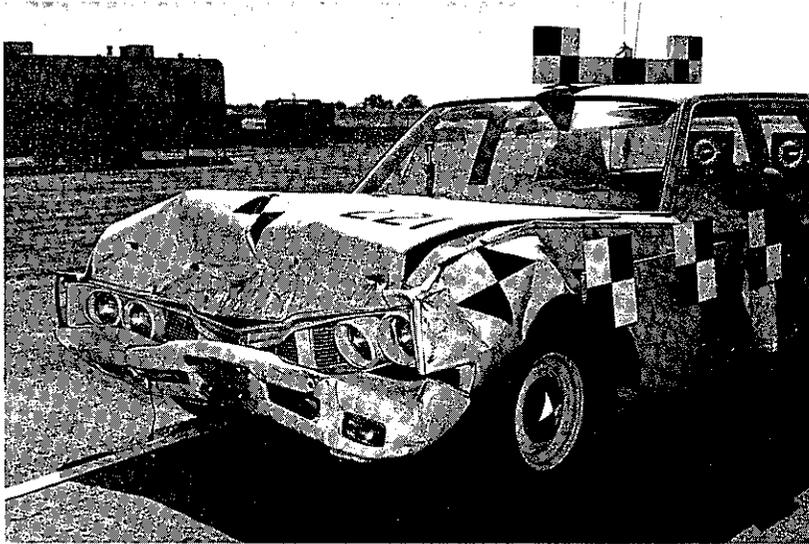
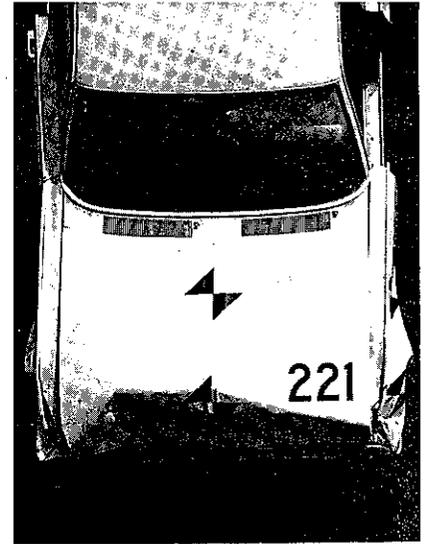
Vehicular damage consisted of some bumper deformation, a cracked windshield, a jammed door on the right front side, damage to both front quarter panels, 3.4 inches of steering column collapse

(energy absorbing steering column), and some dashboard deformation (see Figures 6 and 7, below). Maximum vehicular crush was 16.5 inches.

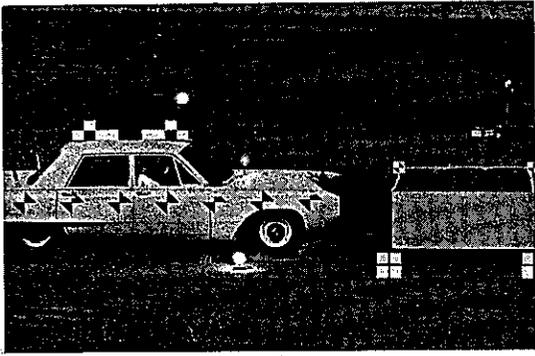
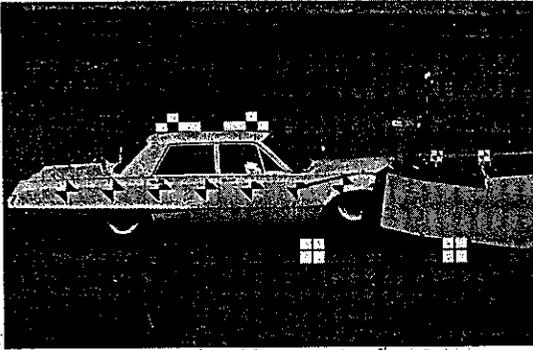
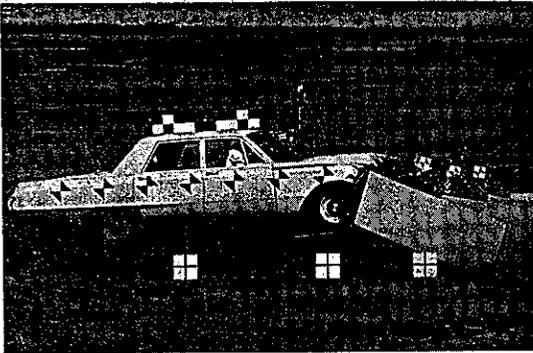
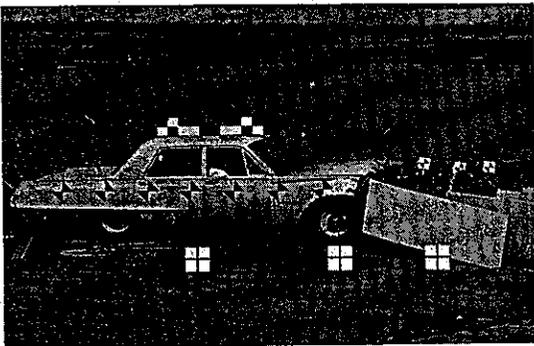
Barrier Depth	19.6 Ft.	Test No.	221
No. of Drums	41	Date	9-11-69
Permanent Displacement of Barrier Nose	10.7 Ft.	Vehicle Weight	1968 Dodge
Deceleration Distance-Passenger Compartment	16.5 Ft.	(W/Dummy and Instrumentation)	4690 Lbs. ²
Maximum Vehicular Deformation	16.5 In.	Impact Velocity	64.2 MPH
Steering Column Collapse ¹	3.4 In.	Impact Angle	Head-On
Passenger Compartment Deceleration	10.3 G's	Dummy Restraint	Lap Belt
(Highest 50 ms avg.)			
Vehicle Average Deceleration-Calculated	8.4 G's

All the drums in the barrier were deformed (see Figures 8 and 9). The cables were slack but undamaged. The plywood fender panels were badly cracked and splintered but remained attached to the barrier as it was deformed around the nose of the bridge approach guardrail. The drums crushed one row at a time, in successive order, as had been assumed in the design procedure. See Plate 3 (following page) for additional test data.

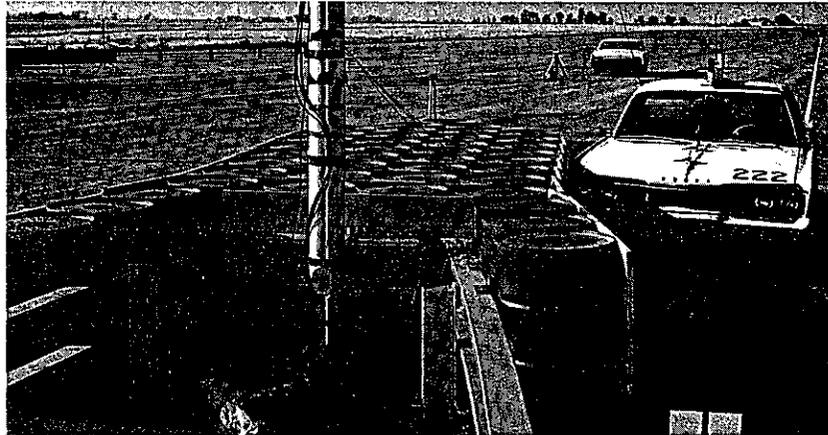
FIGURE 10

The 4760 pound 1968 Dodge sedan impacted the left side of the barrier 10.2 feet in front of the bridge approach guardrail at a speed of 59.8 mph and an angle of 11 degrees with the barrier (see Figure 10, below, for approximate location at impact). The vehicle was redirected but minimal redirection forces were provided by the drums. The vehicle axis was displaced 12 inches laterally from its location at impact before any redirection began (i.e., crabbing occurred). At this time, solid contact with the bridge approach guardrail had been established.

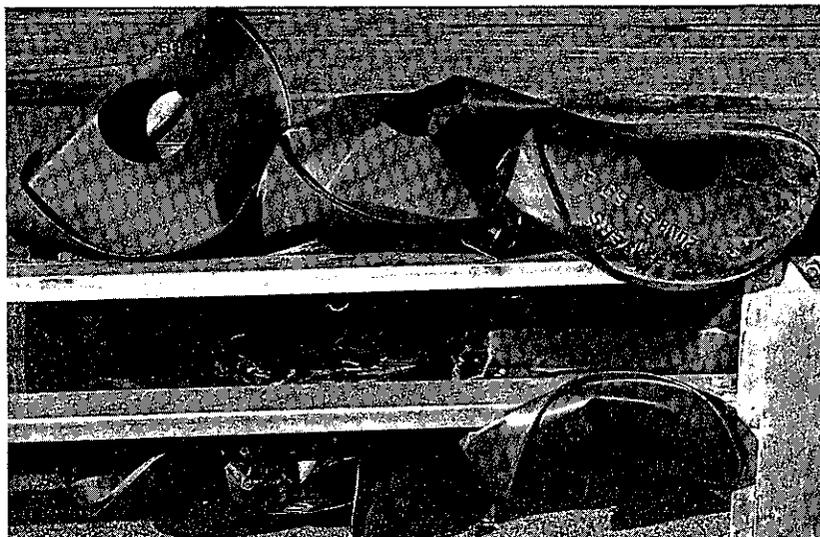
FIGURE 11

The force of the impact caused a clamping action to take place between the rear drums and the bridge approach guardrail, thus preventing drum ejection (see Figure 11).

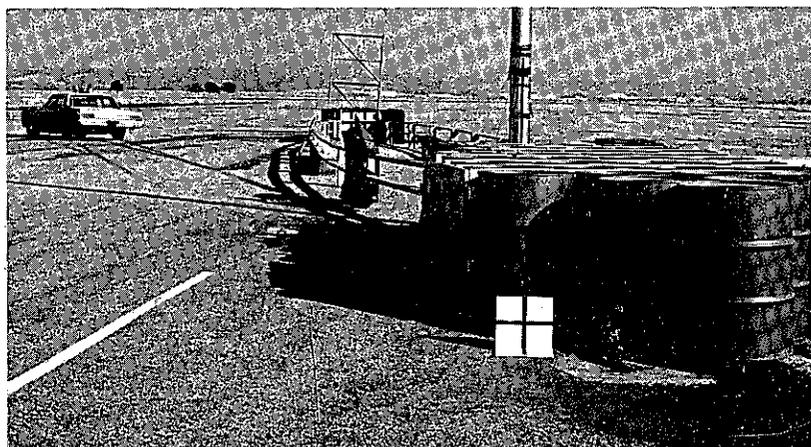
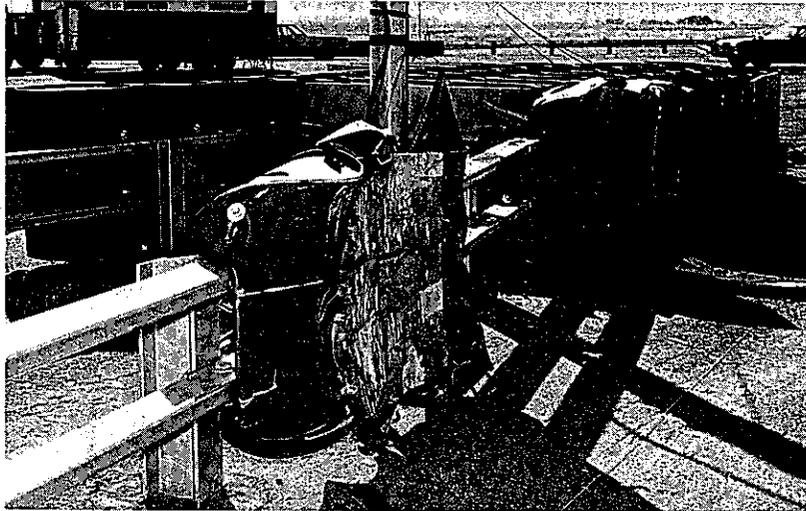
Additional barrier damage consisted of crushing of the outside drums in the back half of the barrier on the impacted side. All the fender panels beyond the point of impact were torn off the barrier. There were some failures at hinge pins; the ends of the last few diaphragms were broken off on the impact side. There was an unacceptable amount of debris deposited in what would be the adjacent traveled way. Some of the fender panel fragments were thrown 155+ feet from the point of impact (see Figures 12 and 13).

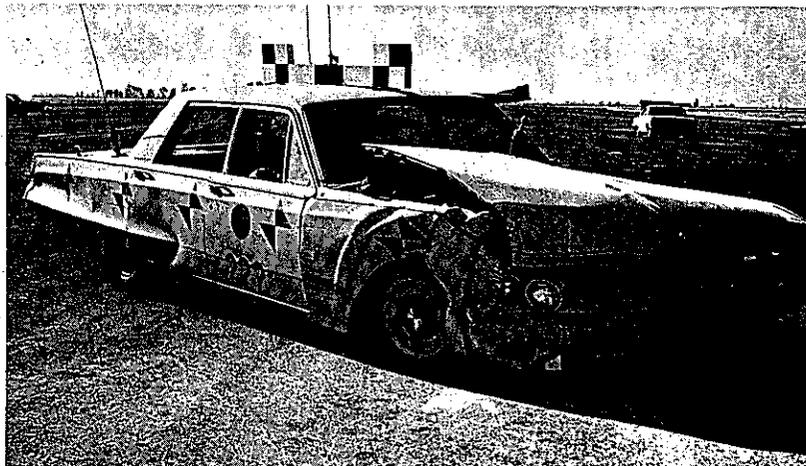
FIGURE 14

Vehicle damage included severe crushing of the right front quarter panel, jamming of the right front door, scars on the right doors and right rear panel, and displacement of the radiator to the point of touching one fan blade (see Figure 14, below). See Plate 4 (following page) for additional test data.

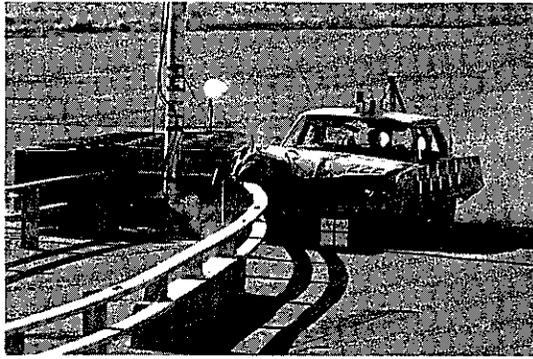
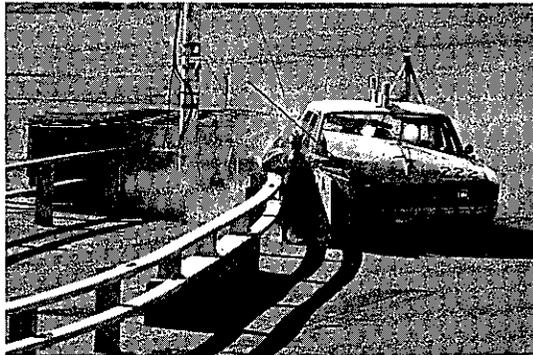
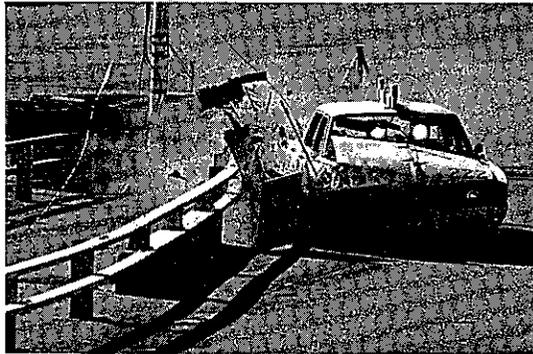
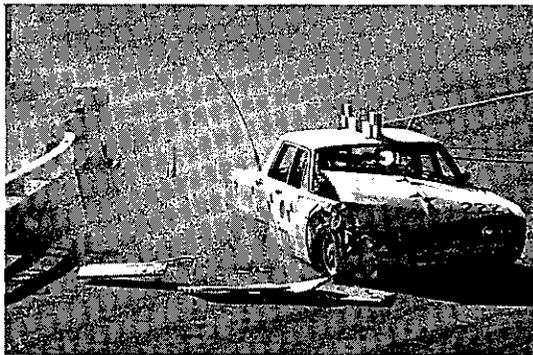
Barrier Depth	19.6 Ft.	Test No.	222
No. of Drums	41	Date	11-21-69
Permanent Displacement of Barrier Nose	None	Vehicle	1968 Dodge
Deceleration Distance-Passenger Compartment	Redirected	Vehicle Weight (W/Dummy and Instrumentation)	4760 Lbs.
Maximum Vehicular Deformation	27 in.	Impact Velocity	59.8 MPH
Steering Column Collapse ¹	None	Impact Angle	110 (Side)
Passenger Compartment Deceleration (Highest 50 ms avg.)	6.6 G's Long. 5.3 G's Lat.	Dummy Restraint	Lap Belt
Vehicle Average Deceleration-Calculated

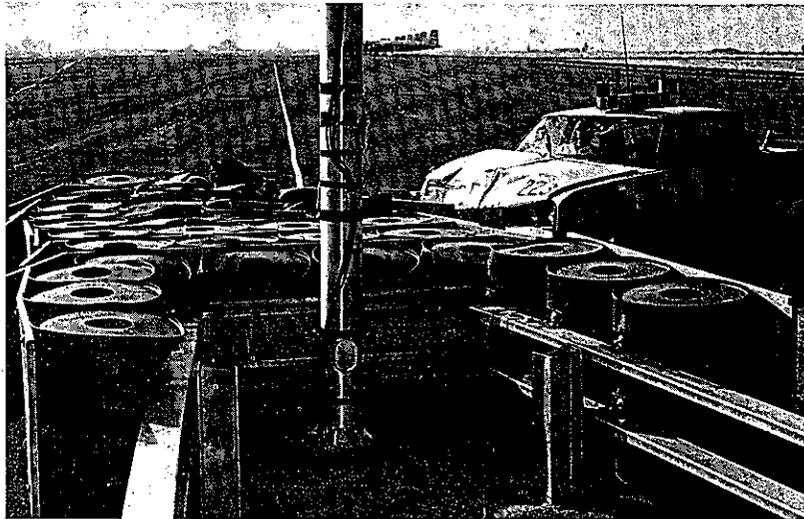
FIGURE 15

Test 223. This test consisted of a 4740 pound 1968 Dodge sedan impacting the same barrier design used for the previous test. The vehicle impacted the left corner of the barrier nose at a speed of 53.6 mph and an angle of 9 degrees. At impact, the center of the front of the vehicle was offset 3.5 feet from the barrier axis. Significant elastic lateral deflection of the barrier took place as the vehicle penetrated 13.2 feet, rotated clockwise, and then rebounded 2.5 feet. The maximum 50 ms average vehicular passenger compartment deceleration, based on accelerometer data, was 10.9 G's (in the longitudinal direction). The average passenger compartment longitudinal deceleration was 7.2 G's. (The vehicular rotation was neglected because the longitudinal velocity was approximately zero before rotation began.) Deceleration of this magnitude would probably result in moderate to severe injury for an unrestrained occupant, minor to moderate injury for an occupant restrained by a lap belt, and little or no injury for an occupant using both a lap belt and a diagonal shoulder harness. The position of the vehicle after the collision was such that it would have been a hazard to adjacent traffic (see Figure 15, below).

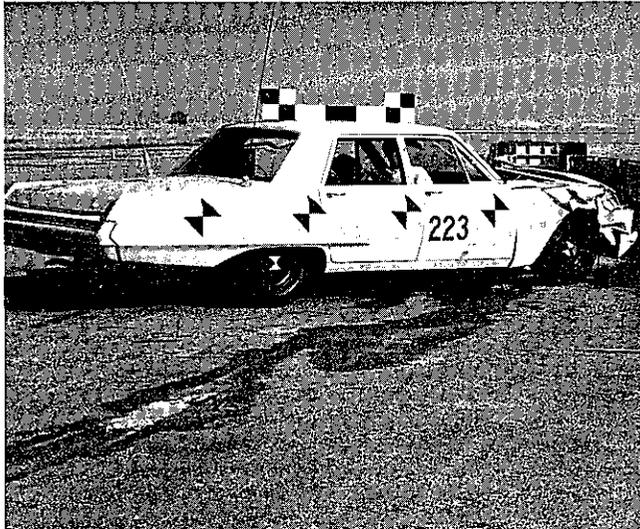
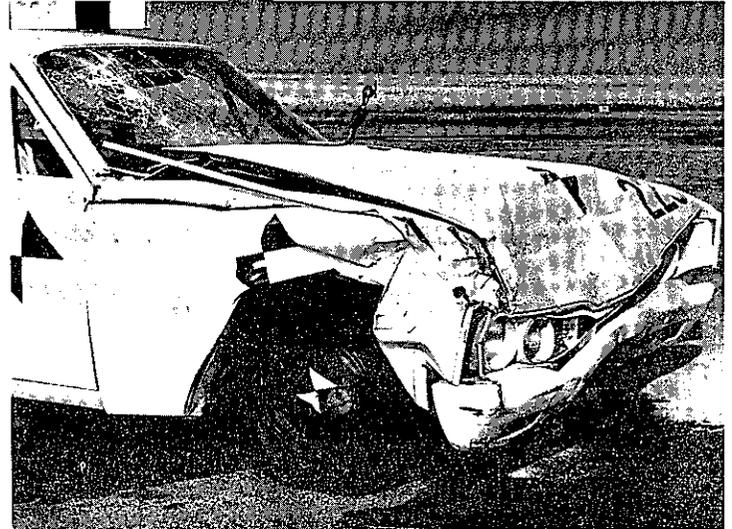
Vehicle damage consisted of a crimp in the roof on the passenger side, extensive hood deformation, slight displacement of the left front quarter panel, and 3.6 inches of (energy absorbing) steering column collapse (see Figures 16 and 17). There was a slash high on the cheek of the dummy driver and the windshield was broken in front of the dummy passenger. The dummy passenger was badly cut on the tip of the bridge of his nose, over his right eye and on his forehead, and on the right side of his face and cheek. This dummy's lower legs were removed before the crash; this may have contributed to some excessive movement of his upper body during the collision.

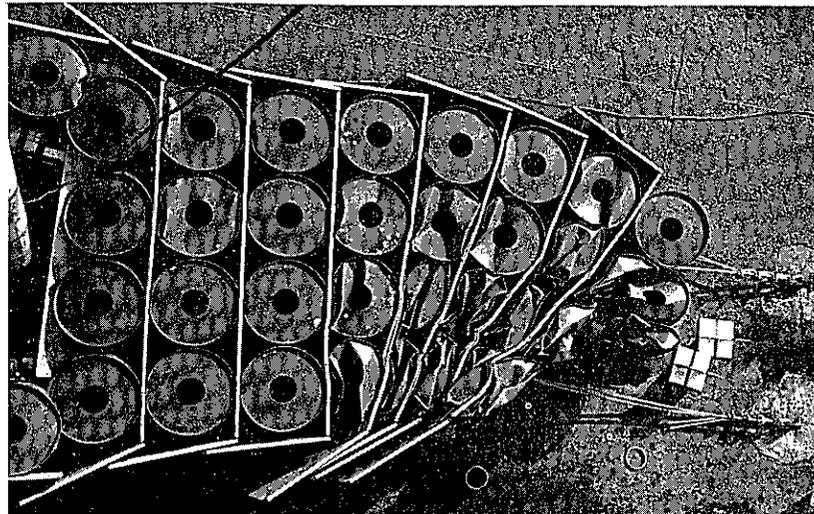
FIGURE 18

All but two drums were damaged. The left front and the right rear plywood fender panels were the only ones damaged. It appeared that the impact force was transmitted somewhat diagonally from the left front to the right rear of the barrier (see Figure 18, below). The left front portion of the barrier was crushed much more than the right front side. The film record shows the drums crushing one row at a time in successive order with the exception of the back row, which was deformed soon after impact. This was very similar to the dynamic barrier compression sequence observed during Test 221 and again verified the design assumptions. From a maintenance standpoint, all the drums would have required replacement.

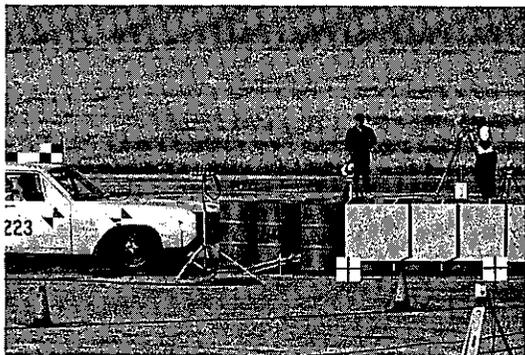
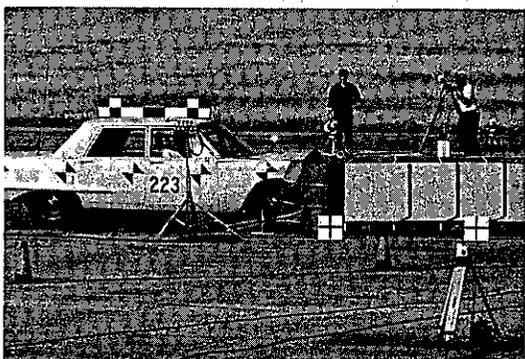
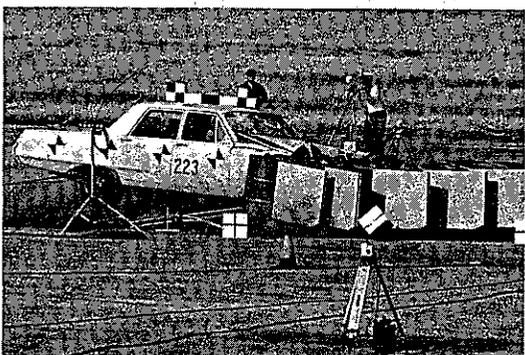
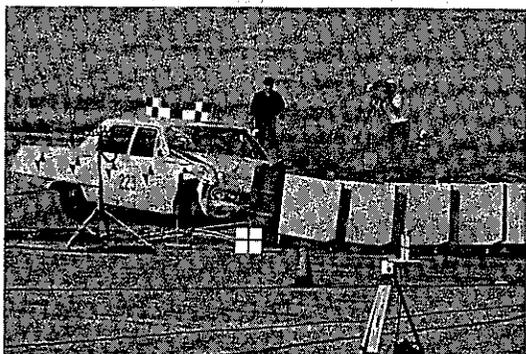
Barrier Depth	19.6 Ft.	Test No.	223
No. of Drums	41	Date	12-5-69
Permanent Displacement of Barrier Nose	5.5 Ft.	Vehicle	1968 Dodge
Deceleration Distance-Passenger Compartment	13.2 Ft.	Vehicle Weight	4740 Lbs. ³
Maximum Vehicular Deformation	14.5 In.	(w/Dummy and Instrumentation)	
Steering Column Collapse	3.6 In.	Impact Velocity	53.6 MPH
Passenger Compartment Deceleration	10.9 G's Long.	Impact Angle	90° (Nose)
(Highest 50 ms avg.)		Dummy Restraint	Lap Belt
Vehicle Average Deceleration-Calculated	7.2 G's ²

The movies showed the car being ejected outward from the barrier due to the elastic energy stored within the barrier. The clockwise rotation of the car was probably caused by a moment couple consisting of the vehicular momentum, acting through the vehicle CG, and this "elastic" energy, acting through the centroid of the vehicle-barrier contact interface. See Plate 5 (following page) for additional test data.

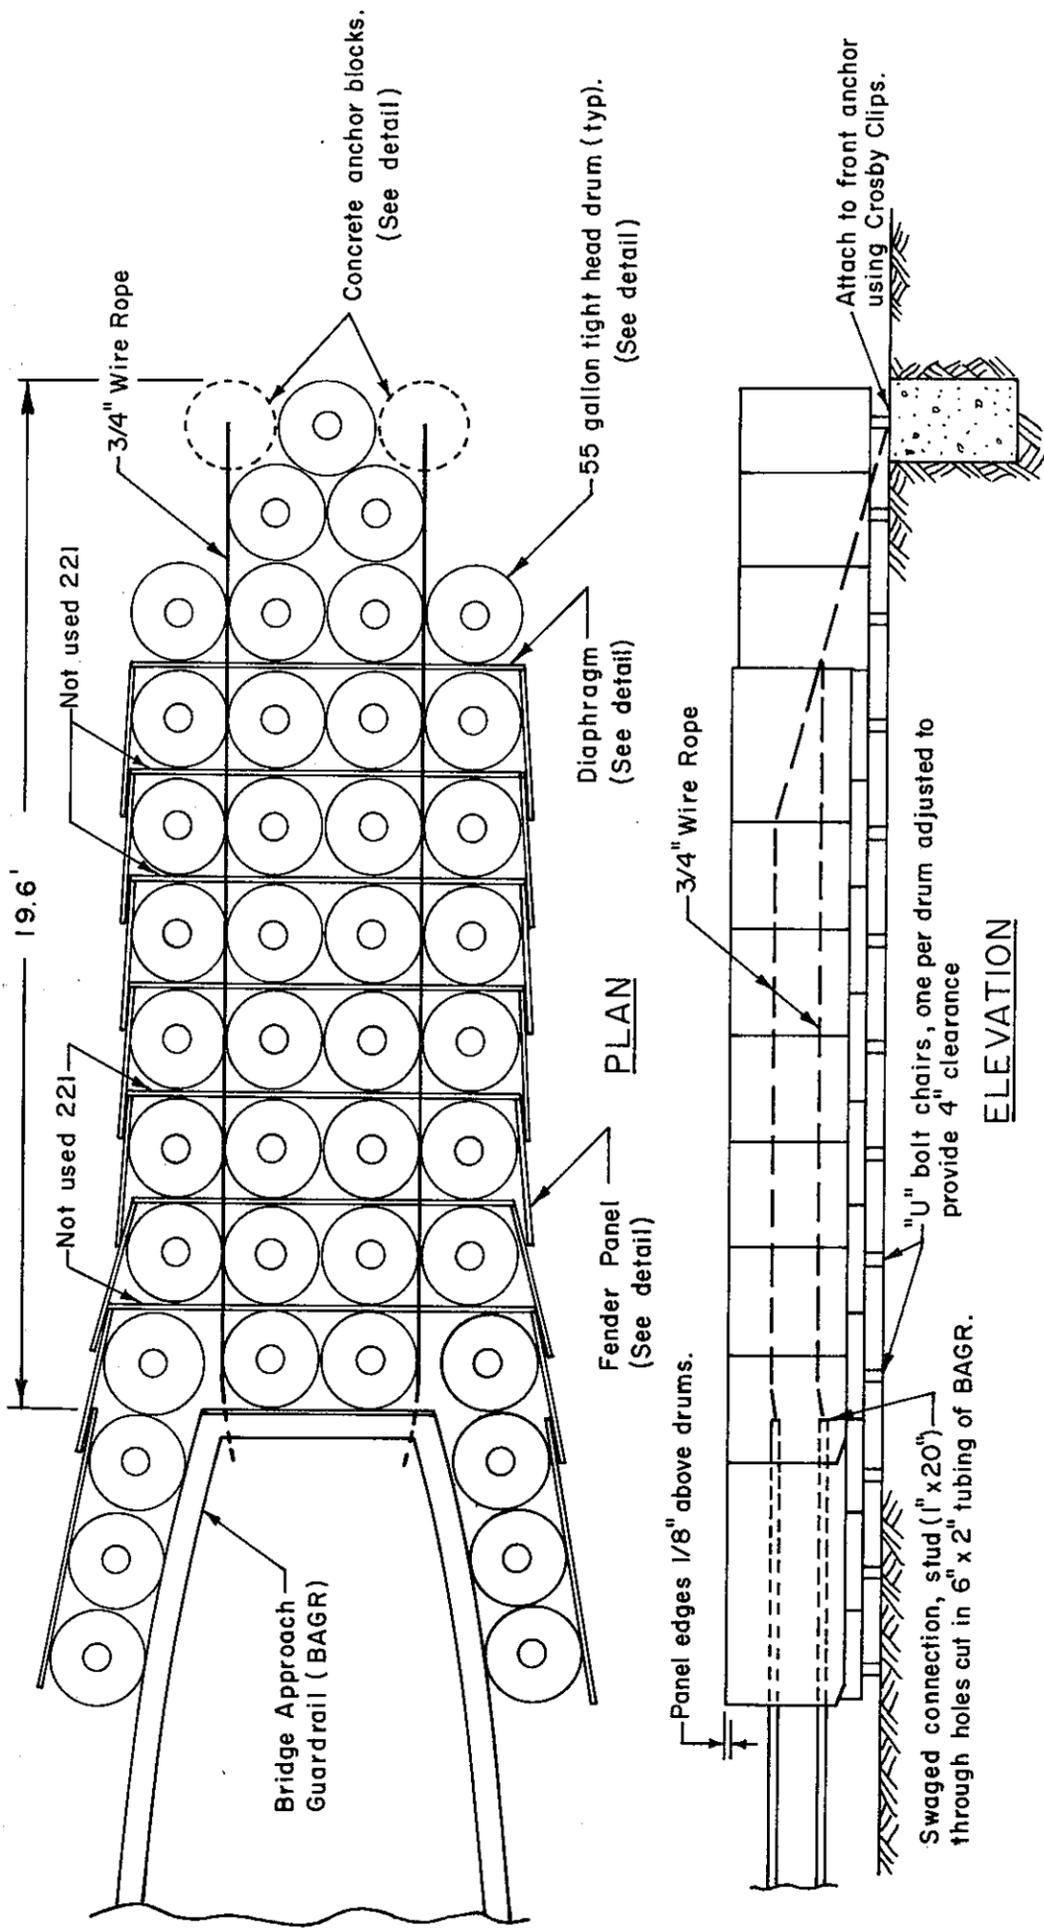
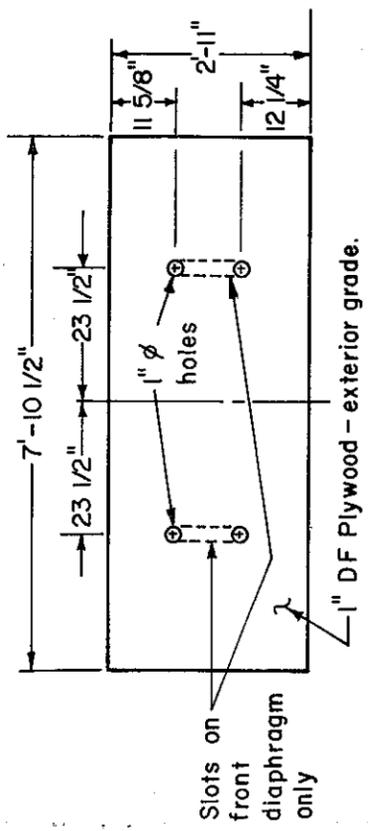
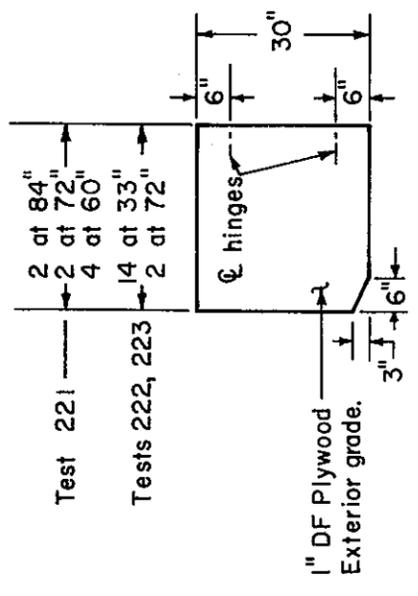
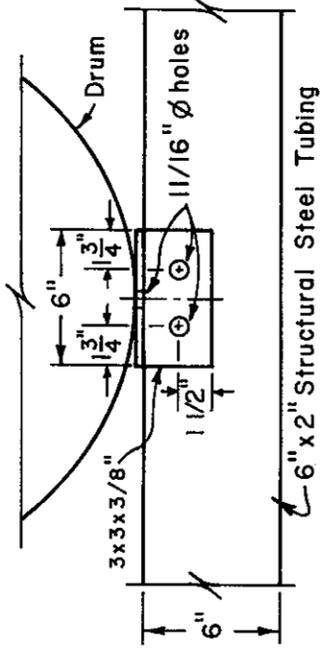
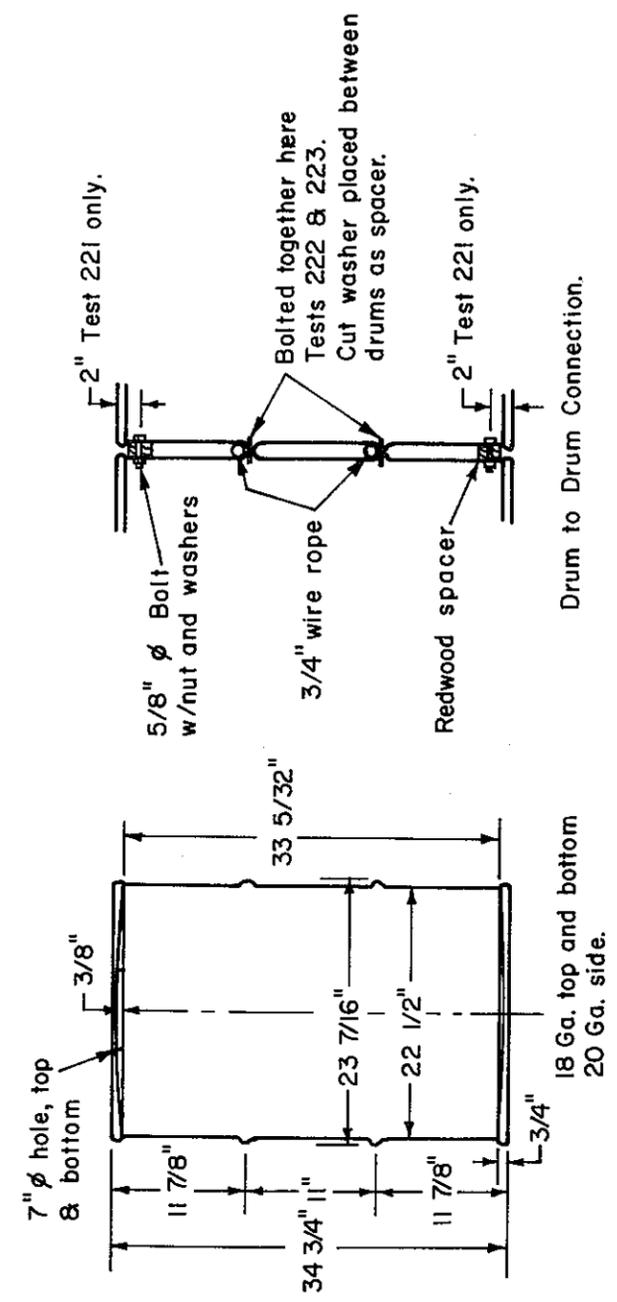
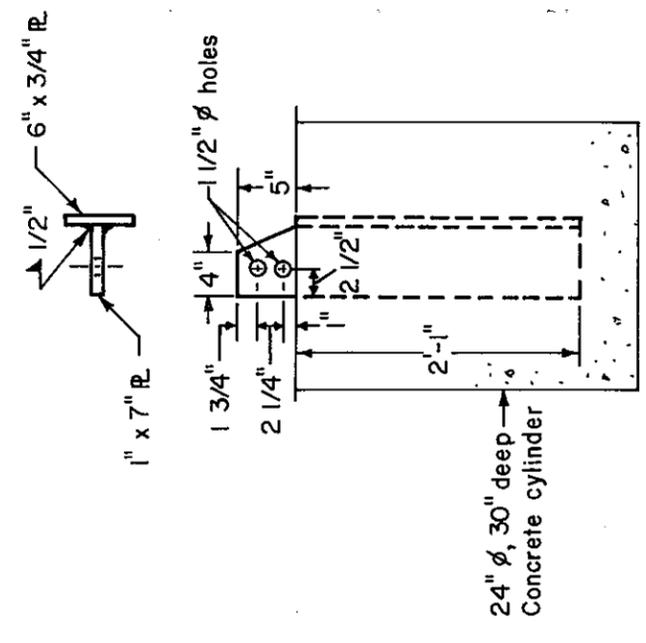
EXHIBIT 1

DIAPHRAGMS

FENDER PANELS

ENERGY ABSORBING BARRIER DETAILS

55 GALLON TIGHT HEAD DRUM

NOSE CABLE ANCHOR

Thus, the test barrier was designed to decelerate a 4700 pound vehicle impacting head on or at an angle of 10° with the barrier axis at an impact velocity of 60 mph without subjecting the vehicular passenger compartment to an average deceleration greater than 10 G's. (This choice of a relatively shallow 10° angle has since been justified, at least to some extent, by reports from several other states indicating that in-service energy absorbing barriers are being impacted head on in almost all cases.) The construction details for the barrier are shown on Exhibit 1.
