A Study Of The Influence Of Highway Deicing Agents On Aquatic Environments In The Lake Tahoe Basin And Drainages Along Interstate 80

July 1975

Ecological Research Associates

INTERIM REPORT

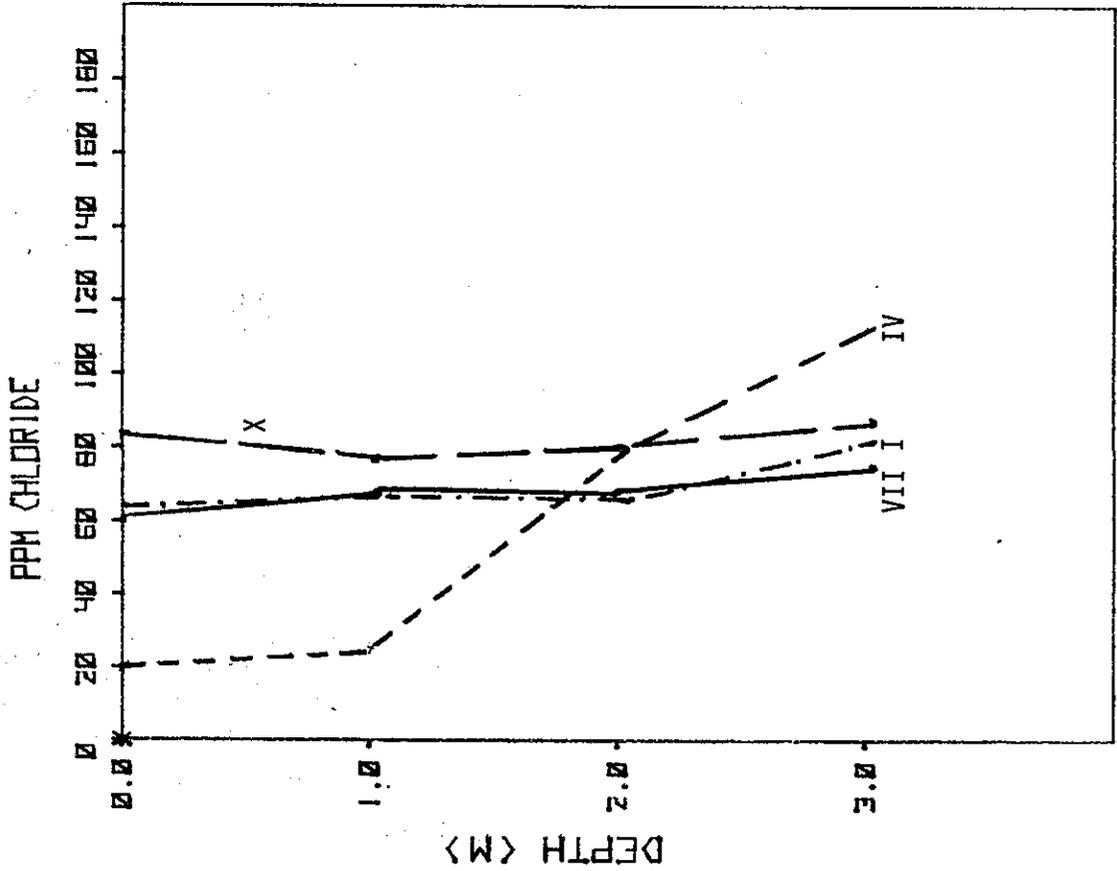
Graph II-3
Putt's Lake Chloride Profile

Depth	Data ppm Chloride			
	I	IV	VII	X
0	64.69	20.00	60.25	82.54
1	70.00	25.00	65.05	77.68
2	70.00	77.50	63.20	82.54
3	80.22	105.00	65.05	82.54
3.5	--	--	62.25	--

10. Putt's Lake, however, exhibits a marked chloride density gradient which maintains an unstable thermal structure during late winter. The shallow lake basin is a key factor in preventing monimolimnion (a dense layer of water which does not mix with the rest of the lake) development, but one could easily have developed in a deeper, more protected, lake basin given the current salt input. A check for monimolimnion development in small lakes near salted highways should be made throughout the state.

The chloride profile of Putt's Lake is plotted in Graph II-3. During the months of January, July, and October, nearly uniform profiles are exhibited. A slight increase (10 ppm) in the bottom two meters is noted in January. By April, this distribution has changed to one exhibiting marked chloride increase with depth. Chloride concentrations increase from 20.00 ppm at the surface to 105.00 ppm at the bottom. This is a 27.5 ppm increase during the last meter, and an average of 28 ppm increase/meter. Putt's Lake also exhibits very high conductivities.

Putt's Lake provides an excellent example of the fact that highway deicing operations in California can provide enough salt to cause a density gradient in small roadside lakes. This is especially true if the lake receives runoff directly from the freeway or a major portion of its watershed is crossed by the freeway. A state-wide survey of roadside lakes should be conducted to check for monimolimnion (non-mixing layer) development due to salt inputs from highway deicing operations. Attention should be given to those deeper lakes that may serve as a sump for road runoff.

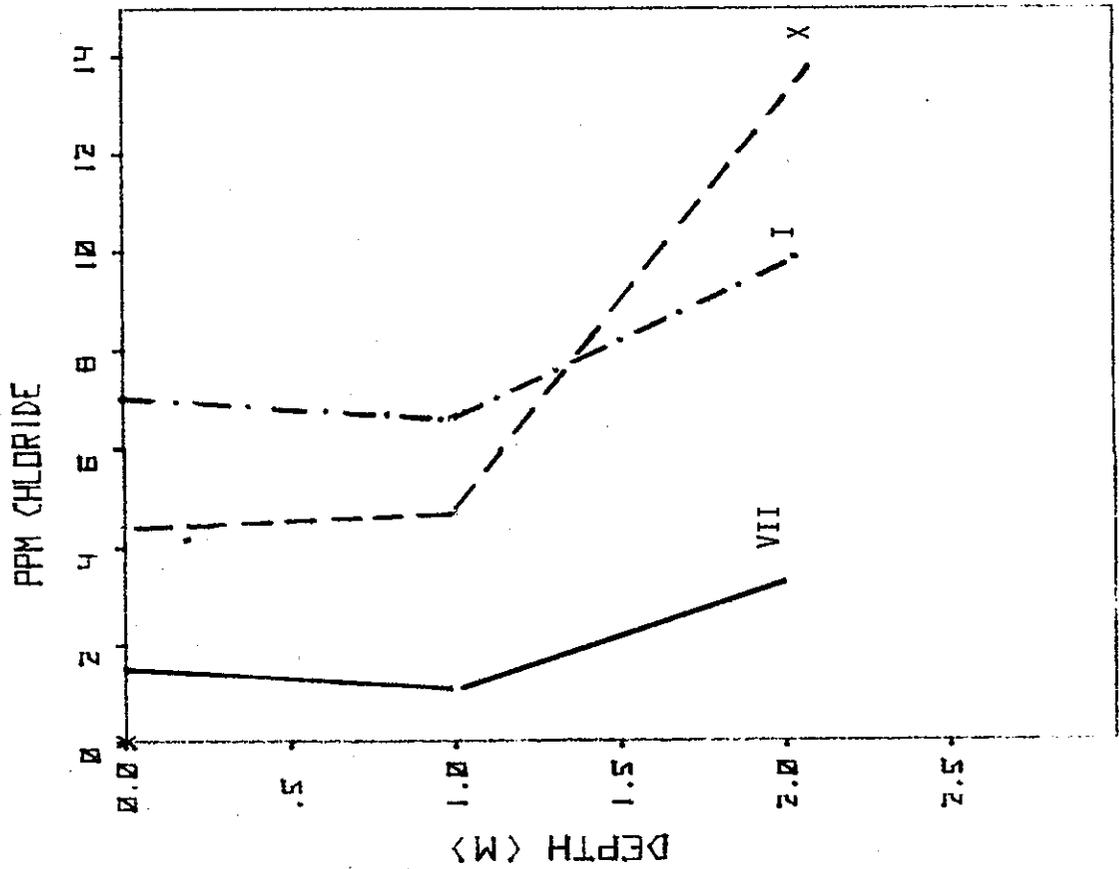
Graph II-4
Summit Roadside Rest
West Pond Chloride Profile

Depth (m)	Data ppm Chloride		
	I	IV	VII
0	7.00	N.S.	1.87
1	7.00		1.45
2	10.00		2.41

12. Gold Run Pond and Summit Roadside West Pond show temporary increases of chloride with depth, but these parallel the thermal structure. A combination of chloride and thermal density gradients are indicated, but both ponds are holomictic (mix completely to the bottom of the lake).

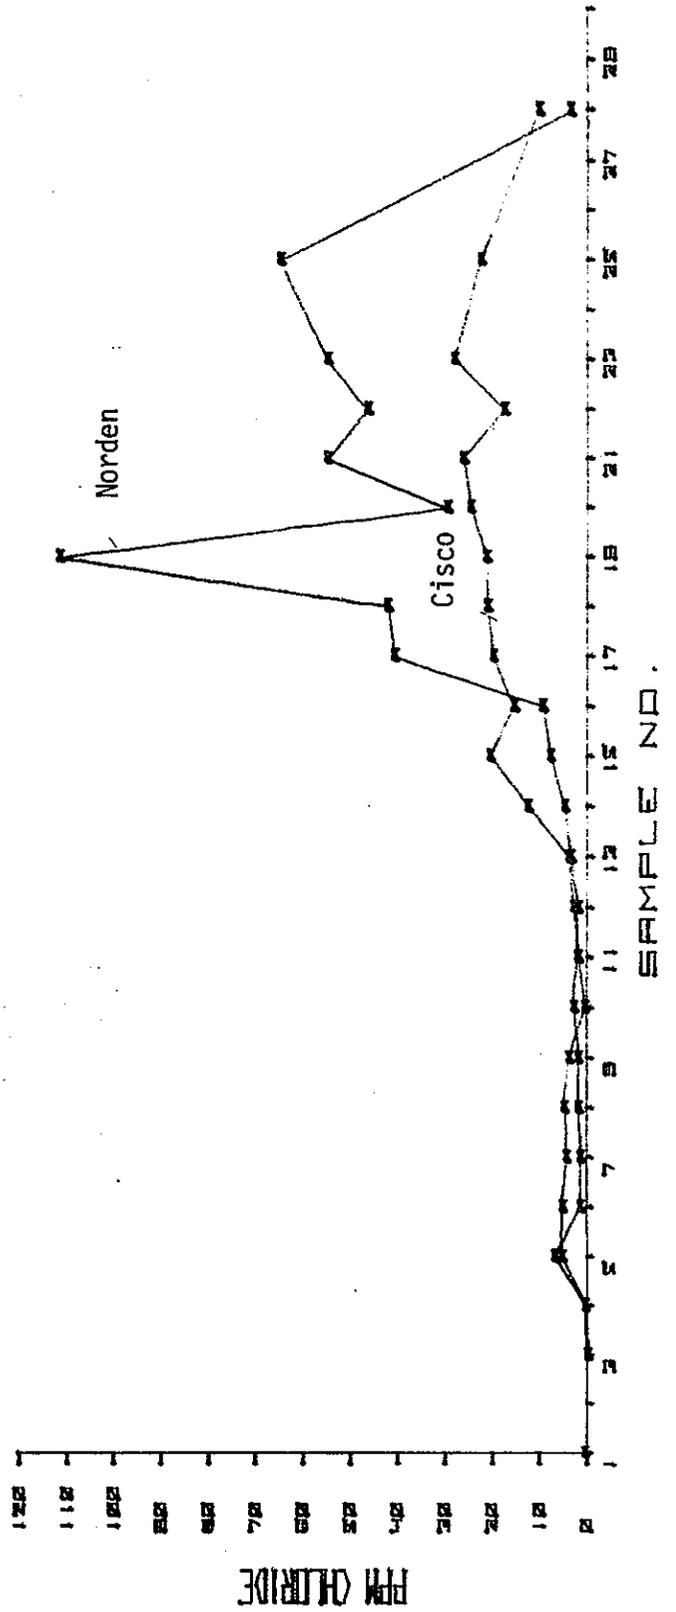
South Fork of the Yuba River

The dilution of chloride levels is seen in Graph III-9 of the South Fork of the Yuba River. Chloride concentrations at the Norden station are high during the winter and closely parallel the levels found in Upper Castle Creek as it enters Lake van Norden. The levels are reduced, and fluctuations are damped on the river at the Cisco Grove Station.
