FHWA/CA/TL-96/06

Long-Term Monitoring of Metallized Zinc Bridge Deck and Soffit Cathodic Protection Systems

December 1995

Office of Materials Engineering and Testing Services
Corrosion Technology Section
California Department of Transportation
Sacramento, California 95819

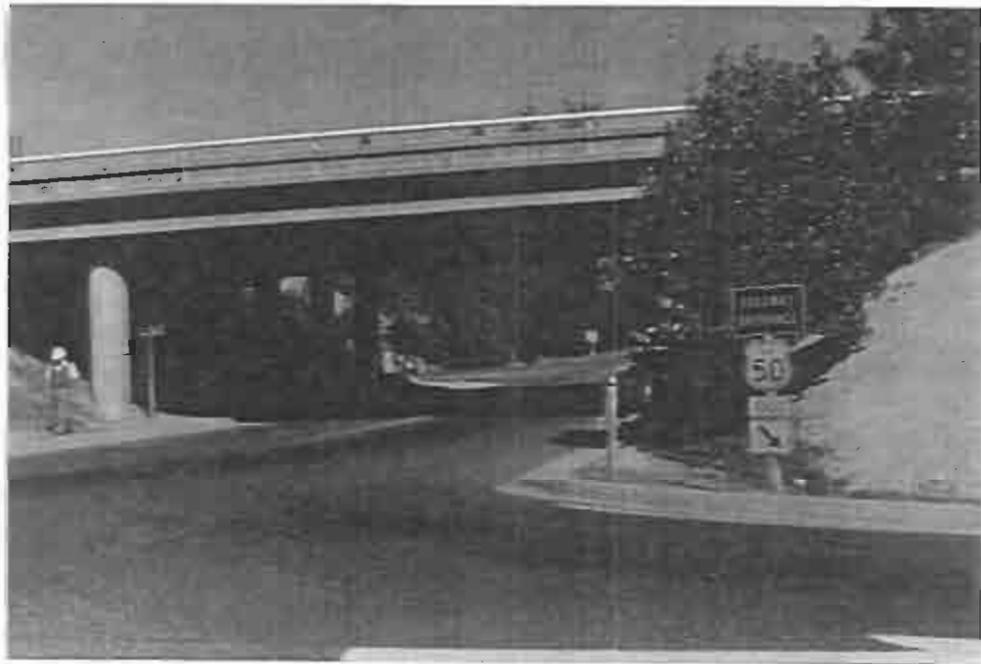
Figure 5-1, EAST CAMINO UNDERCROSSING

The East Camino Undercrossing (Bridge Number 24-40) was the first reinforced concrete bridge deck to use a metallized zinc CP system. This structure is located on State Route 50, approximately 6 miles (9.5 km) east of Placerville, California, at an elevation of 3300 feet (1000 m) (Figure 5-1).

The structure is an 89 foot (27.4 meter) long, 3 span, reinforced concrete T-beam bridge built in 1964, and has a total deck surface area of approximately 7200 square feet (670 square meters).

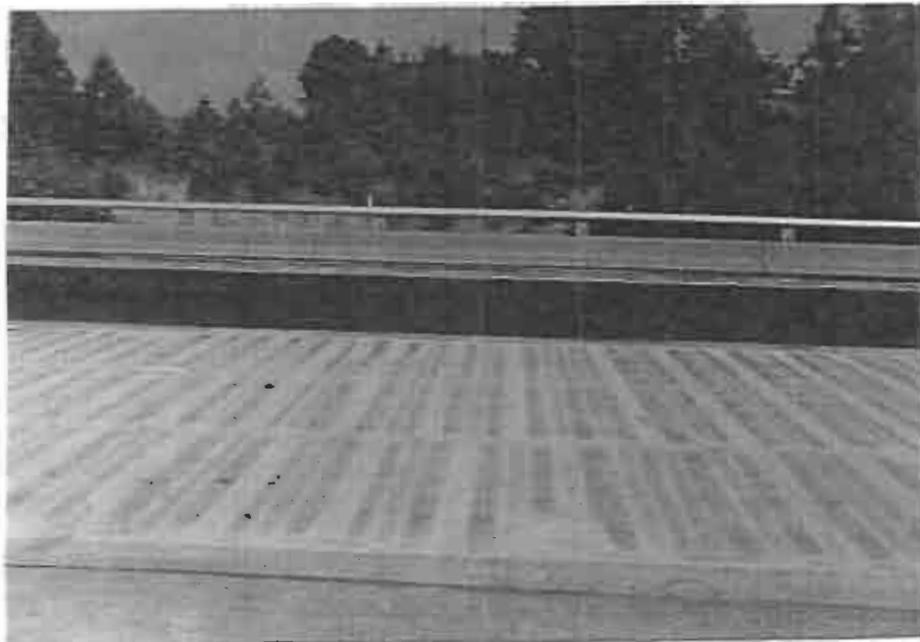
Figure 5-4, DECK METALLIZING GRID PATTERN

The metallized zinc was applied in stripes on the deck, with alternating spaces of bare concrete to allow the asphaltic concrete (AC) overlay to bond directly to the concrete deck. All transverse stripes within each quadrant were electrically connected by spraying longitudinal stripes, the length of the structure, across the transverse stripes. These longitudinal stripes were connected within each quadrant and did not bridge any of the 1 foot (0.3 m) wide clear areas between quadrants. The result was a grid pattern of zinc stripes (Figure 5-4). The zinc stripes also transversed each exposed primary anode pad previously placed in the deck surface in order to make the necessary electrical connection to the CP rectifier.

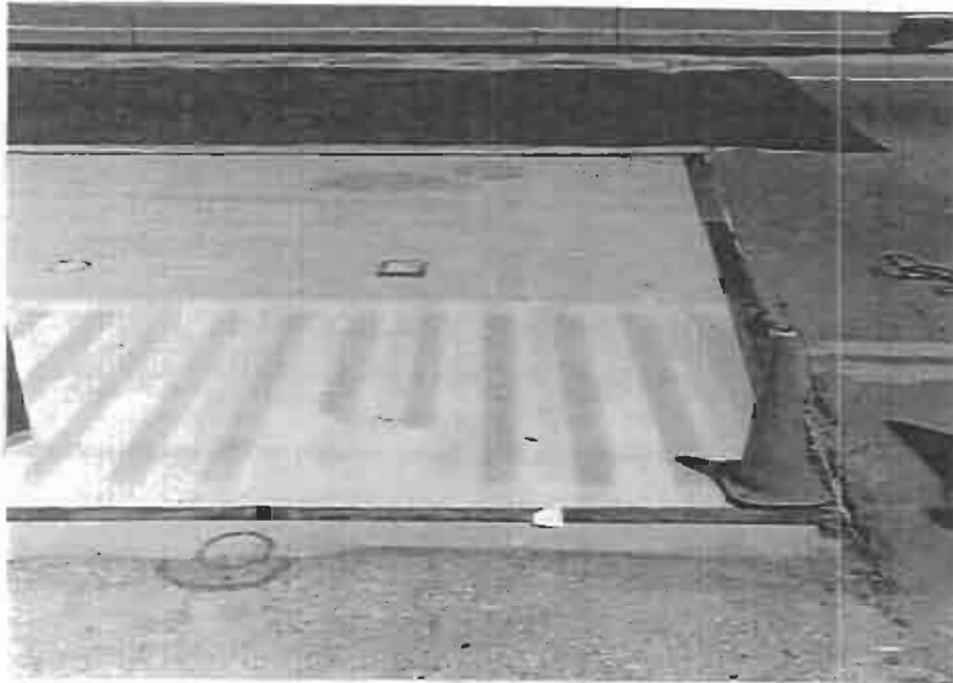
Figure 5-5, METALLIZED GRID PATTERN OVER PRIMARY ANODE PAD

An approximately 18 inch square (0.46 meter square) area around each primary anode pad was sprayed with zinc to ensure direct contact between the pad and several of the nearest zinc stripes (Figure 5-5).

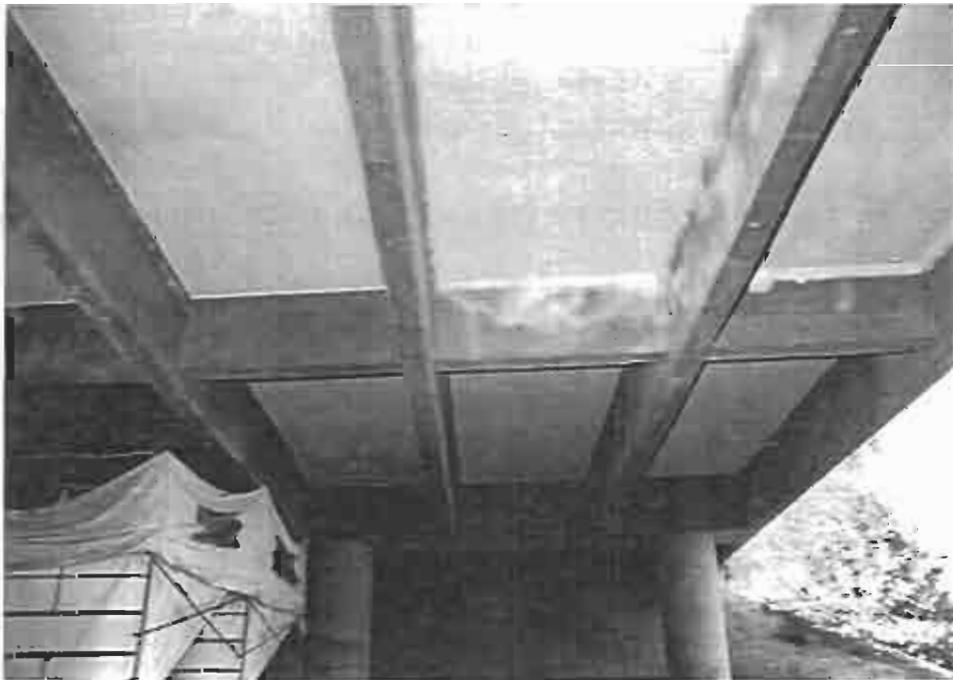
Figure 5-6, EAST CAMINO UNDERCROSSING, SOFFIT SIDE

A metallized CP system was also applied to the bottom surface (soffit) of the East Camino bridge deck to determine the ability of this type of installation to provide CP to the top mat of the reinforcing steel. The metallized zinc soffit system was composed of the horizontal surfaces of the ten bays under the number two span of the westbound lanes (Figure 5-6). The bent caps and diaphragms were not metallized. The other two spans (numbers one and three) under the bridge were reserved for future systems as well as serving as control areas for this study.

The anode pads were recessed and epoxied so that their top surface was flush with the surface of the soffit concrete. Since the metallized zinc did not have to be protected, no overlay was applied and the CP wiring was surface mounted. This installation process is described in detail in the initial report on these systems (1).

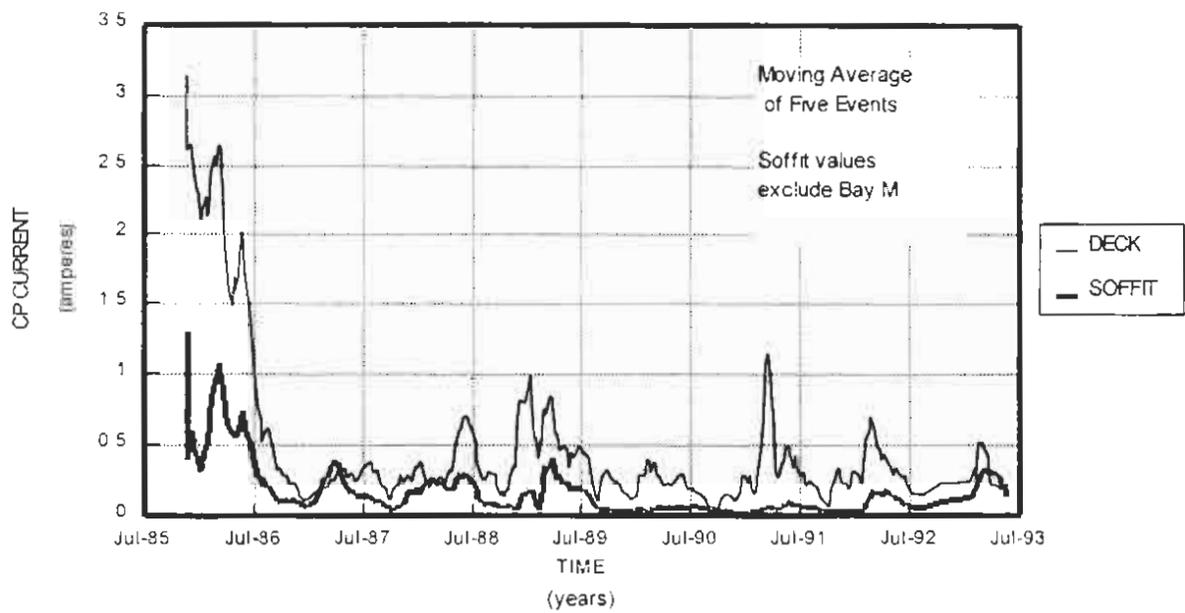
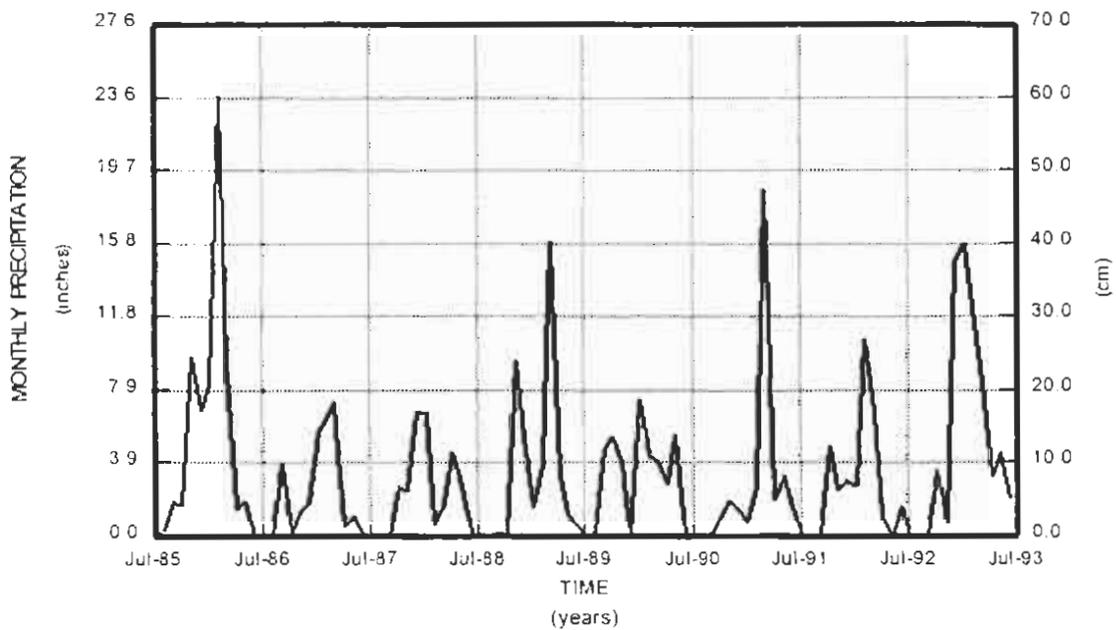
Figure 9-3, CP CURRENT & MONTHLY PRECIPITATION VS TIME, DECK AND SOFFIT CP SYSTEMS

Moisture Affects: As shown in Figure 9-2, seasonal climatological changes affect the electrical resistance of the concrete. As expected, the CP current flow was higher (the electrical resistance lower) during the wet periods as shown in Figure 9-3. The current dropped off during the warm, dry summer as the concrete dried. A higher driving voltage was necessary on the soffit CP system to overcome the high electrical resistance of the dry concrete surface.

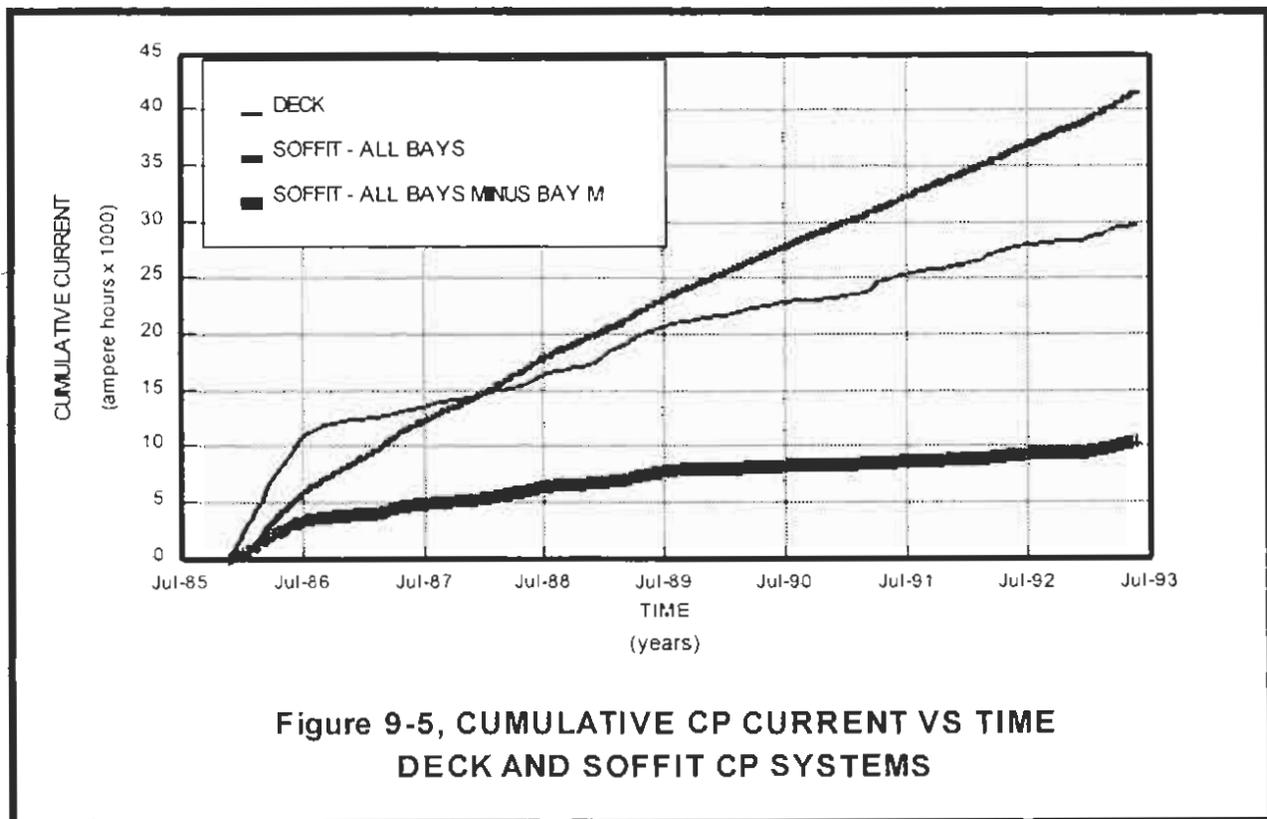
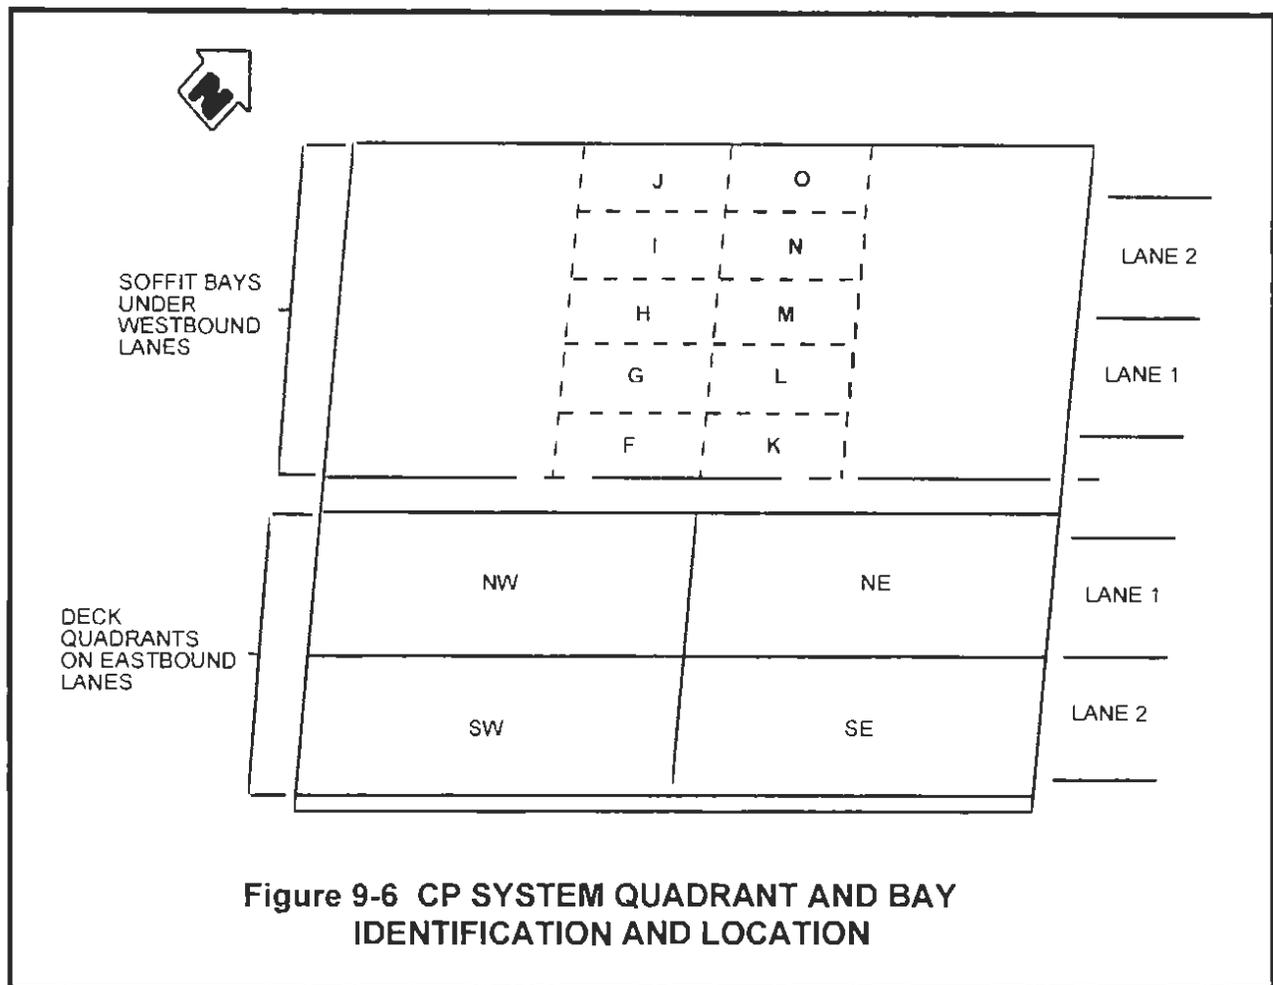
Figure 9-6 CP SYSTEM QUADRANT AND BAY IDENTIFICATION AND LOCATION

Each CP system was divided into quadrants or bays as described earlier. Figure 9-6 identifies the individual quadrants and bays (those areas providing CP current) relative to the deck area of the structure.

Since the quadrants and bays of these systems were independently wired, current flow to each could be monitored separately. Table 9-8 presents the average current density delivered during the first 7.5 years of CP operation to each area protected on the structure.

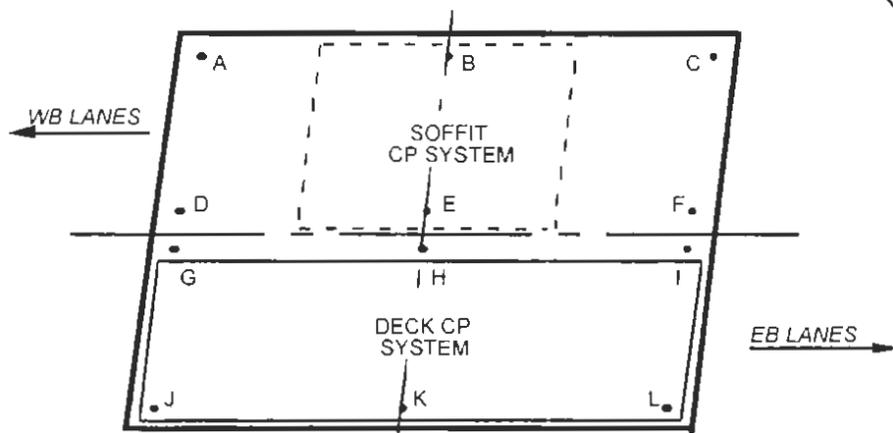
**BRIDGE LOCATION MAP OF DATA COLLECTION
POINTS AND AREAS OF CP APPLICATION**

The polarization decay results from fourteen polarization decay surveys of 1 hour or more duration are presented for eight half-cell locations in Table 9-9. (Access to the structure for sufficient time to perform 4 hour depolarization decay measurements was not always possible.) Values of 80 millivolts or more from the 1 and 2 hour depolarization decay surveys were considered likely to reach 100 millivolts in 4 hours.
