Wire Mesh Reinforcement in Bituminous Resurfacing

State of California
Department of Public Works
Division of Highways

Presented at the 35th Annual Meeting of the Highway Research Board Washington D.C., January 16-20, 1956

WIRE MESH REINFORCEMENT
IN BITUMINOUS RESURFACING

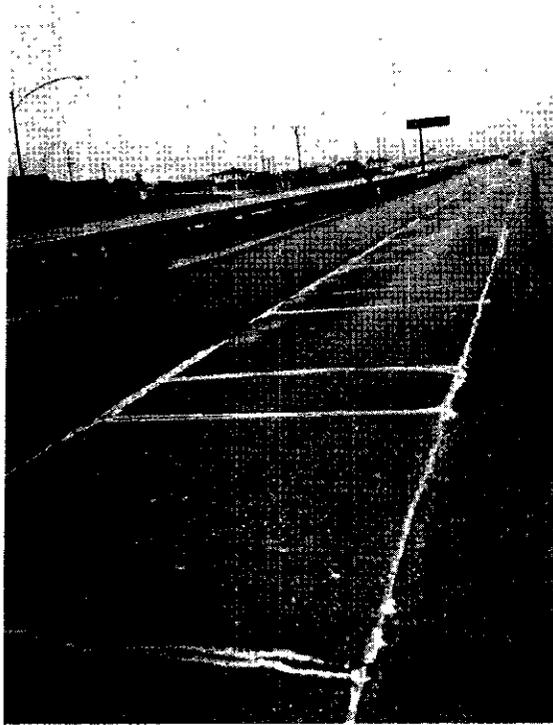
FIG. 1
Typical Reflection Cracking.
Both lanes resurfaced June 1954 with 1-in. thick bituminous mix.
Note absence of cracks in passing lane at left.
Cracks began to appear after 1 month.
US 40 near Fairfield

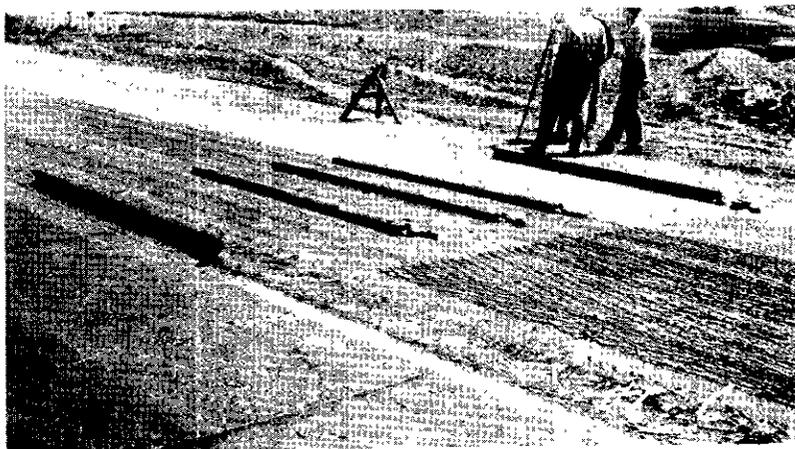
FIG. 13
Sleds used to hold down
road mesh and welded wire fabric.
