Causes of Corrosion of Reinforcing Steel in San Mateo-Hayward Bridge Part II IV-SM, Ala-105-B,A

November 1955

State of California  
Department of Public Works  
Division of Highways  
Materials and Research Department

CAUSES OF CORROSION  
OF  
REINFORCING STEEL  
IN  
SAN MATEO-HAYWARD BRIDGE

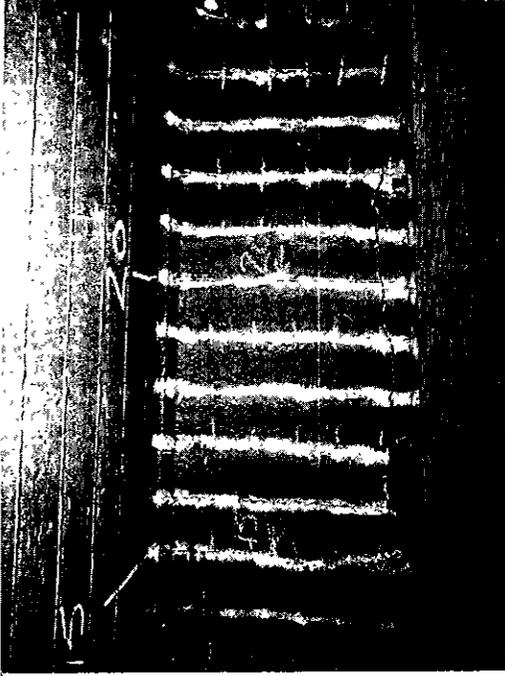
Typical appearance of cracked concrete in bottom of beams. Distance between vertical sandblast lines = 0' - 5" ±

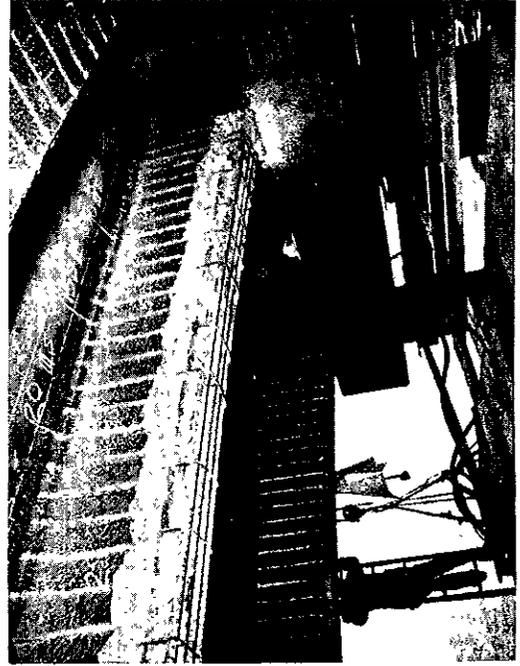
Beam ready for sandblasting.

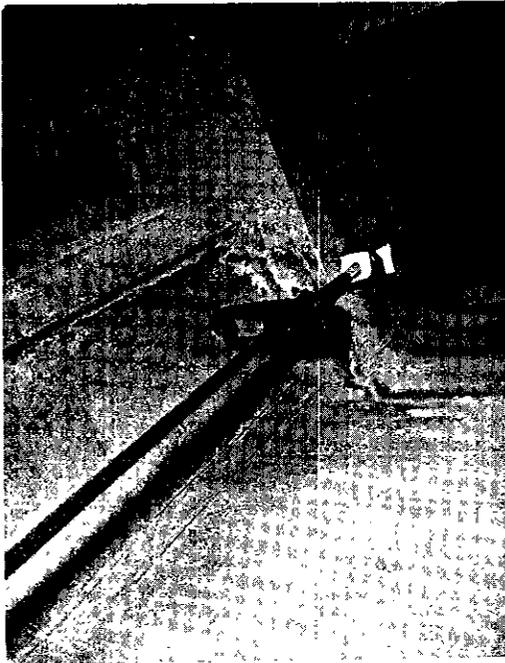
Steel support for insulator of abandoned lighting cable on underside of deck. Note corrosion of steel supports

It is incidental to the main study of this structure, but of interest to note, that the steel bolts, which hold the electrical insulators for the wires of the abandoned lighting system, are severely corroded where they are exposed to the atmosphere. However, it is an exceptional circumstance to find the concrete cracked at the embedded bolts. These bolts are located on the underneath surface of the deck about one foot in from the outside edge of the deck. This appears to support in a small way the preliminary conclusion that the corrosion of the reinforcing steel of this structure was not due to atmospheric attack of any consequence.

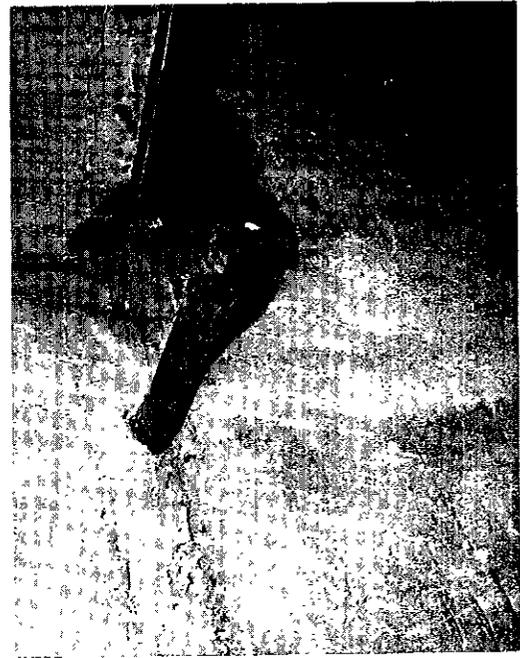
Typical appearance of steel conduit (use unknown) remaining in diaphragm.

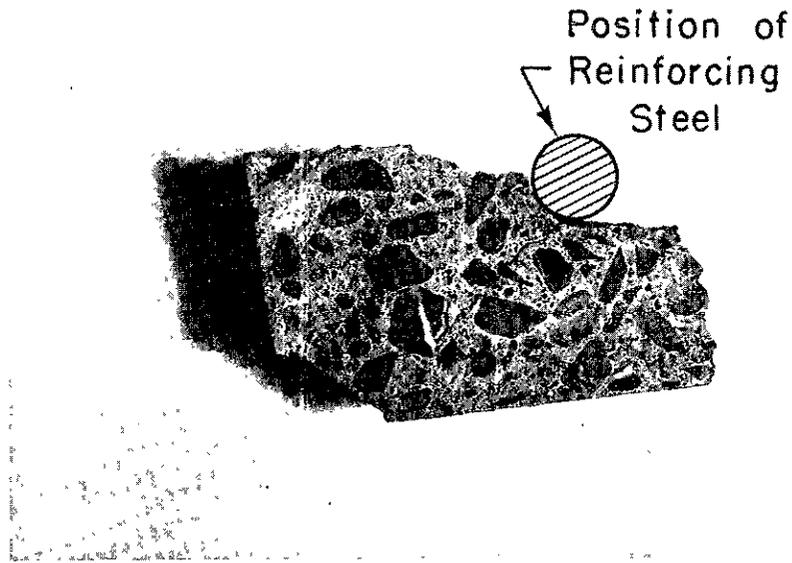
Concrete beam sample obtained from area of steel corrosion and concrete spalling. Note crack in concrete which started at the location of steel contact and has not reached the outside surface of the concrete.

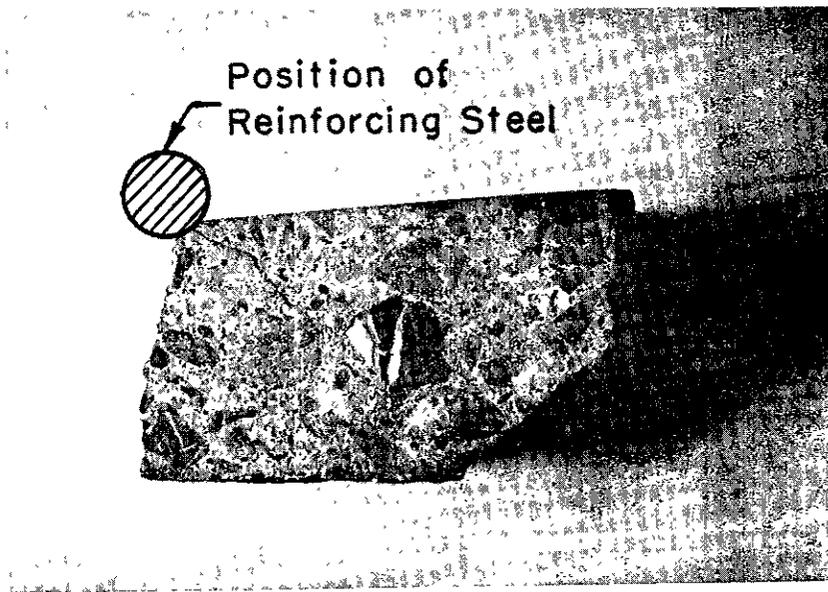
Concrete beam sample obtained from area of steel corrosion and concrete spalling. Note crack in concrete which started at the location of steel contact but has not reached the outside surface of the concrete.

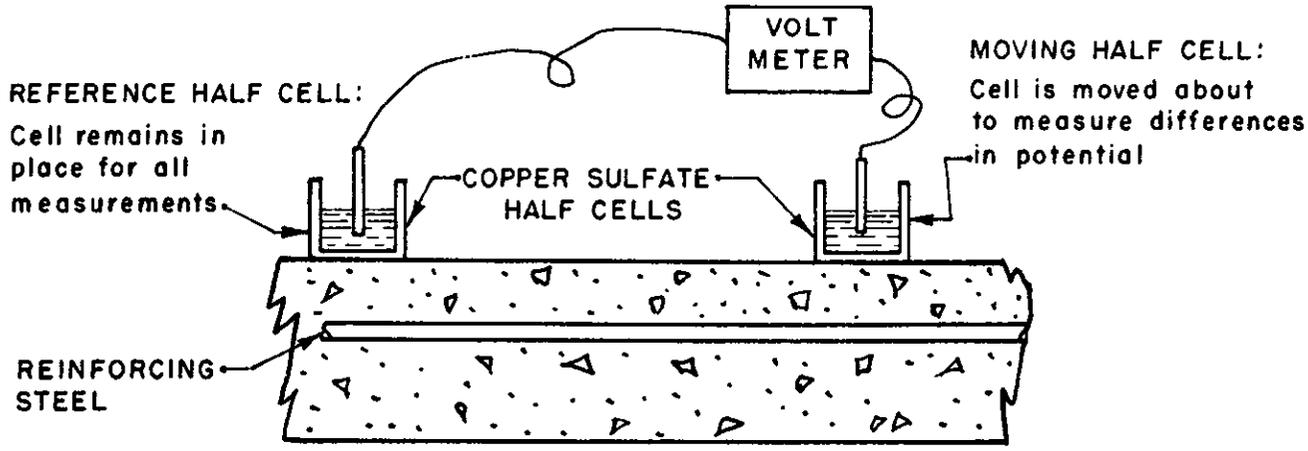
Method for making electrical surface potential gradients.

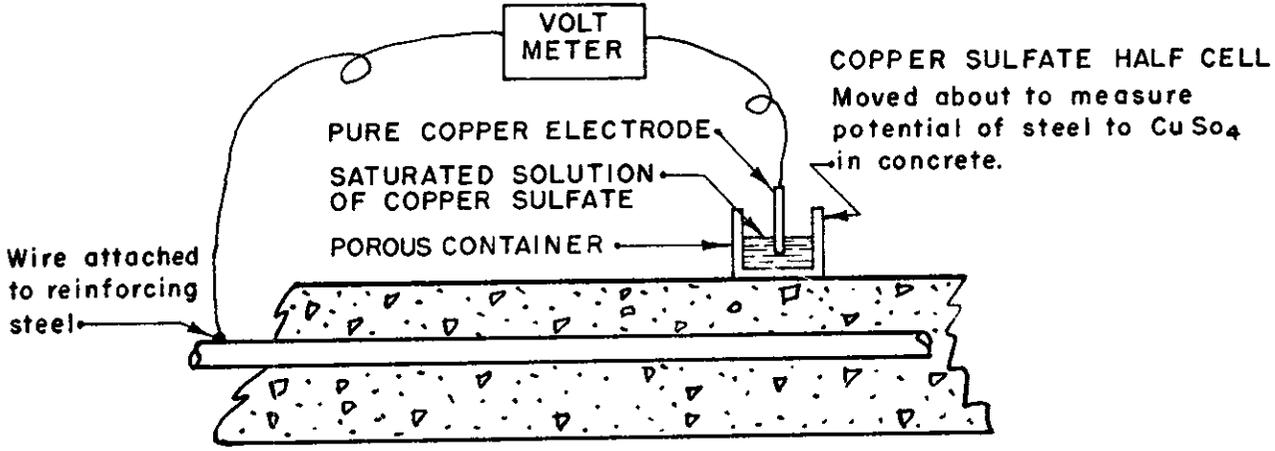
Method for making electrical surface potential measurements using embedded steel and  $CuSO_4$  halfcell.

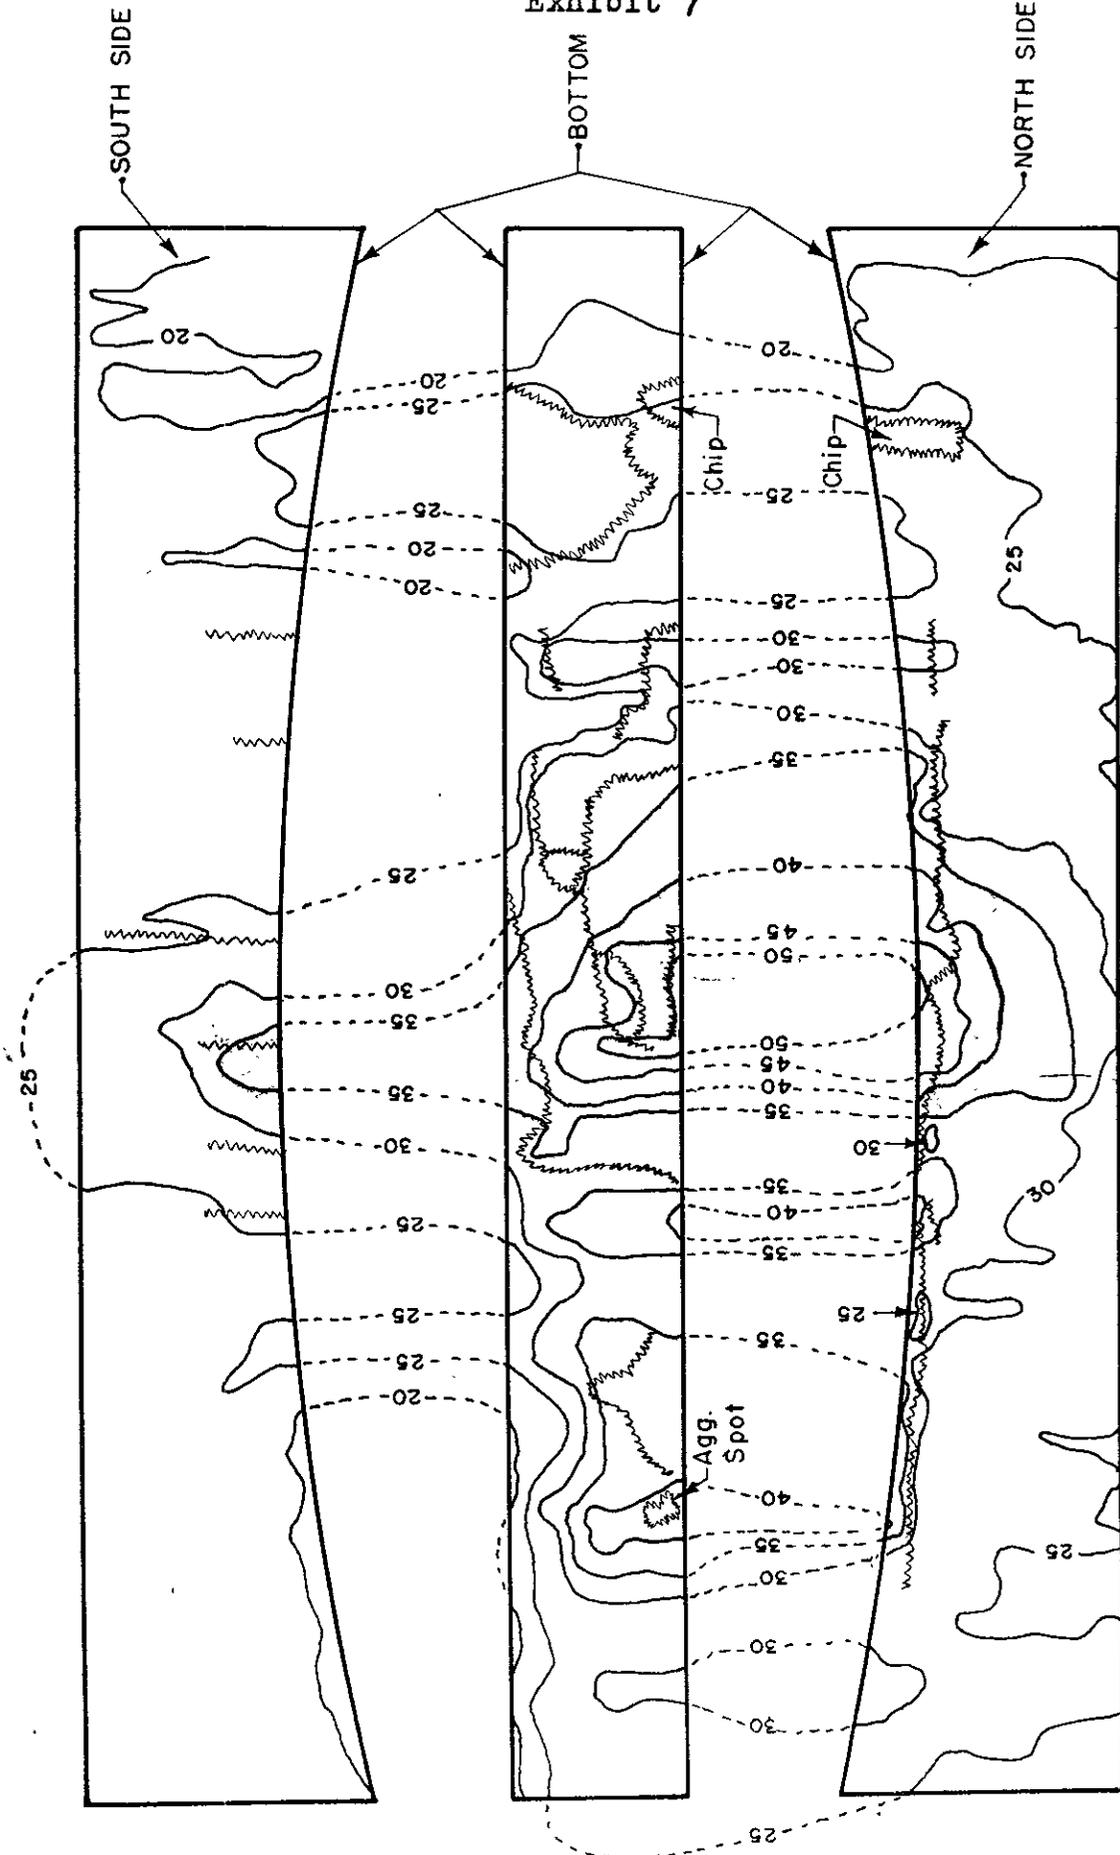
Exhibit 7

CHART I  
Equipotential Contours of

BEAM S-1 BETWEEN BENTS #385 & #386

The equipotential "contours" of these beams are depicted on Exhibits 7, 8 and 9. Charts 1, 2 and 3 respectively, which are in the Appendix. In this survey, as in the previous survey, there was excellent correlation between the potential measurements and actual areas of corrosion of the reinforcing steel.

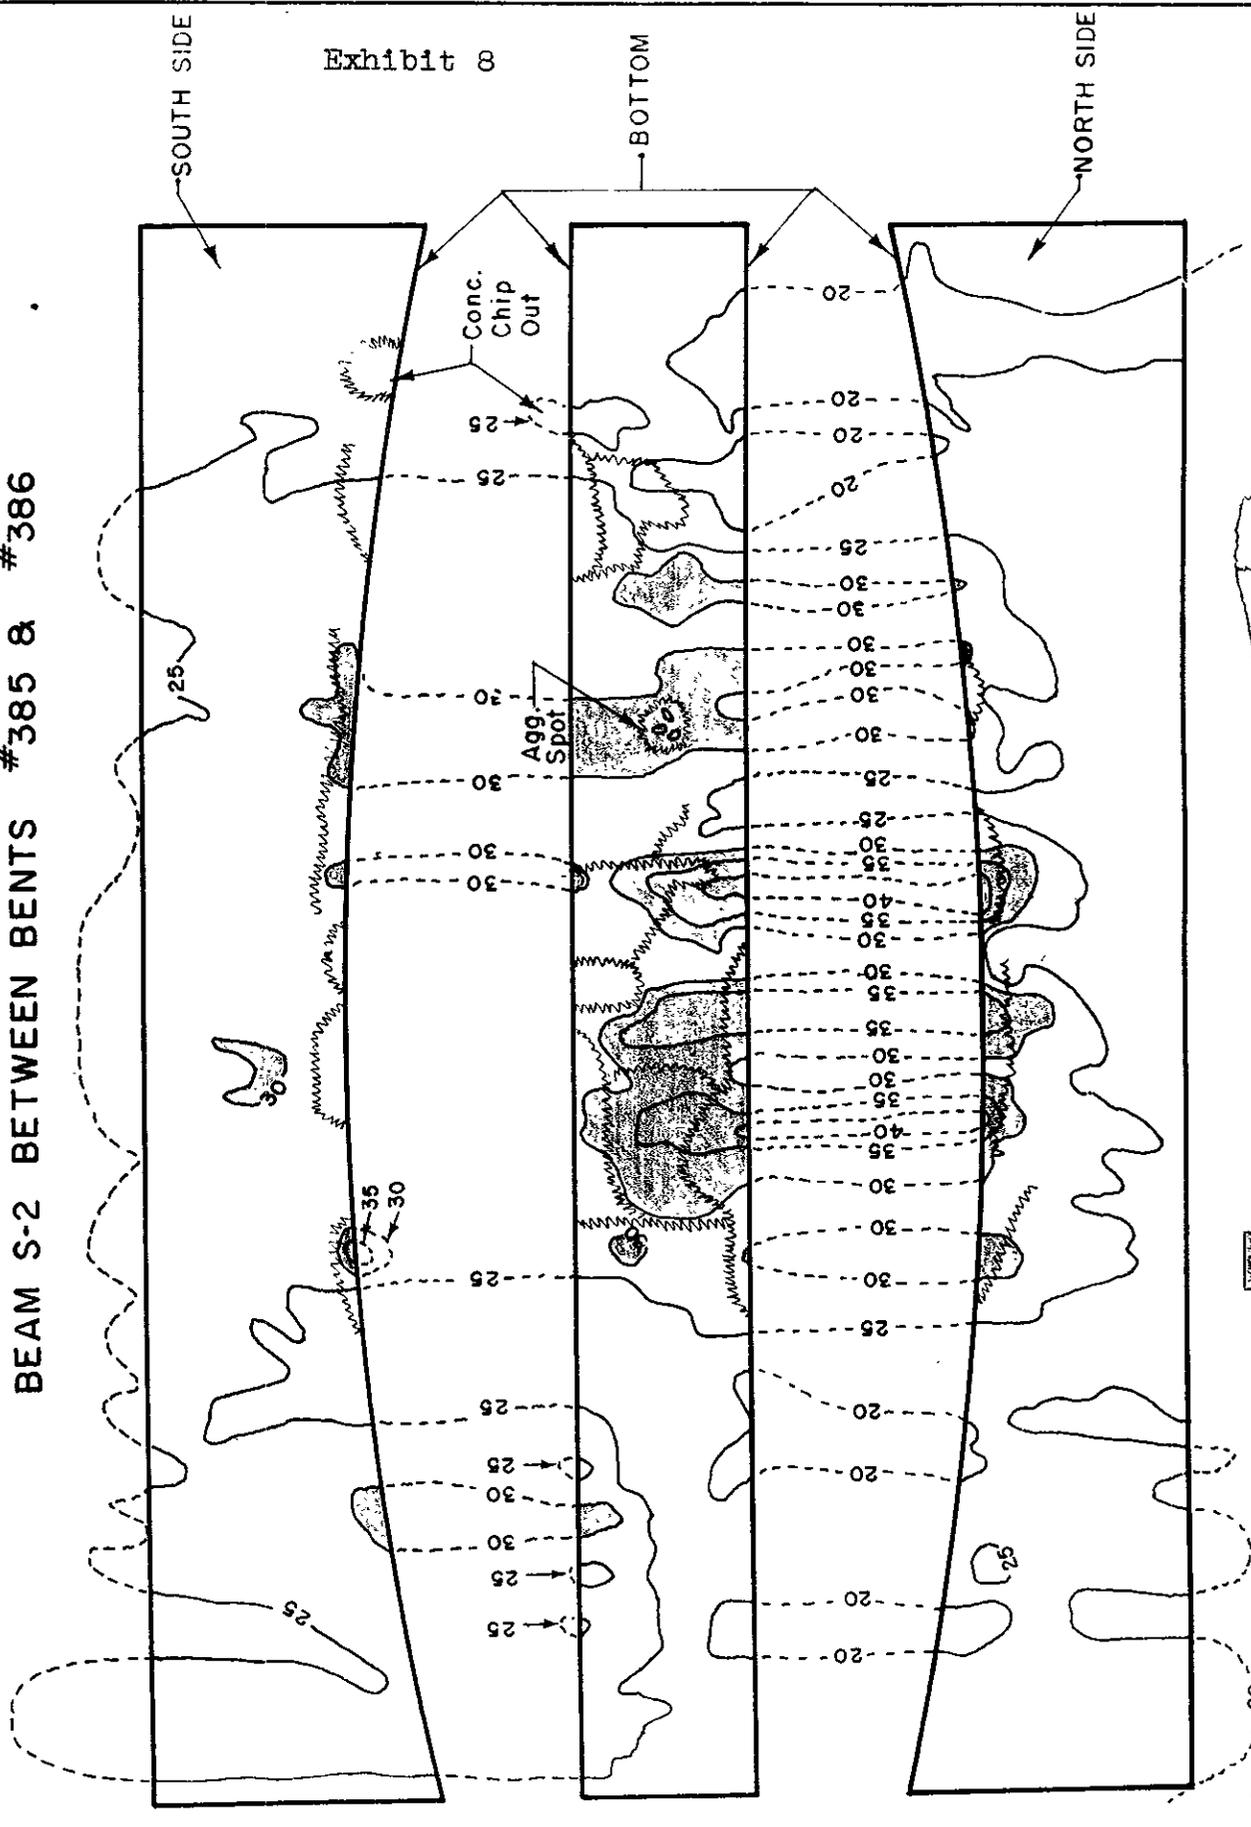
Exhibit 8

BEAM S-2 BETWEEN BENTS #385 & #386

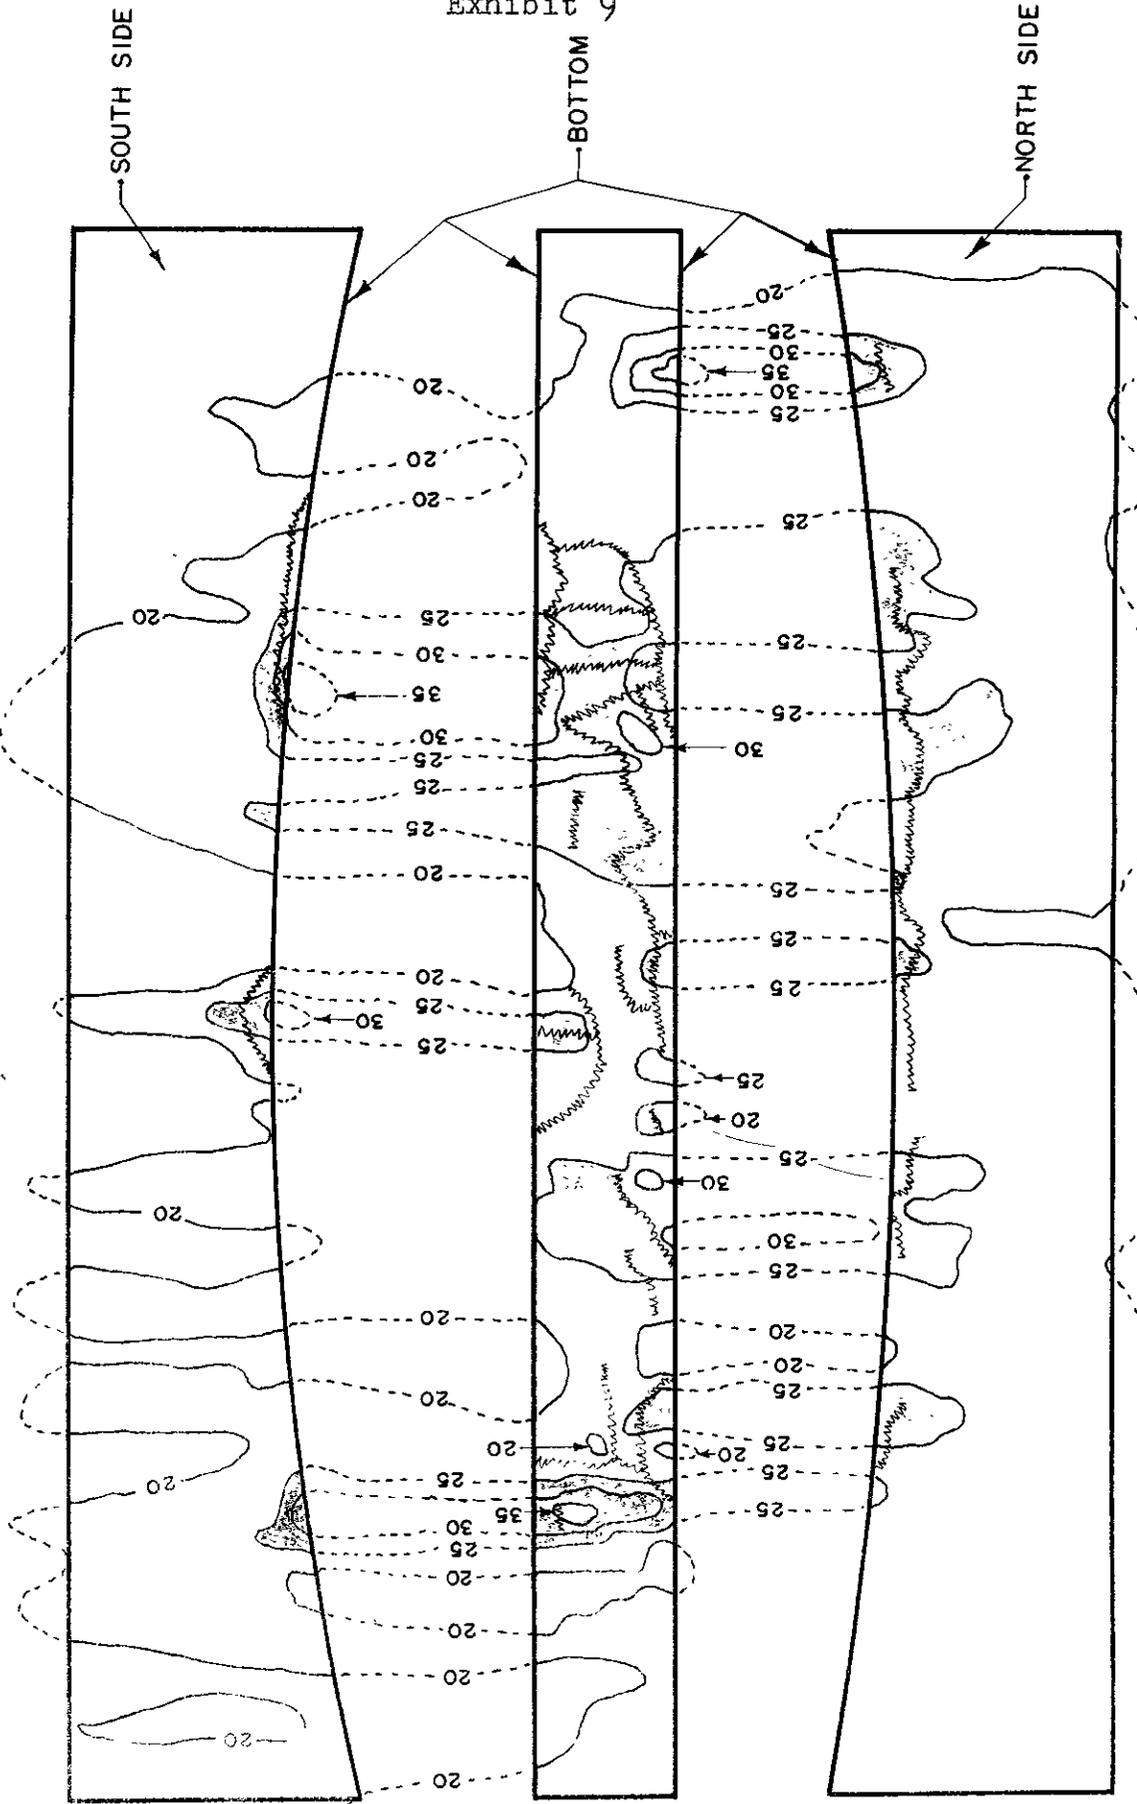
Exhibit 9

BEAM N-2 BETWEEN BENTS #385 & #386

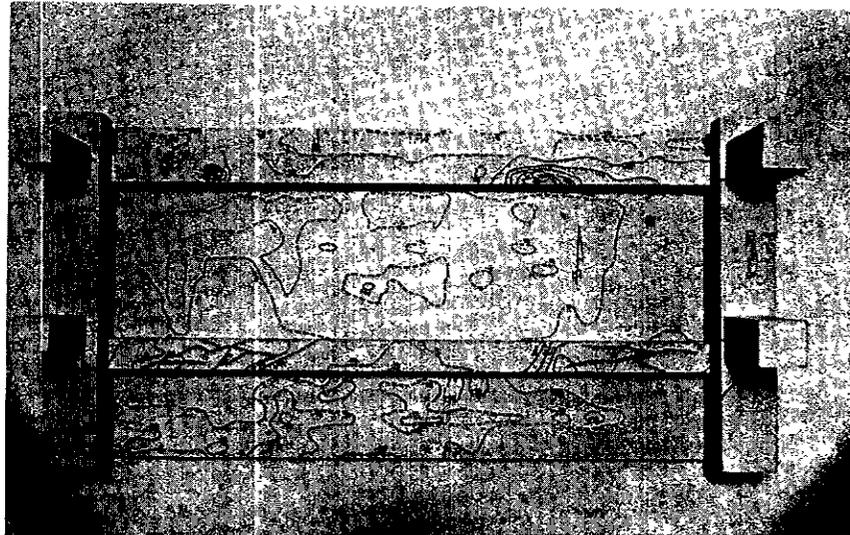
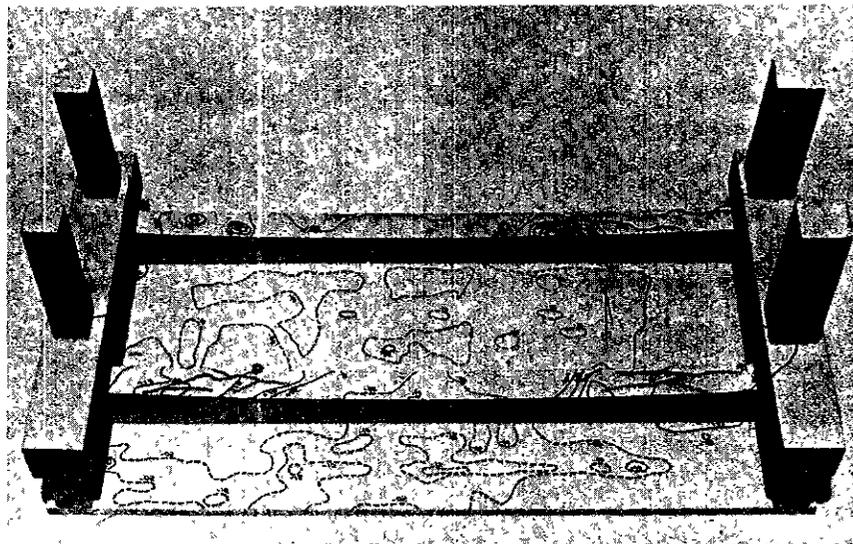
Model of bridge span showing corrosion current contours

Equipotential contours plotted on under surface of scale model of left half of span 512.

- lines are cathodic (non-corroding) voltages.
- lines are anodic (corroding) voltages.
- ~~~~~ lines are cracks in concrete.

Note that the cathodic areas are located in the deck, and the anodes are located in the bottom of the beams.

As indicated by the equipotential contour lines drawn on the bridge model shown in the Appendix, the cathodic areas causing the corrosion of the steel in the beams, are in the deck area.

The cathodic areas for the caps and piles are in the diaphragms and caps. The electrical measurements indicate that the corrosion attacking the reinforcing steel has anodes and cathodes spaced at distances of two to ten feet.

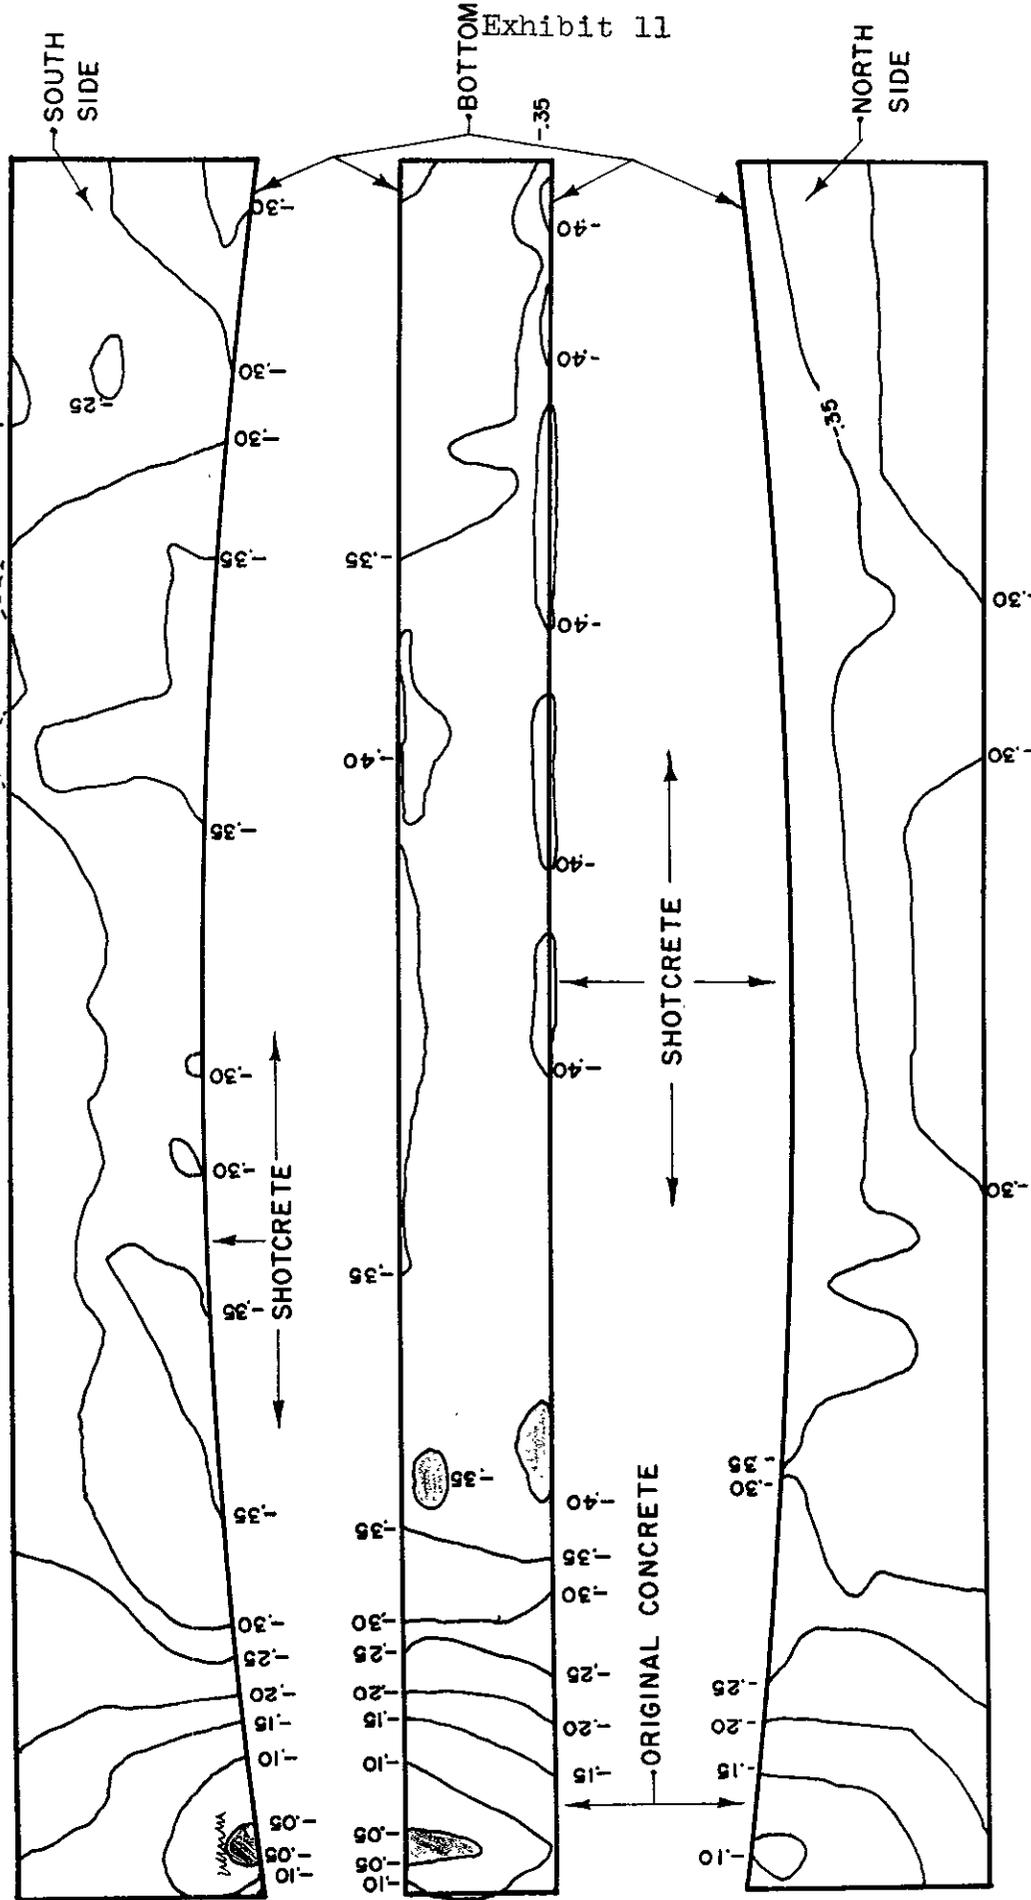
**CHART 4**  
Equipotential Contours of  
**BEAM S-2 BETWEEN BENTS #25 & #26**

A series of potential measurements were made on beam #S-2, and are plotted on Exhibit 11, Chart 4, in the Appendix. This beam was repaired with shotcrete approximately 3 years ago. The potential measurements indicated that corrosion was occurring in the bottom section of the beam approximately 1' east of the cap of bent #25.

The cathodic area was located at the bottom of the same beam #S-2, approximately 11' east of the cap of bent #25. The cathodic area was located within the area repaired by shotcrete while the anodic, or corroding area, was located in an area of original concrete. The voltage gradient measured on the surface of the concrete between the anodic and cathodic areas was 0.42 volts. A horizontal crack in the concrete approximately 1' long was located in the anodic area. The steel was not exposed at this location.

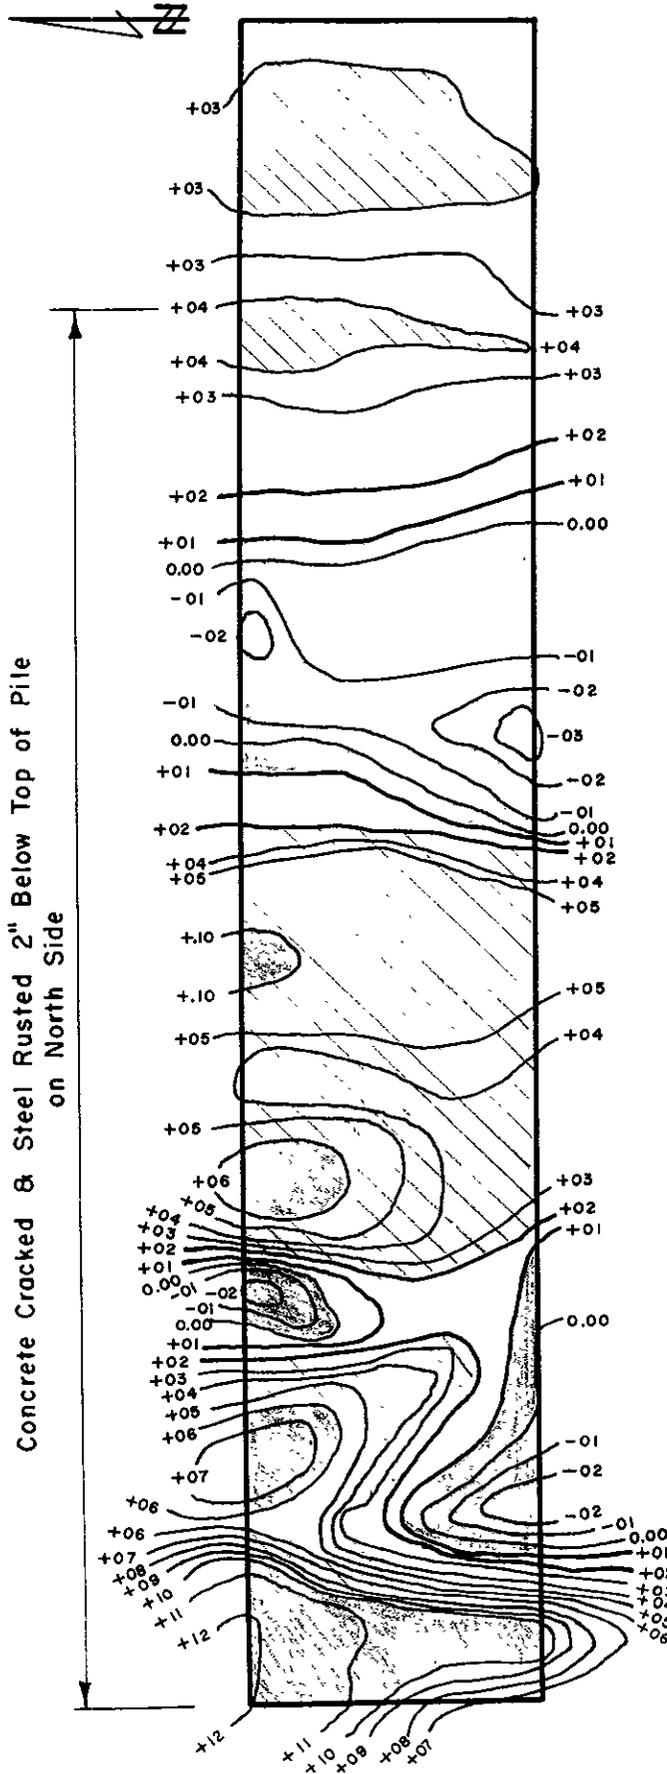
CHART 5  
Equipotential Contours  
PILE A

Abandoned R.C. Pile From Construction of San Mateo-Hayward Bridge

Note: Potentials are to  $CuCuSO_4$  on concrete to a reference  $CuCuSO_4$  on soil at a remote distance.  
 (+) Voltages are anodic.  
 (-) Voltages are cathodic

A potential survey was made on a rejected reinforced concrete pile abandoned during the construction of the San Mateo-Hayward Bridge. This pile, called Pile A, was located approximately 25' north of the west end of the bridge and was in the tidal water zone. The concrete in the pile was cracked in the same typical manner as the piles in the structure. The cracks were longitudinal, and the steel was corroded.

Potential measurements were made on the top face of the pile. These measurements drawn to equipotential contours are shown on Exhibit 12, Chart 5 in the Appendix. The potential measurements on this pile indicate that the corrosion of the steel is caused by a corrosion cell with the anodes and cathodes separated by distances of one or more feet. The corrosion products of the steel are causing the cracking and spalling of the concrete. Indirect evidence of corrosion products causing concrete to crack is shown on Exhibit 5 in the Appendix.

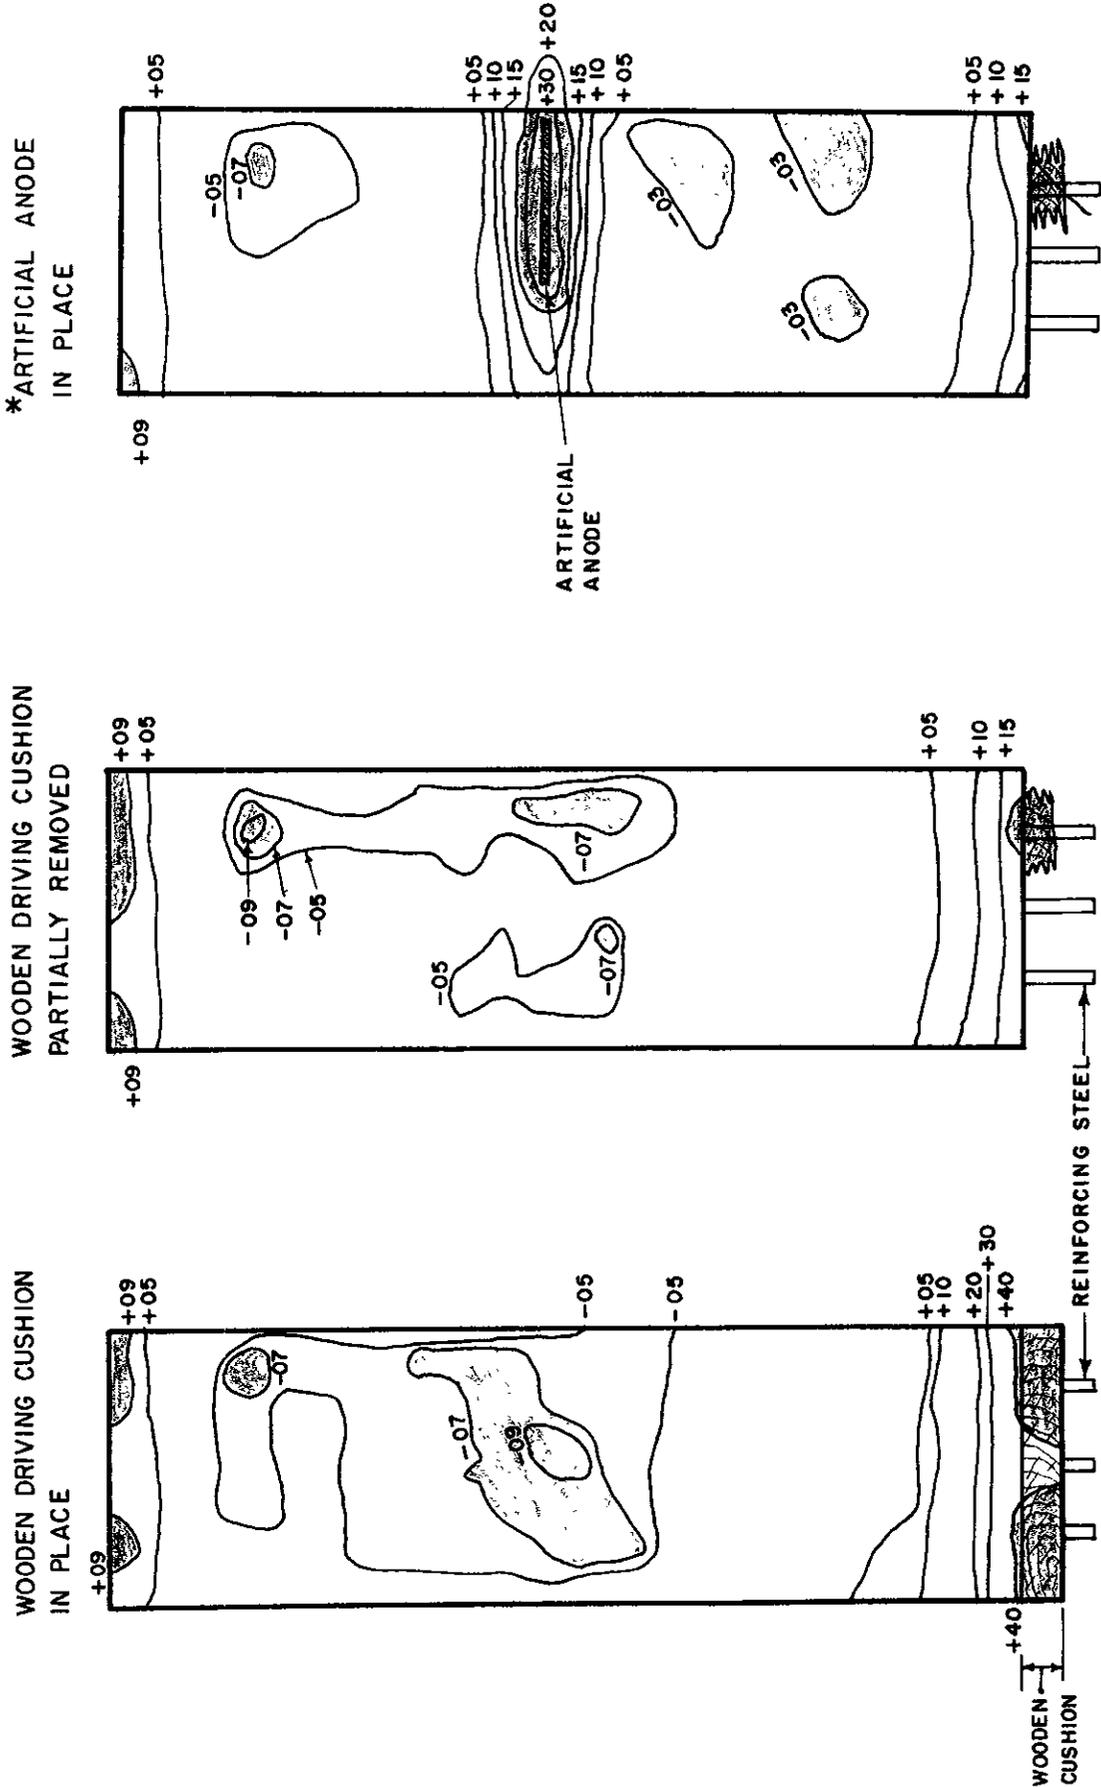
**CHART 6**  
Equipotential Contours on  
**TOP SURFACE OF PILE "B"**

Note: Pile B is an abraded P.G. & E., R.C. Pile, 1 1/2 years old.  
Voltages obtained with a Cu Cu So<sub>4</sub> half cell,  
and referenced to a remote Cu Cu So<sub>4</sub> half cell on soil.

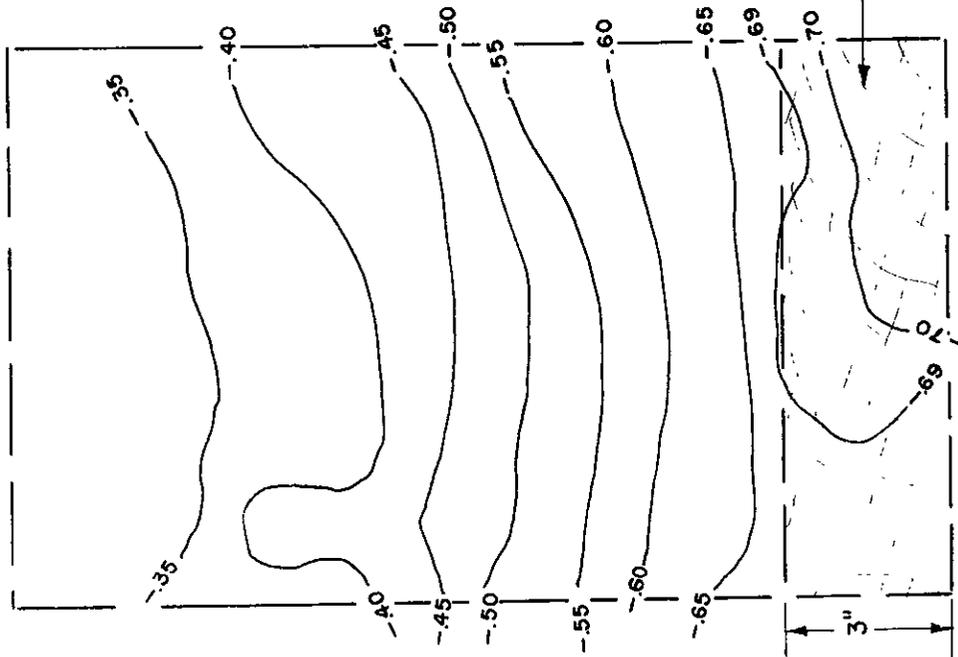
CHART 7  
Equipotential Contours of  
PILE "C"

Top Face Pile "C"  
Equipotential gradient of "Natural"  
currents flowing in reinforced  
concrete pile.

Reference is reinforcing steel bar.  
(+) Voltages are anodic.  
(-) Voltages are cathodic.

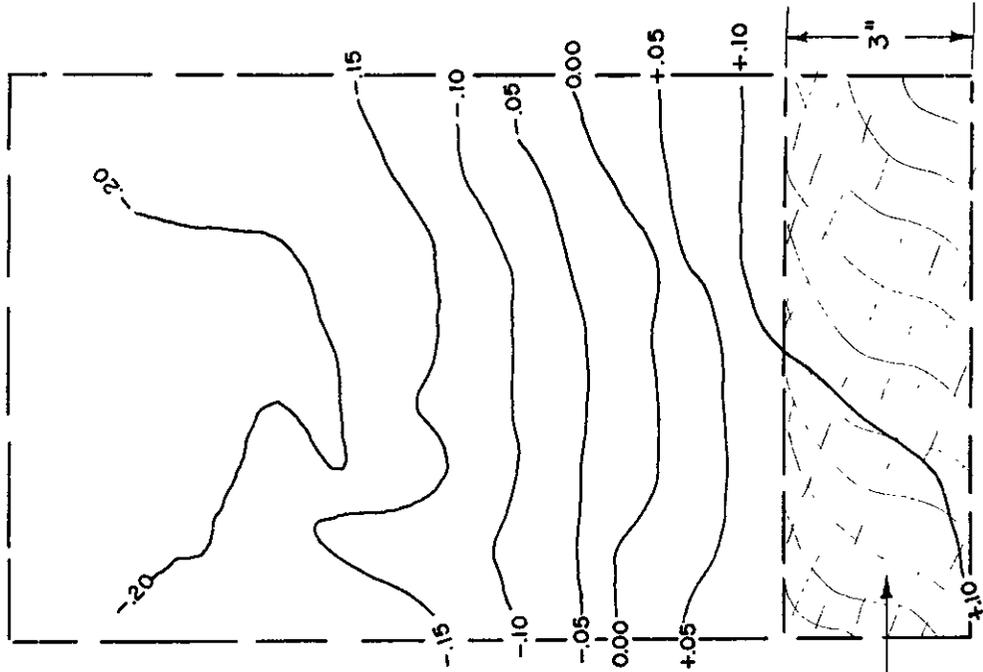
Equipotential gradient of "Natural"  
currents flowing in reinforced  
concrete pile.

Reference is remote CuCuSo4  
half cell.
