Final Report on Testing of Traffic Counting Devices

July 1962

State of California
Department of Public Works
Division of Highways
Materials and Research Department

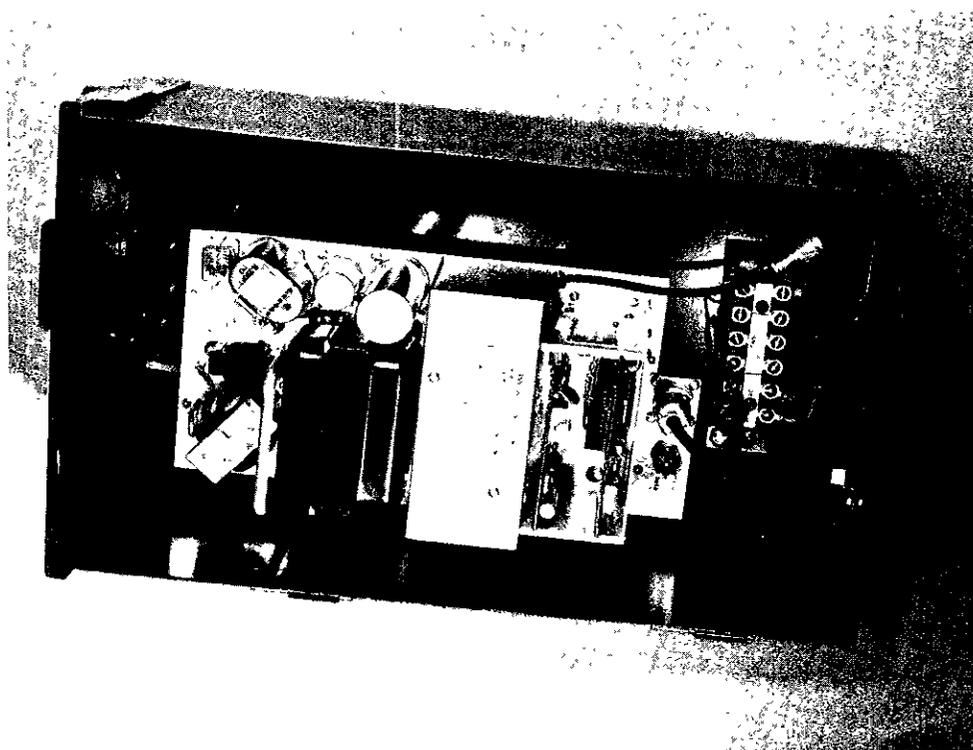
Automatic Signal Radar Detector Chassis

- A. The RC-1 Radar Vehicle Detector (Exhibit 1) performed with an error of 0 to +3% maximum deviation for a period of two months. During a two week period at the optimum setting the error was +1%.

The RC-1 Radar Detector has only the sensitivity control for adjustment. This control is slowly advanced until just one impulse is produced for vehicles and tractor trailer combinations. Different sensitivity settings between $\frac{1}{3}$ and $\frac{2}{3}$ full scale were tried during a two month period. At approximately the $\frac{1}{3}$ setting the counting error is in the $\pm 1\%$ area. By slightly lowering the setting, the accuracy drops off sharply, but increasing the setting to $\frac{2}{3}$ full scale placed the error in the area of 1% to 3% overcount. Observation showed the overcount to be tractor trailer combinations of the type with high trailers.

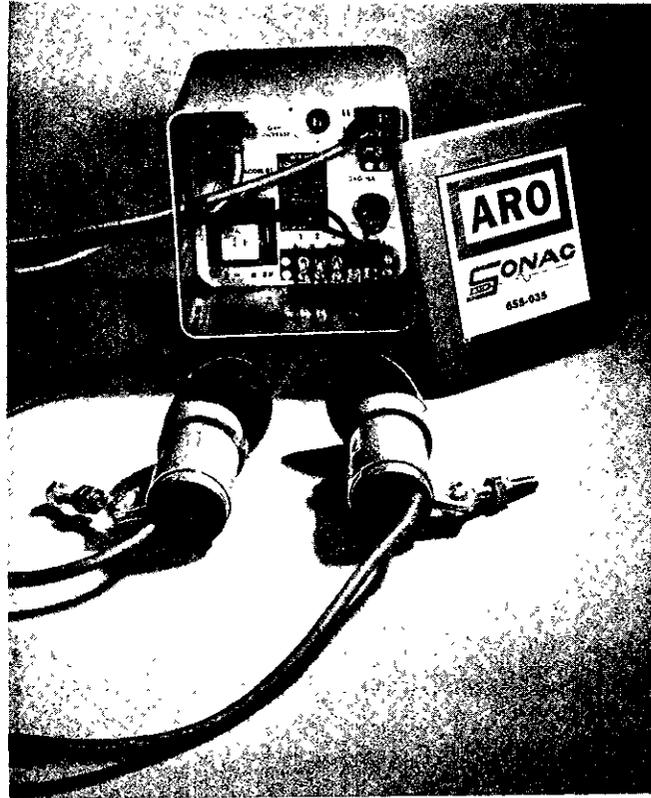
Aro Sonac Ultrasonic Detector

- H. The Aro Sonac Ultrasonic Detector (Exhibit 3) can only be used successfully as a traffic counter by utilizing the reflective principle. Unfortunately, it was unsatisfactory when used on reflective path because of insufficient gain and slow response time.

An inexpensive ultrasonic type of detector manufactured by Aro Manufacturing Company was also tested (see Exhibit 6). The first tests were conducted at a side-fire distance of 25' from the sensors to the vehicle. This distance approximated two lane coverage with an 8' shoulder. Difficulty was experienced in aligning the sensors at the correct angle for the best reflective path. At this distance the gain control adjustment was too critical.

The next tests were 12' to 15' from the sensors to the vehicle. The gain control was not as critical with the shorter reflective path. However, the transistor amplifier showed itself to be sensitive to high temperature, requiring constant readjustment of the gain control, during two successive days when temperatures reached 108° . In addition, the over-all response time of the circuit was determined to be in excess of 140 milliseconds. At high speeds the time required for small vehicles to pass the sensors would decrease below the response time of the circuit. Tests were not made above 30 mph because of the inability of the unit to count small cars at 30 mph and 12' away.

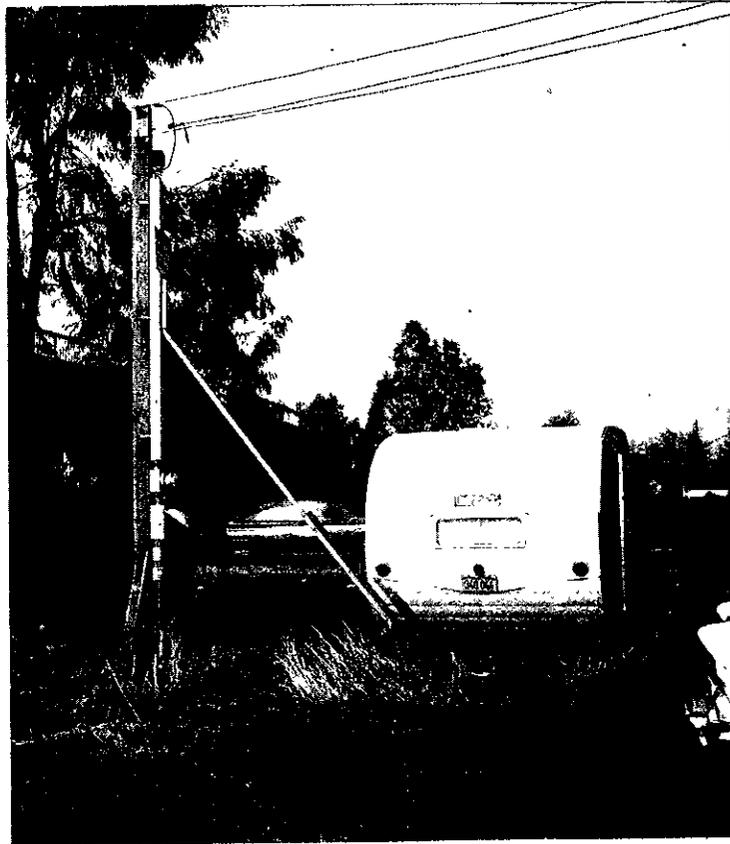
Canterbury Road Test Site

1. In October of 1960, a 12 ft. instrumentation trailer was placed at the test site near Canterbury Overcrossing on Highway 40, one mile north of Sacramento (Exhibit 6). Five slots, $1\frac{1}{4}$ " wide, 1" deep by 10' long, were cut in the concrete pavement. These slots were used in the testing of the Kemco Detectors and Tapeswitch Embedded Detectors.
