Instrumentation Installation for Exposition Boulevard Overhead

State of California
Department of Public Works
Division of Highways
Materials and Research Department

INSTRUMENTATION INSTALLATION
FOR
EXPOSITION BOULEVARD OVERHEAD

October 1963

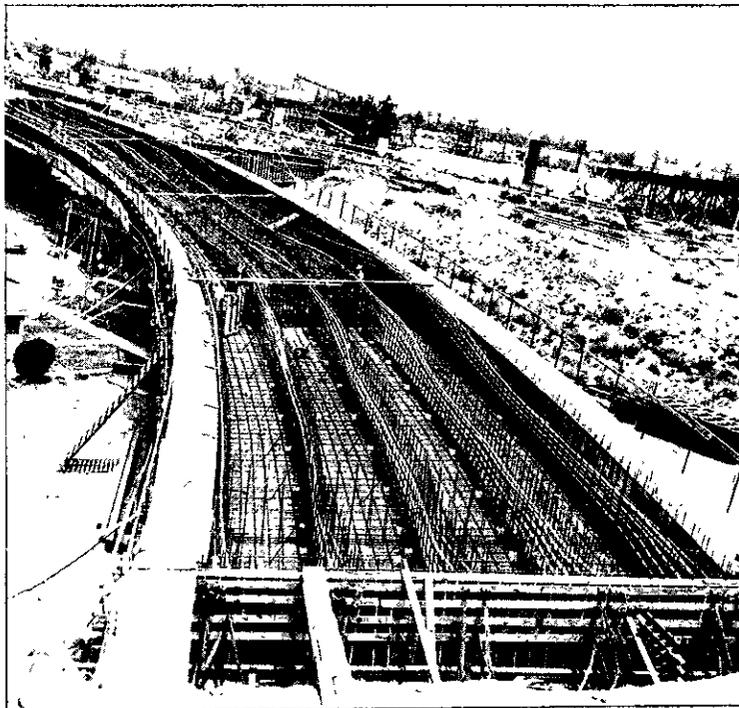
FIGURE 1

The overhead is a continuous prestressed concrete box girder structure approximately 354 feet long consisting of three spans and supported on four bent caps and piers and providing a clear roadway width of 28 feet. The bridge (Br. No. 53-704(OL)) is located in the city of Los Angeles on Route 173 between 0.3 mile west of Sawtelle Boulevard and Overland Avenue; and on Route 158 between 0.4 mile south of National Boulevard and 0.2 mile north of Pico Boulevard, VII-LA-173-LA. Figure 1 is a view of the overhead during the construction phase.

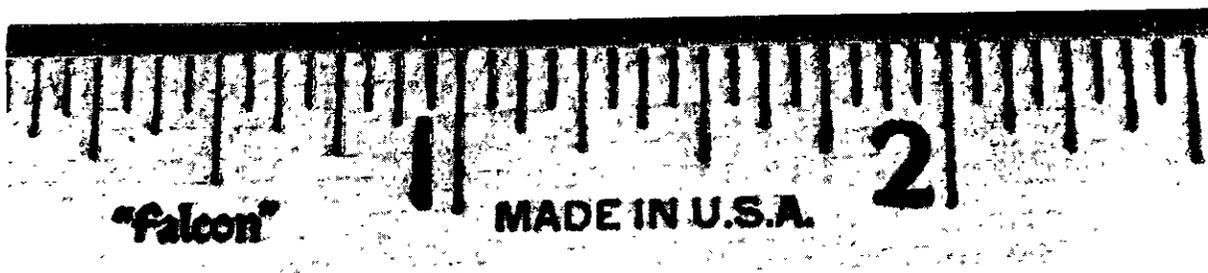
FIGURE 2

Post-tensioning strains in the research tendons were measured with Baldwin FAN-12-S6L SR-4 strain gages. The gage, Figure 2, consists of a thin metal foil 0.25" long by 0.02" wide on an epoxy carrier. The epoxy carrier serves as protection for handling ease and as an insulator when bonded to a metal surface. The gages were self-temperature compensated gages with an expansion coefficient of 6 parts per million per °F. to compensate for steel expansion.

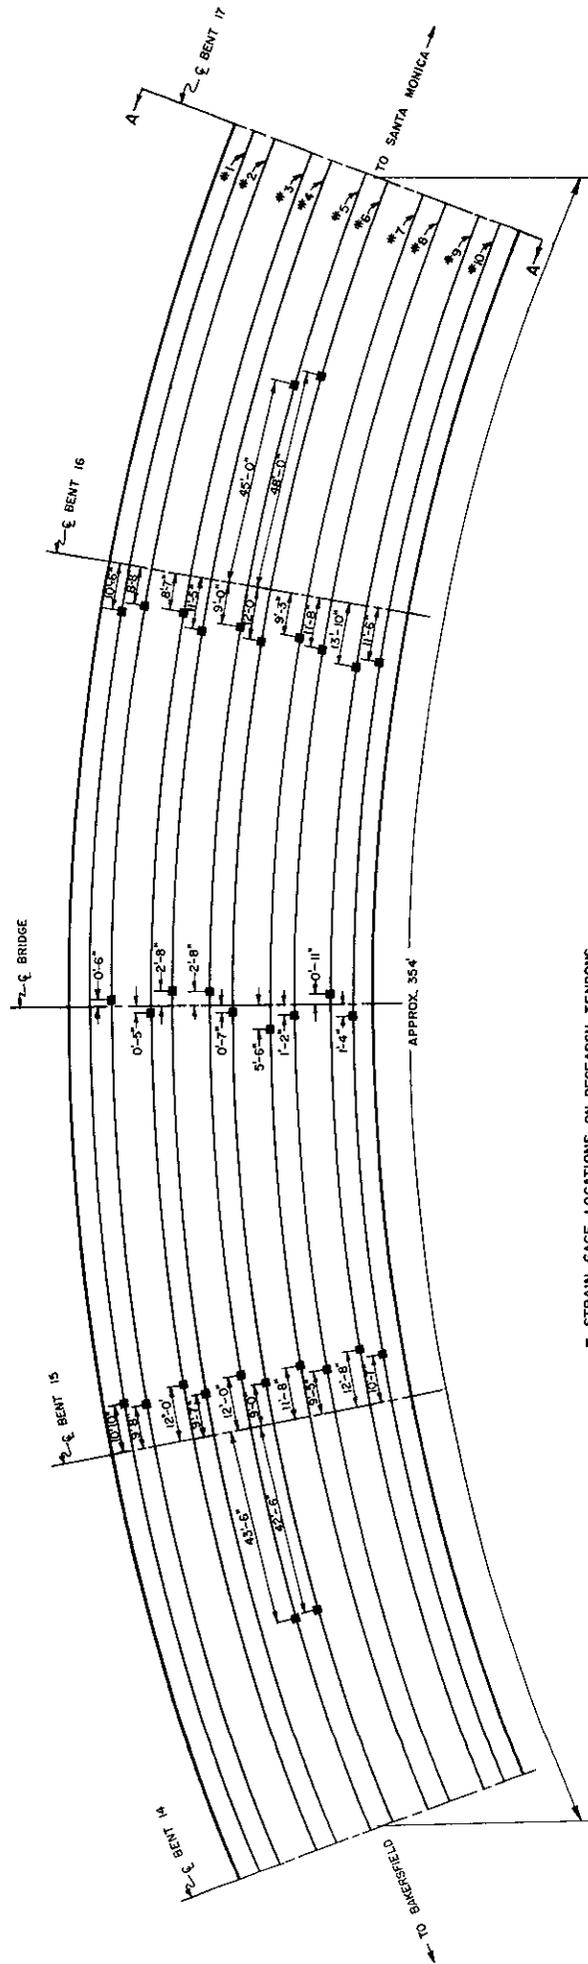
Figure 3A

■ STRAIN GAGE LOCATIONS ON RESEARCH TENDONS
 SCALE: NONE

TENDON No.	TENDON TYPE
# 1	GALVANIZED BBRV IN UNGALVANIZED TUBING
# 2, # 4, # 5, # 6	FREYSSINET IN SHEATH
# 3	UNGALVANIZED BBRV IN SHEATH
# 7	UNGALVANIZED BBRV IN SHEATH
# 8	GALVANIZED ROEBLING IN SHEATH
# 9	UNGALVANIZED BBRV IN GALVANIZED TUBING
# 10	GALVANIZED ROEBLING IN SMALL SHEATH

The overhead was a post-tensioned structure with 10 research tendons out of a total of 38 tendons. Eight of the tendons were encased in a flexible continuous length metal sheath while the remaining 2 tendons were encased in 20 foot lengths of pipe tubing. Figure 3 lists the various types of tendons in the different types of encasement. Figure 3-A shows the research tendons in relation to the other tendons.

Before the strain gages could be installed on the tendons, a portion of the sheath or tubing had to be removed. Eighteen lineal inches of sheath or tubing were removed at each gage location, thus exposing the research tendons. Figure 4 shows the sheath removed from research tendons #5 and #6, exposing the Freyssinet cables. All sheaths were cut with tin snips while the two pipe tubings were cut with a 4 wheel Rigid pipe cutter. The pipe tubing at research tendon #1 at the centerline of the bridge span could not be cut because of its inaccessible location and thus no strain gages were installed on this tendon at the centerline. Figure 5 shows the inaccessible location and the uncut pipe tubing. See Figure 3-A for research tendon numbering system and gage locations.

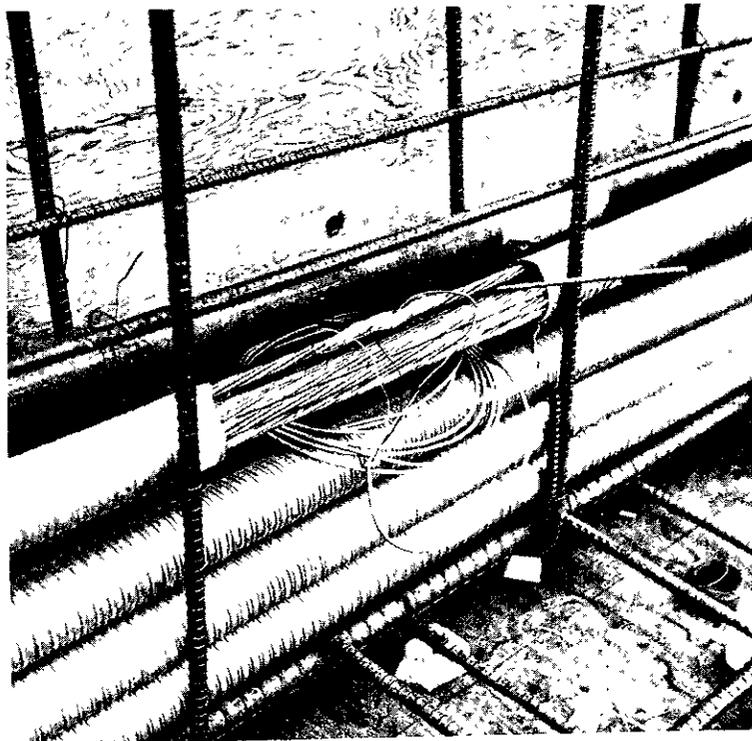
FIGURE 5

material. The uncured mixture was applied over the completed wired-up gage installation and the surrounding area with a wooden tongue blade. Extra care was made to insure that the mixture completely surrounded the connecting #8434 cable. Figure 5 shows a completed mixture installation on a Freyssinet tendon.

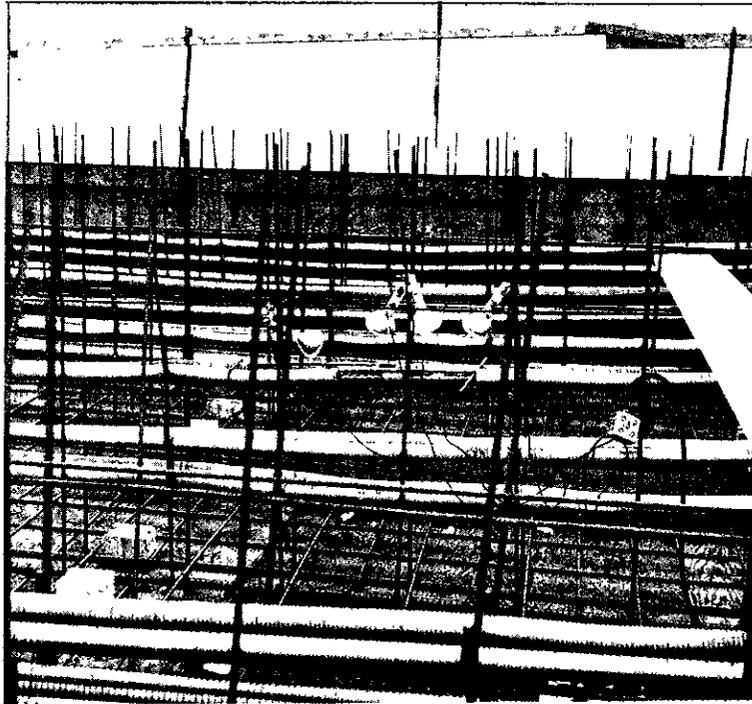
FIGURE 6

Insulated thin copper terminals were also glued alongside of the ends of each strain gage. The copper terminals served as terminations for joining the strain gage lead-out wire and the hookup extension cable. The curing cycle for the cement-gage-terminals combination consisted of approximately 4 hours under several 250 watt infrared heat lamps. The lamps were placed 12 to 14 inches from the gage. Figure 6 shows a completed gage and terminal installation being cured by the heat lamps.

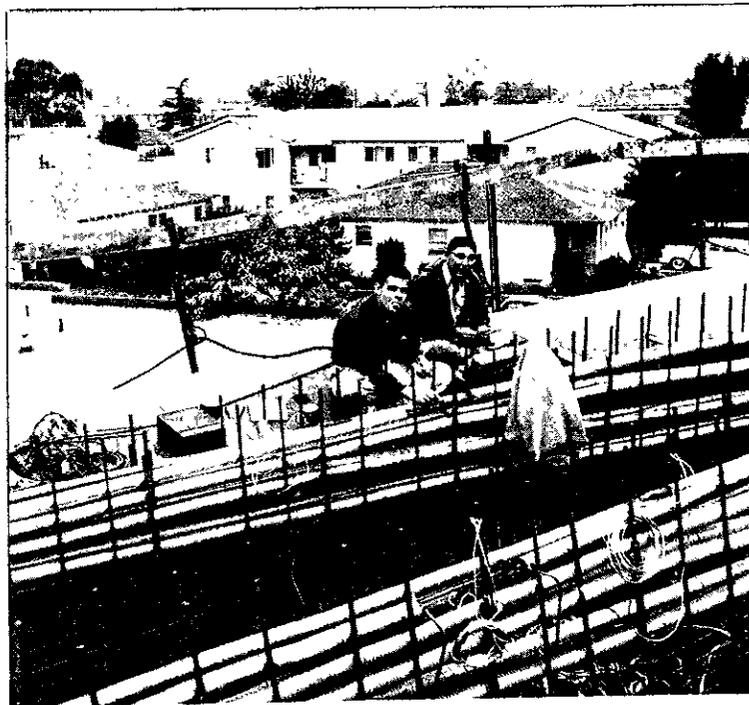
FIGURE 7

The gages were now ready to be electrically wired with hookup-extension cable. The hookup-extension cable used was Belden #8434 strain gage cable. The 8434 cable consists of four conductors color coded black, white, red, and green. The black and white conductor pair was always used to hook up one strain gage, and the red and green conductor pair was always used to hook up the backup strain gage. Figure 7 shows the over-all gaging operation at the bridge centerline.

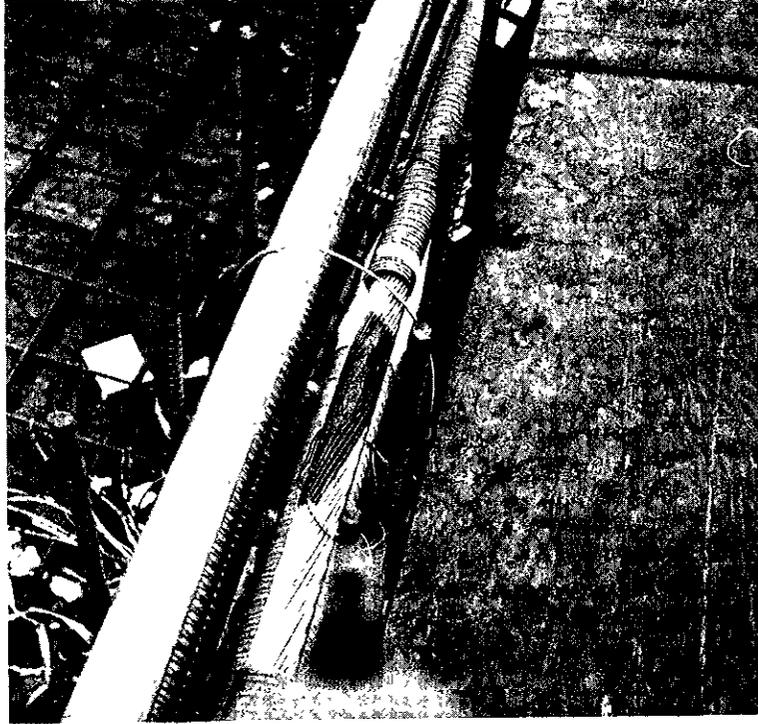
FIGURE 8

After the epoxy-Thiokol mixture had cured overnight, a black colored liquid synthetic rubber was brushed over the mixture. The liquid rubber, RC-9, acted as a surface sealer and was manufactured by Heresite & Chemical Company of Manitowoc, Wisconsin. Figure 8 shows a completed Roebling tendon installation with the black synthetic rubber covering the epoxy-Thiokol mixture.

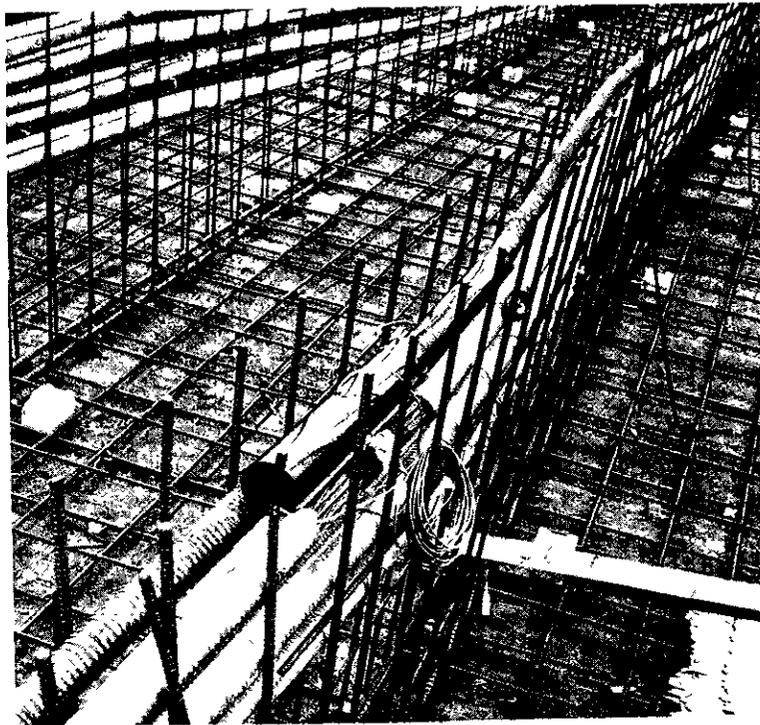
FIGURE 9

The last procedure was to re-encase the exposed tendons with stove pipes. The stove pipes were 4" in diameter by 24" long. Figure 9 shows a stove pipe ready to be encased around a Freyssinet tendon. A hole was drilled in each stove pipe so that the strain gage cable could be passed through the stove pipe prior to encasement. Each end of the stove pipe was closed off with sheet metal caps and taped to prevent grout leakage during the concrete placement. Figure 10 shows the completed installation at the bridge half span point.

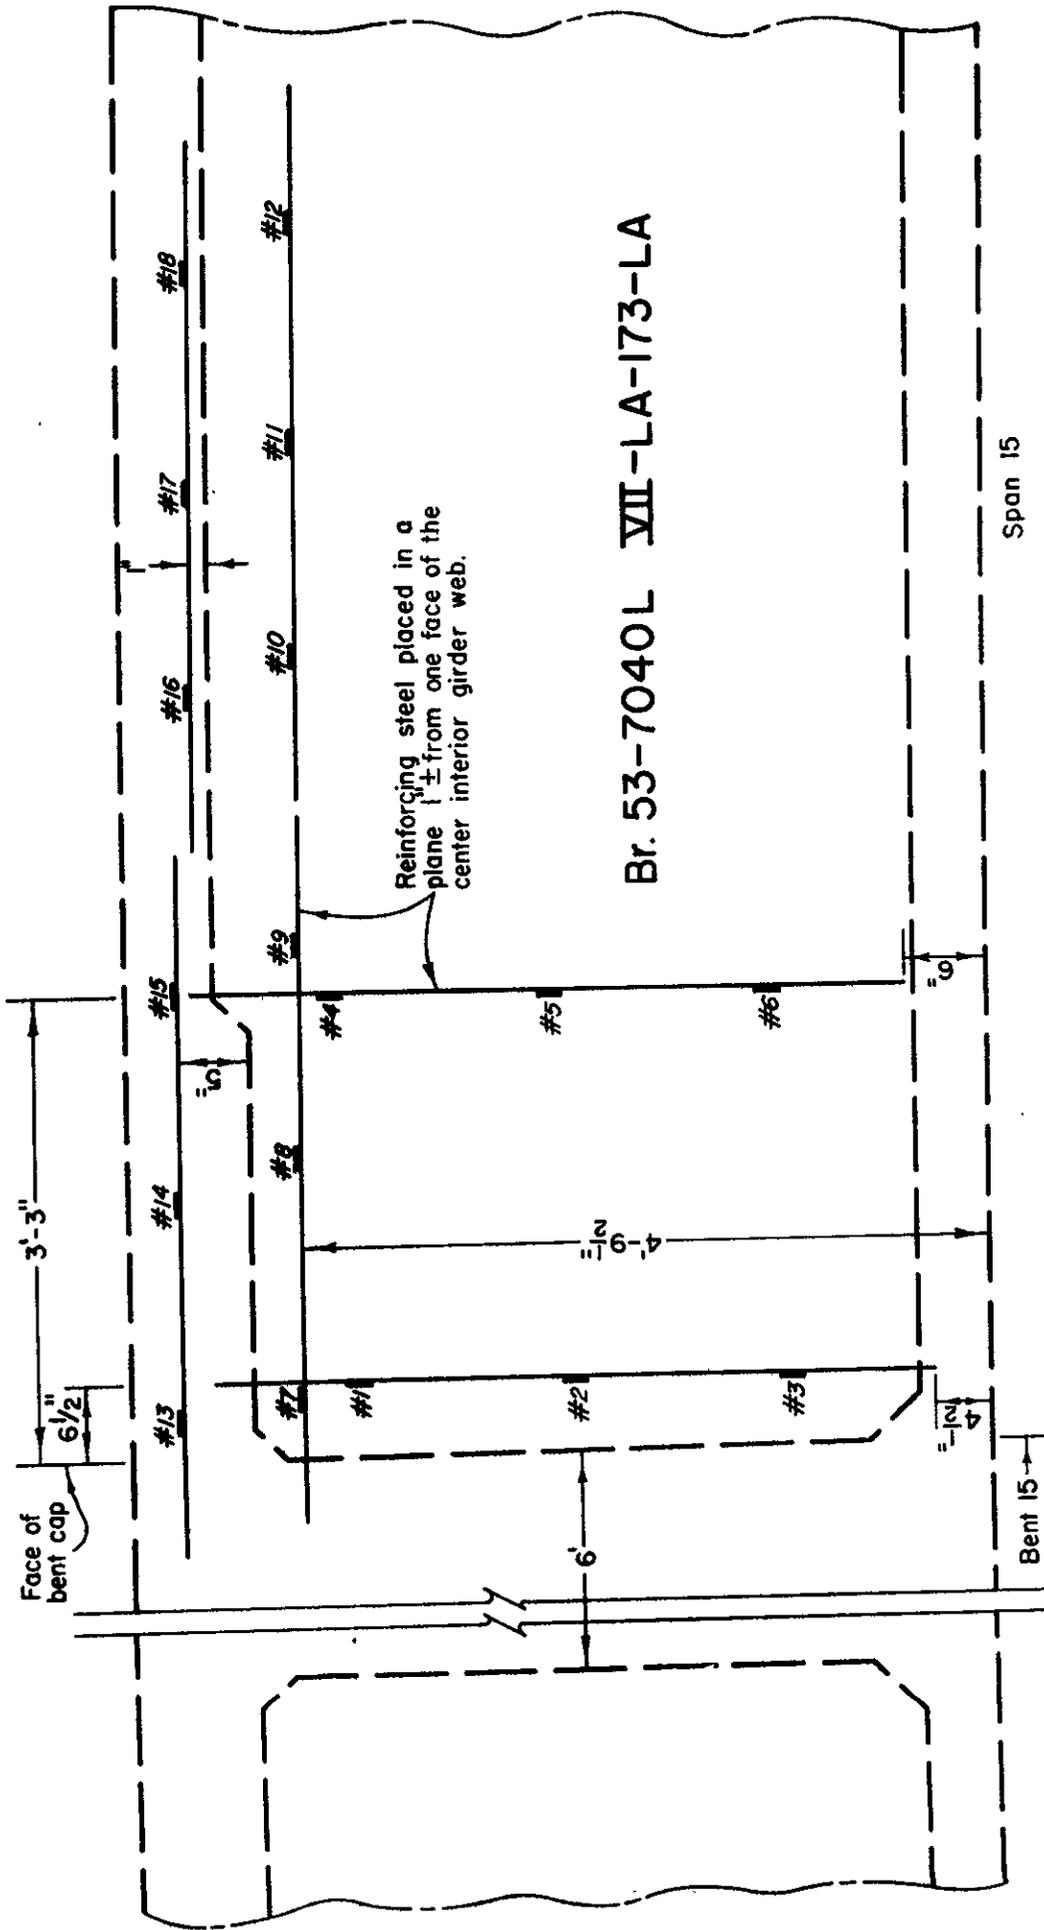
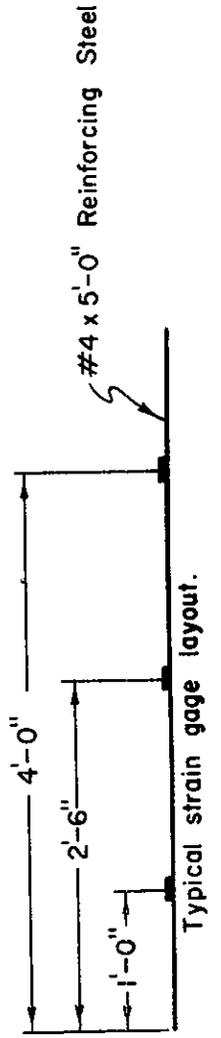
Location of strain gages for web stress measurements

Typical strain gage layout.

Web stresses in the center girder stem at bent 15 were measured by FAN-12-S6L strain gages installed on six 5 foot lengths of #4 reinforcing steel. Three strain gages were installed on each of the six lengths of reinforcing steel. Figure 11 shows the placement of the reinforcing steel and gage locations on the reinforcing steel.

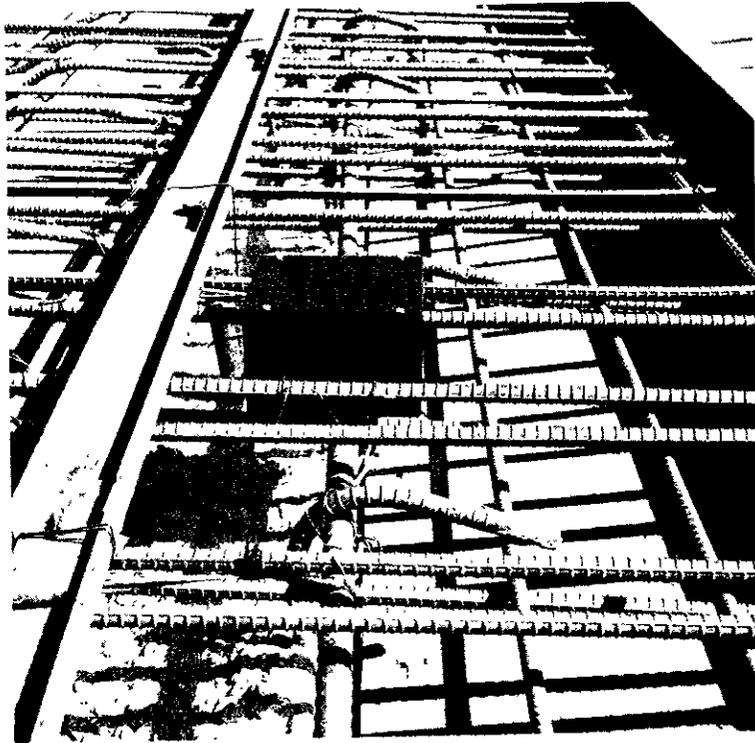
FIGURE 12

Four reinforcing steel bars, with gage numbers #1 through #12, were installed in the girder stems during Phase #1. Stove pipes were not used with the steel bar installations. Extension cables were routed over to conduit boxes, Figure 12, in the same manner as was for the research tendon cables.
