Dynamic Full Scale Impact Tests of Bridge Barrier Rails Test Series VIII

November 1963

State of California  
Highway Transportation Agency  
Department of Public Works  
Division of Highways  
Materials and Research Department

DYNAMIC FULL SCALE IMPACT TESTS  
OF  
BRIDGE BARRIER RAILS  
TEST SERIES VIII

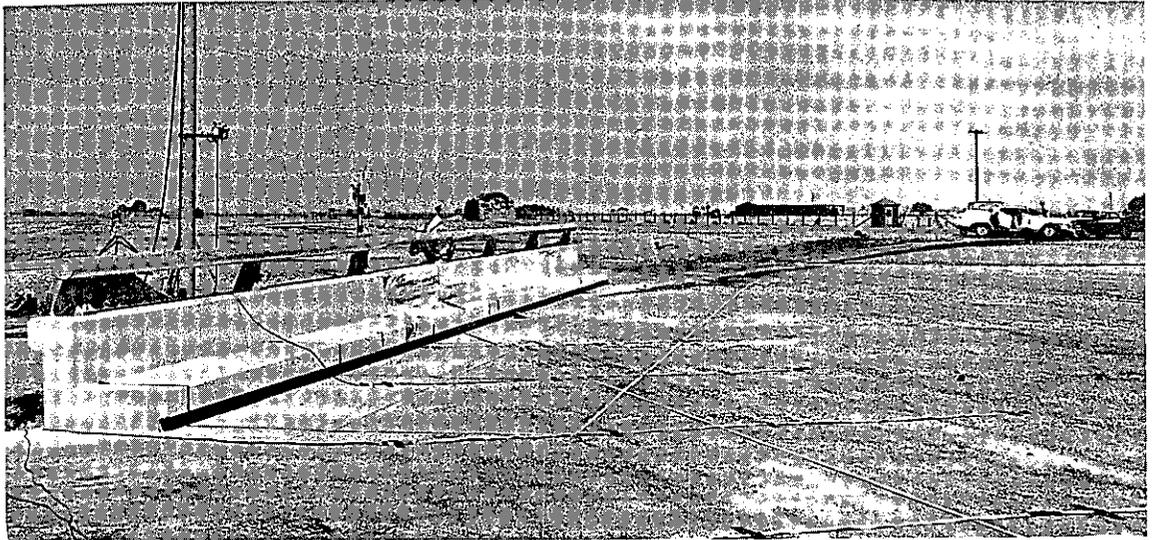
Test B-1 Type 2 Bridge Barrier Rail

Standard Type 2 with aluminum posts and pipe railing. Height of concrete parapet: 28". Height of walkway: 10". Over-all height of barrier: 43"

1. The vehicle did not penetrate the barrier rail. There was no evidence of rising even after crossing the walkway (Exhibit 5). However, it should be noted that previous tests (Reference 2) showed that there was a tendency to jump when the 10" high curb is struck at lower speeds and flatter angles.

2. All parts of the system remained intact. Damage to the concrete was minimal consisting of slight spalling and cracking.
3. There was a smooth progression of the vehicle through impact, even though the fender was torn from the body and lodged between the rail and parapet at the impact post (Exhibit 19).
4. Evidence of a slight spalling and scraping of the concrete was confined to the immediate impact area. Cracking occurred at the junction of the backwall and the walkway. The web of the first post contacted was ripped its entire length adjacent to the base. One section of the aluminum pipe railing was slightly gouged by the vehicle fender and was bent approximately 2 inches (see Exhibit 6).

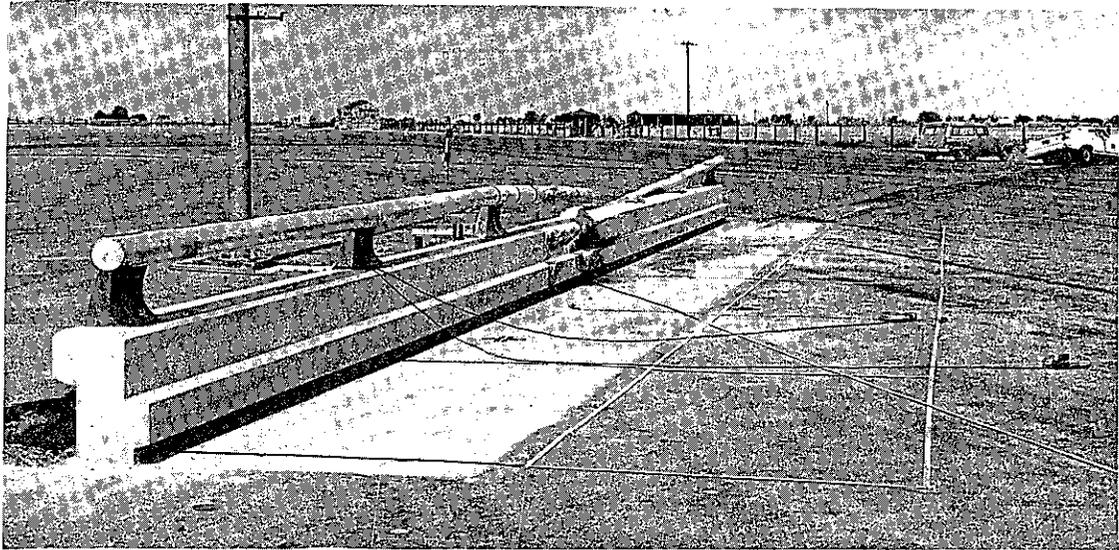
Test B-2 Type 1 Bridge Barrier Rail

Standard Type 1 with aluminum posts and pipe railing. Height of concrete: 21". Over-all height of barrier: 36".

1. Although the vehicle did not penetrate the barrier, it rose approximately 12 inches within 6 feet after initial contact due to excessive deflection of the railing (20 inches). This rise placed critical loading on the railing elements which resulted in their subsequent failure (Exhibit 7).
2. Three posts and three sections of the aluminum pipe railing were torn from the parapet and dropped to the ground behind the barrier. Major cracks developed in the concrete parapet.

3. The vehicle progressed fairly smoothly through impact even though the frame dragged on top of the parapet and sheared three posts before leaving the barrier (Exhibit 20). Excessive deflection of the railing elements and resultant vehicle jump imparted a rolling moment to the vehicle that almost caused a post-impact roll over.
4. Deep spalling and severe cracking of the concrete occurred in the impact area. Three posts were completely sheared from the barrier, and the web of the last post struck was bent. Three sections of the aluminum pipe rail were knocked to the ground behind the barrier; however, the sections remained intact and connected to the last post. Had there been adequate clearance behind the barrier for the pipe to drop, it is felt that the three pipe sections would have broken from the system and fallen to the ground (see Exhibit 8).

The cracking of the concrete parapet was not considered serious enough to necessitate complete replacement of the five foot cracked section adjacent to the expansion joint. Based on operational experience, it was felt that an epoxy resin bonding agent pumped into the cracks would have been sufficient to place the barrier in operating condition. However, as this parapet was to be used for two additional tests and a failure in this section would have influenced the test results, the concrete was jackhammered out, leaving the reinforcing bars intact. Plywood forms were clamped across the open section and a new concrete repair section was poured. The new concrete was bonded to the existing section with an epoxy adhesive applied to the exposed edges. An epoxy-sand mixture was used in resetting the damaged anchor bolts on the fourth post ahead of impact.

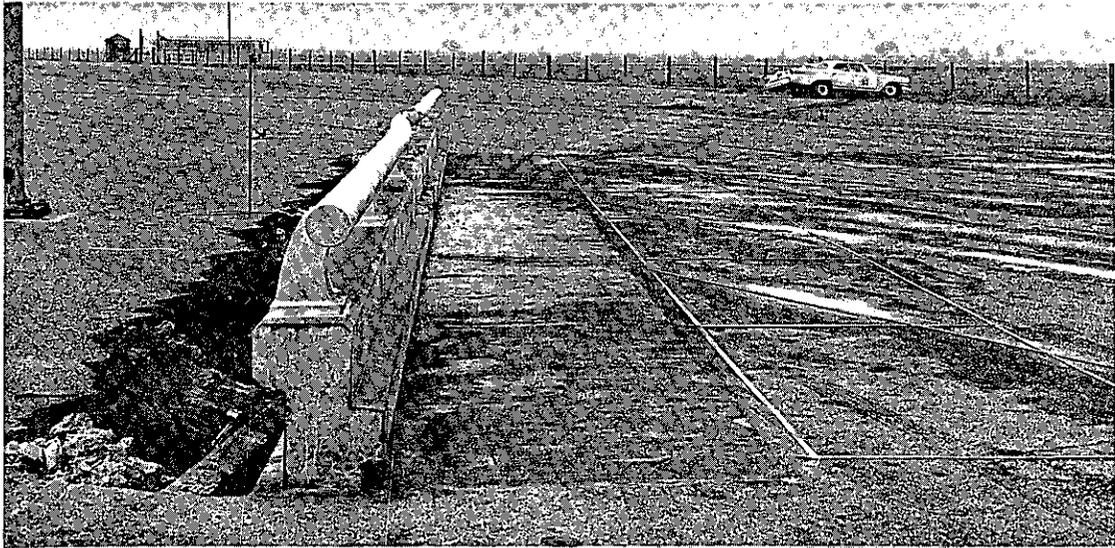
Test B-3 Type 1-A Bridge Barrier Rail

Type 1 parapet with welded steel plate posts and steel pipe railing. Height of concrete: 21" (repaired after Test B-2). Overall height of barrier: 36".

1. The vehicle did not penetrate the barrier. There was very little tendency for the vehicle to rise and no tendency to climb (Exhibit 9).
2. All parts of the barrier remained intact.

3. The vehicle progressed smoothly through impact with no tendency to roll (Exhibit 21).
4. The concrete developed deep cracks behind the first steel post contacted and required replacement of a small section of concrete around the anchor bolts. The front face of the concrete parapet was severely scraped and spalled in the impact area. One section of the steel railing was bent approximately 4 inches and deeply gouged. The welded steel plate posts sustained the impact with no evidence of damage (see Exhibit 10).

It should be noted that the section repaired after the previous test withstood the impact with no evidence of cracking. From a design standpoint it is interesting to note that two anchor bolts effectively developed the strength of the relatively strong welded steel post.

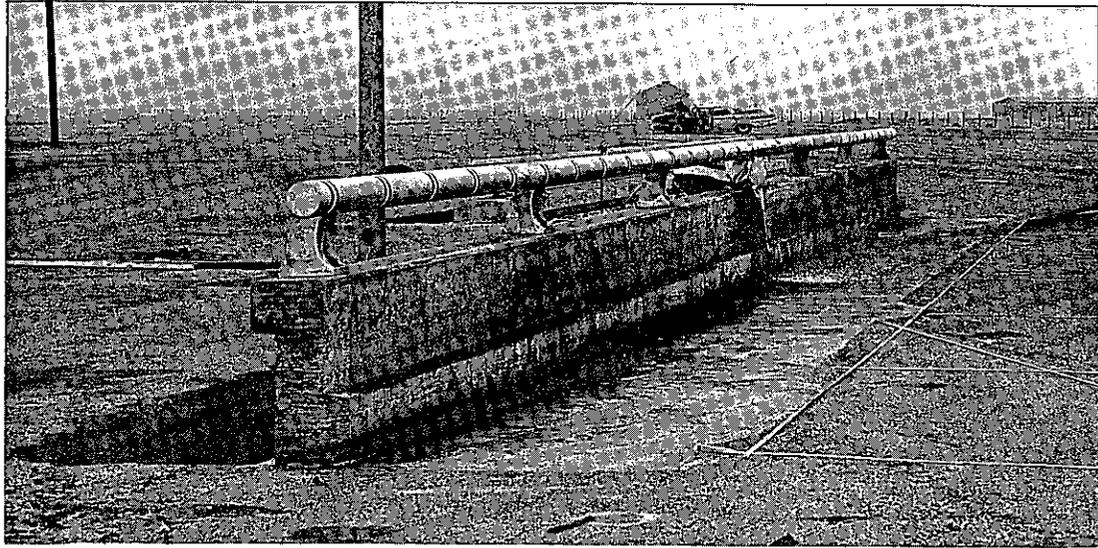
Test B-4 Type 1 Modified Bridge Barrier Rail

Modified Type 1 concrete parapet with aluminum posts and aluminum pipe railing. Height of concrete: 28". Over-all height of barrier: 43".

1. The vehicle did not penetrate the barrier. There was very little tendency for the vehicle to rise and no tendency to climb (Exhibit 11).
2. There was no structural failure in any of the barrier elements.

3. The vehicle progressed reasonably smoothly through impact considering that the front left fender and door panel were torn from the vehicle and lodged between the pipe rail and parapet at the first post after impact (Exhibit 22).
4. Slight spalling and scraping of the concrete was confined to the immediate impact area. The flange of the first post contacted was bent and would have required replacement; however, there was no evidence of failure. One section of the aluminum pipe rail was bent 2 inches (Exhibit 12).

No repairs to the concrete parapet would have been required to place the barrier in operating condition.

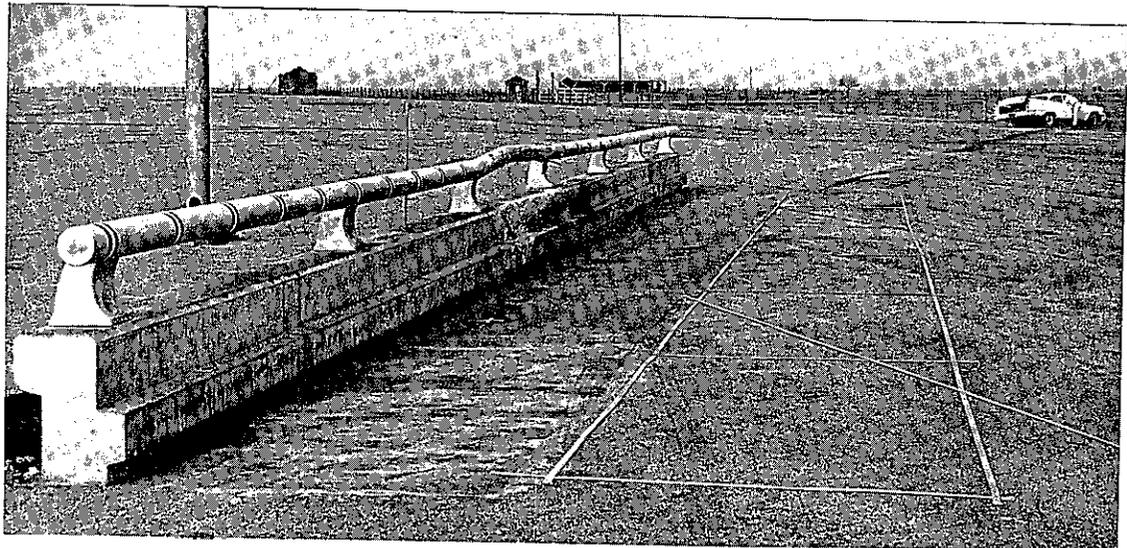
Test B-5 Type 1-B Bridge Barrier Rail

Type 1 parapet with malleable iron posts and aluminum pipe railing. Height of concrete: 21" (repaired after Test B-3). Overall height of barrier: 36".

1. The vehicle did not penetrate the barrier. Deflection of the aluminum pipe rail ( $6\frac{1}{2}$ "") contributed to the 10" rise of the vehicle. This rise was considerably higher than that recorded in Test No. B-3, the same parapet with a steel pipe rail and steel plate posts (see Exhibit 13).
2. All elements of the barrier system remained intact.

3. The vehicle progressed smoothly through impact with no tendency to roll (Exhibit 23).
4. A moderate amount of spalling of the concrete behind the anchor bolts on the first post after impact would have required an epoxy/sand patch and resetting of the anchor bolts to place the barrier in operating condition (see Exhibit 14). The epoxy/sand anchor bolt repair from Test B-3 withstood direct impact with no evidence of failure.

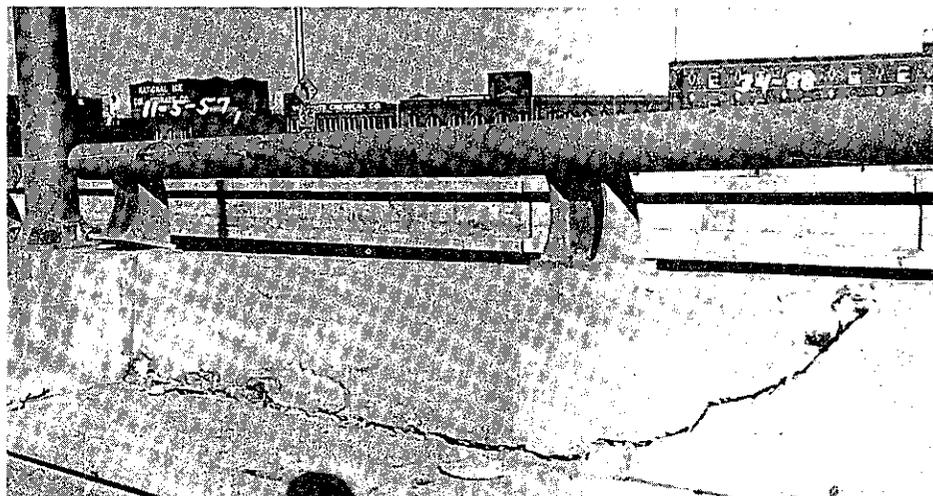
A. Early Barrier Prototype showing insufficiency of reinforcing steel in parapet. (Also see Exhibit 2A).

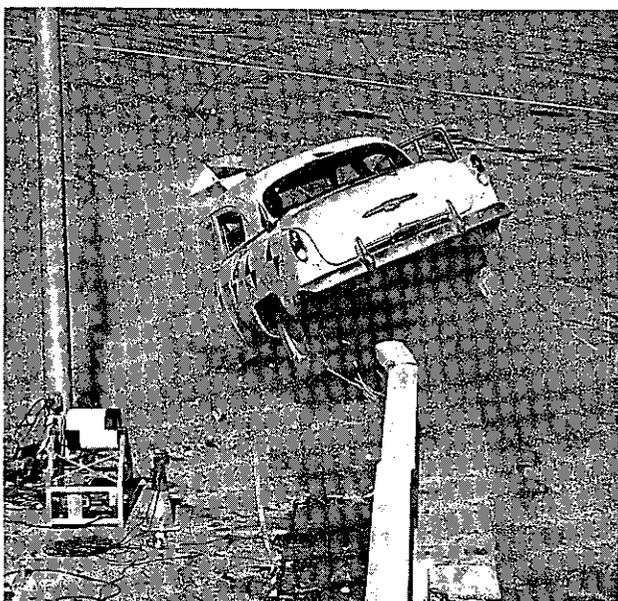
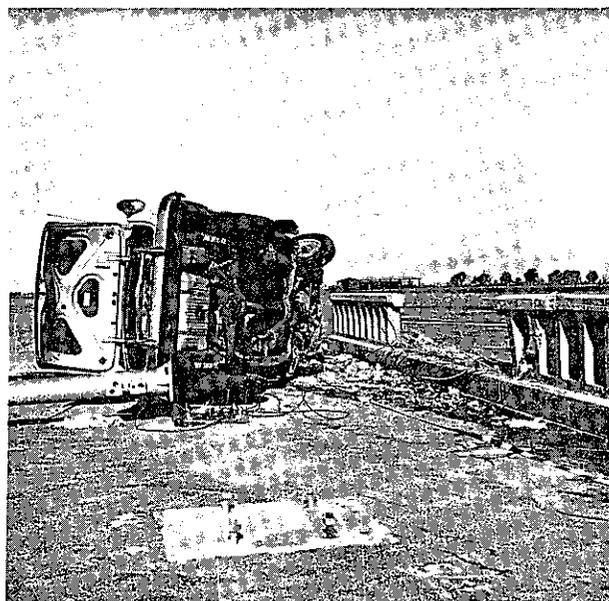
B. Baluster type rail tested during the 1959 test series. Impact speed 57 mph at 28 degrees approach angle.

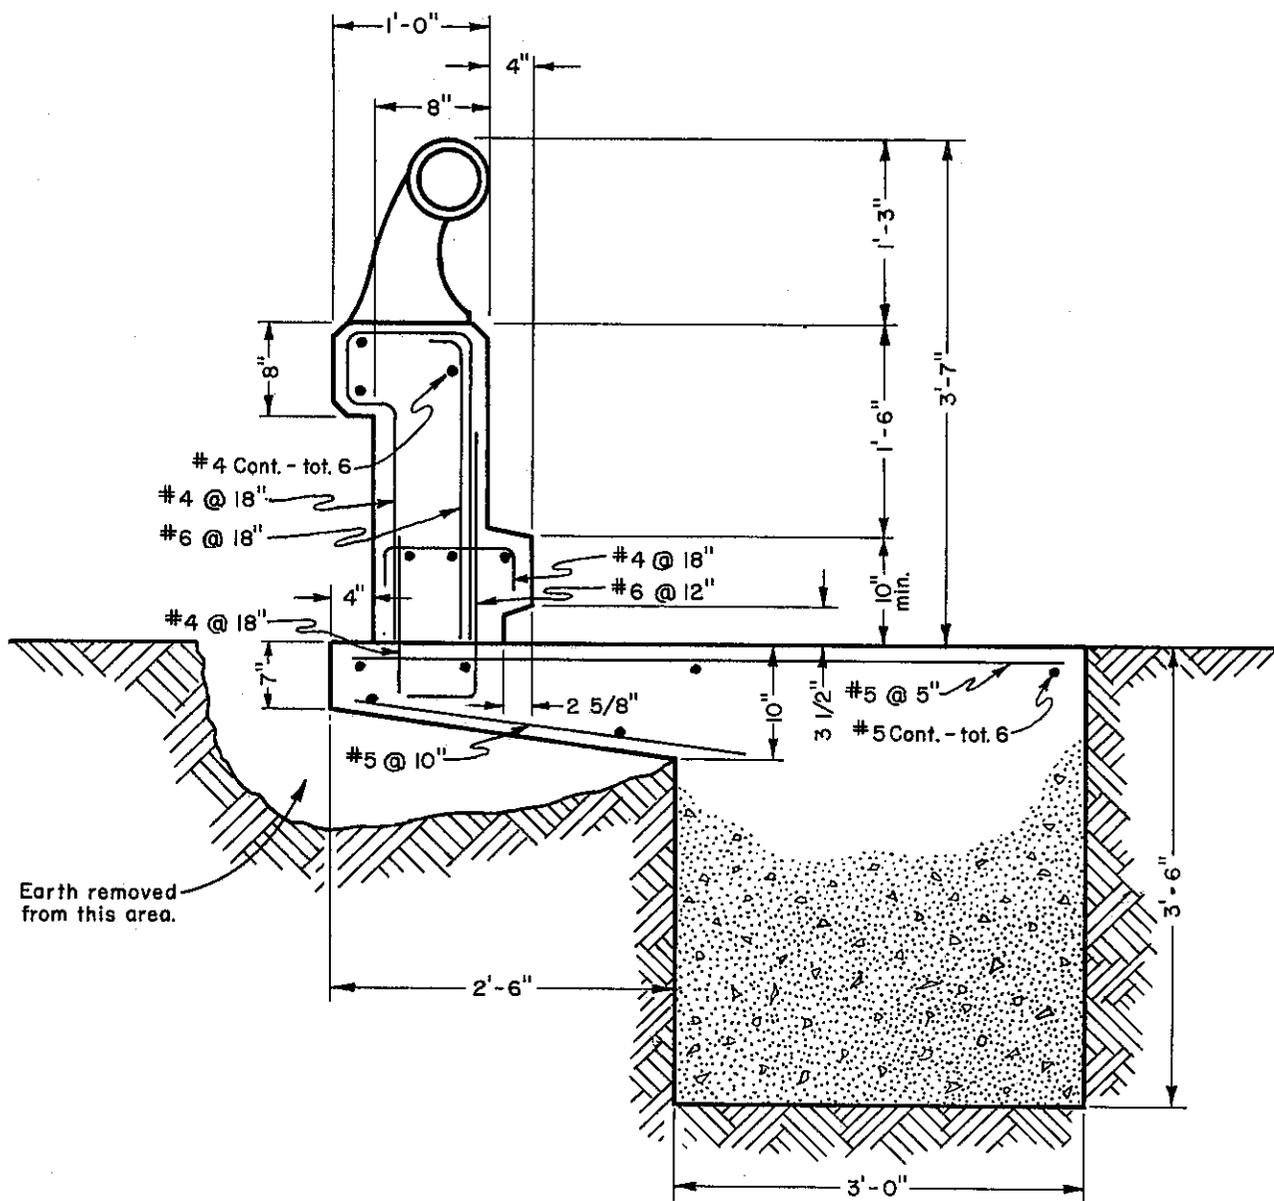
CROSS-SECTION  
BARRIER INSTALLATION FOR MODIFIED TYPE 1 BRIDGE RAIL

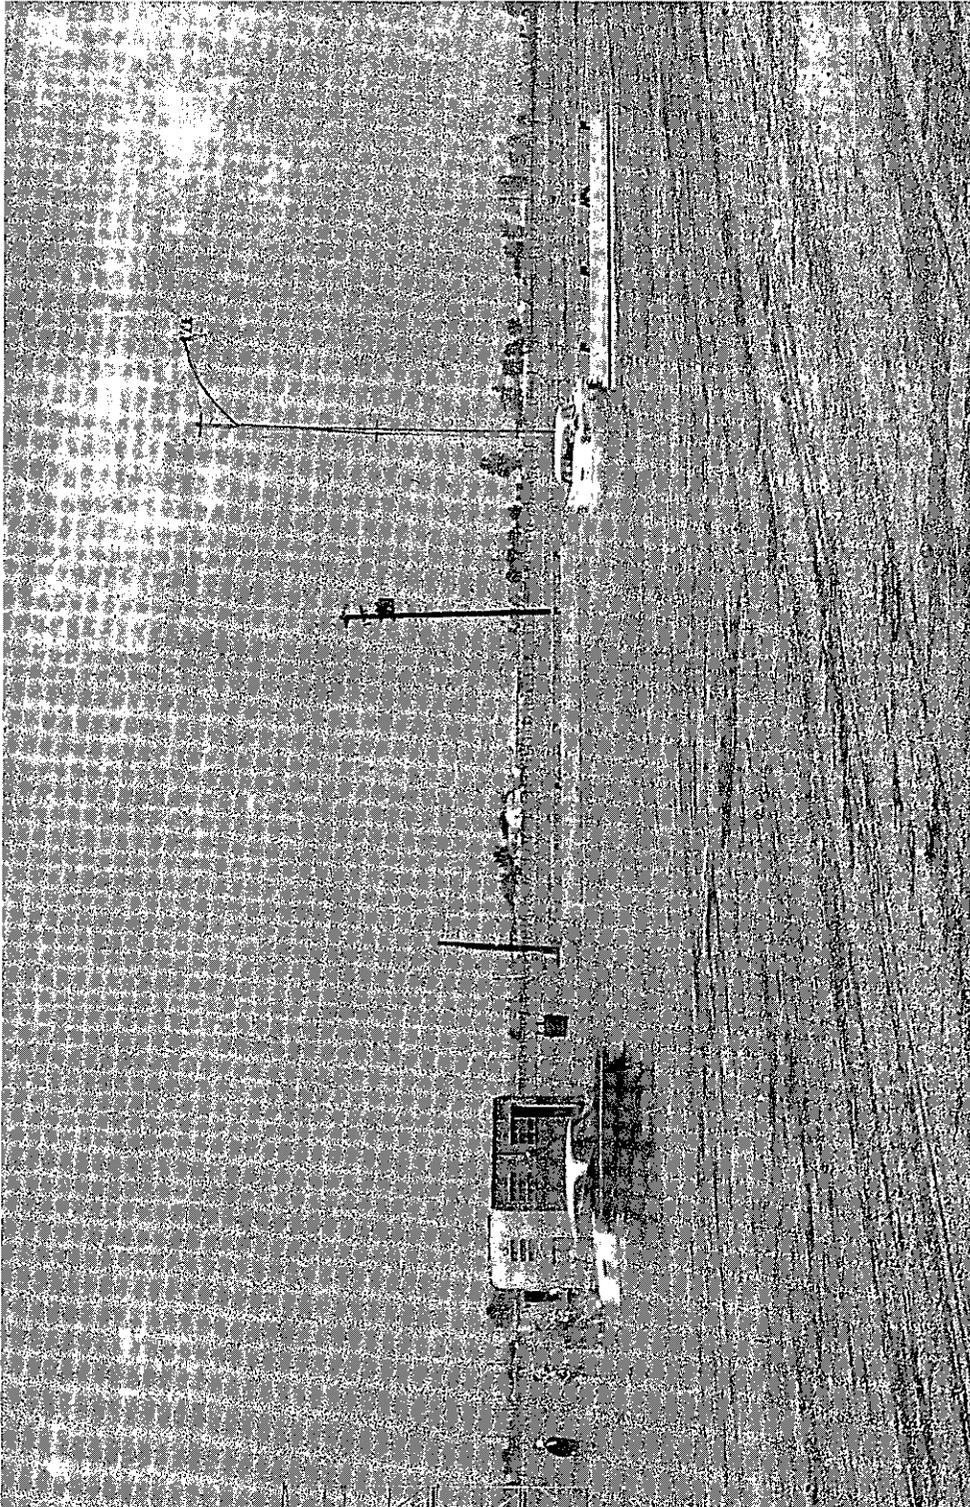
View of Test Site showing general layout. Control center is between camera scaffold and instrumentation trailer.

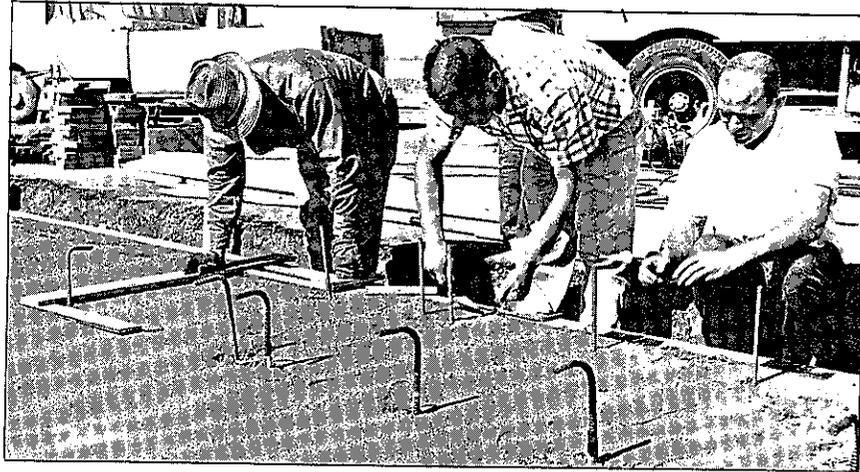
A. Installing strain gage instrumented re-bar dowels for barrier Type 2.

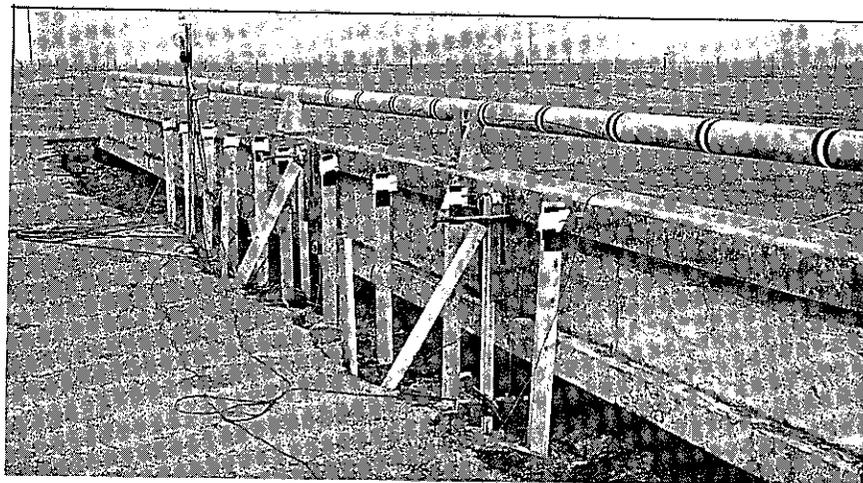
C. Deflection gage installation on Type 1 Modified Barrier Rail.

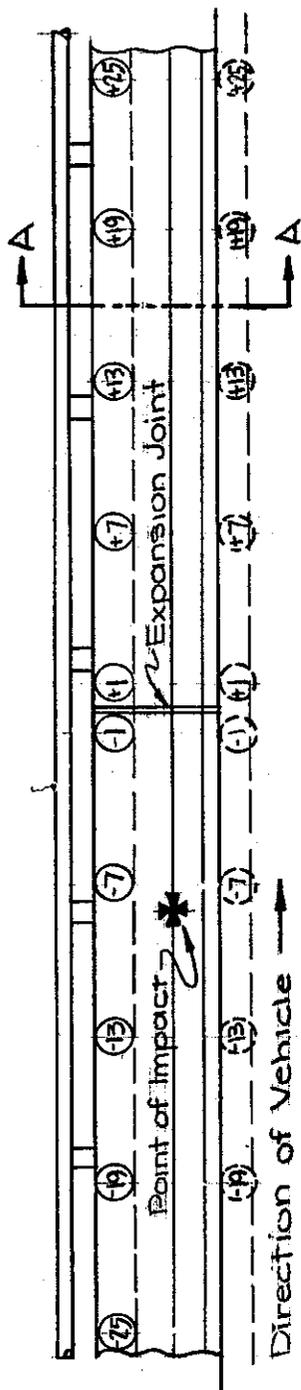
DECK GAGES PARAPET GAGES DEFLECTION IN INCHES

(B) DYNAMIC DEFLECTION OF PARAPET & DECK - RUN B-5

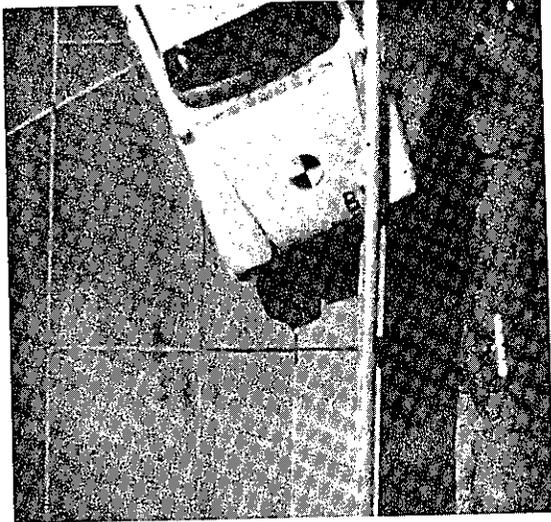
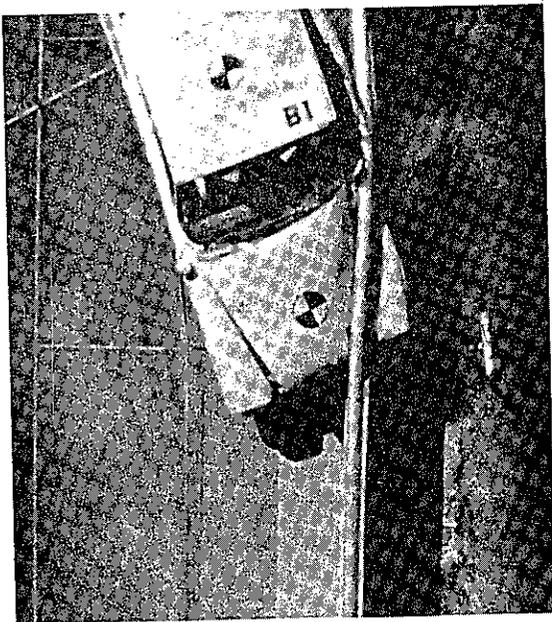
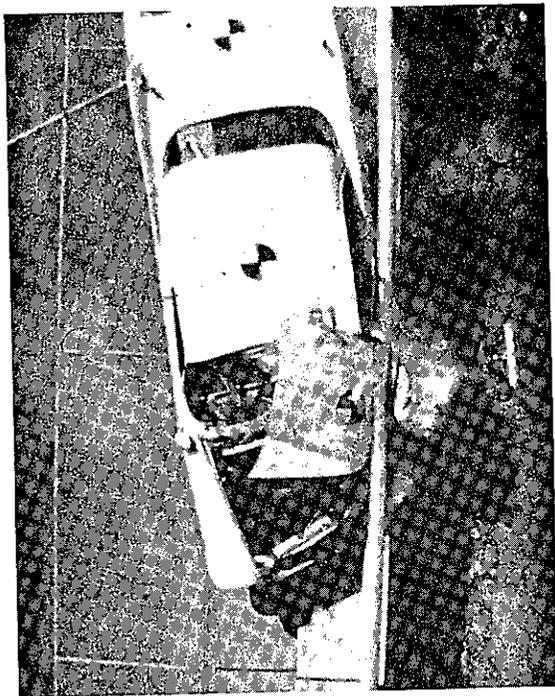
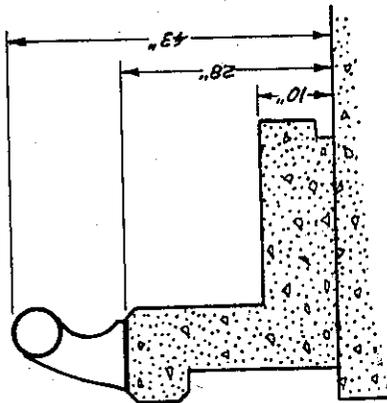
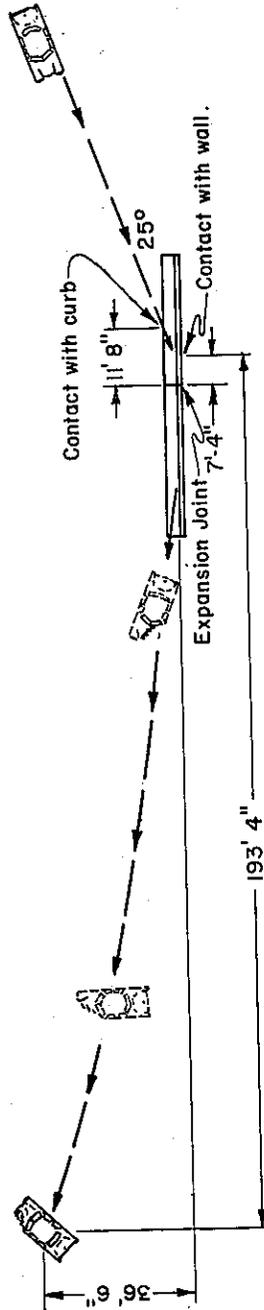
BRIDGERAIL..... Type 2  
 ANCHOR BOLTS..... Steel  
 POST..... Aluminum cast  
 FASTENING BOLTS..... Aluminum  
 RAIL..... Aluminum  
 POST SPACING..... 10' O.C.  
 LENGTH OF INSTALLATION... 62'  
 LENGTH OF CONTACT... 35'  
 WALL DAMAGE..... Minor spalling and cracking where wall joins walkway.  
 POST DAMAGE..... One post ripped thru entire web width adjacent to base.  
 PERMANENT DEFORMATION IN RAIL... 1 1/2"  
 TEST NO..... B-1  
 DATE..... 9-21-62  
 VEHICLE..... 1960 Dodge  
 SPEED..... 76 mph  
 IMPACT ANGLE..... 25°  
 VEHICLE WEIGHT... 4300 lbs.  
 (W/ DUMMY & INSTRUMENTATION)

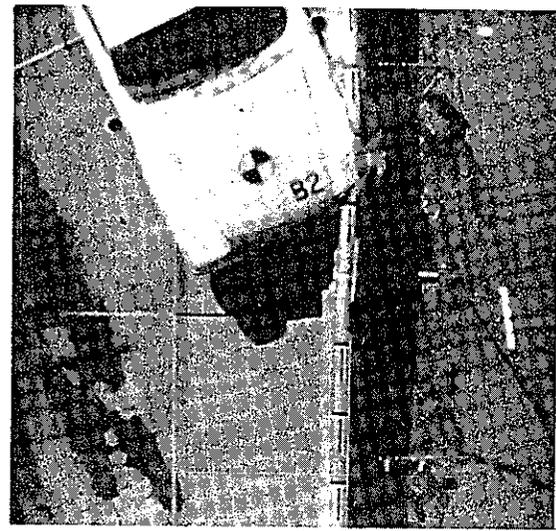
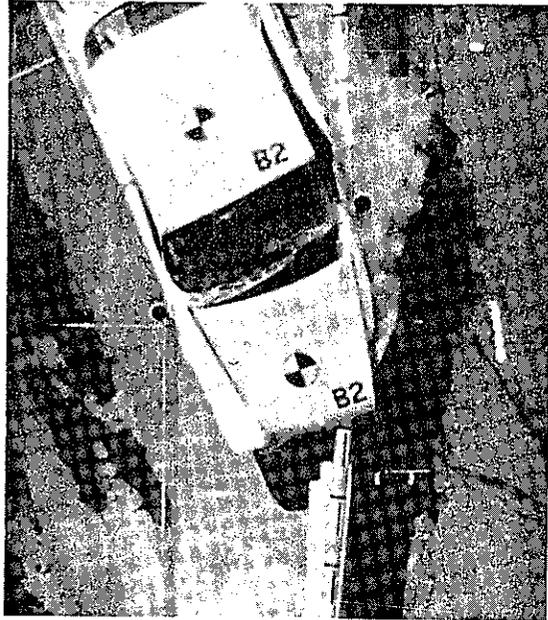
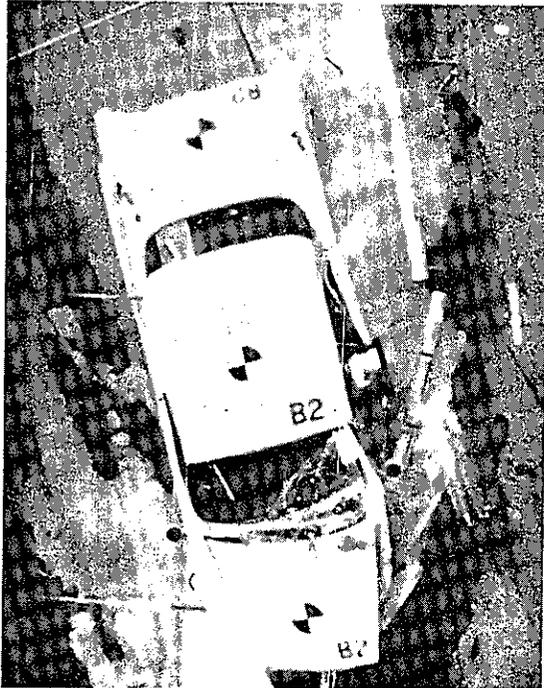
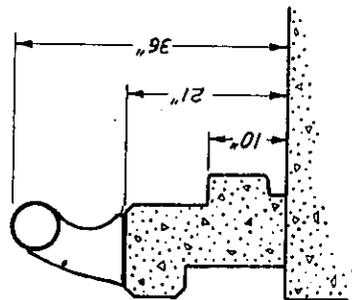
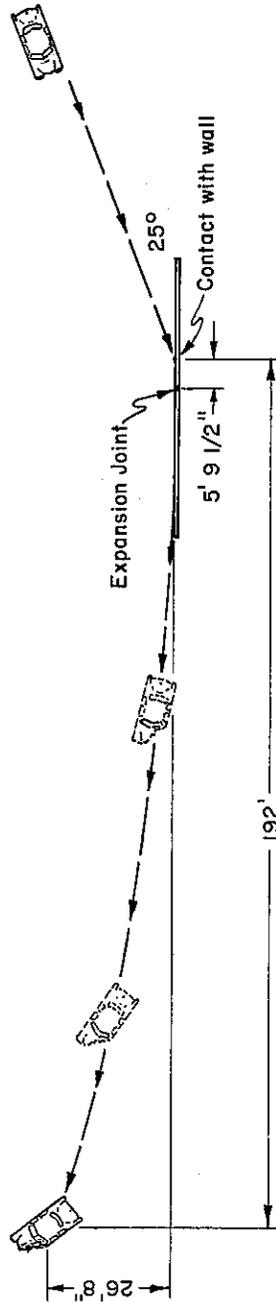
BRIDGERAIL.....	Type I	TEST NO.....	B-2
ANCHOR BOLTS.....	Steel	DATE.....	9-27-62
POST.....	Aluminum cast	VEHICLE.....	1960 Dodge
FASTENING BOLTS.....	Aluminum	SPEED.....	76 mph
RAIL.....	Aluminum	IMPACT ANGLE.....	25°
POST SPACING.....	10' O.C.	VEHICLE WEIGHT.....	4300 lbs.
LENGTH OF INSTALLATION..	62'	(W/ DUMMY & INSTRUMENTATION)

LENGTH OF CONTACT... Entire length of rail from point of impact.  
 WALL DAMAGE..... Severe cracking adjacent to post #4. Req. replacement of 5' of concrete wall.  
 POST DAMAGE..... Post nos. 4, 5 & 6 sheared at base; 1 web slightly bent.  
 PERMANENT DEFORMATION IN RAIL... 3 sections of rail pulled out of posts.

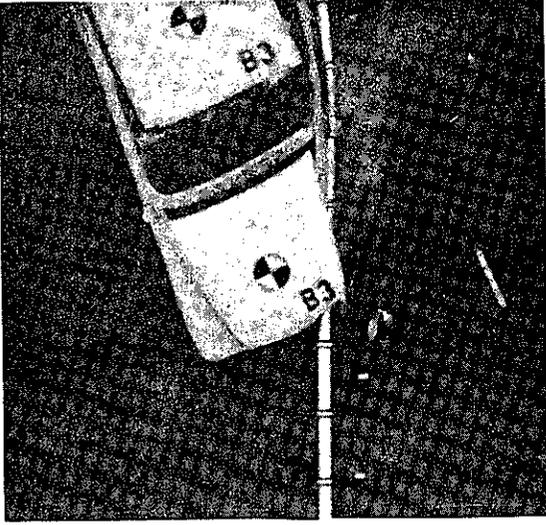
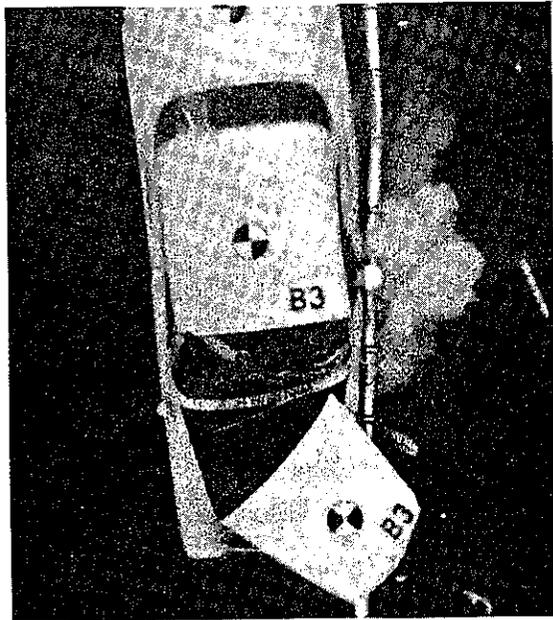
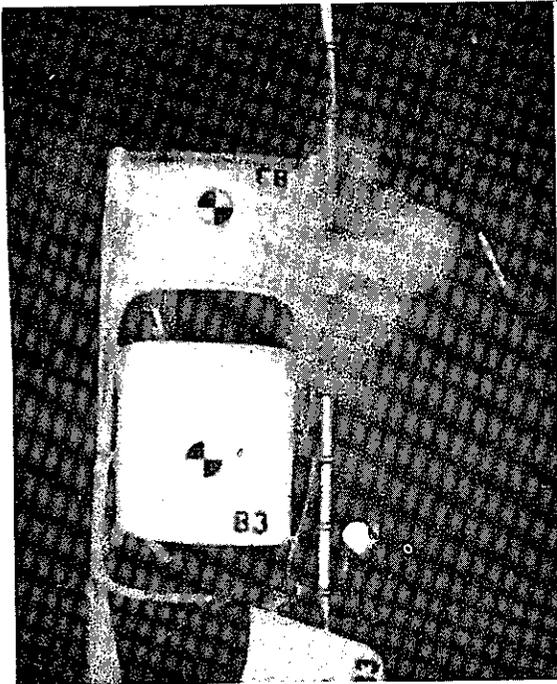
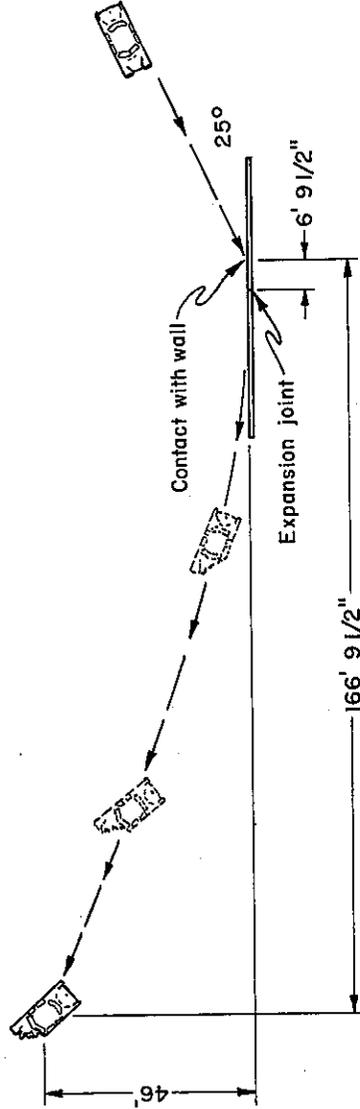
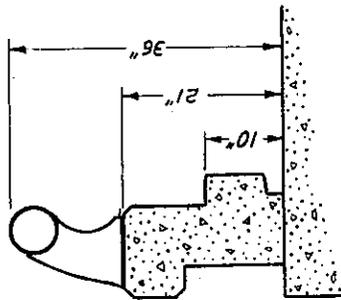
TEST NO..... B-3  
 LENGTH OF CONTACT... 26'  
 WALL DAMAGE..... Deep spalling & cracking at DATE..... 1-10-63  
 post #4. Reg. epoxy/agg. VEHICLE..... 1960 Dodge  
 patch & replacement of post SPEED..... 73 mph  
 anchor bolts. IMPACT ANGLE..... 25°  
 POST DAMAGE..... No visible damage. VEHICLE WEIGHT... 4300 lbs.  
 PERMANENT DEFORMATION IN RAIL... 3" (W/ DUMMY & INSTRUMENTATION)

BRIDGERAIL..... Type I  
 ANCHOR BOLTS..... Steel  
 POST..... Steel plate (Welded)  
 FASTENING BOLTS..... Steel  
 RAIL..... Steel  
 POST SPACING..... 10' O.C.  
 LENGTH OF INSTALLATION... 62'

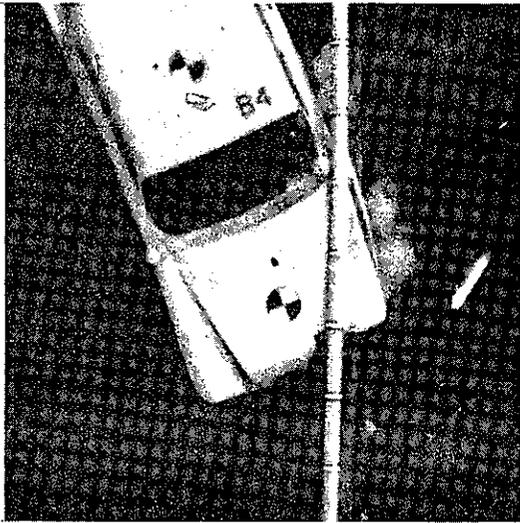
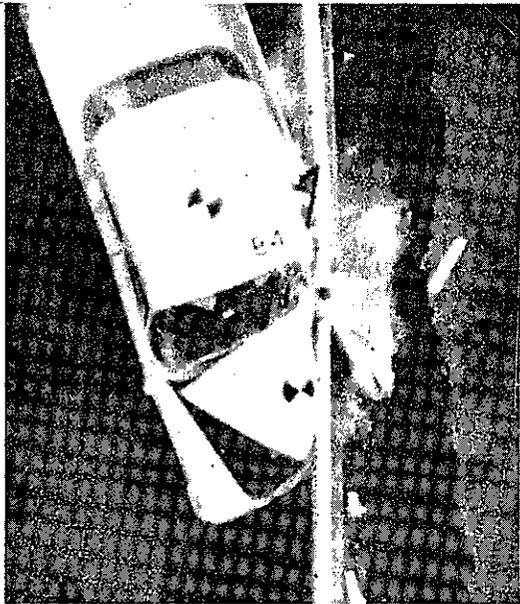
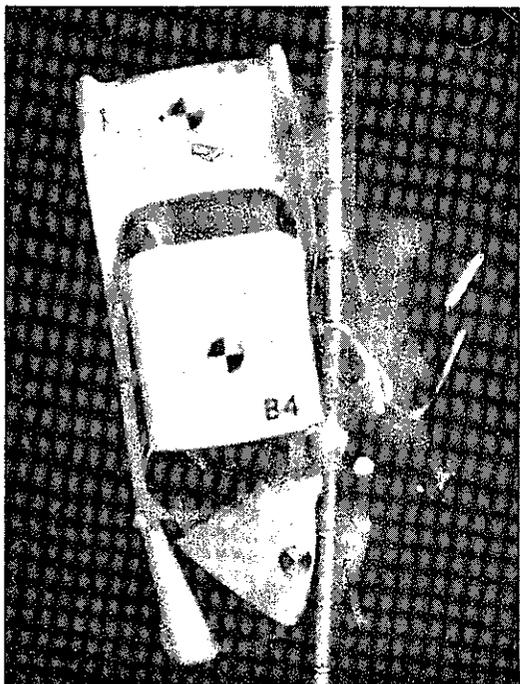
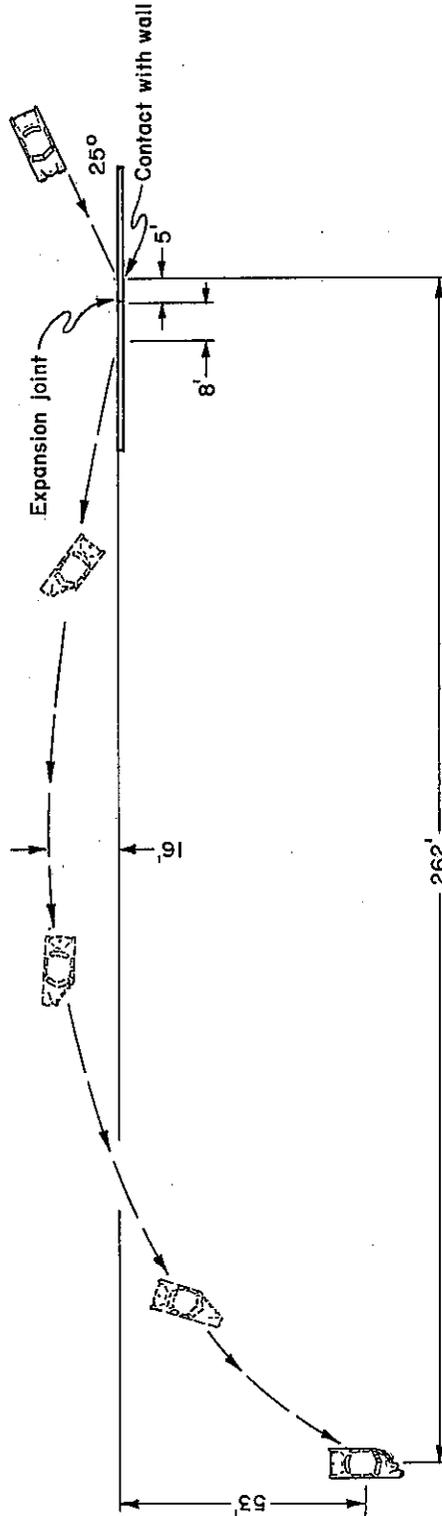
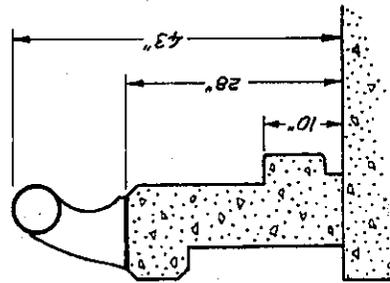
BRIDGERAIL..... Type 1, modified  
 ANCHOR BOLTS..... Steel  
 POST..... Aluminum cast  
 FASTENING BOLTS..... Aluminum  
 RAIL..... Aluminum  
 POST SPACING..... 10' O.C.  
 LENGTH OF INSTALLATION.. 62'

LENGTH OF CONTACT... 20'  
 WALL DAMAGE..... Slight spalling.  
 POST DAMAGE..... One flange bent.  
 PERMANENT DEFORMATION IN RAIL... 1"

TEST NO..... B-4  
 DATE..... 1-24-63  
 VEHICLE..... 1960 Dodge  
 SPEED..... 77 mph  
 IMPACT ANGLE..... 25°  
 VEHICLE WEIGHT.. 4300 lbs.  
 (W/ DUMMY & INSTRUMENTATION)

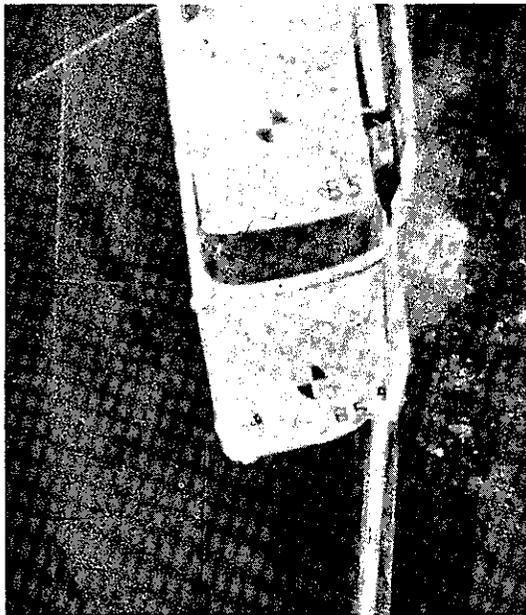
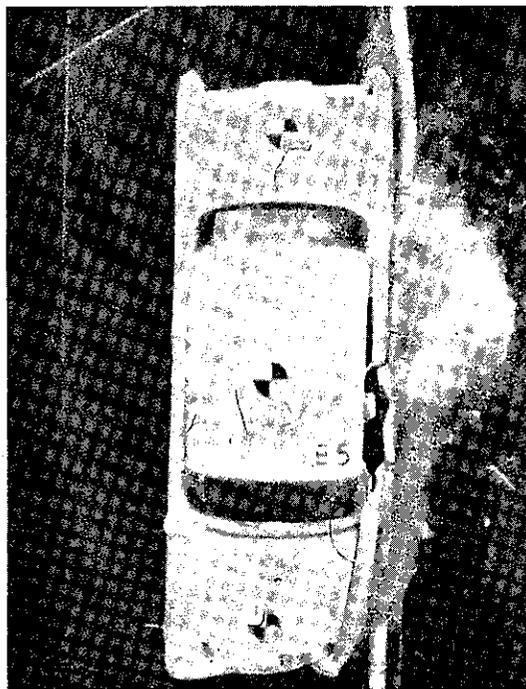
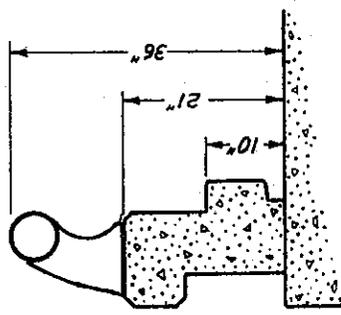
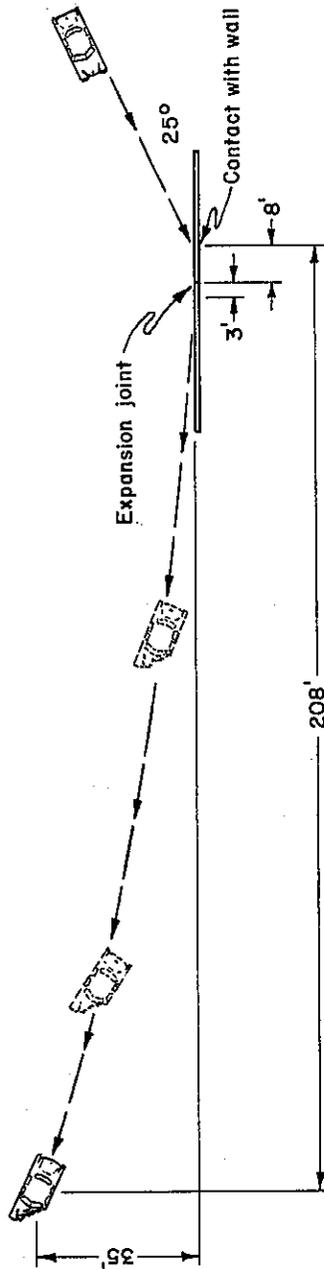
BRIDGERAIL.....	Type 1	TEST NO.....	B-5
ANCHOR BOLTS.....	Steel	DATE.....	2-7-63
POST.....	Malleable cast iron	VEHICLE.....	1959 Dodge
FASTENING BOLTS.....	Steel	SPEED.....	78 mph
RAIL.....	Aluminum	IMPACT ANGLE.....	25°
POST SPACING.....	10' O.C.	VEHICLE WEIGHT..	4300 lbs.
LENGTH OF INSTALLATION..	62'	(W/ DUMMY & INSTRUMENTATION)

LENGTH OF CONTACT... 19'	WALL DAMAGE.....	Cracked around #4 post anchor bolts.
POST DAMAGE.....	One post web slightly dented.	
PERMANENT DEFORMATION IN RAIL..	5 1/2"
