Load Relaxation and Friction Losses in Two Tendons of A
Continuous Post-Tensioned Three Span Structure

July 1964

State of California
Department of Public Works
Division of Highways

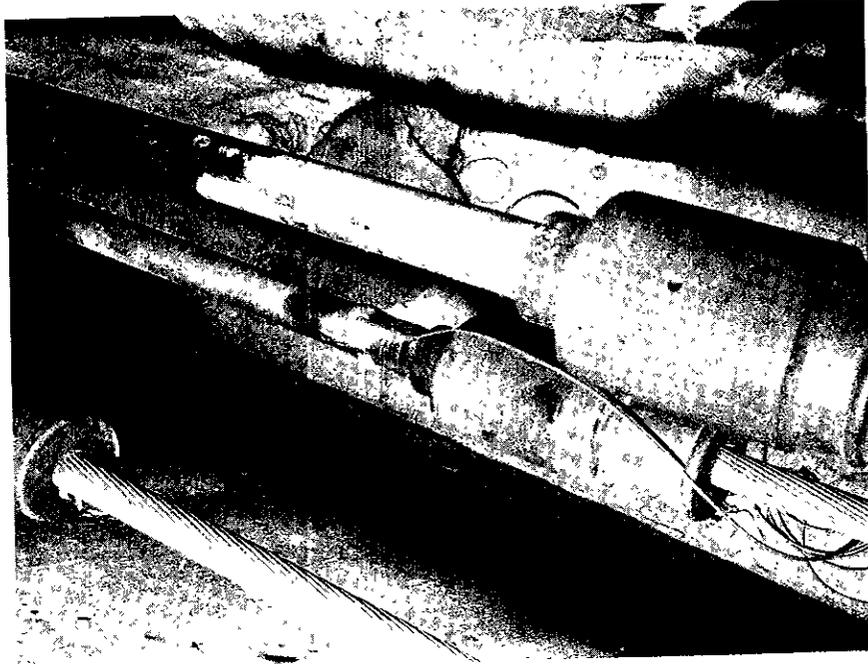
Figure 11.

Completed strain gage installation on jacking rod.

Strain gages were attached to the jacking rods by first using acetone to dissolve and wipe away the rust inhibitor and lubricating grease that was applied to the jacking rods before installation. Then a file was used to clean an area large enough to place one longitudinal and one transverse strain gage. The strain gage installation generally was the same as on the strand except that the two gages were wired up in a half bridge circuit so that the longitudinal gage was the active or measuring gage and the transverse gage was the dummy or temperature compensating gage (see Figure 10). Figure 11 shows the completed strain gage installation on one of the jacking rods.

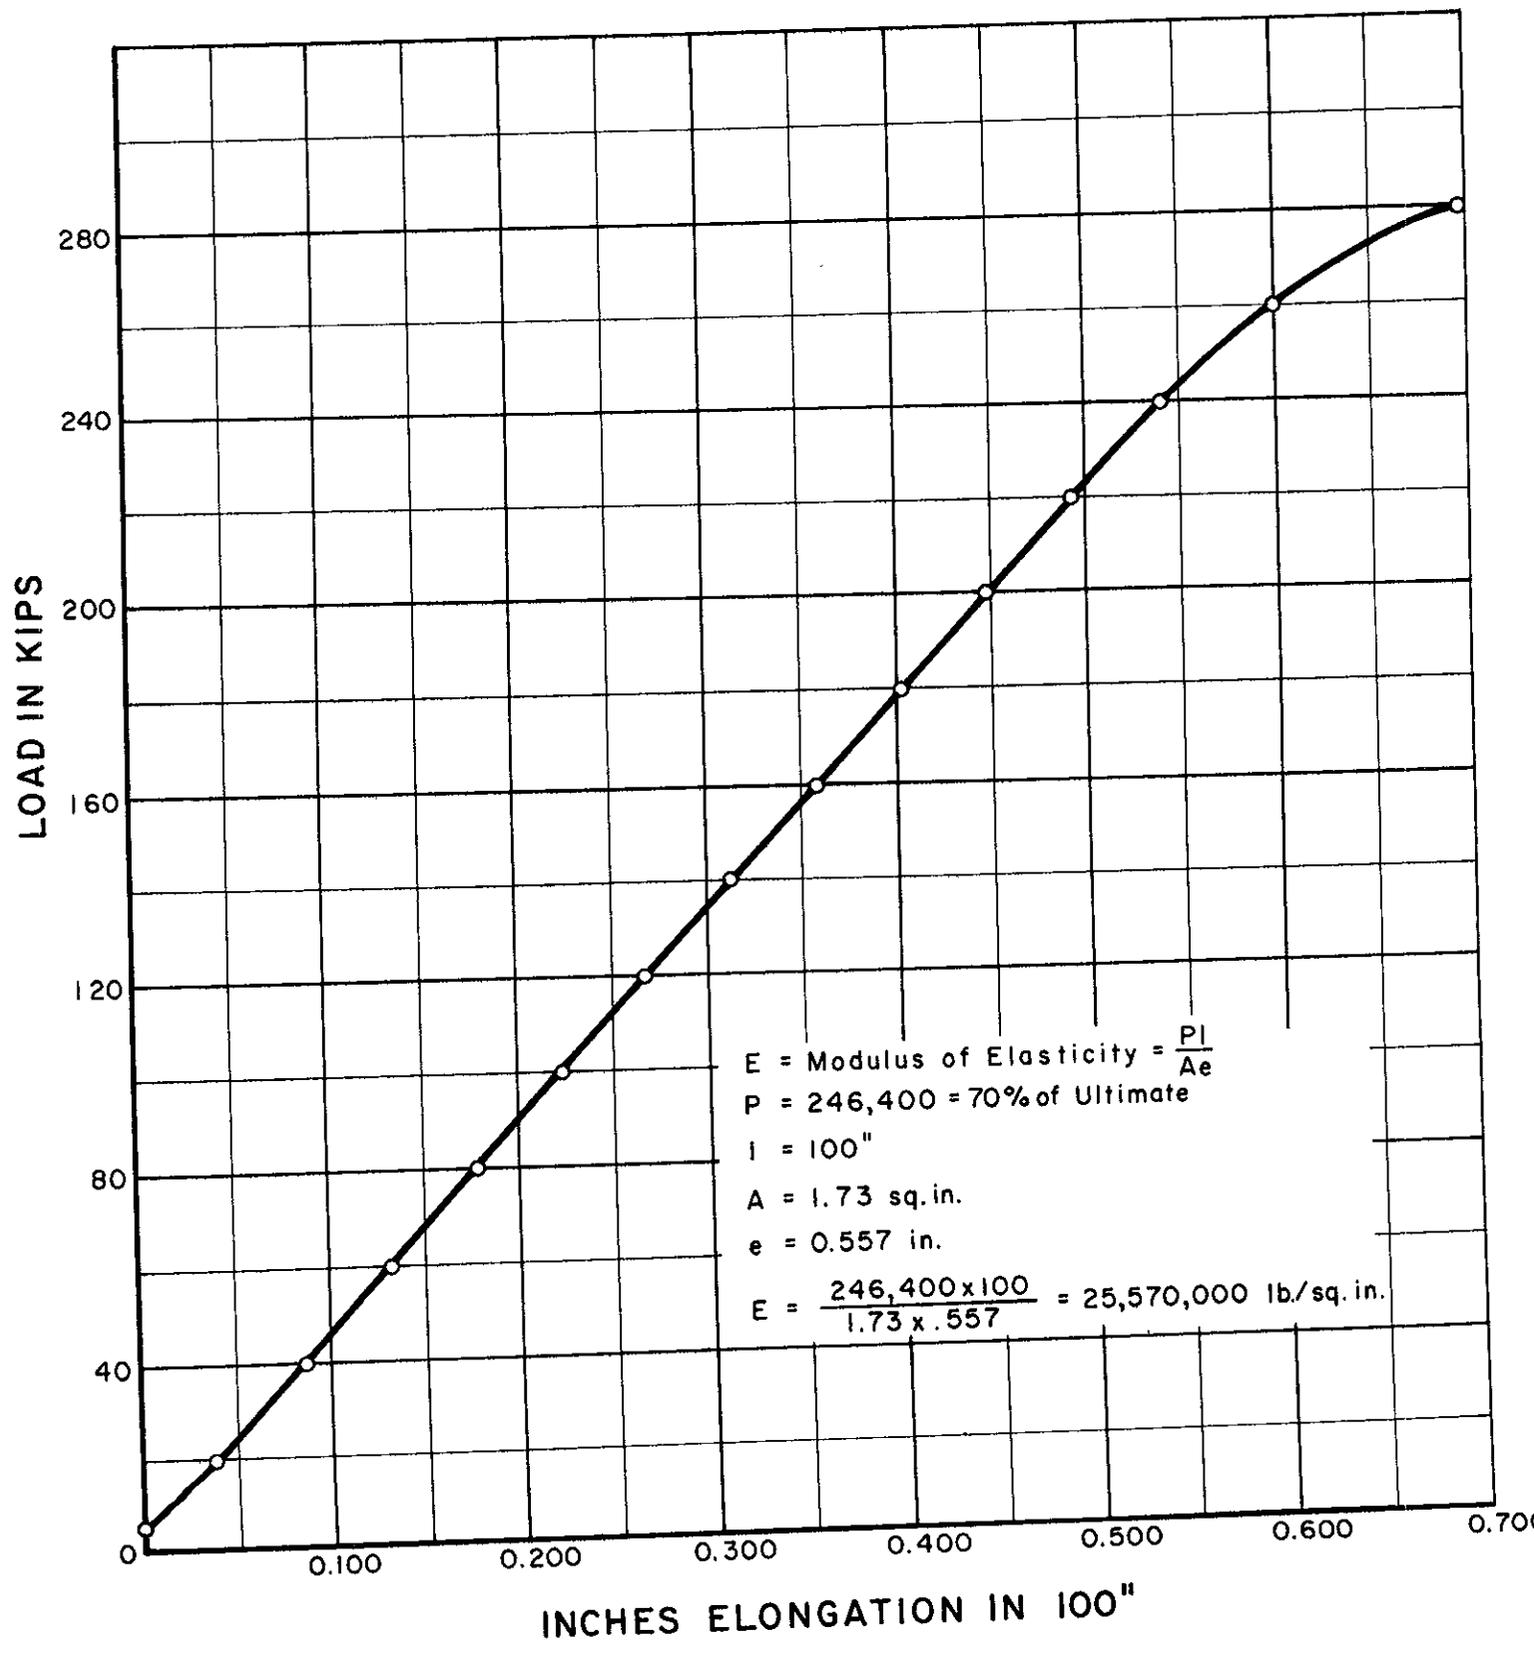
ELONGATION VS LOAD CURVE

1 $\frac{11}{16}$ " DIA. 69 WIRE GALV. STEEL BRIDGE STRAND

The second method considered was to install strain gages on the tendon and use the elongation vs load curves supplied by the manufacturer to determine the loads. Figures 16 and 17 are two such curves supplied by the manufacture of the strands used in this structure. The two curves were developed from lab tests on two 100 inch long specimens taken from two reels of the strand. This method was not used because of past experience that the modulus of elasticity is not uniform over the length of a strand.

For example, at 246,000 pounds of load one test specimen showed a modulus of elasticity of 25,070,000 pounds per square inch while the other specimen showed a modulus of elasticity of 25,570,000 pounds per square inch. Since strain gages would have to be used to measure elongation and since elongation is inversely proportional to the modulus of elasticity, there is a difference of 2% between the two specimens. This difference is already greater than the friction loss calculated over one saddle which is only 1.2%. Further evidence that the modulus of elasticity varies in a given specimen is shown in Figures 14 and 15. At each gage location two strain gages (BW and RG) were glued on two adjacent wires to measure elongation. The differences of the two strain gage readings varied from 1.8% to 12.1%. Full load strain readings from the two gages at location 34-11, for example, were 4920 and 4390 microinches per inch. This would represent a difference of 12.1%. Full load strain readings at location 10-13 were 4480 and 4560 microinches per inch, representing a difference of 1.8% which still was higher than the friction losses over one saddle. Since friction was also to be determined, this method was not considered accurate enough.
