A Report on Vehicle Response to Pavements

August 1964

Project W.O. 61245-R

State of California
Department of Public Works
Division of Highways
Materials and Research Department

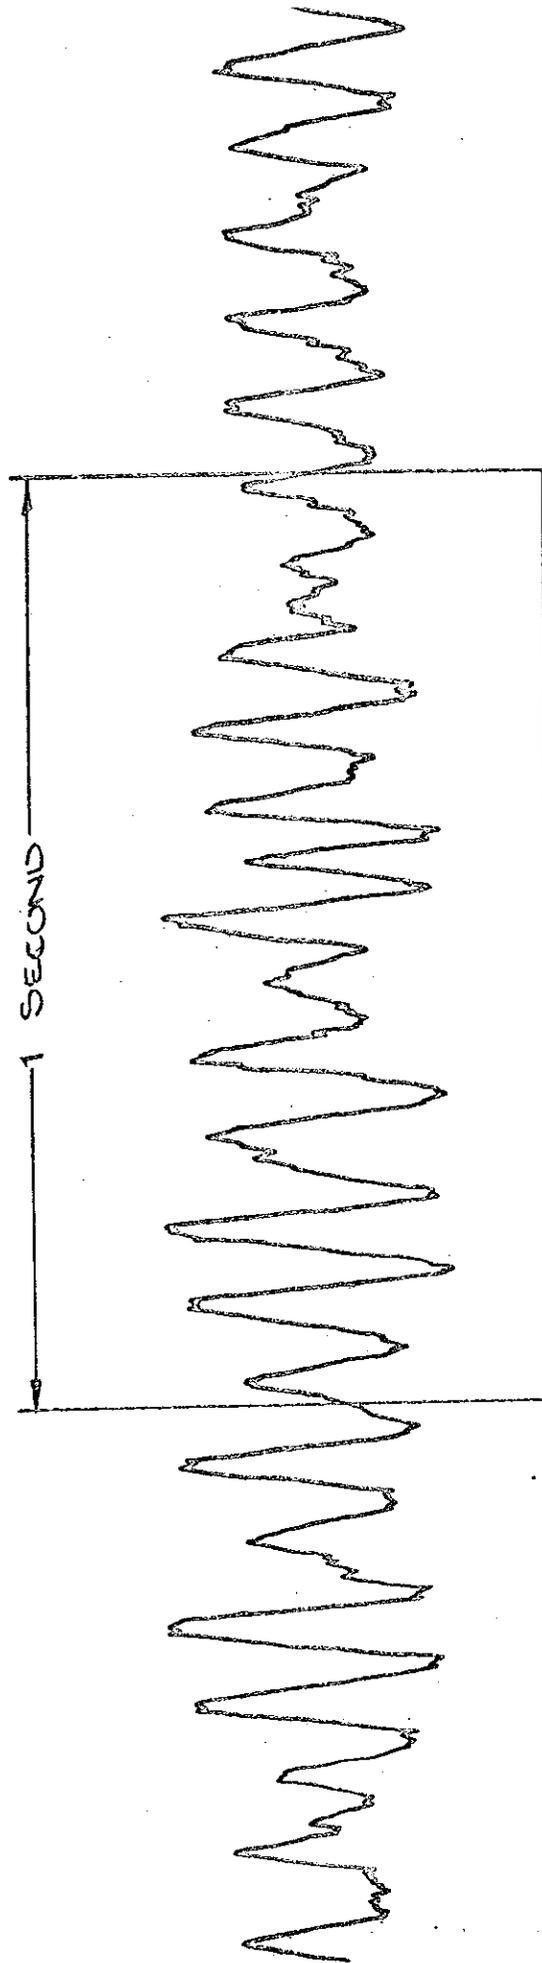
FIGURE 3

RUN # 128 ~ LOCATION: CHIP ACADEMY
TEST TRACK ~ SPEED: 55 M.P.H.
ACCELEROMETER W/CHOKE ON CHASSIS
FREQUENCY = 1.14 CY./SEC.

finding some correlation between pavement joints and differential movements between chassis and wheel. An additional accelerometer was mounted directly beneath the driver's seat in hopes that "hop" would transmit through the car floor into the car seat. This method also did not indicate any "hop" due to the masking effects of the car's springs and unsprung frequencies. Figures 2 through 6 show some of the various accelerometer locations tried and typical curves obtained.

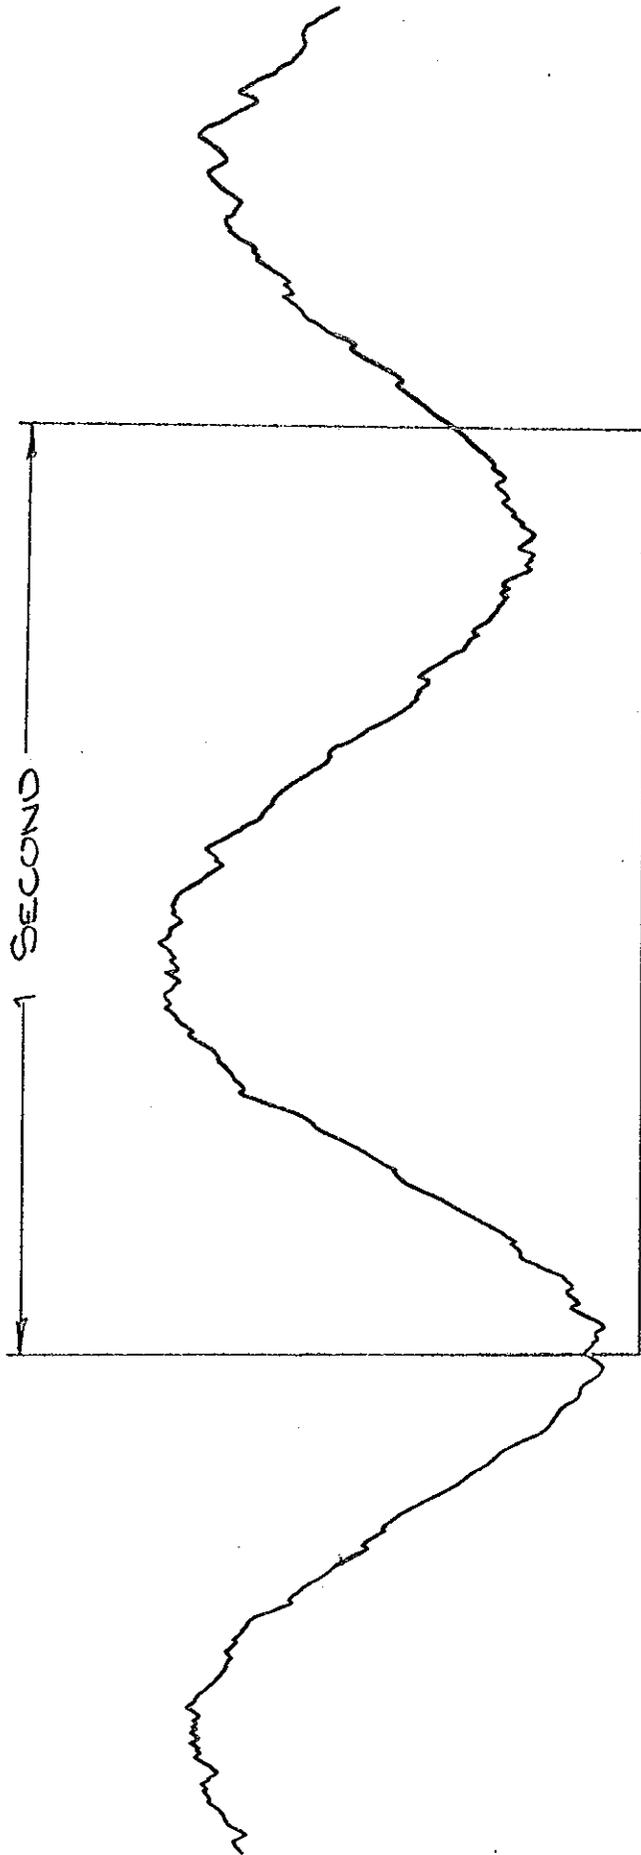
FIGURE 4

RUN # 146 ~ LOCATION: ROSEVILLE, WEST BOUND,
OUTSIDE LANE ~ SPEED: 35 MPH ~ ACCELER-
OMETER ON RIGHT FRONT WHEEL SUSPENSION.

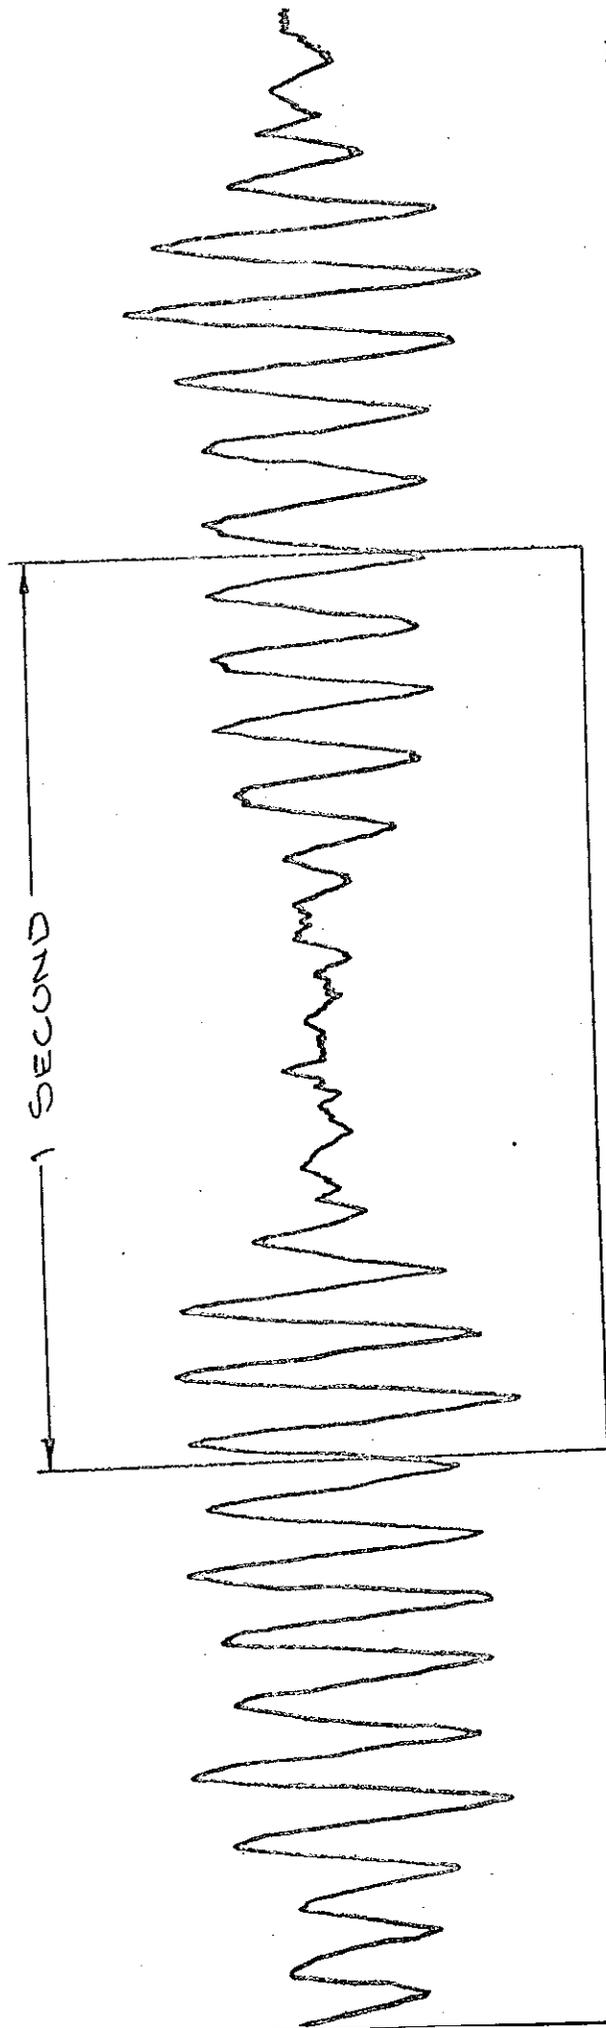
FIGURE 5

RUN #160 ~ LOCATION: ROSEVILLE, WEST BOUND,
OUTSIDE LANE ~ SPEED: 35 MPH ~ ACCELEROMETER
METER ON CHASSIS ~ FREQUENCY = 50 CY. / SEC.

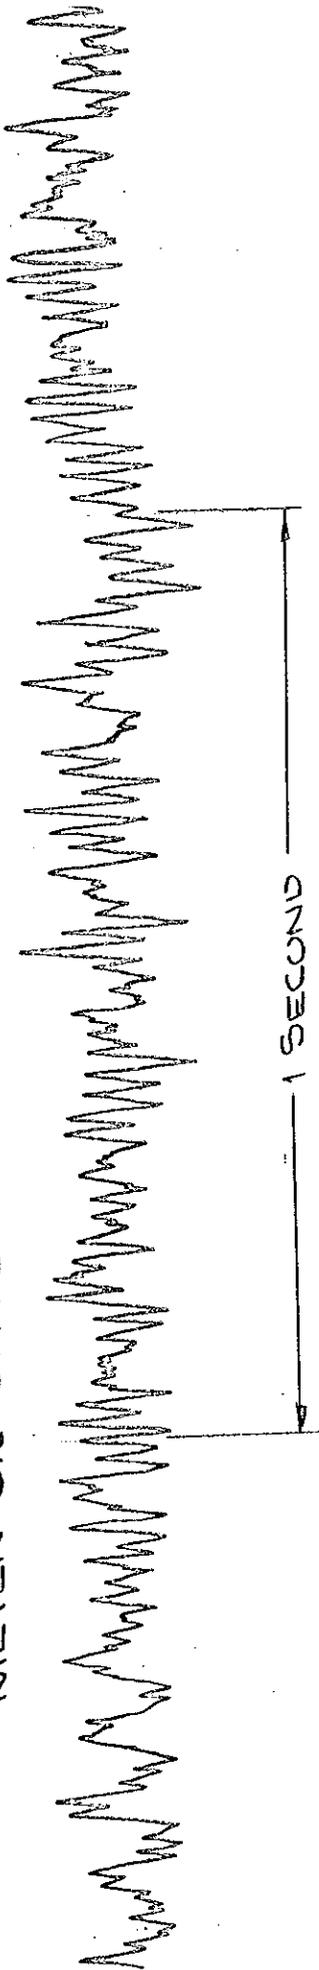
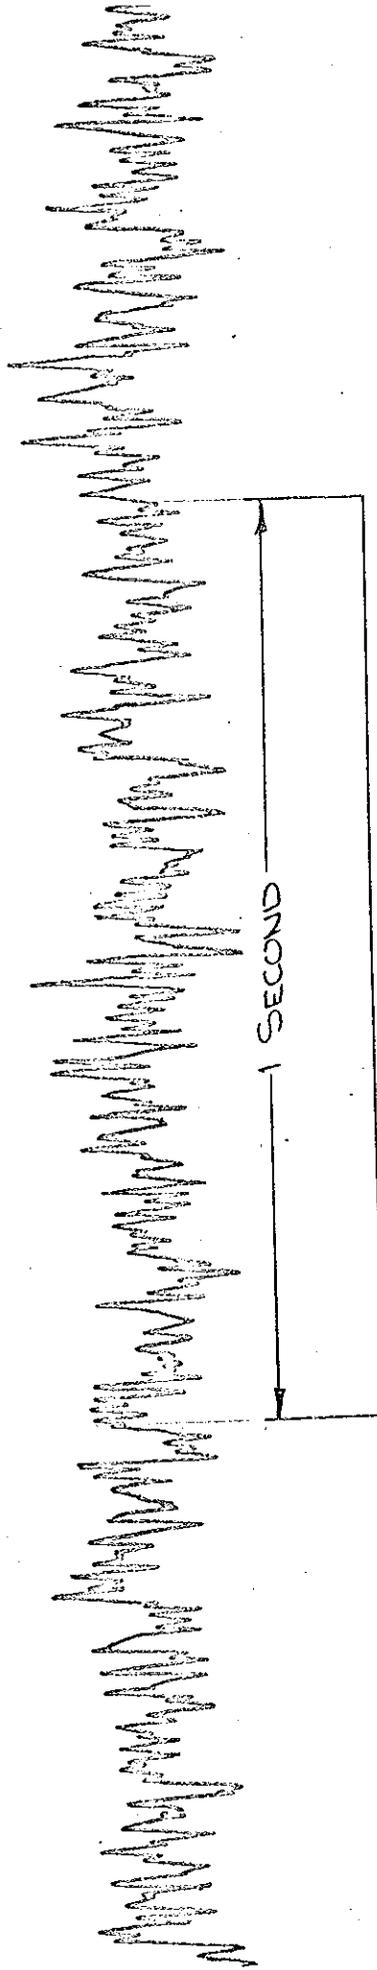
FIGURE 6

RUN #80 ~ LOCATION: DIXON, EAST BOUND, OUT -
SIDE LANE ~ SPEED: 55 MPH ~ ACCELEROMETER
ON CHASSIS ~ FREQUENCY = 75 CY. / SEC.

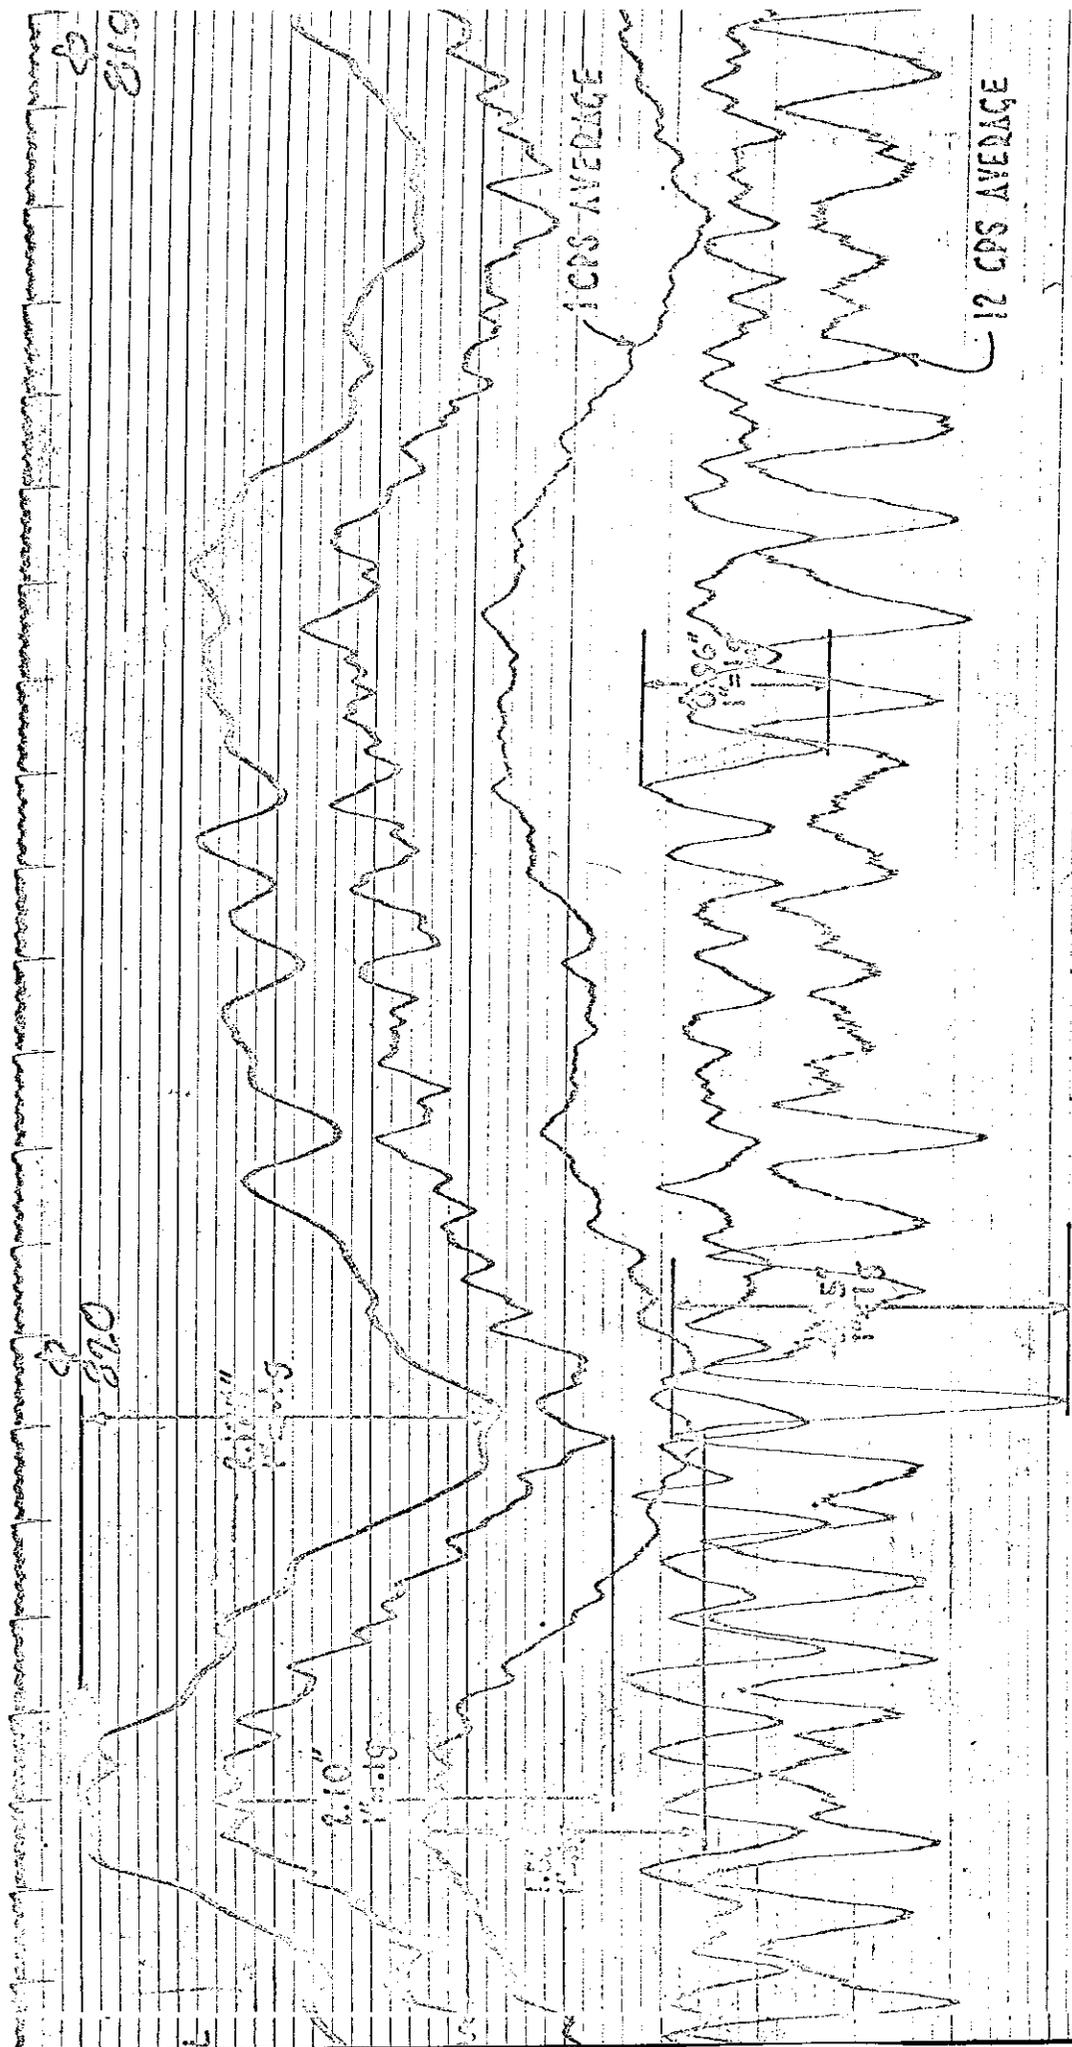
FIGURE 11

ALDSBUDG FREEWAY (NORTHBOUND OUTSIDE LANE)
EED = 55 MPH

RIGHT FRONT WHEEL

During this period of investigation a 50 lb. weight, Figure 10, was also instrumented with an accelerometer and placed at various locations on the car floor. Also, car motion noises were thought to contribute to discomfort so that interior car noises were also recorded. Typical records obtained during this phase of the investigation are shown on Figure 11. Car noises and the 50 lb. weight did not provide significant information.

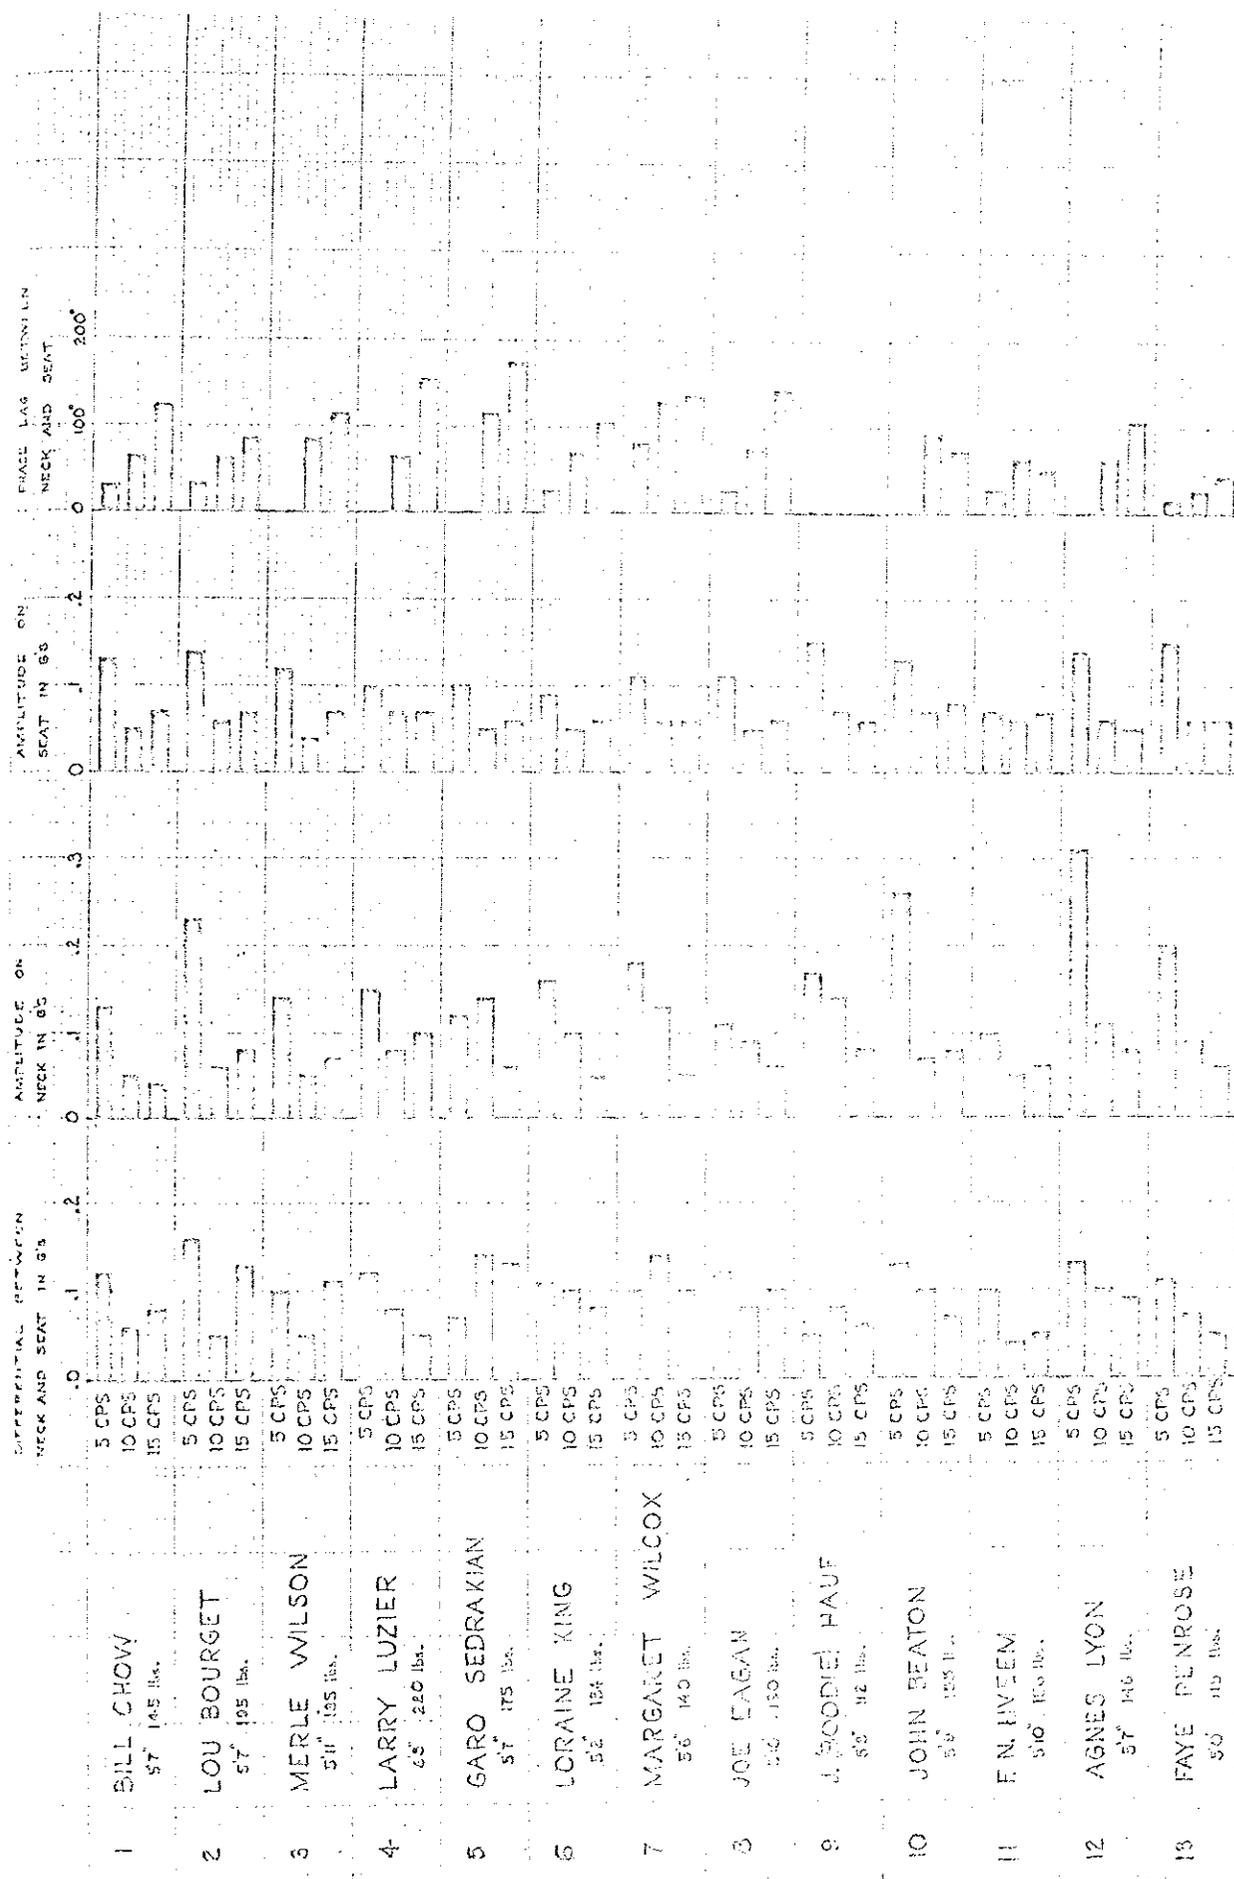
SUBJECTIVE RESPONSE ON

SHAKE TABLE

— SITTING BACK —

previously developed. A large range of body types was chosen for this investigation. Results indicated that no two persons responded alike and even "similar" body types responded differently. A typical body type with typical response simply did not exist. Figures 20A and 20B are included for the record to show the response variations recorded on various body types.

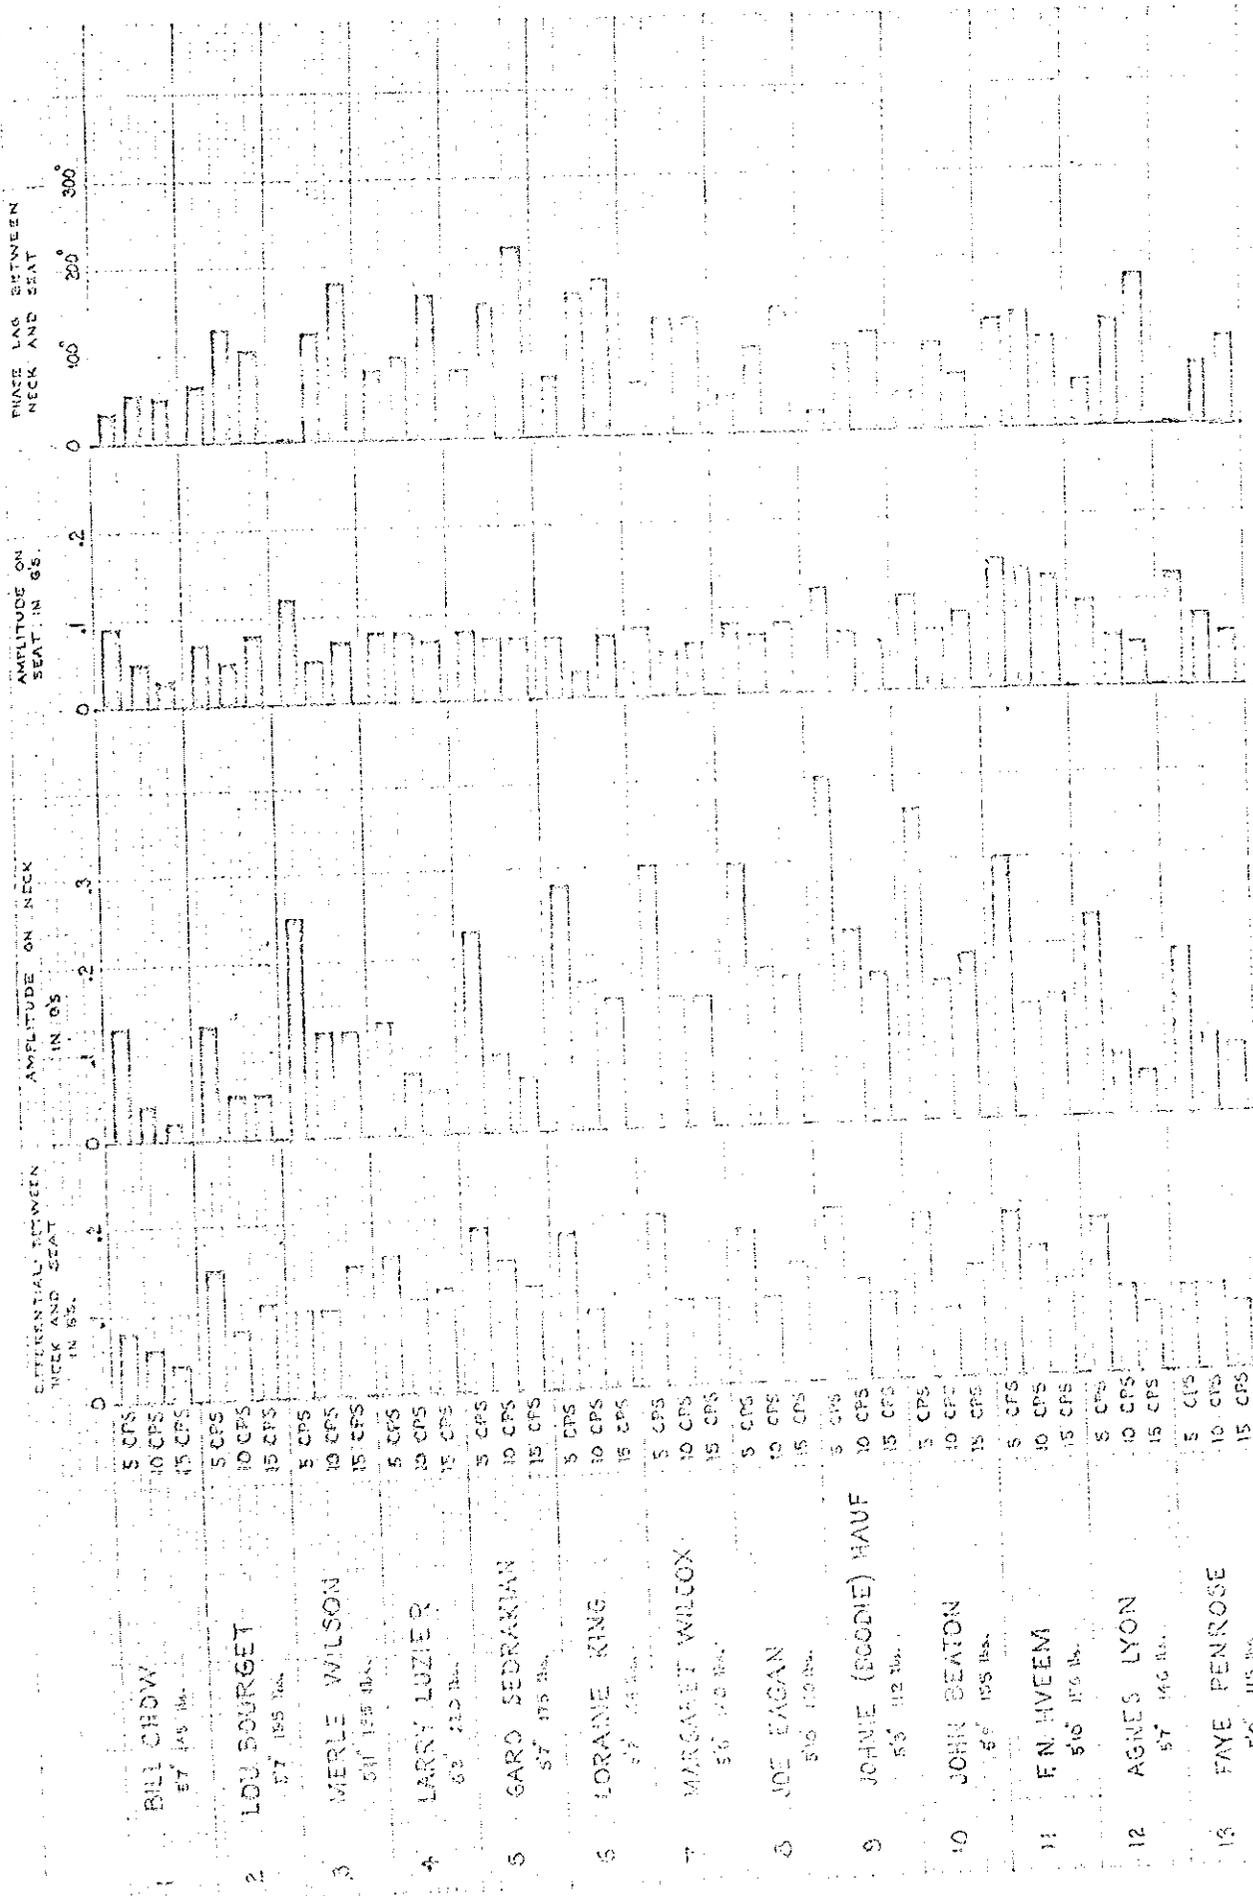
SUBJECTIVE RESPONSE ON SHAKE TABLE — SITTING UPRIGHT
