Report of Field Evaluation of the Lane-Wells Road Logger

State of California
Department of Public Works
Division of Highways
Materials and Research Department

Field Evaluation of the Lane-Wells Road Logger

NO. M & R 226208-1

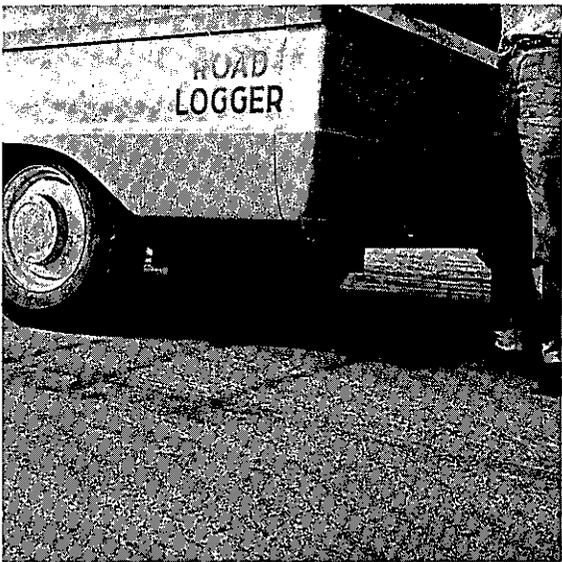
PHOTO 6 Looking underneath rear of Road Logger truck, with moisture sensor in logging position.

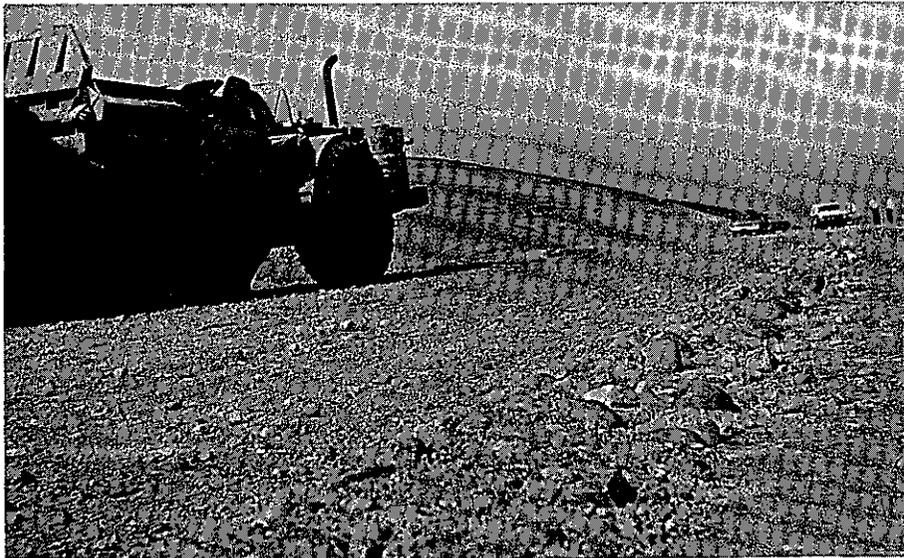
PHOTO 23 Large rocks in right-center are too rough for moisture probe.

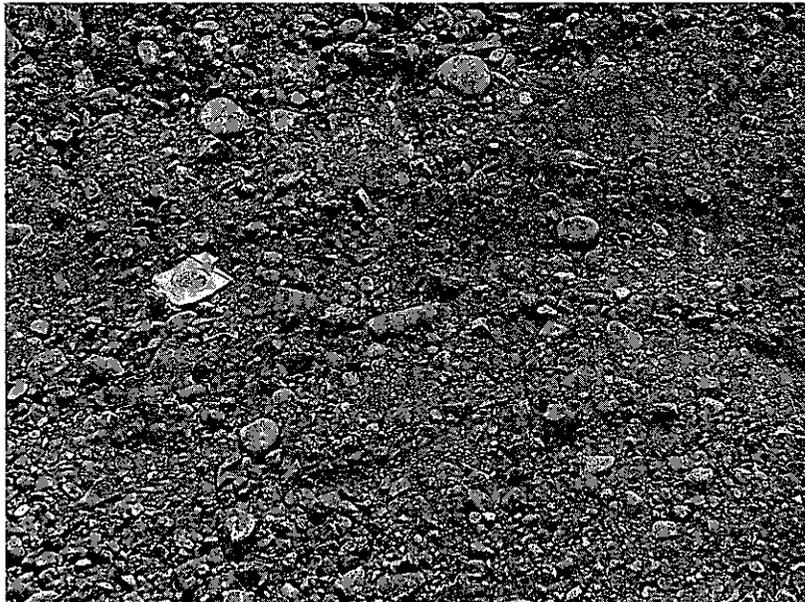
PHOTO 34 Poor surface (too loose).
