A Dynamic Full Scale Impact Test On A Precast, Reinforced Concrete Median Barrier Series XII

October 1966

State of California
Highway Transportation Agency
Department of Public Works
Division of Highways
Materials and Research Department

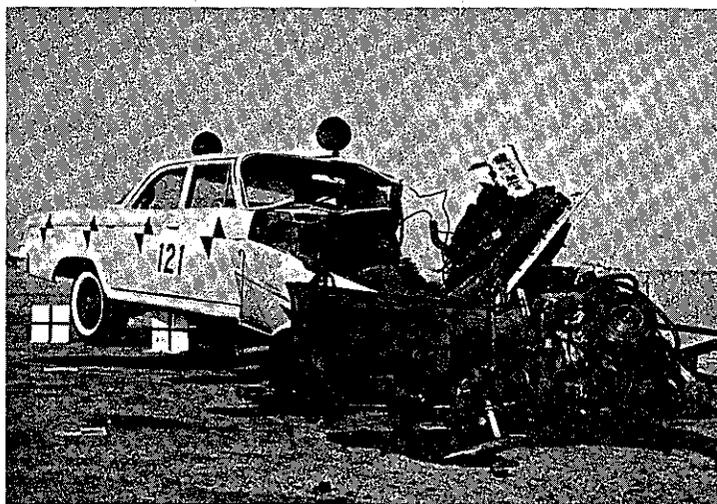
Figure 4

The performance of the barrier proved to be completely unsatisfactory. The lack of adequate beam strength in the 7" x 8" posts under this severe impact loading and the failure of the connection to transfer or absorb a significant part of the load permitted excessive horizontal deflection of the unit (see Plate D). The vehicle was thus permitted to penetrate across the barrier centerline and impact head-on into the exposed end of the adjacent unit, resulting in the complete demolition of its front end (see Figure 4). The impact was so severe that the engine was ejected from the vehicle, coming to rest 8 feet beyond the car. The dummy's head was thrown 23 feet from impact when the three $\frac{1}{4}$ " diameter high-strength bolts in the neck joint were sheared as the shoulder struck the windshield post (see Plate E).

To effectively redirect an impacting vehicle, the deformation of the beam and post must be within the limits attainable with the material being used. The allowable deflection for concrete is relatively low due to its inability to sustain tensile stresses much in excess of 10-15% of its compressive strength. This stress can be controlled either through the construction of a larger section to increase flexural resistance or by increasing the amount of reinforcement. Either method would increase the cost and the weight of the barrier.
