Dynamic Tests Of Concrete Median Barrier, Series XVI

State of California
Department of Public Works
Division of Highways
Materials and Research Department

Interim Report

August 1967
Interim Report
M&R No. 636392

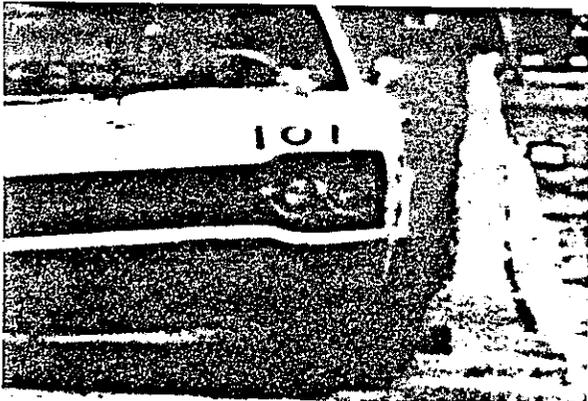
TEST 161-A PLATE A

TEST NO. 161-A
 DATE 5-4-67
 VEHICLE 1965 Dodge sedan
 VEHICLE WEIGHT 4540 #
 (W/DUMMY AND INSTRUMENTATION)
 IMPACT SPEED 38 mph
 IMPACT ANGLE 7°
 EXIT ANGLE 0°

BARRIER Unreinforced Concrete
 LENGTH OF INSTALLATION 160 ft.
 UNIT LENGTH 20 ft.
 UNIT WEIGHT 13,200 #
 GROUND CONDITION Dry
 CONTACT W/BARRIER95"
 MAX. VEHICLE CLIMB 8"
 MAX. VEHICLE REBOUND 0

This first remote radio controlled test was conducted at an approach angle of 7 degrees and at a speed of 38 mph.

The test vehicle was effectively redirected with no rebound into the traveled lanes and with a maximum roll of 2 degrees away from the barrier. Within 3 feet of initial contact the impacting wheel had climbed 8 inches up the sloping lower face and remained approximately at this height throughout the remaining 92 feet of contact with the barrier.

The vehicle body contacted the upper barrier parapet 3 feet beyond initial impact and for a distance of 6.5 feet. The only damage sustained by the vehicle was slight sheet metal damage and paint scratches in the left front fender area. A close inspection of the steering mechanism and running gear revealed no damage or misalignment that would alter the vehicle's steering characteristics. This vehicle was used without repairs for the succeeding test.

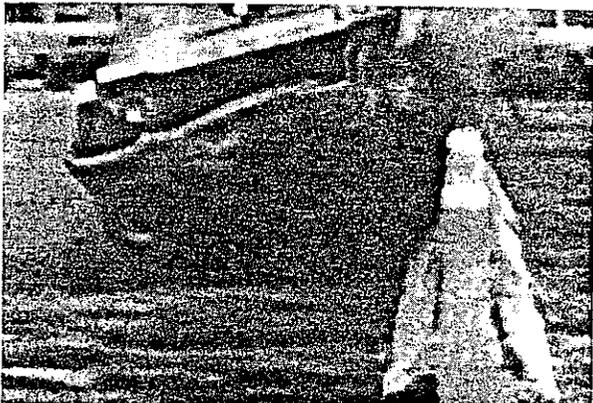
TEST 162 PLATE A

TEST NO.162
 DATE5-9-67
 VEHICLE1965 Dodge sedan
 VEHICLE WEIGHT4540 #
 (W/DUMMY AND INSTRUMENTATION)
 IMPACT SPEED63 mph
 IMPACT ANGLE25°
 EXIT ANGLE16°

BARRIERUnreinforced Concrete
 LENGTH OF INSTALLATION160 ft.
 UNIT LENGTH20 ft.
 UNIT WEIGHT13,200 #
 GROUND CONDITIONDry
 CONTACT W/BARRIER12.5'
 MAX. VEHICLE CLIMB21"
 MAX. VEHICLE REBOUND19.0'

The vehicle was redirected to an exit angle of 12 degrees at a maximum roll of 25 degrees away from the barrier. The impacting wheel climbed 21 inches up the lower sloping face immediately after initial contact and remained approximately at this height for a distance of 12.5 feet. As the vehicle left the barrier, it was entirely airborne for a distance of 20 feet before coming down on the right front wheel 32 feet beyond impact and 4 feet out from the face of the barrier.

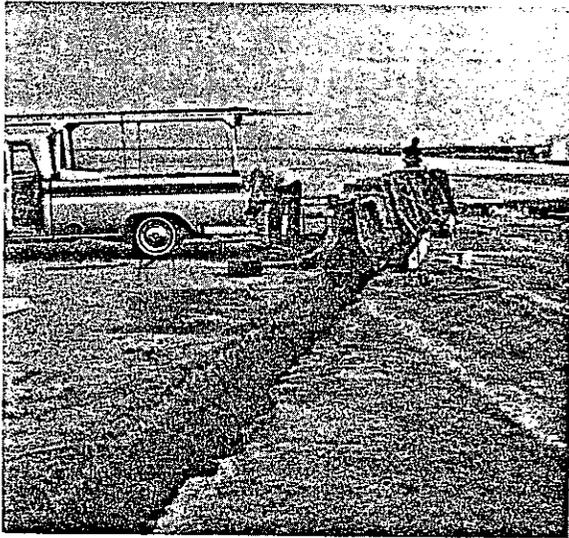
EXHIBIT 1

CALIFORNIA TEST INSTALLATION

The installation consisted of eight 32 inch high, 20 ft. long, nonreinforced, cast-in-place concrete wall sections. Each individual section consisting of a footing and parapet was a single monolithic pour of approximately 3 cubic yards weighing 6 tons. Adjacent sections were not doweled or connected at the expansion joints (Exhibit 1). The strength of the Class A concrete, specified at 3000 psi minimum at 28 days, was in excess of 6200 psi at the time of the impact test.

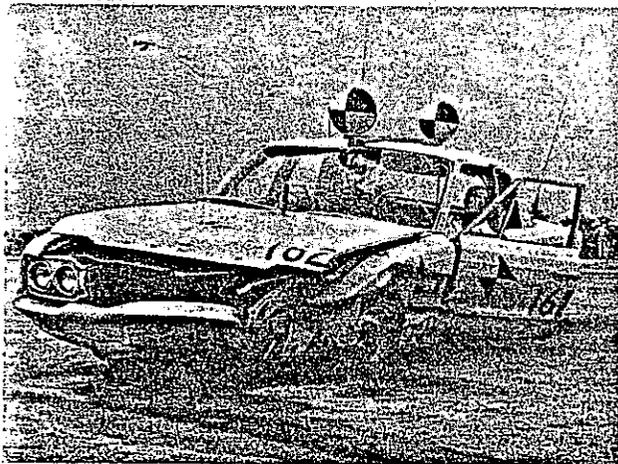
EXHIBIT 4

TEST 162 - NEW JERSEY CONCRETE MEDIAN BARRIER

TEST B-5 CONCRETE PARAPET BRIDGE RAIL (TYPE I)

TEST 101 - "W" BEAM MEDIAN BARRIER

COMPARISON OF VEHICLE DAMAGE ON THREE BARRIER TYPES

Although the damage to the vehicle was considered severe, it was comparable to that sustained in similar high-speed, wide-angle tests on the standard blocked-out beam type barrier and a test on a concrete parapet bridge rail (Exhibit 4).
