Corrosion of Steel in Continuously Submerged Reinforced Concrete Piling

CORROSION OF STEEL IN CONTINUOUSLY SUBMERGED REINFORCED CONCRETE PILING

RESEARCH REPORT

NO. M & R 635116

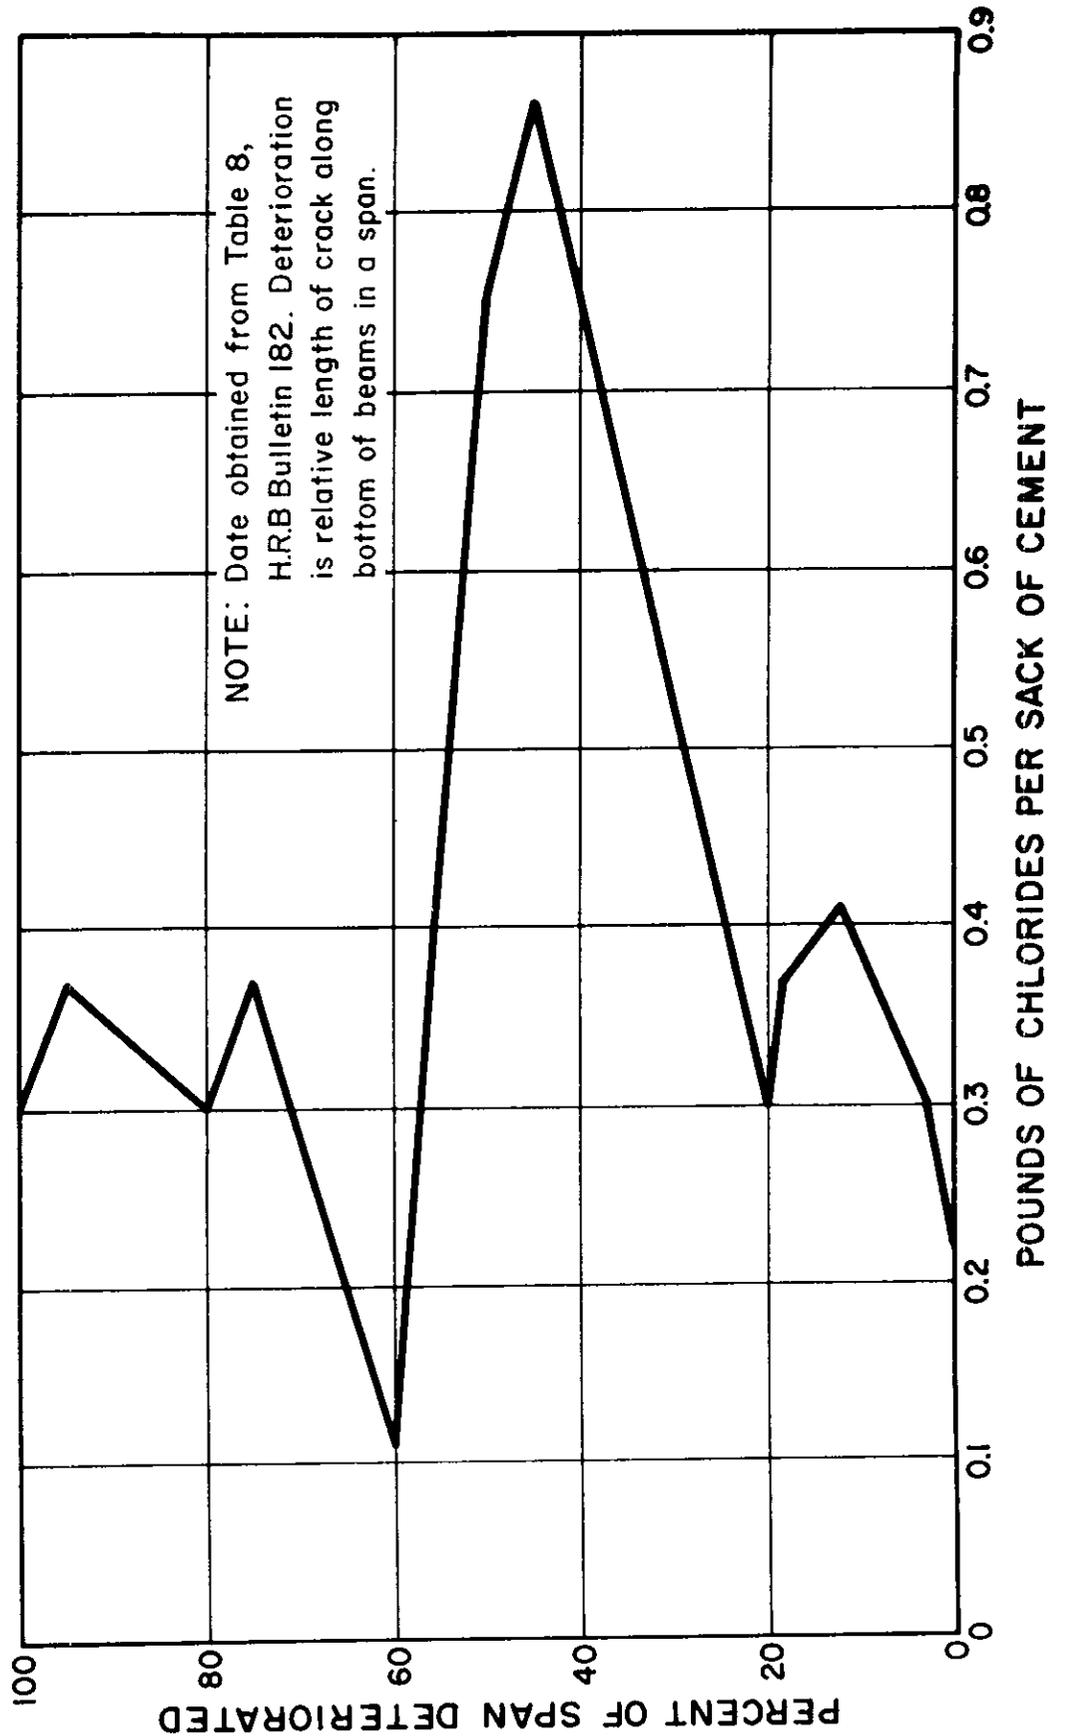
Fig. 1

The corrosion of steel in concrete has been reported when there are differentials in the salt content within the concrete^{1,12,14}. However, corrosion of the steel is not known to normally occur in relatively salt-free concrete in California bridges. Figure 1, Deterioration of a Structure versus Chloride Content, shows that at chloride contents in excess of approximately 0.1-pound per sack of cement in a 5.4-sack concrete, the degree of deterioration of the concrete as a result of corrosion of the steel is not directly related to the chloride content¹. These data were obtained from atmospherically exposed beams of a bridge. The chloride contents shown in Figure 1 are averages for 1-inch thick disks cut from 2-inch diameter cores.

DETERIORATION OF A STRUCTURE VERSUS CHLORIDE CONTENT

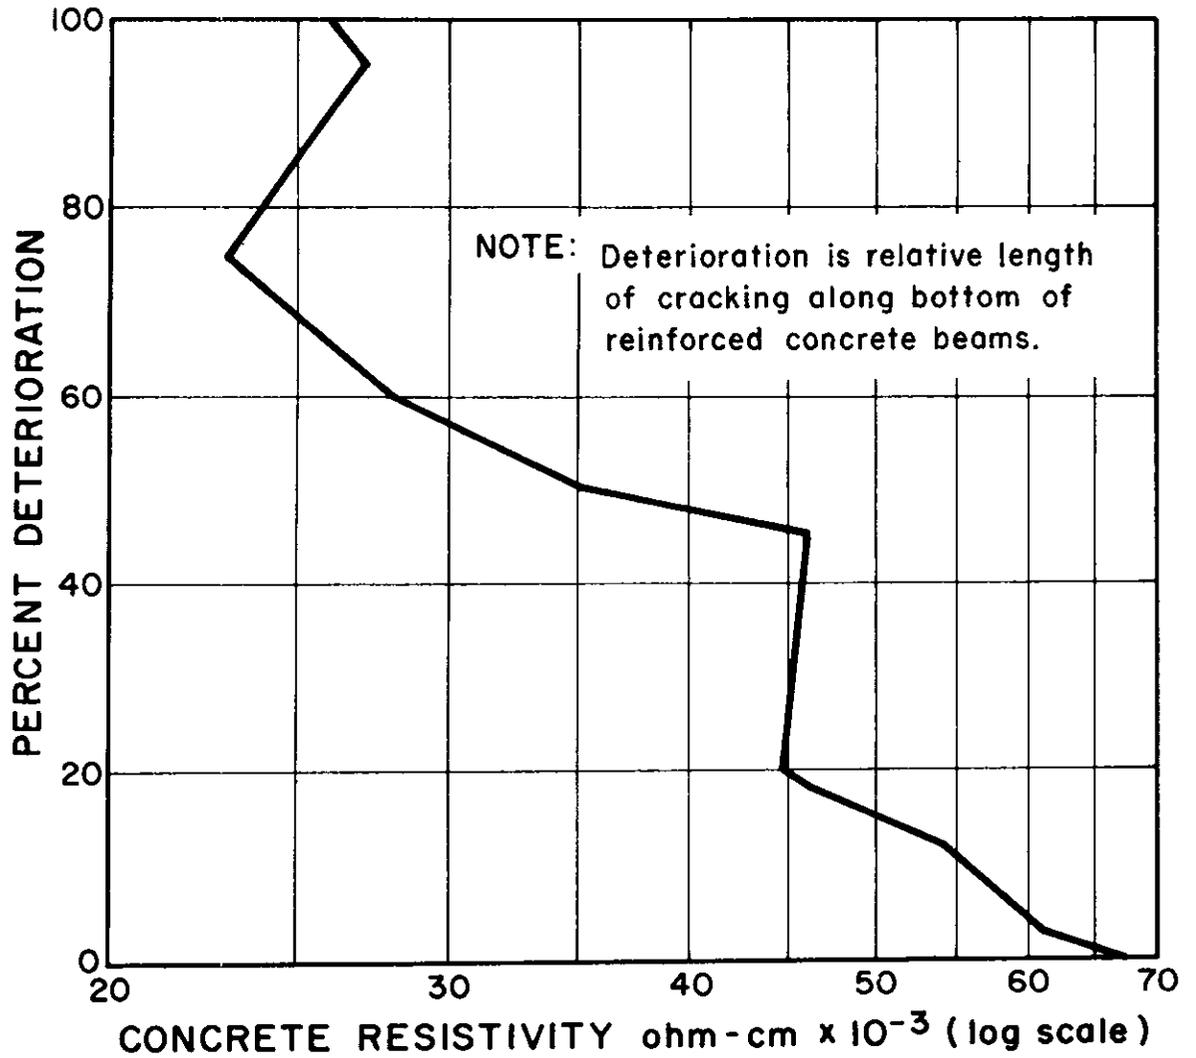
Fig. 2

For this same bridge, Figure 2, Deterioration Versus Resistivity, the data indicate that once the chloride content of the atmospherically exposed concrete is sufficiently great, the resistivity of the concrete in the anodic areas is a controlling factor in the deterioration¹. Within certain limits, the resistivity of a concrete is inversely related to its moisture content¹. Therefore, it would seem that if a concrete contained a high level of chloride-ion and was submerged so that its resistivity was low, corrosion of the steel could occur. It is assumed that the rate or even the incidence of visible results of corrosion would probably be controlled by polarization effects, the relative surface areas of the anode and cathode, and also, time.

DETERIORATION VERSUS RESISTIVITY

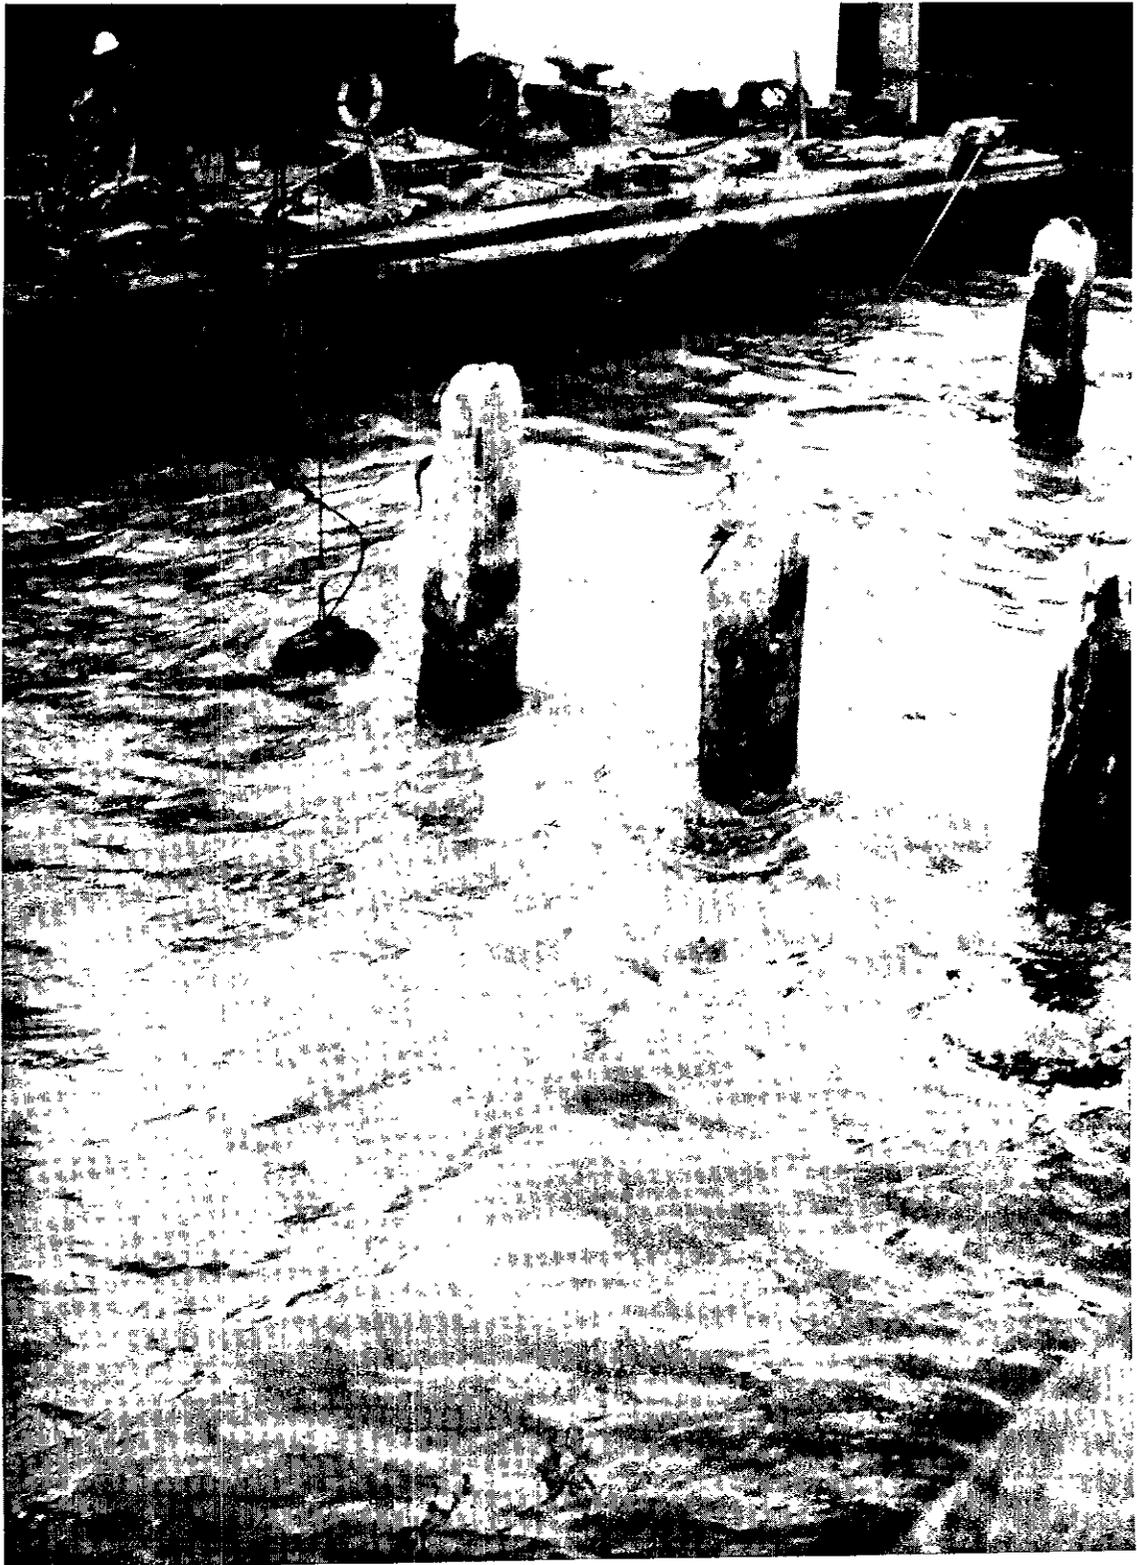
In general, the method for removal of the piling was first to excavate approximately five feet of mud below the base of the pile, then repeatedly bend it until it broke. Figure 3 shows the piling in place while excavation of the bay mud from the base of the piles was in progress. In many cases, concrete was stripped from the pile in such a way as to twist the steel reinforcement. Only the steel in those piles exhibiting the least amount of removal damage at the mud line were sampled.

Figure 3. Excavating mud from base of piers. Superstructure removed.

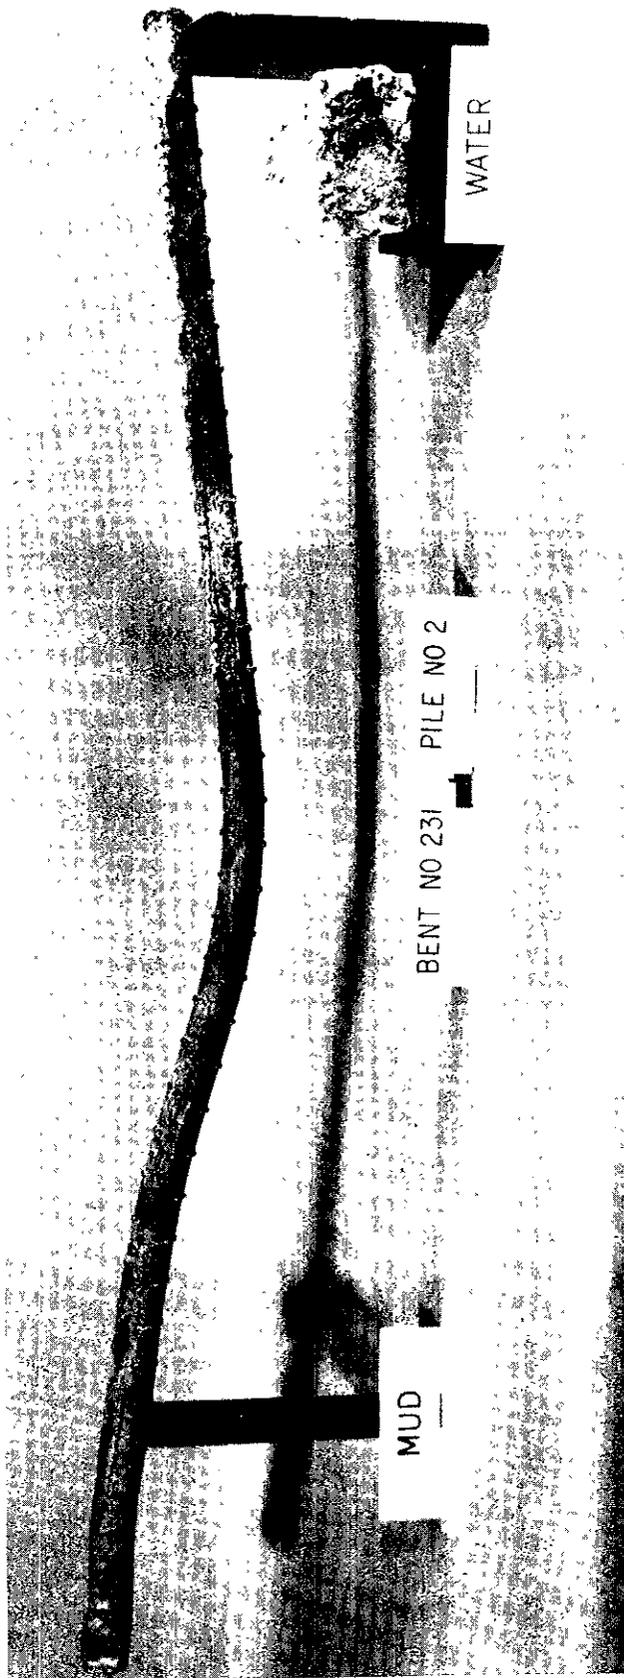
Figure 7 shows the appearance of a removed oval-shaped and approximately 4-foot long reinforcing bar. The locations of the mud or water, which was in contact with the concrete, are noted on the photograph.

Figure 7. Condition of 1.10" x 1.37" oval reinforcing steel. Notations of "Mud" and "Water" are where the pile was in contact with those environments.

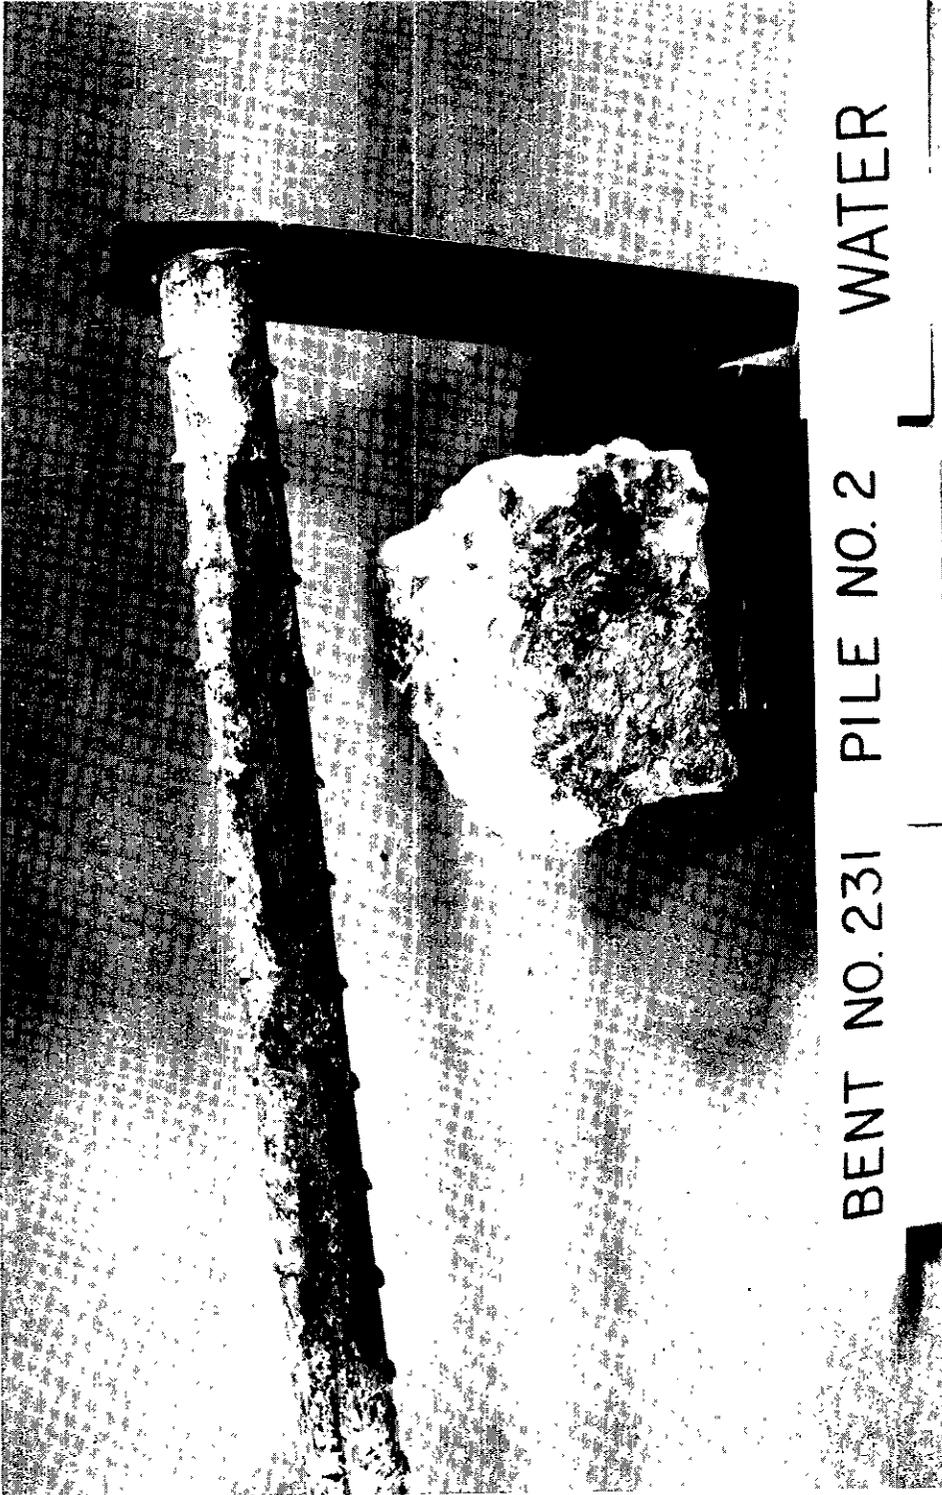
Figure 8 is a close view of the corrosion of the same steel bar which is shown in Figure 7, and shows a fragment of the concrete which was in contact with the steel. The dark area on the surface of the concrete fragment is a rust stain. On Figure 8, the area of relatively non-corroded steel is the lightly colored area. The "spotty" or localized corrosion of the steel was typical.

Figure 8. Close view of section of steel that is shown in Figure 7. Area where concrete was in continuous contact with bay water. Maximum metal loss in this area was 0.117". Dark area on concrete fragments is rust stain from the steel.

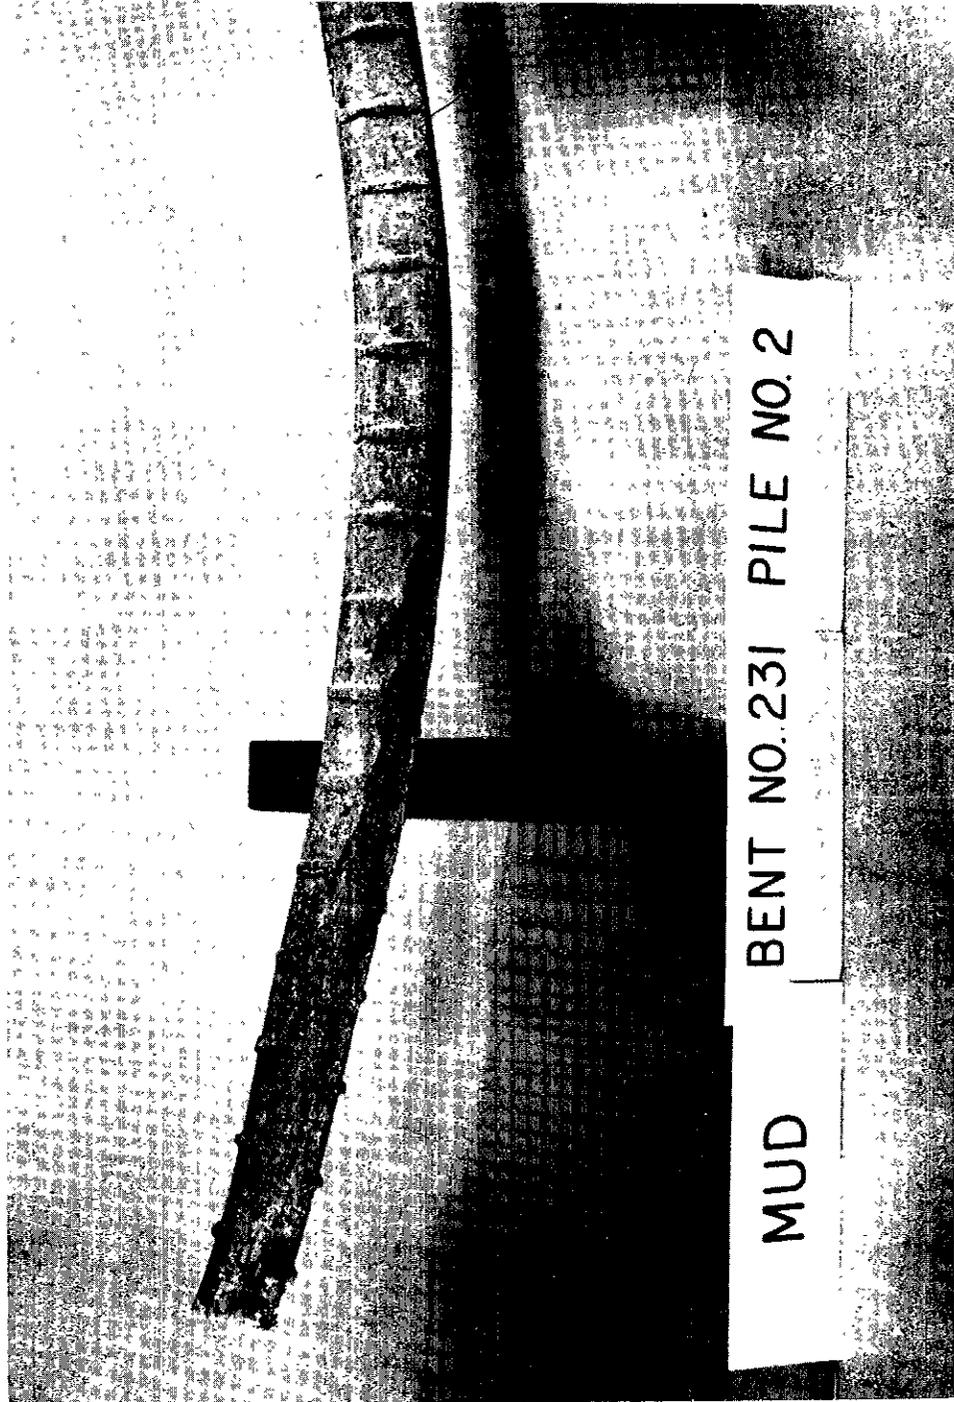
Figure 9 shows a close view of the corrosion attack at a different location than that shown in Figure 8, but is on the same piece of steel which is shown in Figure 7. This location is where the concrete was apparently in continuous contact with the bay mud. In all cases, the bay mud line on the piles was at least ten feet below the low tide water level at the time of inspection.

Figure 9. Close view of section of steel that is shown in Figure 7. Area where concrete was in continuous contact with bay mud. Maximum metal loss in this area was 0.210".

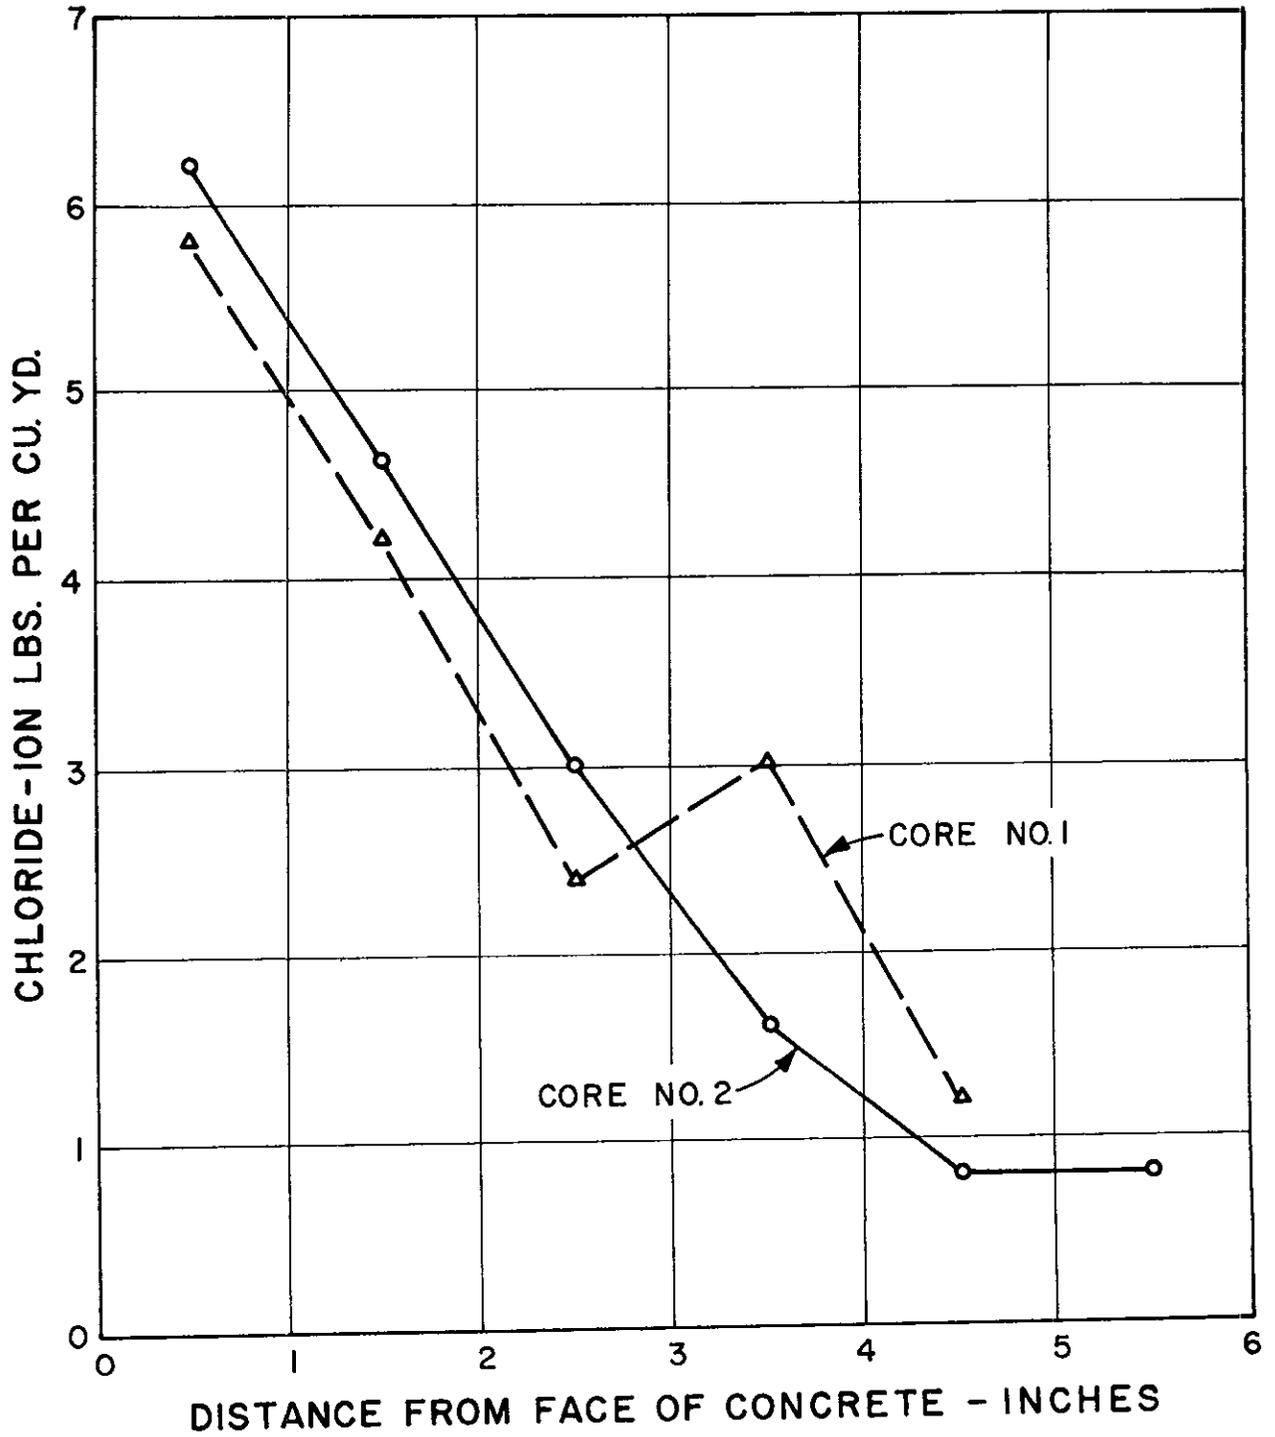
Fig. 10

As a comparison, Figure 10 shows the chloride-ion concentration which was previously found in atmospherically exposed sections of piling in this same bridge after approximately 28 years of exposure¹. The chloride contents shown in Figure 10 are averages for 1-inch thick disks cut from 2-inch diameter cores. It was calculated that for a 2-inch depth of cover and 28 years of exposure to salt spray, the average chloride content in this concrete was approximately five pounds per cubic yard. However, an average of 25 pounds of chloride-ion was found in the submerged (but different) piling in this structure after approximately 37 years of service.

CHLORIDE - ION IN ATMOSPHERICALLY EXPOSED PILING SAN MATEO-HAYWARD BRIDGE
