Interim Report on Plastic Tapes Compared to Extruded Thermoplastic Traffic Paint Used for Traffic Lane Delineation

March 1967

State of California
Department of Public Works
Division of Highways
Materials and Research Department

Interim Report

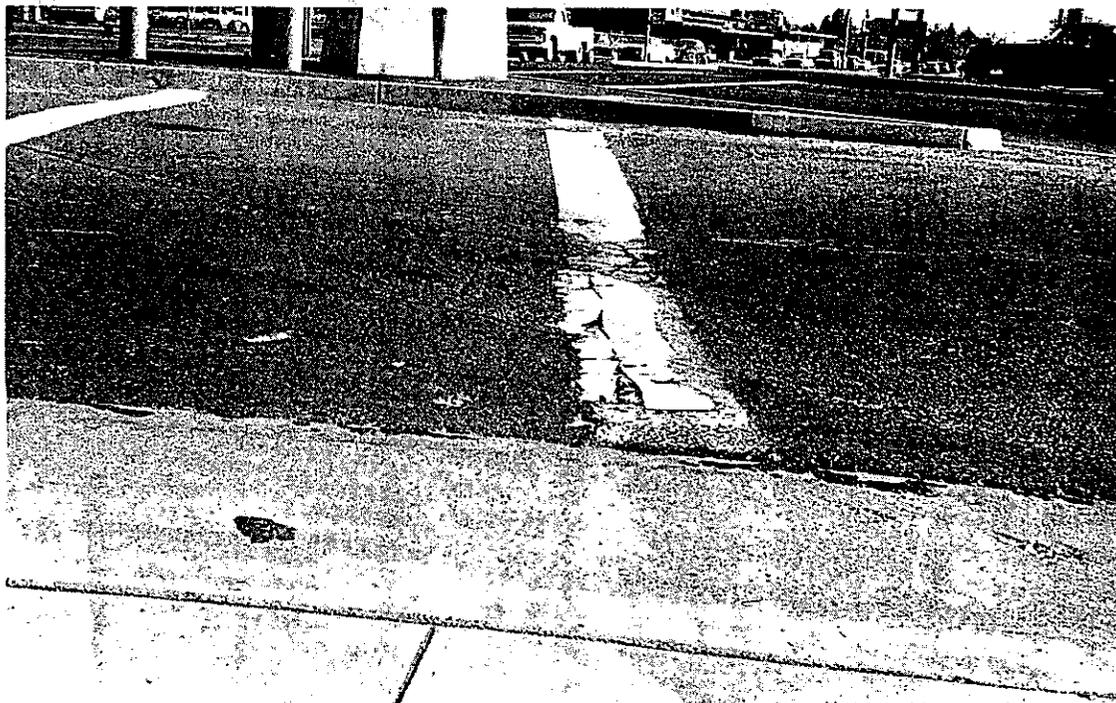
No. 8. Condition on 2/14/67 of Plastic Tape installed 9/64 on S.W. corner turn lane at Fair Oaks Blvd. and Watt Avenue.

Photograph No's. 8 to 11 show the condition of the plastic tape after 2½ years when used on crosswalks on asphaltic concrete pavements at stop signals on Sacramento County Roads. Due to the accelerating and turning action of vehicles there is excessive wear and movement of the tape at these locations. In the many instances where the tape is missing, it has lost its bond to the pressure sensitive adhesive, not the pavement. Photographs No's.

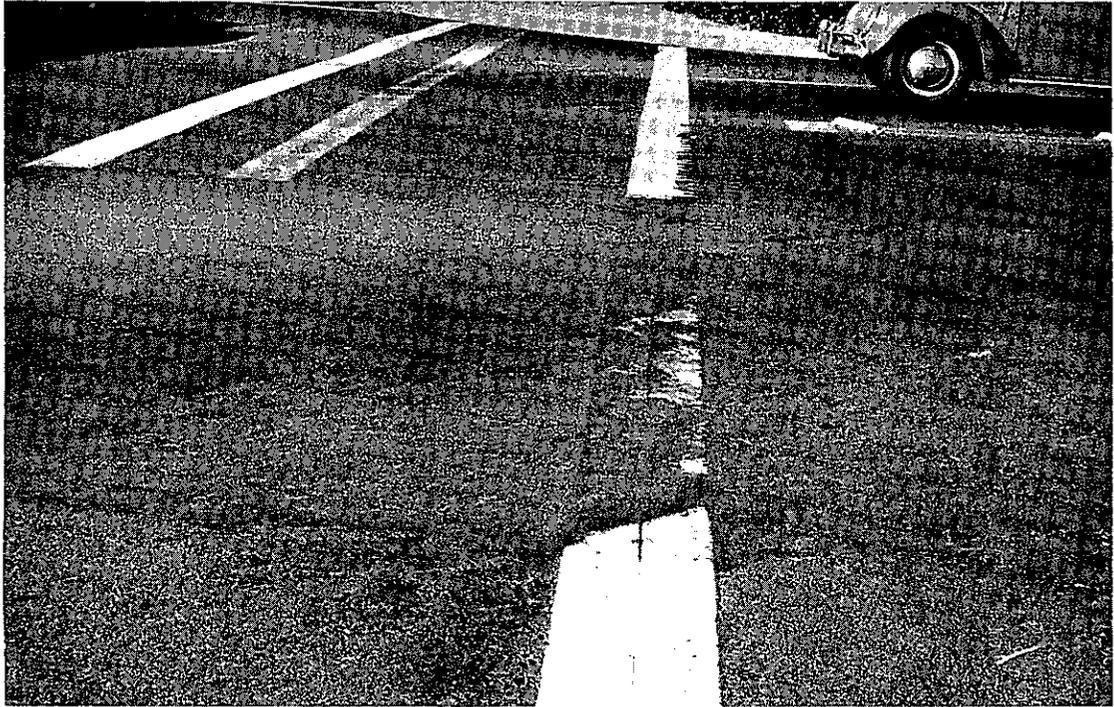
No. 9. Condition on 2/14/67 of plastic tape installed 9/64 on crosswalk at N.E. corner of Arden Way and Professional Drive. (Line at far right)

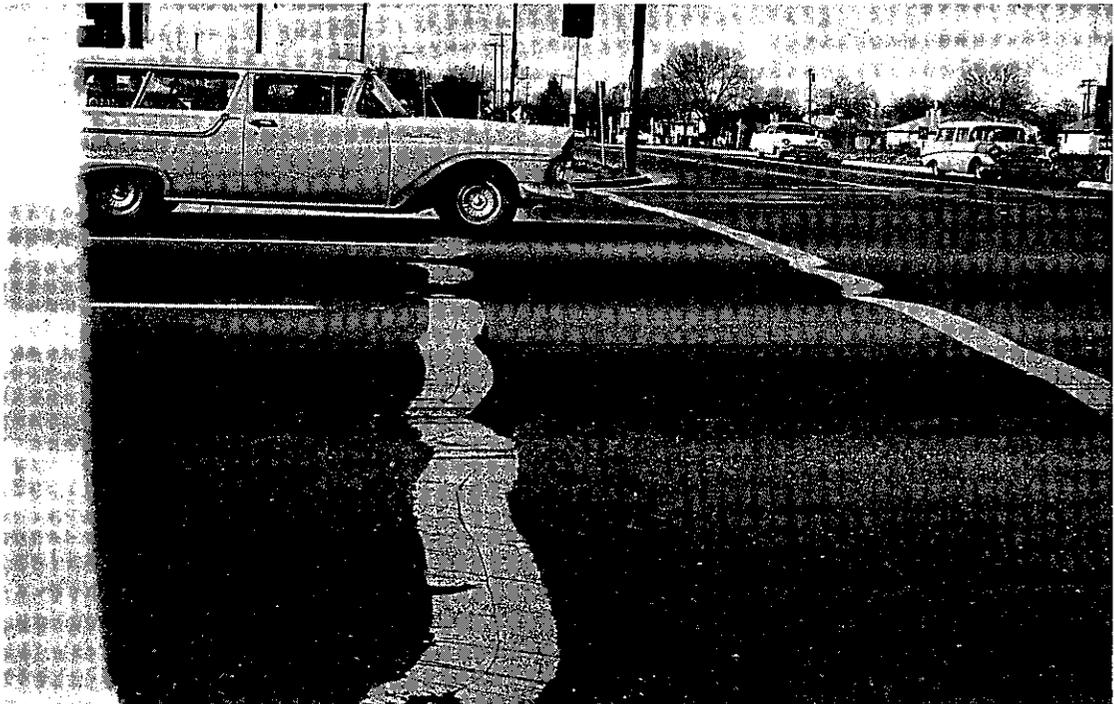
No. 10. Condition on 2/14/67 of plastic tape installed 9/63 on crosswalk at S.E. corner of El Camino and Eastern Avenue.

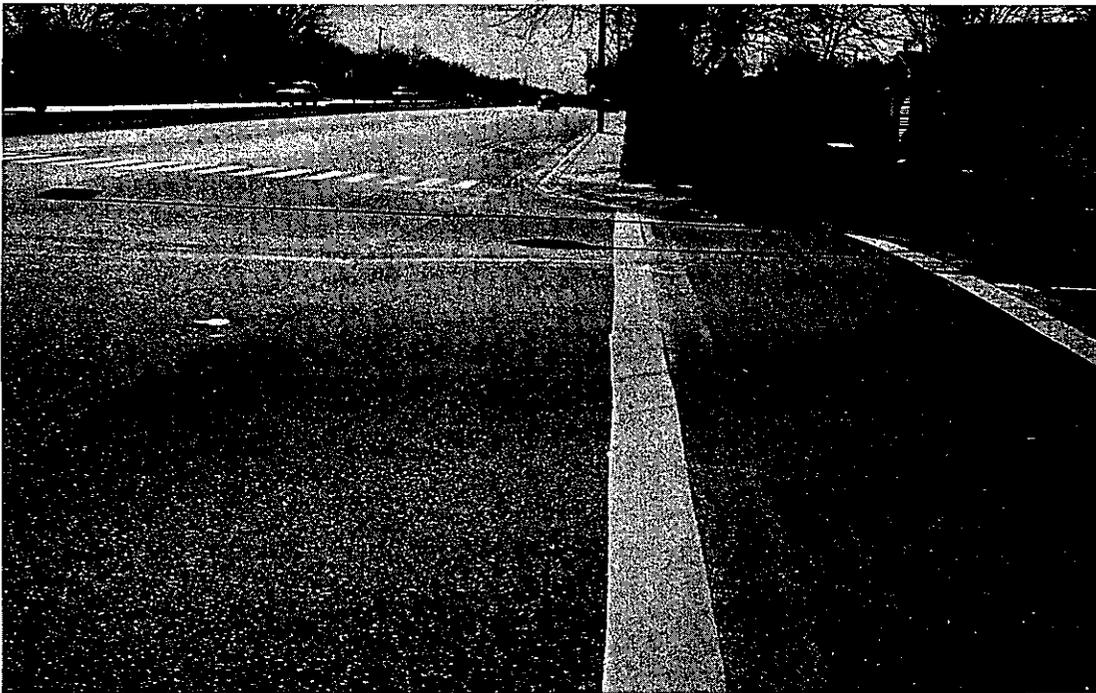
No. 12. Condition on 2/14/67 of thermoplastic traffic line installed 9/62 on crosswalk at N.W. corner of Watt Avenue and Hurley Way.

12 to 14 illustrate the superior wear resistance of the thermoplastic stripe applied in 1962 at similar locations subject to accelerating and turning action. Of course, should the pavement itself be unstable and move under traffic, the thermoplastic would also distort.

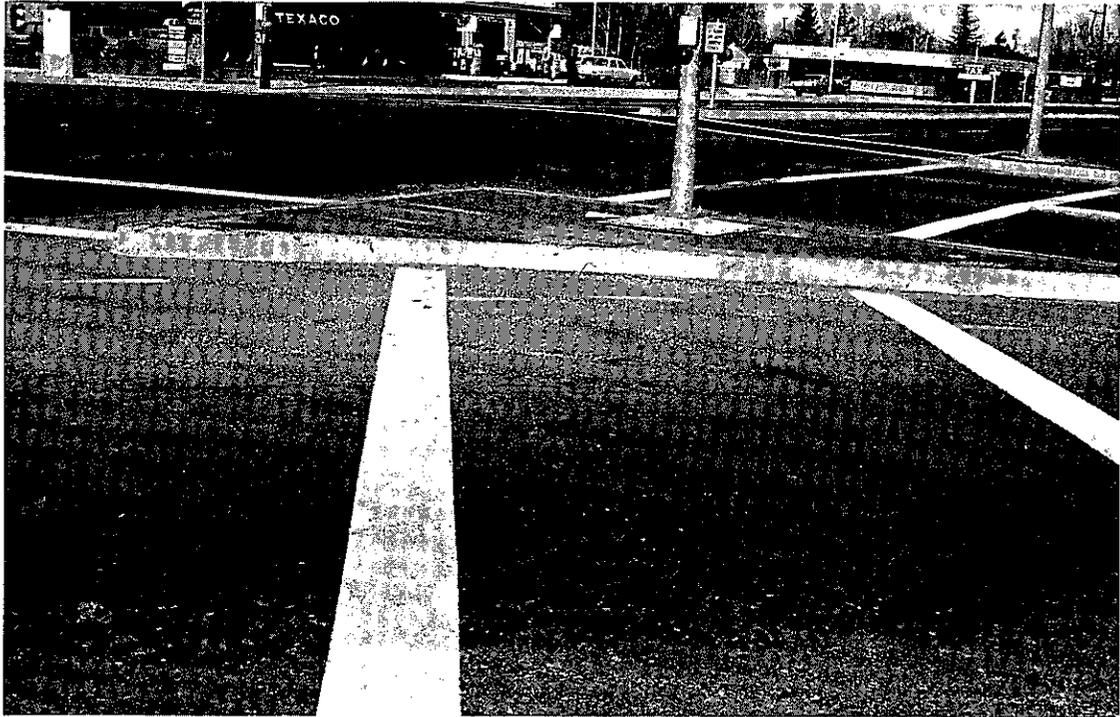
No. 13. Condition on 2/14/67 of thermoplastic traffic line installed 9/62 on S.E. corner crosswalk (turn lane) at Watt and Whitney Avenues.

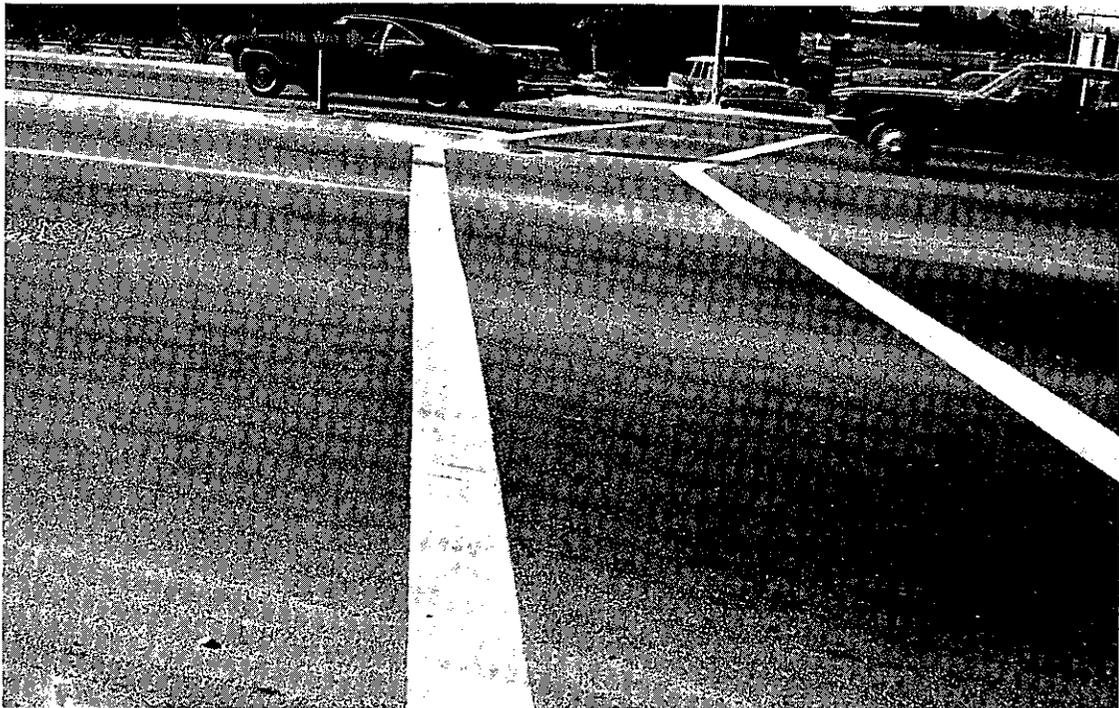
No. 14. Condition on 2/14/67 of thermoplastic traffic line installed 9/62 on crosswalk at N.E. corner of Watt Avenue and Cottage Way.
